King Ranch, Inc./King Ranch Feedyard  
Inspection Date 09/19/2022

**Region 6 - Enforcement & Compliance Assurance Division**  
**INSPECTION REPORT**

| Facility Name: | <b>King Ranch Feedyard (27.516069, -97.972834)</b> | |

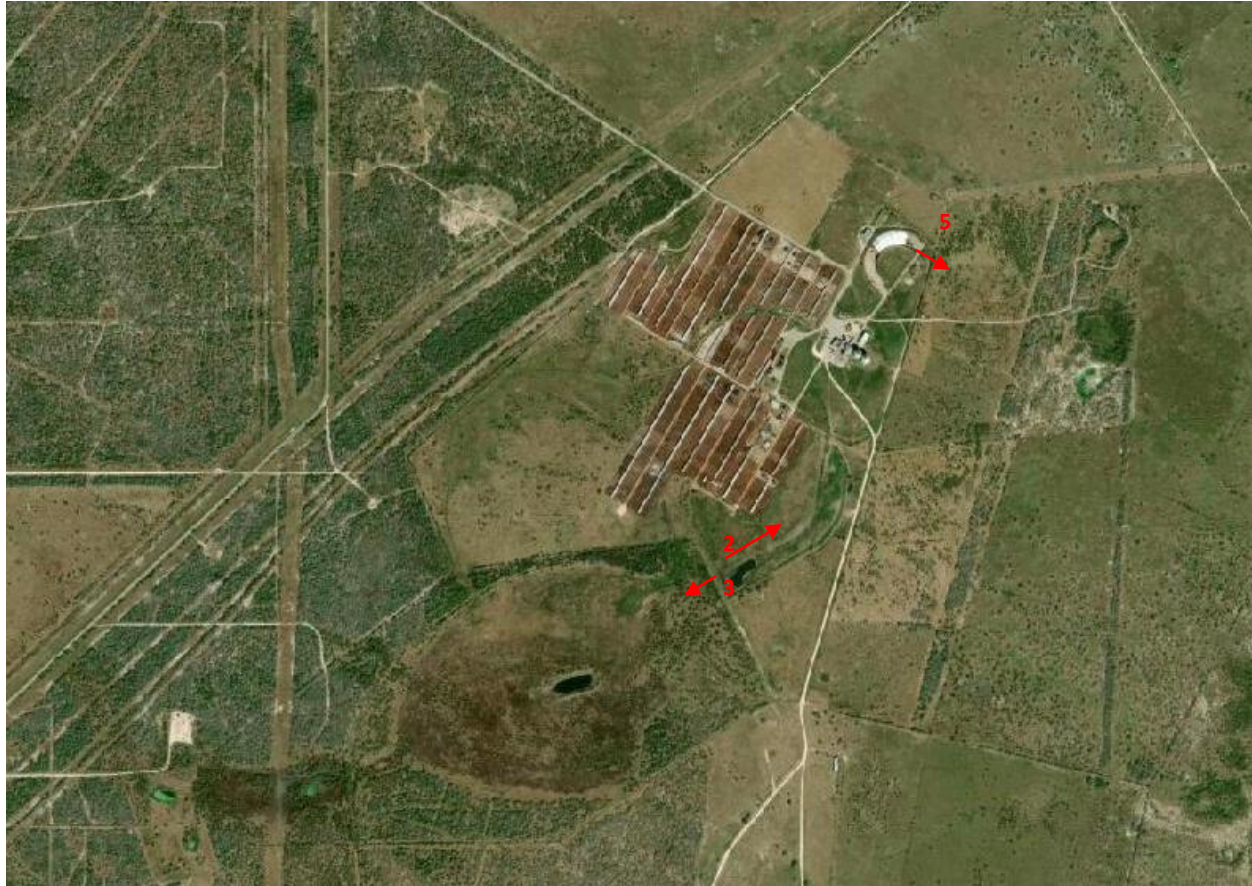
First, the RCS 2 playa lake has a significant number of large trees growing within the RCS. Photo 3 of the photolog found in Appendix 1 shows the pole marker for RCS 2 located within a wooded area of RCS 2. Also note the feedyard aerial photographs and topographic maps found in Appendix 1 showing the location of RCS 2 relative to the cattle pens and the trees within RCS 2.

King Ranch Feedyard DigitalGlobe aerial from 6/27/22, significant photo locations

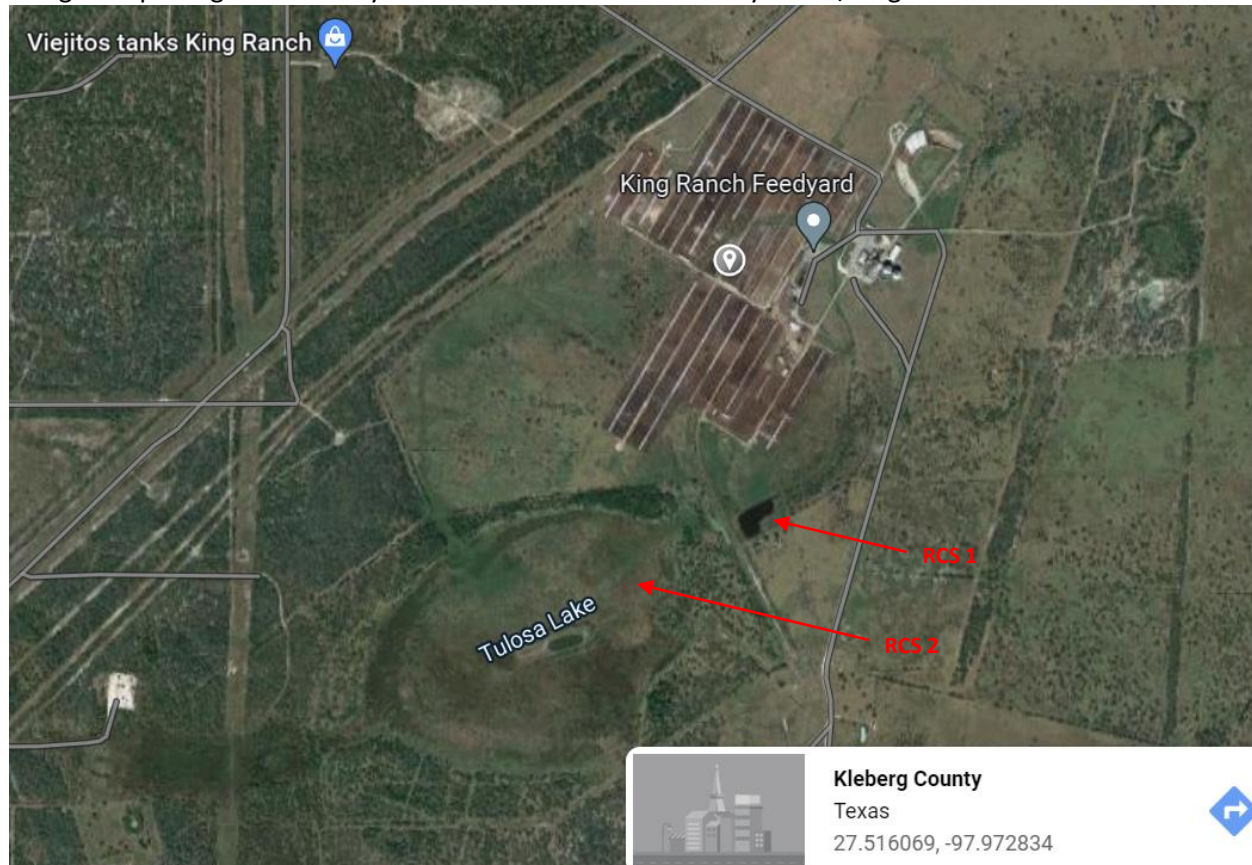
Photo No. 8

Google Maps King Ranch Feedyard RCS site locations and feedyard lat/long

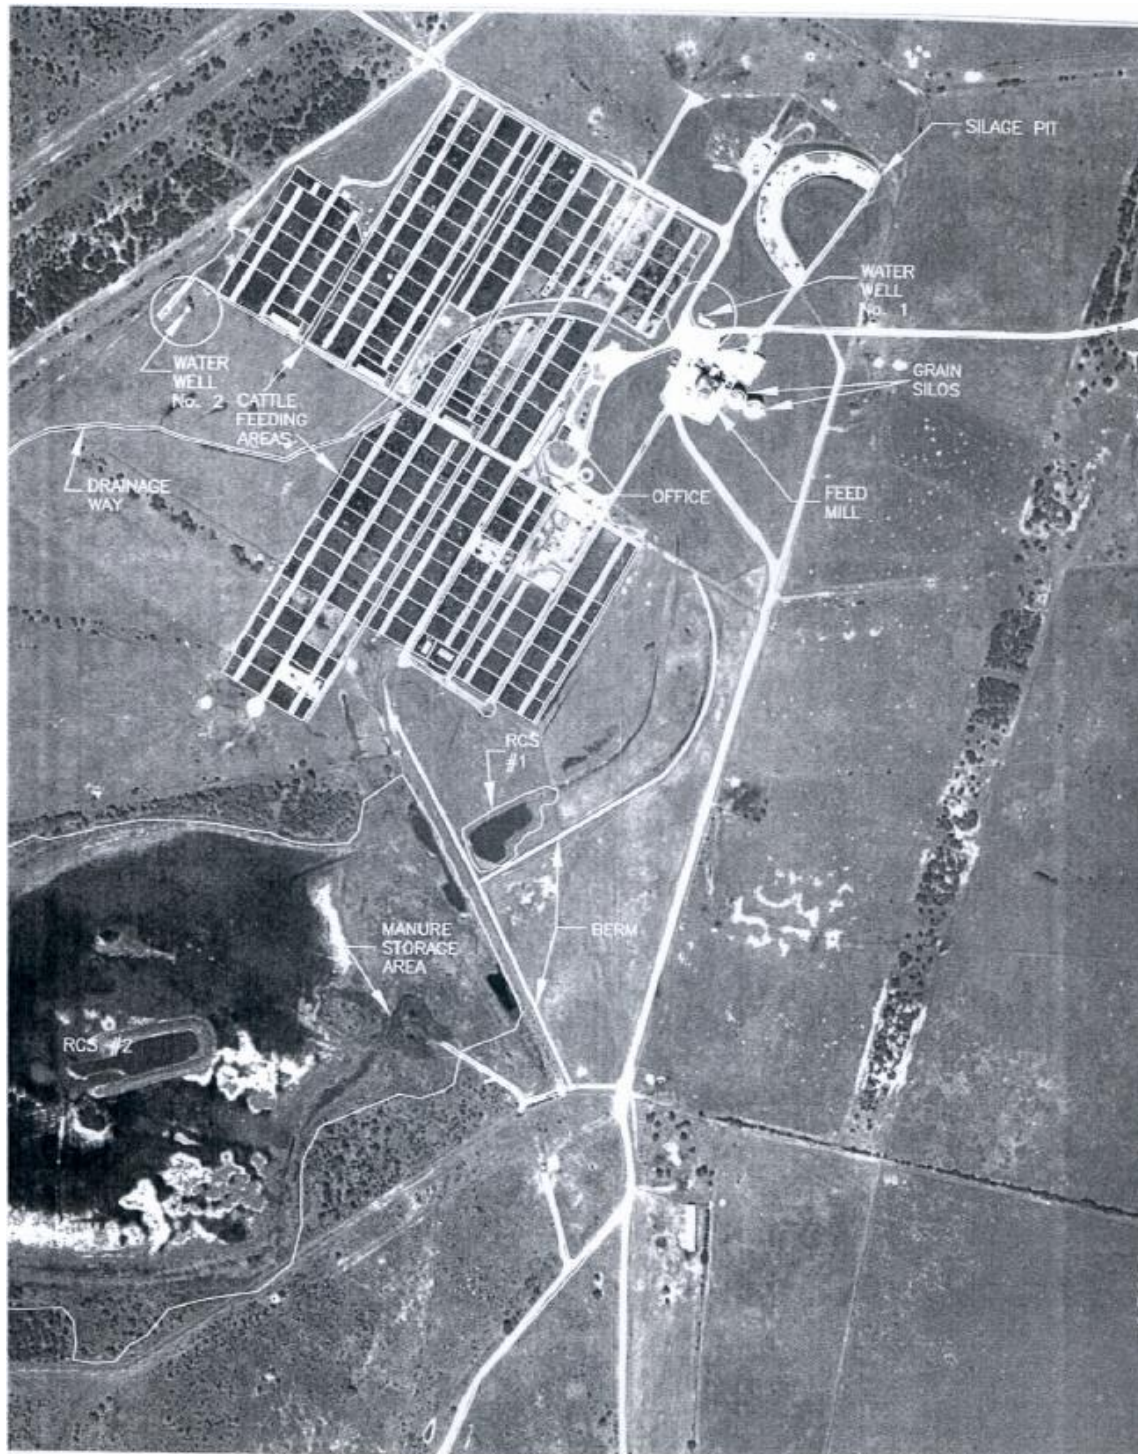
Photo No. 9

Map of the King Ranch Feedyard provided after the inspection by King Ranch showing monitoring/water well locations and other features

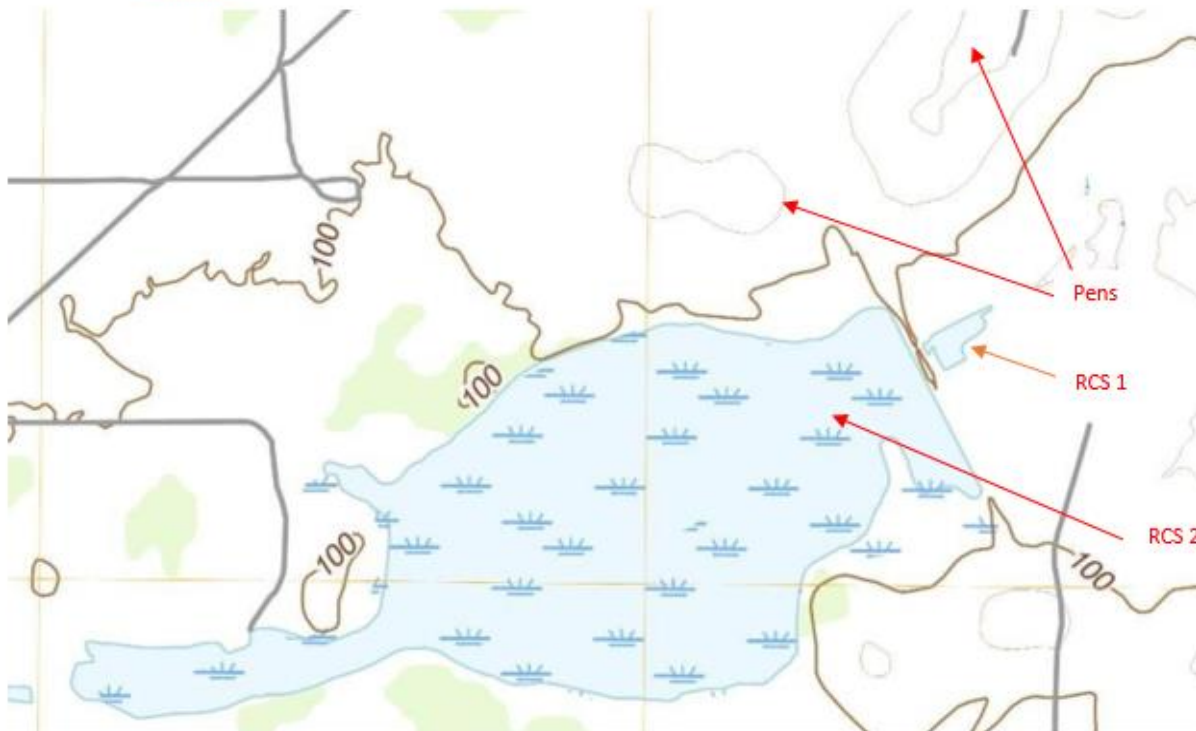
Photo No. 10

The USGS topographic maps found in Appendix 1 show the playa lake formation from 1979 (prior to the existence of the feedyard which was first permitted in 1994). This topographic map shows the surrounding elevations around the playa lake which are higher than that of the playa lake. There is also a topographic map from 2022 showing the playa lake RCS relative to the approximate locations of the cattle pens.

King Ranch Feedyard from 2022 USGS Kingsville West Topographic Map
