## EPA Region 10 Enforcement and Compliance Assurance Division

## Clean Water Act (CWA) Inspection Report

| Type of Inspection | CEI - Compliance Evaluation Inspection | | | |
| Permittee Name | Trails End Recovery | | | |

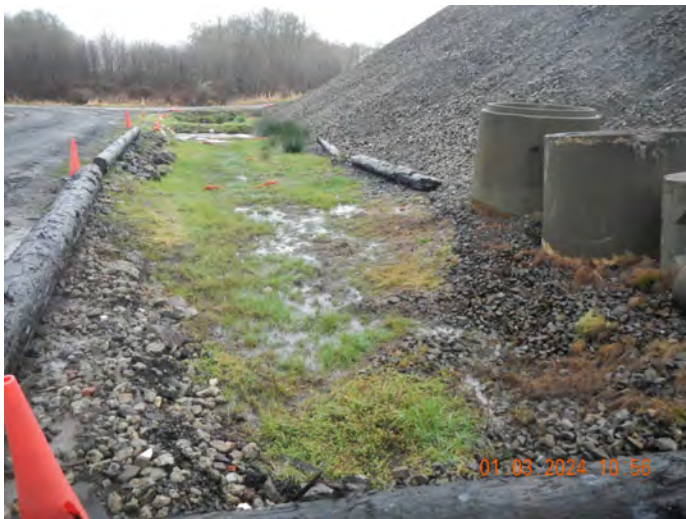
Photo #:19 (DSCN3468)  
Description: Facing north, photo of Pond 4.

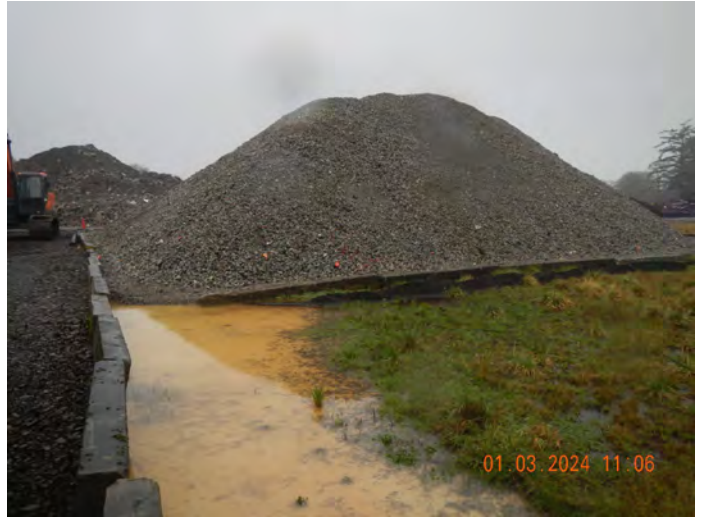
Photo #:26 (DSCN3475)  
Description: Facing north, ponded stormwater south of inerts storage area.

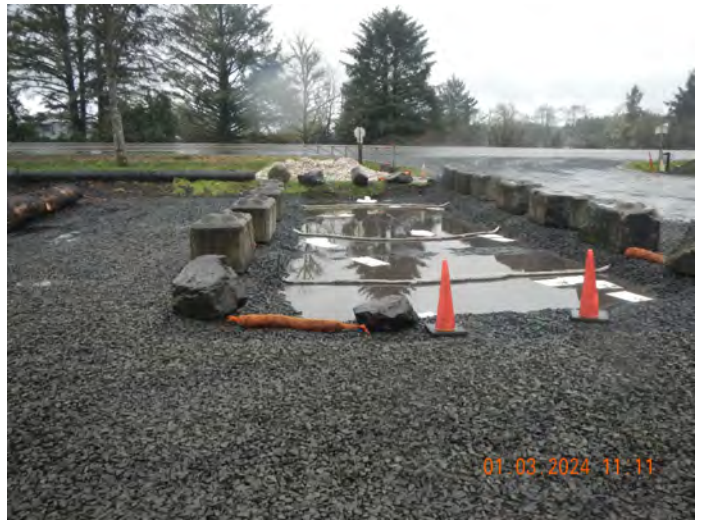
We continued to Pond 2, located along the east side of a Facility access road to Highway 101 Alternate (**Photo 30**). Pond 2 generally serves the areas north and northeast of Pond 2 (**Photo 31 & 32**). Ecology blocks were placed around the perimeter of the pond, I observed oil absorbant “snakes” placed across the pond with “bio-bags” placed in the north and northwest perimeter, oil absorbant pads were also placed within the pond (**Photo 33**). Pond 2 baffles were observed to need maintenance. When viewing the Pond 2 discharge into the roadside ditch (DP002), the discharge appeared to be turbid (**Photo 34**). I observed stormwater entering Pond 2 from a southeast area, near the pond’s outfall structure. I discussed that stormwater entering the pond near the outfall structure could potentially impact the turbidity seen at the DP002, as the pond could be “short-circuiting” where the settling in the pond is limited and BMP’s within the pond aren’t fully utilized.

Photo #:30 (DSCN3479)  
Description: Facing south, photo of Pond 2.

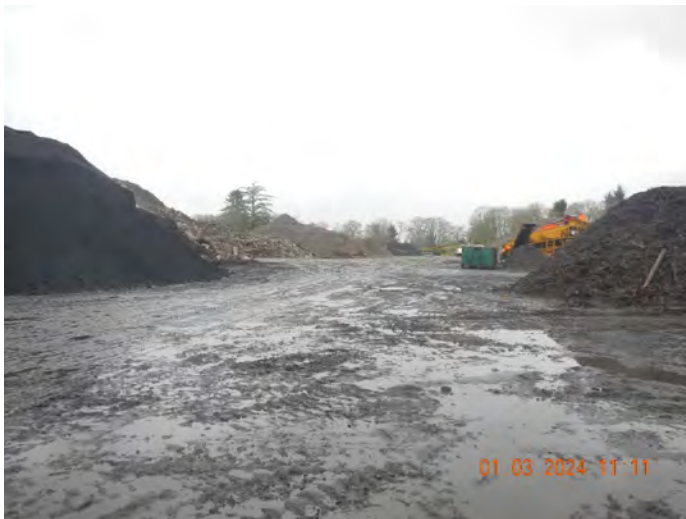
Photo #:31 (DSCN3480)  
Description: Facing east, photo of area east of Pond 2 and north of the processing/screening area.

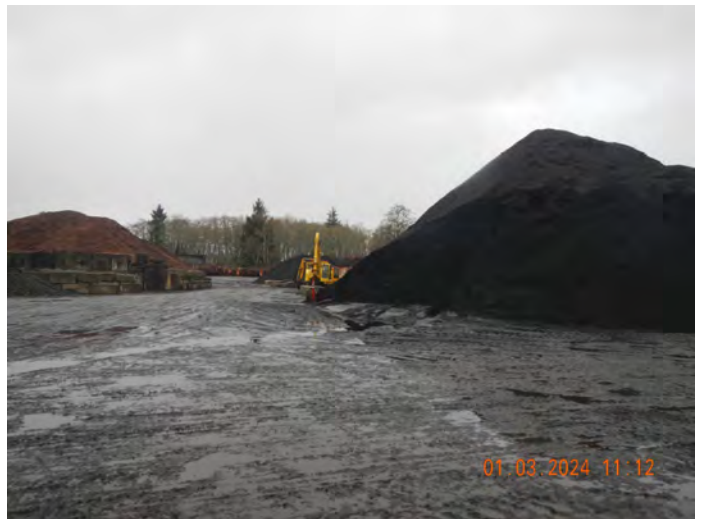
Photo #:32 (DSCN3481)  
Description: Facing north, photo of area north/northwest of Pond 2.

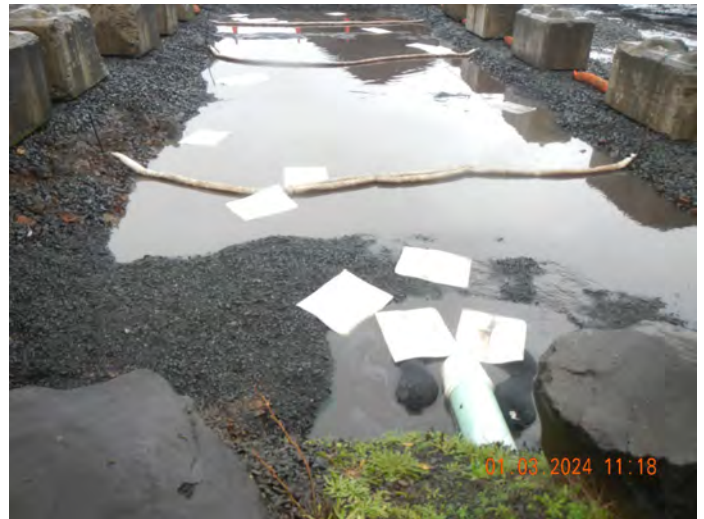
Mr. Raichl discussed that the Facility had also purchased and installed “bio-char filter socks” at the Pond 2 outfall structure, oyster shells were also being utilized within the Pond and were stockpiled south of the pond (**Photo 35 & Photo 36**). From this area we also observed the Pond 2 receiving water, the roadside ditch along Highway 101 Alternate (**Photo 37 & Photo 38**). We continued west and observed areas north/west of Pond 2 (**Photo 39**), including designated product/landscape material storage areas, where products (i.e., topsoil) are available for commercial/public sale. Many products/materials were tarped at the time of inspection (**Photo 40**).

Photo #:36 (DSCN3485)  
Description: Facing north, photo of Pond 2.

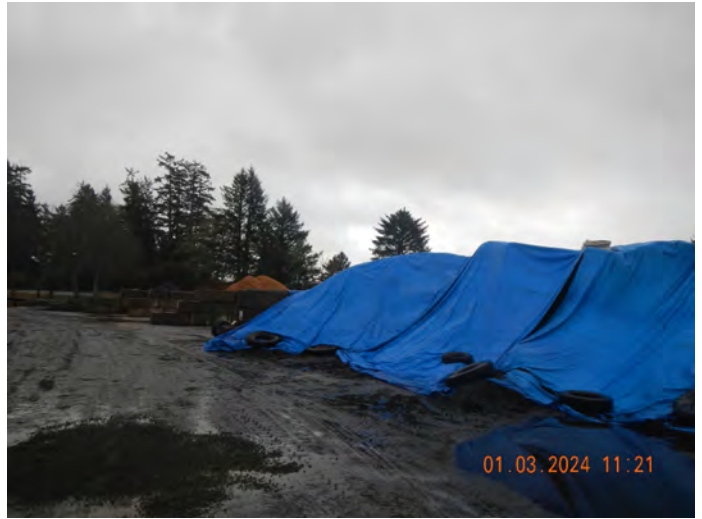
Photo #:40 (DSCN3489)  
Description: Photo of covered stockpiled material/topsoil for commercial/public sale.

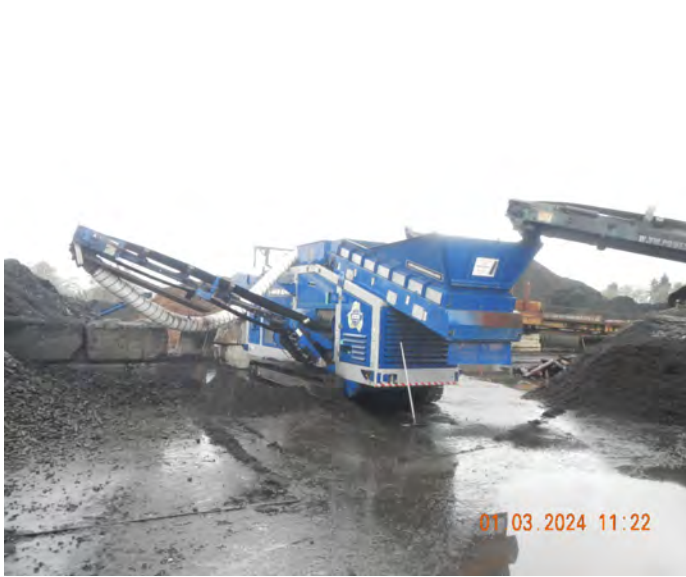
Photo #:41 (DSCN3490)

Within SB-3, we first observed the Facility's air separator, an EDGE MC1400 Material Classifier (**Photo 41**) used to remove/classify material such as rock. According to Mr. Raichl, the Facility had previously used a "water separator" made by Flocait which was taken off-line and removed approximately 3 years ago. While viewing the air separator location, I observed staining/sheens on the surface downslope of the device (**Photo 42 & Photo 43**). According to Mr. Raichl, sheens observed are likely the result routine maintenance performed on the machine, as equipment such as the air separator have set maintenance schedules and receive grease applications at various points every 8-hours of run time. At the time of inspection, stormwater flowing from this area was observed to be traveling downslope towards Pond 3. We also observed stormwater from the receiving/sorting area traveling south towards Pond 3 (**Photo 44**).

Description: Facing northeast, photo of the air separator. In service for approx. 3 years and replaced Flocait water separator.

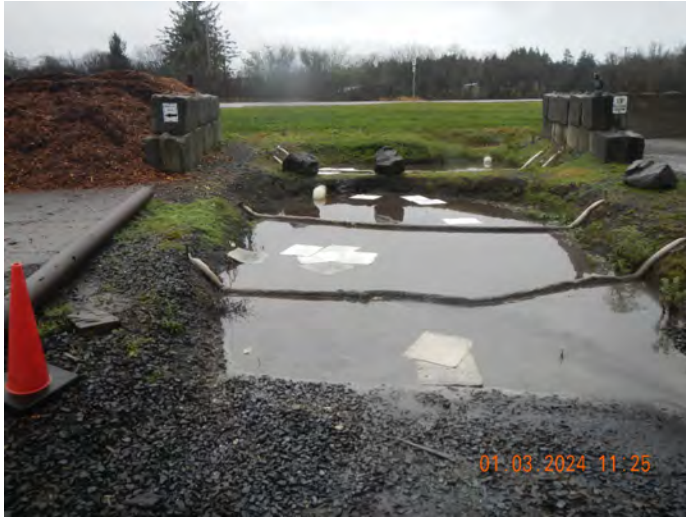
We then observed Pond 3 (**Photo 45**), which was receiving stormwater at the northwest corner of the pond (**Photo 46**), primarily from the receiving/sorting area. Pond 3 was constructed with 2 cells/chambers separated by an earthen berm with a PVC pipe allowing flow between. I observed oil absorbent "snakes" placed across the pond as well as oil absorbent pads placed within the cells (**Photo 47**). We observed the Pond 3 discharge (DP003) into the roadside ditch along Highway 101 Alternate as well as the upstream and downstream portions of the roadside ditch (**Photo 48 & Photo 49**). The discharge pipe was partially submerged within the roadside ditch, turbid water was observed within the ditch (upstream/downstream) as well as at discharge point. No sheen was observed. We further observed Pond 3's influent flow from the receiving/sorting area and air separator area (**Photo 50**).

Photo #:45 (DSCN3493)  
Description: Facing south, photo of Pond 3.

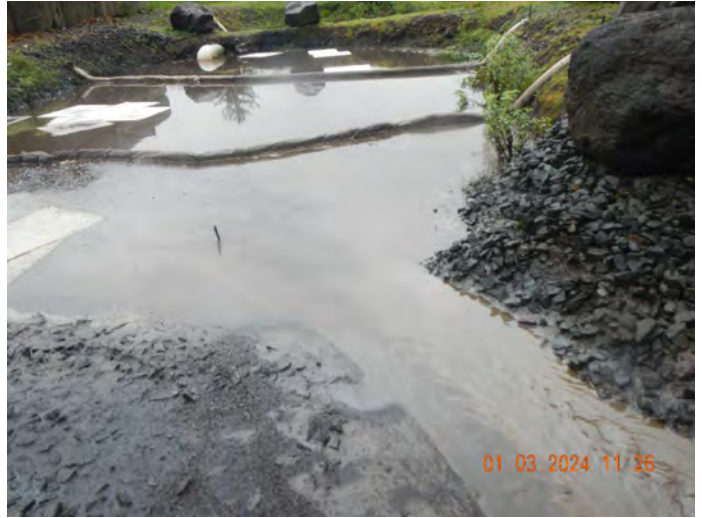
Photo #:46 (DSCN3495)  
Description: Facing south, photo of the influent flow into Pond 3.

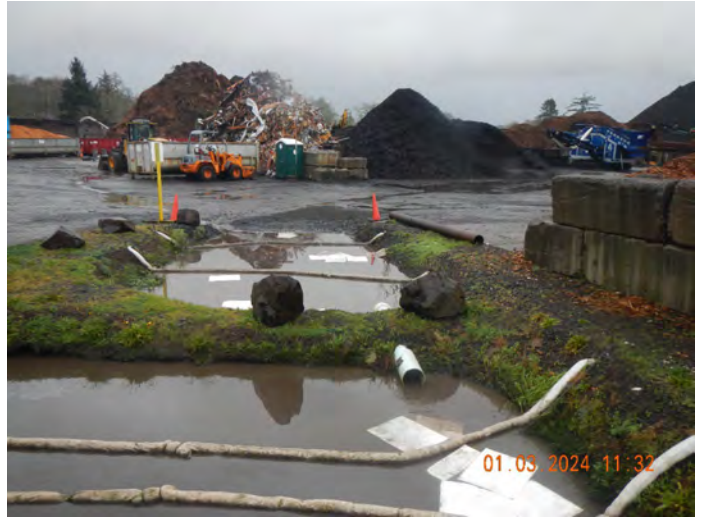
Photo #:50 (DSCN3499)

Description: Facing north, photo of Pond 3 and contributing drainage area.

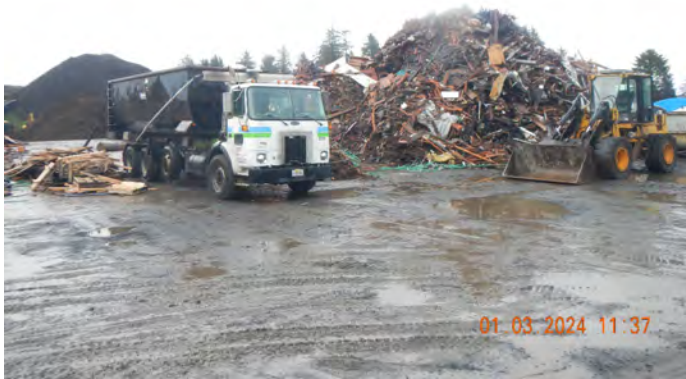
Photo #:51 (DSCN3500)

We continued north to the receiving/sorting area (**Photo 51**), at the time of inspection the Facility was receiving/sorting a bin of mixed construction debris/material from Recology at the time of inspection. We also observed temporary storage bins staged within the area, stormwater from this area was observed to be ponded or traveling downslope towards Pond 3 as sheet flow.

As discussed earlier in this report, during the walk-through within Sub-Basin 3, turbid stormwater from the receiving/sorting area was observed to be ponded or traveling downslope into Pond 3 as sheet flow (**Photo 44, Photo 51**). Turbid stormwater and sheens were also observed near the separating area (air separator) and was observed to flowing towards Pond 3. Stormwater entering/exiting Pond 3 was observed to be turbid.

Description: Facing west, photo of the receiving/sorting area.

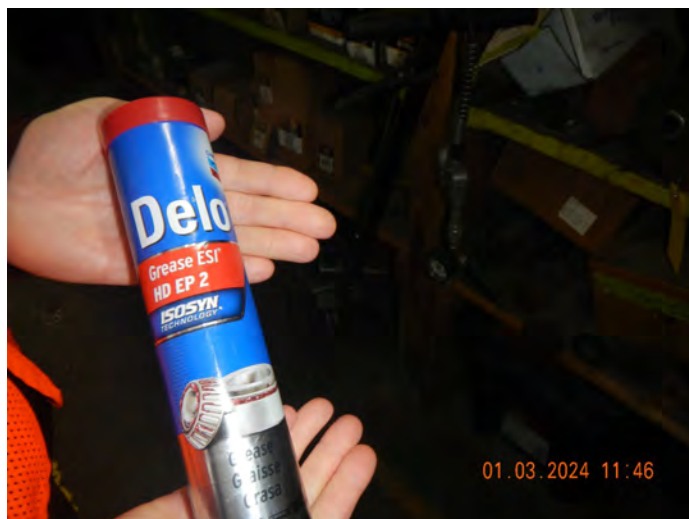
Photo #:57 (DSCN3506)

Mr. Raichl then led us to another garage bay within the maintenance shop where he displayed the various greasing agents used on the outdoor machinery. Greasing agents included "Chevron Delo®," "Chevron Starplex®" and "Bio-High Temp 180" (**Photo 57- Photo 59**). Mr. Raichl discussed that the Bio-High Temp 180 product was believed to be biodegradable product and had been recently incorporated into Facility maintenance operations.

Description: Photo from inside the maintenance shop, grease cartridge used on on-site machinery.

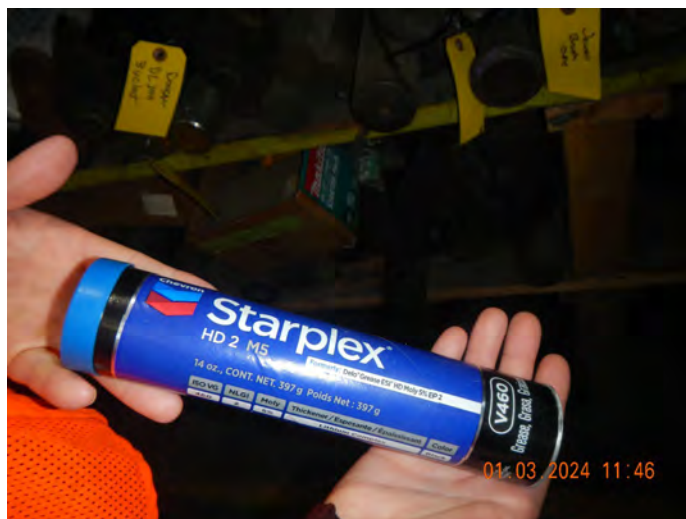
Photo #:58 (DSCN3507)

Description: Photo from inside the maintenance shop, grease cartridge used on on-site machinery.

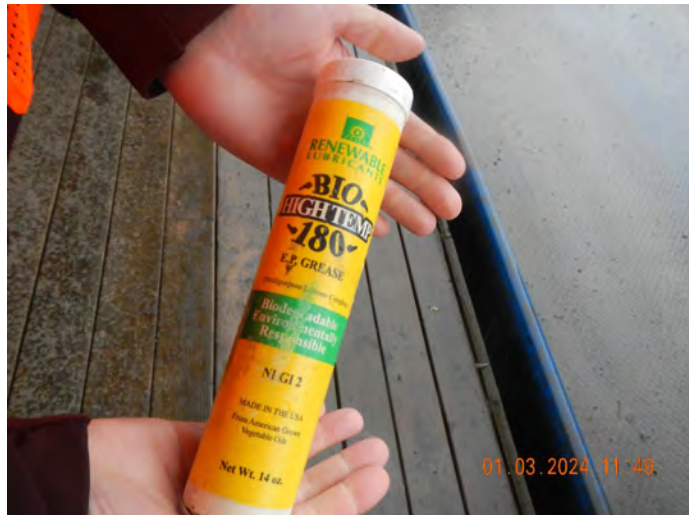
Photo #:59 (DSCN3508)

Description: Photo from inside the maintenance shop, grease cartridge used on on-site machinery.

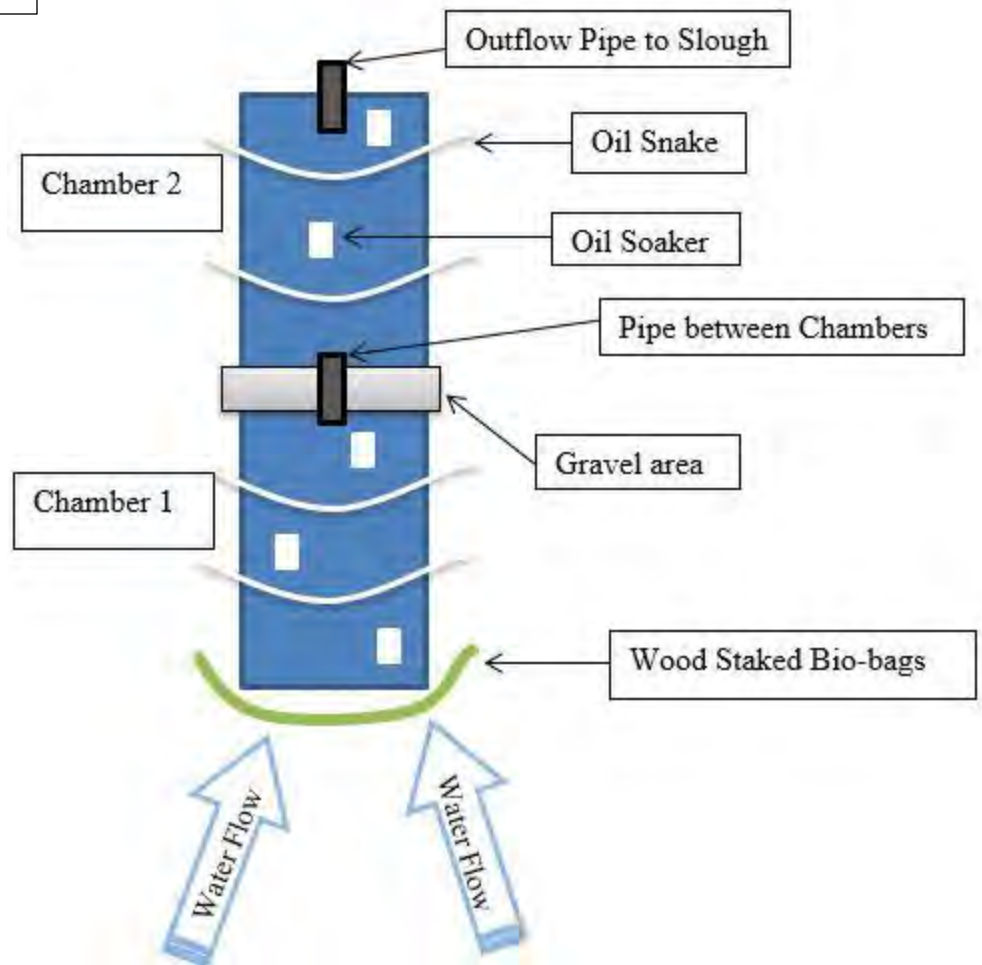
## **Pond #1**-Near hogfuel area

1. Hogfuel debris can runoff into pond.
2. Road around pond tends to get muddy.
3. Bio-bags will need inspected regularly and replaced as needed.
4. Machines are closest to this pond; beware of oil sheen or runoff.

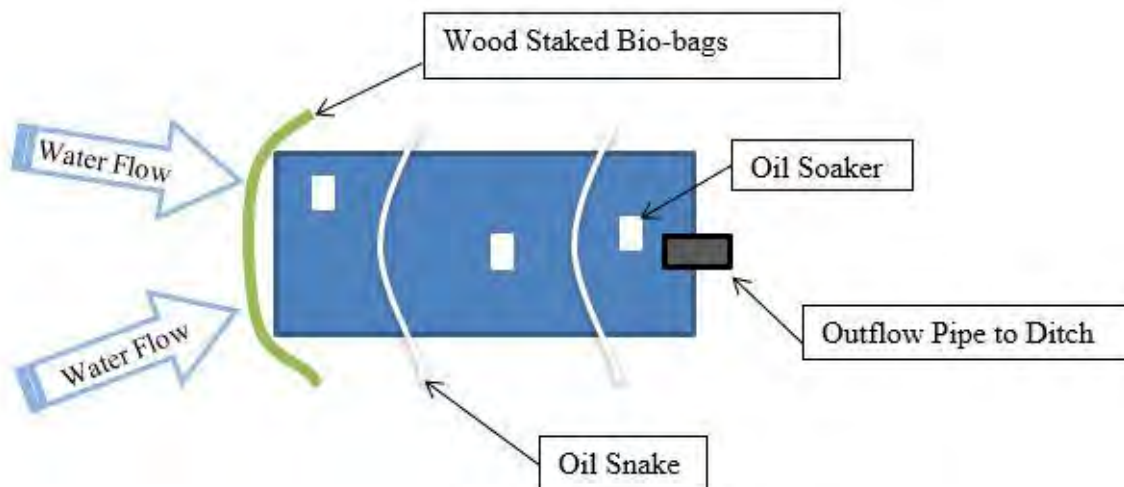
## **Pond #2**- Near back gate

1. Near bark pile, watch for floating bark-remove daily.
2. Lots of traffic near pond, watch for garbage and runoff.

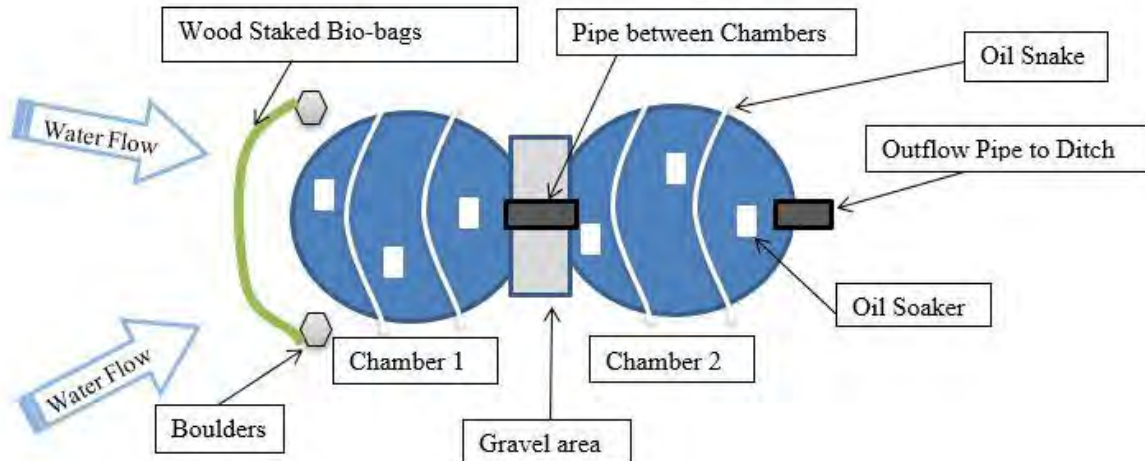
**Pond #3-** Near Product Bins

1. Road in front of chamber 1 can get muddy. Add gravel when needed.
2. Bio-bags need checked regularly (broken or plugged) and replaced as needed.

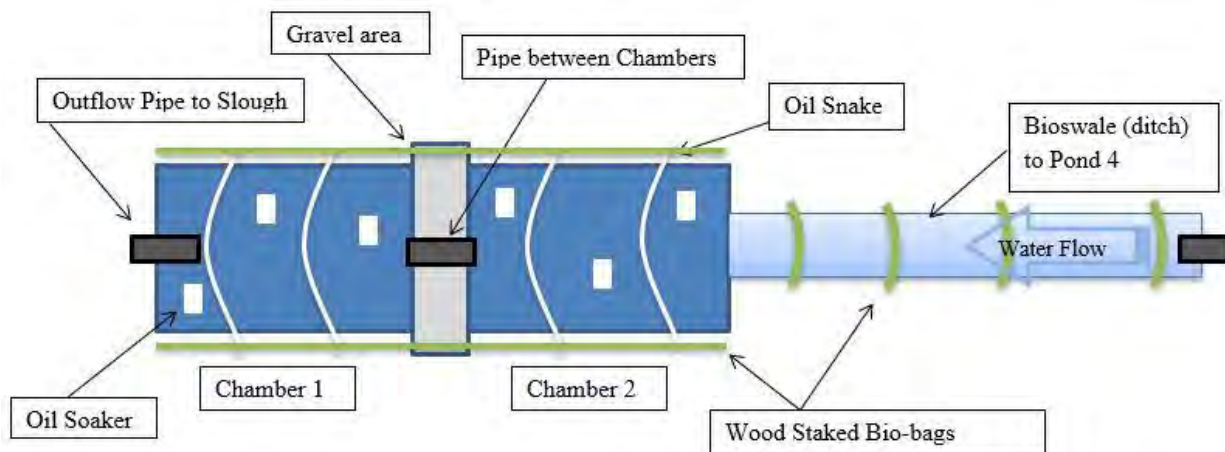
**Pond #4-** Near the backside of the concrete pile

1. Bio-bags need checked regularly in the bioswale (ditch)
2. Keep concrete chunks away from the pond.

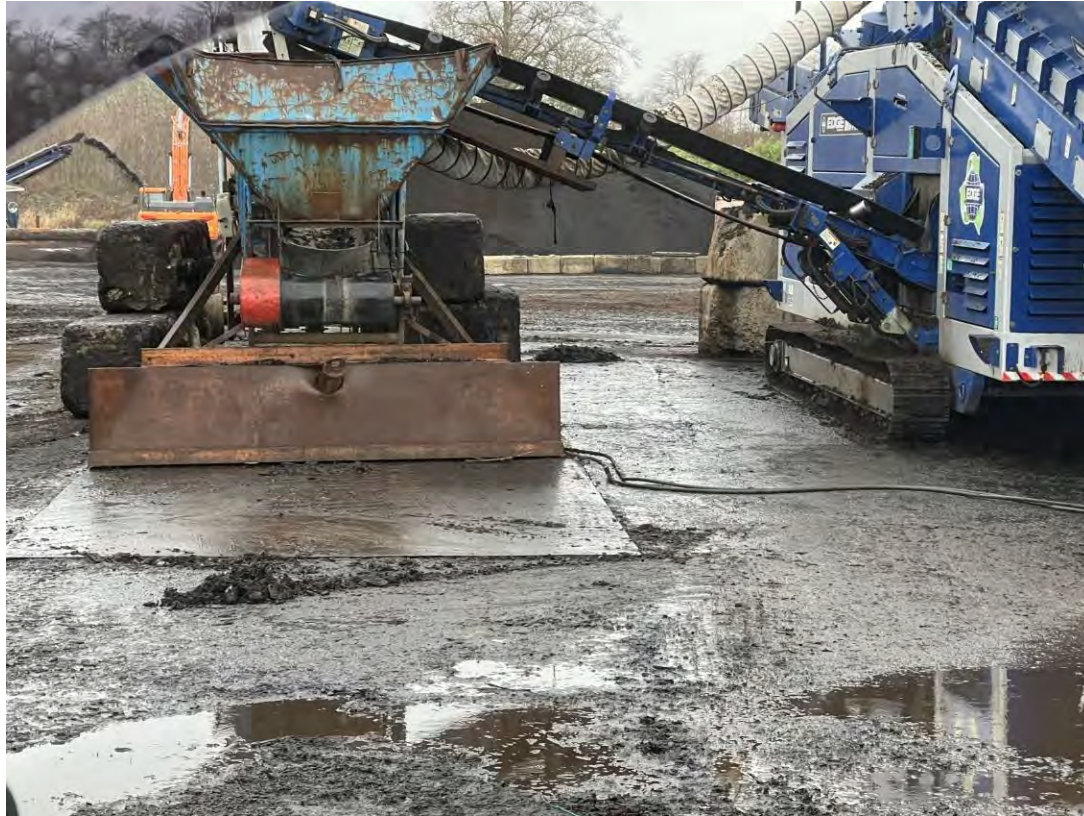
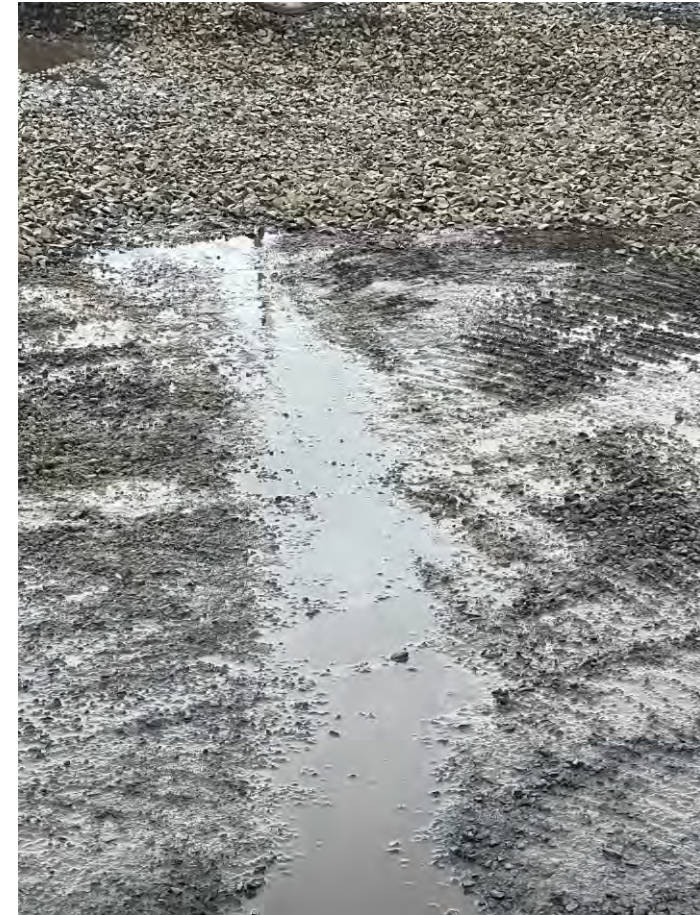
Sheen from the recent oil change on the Edge Air Screener (adjacent to inlet to Pond 3) was cleaned up with absorbent pads. Additional rock was added around Pond 3.

Pond 4 - added additional absorbent pads

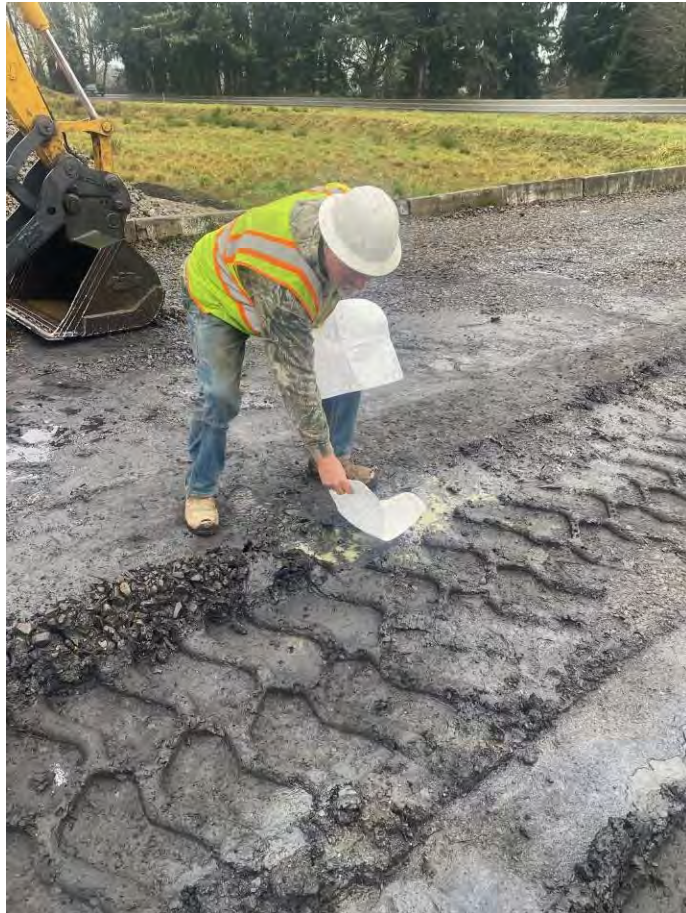
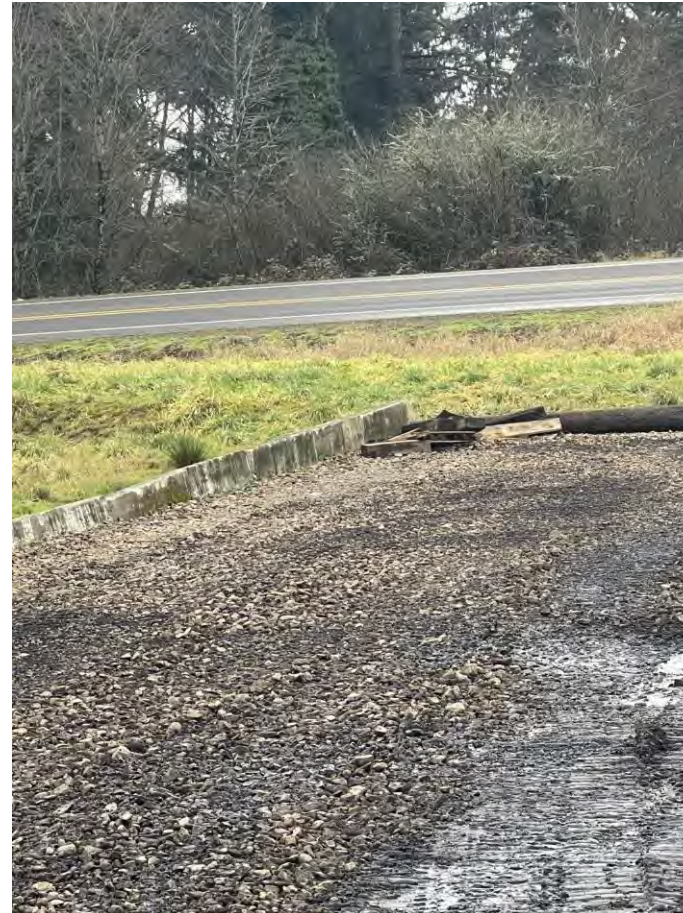
Small leak from the 500 loader was cleaned up, the machine hoses were capped and it was moved to the shop for repairs.
