**CWA COMPLIANCE EVALUATION INSPECTION REPORT  
U.S. ENVIRONMENTAL PROTECTION AGENCY, REGION 5**

Compliance Evaluation Inspection

Pilkington North America, Inc.  
300 20<sup>th</sup> Avenue  
Ottawa, Illinois 61350  
LaSalle County  
41.330620202591625, -88.87690647116492

March 13, 2025

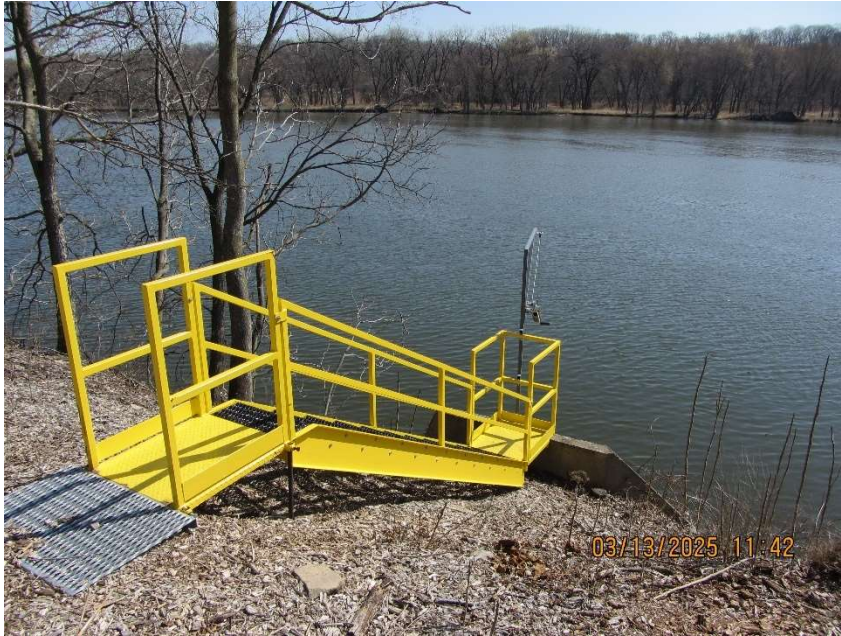
36: IMG\_0213

The Inspectors then walked northeast to what was identified by the facility personnel as Outfall 002. The Inspectors observed that there was flow from the outfall (photos 36 and 37). The Inspectors asked when the most recent precipitation event had occurred. The facility personnel stated it was March 4<sup>th</sup>. The Inspectors walked north and observed a storm water drain (photo 38). The Inspectors heard the sound of water flowing in the

Description: Identified as Outfall 002 during inspection. Later clarified as actually being Outfall 003.

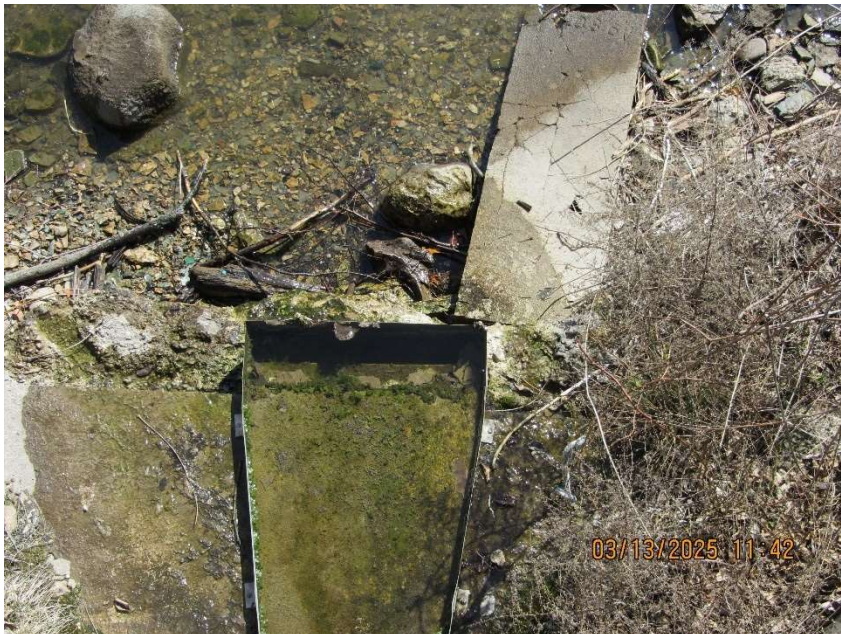
37: IMG\_0214

Description: Identified as Outfall 002 during inspection. Later clarified as actually being Outfall 003. Note flowing water.

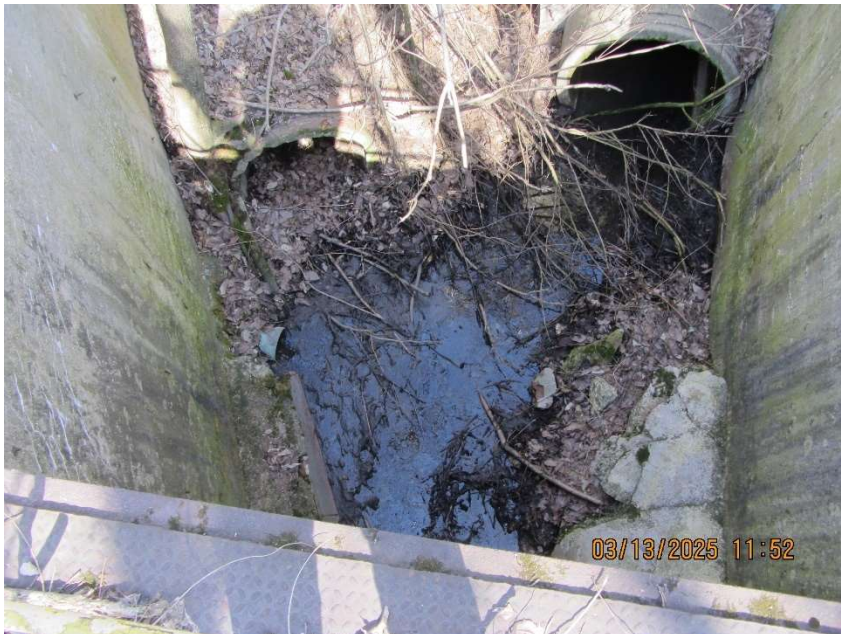
39: IMG\_0216

drain. The Inspectors walked northeast and observed a concrete structure into which it appeared that two pipes discharged from the north and one pipe conveyed flow to the south toward the Illinois River (photos 39 and 40). The Inspectors then walked southeast and observed what was identified as Outfall 003. The Inspectors observed flow coming from the outfall to the Illinois River (photo 41). The Inspectors observed a white manhole east of Outfall 003 (photo 42). The Inspectors continued to walk northeast and observed what was identified as Outfall 005. The Inspectors observed slight flow coming from the outfall and more flow from under the outfall pipe (photo 43). The facility personnel stated that this outfall was sampled monthly using a 6-foot sampling pole.

Description: Concrete structure with two inlet pipes and one outlet pipe north of Outfall 004.

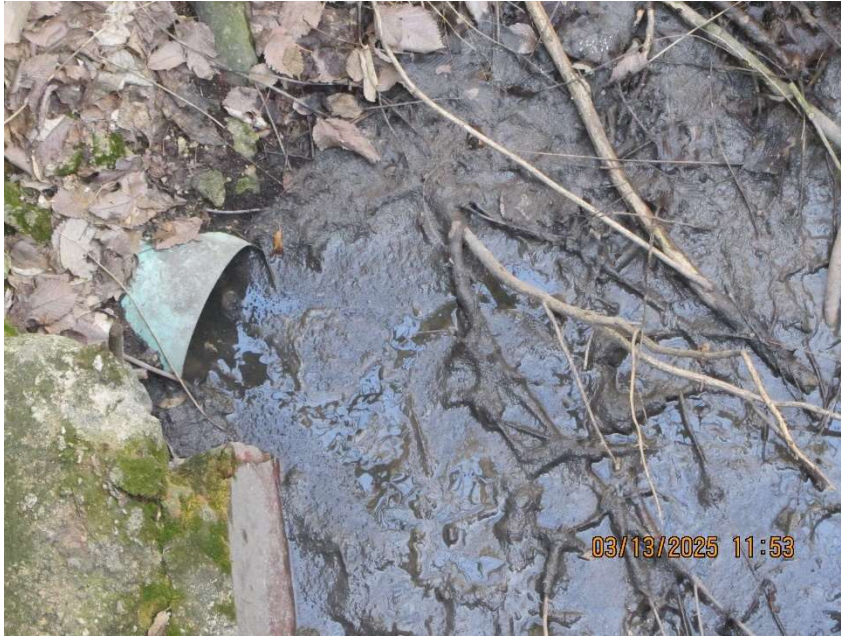
40: IMG\_0217

Description: Outlet pipe receiving flow from the two inlet pipes in the concrete structure north of Outfall 004.

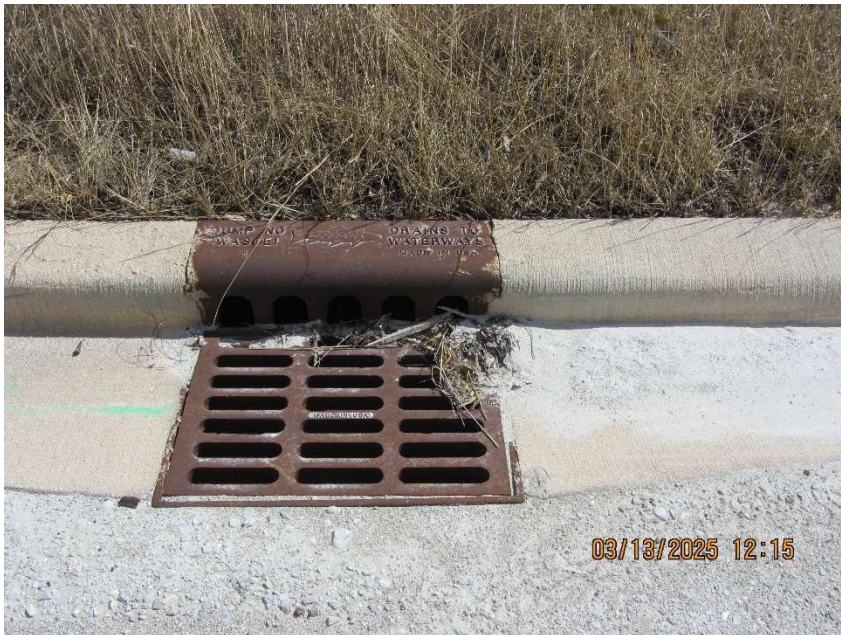
49: IMG\_0226

The Inspectors walked northeast and observed the area around the bulk batch building. The Inspectors observed white powder on the road, ground, on the concrete slope down to the Illinois River, and around a storm water drain (photos 44-49). The Inspectors also observed Outfall 008 (photo 50). The Inspectors observed a waste bag with white powder around the base near a storm water drain inlet on the northeast side of the bulk batch building (photo 53 and 54). The Inspectors also observed a white pipe discharging a liquid from the northeast side of the bulk batch building (photos 55 and 56). The Inspectors also observed a storm water drain with a sediment filter (photo 57).

EPA observed white powder around the bulk batch building including in the road, around storm water drains, and on the concrete embankment, and up to the edge of the Illinois River which had not been properly and promptly cleaned.

EPA observed white powder around the bulk batch building including in the road, around storm water drains, and on the concrete embankment, and up to the edge of the Illinois River which is not achieving the general objective of controlling pollutants in storm water discharges.

Description: Storm drain with white powder on it.

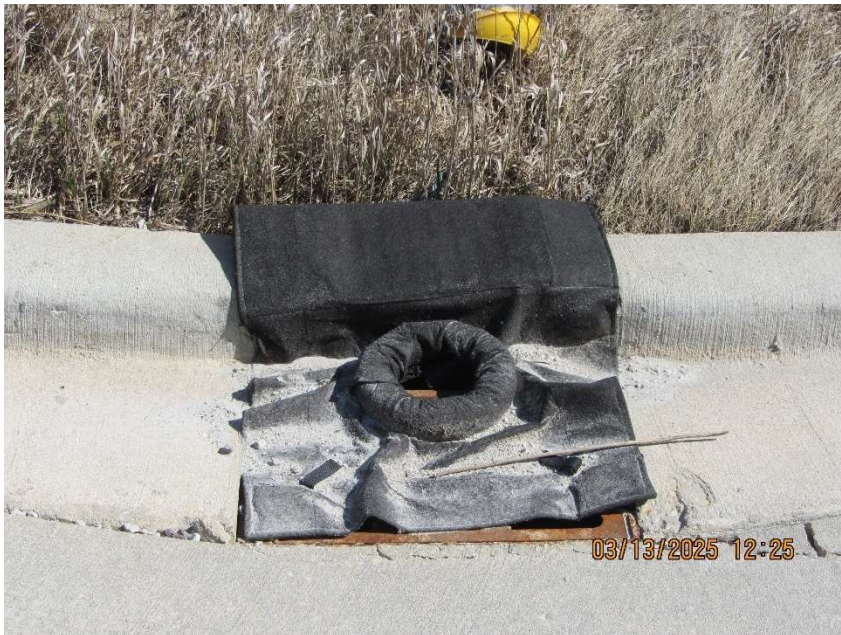
57: IMG\_0234

Description: Storm water drain with filter.

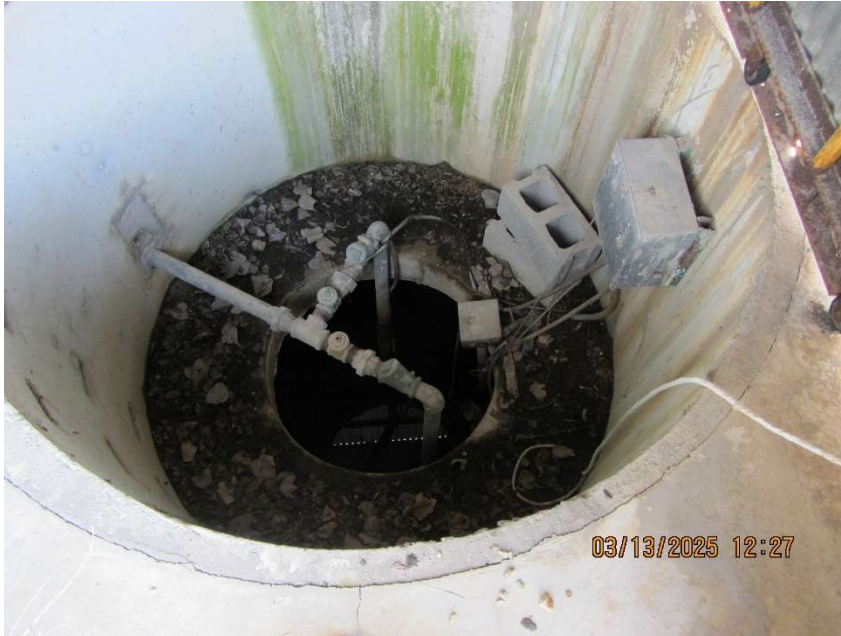
58: IMG\_0235

The Inspectors walked northeast and observed a structure with a concrete pit with pipes (photos 58 and 59). Facility personnel stated that they weren't sure what the structure had been used for, but that it was no longer in use. The Inspectors walked southwest to the area south of the south end of the furnace building and observed an open topped dumpster with damage that would allow storm water to flow out, a storm water drain with no filter, and a storm water drain with a filter (photos 60, 61, and 63). The Inspector then walked into the north end of the furnace building and observed where mixed batches of raw materials are fed into the furnace (photo 62).

Description: Building with a small pipe heading northeast.

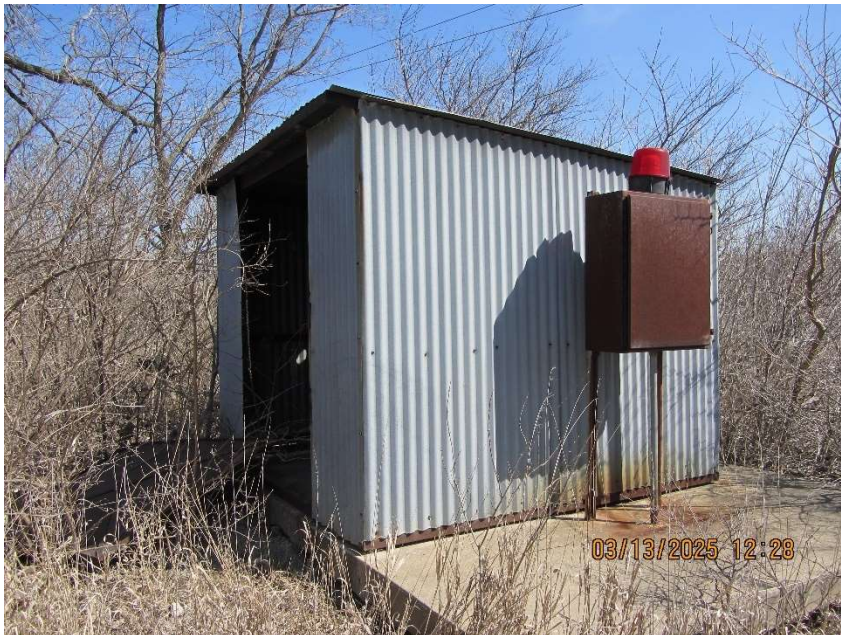
59: IMG\_0236

Description: Unnamed structure with small pipe inside heading northeast.

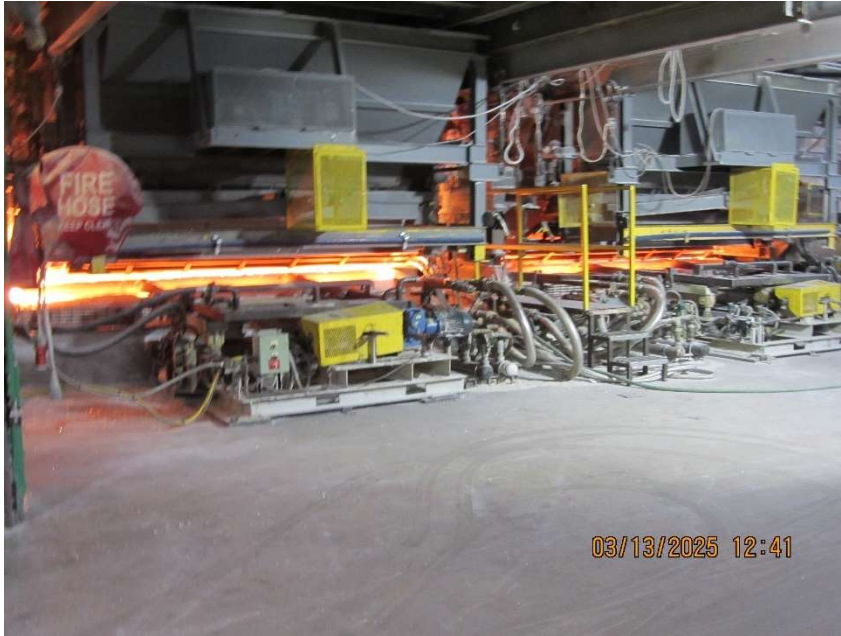
62: IMG\_0239

Description: Batch entering furnace on the south end of plant 5.

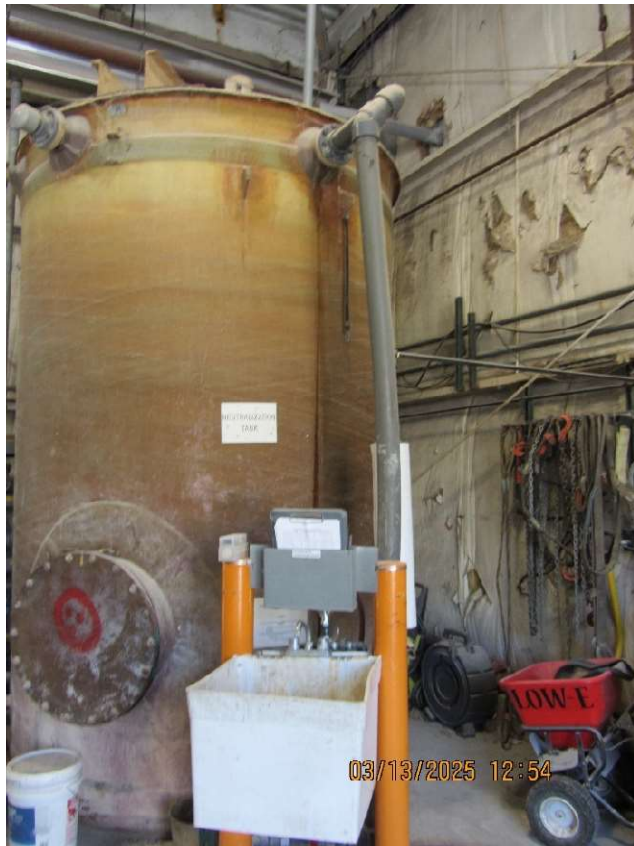
64: IMG\_0241

The Inspectors then walked to the maintenance building and observed the pH neutralization tank (photos 64 and 66). The facility personnel stated that the wash water from the coating applicators was collected and sent to the tank for testing and pH adjustment, if necessary, prior to discharge to the sanitary sewer. The Inspectors observed the "Neutralization Tank Drainage Record" (photo 65). The Inspectors noted that the pH seemed relatively stable around pH 7 with one outlier showing a pH of 2.28 with the note "Not drained. Added NaOH".

Description: Neutralization tank which receives collected waste from coating sprayer wash.

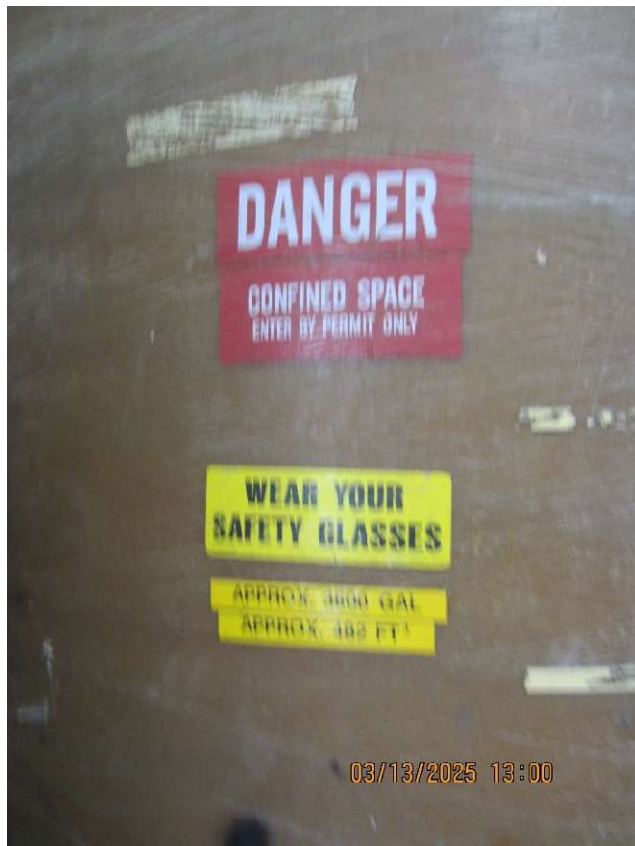
66: IMG\_0243

Description: Sign on neutralization tank showing the capacity of the tank.

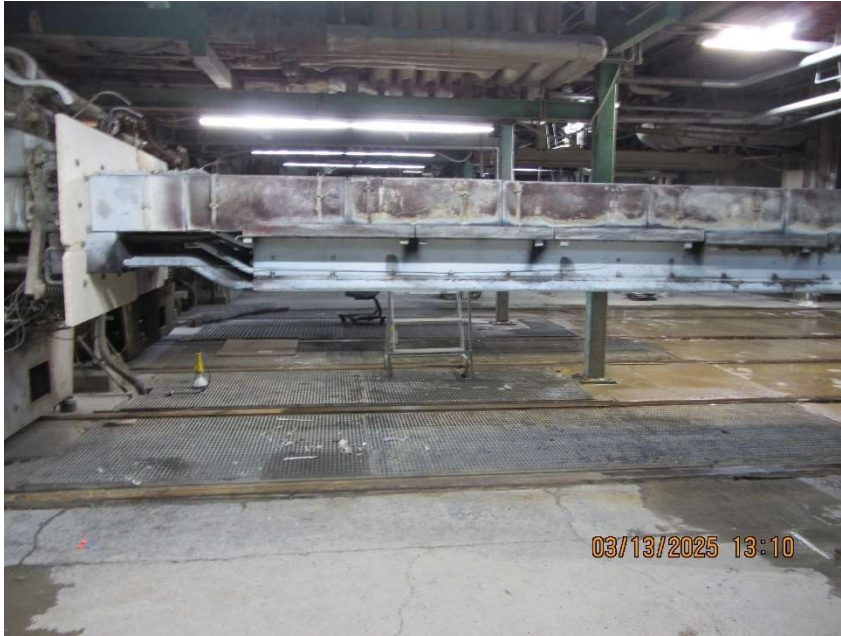
67: IMG\_0244

Description: Coating sprayers and sump below sprayers.

Location: North side of the hot end of the furnace building.

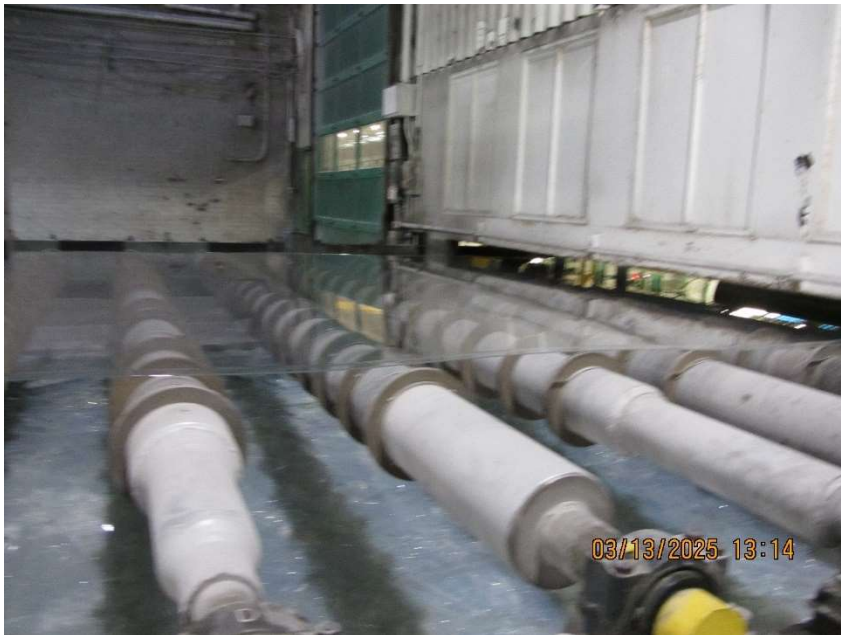
68: IMG\_0245

Description: Glass leaving furnace (hot end) and entering cold end of the furnace building.

Location: Furnace building cold end.

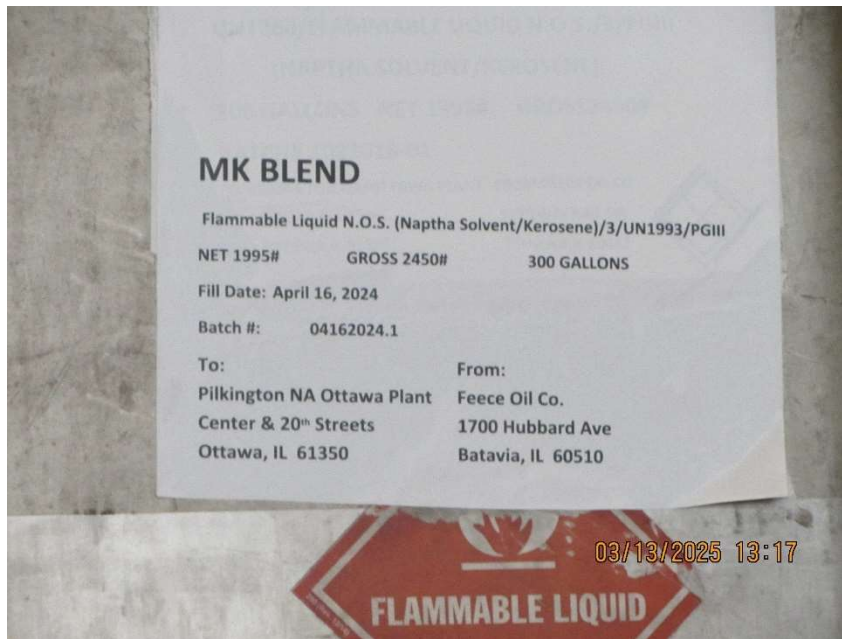
69: IMG\_0246

Description: Description of chemical contents on container on the south side of the cold end.

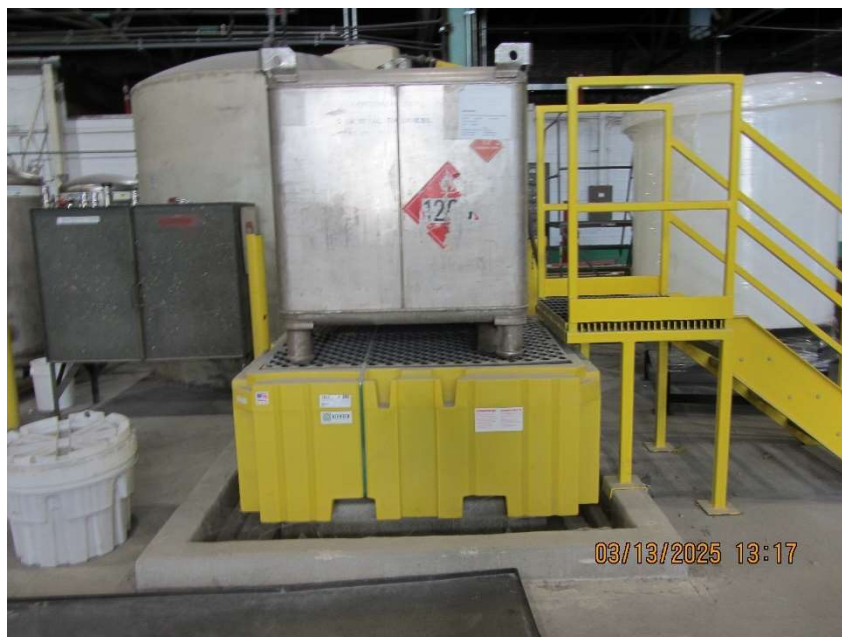
70: IMG\_0247

Description: Containment with contents listed in photo 69.

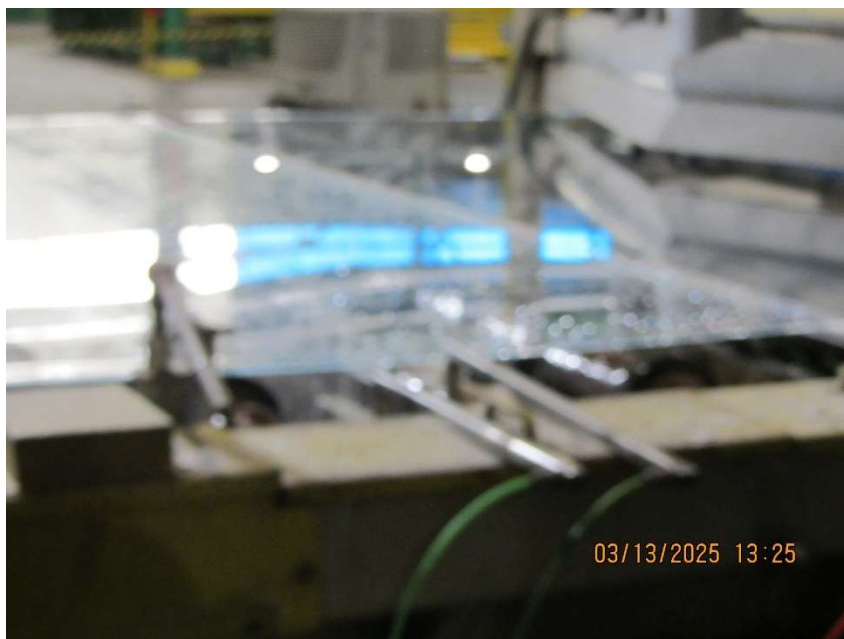
72: IMG\_0249

Description: Water used to wash coating off bottom of glass.

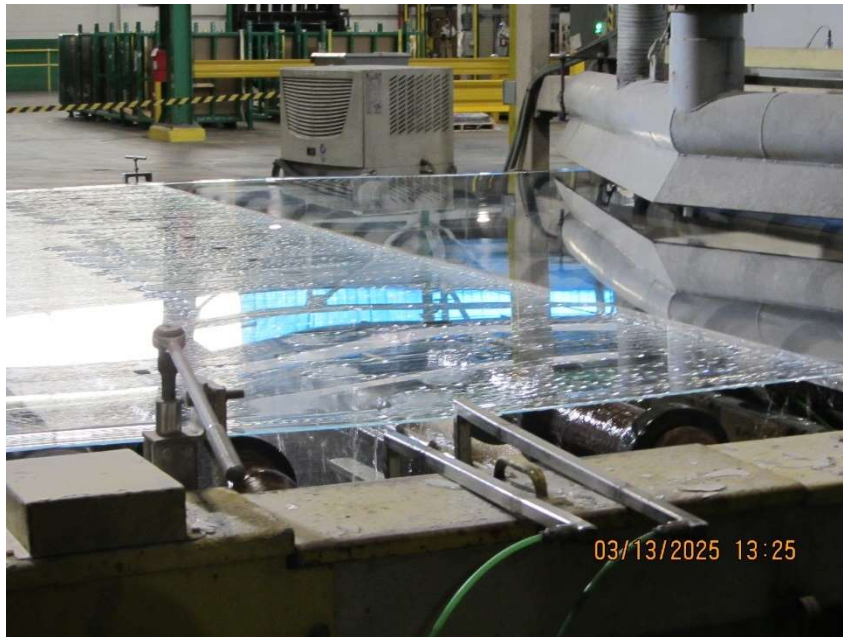
73: IMG\_0250

Description: Water being used to wash coating off bottom side of glass.
