**RE: ALCOA BUILDING ENVIRONMENTAL ASSESSMENT  
MODIFIED PHASE I FINAL REPORT**

**RE: ALCOA BUILDING - MODIFIED PHASE I  
ENVIRONMENTAL ASSESSMENT DRAFT REPORT**

Subject: Phase I Environmental Assessment  
Alcoa Building  
Color Photos from Final Report

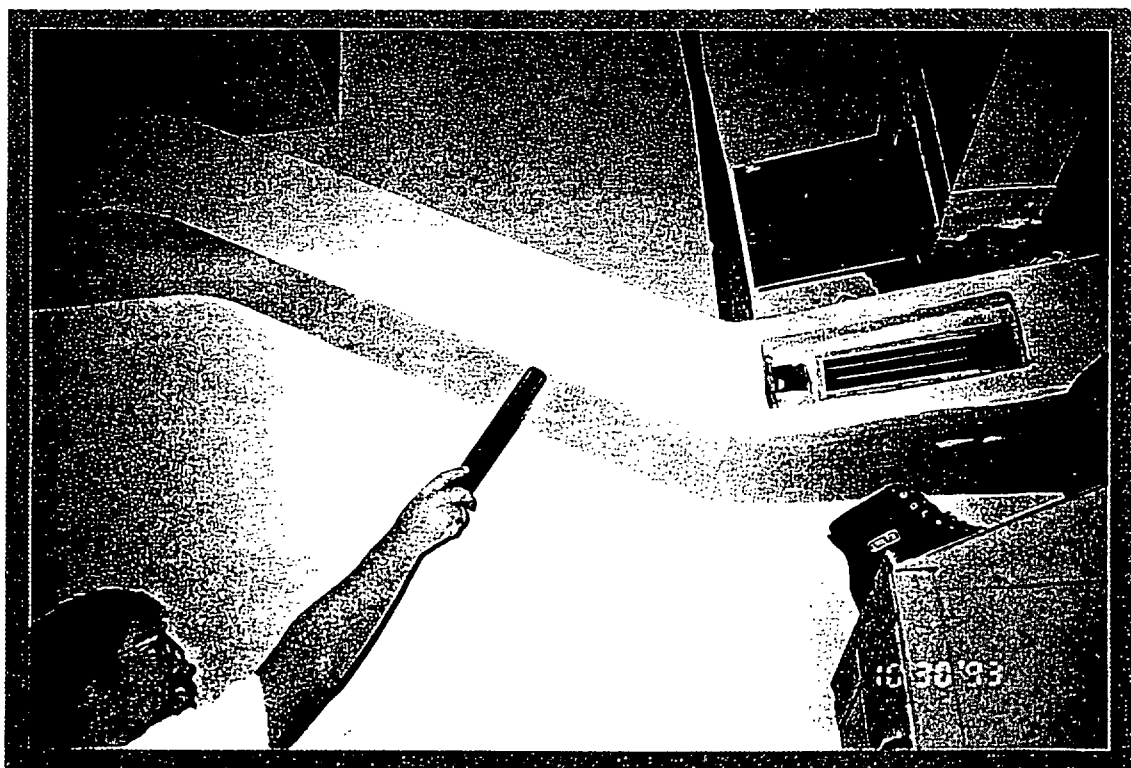
*Breaching over ductwork insulation in subbasement locker room.*

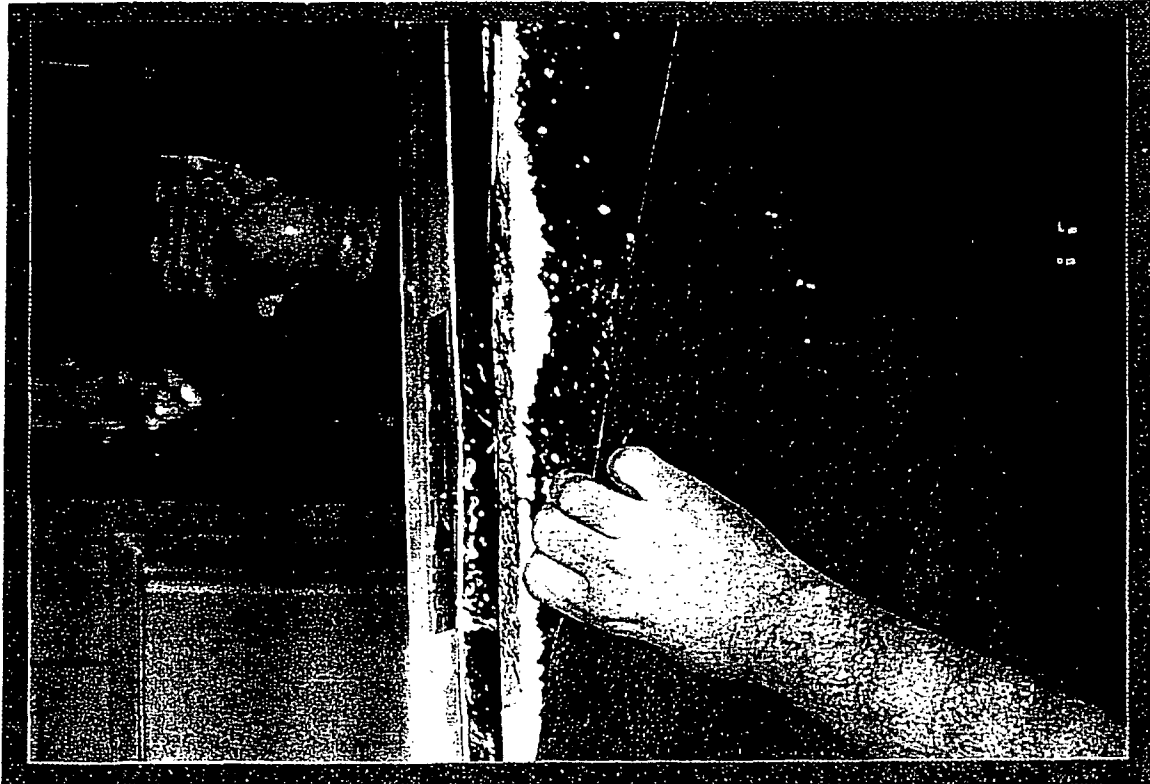
*Fireproof insides of fire door to room B-74 (asbestos sample B-6).*

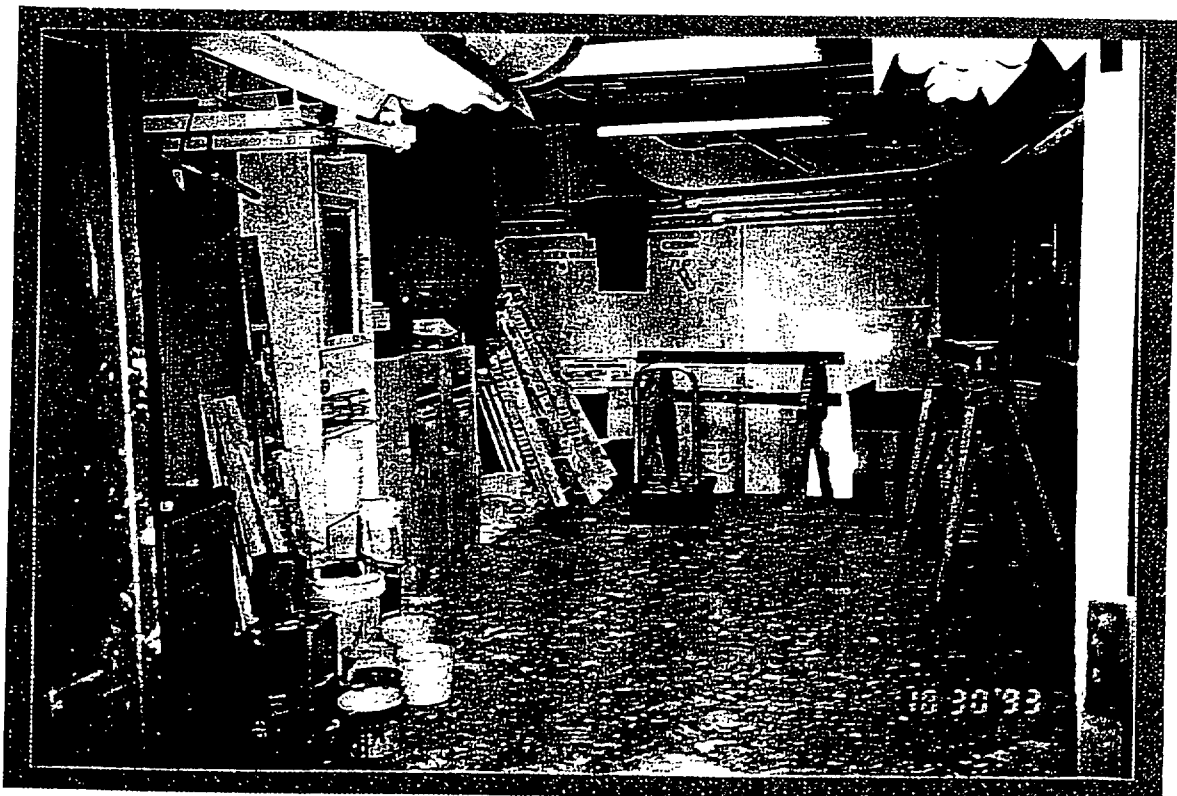
*Paint spray shop in basement, room B-28A.*

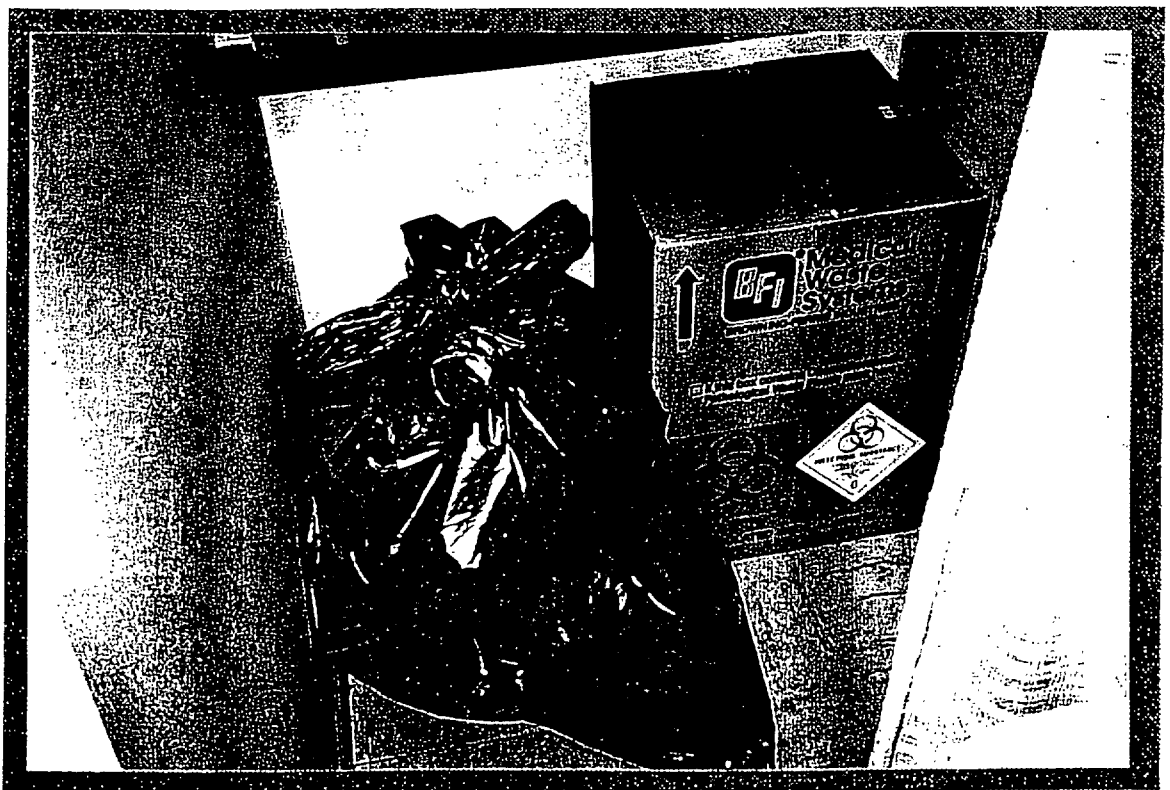
*Medical waste storage area on 15th floor.*

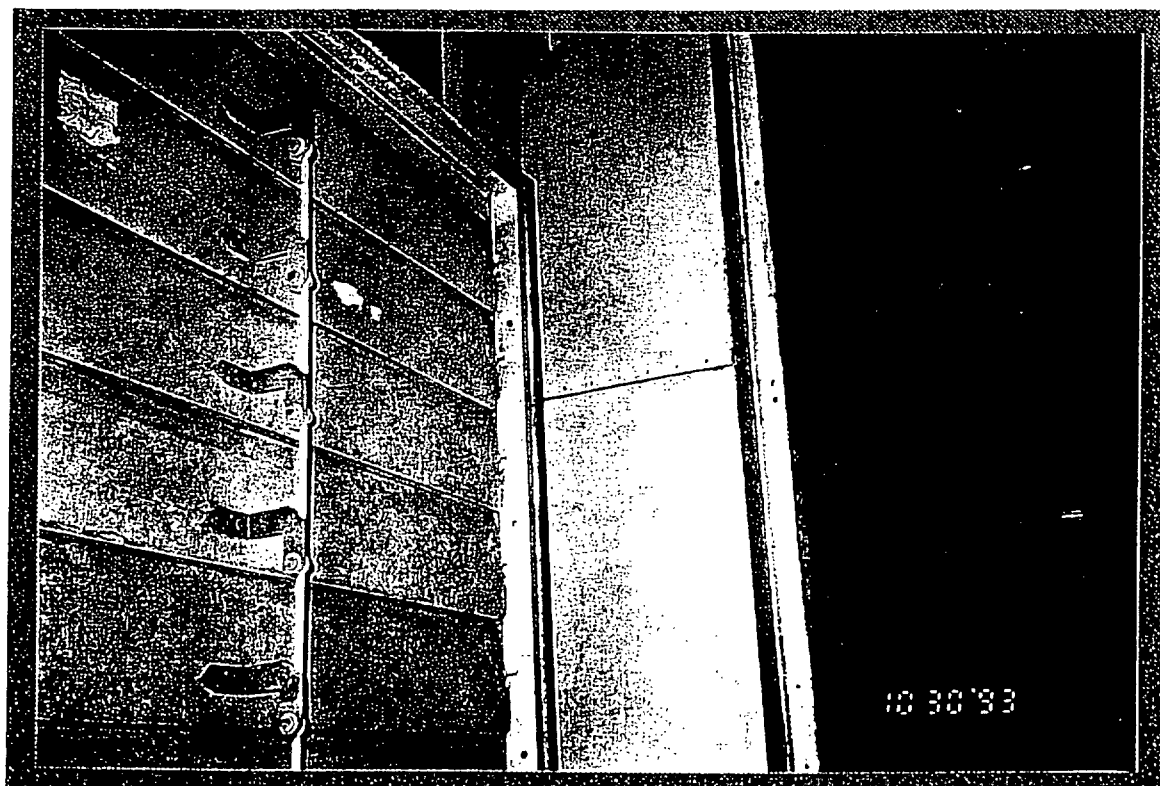
*Intake chamber for outside makeup air in 14th floor primary air handling crossovers (outermost chamber).*

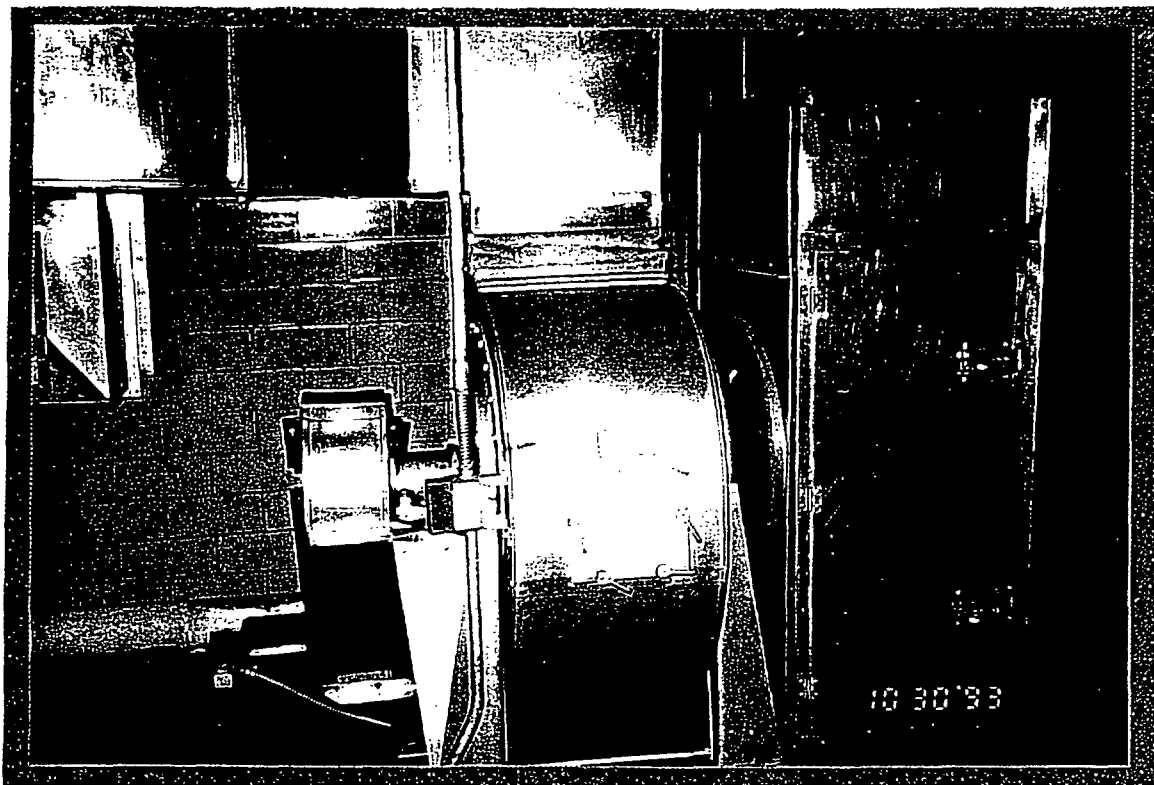
*Exhaust system for medical floor air.*
