**Region 6 - Enforcement & Compliance Assurance Division**  
**INSPECTION REPORT**

| Inspection Date(s): | 7/31/2023 – 8/2/2023 | |
| Company Name: | Clean Harbors Environmental Services, Inc. | |
| Facility Name: | Clean Harbors Environmental Services, Inc. (CHESI) | |

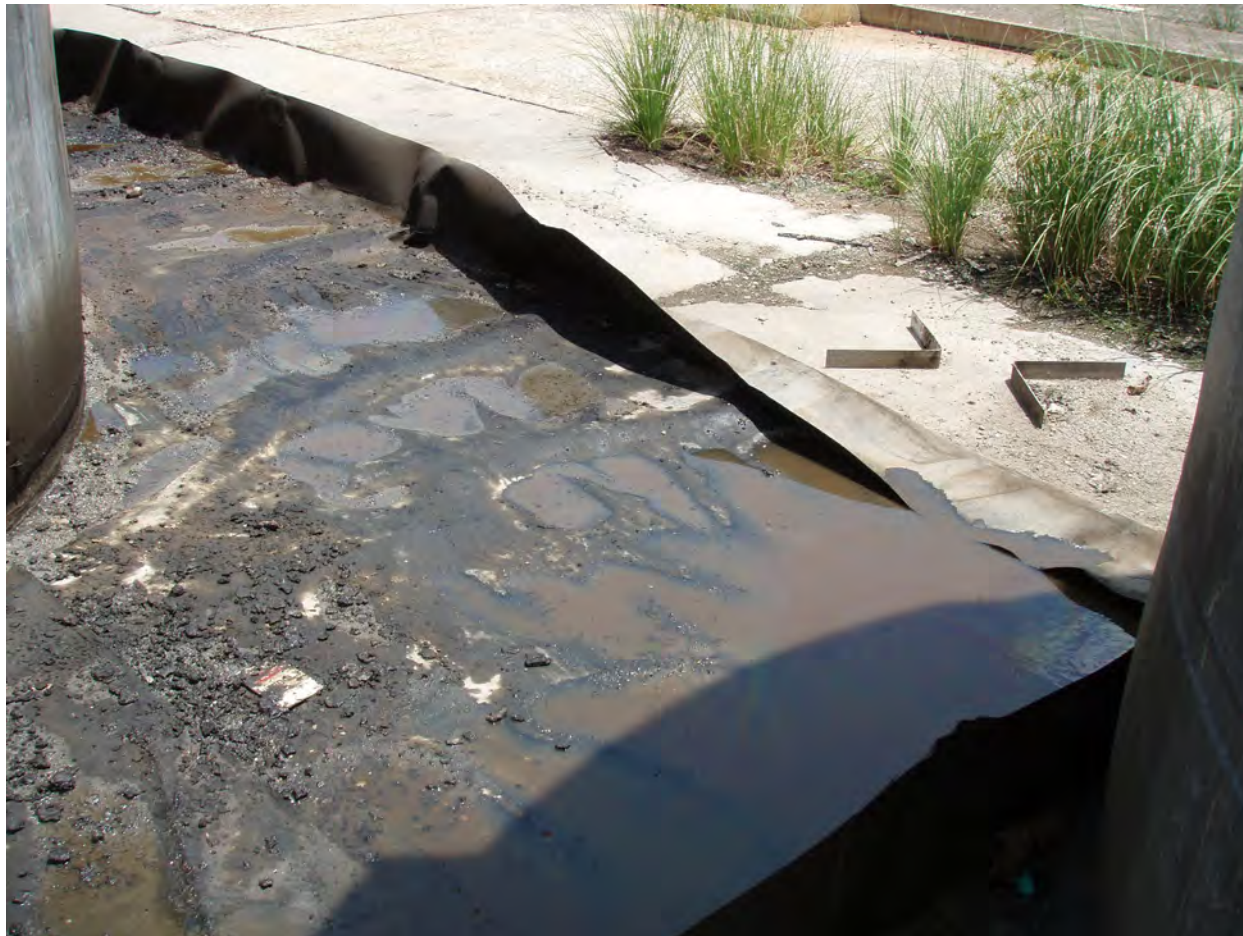
**PHOTO No. 16**

| Sum of<br>Photos in<br>Report | Photo #<br>Referenced<br>in Report | Photo # | Description / Direction Facing | Direction (see<br>attached<br>maps) | File Name<br>PXXXXXXX.JPG | Time | Date |
|---|---|---|---|---|---|---|---|
| 10 | 16 | 16 | CHESI Tank Wash Area - Close up of residue and liquid puddles inside of the 4 HW tank secondary containment liner. Part of the liner wall was collapsed. Some of the liquid observed on top of the liner wall that collapsed. L-shaped angle braces located near liner wall where collapsed. Weeds growing in and around seams of concrete pad the liner sits on. | SE | 7310016 | 2:07 PM | 7/31/2023 |

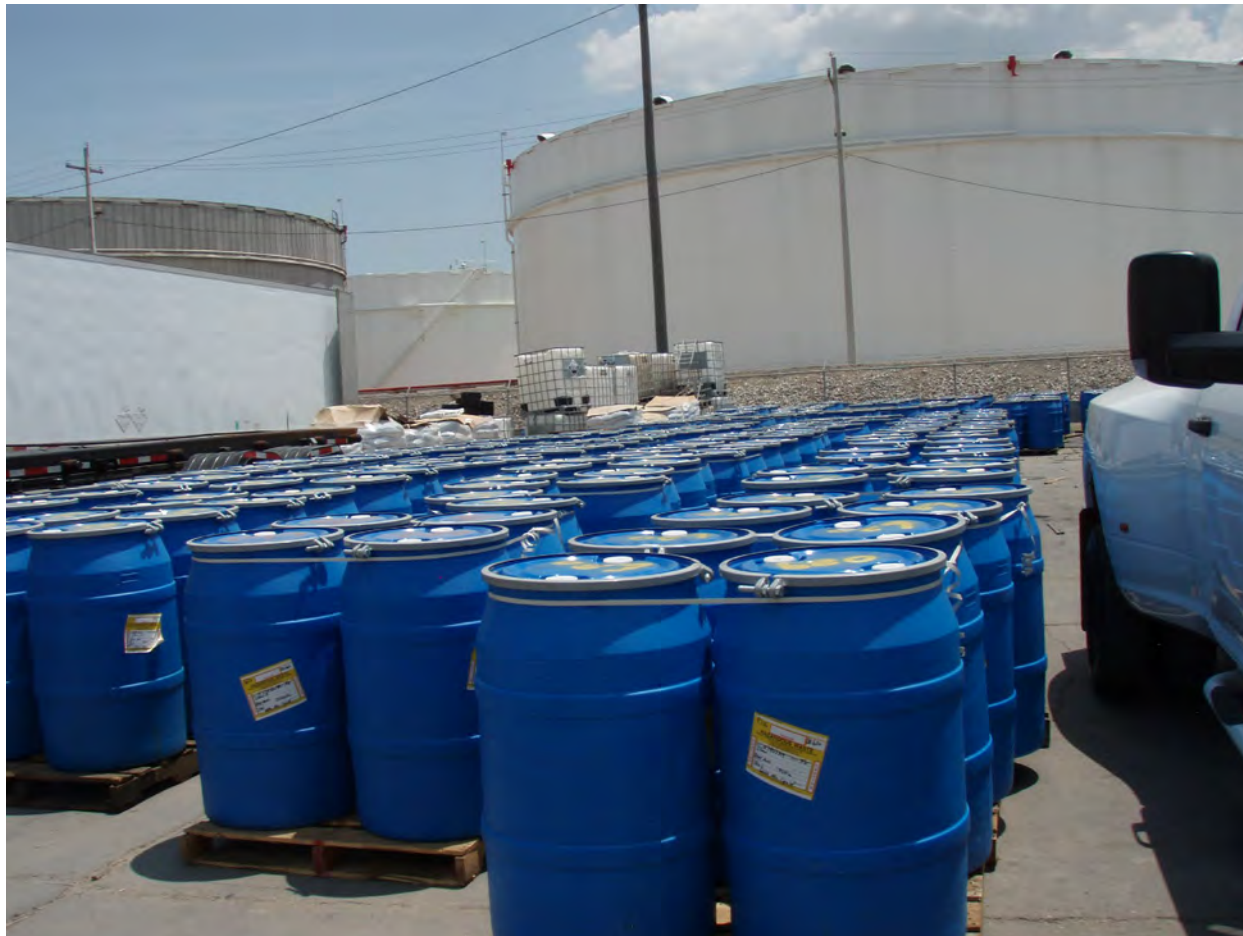
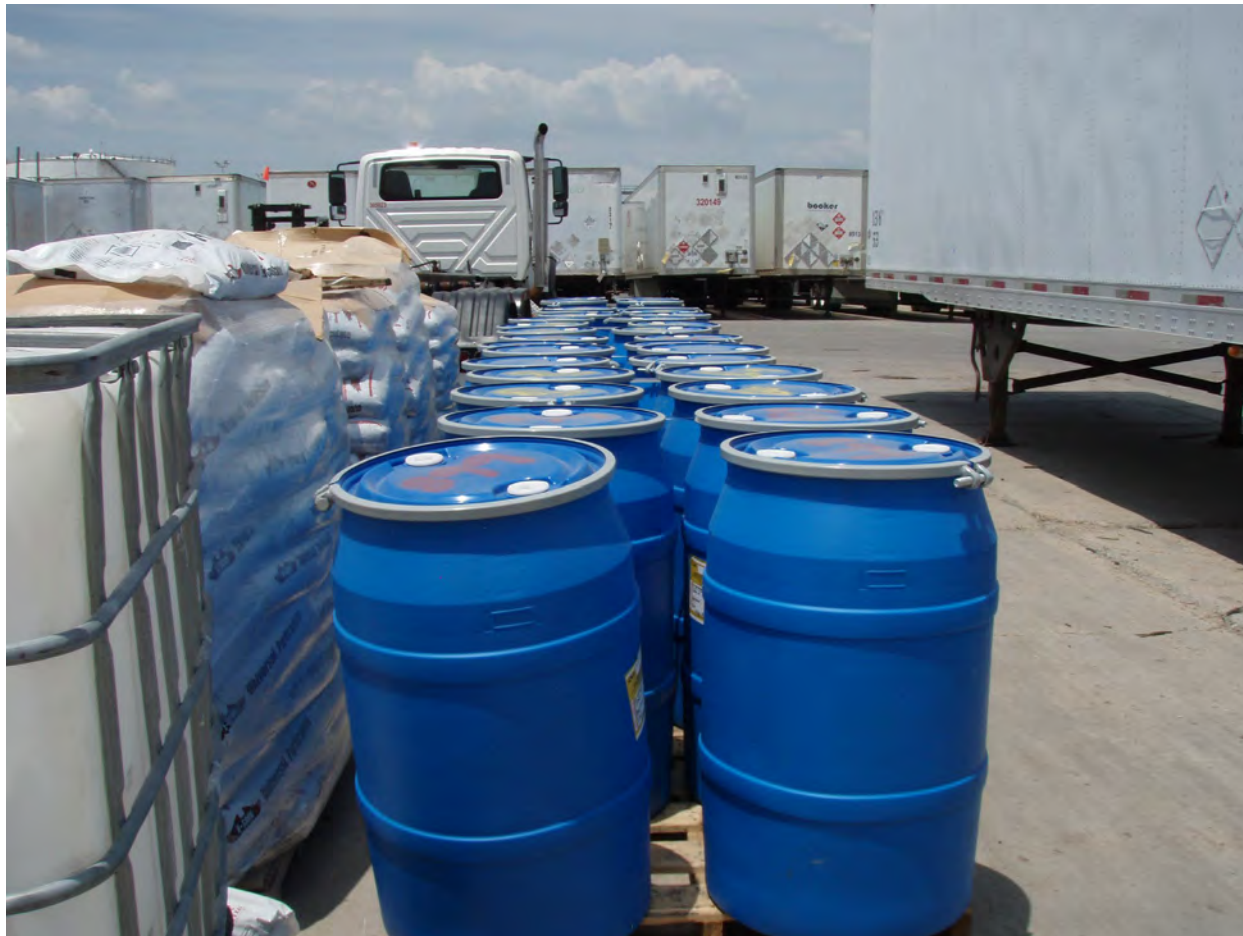
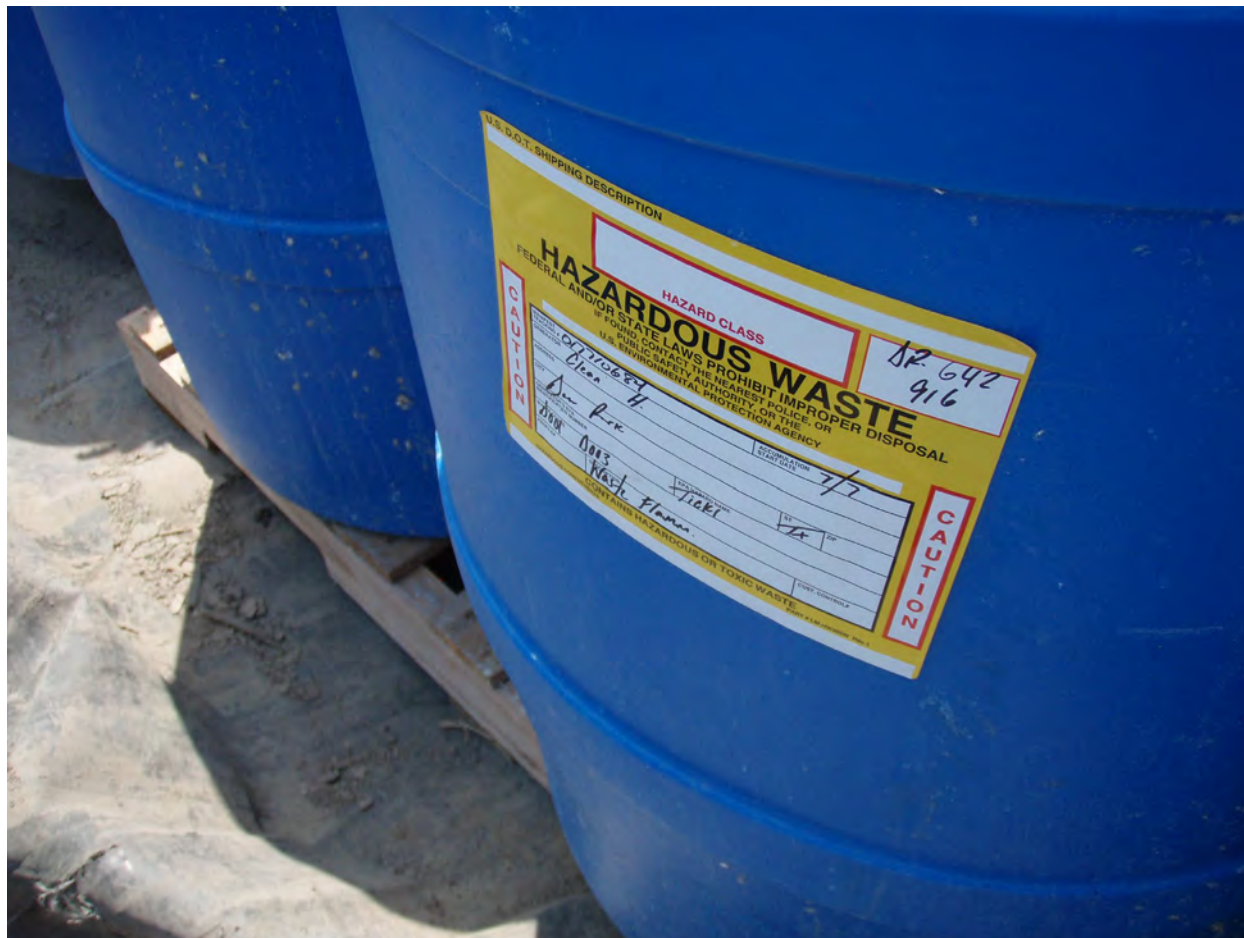
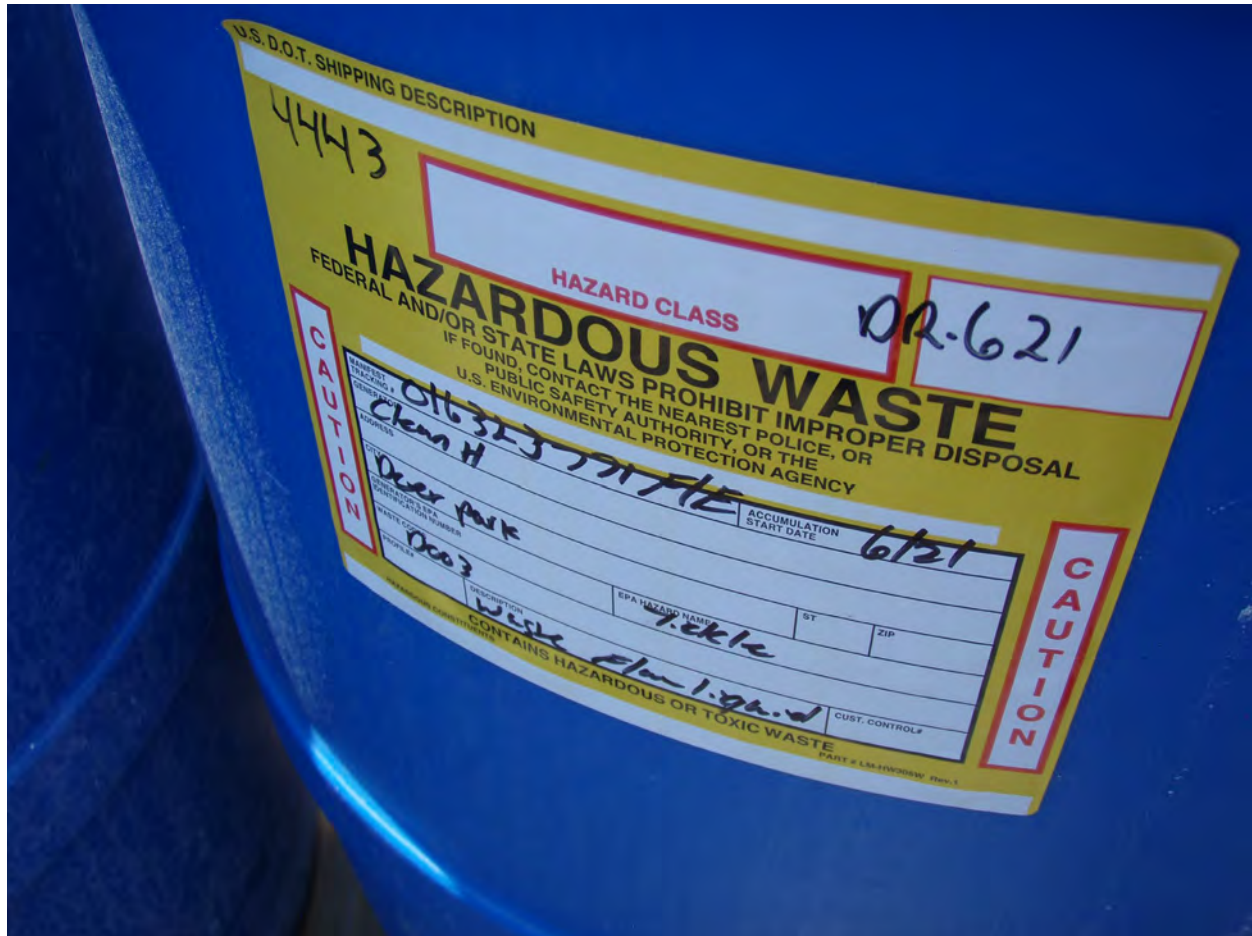
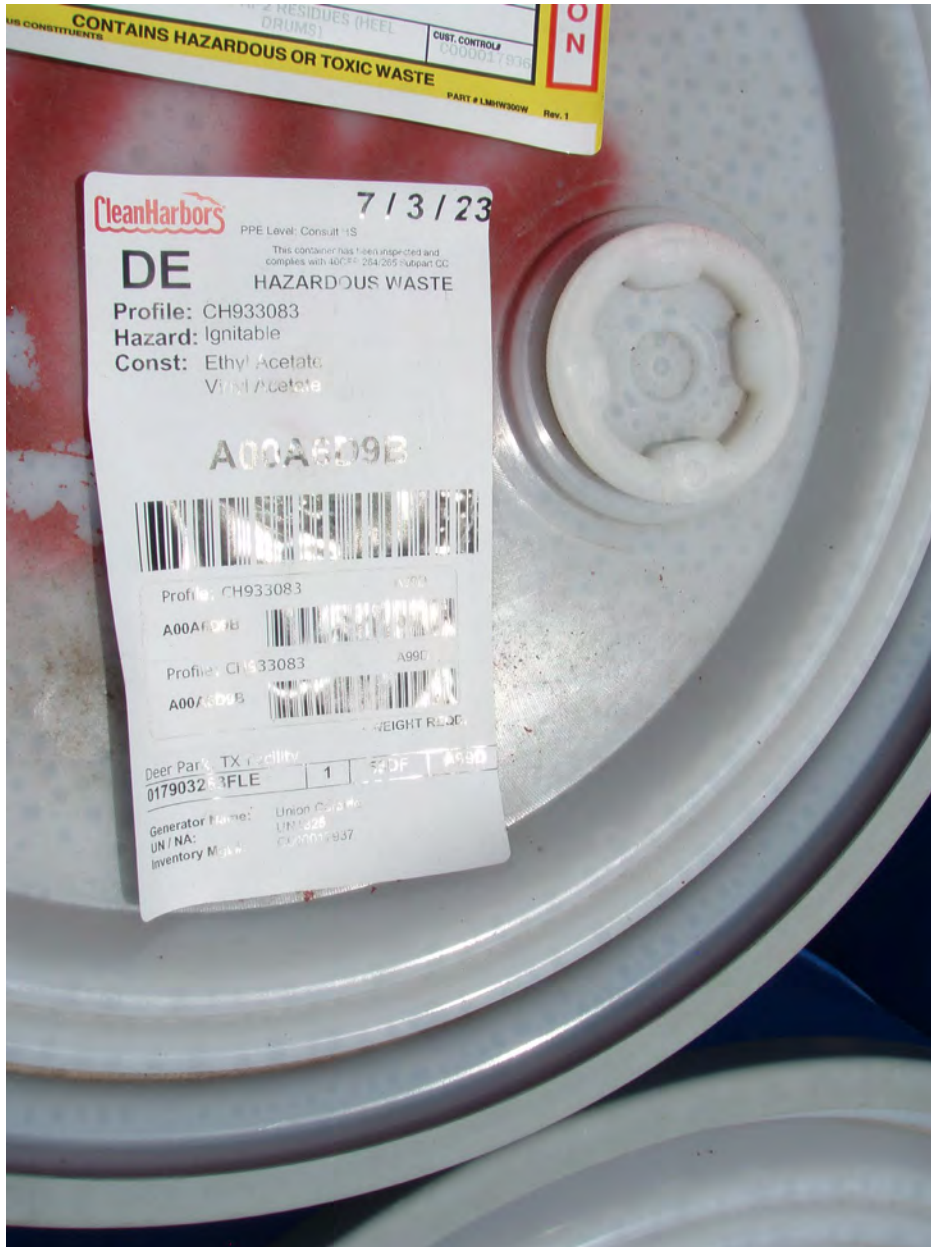
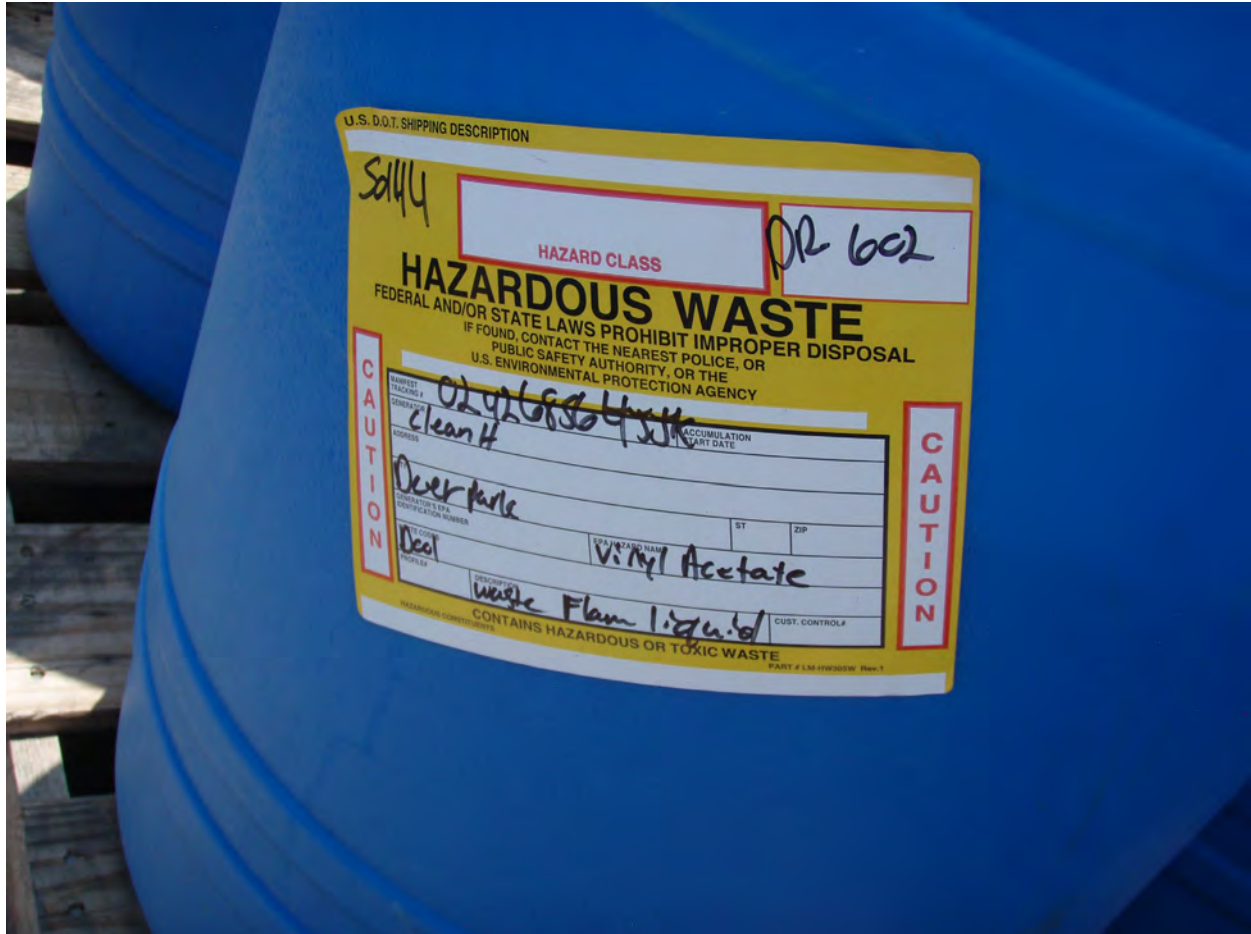
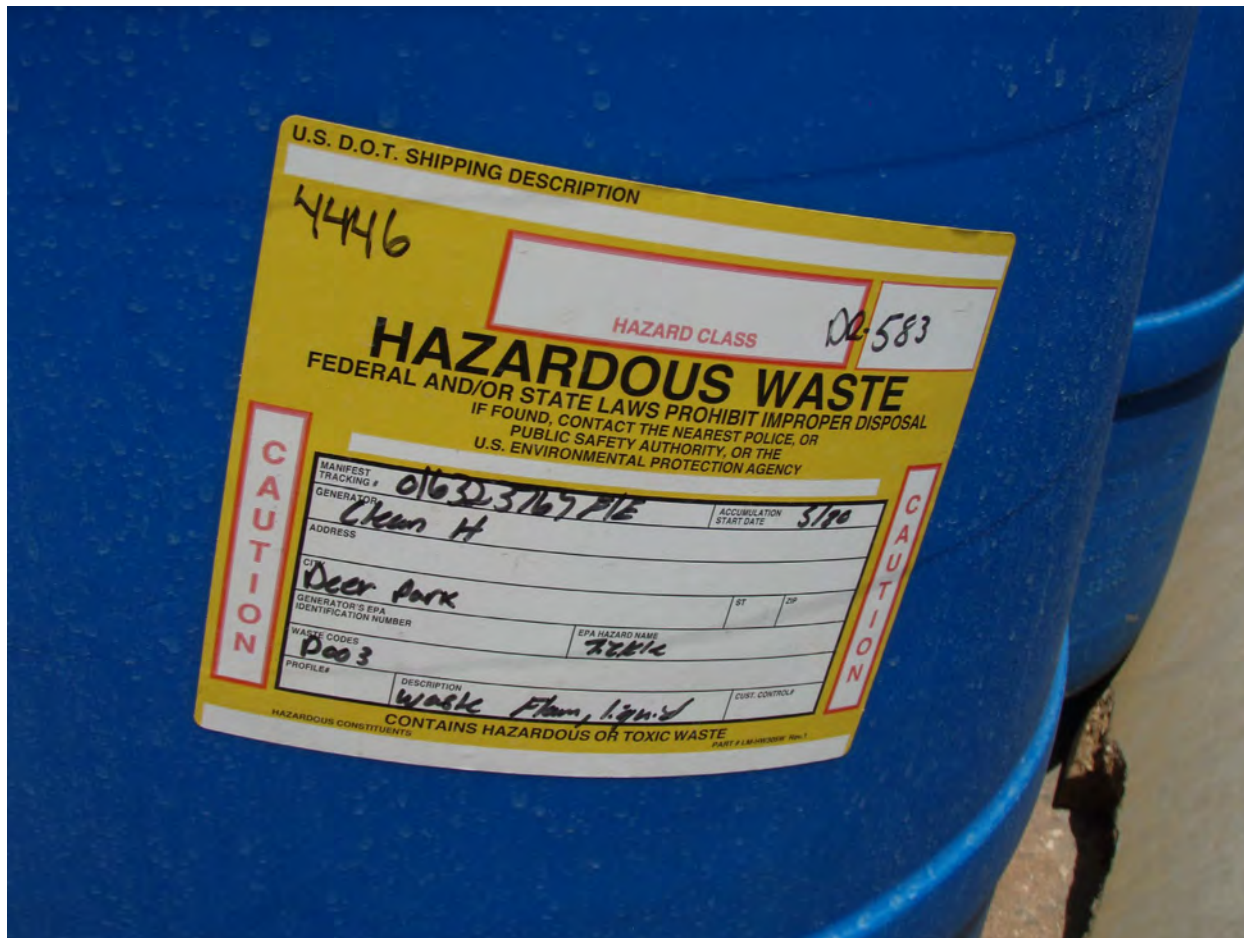
| # | WASTE NAME | GENERATION PROCESS | FACILITY'S HAZ. WASTE DETERMINATION | ESTIMATED GENERATION RATE & AMOUNT ACCUMULATED ON-SITE | ON-SITE MANAGEMENT | OFF-SITE MANAGEMENT |
|---|---|---|---|---|---|---|
| <p>I observed the following regarding the approximately 397, 55-gallon drums being stored in the CSA:</p> <ul style="list-style-type: none"> <li>At least 144 drums stored over 10 days dating back to May 20, 2023 (see Appendix 6A for partial inventory and Photos 18, 22, 23, 25, 30, 32, 33, and 36). <b>(AOC #2.b)</b></li> <li>Drums labeled with yellow/white hazardous waste labels that contained partial dates (month/day), except one drum label had no date (see Photo 33). Also, the approximately 14 drums generated that day (July 31, 2023) had no label or date. As explained in Appendix 4, labels with dates are sent by the CH branch after they receive the wash ticket. <b>(AOC #2.b)</b></li> <li>All but 6 drums were awaiting a CHDP white barcoded label. The 6 white barcoded labels were dated 7/3/23 (see Photos 32 and 91).</li> <li>Concrete in the CSA apparently unsealed/uncoated and has cracks and spalling as shown in Photos 18, 22, 23, 42, 45, 91, 134, 144, and 145. Mr. Robbins stated that the plastic liner I observed on part of the ground after some of the drums were removed (see Photos 42, 145, and 151) was originally put in place as secondary containment for the drums when they first started. However, they quickly outgrew it within three weeks of operating. <b>(AOC #2.b)</b></li> <li>Potential incompatibles being stored including drums of corrosives (Meta-Phos - phosphoric acid) near chlorinated compounds (see Photos 25, 30, 36, 44, and 45). <b>(AOC #2.b)</b> Dyna Strip 777 Presolve product drums were being stored in the area, but they were empty.</li> </ul> <p>On August 1, 2023, Mr. Robbins and Mr. Jones stated that they had received some of the CHDP barcoded labels, labeled the applicable drums, and shipped them to CHDP that day (August 1, 2023) (see Photo 134). Also, two drums of heels flush generated that day was labeled and dated with the year included (see Photos 87 and 89). They planned to have the remaining drums labeled and shipped to CHDP by the next day (August 2, 2023). On August 2, 2023, another approximately 100 drums of heels flush had been shipped to CHDP according to Mr. Robbins (see Photos 144, 145 and 151). CHESI Tank Wash also expected to transport the remaining drums to CHDP that day (August 2, 2023).</p> | | | | | | |

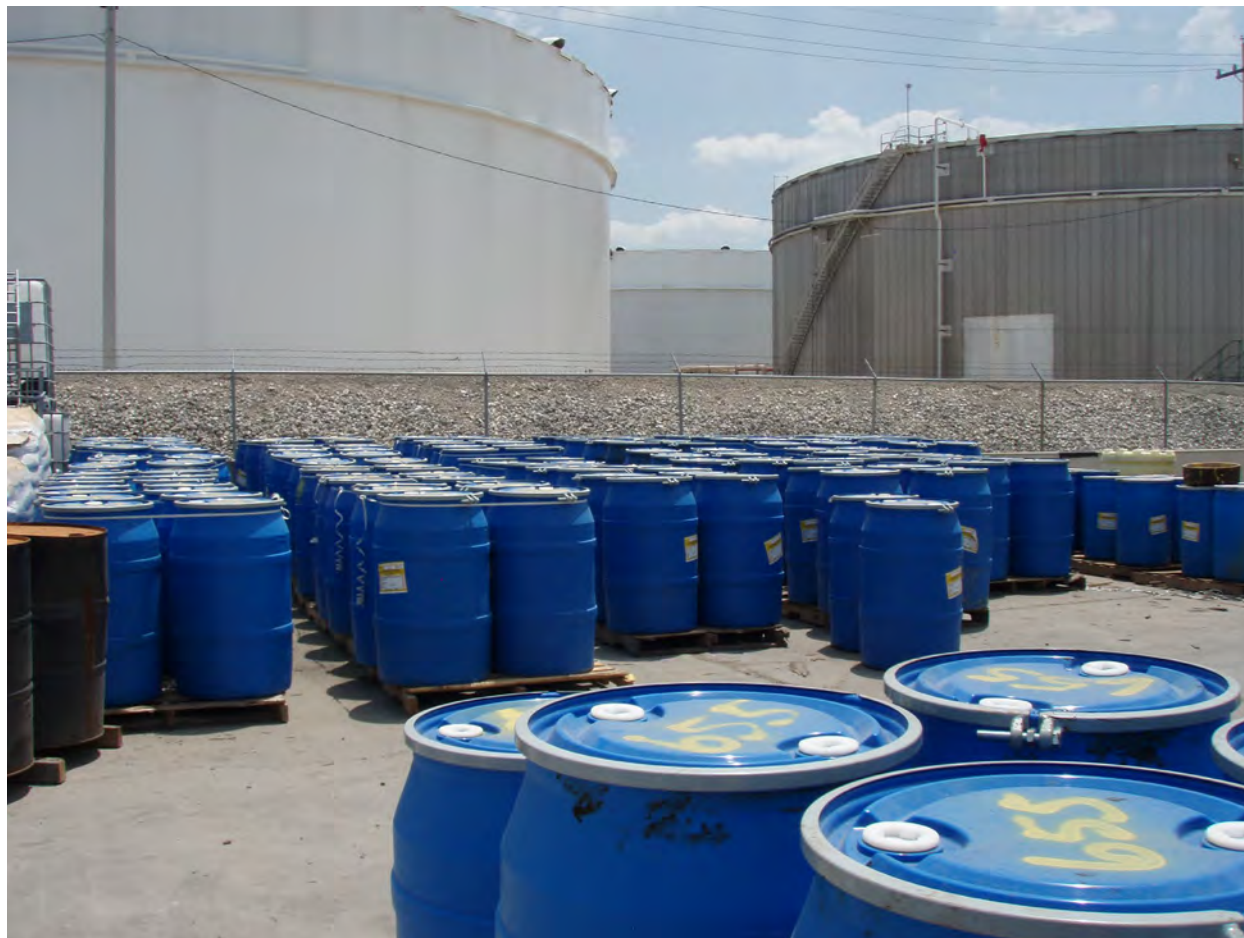
**PHOTO No. 22**

- Flushed with water which is also accumulated in the drum.
      - This completes the wastes added into the drums of heels flush generated from each tanker. The drums from each cleaning are assigned an internal batch number which is painted on top of each drum (see Photo 22).

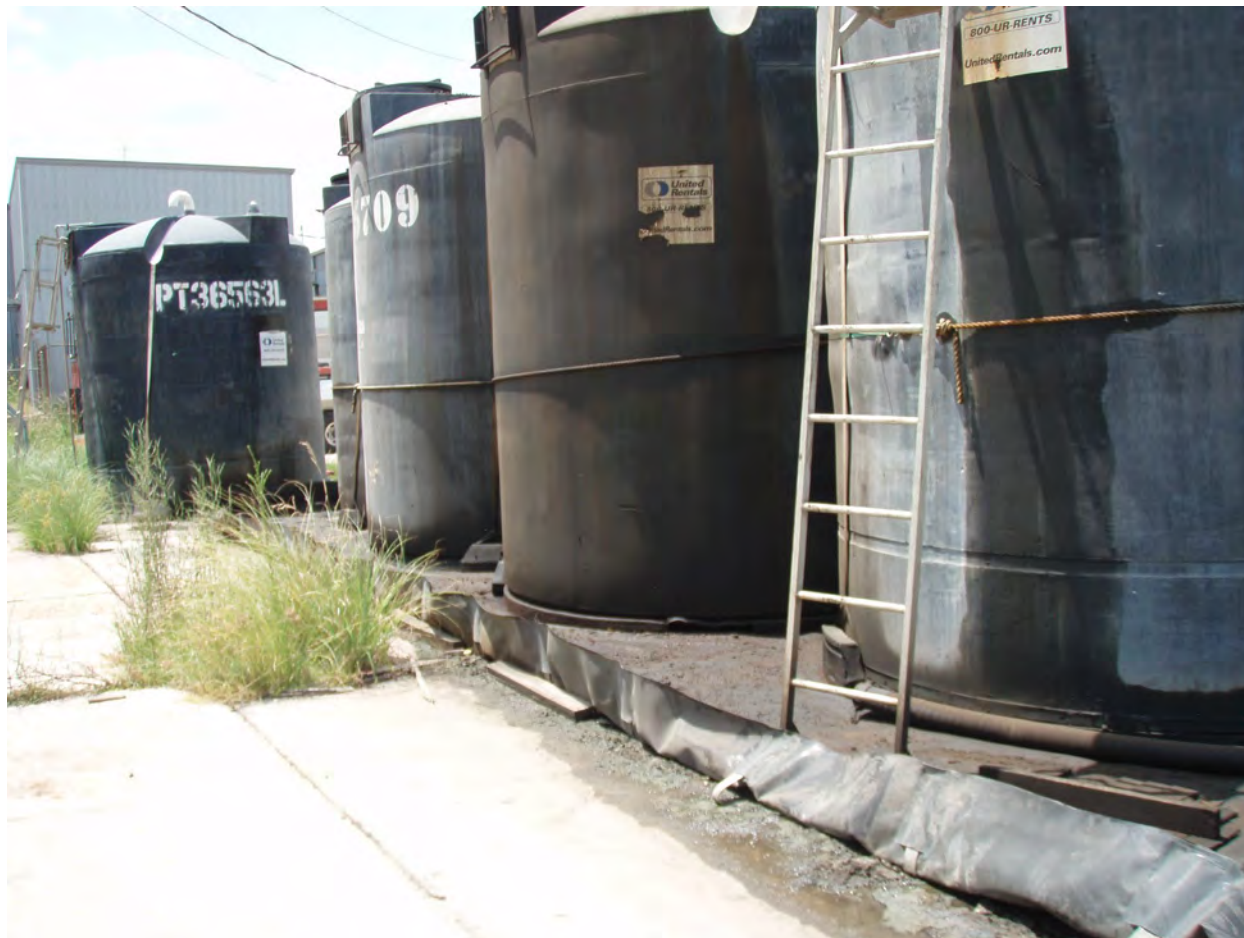
**PHOTO No. 38**

| Sum of<br>Photos in<br>Report | Photo #<br>Referenced<br>in Report | Photo # | Description / Direction Facing | Direction (see<br>attached<br>maps) | File Name<br>PXXXXXXX.JPG | Time | Date |
|---|---|---|---|---|---|---|---|
| 20 | 38 | 38 | CHESI Tank Wash Area - 4 HW tanks and water tank. Weeds growing in and around concrete seams that the HW tank secondary containment liner sits on. Liquid stains on concrete next to liner. | NW | 7310038 | 2:17 PM | 7/31/2023 |

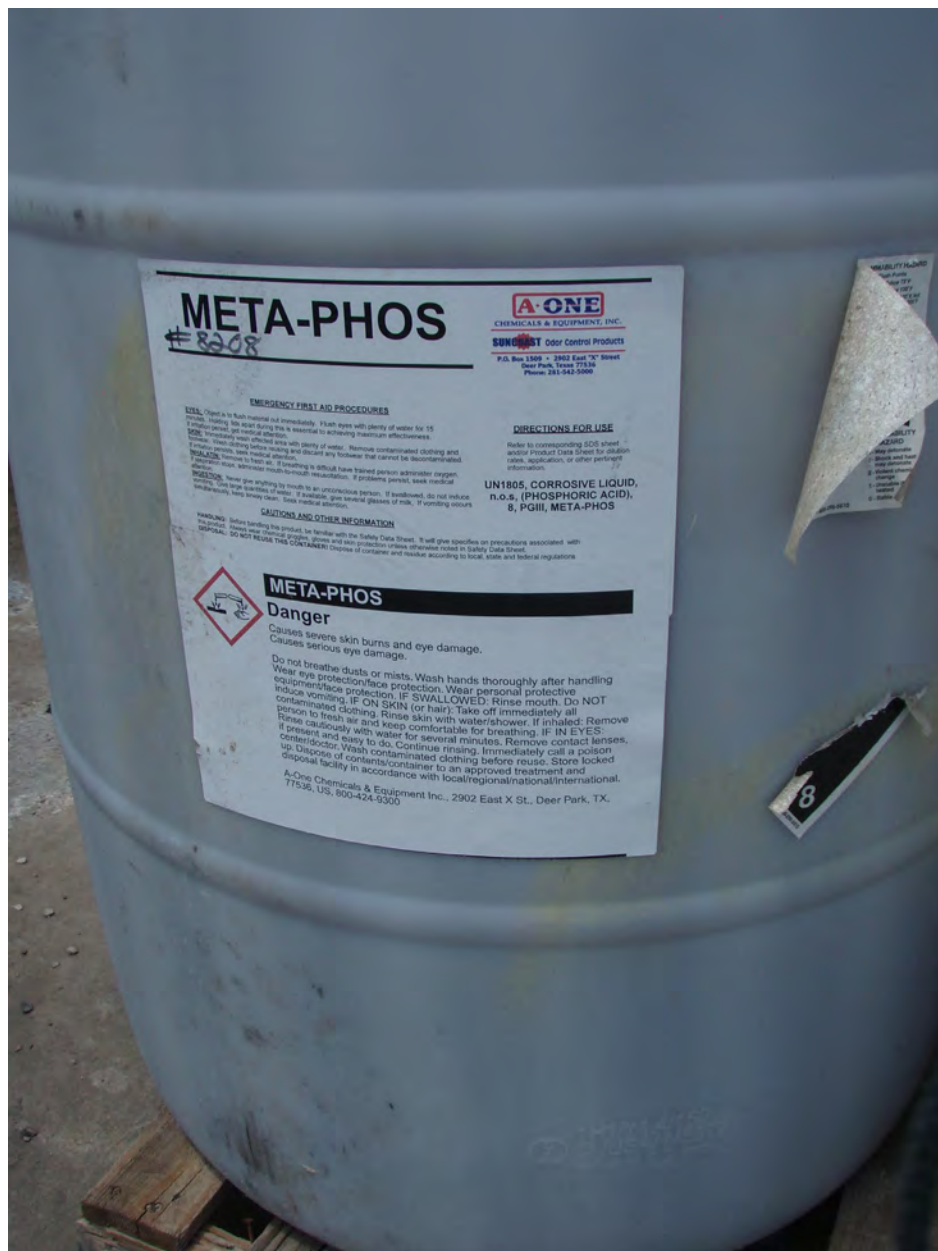
PHOTO No. 44

| Sum of<br>Photos in<br>Report | Photo #<br>Referenced<br>in Report | Photo # | Description / Direction Facing | Direction (see<br>attached<br>maps) | File Name<br>PXXXXXXX.JPG | Time | Date |
|---|---|---|---|---|---|---|---|
| 22 | 44 | 44 | CHESI Tank Wash Area - CSA - Close up of cleaning compound, Meta-Phos (corrosive, phosphoric acid), shown in Photos 37 and 45. | N | 7310044 | 2:18 PM | 7/31/2023 |

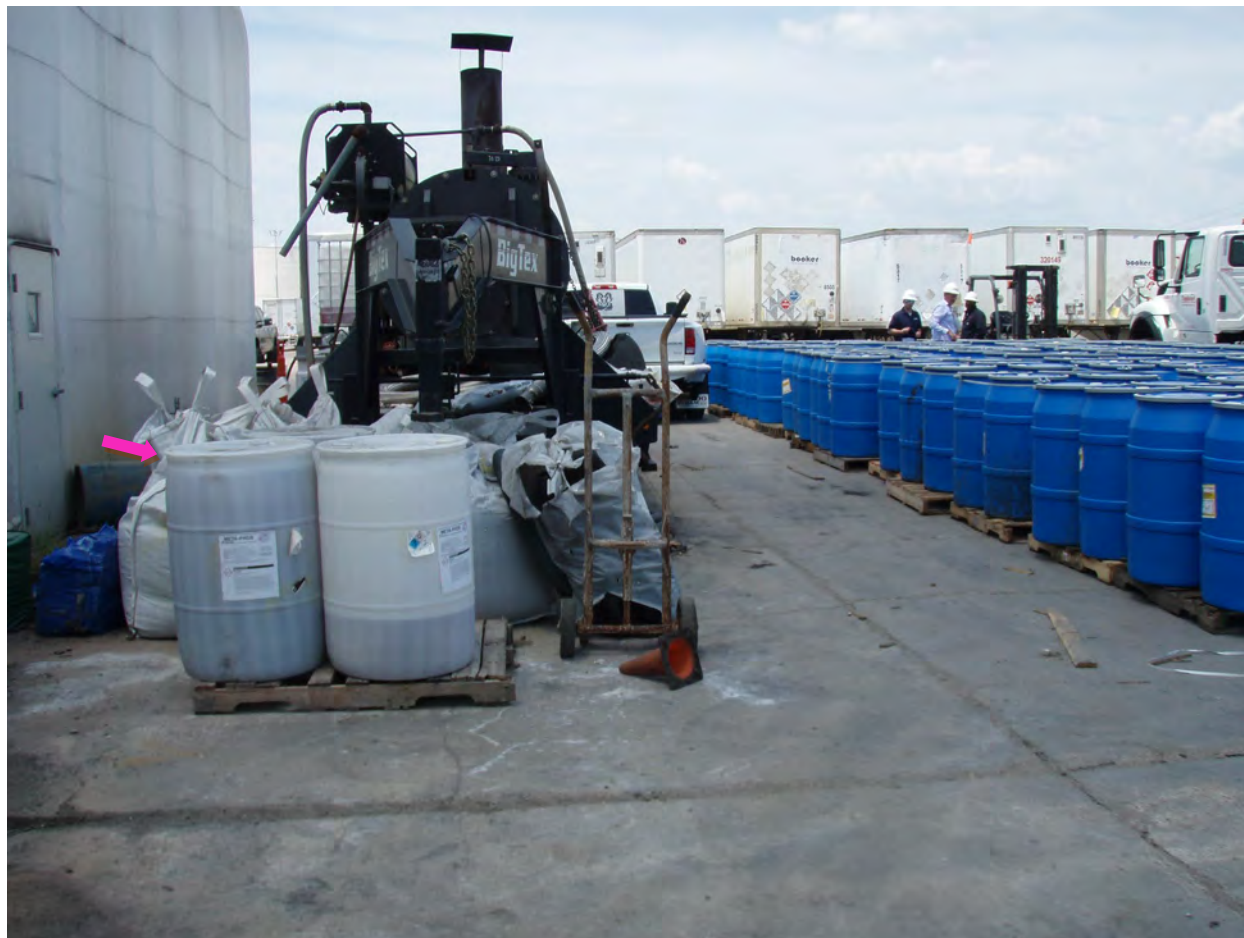
**PHOTO No. 45**

| Sum of<br>Photos in<br>Report | Photo #<br>Referenced<br>in Report | Photo # | Description / Direction Facing | Direction (see<br>attached<br>maps) | File Name<br>PXXXXXXX.JPG | Time | Date |
|---|---|---|---|---|---|---|---|
| 23 | 45 | 45 | CHESI Tank Wash Area - East side of wash pad next to CSA where products are stored in white drums and super sacks of carbon. Includes cleaning compound Meta-Phos (corrosive, phosphoric acid) (pink arrow) near numerous drums of HWorganics. | NE | 7310045 | 2:19 PM | 7/31/2023 |

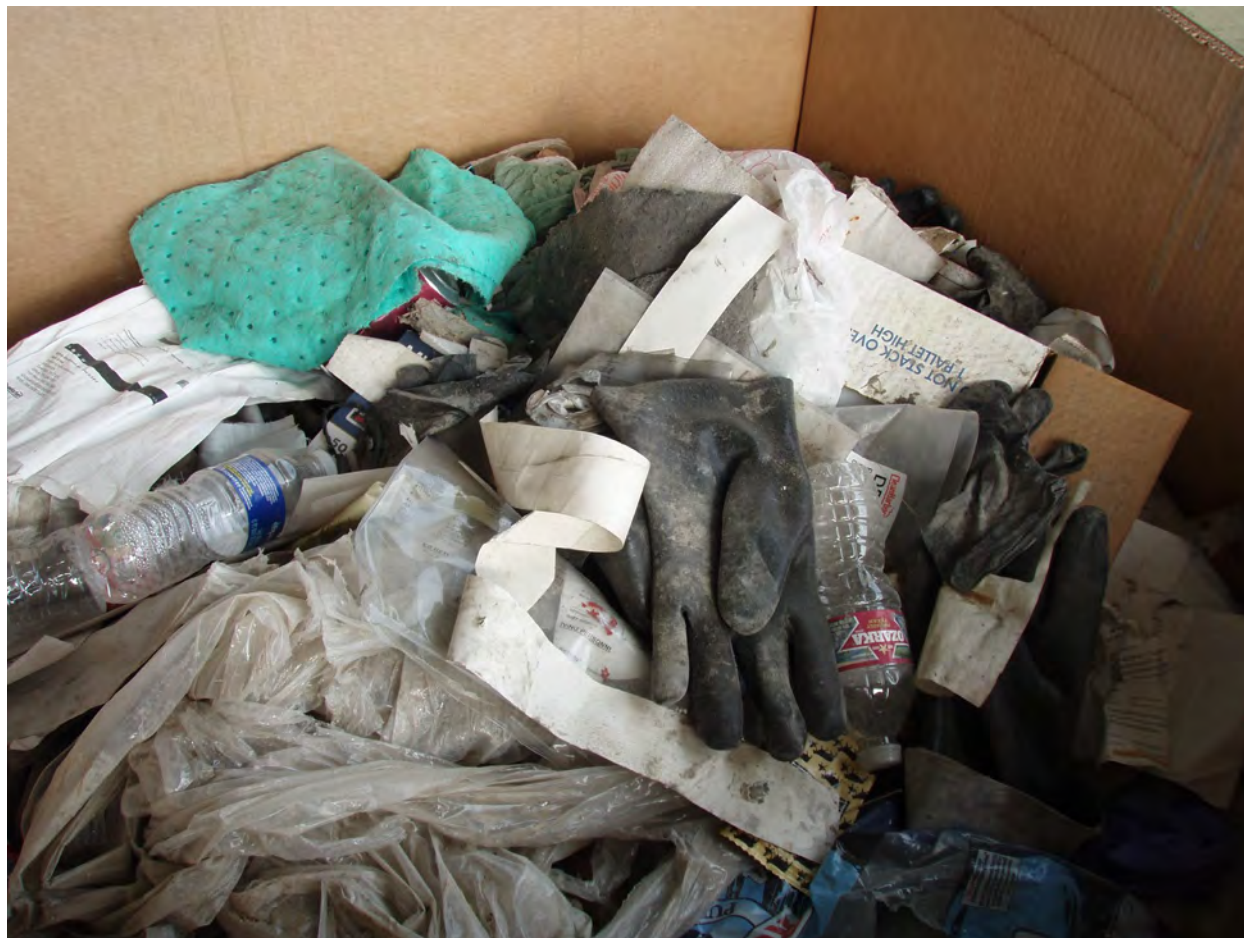
**PHOTO No. 56**

Description: CHESI Transfer Area - Sampling Bay - One 1-yd<sup>3</sup> open box about 1/3rd full of spent PPE labeled HW. Looking inside box on left in Photo 55.

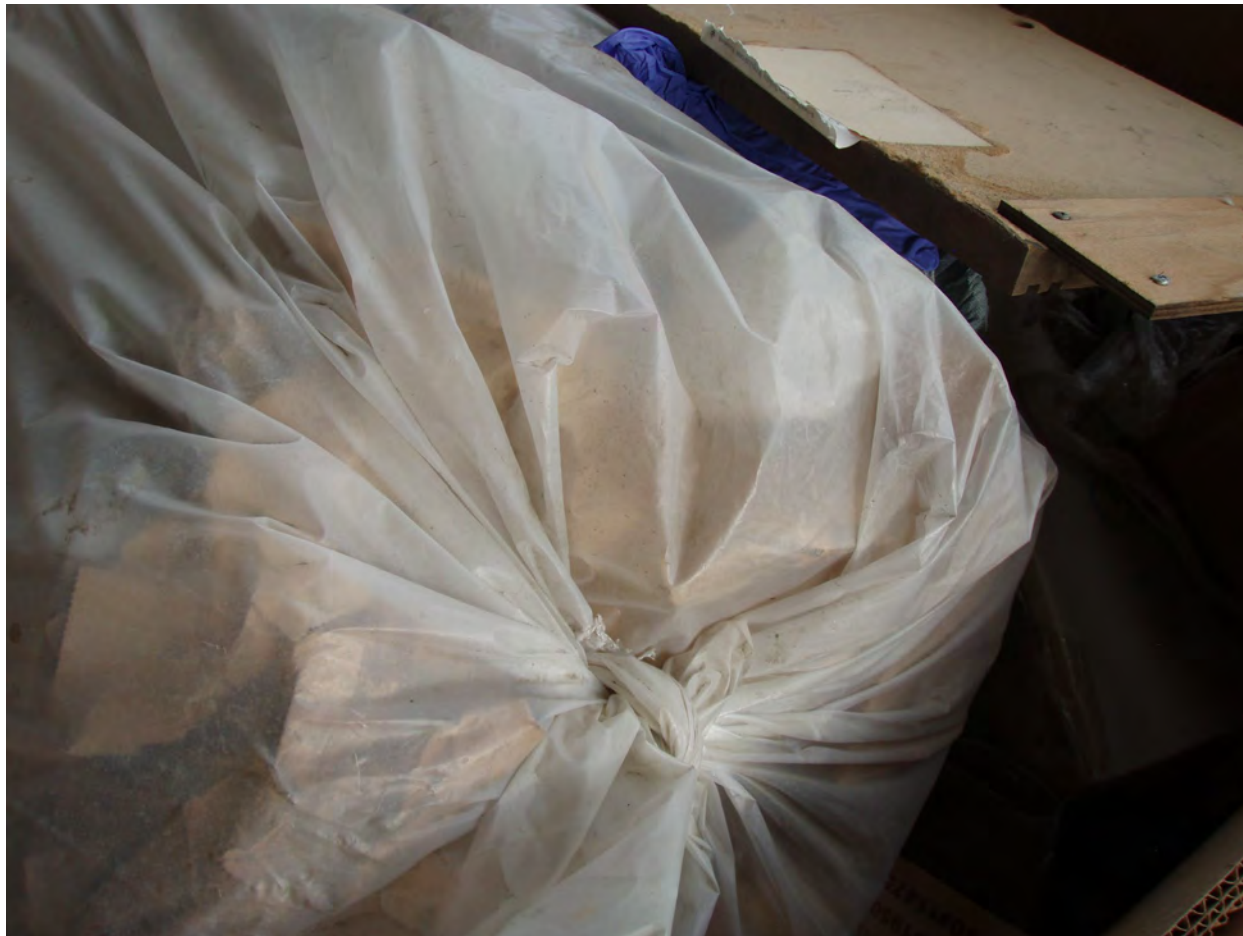
**PHOTO No. 57**

Description: CHESI Transfer Area - Sampling Bay - One 1-yd<sup>3</sup> open box about 1/3rd full of spent PPE labeled HW. Looking inside box on right in Photo 55.

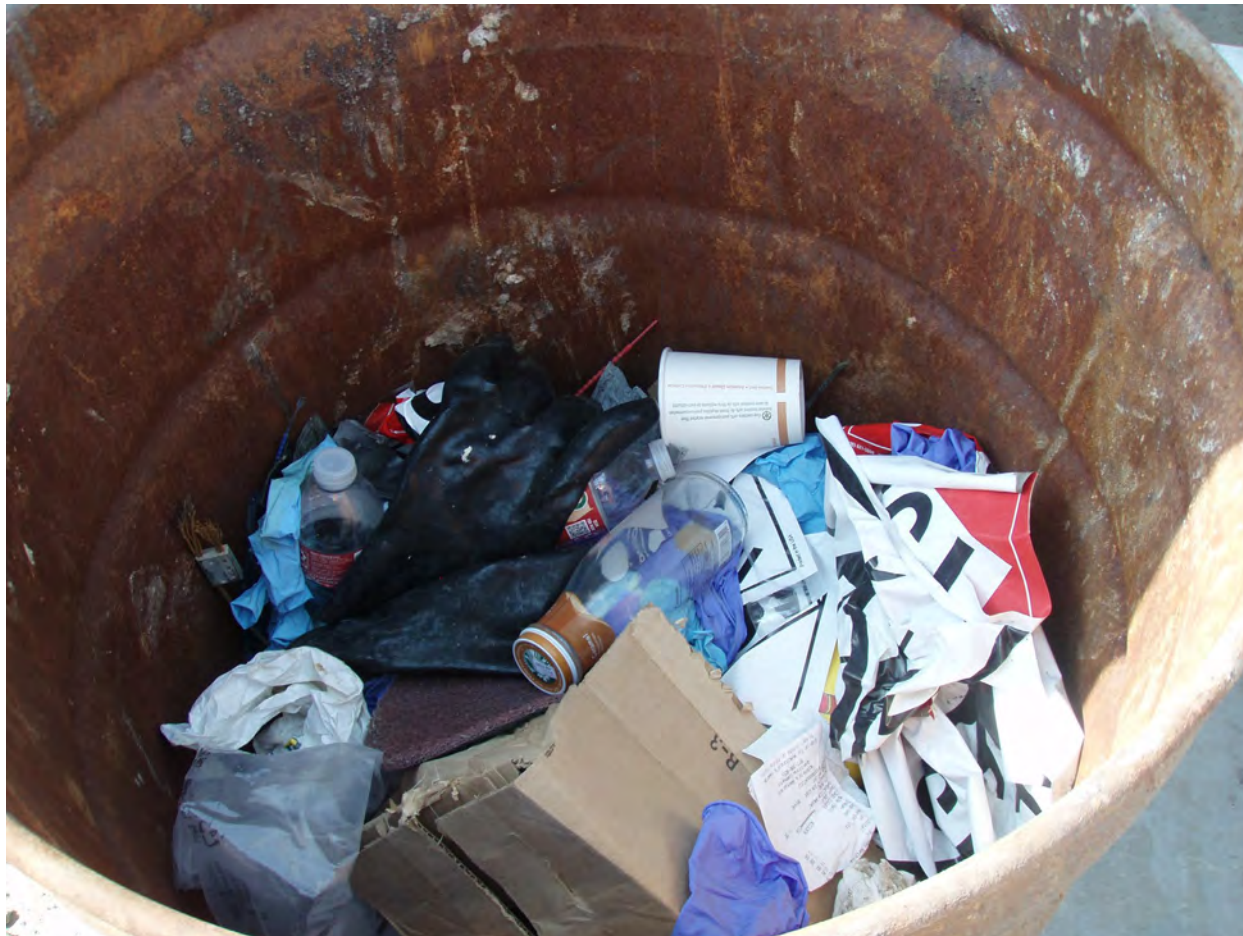
**PHOTO No. 79**

Description: CHESI Tank Wash Area - Looking inside open unlabeled drum approximately half full of spent PPE/general trash shown in Photo 80.

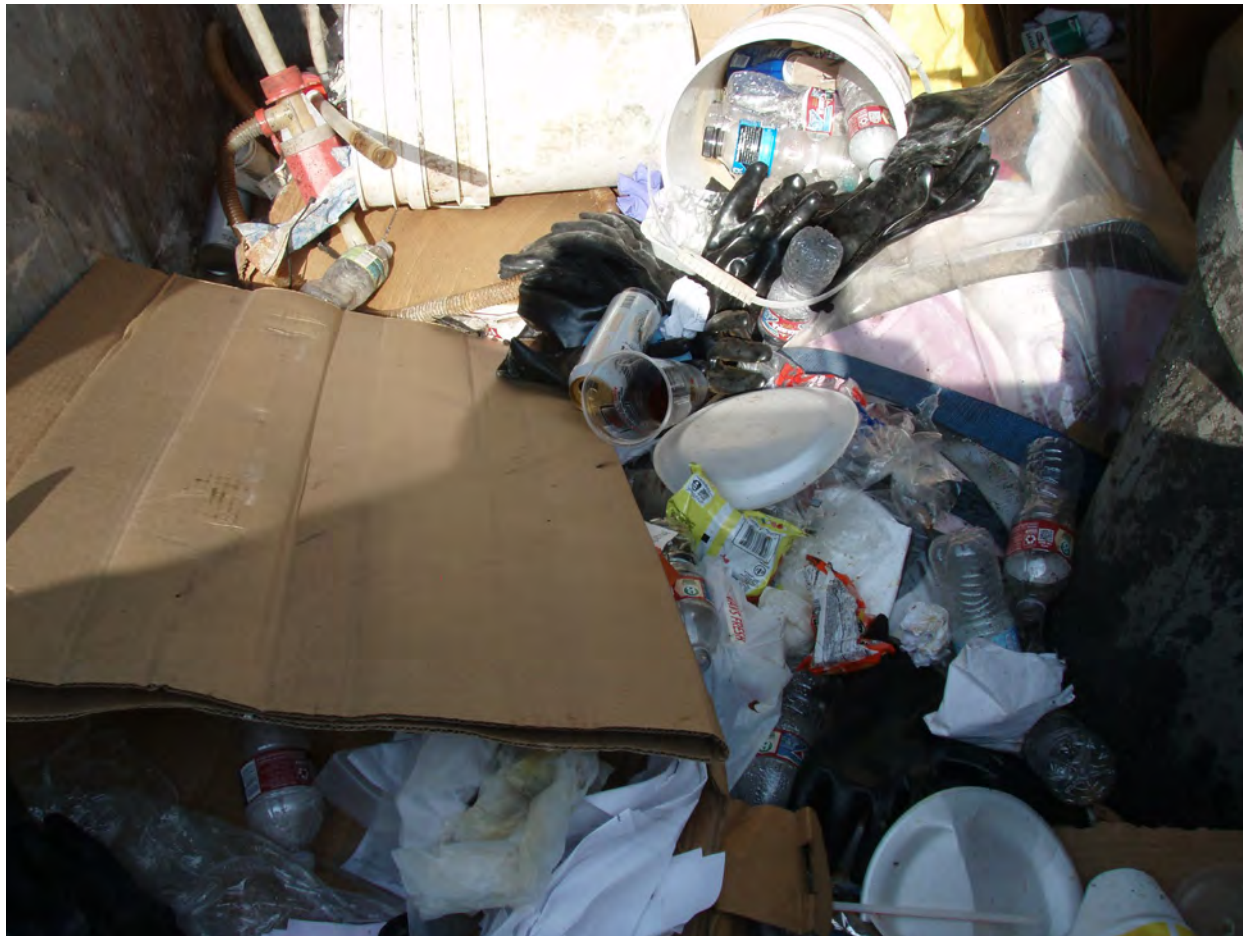
**PHOTO No. 103**

| Sum of<br>Photos in<br>Report | Photo #<br>Referenced<br>in Report | Photo # | Description / Direction Facing | Direction (see<br>attached<br>maps) | File Name<br>PXXXXXXX.JPG | Time | Date |
|---|---|---|---|---|---|---|---|
| 51 | 103 | 103 | CHESI Tank Wash Area - Looking inside the Waste Management approximately 3-cubic yard dumpster about half full of spent PPE/general trash that was open, unlabeled, and undated shown in photo 141. | SW | 8010103 | 10:07 AM | 8/1/2023 |

Description: CHESI Tank Wash Area - Looking inside the Waste Management approximately 3-cubic yard dumpster about half full of spent PPE/general trash that was open, unlabeled, and undated shown in photo 141.

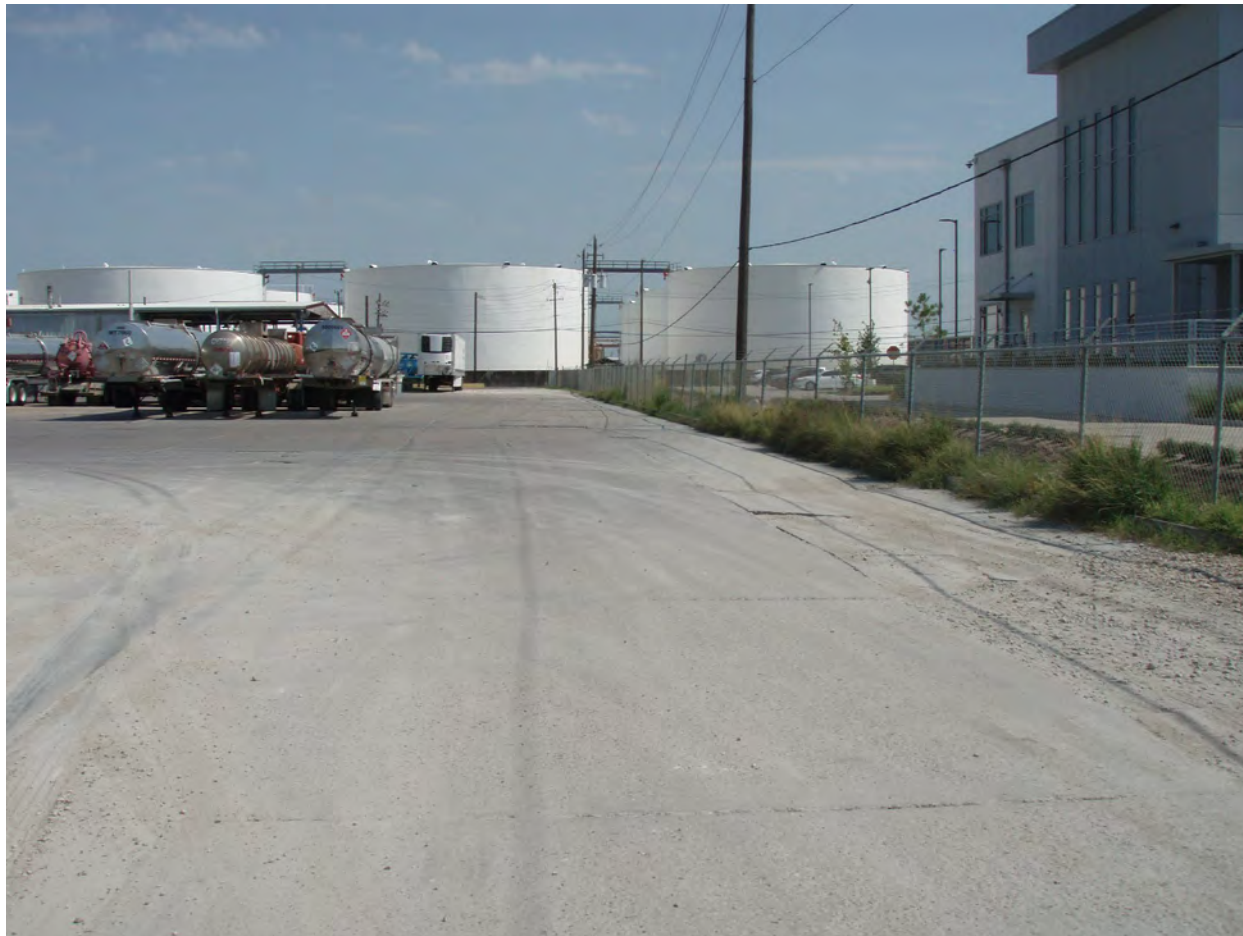
**PHOTO No. 112**

Description: CHESI Transfer Area - East property line security fence along the roll-off 10-day storage area and cracks and spalling in concrete.

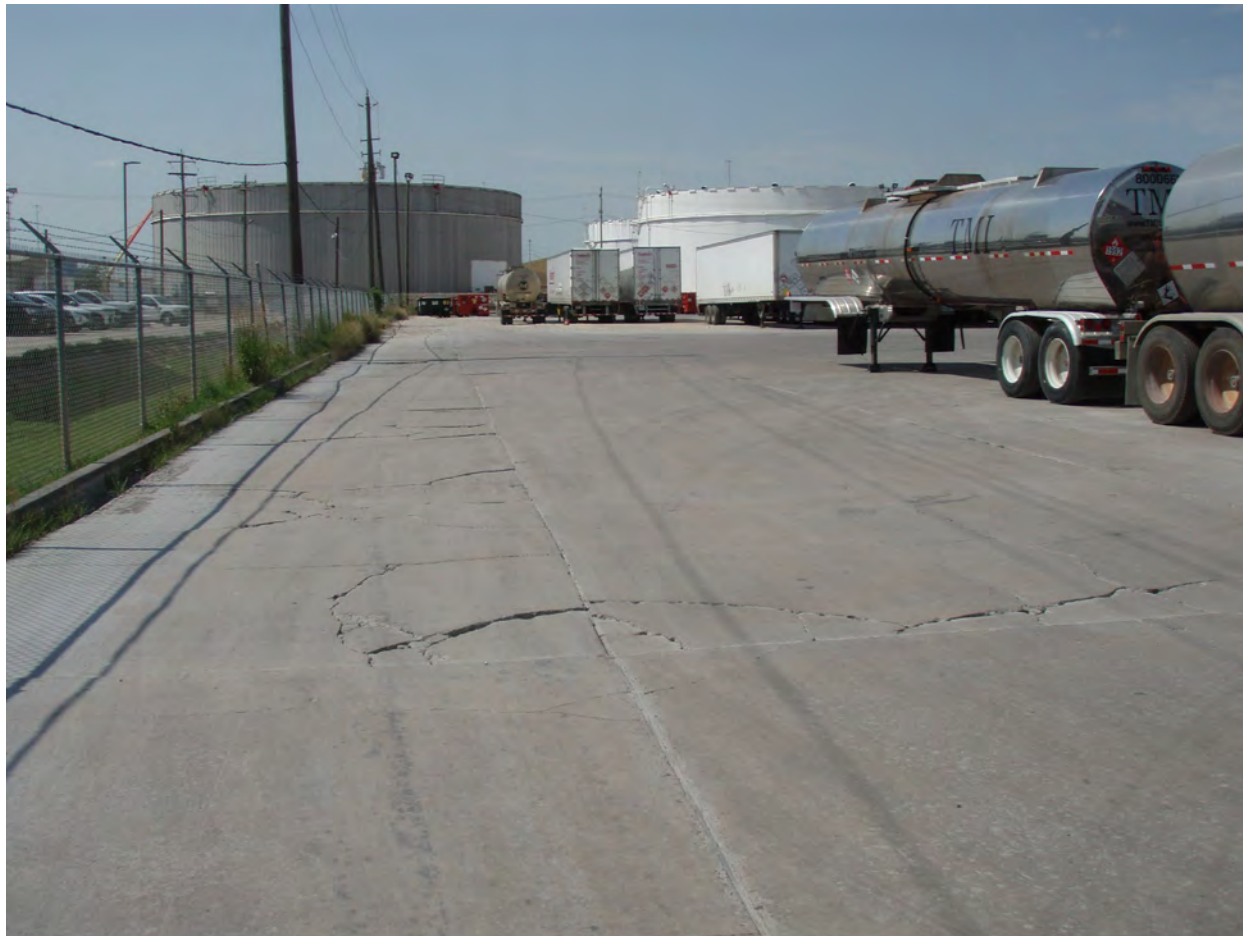
**PHOTO No. 114**

Description: CHESI Transfer Area - East property line security fence along the roll-off 10-day storage area and cracks and spalling in concrete.
