**Region 6 - Enforcement & Compliance Assurance Division**  
**INSPECTION REPORT**

| Inspection Date(s): | 7/31/2023 – 8/2/2023 | |
| Company Name: | Clean Harbors Environmental Services, Inc. | |
| Facility Name: | Clean Harbors Environmental Services, Inc. (CHESI) | |

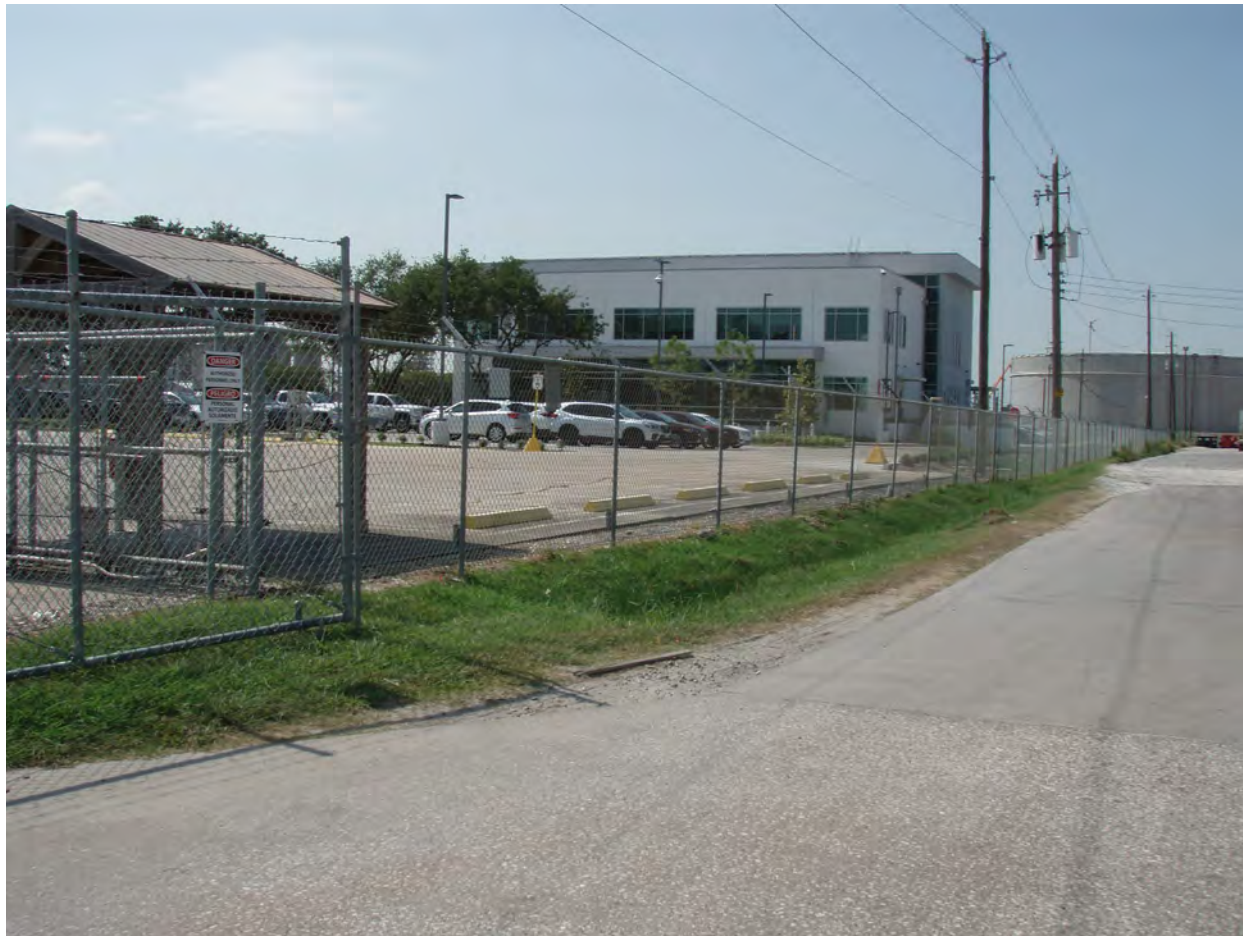
**PHOTO No. 116**

- The north security fence has three openings of which two have gates that remain open. The other opening near the transportation office has no gate and I observed no warning signs near it (see Photos 116 - 118, 129, 136 and 139). Also, I observed warning signs posted on the north, south, and east fences but spaced far apart (see Photos 18, 100, 108, 112, 114, and 125). **(AOC #1.d)** Mr. Riffel stated that they have ordered more warning signs to be posted around the facility.

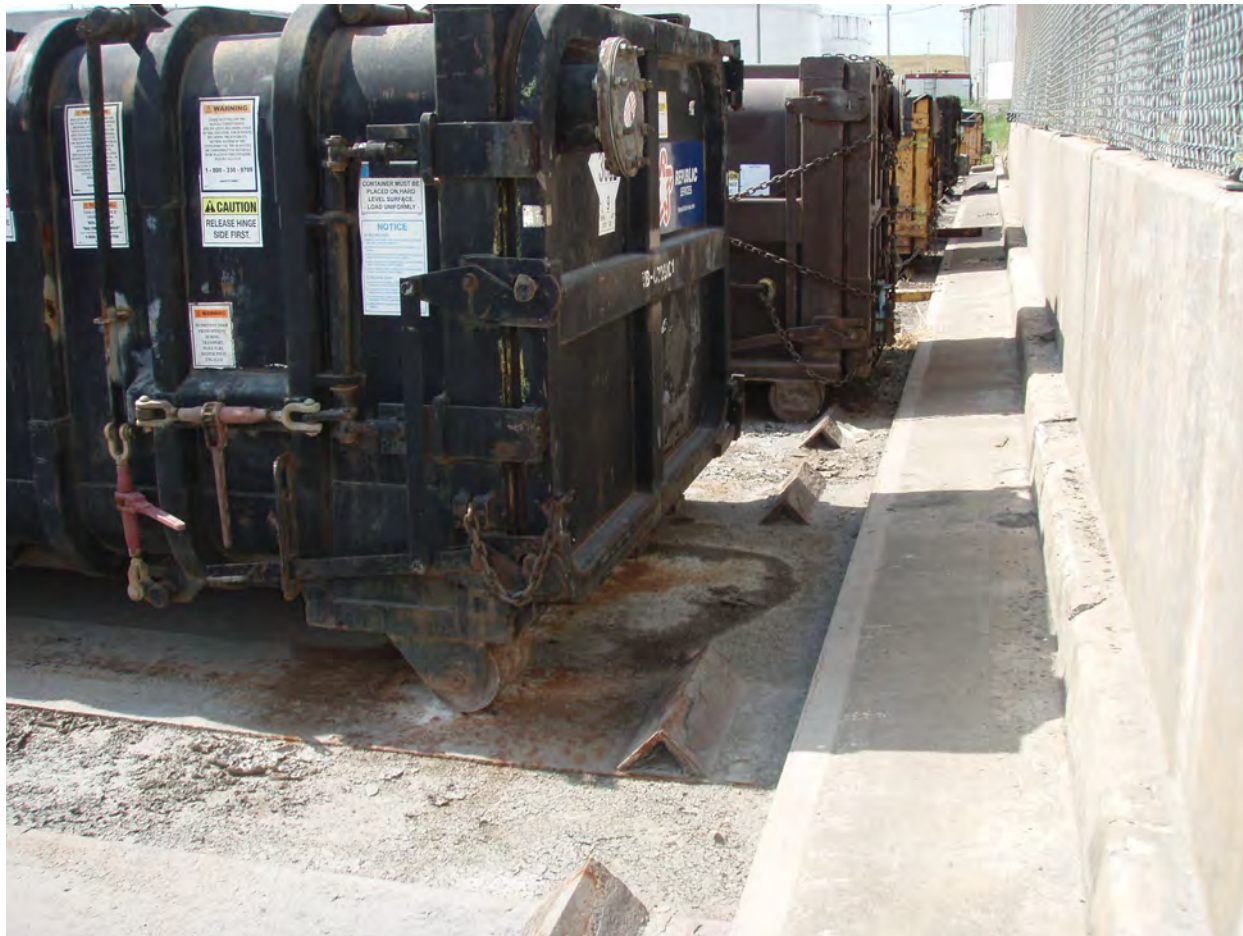
**PHOTO No. 122**

- Container labeled with Manifest #018168736FLE – I observed a stain underneath it (see Photos 122 and 124). **(AOC #3.c)**

Description: CHDP Waste Receiving Pad - BIN with HW label stating manifest #018168736FLE and stain under the west end of container. Residue in containment area.

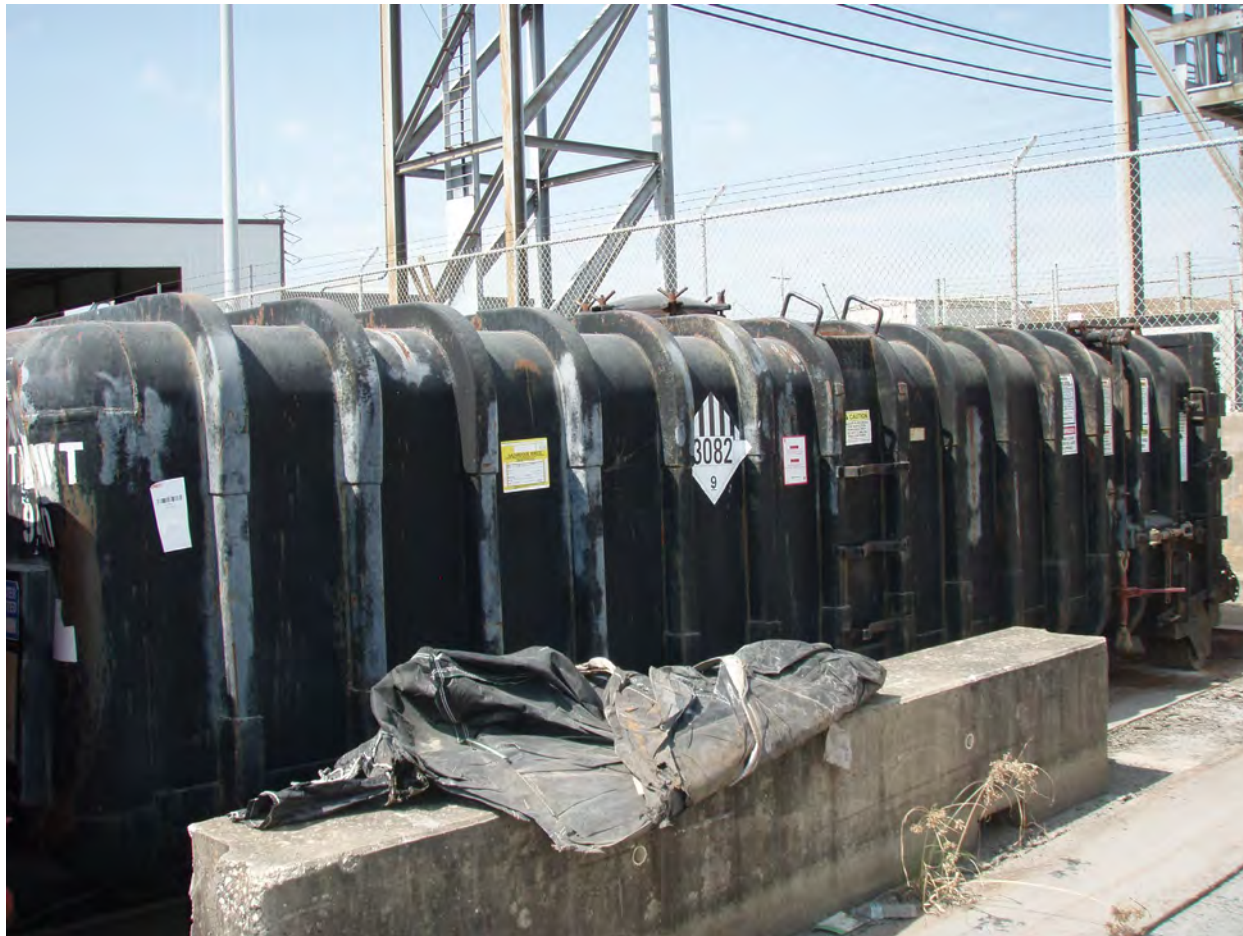
**PHOTO No. 124**

Description: CHDP Waste Receiving Pad - BIN with HW label stating manifest #018168736FLE and stain under the west end of container.

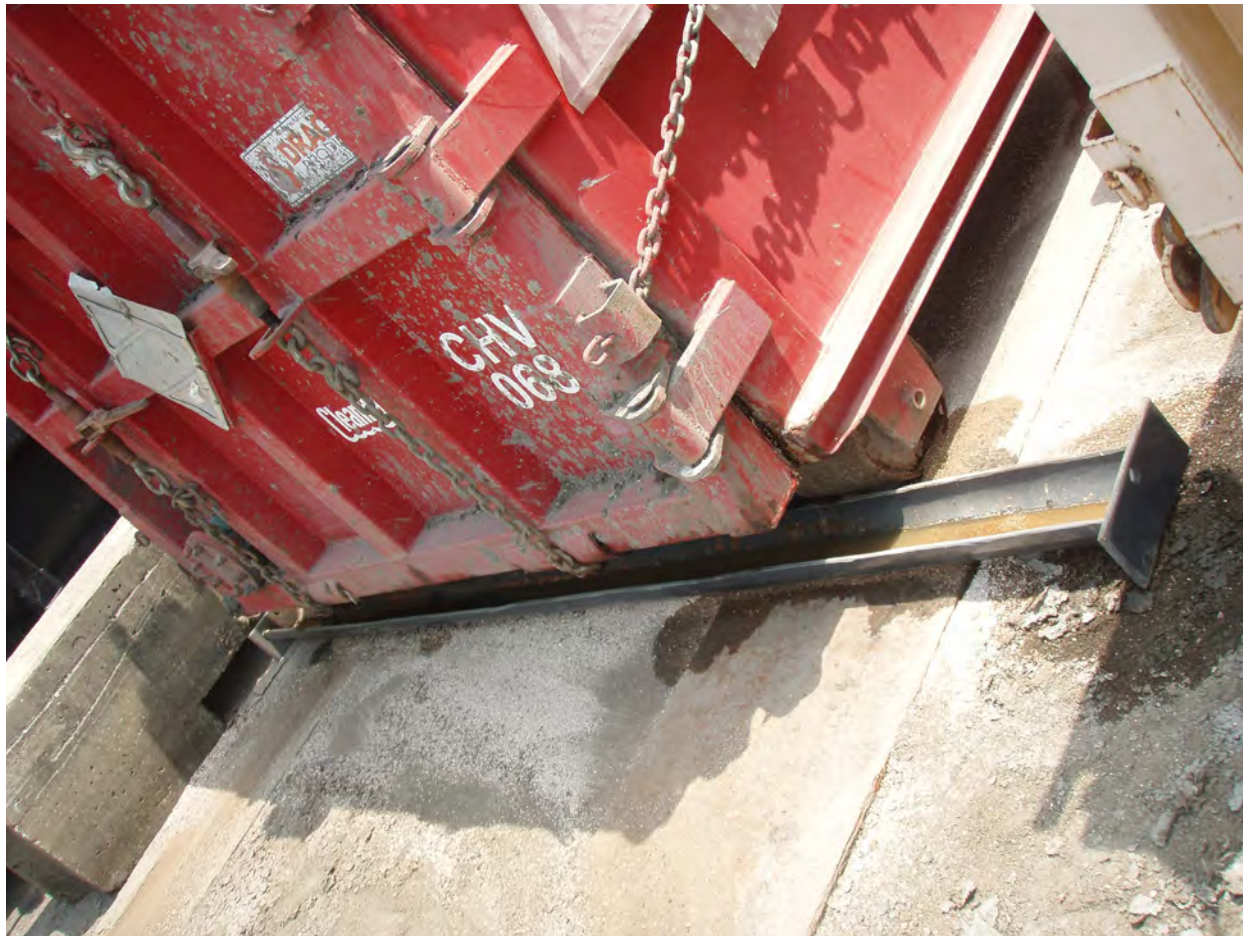
**PHOTO No. 135**

- I selected the following roll-offs to review related manifests and waste profiles:
  - Container #VB12007 – randomly selected for tracking.
  - Container #CHVB0684 – leaking, labeled PCBs, and believed to be empty (see Photos 66 and 70). Since it was leaking, I noted it as a concern to verify that it did not contain a hazardous waste since roll-offs are reused and PCBs could be mixed with hazardous waste. **(AOC #3.b)** A catch container was placed underneath to catch any leaks/spills until cleaned up (see Photos 135).

Description: CHDP Waste Receiving Pad - BIN #CHVB0684 that was labeled PCB and leaking after a catch container was placed underneath the leak to catch the waste.

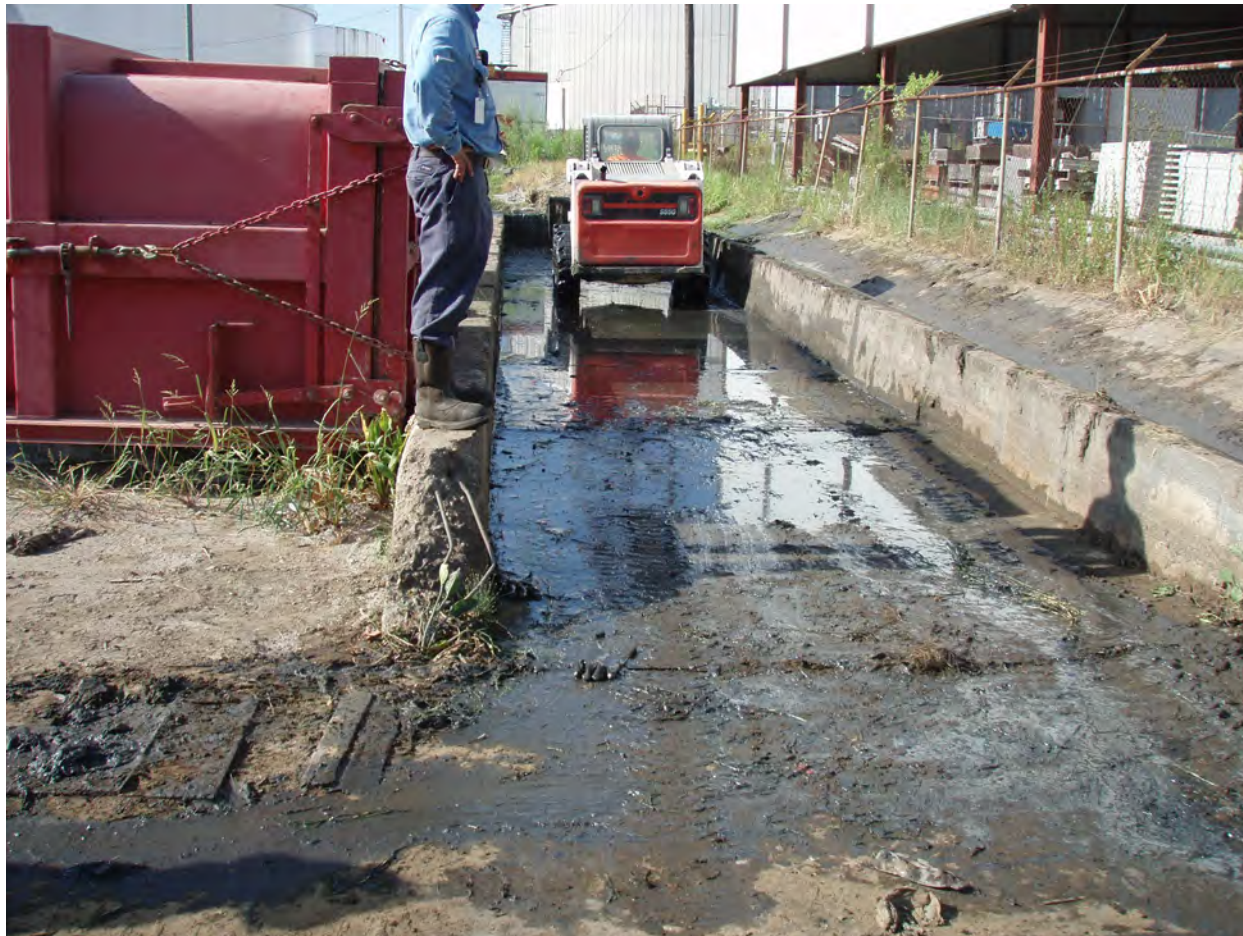
**PHOTO No. 140**

- I observed in the drainage collection area cracks in a wall along with weeds, algae, residue, accumulated liquid, and little fish swimming (see Photos 72, 75, 77, and 78). Also, I observed a crack on the south end, stains as stated below, and residue throughout the containment that Mr. Riffles stated was dirt being blown/tracked in (see Photos 66, 75 - 77, 122, 125, and 135). **(AOC #3.a)** During the inspection, CHDP started cleaning out this containment area (see Photo 140).

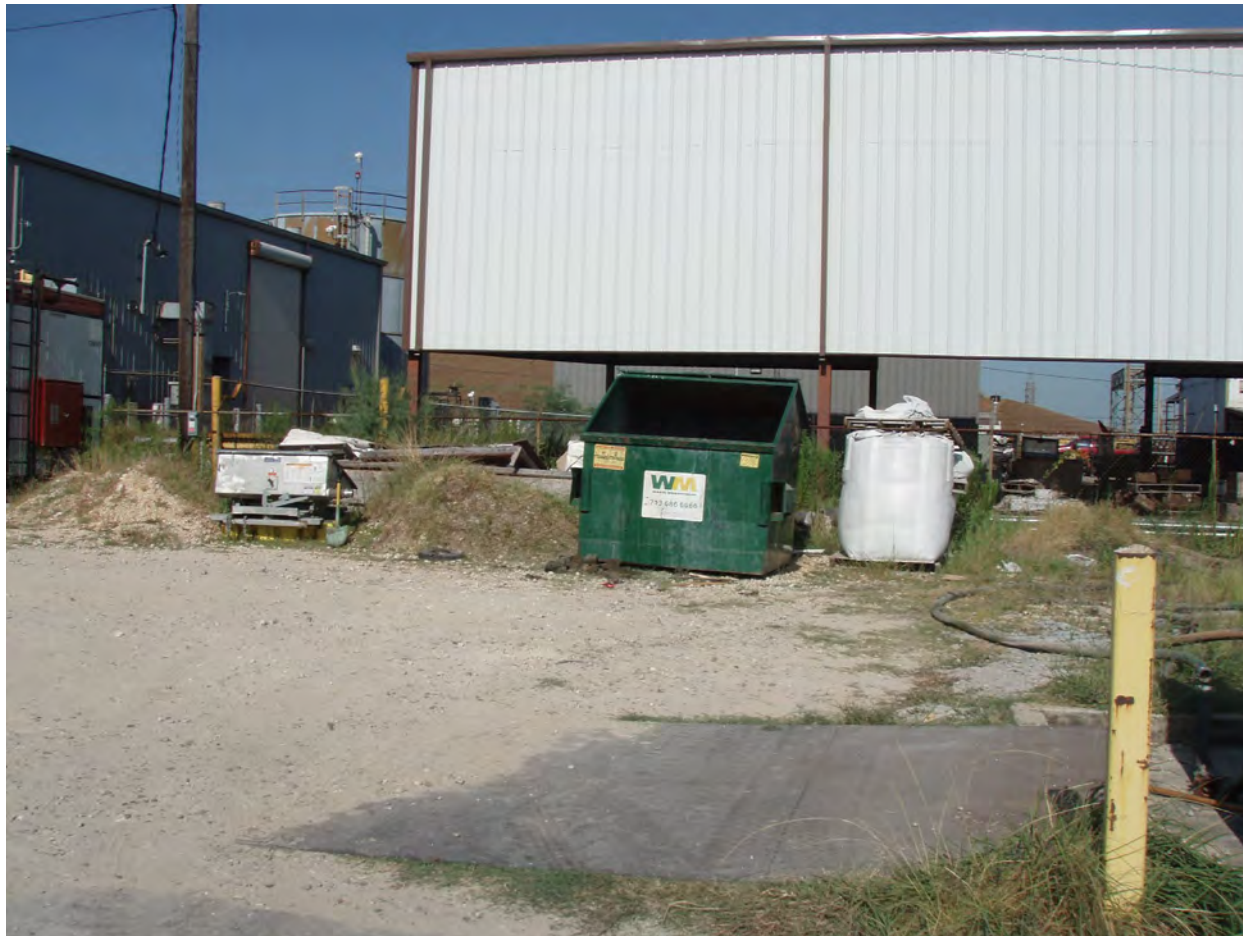
**PHOTO No. 141**

| Sum of<br>Photos in<br>Report | Photo #<br>Referenced<br>in Report | Photo # | Description / Direction Facing | Direction (see<br>attached<br>maps) | File Name<br>PXXXXXXX.JPG | Time | Date |
|---|---|---|---|---|---|---|---|
| 73 | 141 | 141 | CHESI Tank Wash Area - Waste Management approximately 3-cubic yard dumpster about half full of spent PPE/general trash that was open, unlabeled, and undated and screened hopper shown in photo 106. | SW | 1010141 | 10:32 AM | 8/2/2023 |

Description: CHESI Tank Wash Area - Waste Management approximately 3-cubic yard dumpster about half full of spent PPE/general trash that was open, unlabeled, and undated and screened hopper shown in photo 106.

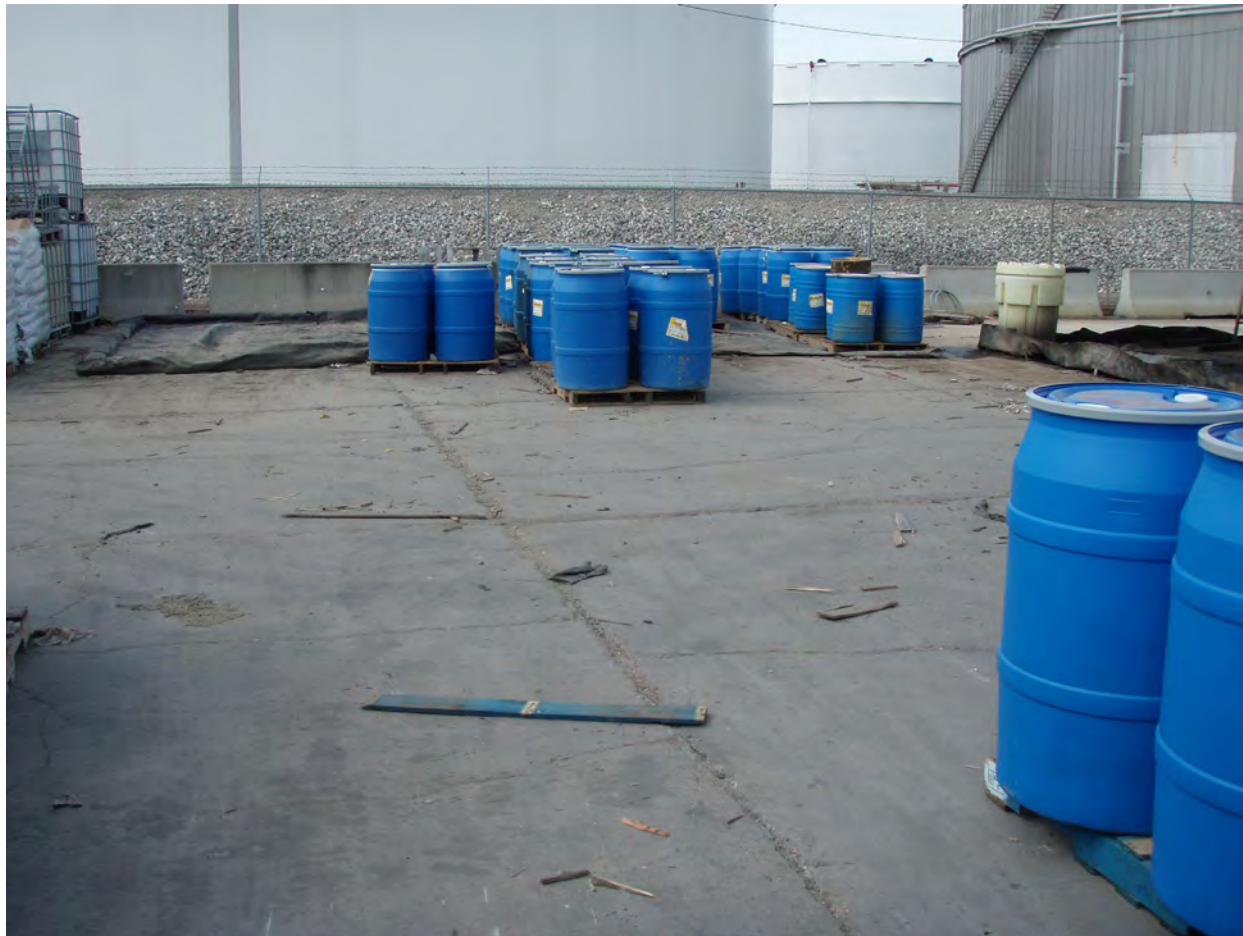
**PHOTO No. 145**

Description: CHESI Tank Wash Area - CSA after some of the drums of heel flushes had been removed and taken to CHDP. Black liner was originally put in place as secondary containment for the drums when they first started. Spill kit in yellow drum inside the 4 HW tank containment liner. Cracks and spalling throughout storage area.

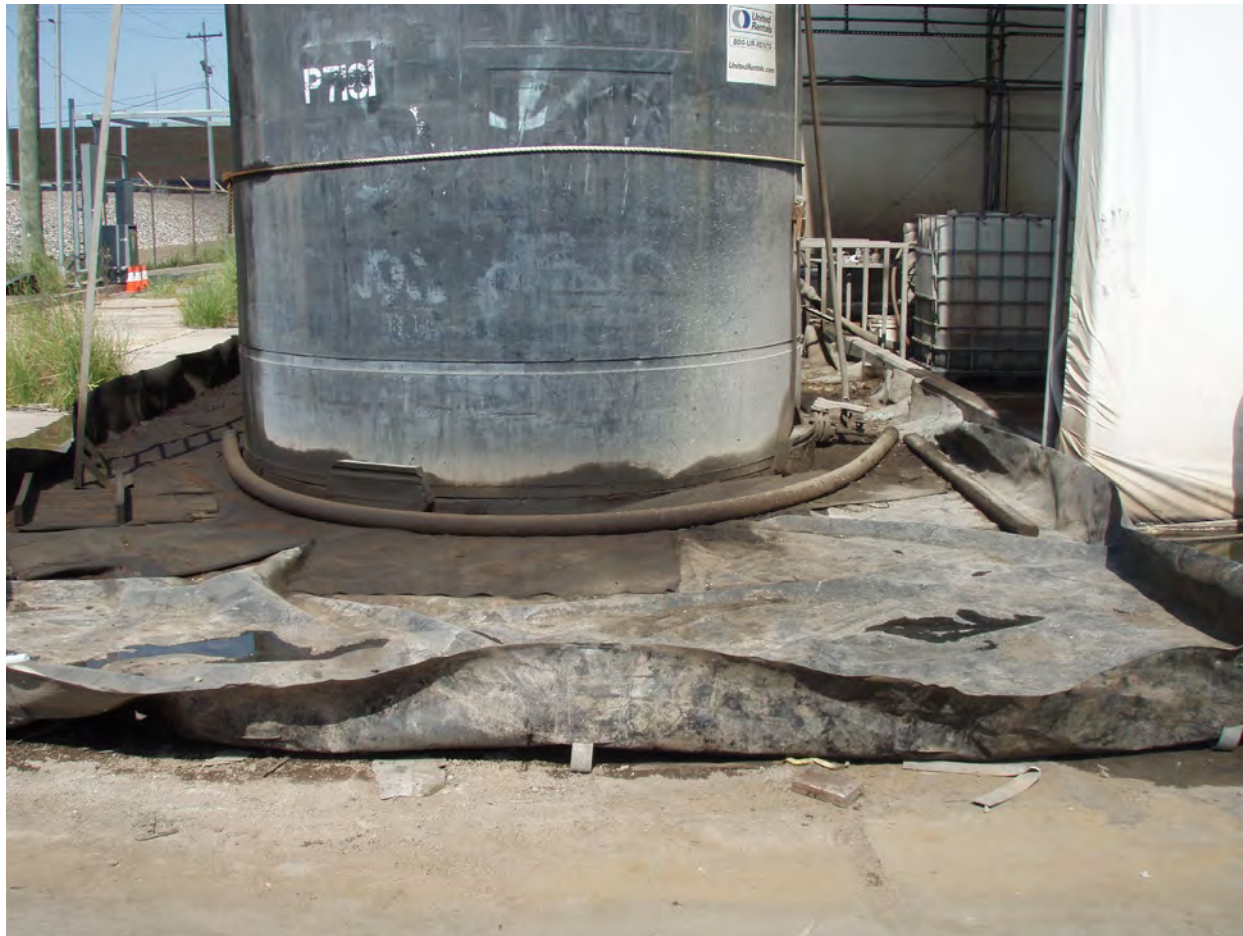
**PHOTO No. 146**

| # | WASTE NAME | GENERATION PROCESS | FACILITY'S HAZ. WASTE DETERMINATION | ESTIMATED GENERATION RATE & AMOUNT ACCUMULATED ON-SITE | ON-SITE MANAGEMENT | OFF-SITE MANAGEMENT |
|---|---|---|---|---|---|---|
| <p>During the inspection, they started cleaning out the containment liner on the south and east sides (see Photos 146 and 149). Mr. Robbins stated that he plans to have the tanks cleaned prior to returning them to the rental company. Mr. Robbins stated that they will be removing two tanks and placing a concrete containment around the remaining two tanks.</p> <p><b>Wash Bays Condition</b> – On July 31, 2023, the two wash bays had not been used in about a week according to Mr. Robbins. I observed no one working in the area and some liquid on the wash bay concrete floor that Mr. Robbins stated was from recently washing down the pad (see Photos 2 and 3). He stated that the pad is power washed after each cleaning. The sump contained a small amount of liquid with a sheen (see Photo 3). Also, on August 1, 2023, I observed in the wash bay a tanker trailer (#SST708015) for cleaning, and no one working in the area. Liquid was puddled on the pad and the sump was full up to about 6 inches from the top and had a sheen near and inside (see Photo 85). Two drums of heels flush had been generated and dated 8/1/23 (see Photos 87 and 89). The wash bay concrete floor had some of the seams/cracks sealed as pointed out by Mr. Robbins. However, I observed liquid puddles and cracks in the floor that is used to convey the hazardous waste to the sump. See Photos 2, 3, 81, and 89. <b>(AOC #2.e)</b></p> <p>The hazardous waste tank secondary containment liner sits on a concrete area that appears uncoated/unsealed and has cracks, spalling, and weeds growing in between the seams (see Photos 16, 17, 38, 99, 100, 146, and 149). Mr. Robbins stated that as the tankers are being cleaned, there is overspray from the top of the tankers onto the pad and tank containment liner. In addition, he stated that there are holes in the hoses that have been taped with duct tape (see Photos 11 - 13), but waste still sprays from these holes onto the pad and containment liner. Based on this, it appears that waste would be released from the wash bay pad onto the concrete area between the wash pad berm and the tank containment liner wall and also onto the west side of the pad (see Photos 3, 6, and 11). Therefore, I noted as a concern failing to operate to minimize a release. <b>(AOC #2.d)</b></p> | | | | | | |
