Clean Water Act (CWA) Inspection Report

| <b>Type of Inspection</b> | CEI - Compliance Evaluation Inspection | | | |
| <b>Permittee Name</b> | Emerald Forest Products – Plant 1 | | | |
| <b>Permit # / ODEQ File #</b> | ORR222065 / 10889 | | | |

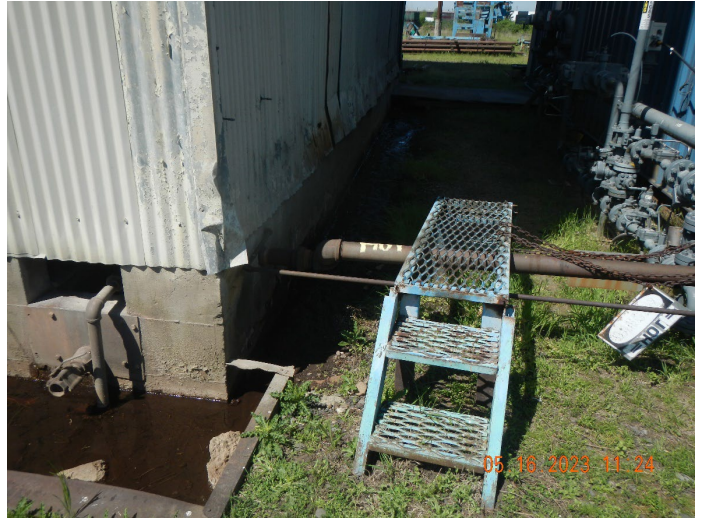
Photo #:05 (DSCN3260)

Description: Facing west, photo of basin off of the boiler building, discharging to the channel. Observed slight crack in the concrete structure holding the interior boiler make-up water being routed to sanitary.

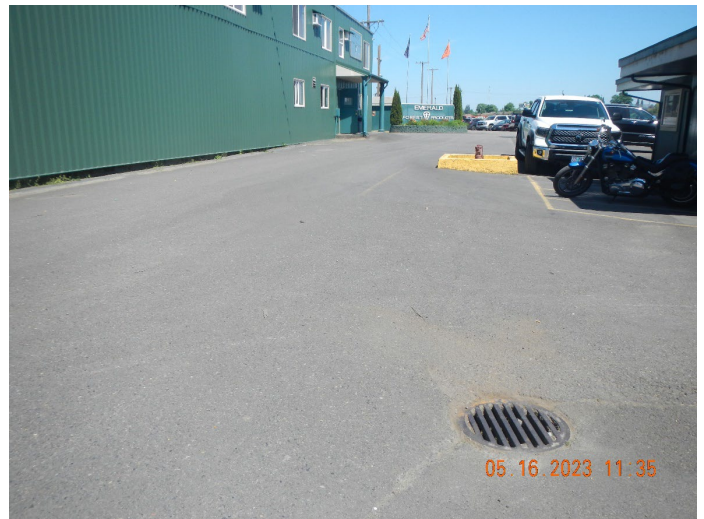
We observed a northern catch basin within Basin #1 (**Photo 9**). We also observed a small amount of water flowing into the eastern portion of the municipal drainage basin from a subsurface pipe (**Photo 10**). Mr. Maples wasn't aware of source of the observed water. We continued south and observed the paved areas around the metal fabrication shop within Drainage Basin #5. (**Photo 12**).

Photo #:12 (DSCN3267)  
Description: Facing north, photo of storm drain catch basin west of the metal/fabrication shop.

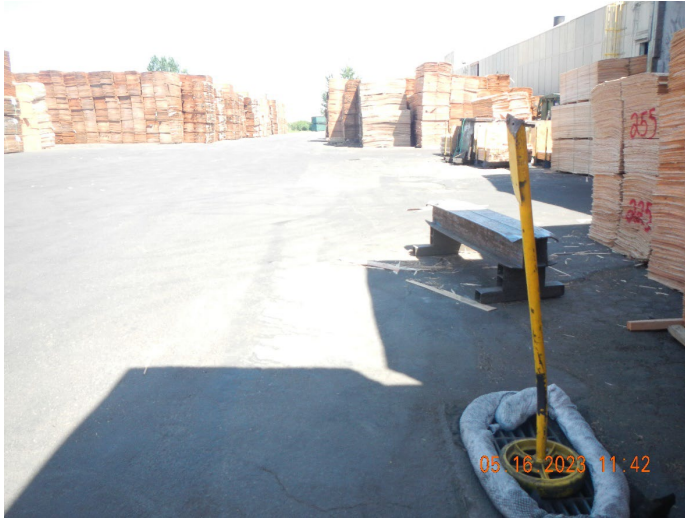
Photo #:13 (DSCN3268)

Description: Facing north, photo of the Outfall #1 monitoring catch basin.

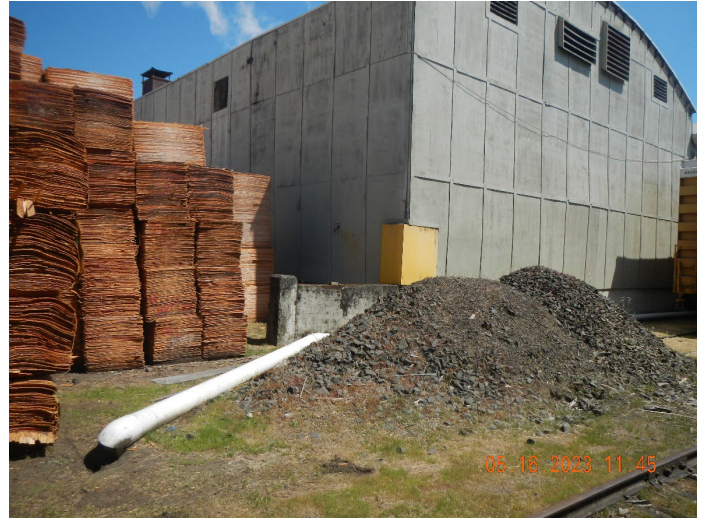
Photo #:14 (DSCN3269)

The walk-through concluded after viewing the discharge location for Basin #4. Basin #4 includes approximately 80% of the manufacturing facility roof, including the south half of the finished plywood storage are roof. Roof drains enter an 8" PVC pipe located on the south of the production building. The pipe discharges to a dead-end sump, located in the vegetated area where stormwater is either infiltrated or evaporated (**Photo 14**).

Description: Facing north, photo of roof drain downspout off of the southwest manufacturing facility roof.
