**Region 6 - Enforcement & Compliance Assurance Division**  
**INSPECTION REPORT**

| Inspection Date(s): | 03/12/2024 | |
| Company Name: | <b>Jerry Langley Oil Company, LLC</b> | |
| Facility Name: | <b>Bertie No. D-7 SWD</b> | |

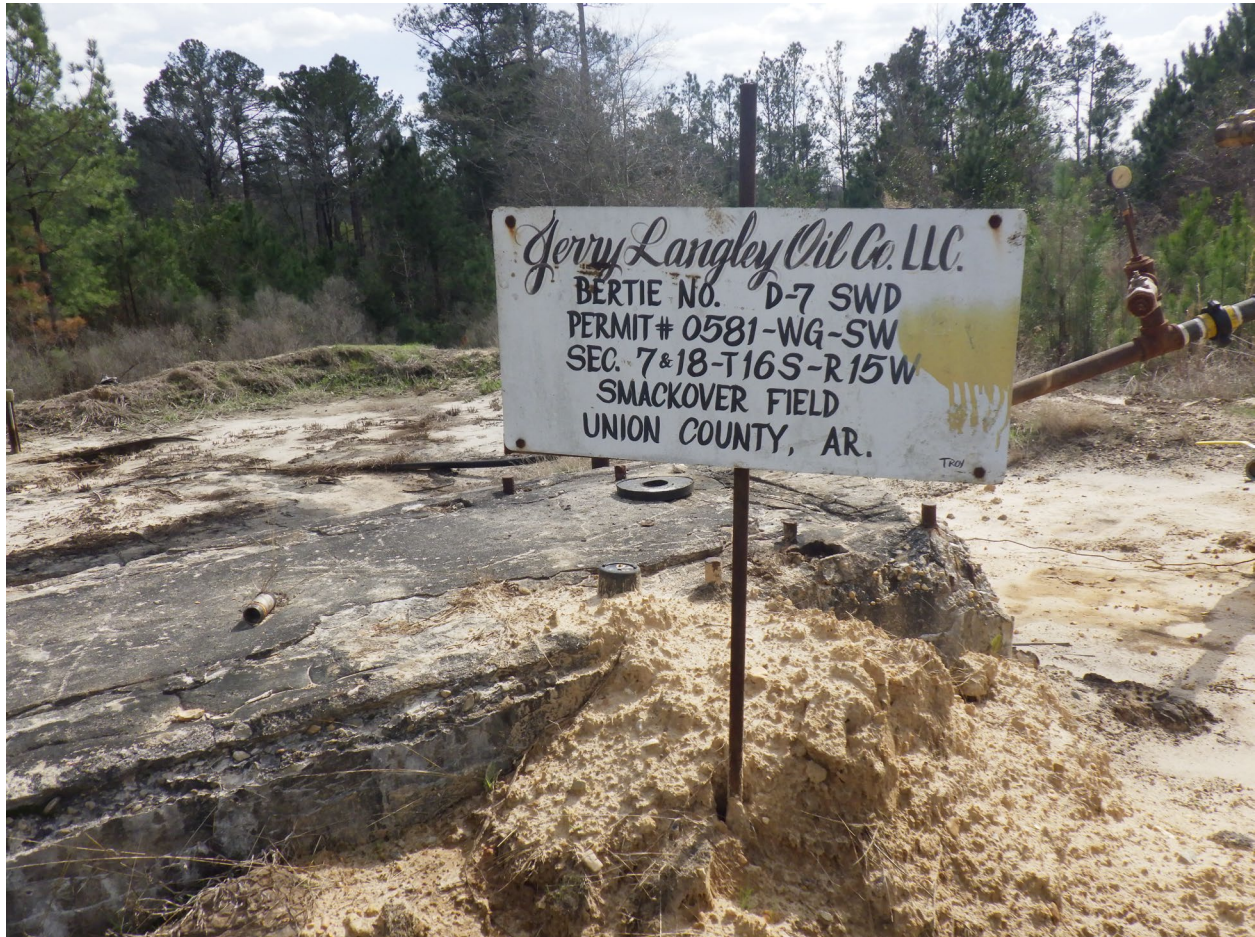
I observed the facility sign, secondary containment, pipes, valves, and tank located at the facility; see Appendix 1 (photo log), photo No. 1 and No. 2. For additional GPS location and photo metadata, see Appendix 1.

**Photo File Name:** R0010210**Orientation:** SW**Date of Photo:** 03/12/2024**Time of Photo:** 3:12 PM**Latitude:** 33.335812**Longitude:** -92.688705**Photographer:** Uma Lad**Description:** This photo was taken looking southwest and shows the facility sign.

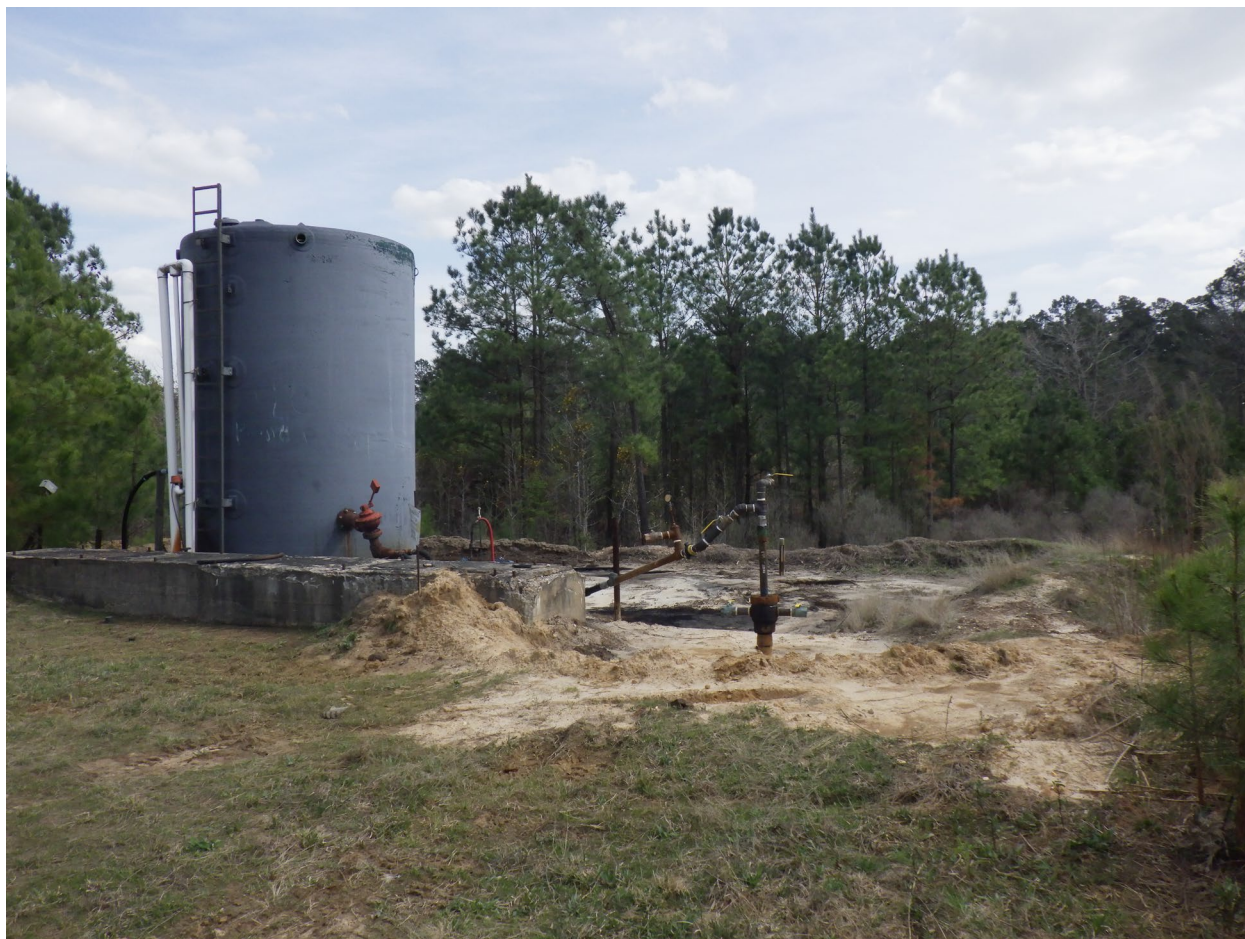
**Photo File Name:** R0010211**Orientation:** ESE**Date of Photo:** 03/12/2024**Time of Photo:** 3:12 PM**Latitude:** 33.335812**Longitude:** -92.688705**Photographer:** Uma Lad**Description:** This photo was taken looking east-southeast and shows an overview of the facility.
