**UNITED STATES ENVIRONMENTAL PROTECTION AGENCY  
REGION 8  
RESOURCE CONSERVATION AND RECOVERY ACT**

**Facility Name:** Safety-Kleen Systems, Inc. – **Facility Location:** 2801 S Tejon St.  
Englewood Englewood, Colorado 80110

**Type and Purpose of Inspection:** Focused Compliance Inspection

Inspection focused on compliance with RCRA air regulations in 40 C.F.R. Part 264, Subparts AA, BB and CC [6 CCR 1007-3 Part 264, Subparts AA, BB and CC]

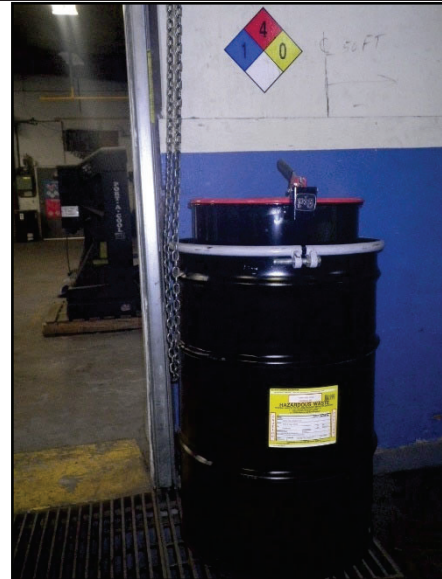
| Attributes | |
|---|---|
| Title | Photo 1 |

| Attributes | |
|---|---|
| Description | Hazardous waste<br>drum for used oil<br>samples |

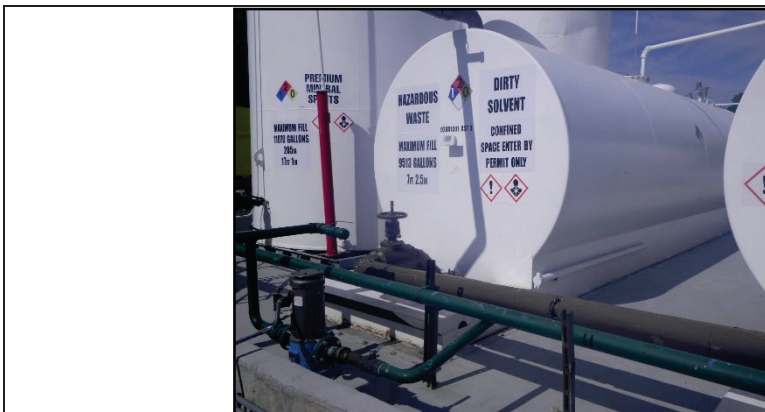
| Attributes | |
|---|---|
| Title | Photo 5 |

| Attributes | |
|---|---|
| Description | Dirty solvent hazardous waste tank |

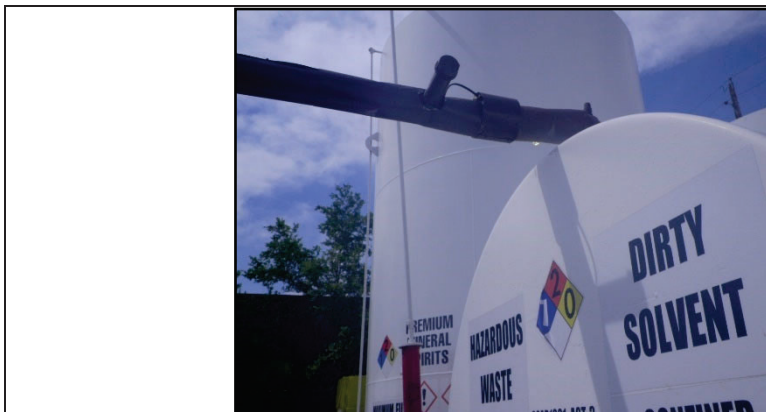
| Attributes | |
|---|---|
| Title | Photo 8 |

| Attributes | |
|---|---|
| Description | Capped line on dirty solvent hazardous waste tank |

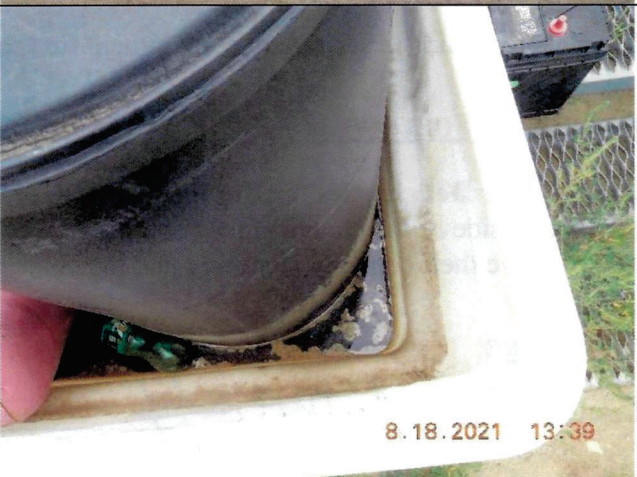
| Attributes | | |
|---|---|---|
| Title | Photo 2 | |

| Attributes | | |
|---|---|---|
| Description | Inside the secondary containment for the waste collection area. This is the secondary containment on the right in Photo 1. | |

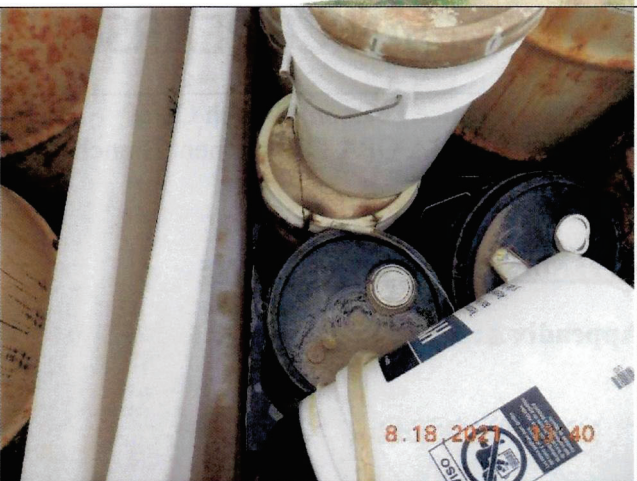
| Attributes | | |
|---|---|---|
| Title | Photo 3 | |

| Attributes | | |
|---|---|---|
| Description | Inside the secondary containment for the waste collection area. This is the secondary containment on the right in Photo 1. | |

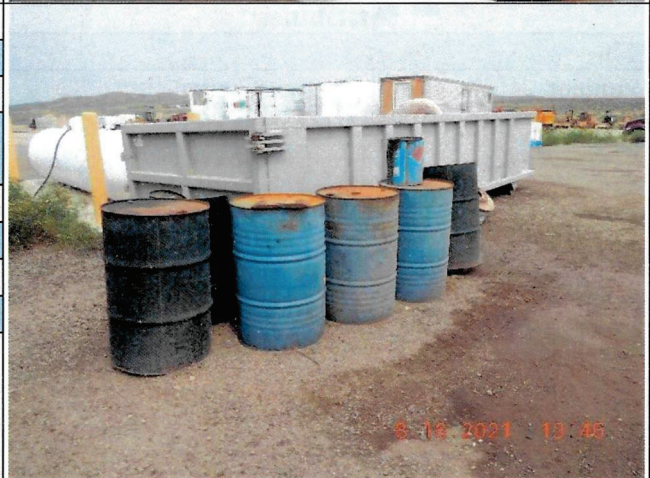
| Attributes | |
|---|---|
| Title | Photo 6 |

- Six containers, each was a 55-gallon drum, were located on the east side of the garage; none were labeled and they were in poor condition with rust and dents visible. There was no evidence of any leaks. Tim Payne did not know what the contents of the drums were. The containers were not within secondary containment.

| Attributes | |
|---|---|
| Description | Damaged container on east side of the garage. The container is located behind the row of containers in Photo 5. |

**Deficiencies or Concerns:** There were unlabeled containers in the Waste Collection area, on the east side of the garage, on the southwest side of the garage, and the northwest side of the Facility. These containers need to be labeled with the contents of the containers. Used oil containers must contain the label "Used Oil". Hazardous waste containers, if present, must contain the label "Hazardous Waste" and an indication of the hazard. e.g., flammable, corrosive, toxic, etc.

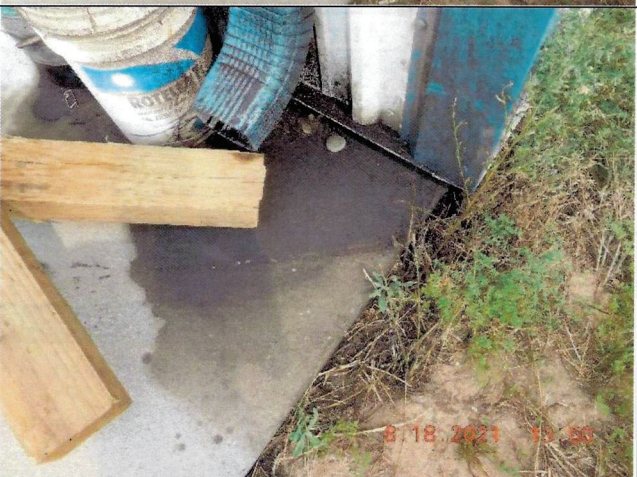
| Attributes | | |
|---|---|---|
| Title | Photo 8 | |

- A smaller container located next to the six containers was labeled antifreeze, but it looked like used oil had spilled out of it.
- Two containers, each was a five-gallon bucket, were located on the southwest corner of the garage, and they looked like they contained used oil and appeared to be leaking with oil running off the concrete pad and onto the ground.

| Attributes | | |
|---|---|---|
| Description | Stained concrete and contaminated soil from contents of containers in Photo 7, which is likely used oil. | |

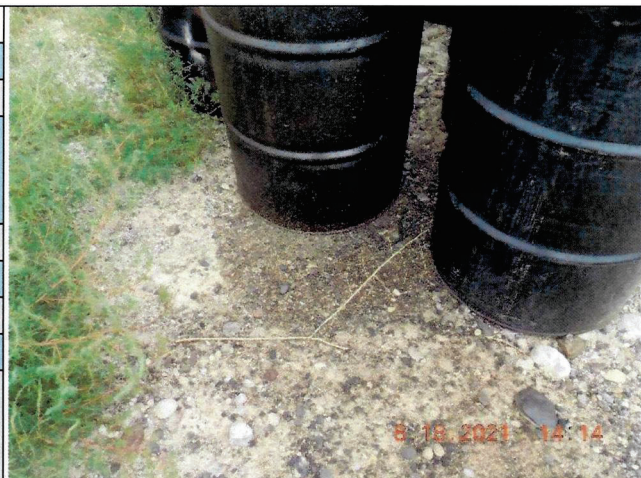
| Attributes | |
|---|---|
| Description | Contaminated soil from the contents of one of the drums in Photo 12. |

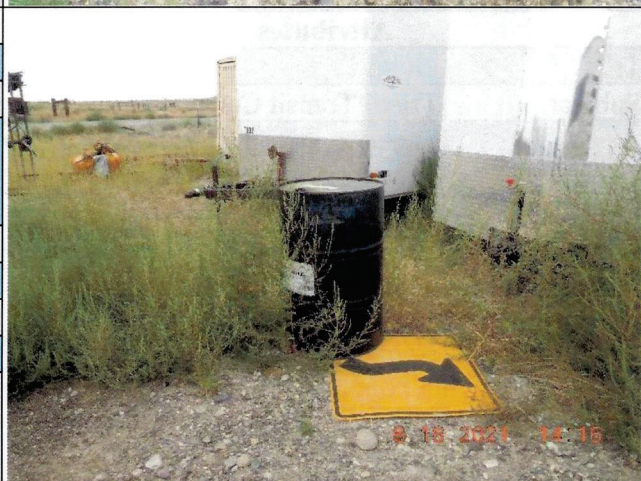
| Attributes | |
|---|---|
| Title | Photo 14 |

| Attributes | |
|---|---|
| Description | Another container near the containers in Photo 12 with the label "Rock Drill ISO 100". |
