## Attachment C

**Pit Worx, Inc.  
Pearson Pit  
Site Inspection Photographic Log**

Autaugaville, Autauga County, Alabama

April 17, 2024

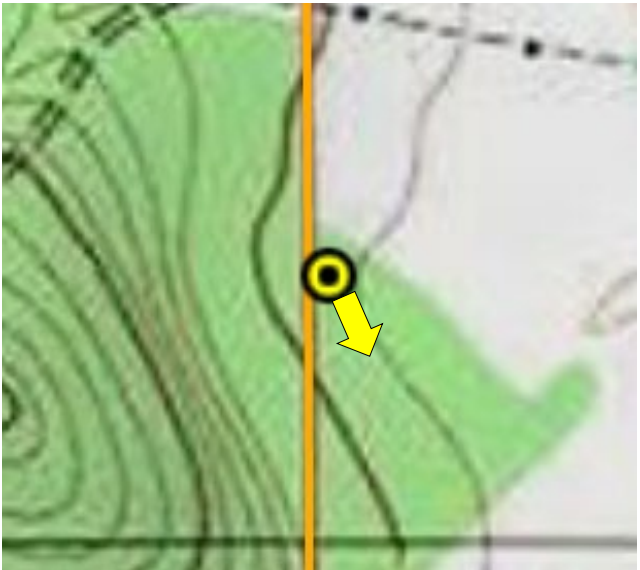
| Title | Photo 1 |

| Description | Striking toward remaining trees where potentially jurisdictional wetlands are located. Additional clearing has potentially occurred since the aerial imagery was taken.<br>*Camera clock was set to Eastern Standard Time. |

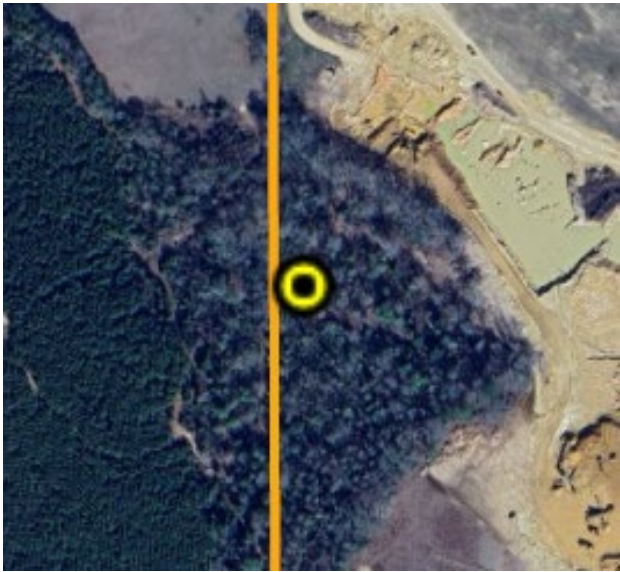
| Title | Photo 2 |

| Description | Soil profile, S1. Location where BioResources documented wetland conditions (November 2023 WOTUS report). |

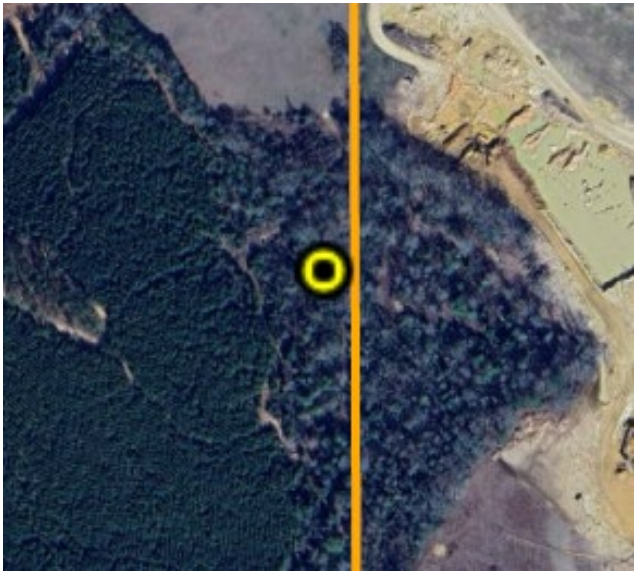
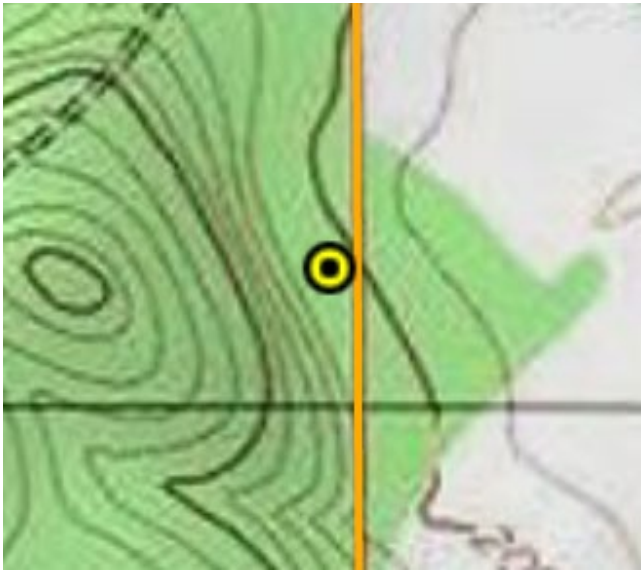
| Title | Photo 5 |

| Description | Additional angle of S2. |

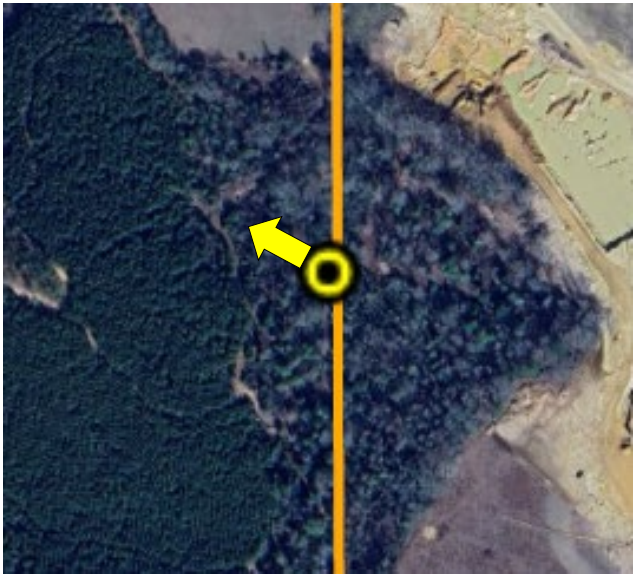
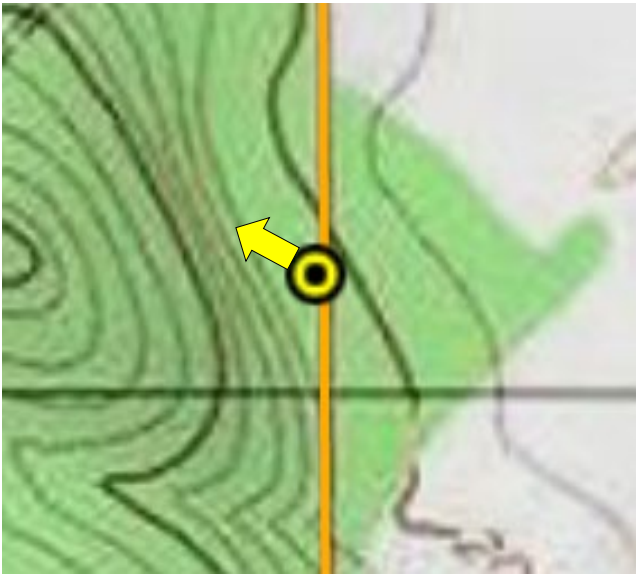
| Title | Photo 6 |

| Description | Landscape, taken approximately 10 feet from S2. |

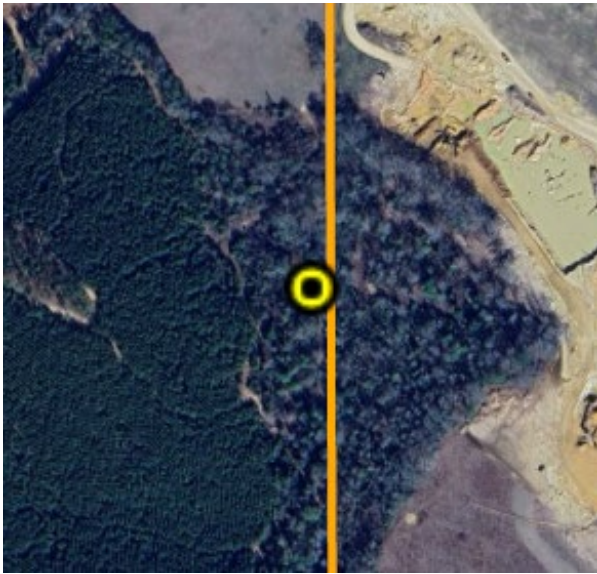
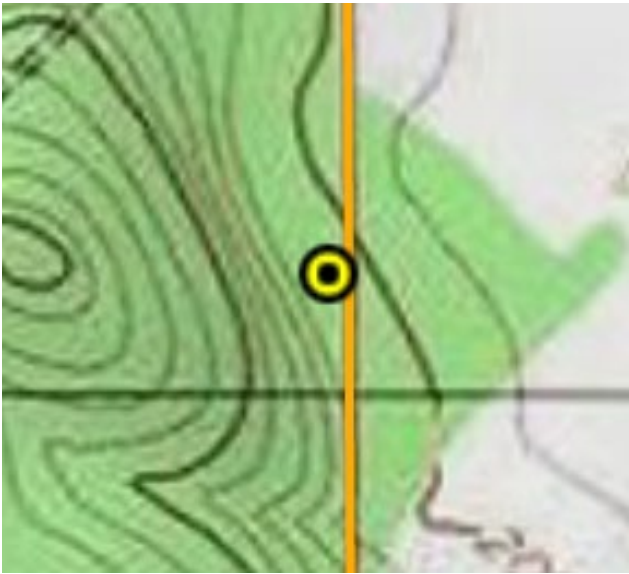
| Title | Photo 8 |

| Description | Location of soil profile S3. Notice water within 12 inches from the soil surface. |

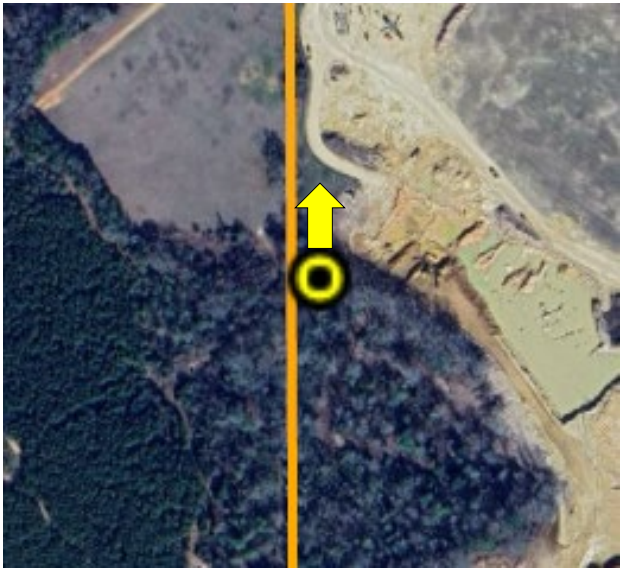
| Title | Photo 10 |

| Description | Coming out of the forested area, notice evidence of mechanized earth-moving equipment. |

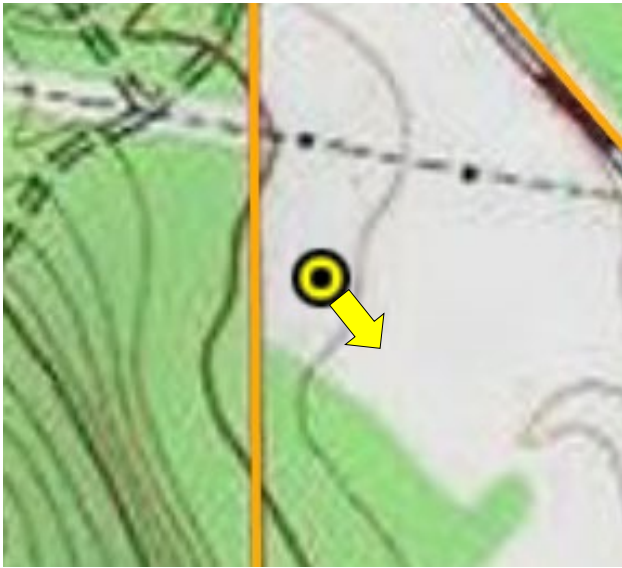
| Title | Photo 12 |

| Description | Same description as Photo 11, different view. |

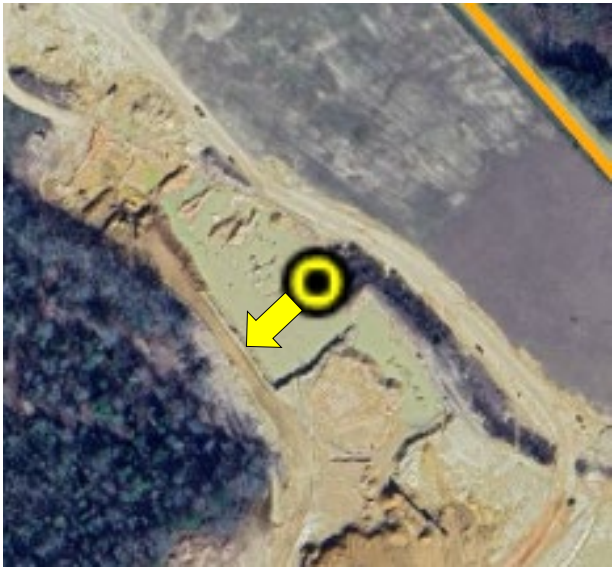
| Title | Photo 13 |

| Description | Overlooking a past vegetated oxbow feature that has since been excavated circa late 2023/early 2024, per operator. Approximately 600 feet northwest from Stream 1, delineated by BioResources in their 2023 WOTUS report. |

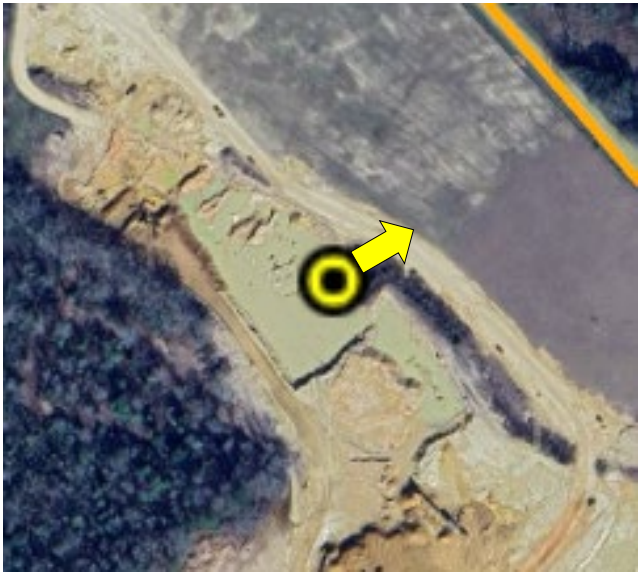
| Title | Photo 14 |

| Description | Standing in the vegetated channel, striking in the opposite direction in relation to Photo 13. Observed <i>Juncus effusus</i> , <i>Panicum hemitomon</i> , <i>Salix caroliniana</i> . |

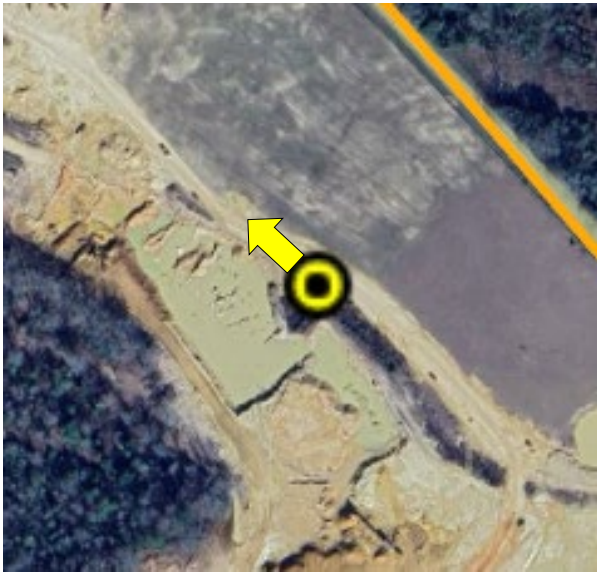
| Title | Photo 18 |

| Description | Standing over location of S6. |

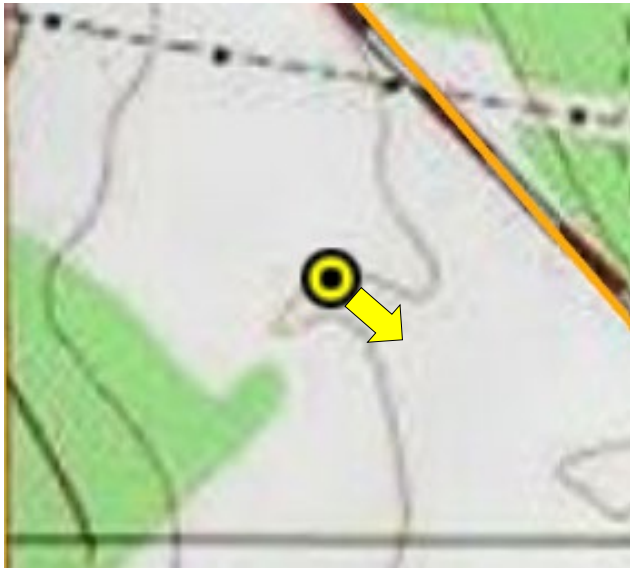
| Title | Photo 19 |

| Description | Opposite direction in relation to Photo 18. |

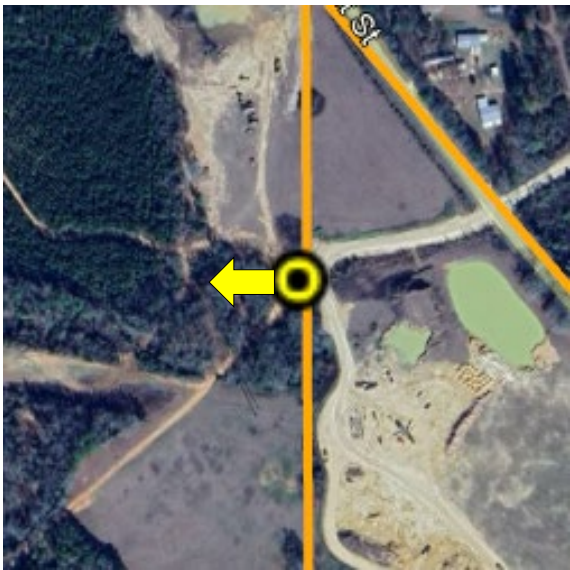
| Title | Photo 20 |

| Description | Striking upstream of flow coming from adjacent property to the west of the orange Pit Worx property lines. Red arrow in top photo indicates the direction of flow. |

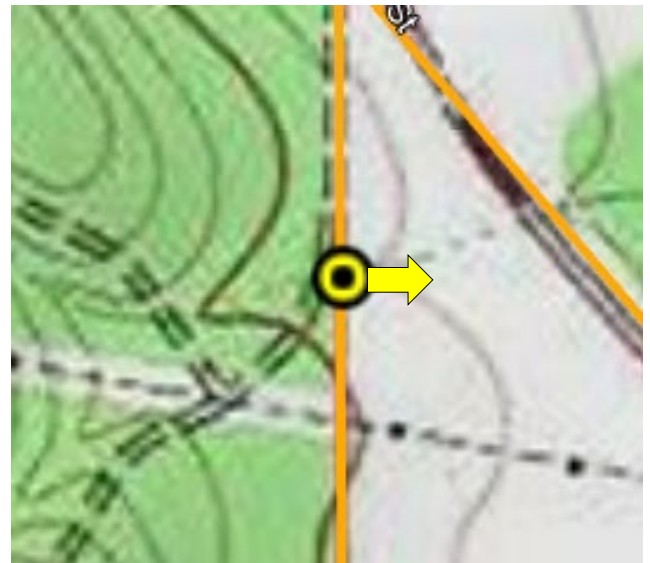
| Title | Photo 21 |

| Description | Striking from the opposite side of the road, following the flow downstream. Red arrow in top photo indicates the direction of flow. |

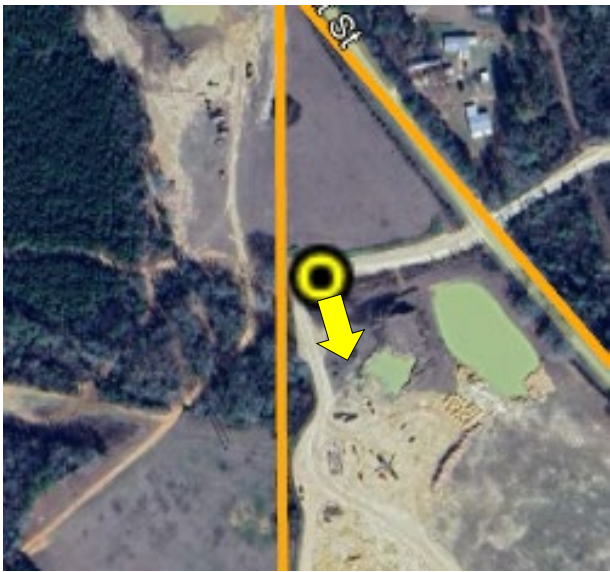
| Title | Photo 23 |

| Description | Continuing to follow the flow/ponding created by the blocked culvert to the west. Notice iron flocculation in water. Red arrow in top photo indicates the direction of flow. |

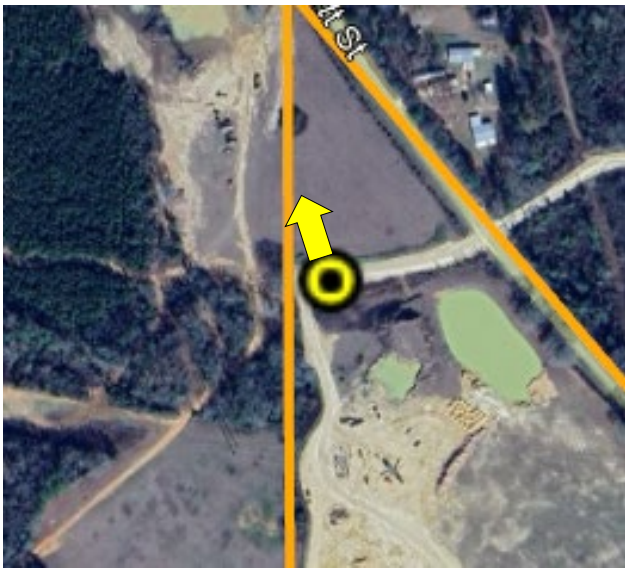
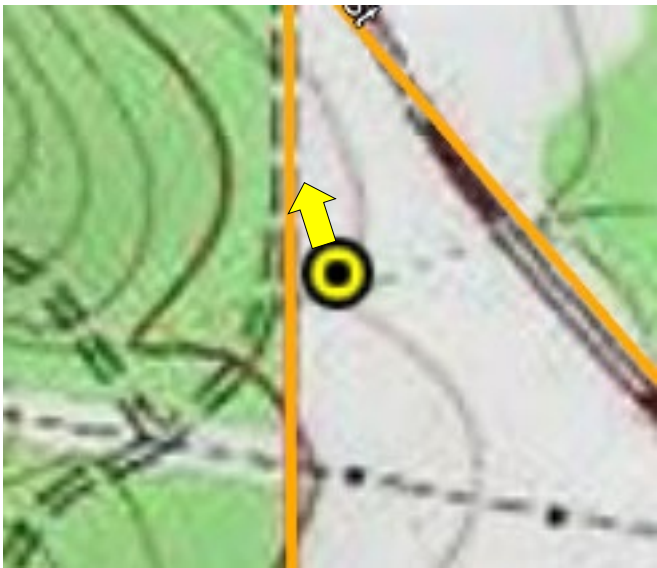
| Title | Photo 26 |

| Description | Continuing to follow the flow/ponding created by the blocked culvert to the west. Red arrow in top photo points out new high water marks on trees in the vicinity. |

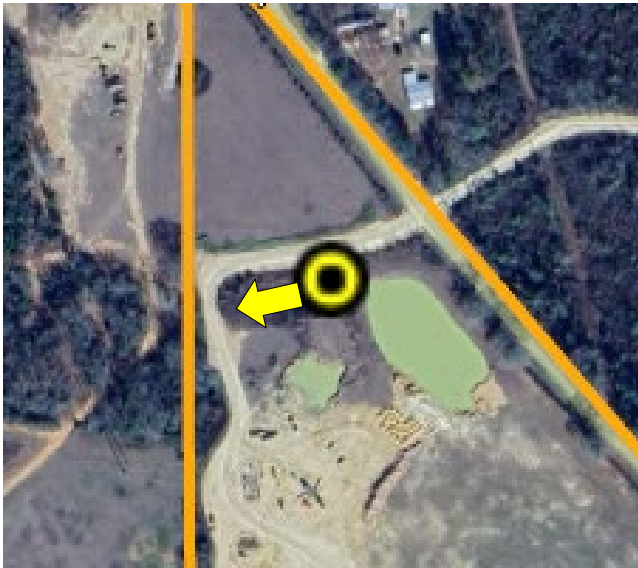
| Title | Photo 27 |

| Description | Continuing to follow the flow/ponding created by the blocked culvert to the west. |

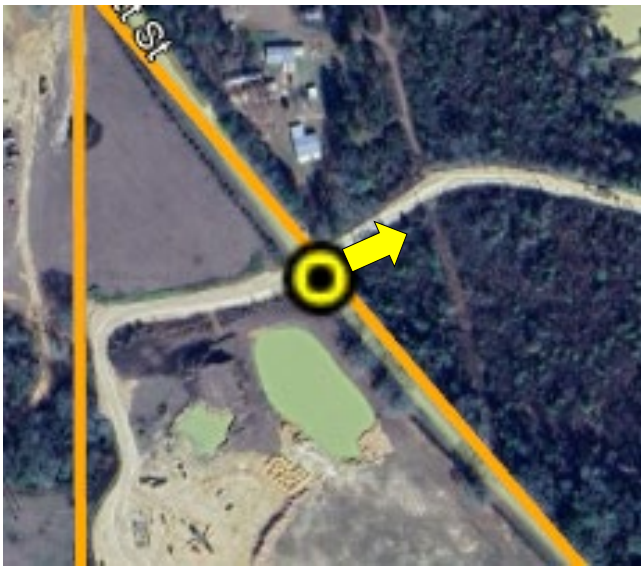
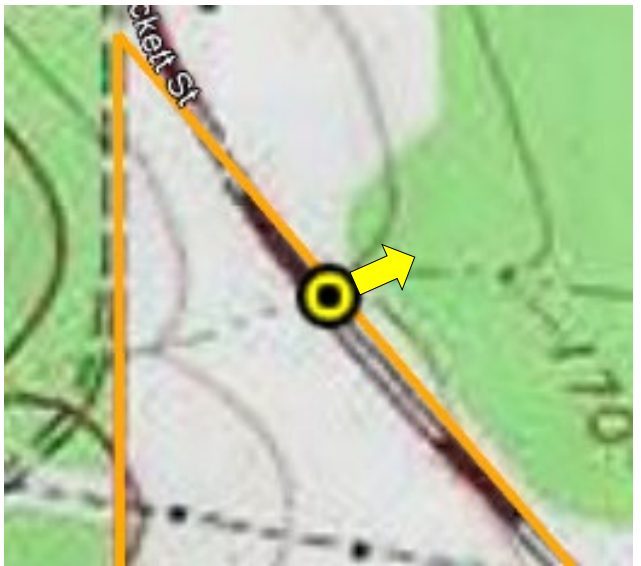
| Title | Photo 28 |

| Description | Flow after it has traveled under County Road 19 North, toward Pit Worx property to the east. |

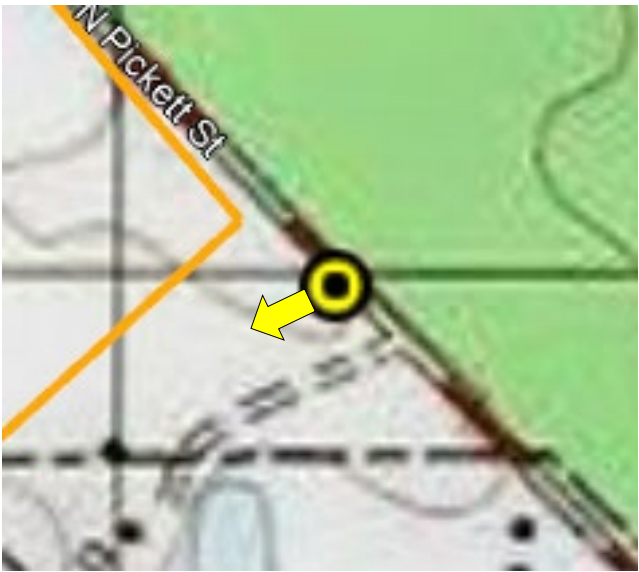
| Title | Photo 29 |

| Description | Striking toward Pickett Pond, with flow from the vegetated channel meeting a culvert that conveys it across County Road 19 North. Red arrow in top photo indicates the direction of flow. |

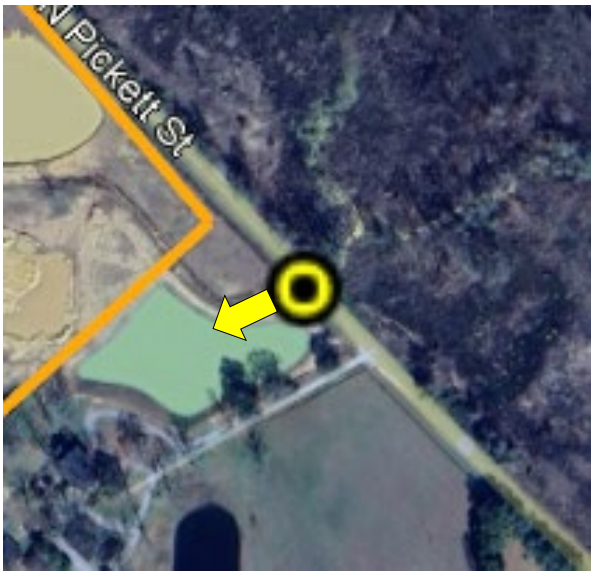
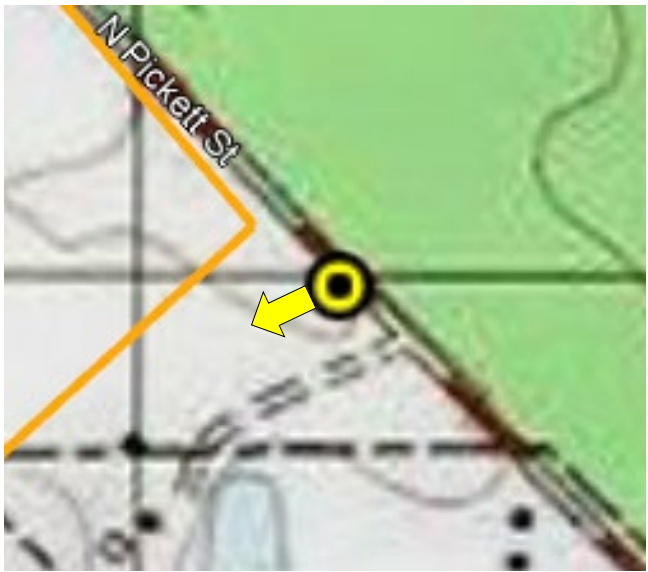
| Title | Photo 30 |

| Description | The landscape/channel northwest of Pickett Pond. Red arrow in top photo indicates the direction of flow. |

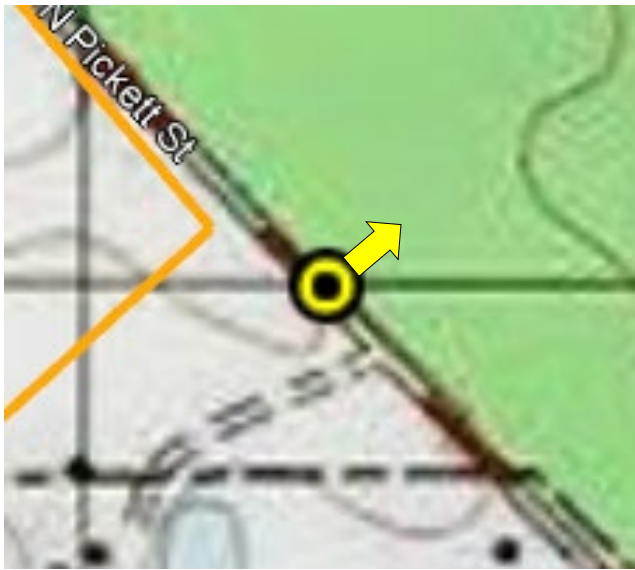
| Title | Photo 31 |

| Description | Flow from vegetated channel across the road from the Site; Swift Creek lies to the east. Red arrow in top photo indicates the direction of flow. |

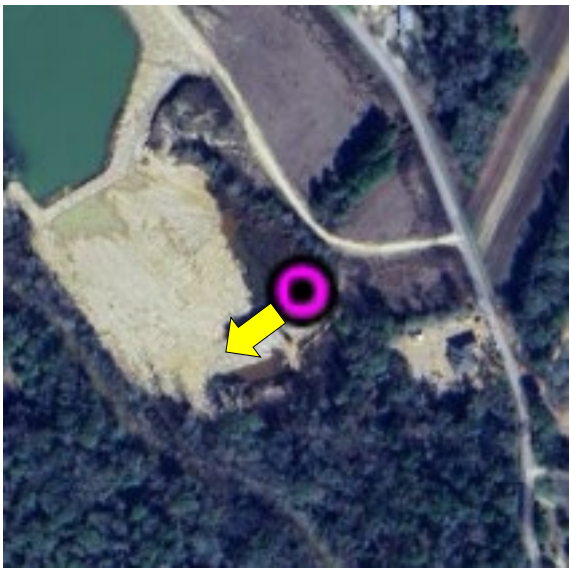
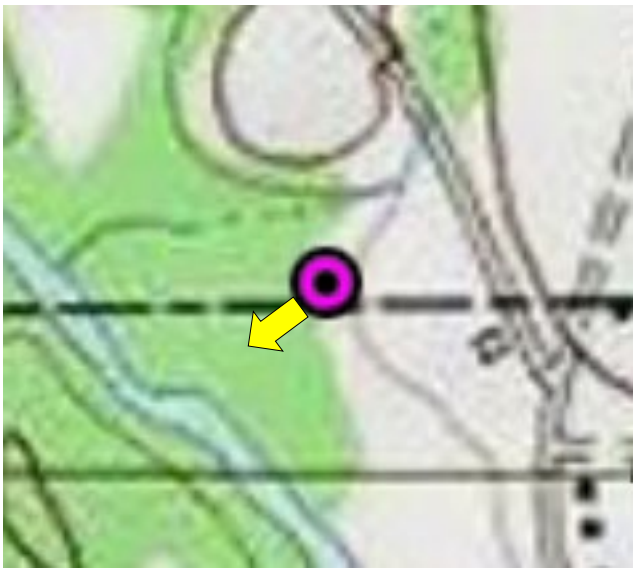
| Title | Photo 32 |

| Description | Unnamed tributary at the Meeks' property and its new flowpath post-impact. *EPA inspection team visited this current enforcement action due to its proximity to the Site (i.e., east of County Road 19 North). |
