**UNITED STATES ENVIRONMENTAL PROTECTION AGENCY  
REGION 2, ECAD-WCB  
290 Broadway, 21<sup>st</sup> Floor, New York, NY 10007**

<b>Program:</b> Sanitary Sewer System		<b>Inspection Type:</b> Compliance Evaluation Inspection	
<b>Permittee Name:</b> East Windsor MUA		<b>NPDES/ICIS No.:</b> NJ0023787, PID NO. 95449	
<b>Inspection Entry Date:</b> September 20, 2022 <b>Inspection Entry Time:</b> 8:00 AM		<b>Inspection Exit Date:</b> September 20, 2022 <b>Inspection Exit Time:</b> 5:30 PM	
<b>Facility Information:</b> East Windsor Municipal Utilities Authority <b>Lat, Long:</b> 40.294641°, -74.563824° 147 Millstone Road, East Windsor NJ <b>NAICS / SIC Code:</b> SIC Code 4952, sewer systems			
<b>EPA Representative(s):</b> Murray Lantner, P.E. Environmental Engineer, EPA Region 2, ECAD-WCB. (212) 637-3976			
<b>State Representative(s):</b>			
<b>On-Site Facility Representative</b> Angel Perez, Collections Operator Bryan Laurendeau, Collections Operator Nick Pietrefesa, Supervisor EWMUA, npietrefesa@eastwindsormua.com, 908-797-2532

## **A. Background and Findings and Opening Conference**

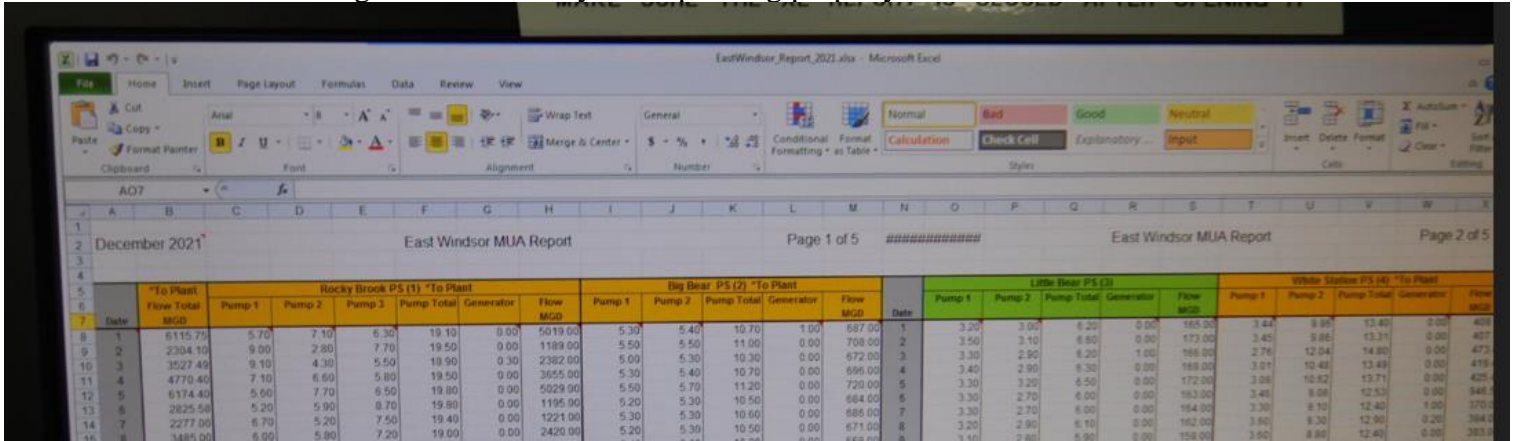
system in place for the pump stations. During the inspection, a photo taken of the SCADA system flow monitoring for December 2021 identified that the SCADA system is not accurate and the flow numbers are off by several orders of magnitude. For example as shown below on December 1, 2021 the flow to the WWTP, Rocky Brook PS (1), Big Bear PS(2), Little Bear PS (3), and White Station PS (4) was recorded as 6115, 5019, 687, 165, and 409 MGD, respectively for this plant that typically treats about 2.3 to 2.7 MGD. EWMUA said that they would work to get the SCADA system operating properly.

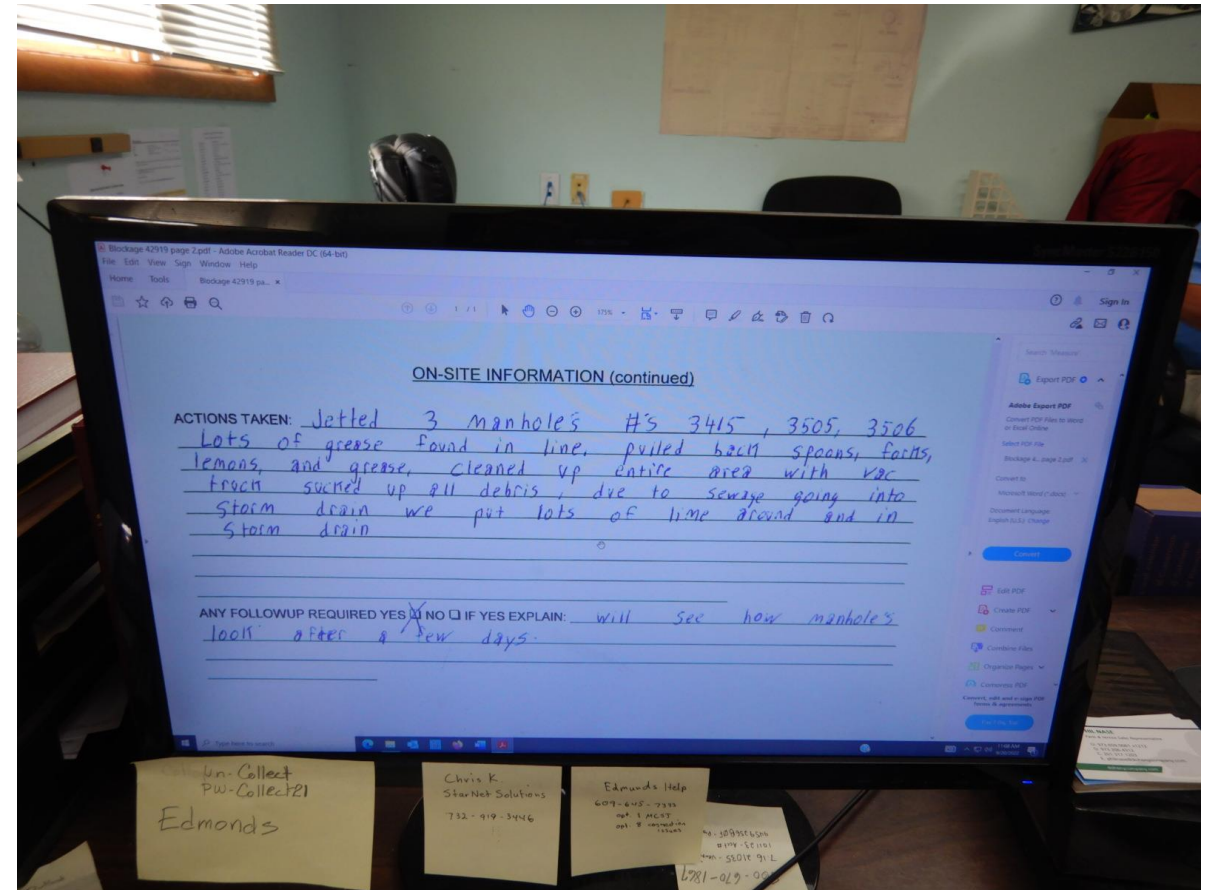
13. EWMUA does maintain a sewer system hot spot list that it jets on a routine basis as shown below. However, based on the entries its unclear if the jetting schedule is being maintained. EPA recommends keeping a database or work order system with the hot spot cleaning records.

DSCN1922 – Hot Spots

3. As described in paragraph 13 above, provide a list of the current hot spots and cleaning frequencies and indicate whether this frequency is being maintained. EPA recommends keeping a database or work order system with the hot spot cleaning records.

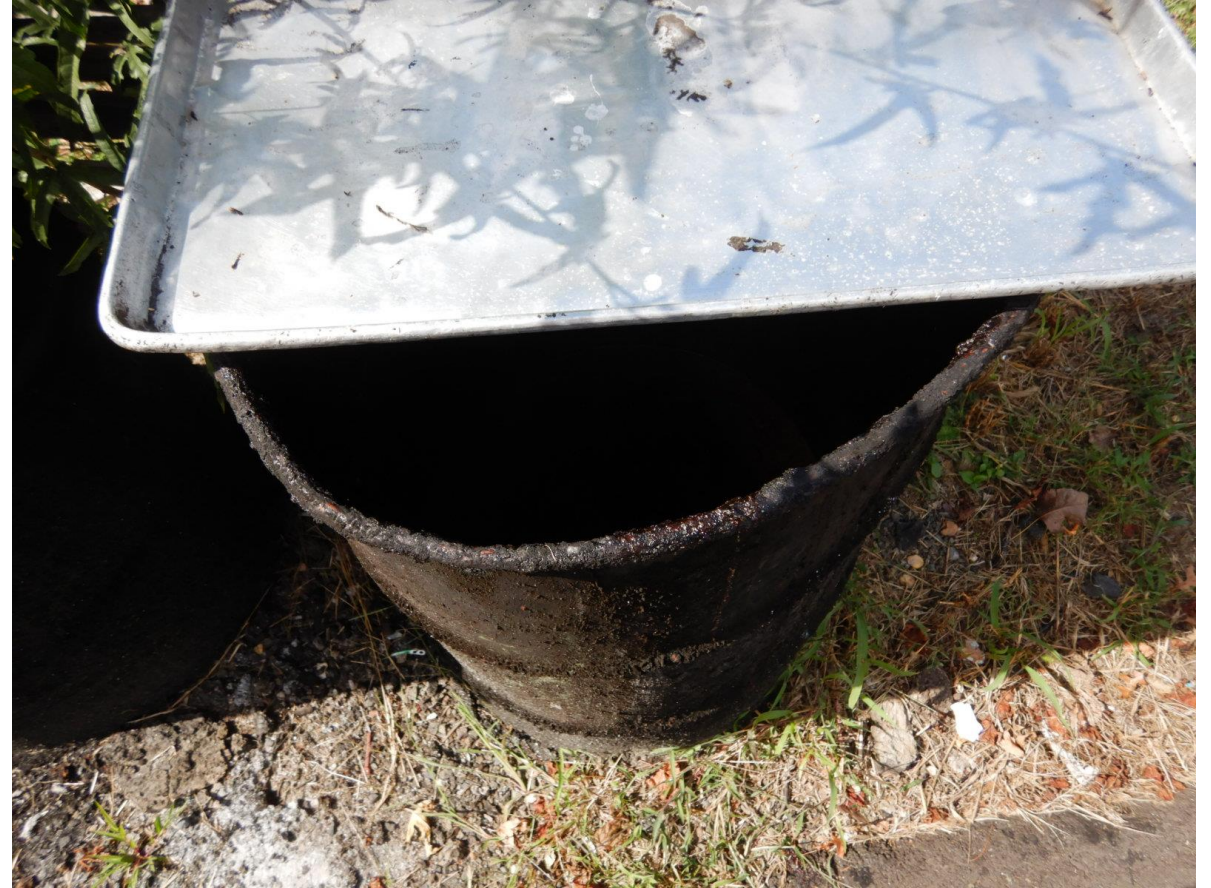
DSCN1938 - Grease outside of a grease dumpster at Royal Plaza
