SUMMARY OF SPECIAL C-8 SAMPLING PROJECT

Jennifer Nichols  
Environmental Lab LSE

9-16-97

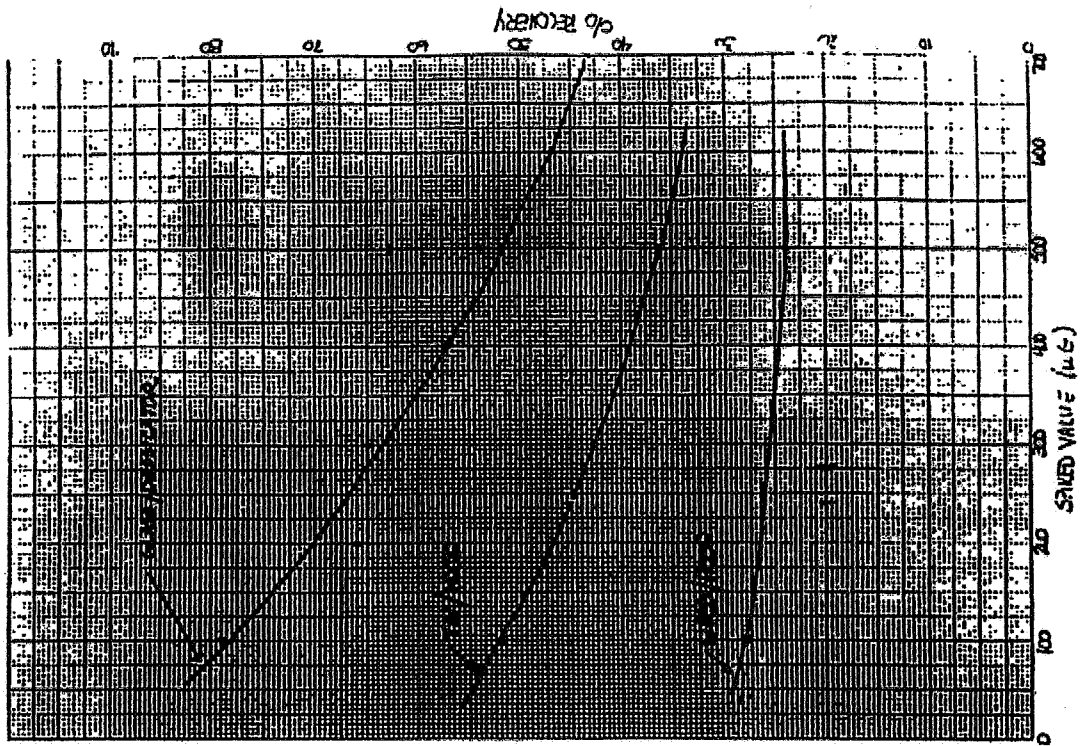
FIGURE 3: PERCENT RECOVERY OF WIPE SAMPLES

Forty-seven samples -- 31 from Homopolymers (includes roof samples) and 16 from FEP -- along with a blank sample were submitted for analysis. Analysis was conducted by Teflon\* Lab personnel using method WW3627. A recovery study was set up on Pyrex\* dishes and aluminum lab pans. Results indicate that as concentrations increase, the percent recovery decreases (figure 3). Many factors (such as evaporation, size of smear tab, dry time) may contribute to this. Because of the field variables (i.e., conditions in the area, type of surface sampled) setting up a thorough recovery study would be time consuming. If future wipe sampling campaigns are conducted and time permits, this should be considered in a pathforward.
