**UNITED STATES ENVIRONMENTAL PROTECTION AGENCY, REGION 2**  
**Enforcement and Compliance Assurance Division Water**  
**Compliance Branch**

| <b>Clean Water Act (CWA) Inspection</b><br><b>Report Program:</b> Industrial Stormwater | <b>Inspection Type:</b> Compliance Evaluation Inspection |
| <b>Site Name:</b> Curran Renewable Energy LLC<br>(Does not have a permit) | <b>NPDES/ICIS No.:</b> NYU065324 |

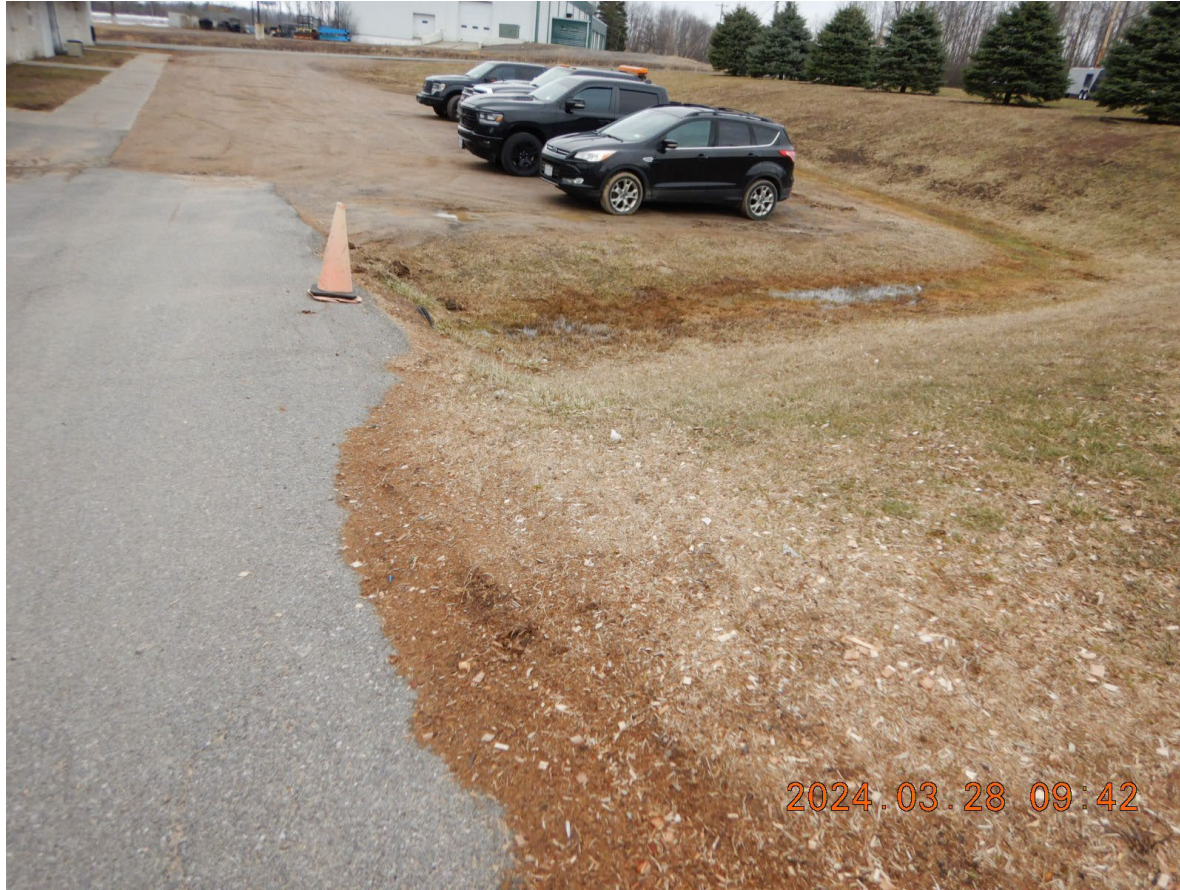
DSCN2661 - Stormwater channel that enters a pipe and flows downslope W towards storm drainage along rail line

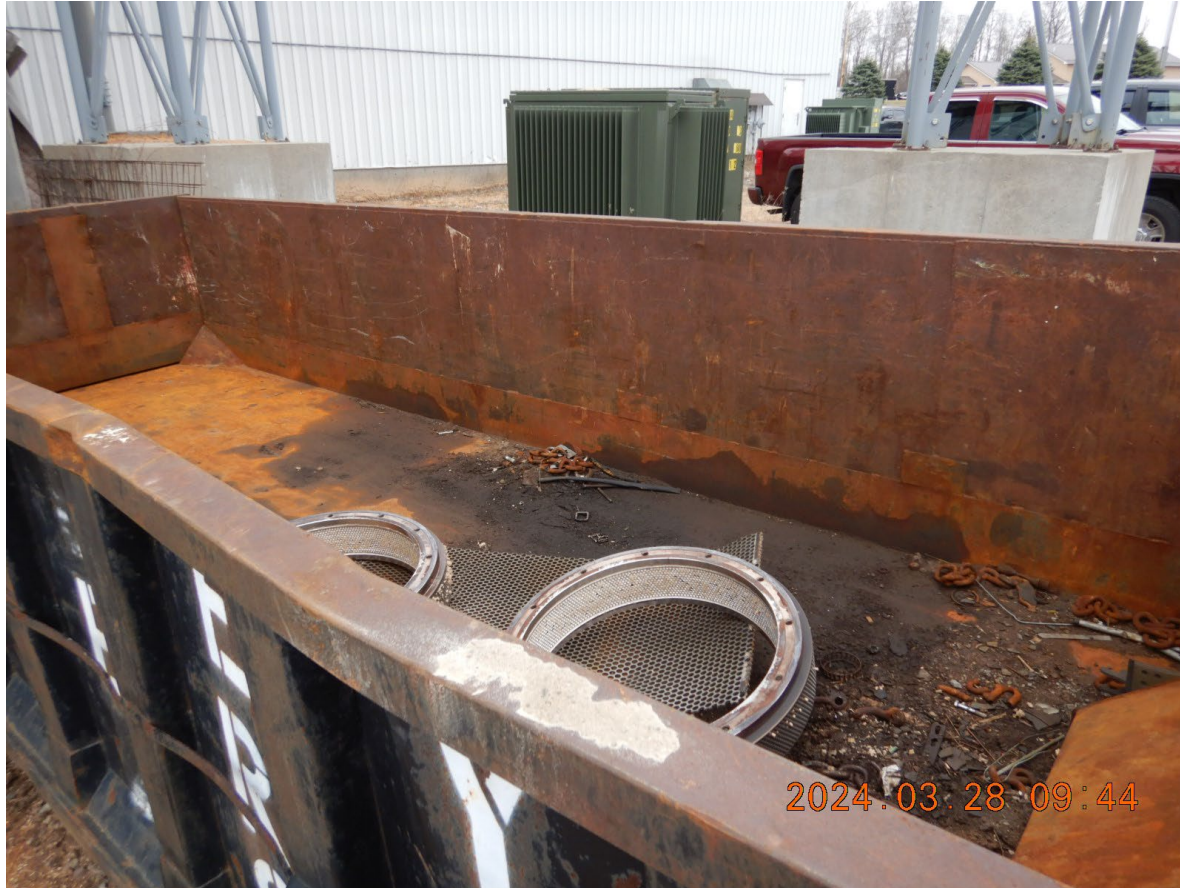
- a. At the time of the CEI, EPA observed an uncovered dumpster and materials, scrap and waste exposed to stormwater (Attachment 1; DSCN2664, DSCN2680 and DSCN2686).

DSCN2664 - Uncovered dumpster on the S side of the packaging warehouse

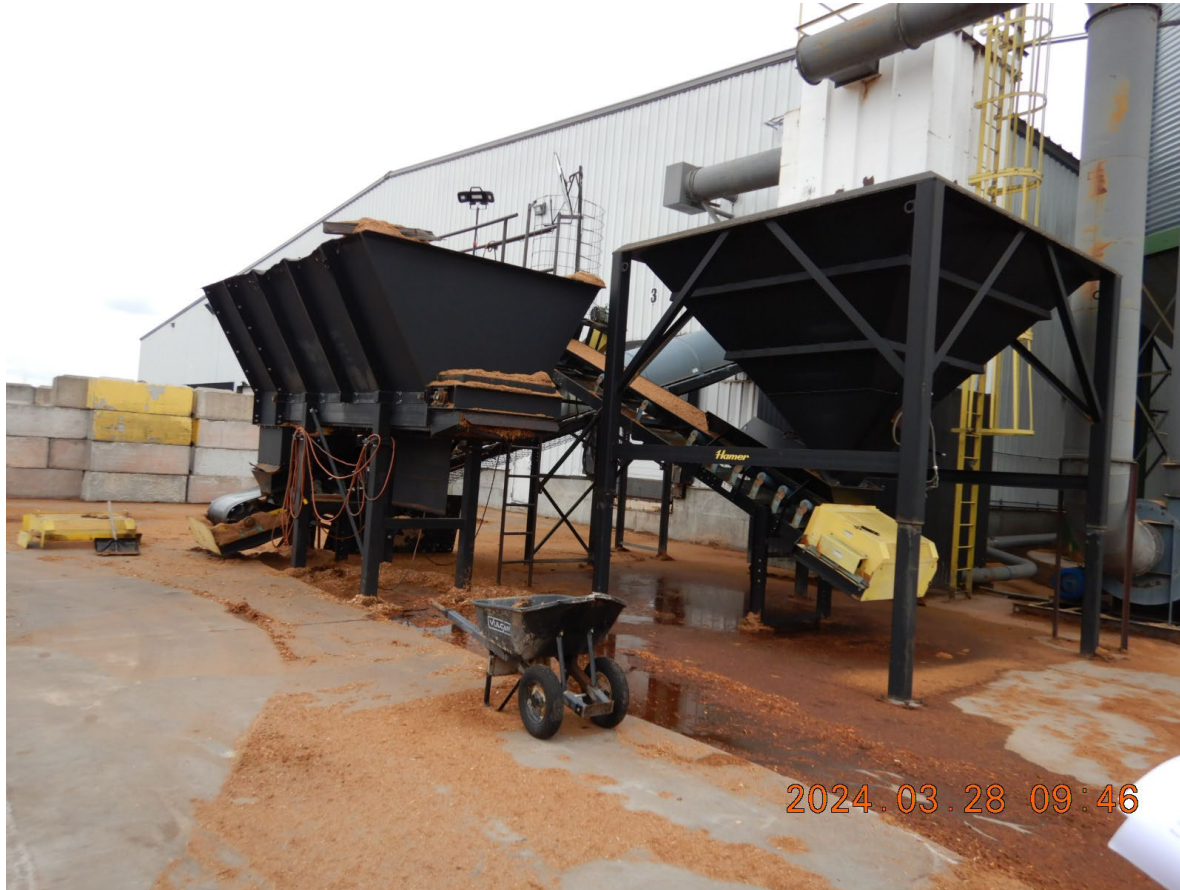
DSCN2666 - Mulch loading area located on the SW corner of the packaging warehouse

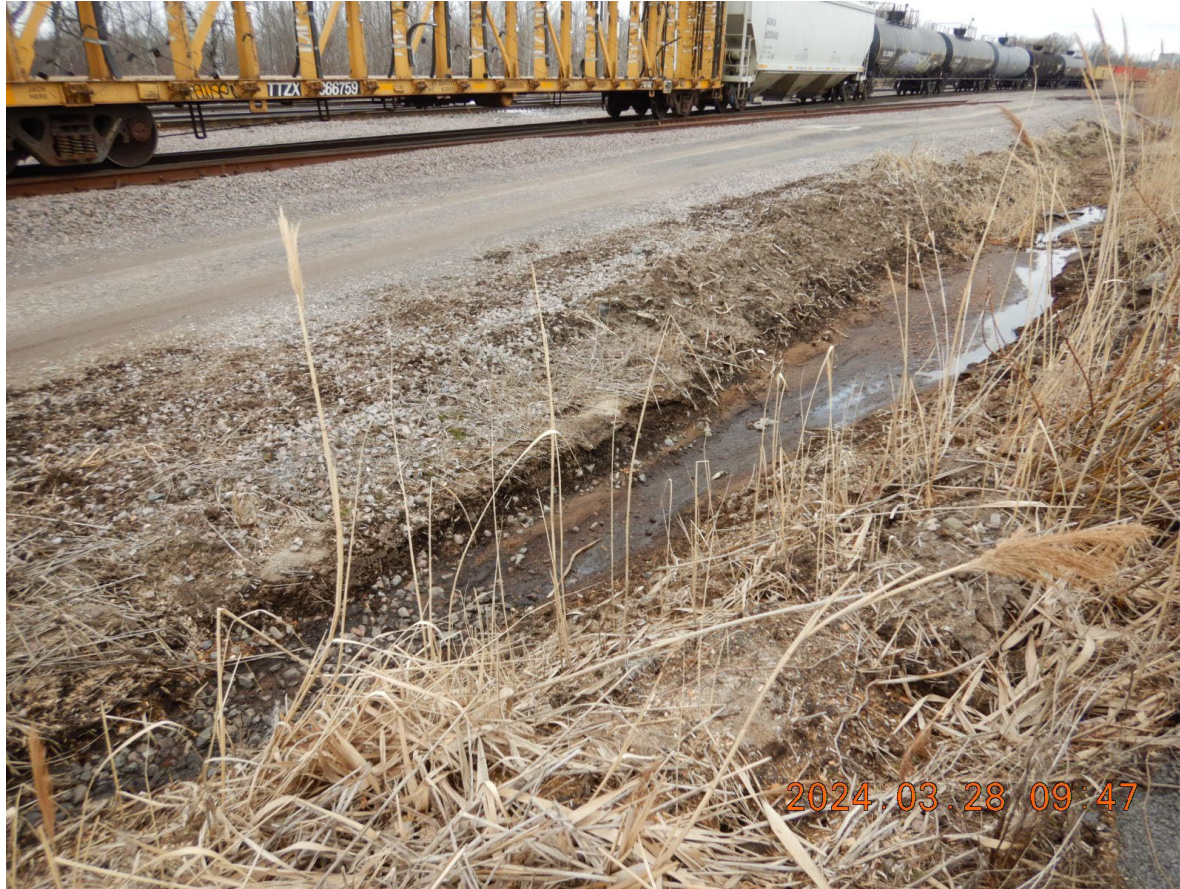
DSCN2668 - Stormwater channel with water in it along CSX rail line on western side of Site

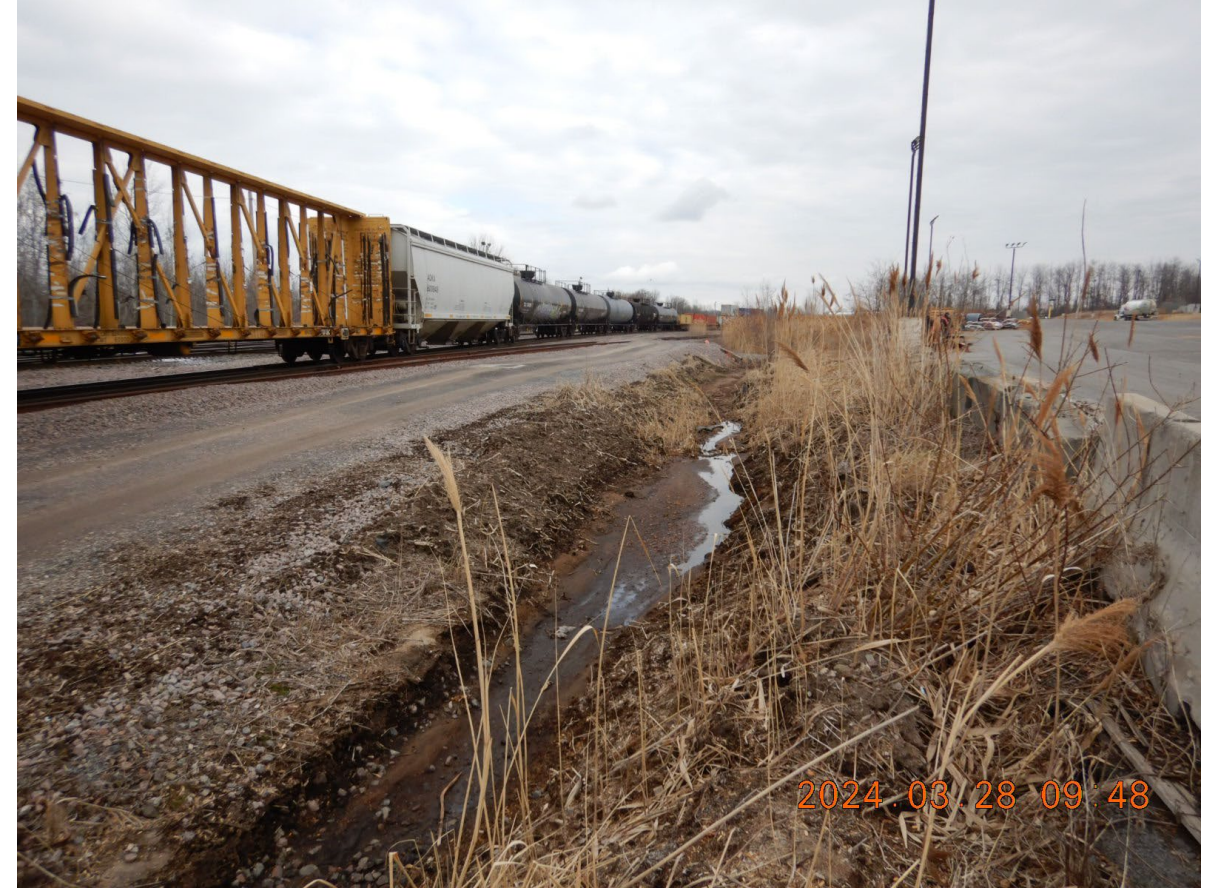
DSCN2669 - Stormwater channel with water in it along CSX rail line on western side of Site

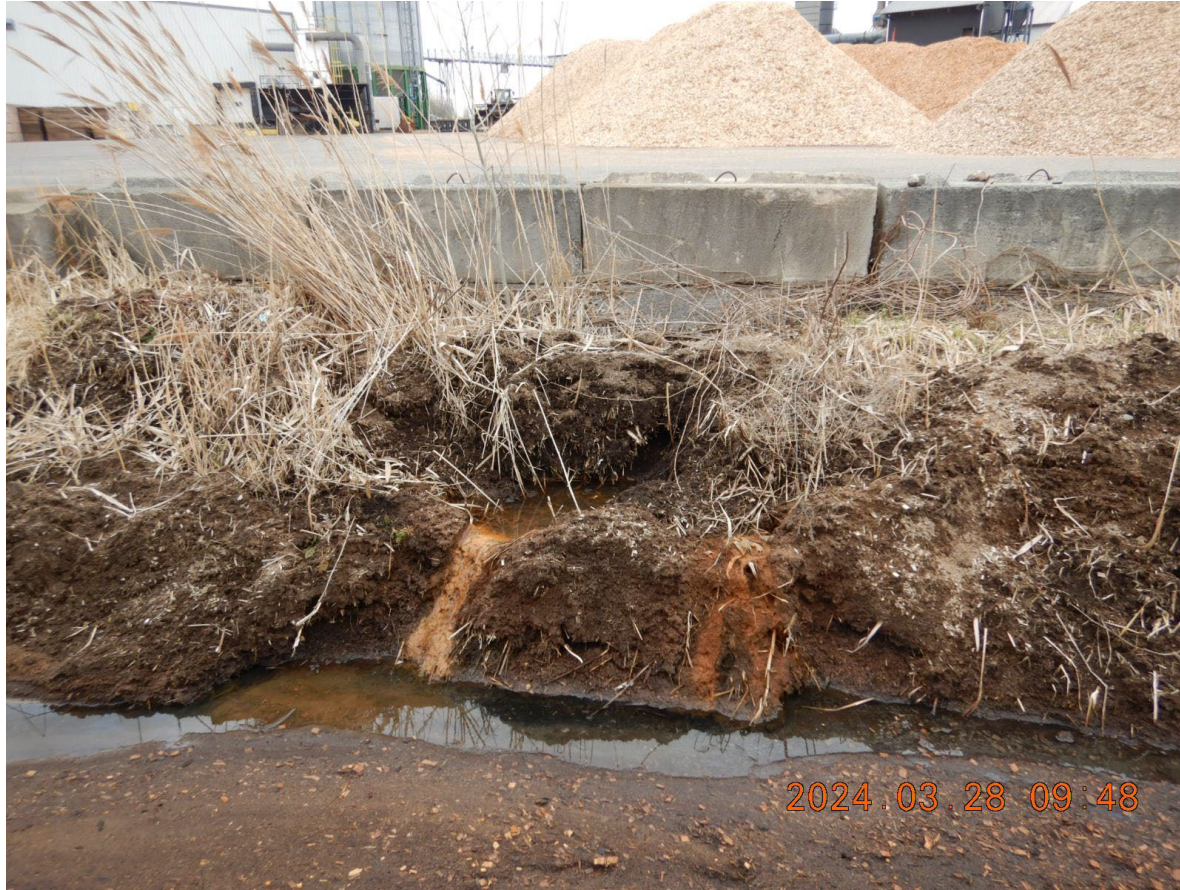
2. Part II.A.3 of the Permit states that the owner or operator must minimize pollutant discharges and achieve the effluent limitations in this permit, all industrial equipment and systems and control measures must be maintained in effective operating condition. EPA observed catch basins in need of maintenance. For example, photo 2754 shows a storm inlet with a large amount of wood chips and mulch within it, and photo 2662 shows a storm inlet partially blocked with vegetation (Attachment 1; DSCN2662, DSCN2671, DSCN2753, DSCN2754, DSCN2756).

DSCN2671 - Stormwater outfall on the W edge of Site; Stormwater from Catch Basin #1 located near the S corner of the packaging warehouse. The outfall is not visible (and needs to be cleaned)

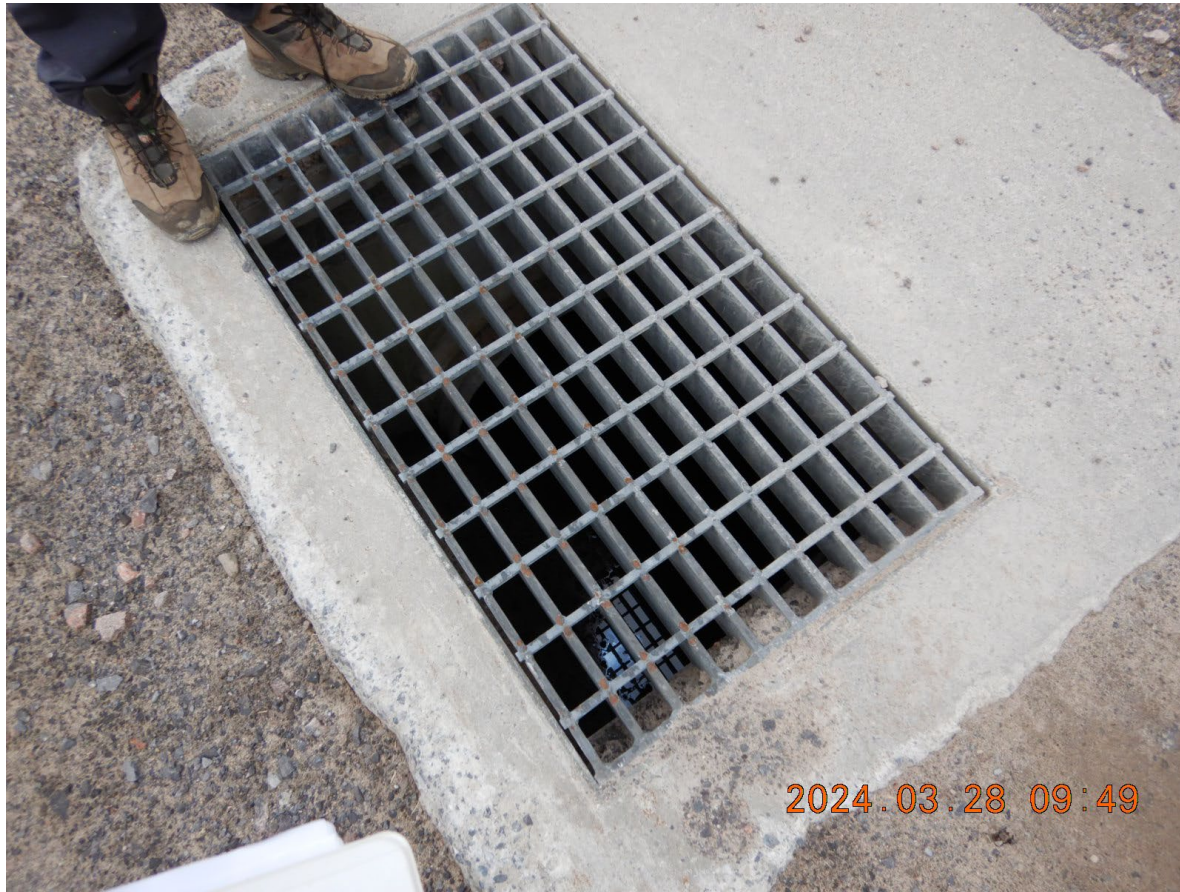
DSCN2673, DSCN2691, and DSCN2693). A retention pond and a gravel drive built over the stormwater channel was also observed by EPA representatives (Attachment 1, DSCN2674, DSCN2675 and DSCN2676). In addition to the collection of water on the west side of the Site, EPA observed water collected and flows from the central stockpile area and South stockpile lot (Attachment 1; DSCN2665, DSCN2667, DSCN2703, DSCN2707, DSCN2708, DSCN2709, DSCN2710, DSCN2716, DSCN2717, and DSCN2719). Mr. Measheaw stated that waste ash (from burning wood in boilers) created during pellet manufacturing was collected into two (2) metal collection bins (Attachment 1; DSCN2724). These bins are then emptied outside at the most southern waste stockpile lot. At the time of the CEI, EPA representatives also observed runoff and condensate flows from industrial equipment at the Site (Attachment 1; DSCN2666, DSCN2748, DSCN2749, DSCN2750 and DSCN2751). EPA observed a catch basin near the south side of the pellet manufacturing building filled with woodchip and pellet debris. EPA observed that this catch basin emptied to the south side of the Site (Attachment 1; DSCN2753, DSCN2754, DSCN2752, DSCN2755, DSCN2756, DSCN2757 and DSCN2758).

DSCN2673 - Catch Basin #2 located on what appears to be railroad property on W edge of Site, stormwater piping seen in the storm sewer

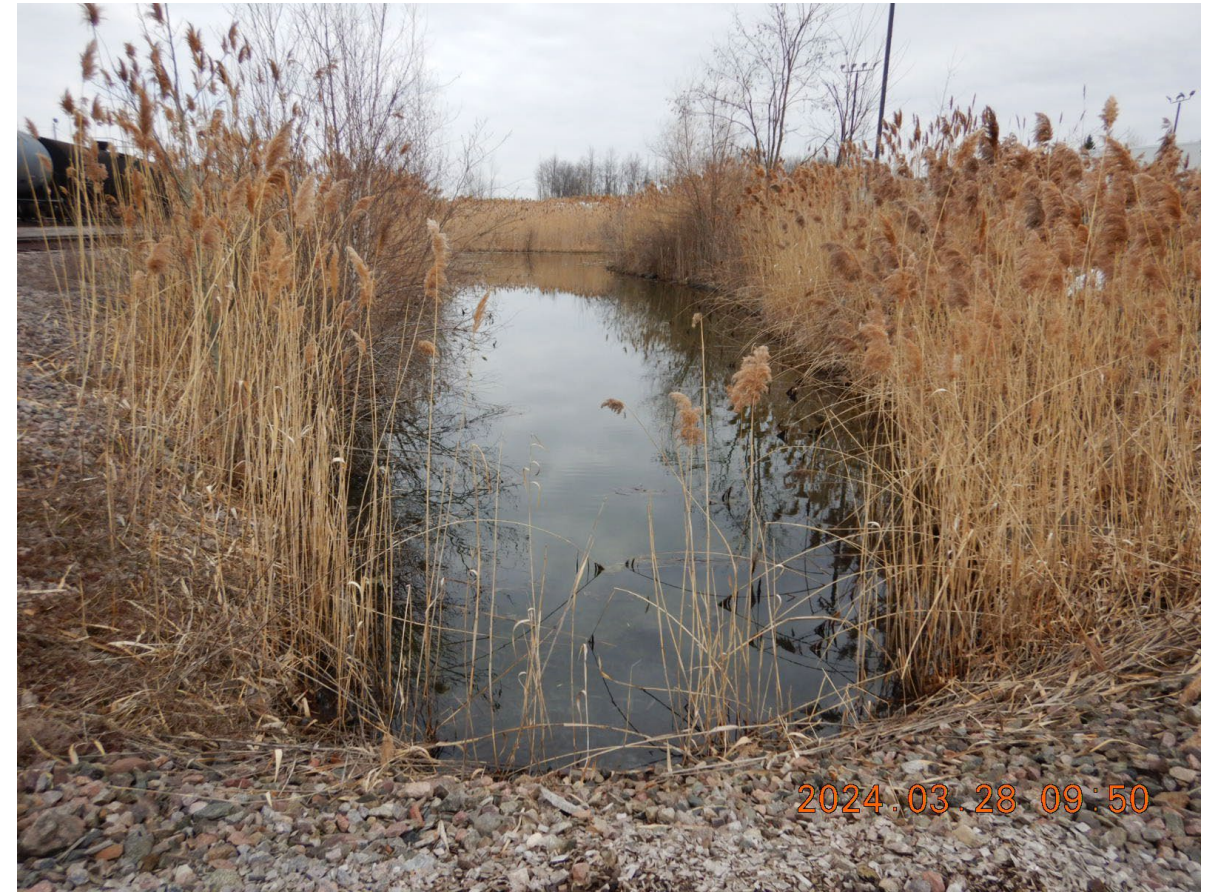
DSCN2674 - Retention pond on W side of the Site said to be part of the Facility's stormwater system. It is adjacent to the CSX rail line

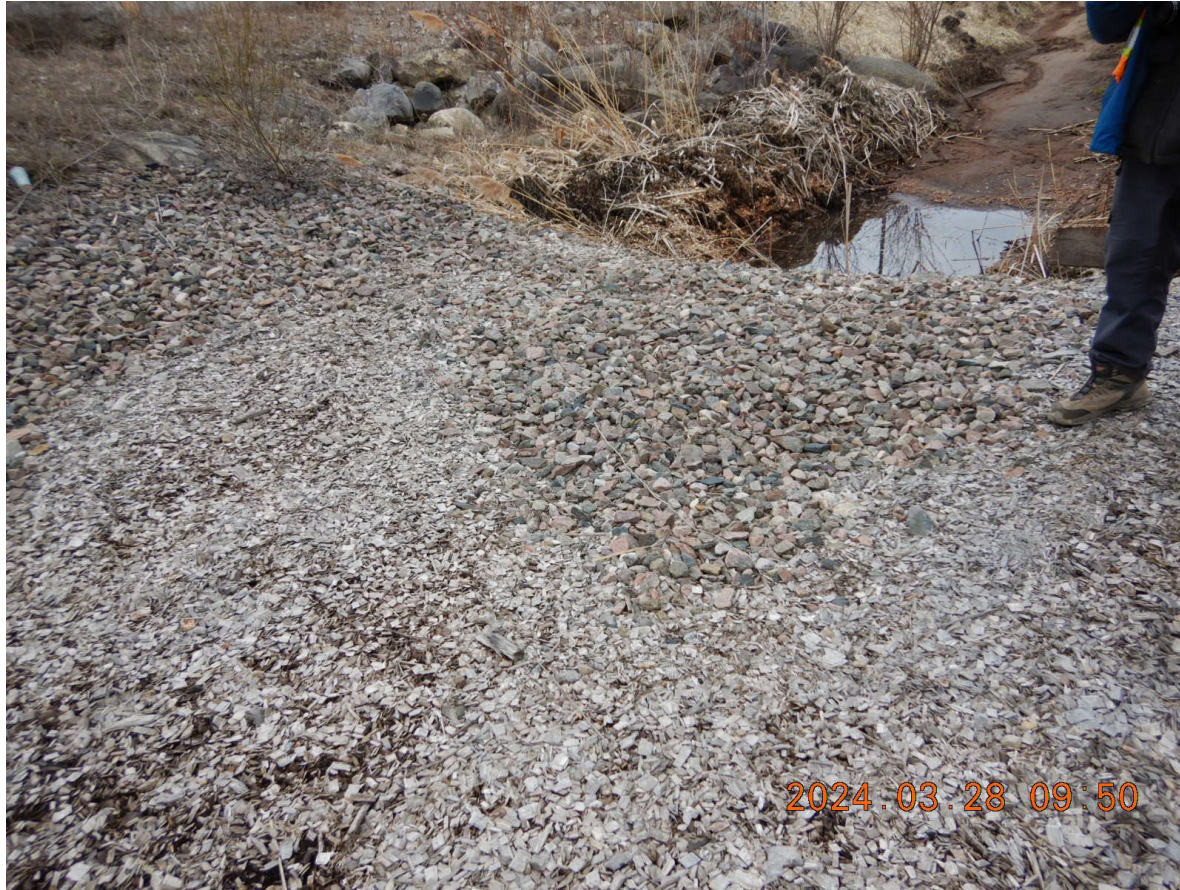
DSCN2675 - Gravel drive over stormwater runoff area connecting railroad area to loading parking lot on W side of Site

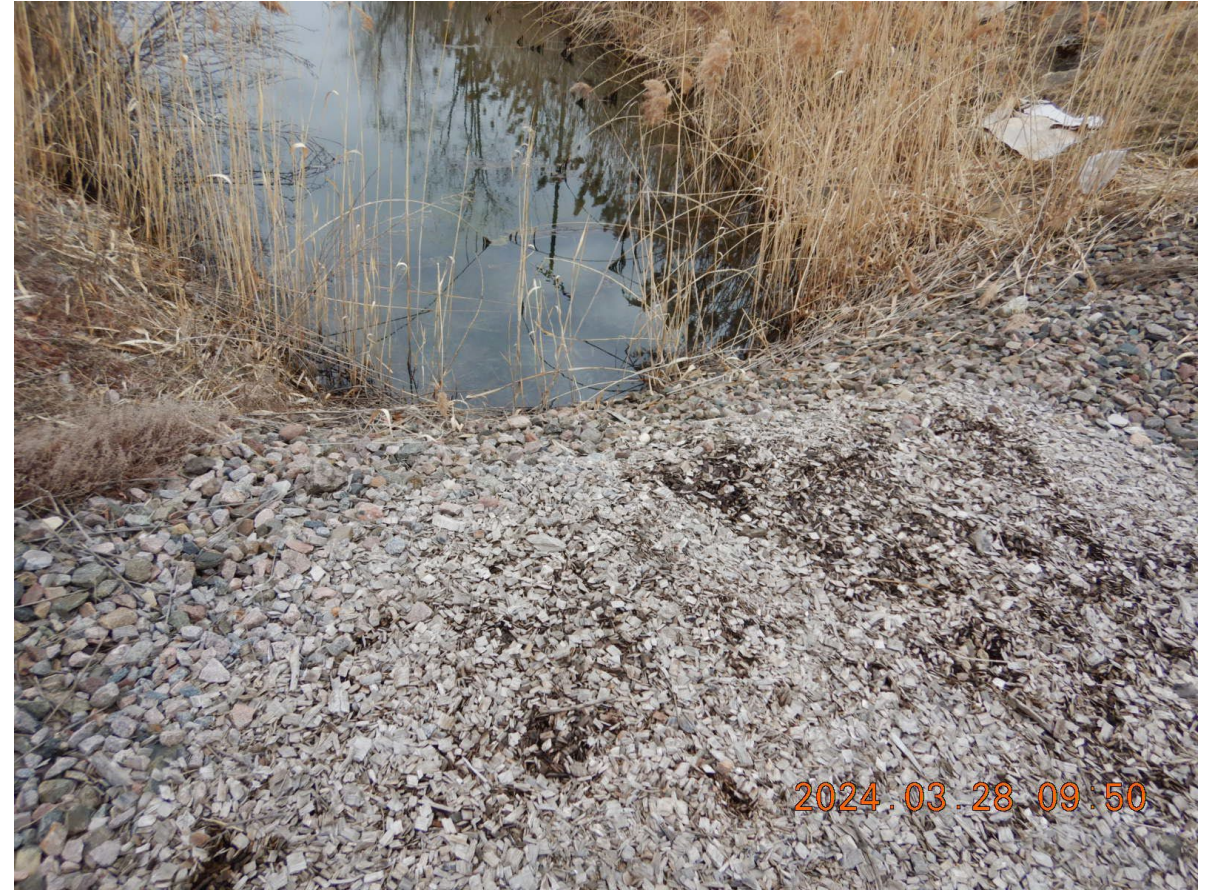
DSCN2676 - Gravel drive over stormwater runoff area connecting railroad area to loading parking lot on W side of Site

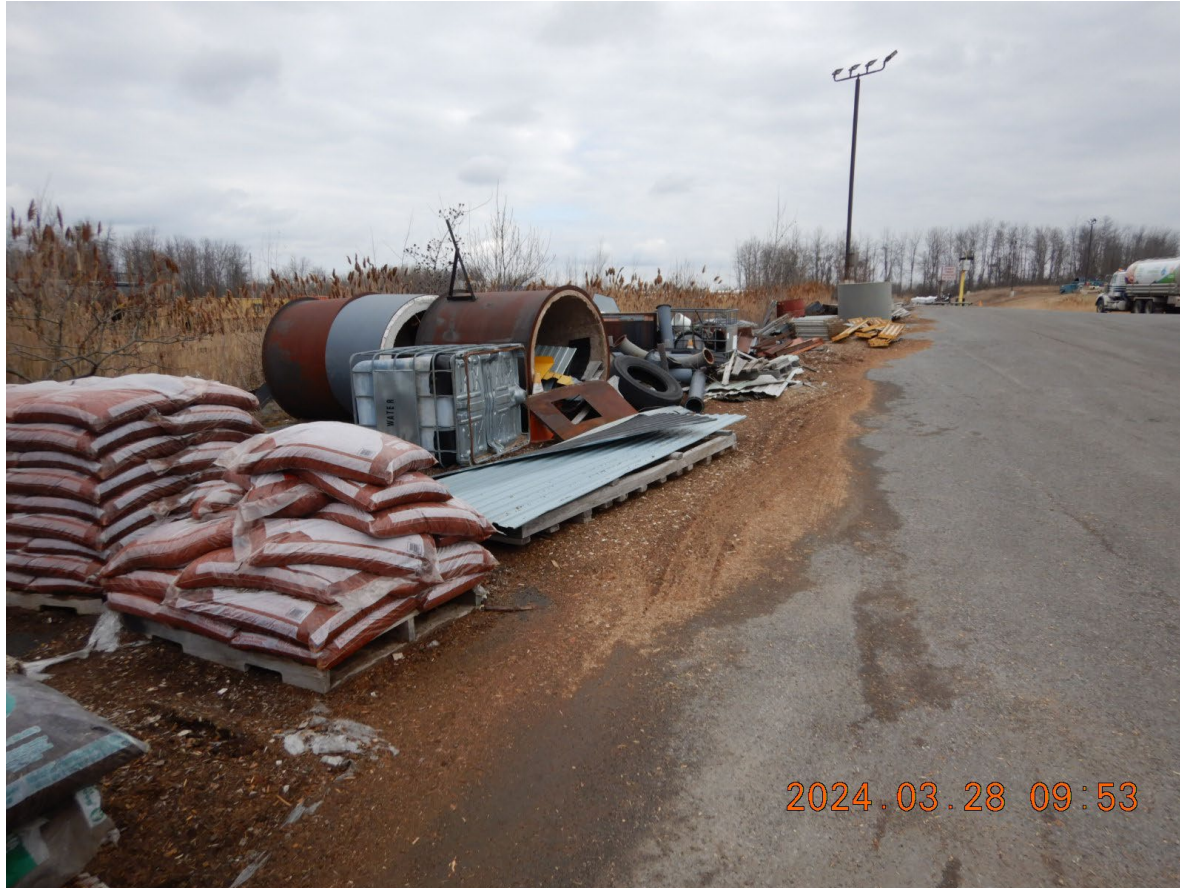
DSCN2680 - Materials, scrap, and waste storage on W side of Site near retention pond

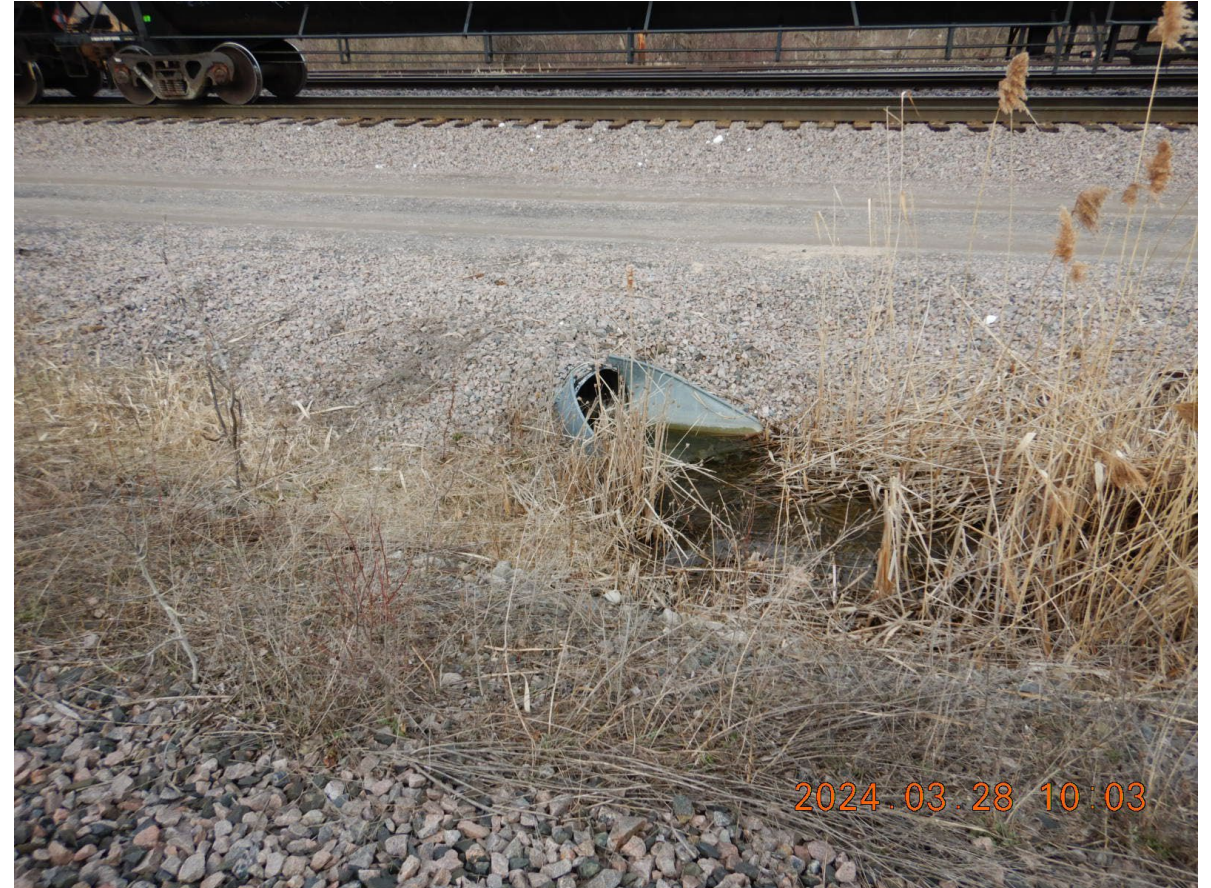
At the time of the CEI, water was observed in channels/drainages along the West and Southwest edge of the Site (Attachment 1; DSCN2667, DSCN2686, DSCN2690, DSCN2697 and DSCN2699). Mr. Measheaw stated that during wet weather water would flow from a catch basin in the parking lot outside of the packaging warehouse to an outlet on the West edge of the Site (Attachment 1; DSCN2661, DSCN2662, DSCN2668, DSCN2669, DSCN2671 and DSCN2672). EPA representatives numbered catch basins in the order that they were observed during the inspection. Along the west edge of the site, EPA representatives observed a railroad catch basin as well as an outlet pipe leading to areas thought to be railroad property (Attachment 1;

DSCN2686 - Stormwater drainage on the W side of materials and waste storage

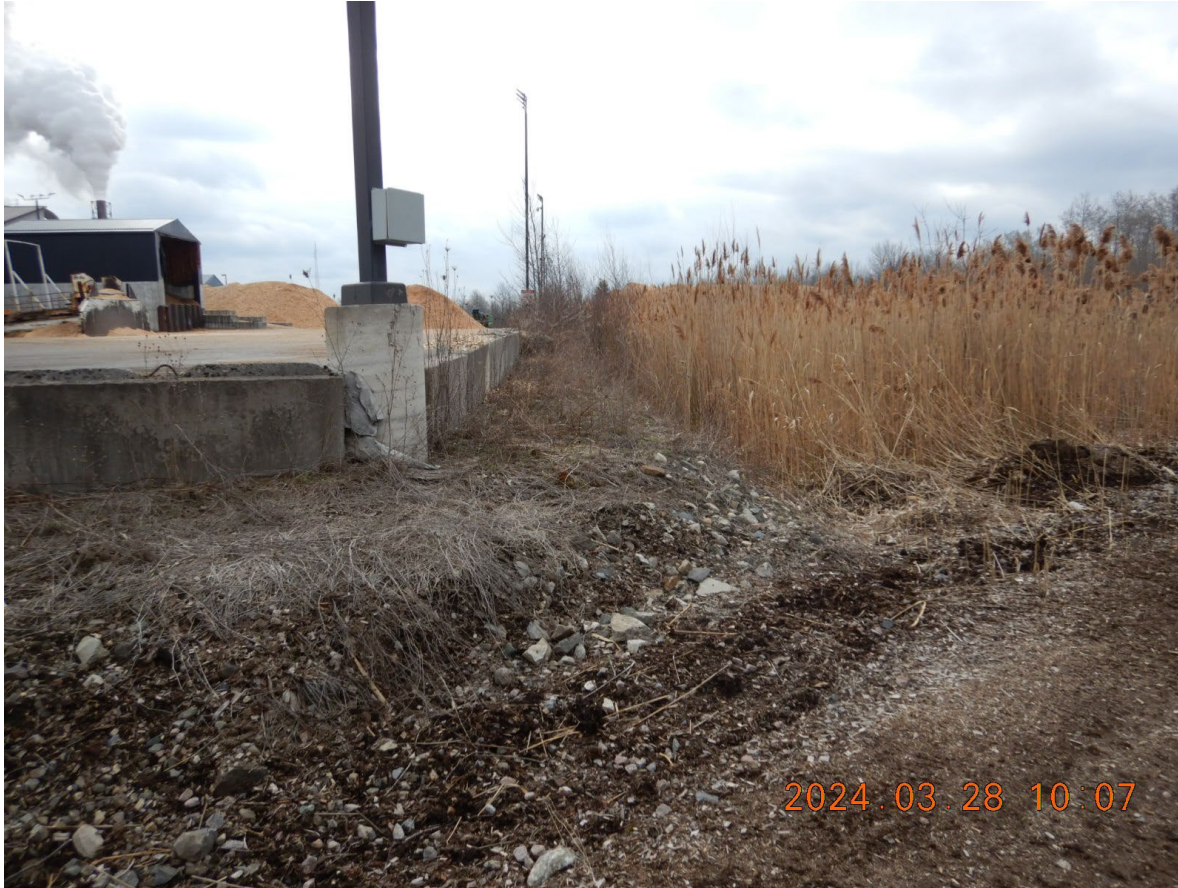
DSCN2690 - Stormwater drainage of furtherest W corner of Site

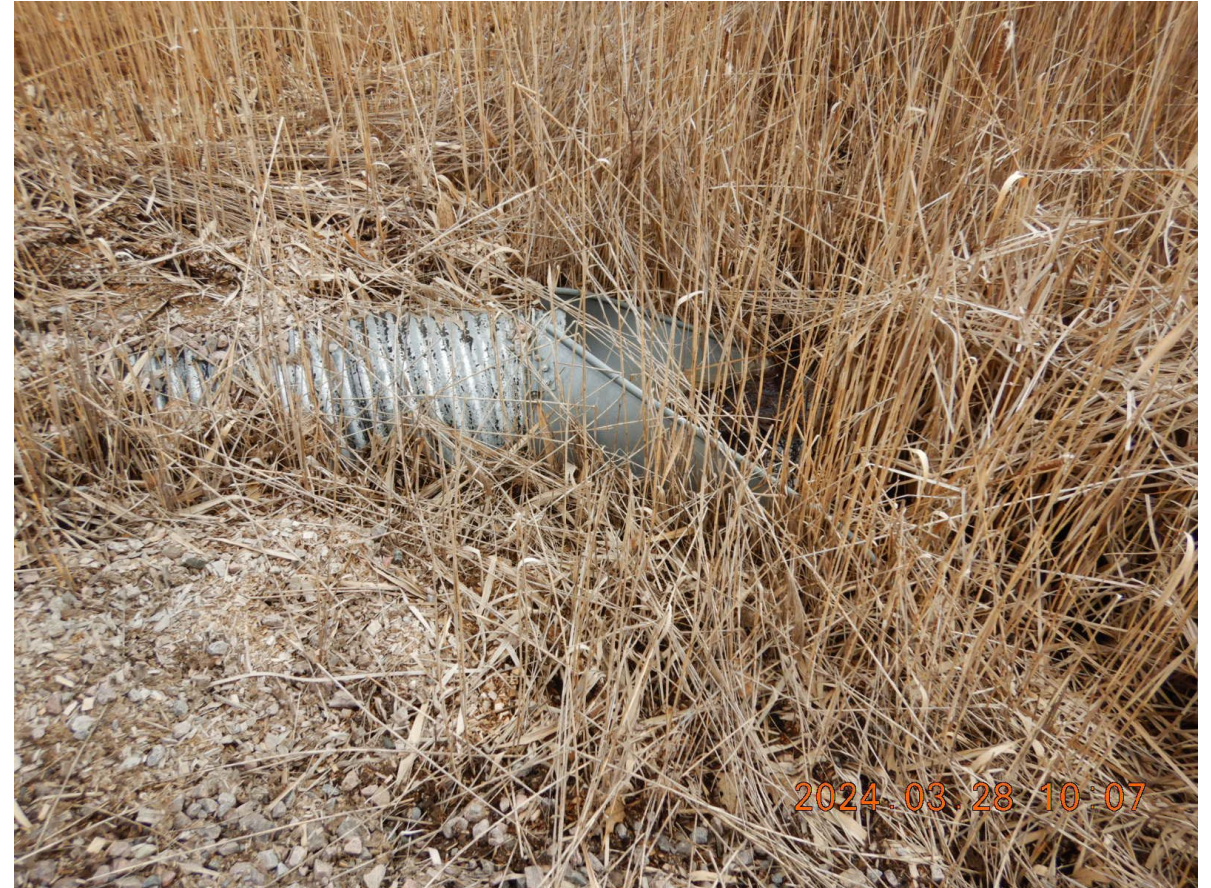
DSCN2691 - Outlet pipe of W corner and continues under gravel road to railroad property

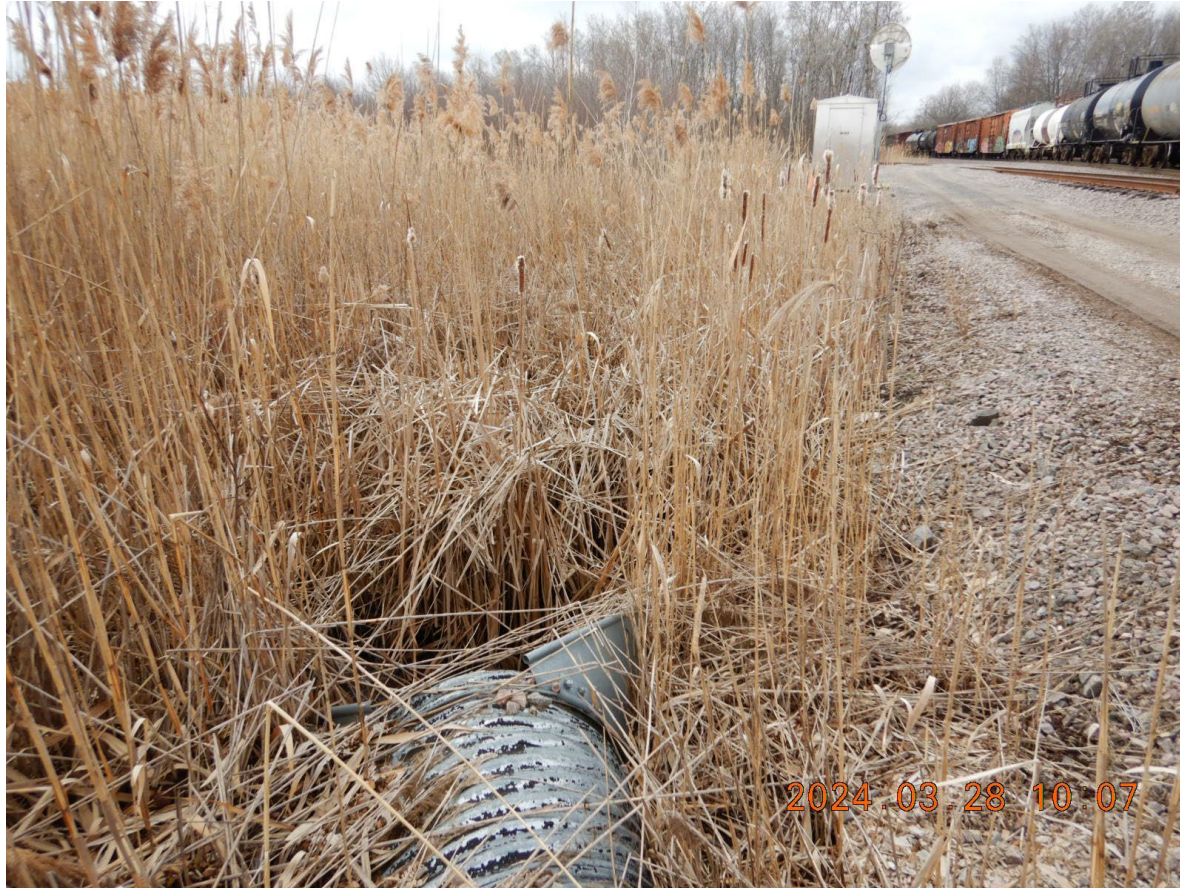
DSCN2693 - Outlet pipe of W corner and continues under gravel road to railroad property

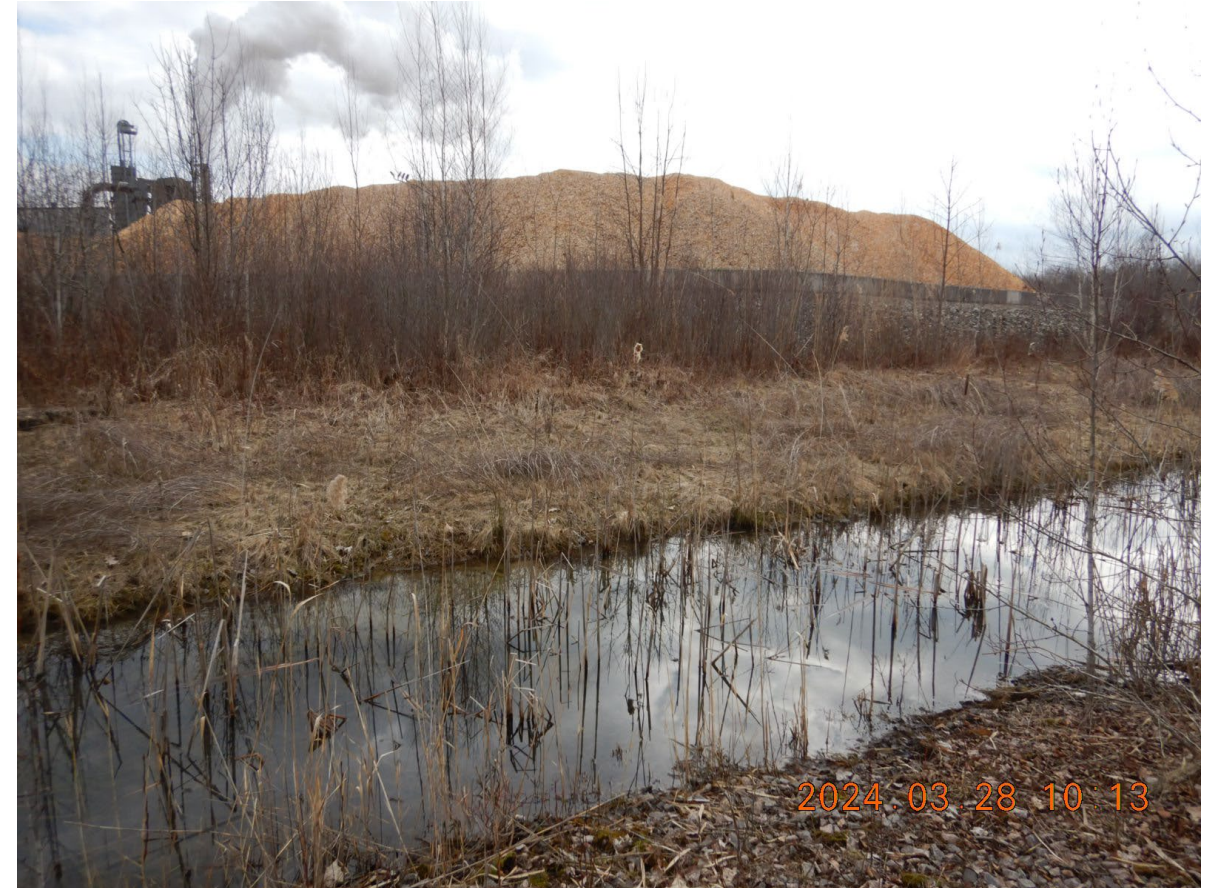
DSCN2697 - Stormwater runoff on SW side of Site

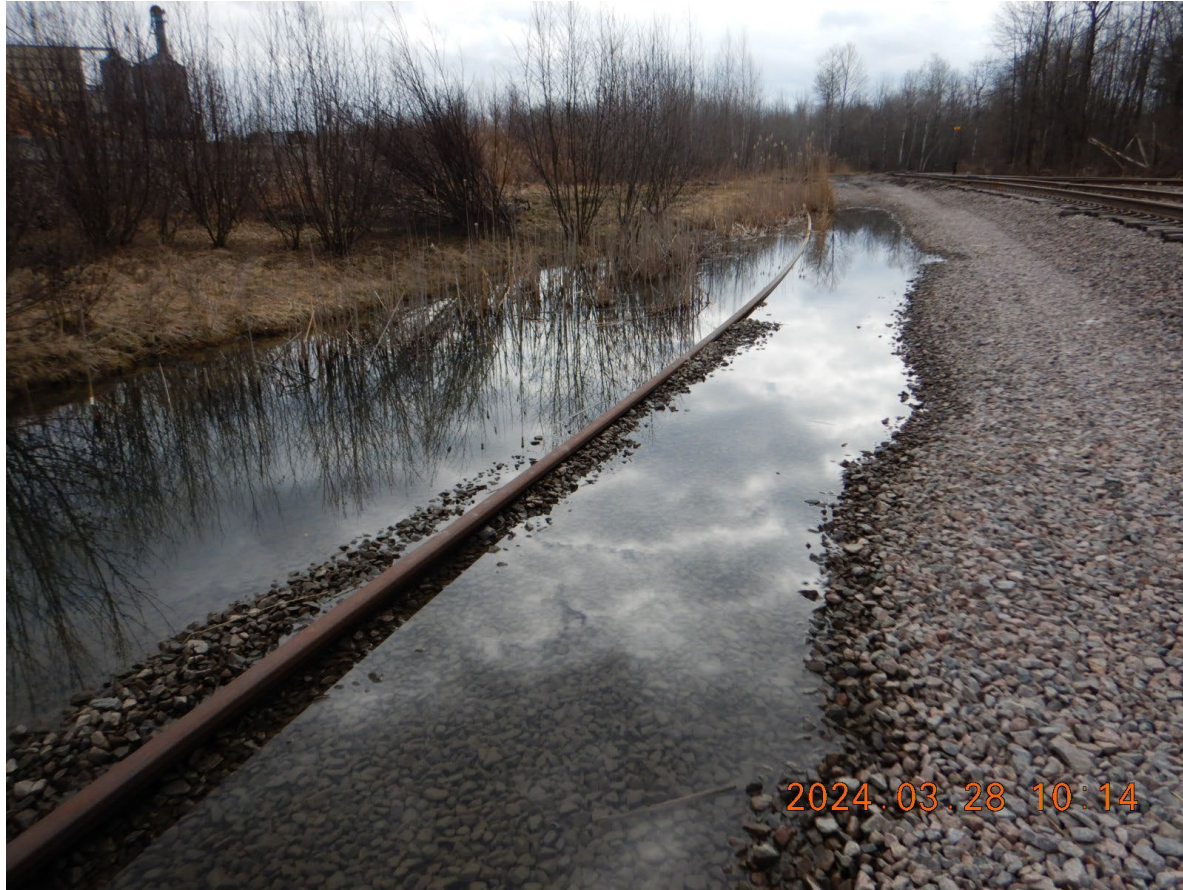
DSCN2699 - Stormwater runoff on SW side of Site

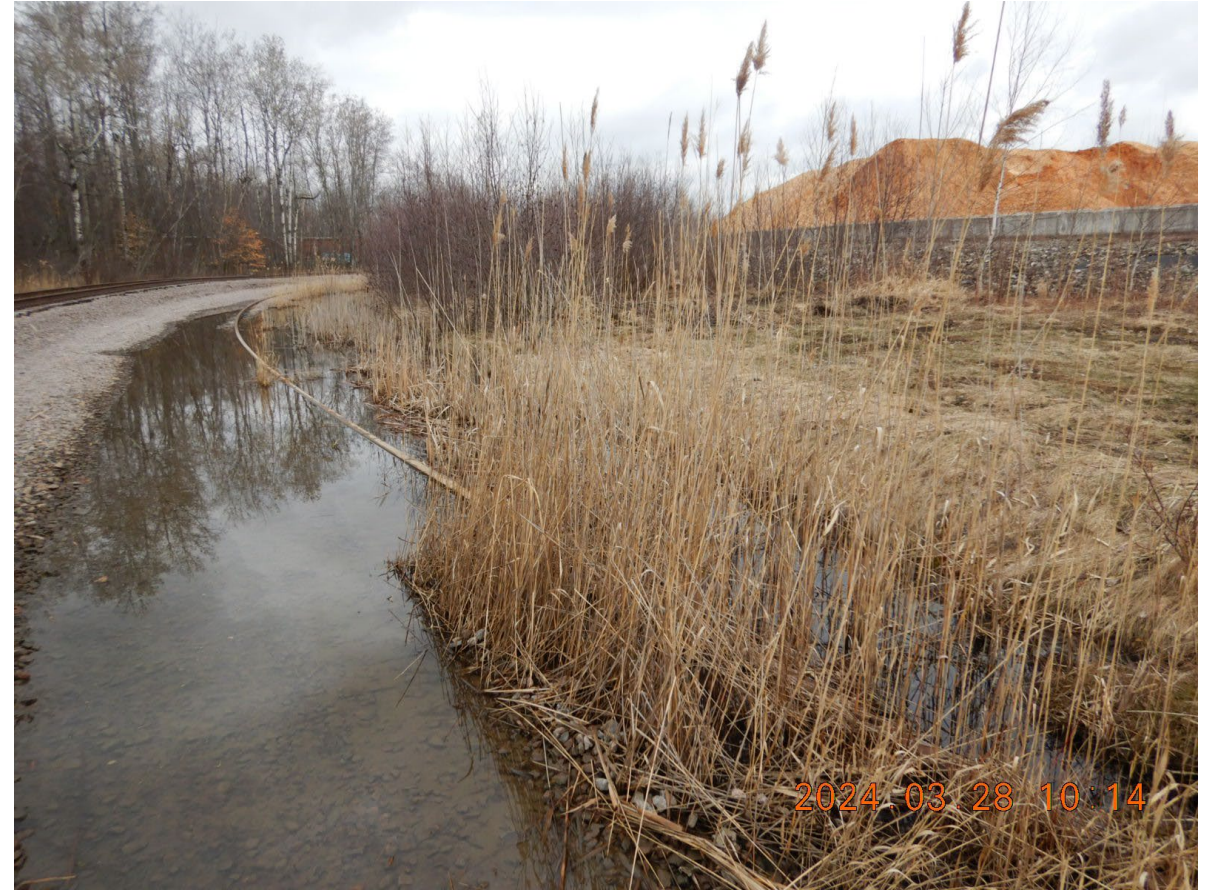
DSCN2701 - Stormwater runoff on SW side of Site

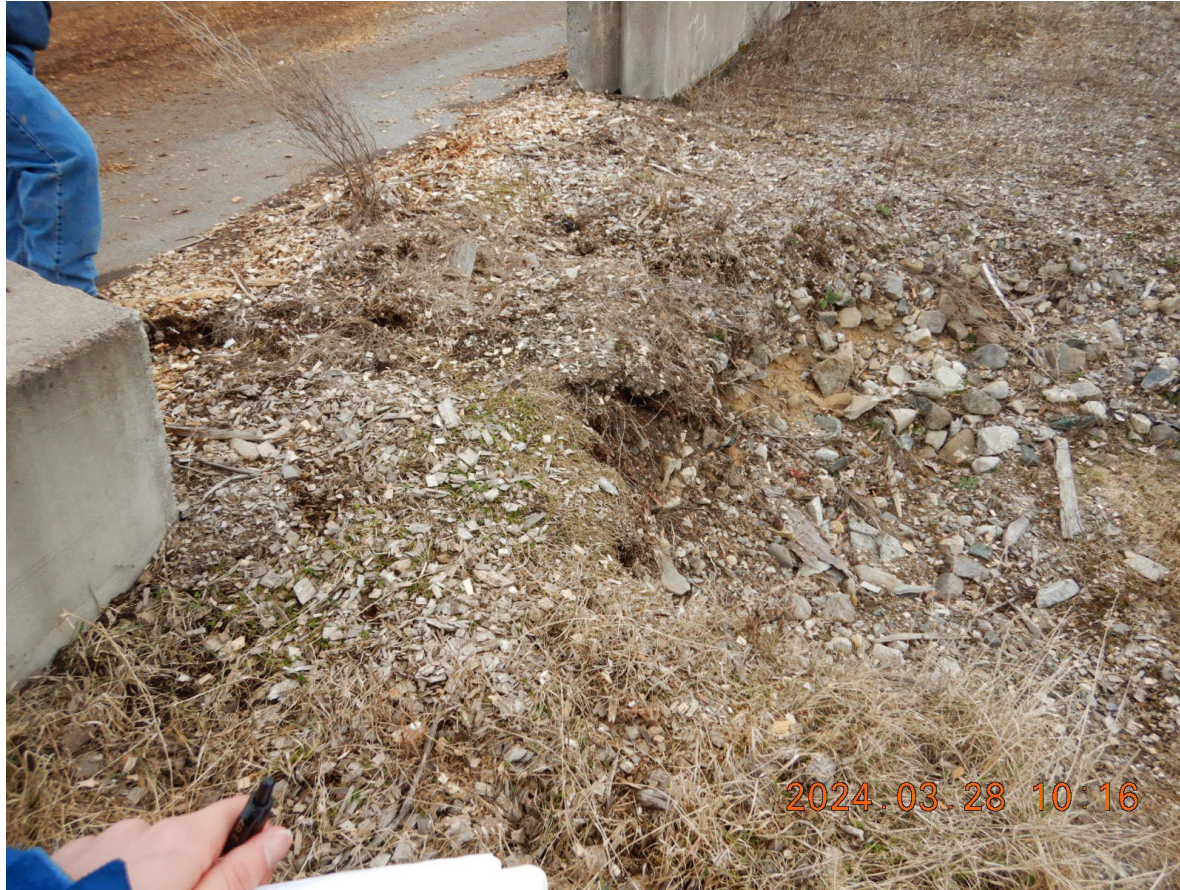
gaps in the concrete block wall in certain locations and piping that allow stormwater associated with industrial activities to reach stormwater channels (Attachment 1; DSCN2703, DSCN2707, DSCN2708, DSCN2709, and DSCN2716).

- b. EPA observed lack of effective structural or stabilization methods to prevent or minimize stormwater contact and runoff at the centrally located and southern stockpiles (Attachment 1; DSCN2665, DSCN2667, DSCN2703, DSCN2707, DSCN2708, DSCN2709, DSCN2710, DSCN2716, DSCN2717, DSCN2719, DSCN2731, DSCN2732, DSCN2734, DSCN2735, DSCN2736, DSCN2739, DSCN2741, DSCN2744, DSCN2745, DSCN2746, DSCN2748, DSCN2749, DSCN2750, and DSCN2751).

DSCN2703 - Stormwater flow path and erosion on S lot of Site

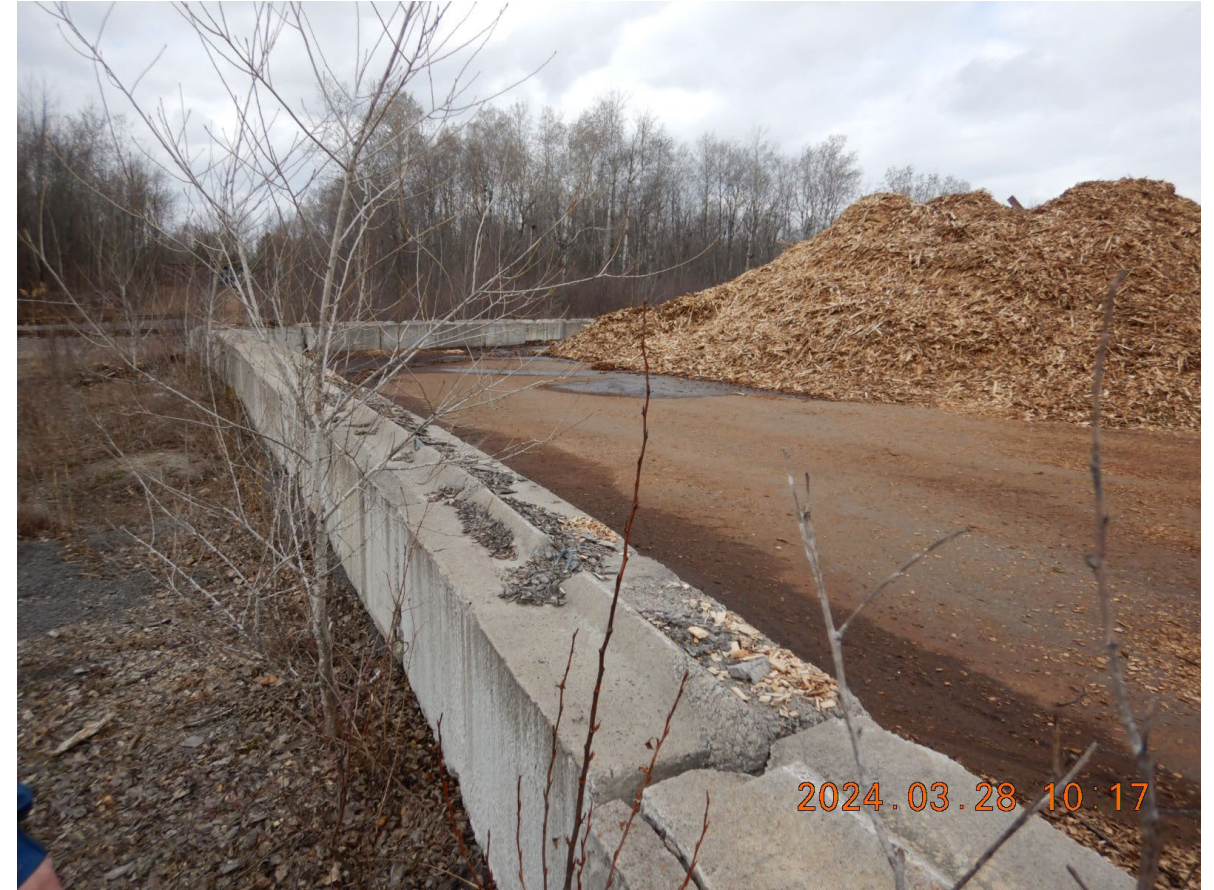
DSCN2707 - Stormwater runoff on S lot of Site. There are small gaps in the block wall where stormwater could flow out of.
