**UNITED STATES ENVIRONMENTAL PROTECTION AGENCY, REGION 2**  
**Enforcement and Compliance Assurance Division Water**  
**Compliance Branch**

| <b>Clean Water Act (CWA) Inspection</b><br><b>Report Program:</b> Industrial Stormwater | <b>Inspection Type:</b> Compliance Evaluation Inspection |
| <b>Site Name:</b> Curran Renewable Energy LLC<br>(Does not have a permit) | <b>NPDES/ICIS No.:</b> NYU065324 |

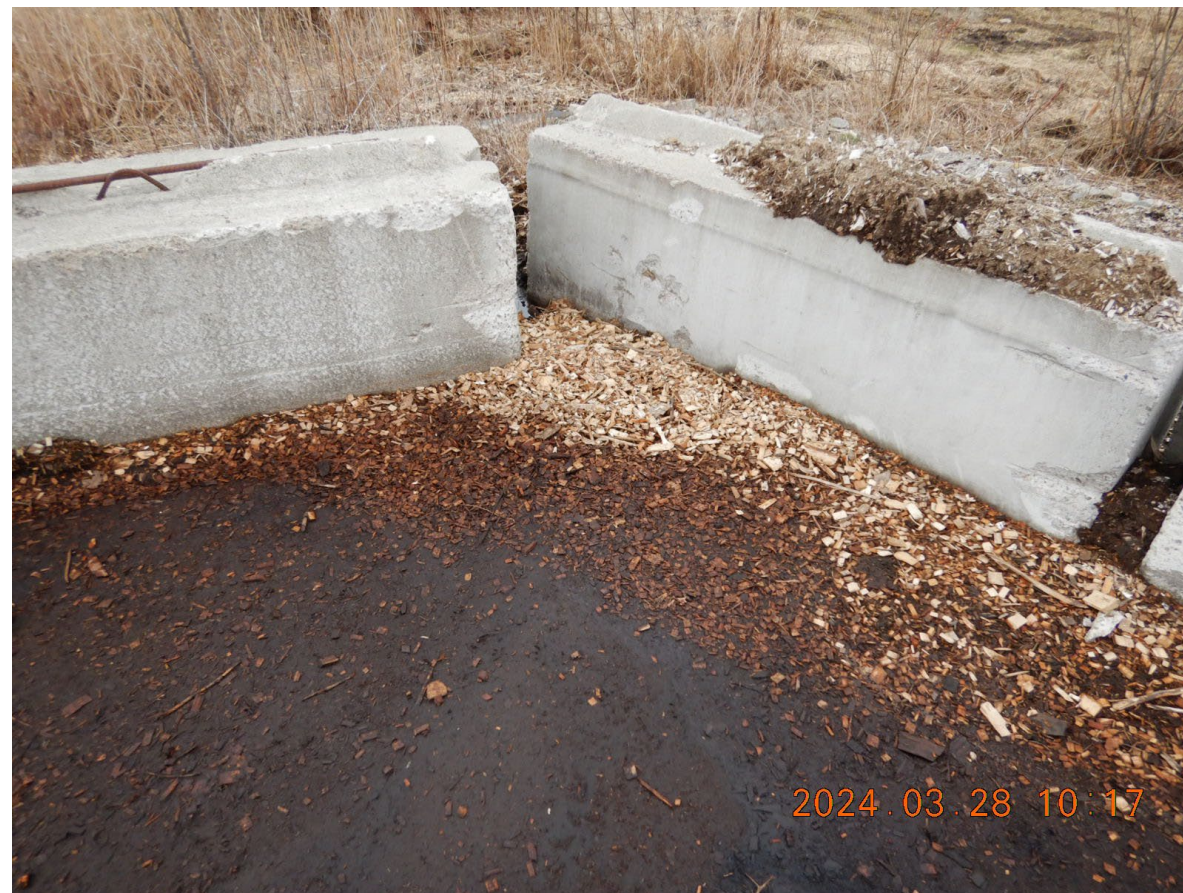
gaps in the concrete block wall in certain locations and piping that allow stormwater associated with industrial activities to reach stormwater channels (Attachment 1; DSCN2703, DSCN2707, DSCN2708, DSCN2709, and DSCN2716).

- b. EPA observed lack of effective structural or stabilization methods to prevent or minimize stormwater contact and runoff at the centrally located and southern stockpiles (Attachment 1; DSCN2665, DSCN2667, DSCN2703, DSCN2707, DSCN2708, DSCN2709, DSCN2710, DSCN2716, DSCN2717, DSCN2719, DSCN2731, DSCN2732, DSCN2734, DSCN2735, DSCN2736, DSCN2739, DSCN2741, DSCN2744, DSCN2745, DSCN2746, DSCN2748, DSCN2749, DSCN2750, and DSCN2751).

DSCN2709 - Stormwater runoff on S lot of Site

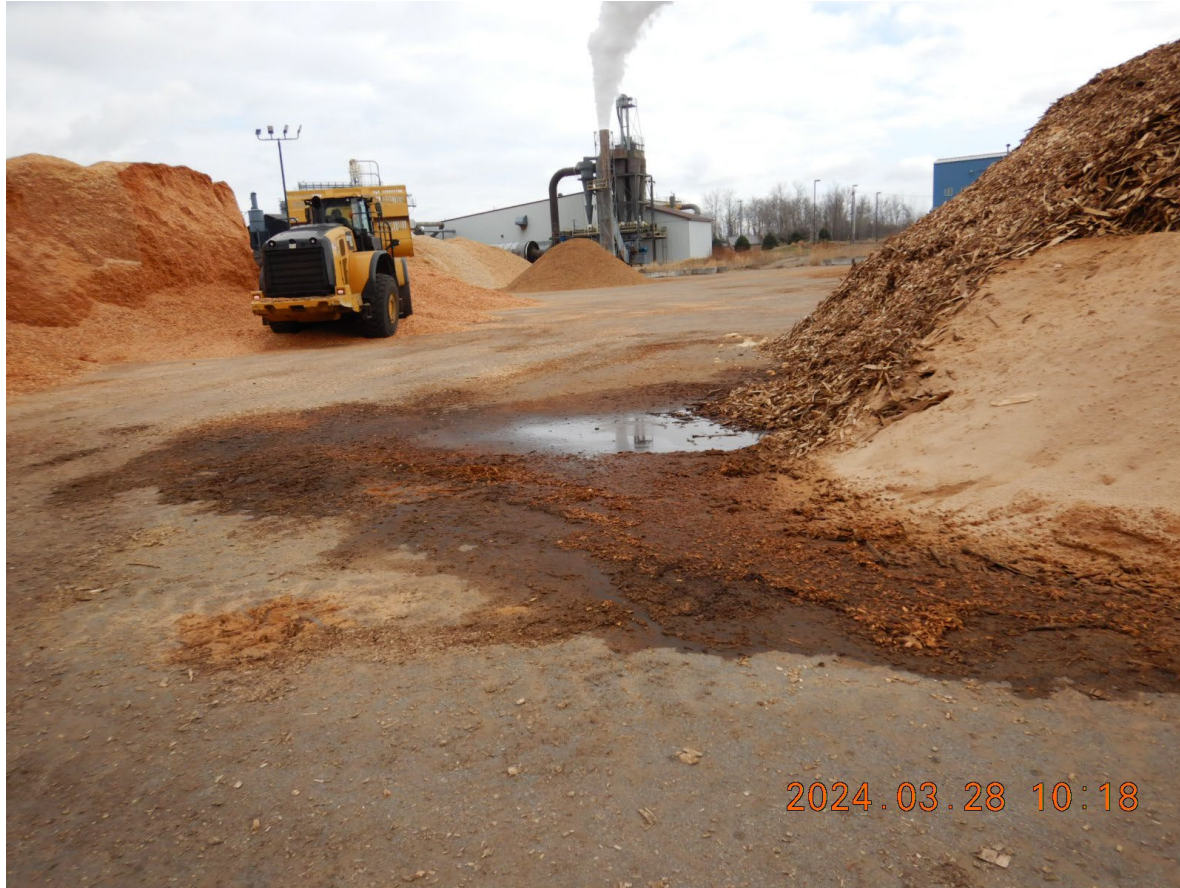
DSCN2710 - Stormwater runoff on S lot of Site

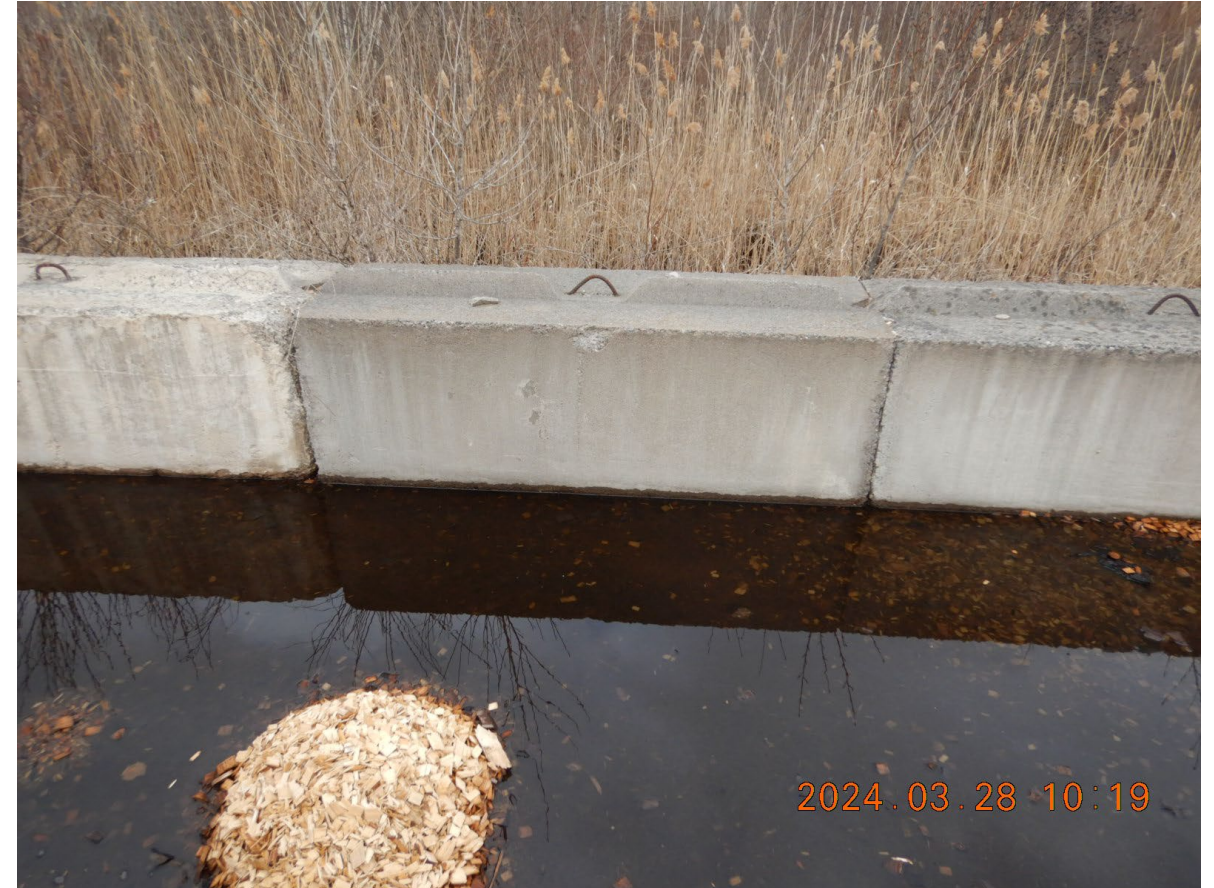
DSCN2716 - Stormwater runoff on S lot of Site

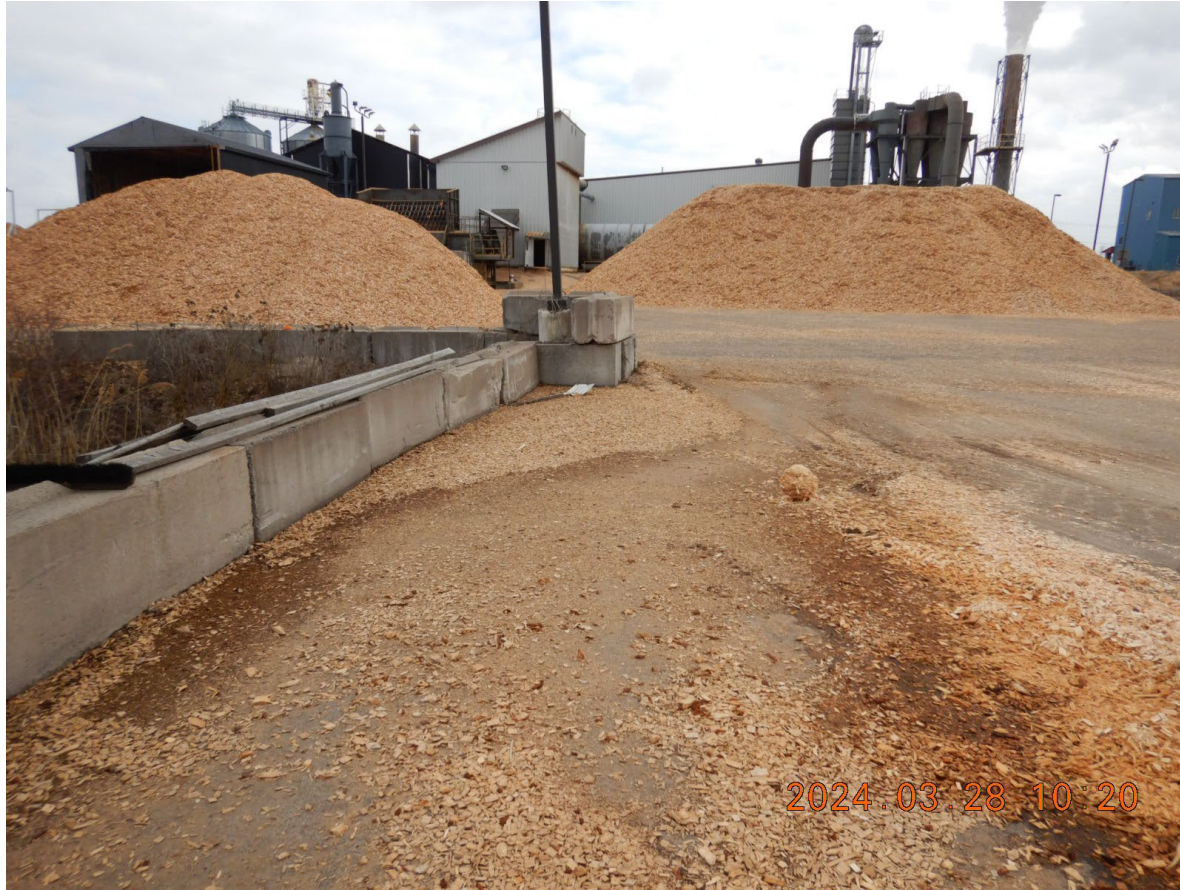
DSCN2717 - Stormwater runoff on S lot of Site

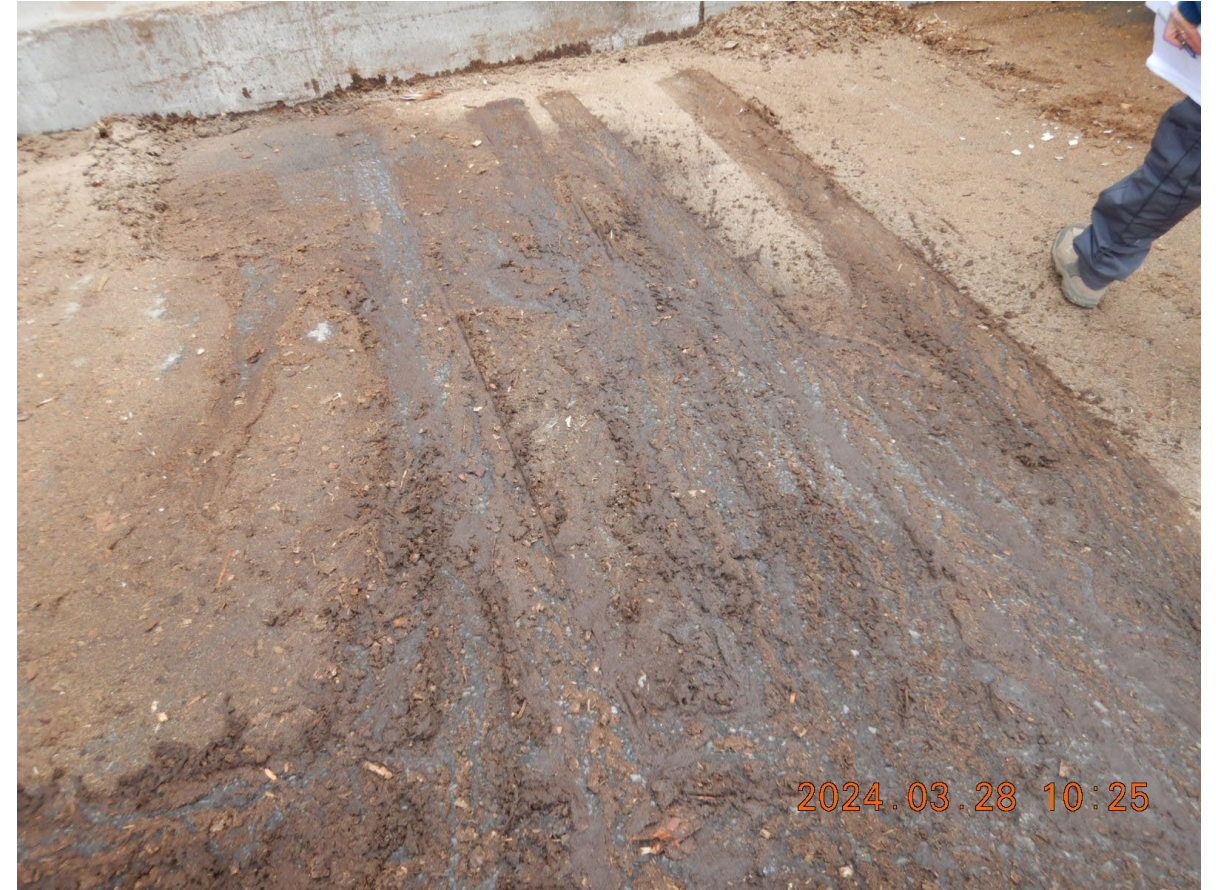
DSCN2719 - Stormwater runoff on S lot of Site

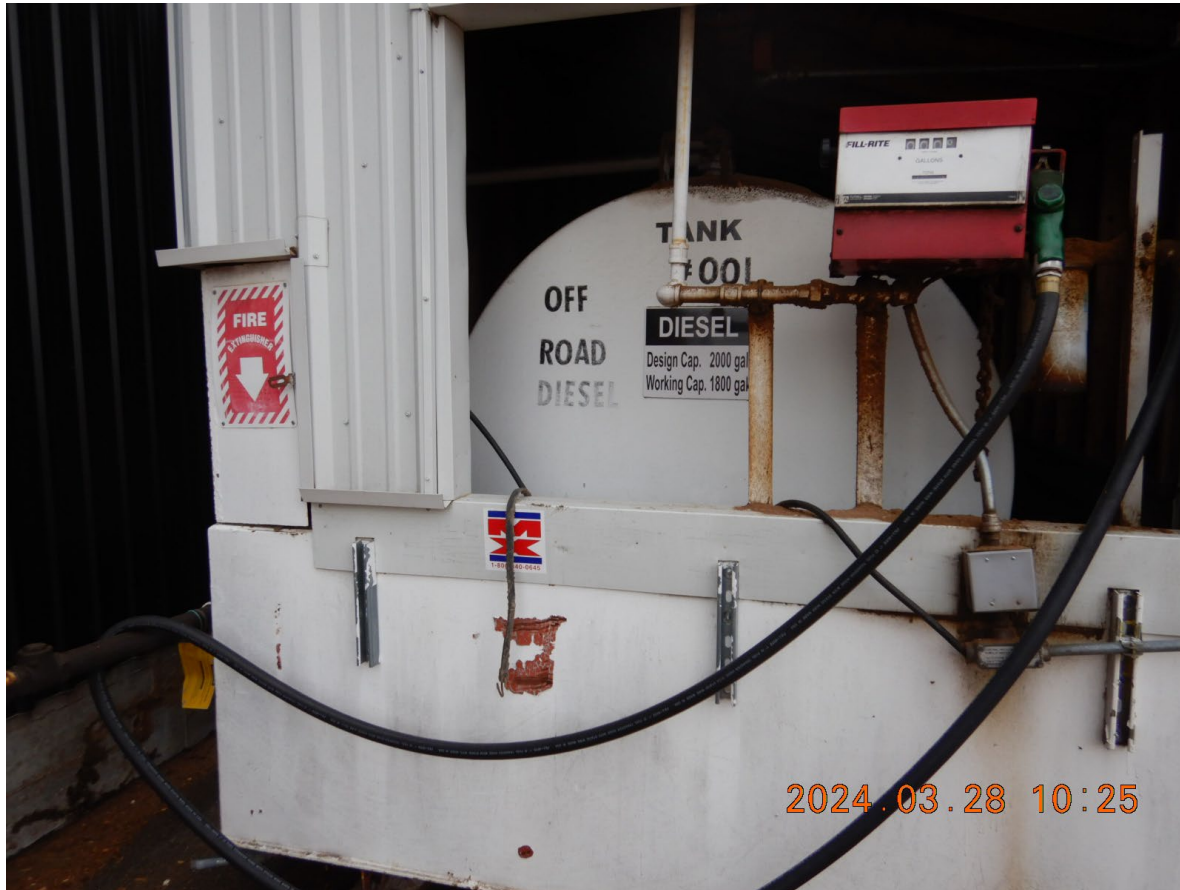
3. As shown in photo DSCN2722, the Facility has a 2,000-gallon tank for off road diesel fuel, which is used for fueling equipment. The facility representative said that they have a Spill Prevention Control and Countermeasures ("SPCC") Plan required by 40 CFR 112. EPA requests to be provided a copy of the SPCC plan.

DSCN2722 - Diesel Tank located near woodchip unloading and loading in central area of Site

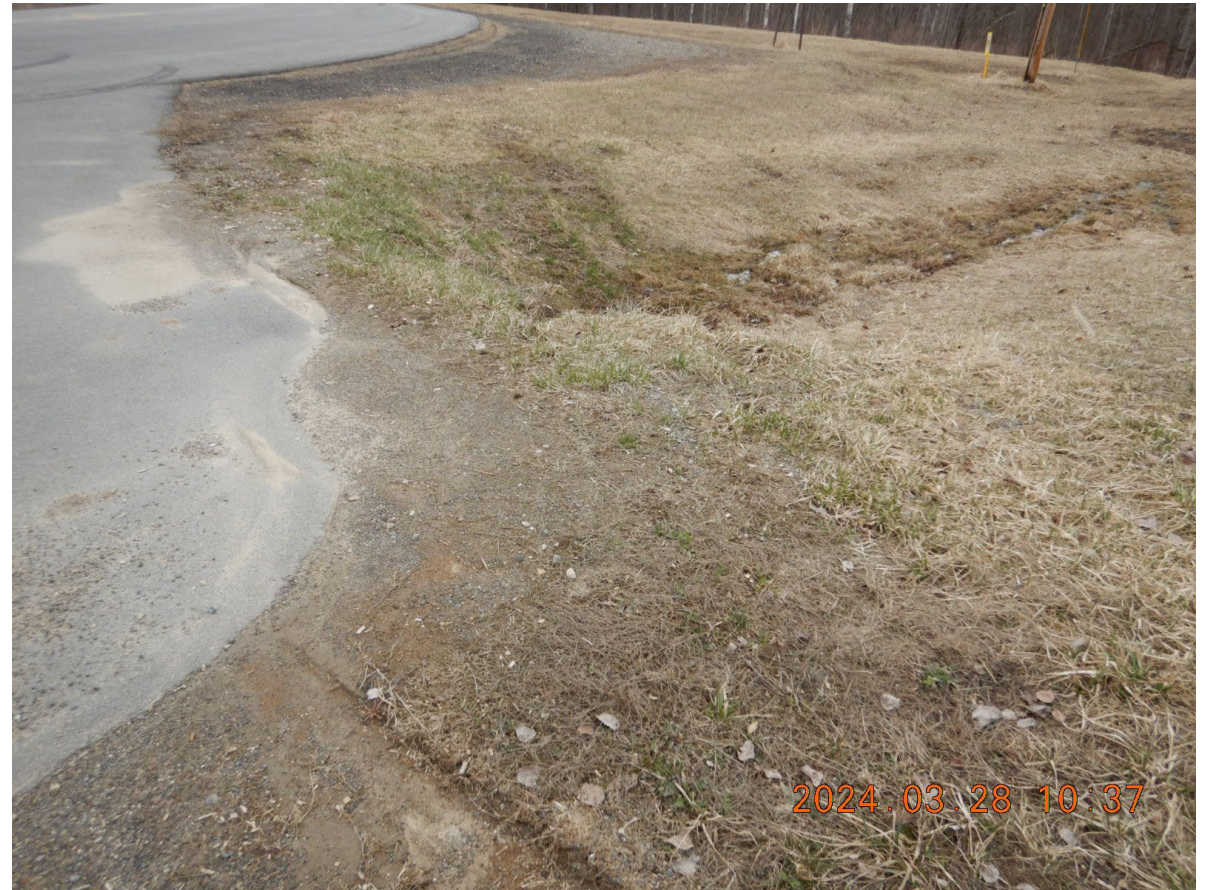
DSCN2729 - Stormwater drainage along Trade Drive – some dirt seen on roadway

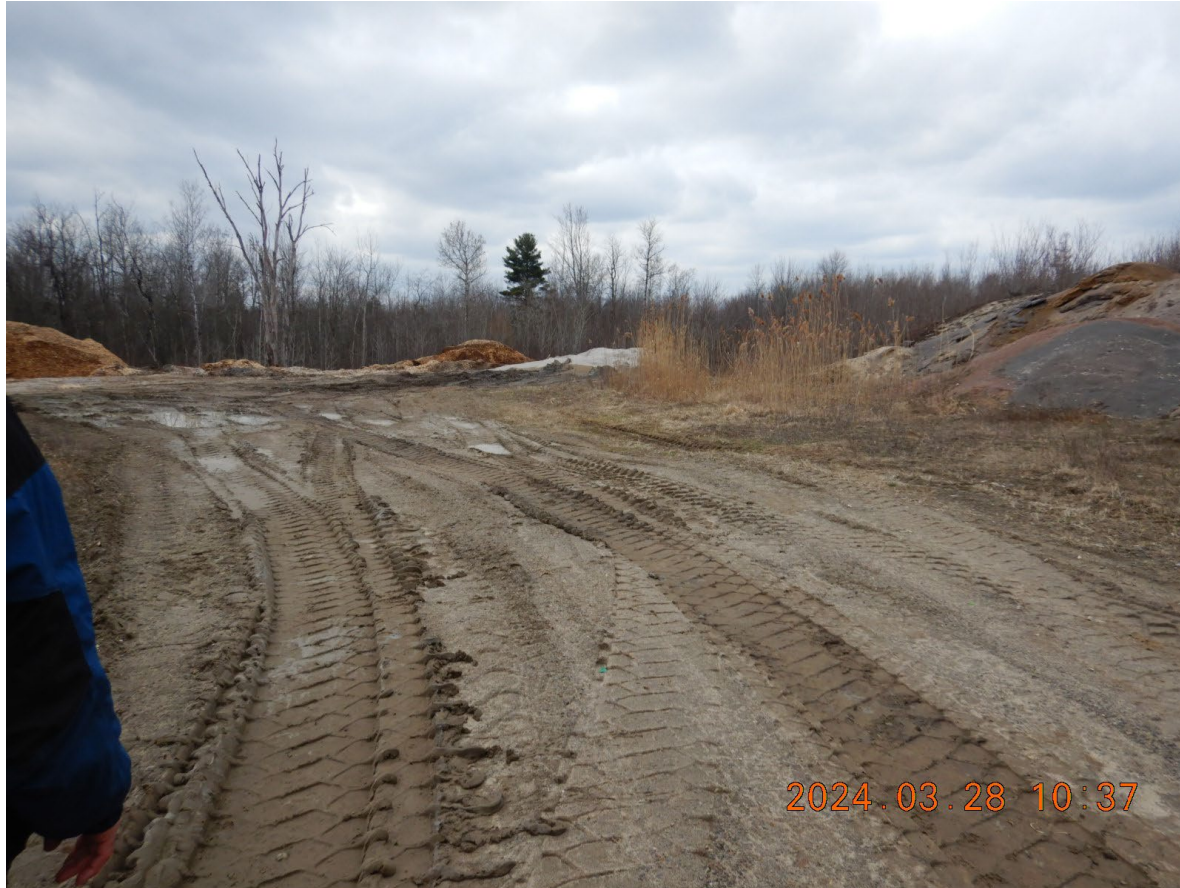
DSCN2731 - Pellet ash (from boilers) stockpile area on SE corner of Site and other material stockpiles

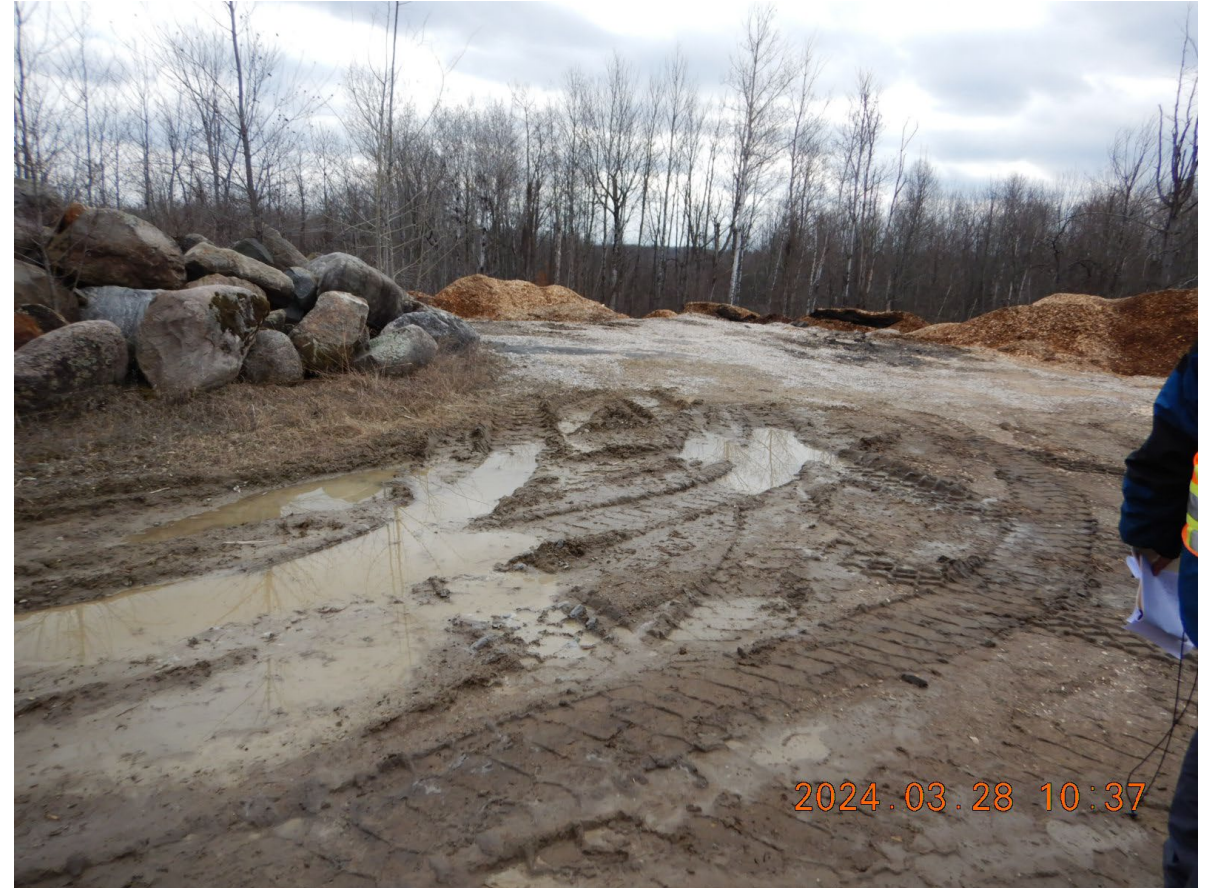
DSCN2732 - Pellet ash stockpile area and other stockpiles on SE corner of Site

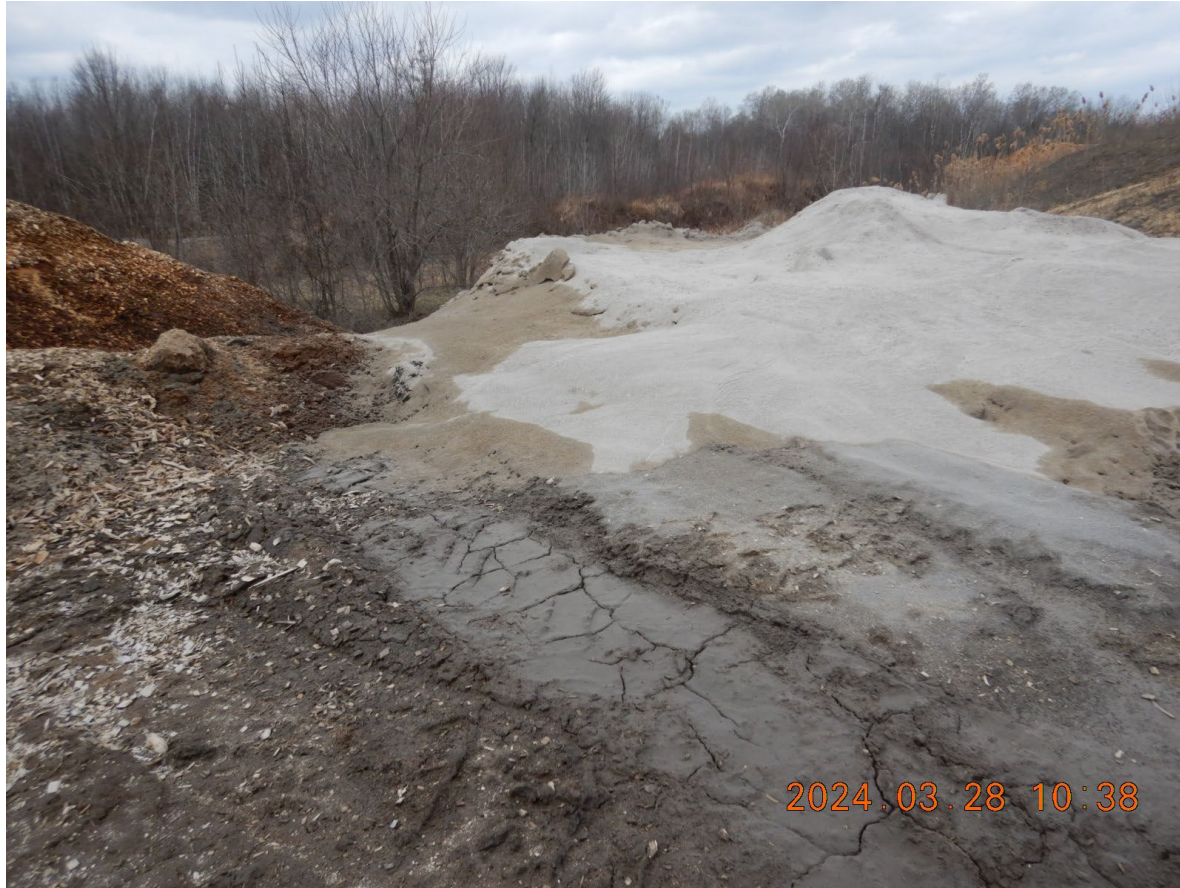
DSCN2734 - Pellet ash pile with stormwater runoff

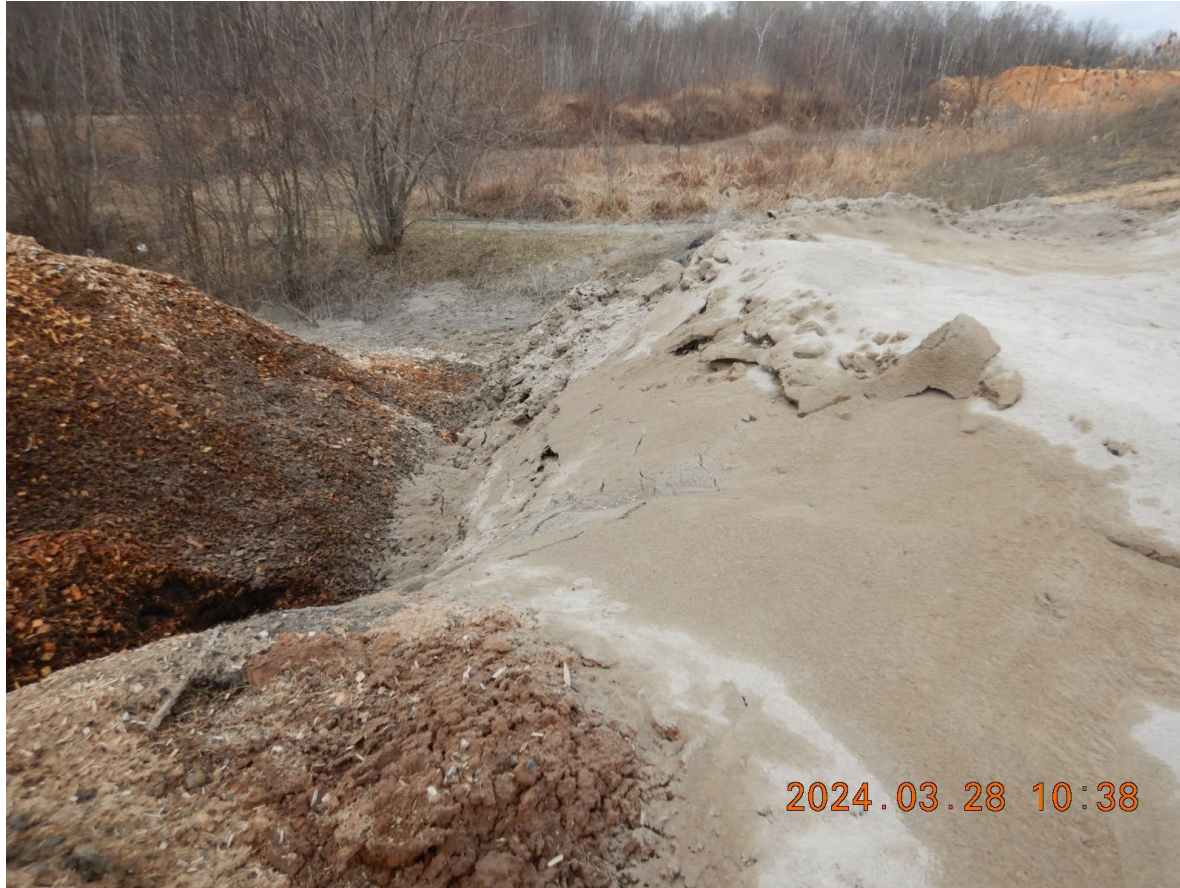
DSCN2736 - Pellet ash and stormwater runoff on S end of Site

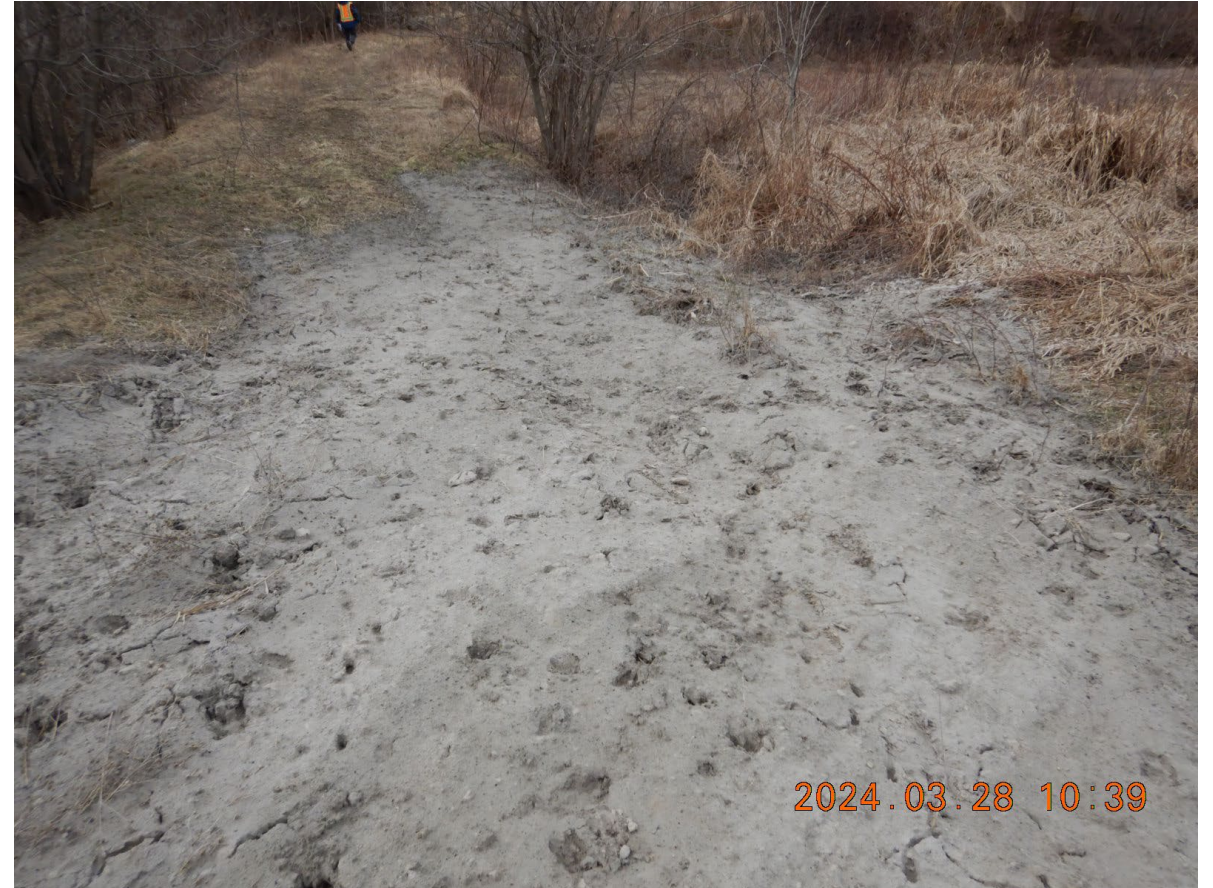
DSCN2739 - Pellet ash and stormwater runoff on S end of Site

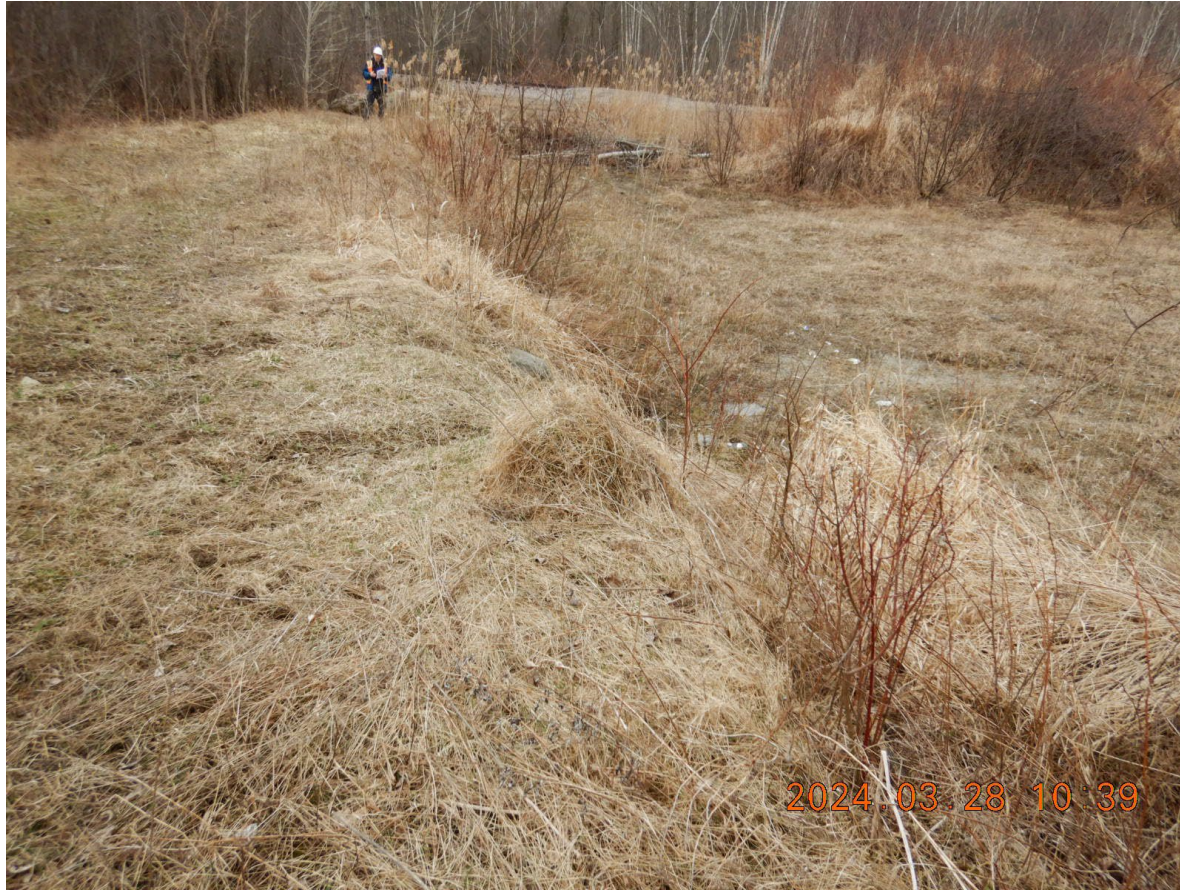
DSCN2741 - Stormwater drainage near pellet ash collection area

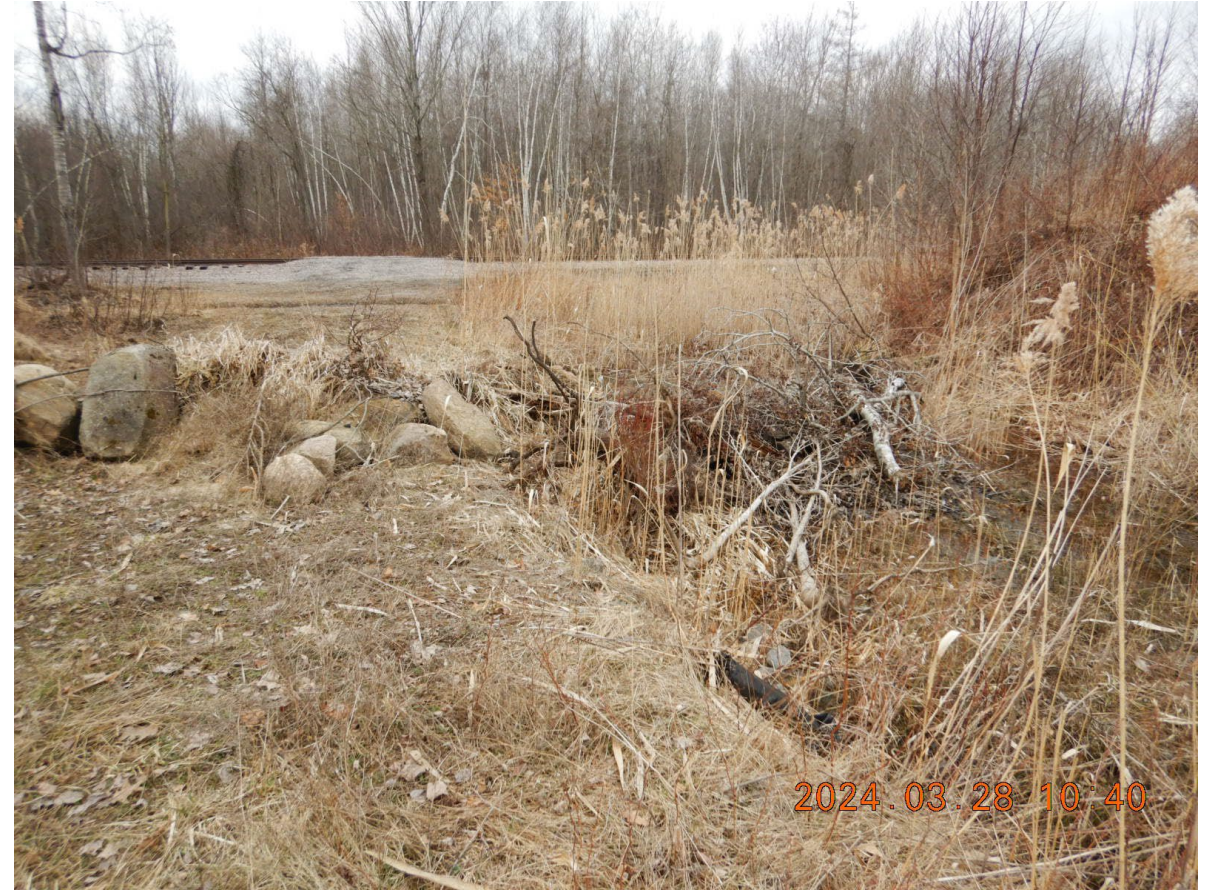
DSCN2744 - Stormwater drainage near pellet ash collection area

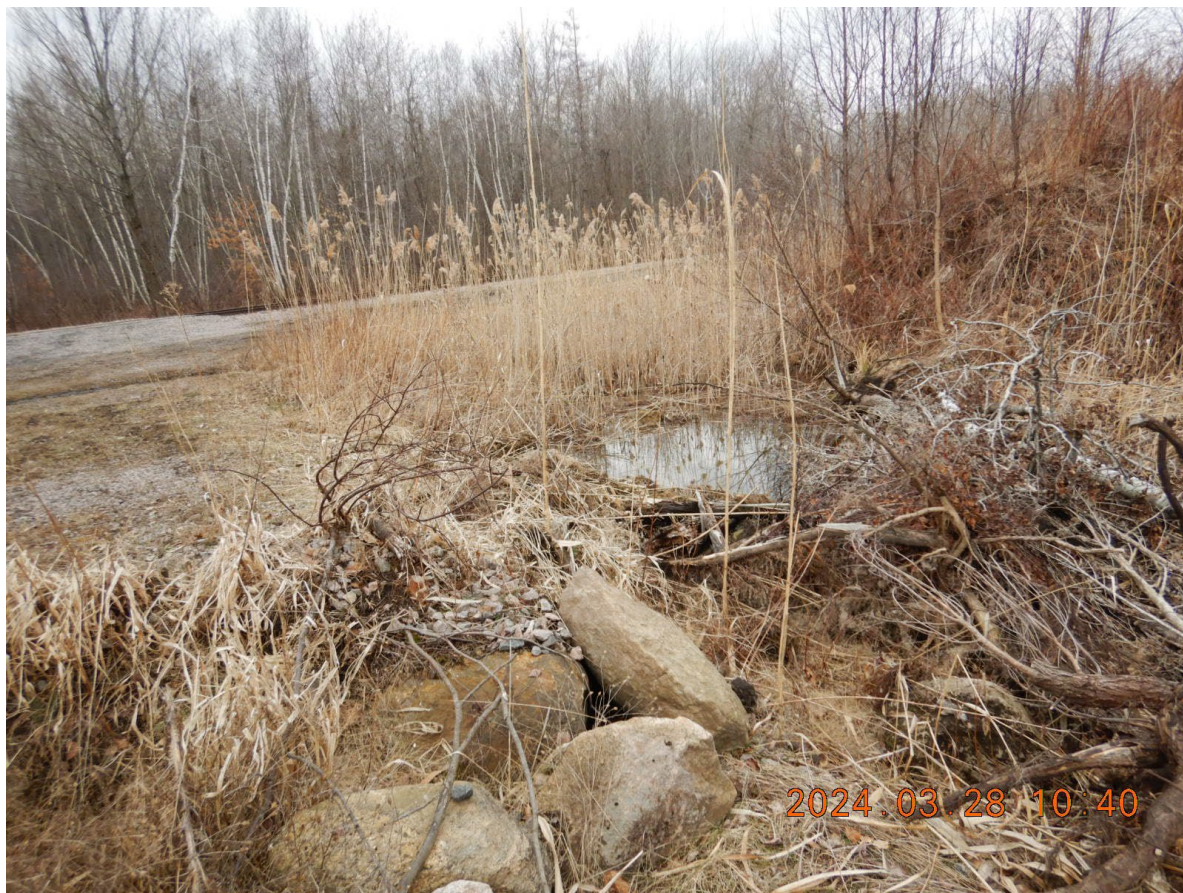
DSCN2745 - Stormwater drainage downhill of pellet ash stockpile area

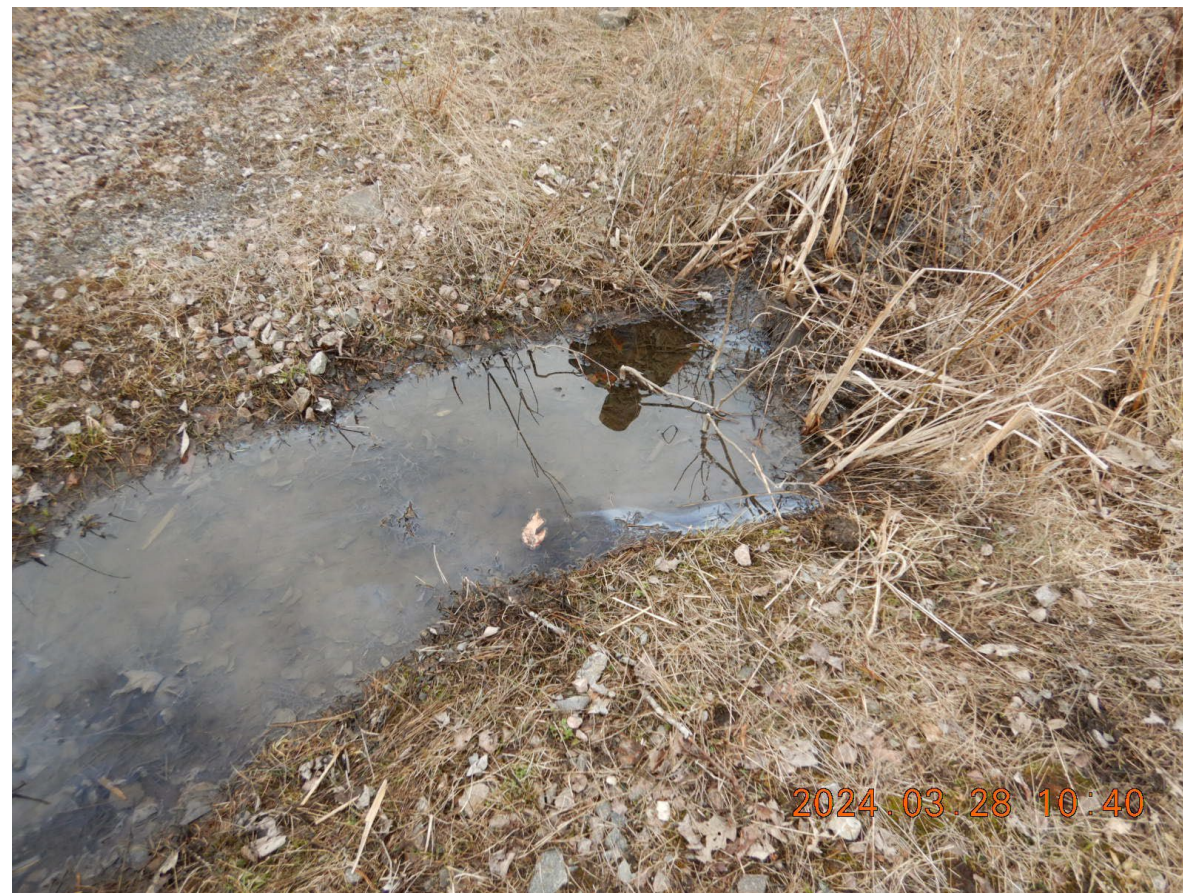
DSCN2746 - Stormwater channel with water near forested area on S end of Site

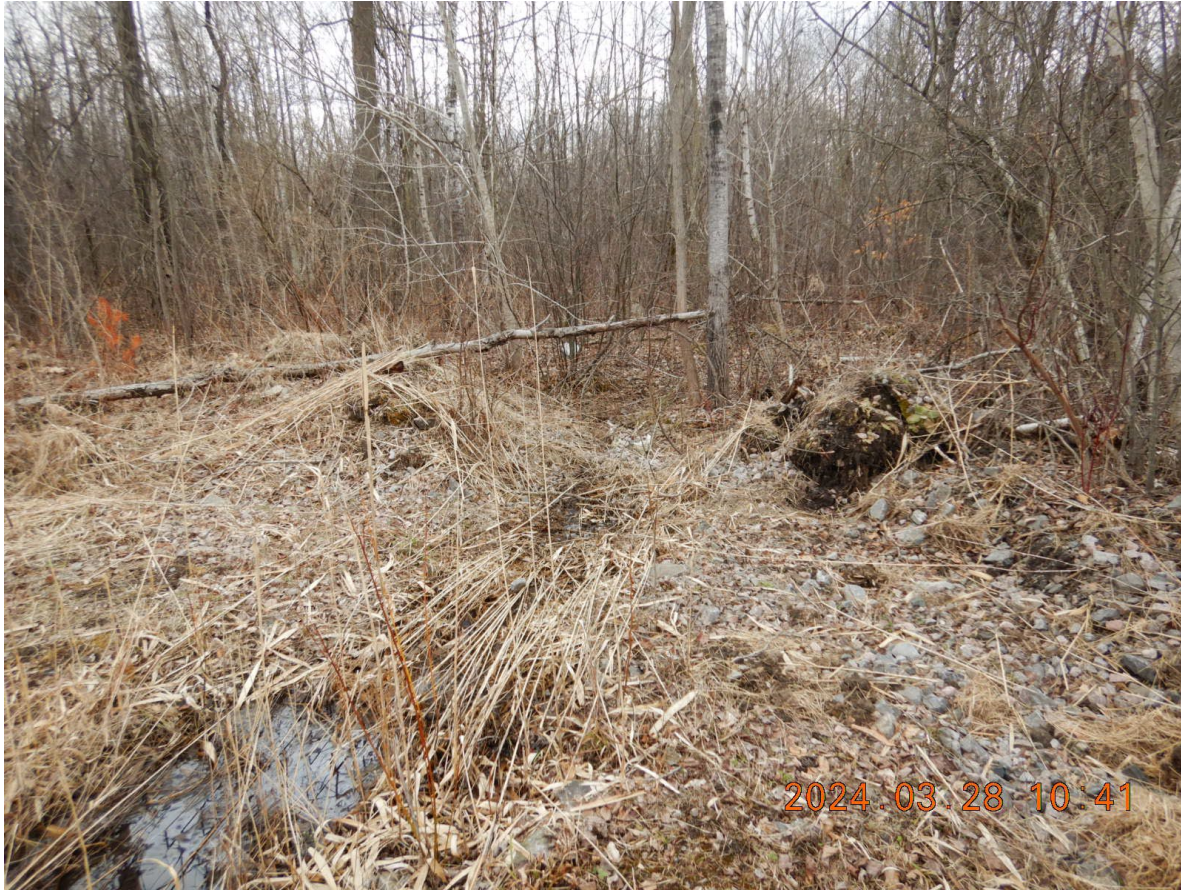
DSCN2747 - Stormwater drainage near pellet ash collection area; stormwater near forested area on S end of Site

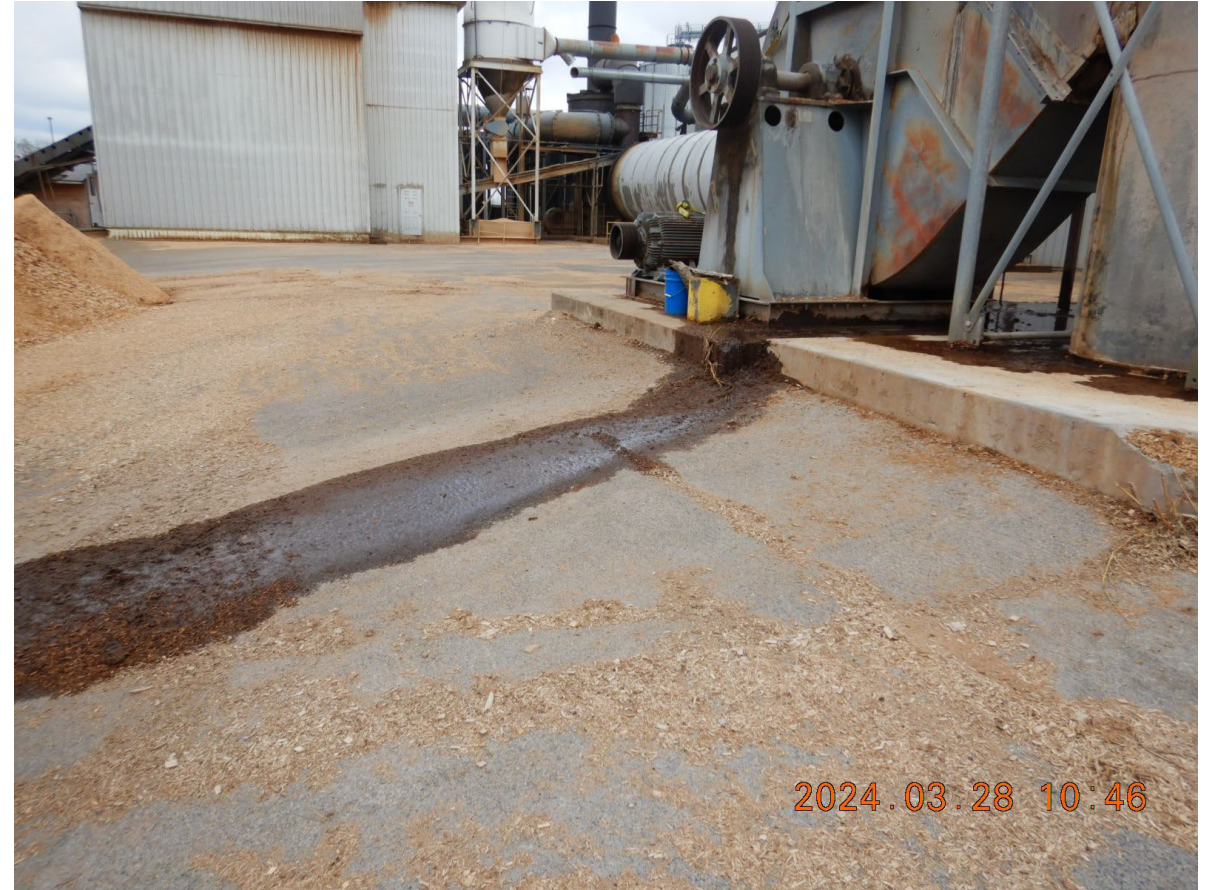
- c. Runoff of condensate from the Facility equipment towards a stormwater channel (Attachment 1; DSCN2751, DSCN2749, DSCN2750, and DSCN2748). Part I.B.2 of the MSGP does not authorize non-stormwater discharges of condensate of gas streams (except for uncontaminated steam or air conditioning condensate) as cited in 6 NYCRR 750-1.2(a)(29)(vi).

DSCN2748 - Condensate from manufacturing process

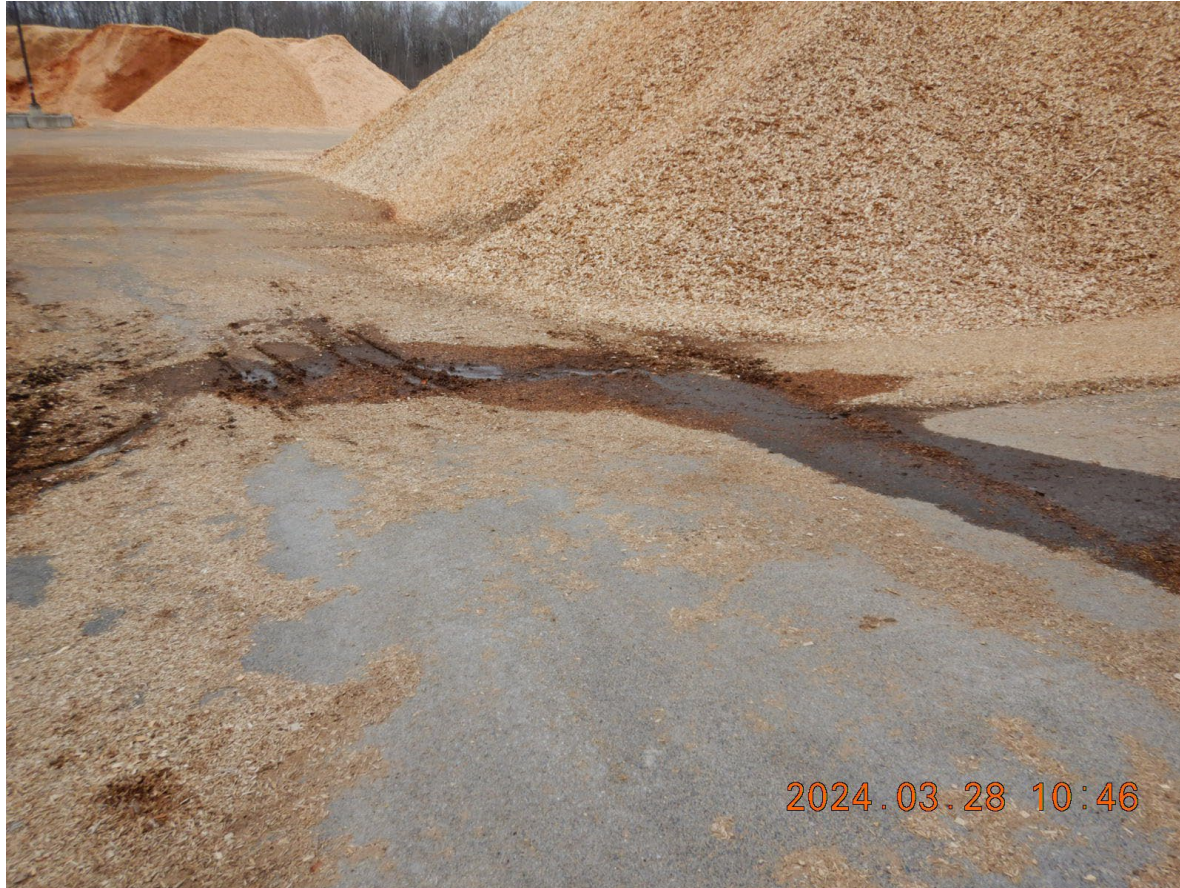
DSCN2749 - Condensate runoff from manufacturing process

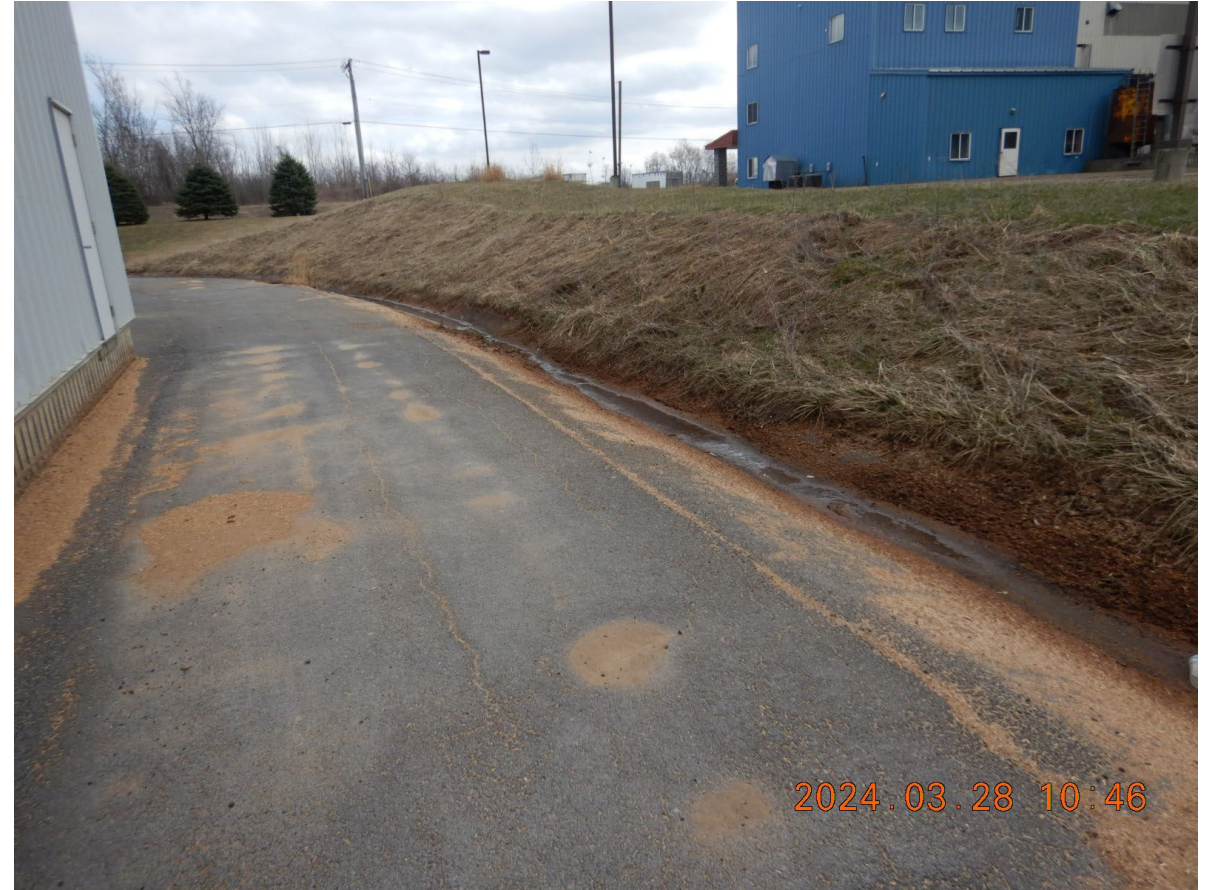
DSCN2673, DSCN2691, and DSCN2693). A retention pond and a gravel drive built over the stormwater channel was also observed by EPA representatives (Attachment 1, DSCN2674, DSCN2675 and DSCN2676). In addition to the collection of water on the west side of the Site, EPA observed water collected and flows from the central stockpile area and South stockpile lot (Attachment 1; DSCN2665, DSCN2667, DSCN2703, DSCN2707, DSCN2708, DSCN2709, DSCN2710, DSCN2716, DSCN2717, and DSCN2719). Mr. Measheaw stated that waste ash (from burning wood in boilers) created during pellet manufacturing was collected into two (2) metal collection bins (Attachment 1; DSCN2724). These bins are then emptied outside at the most southern waste stockpile lot. At the time of the CEI, EPA representatives also observed runoff and condensate flows from industrial equipment at the Site (Attachment 1; DSCN2666, DSCN2748, DSCN2749, DSCN2750 and DSCN2751). EPA observed a catch basin near the south side of the pellet manufacturing building filled with woodchip and pellet debris. EPA observed that this catch basin emptied to the south side of the Site (Attachment 1; DSCN2753, DSCN2754, DSCN2752, DSCN2755, DSCN2756, DSCN2757 and DSCN2758).

DSCN2752 - Stormwater drainage on S side of pellet manufacturing building
