**UNITED STATES ENVIRONMENTAL PROTECTION AGENCY, REGION 2**  
**Enforcement and Compliance Assurance Division Water**  
**Compliance Branch**

| <b>Clean Water Act (CWA) Inspection</b><br><b>Report Program:</b> Industrial Stormwater | <b>Inspection Type:</b> Compliance Evaluation Inspection |
| <b>Site Name:</b> Curran Renewable Energy LLC<br>(Does not have a permit) | <b>NPDES/ICIS No.:</b> NYU065324 |

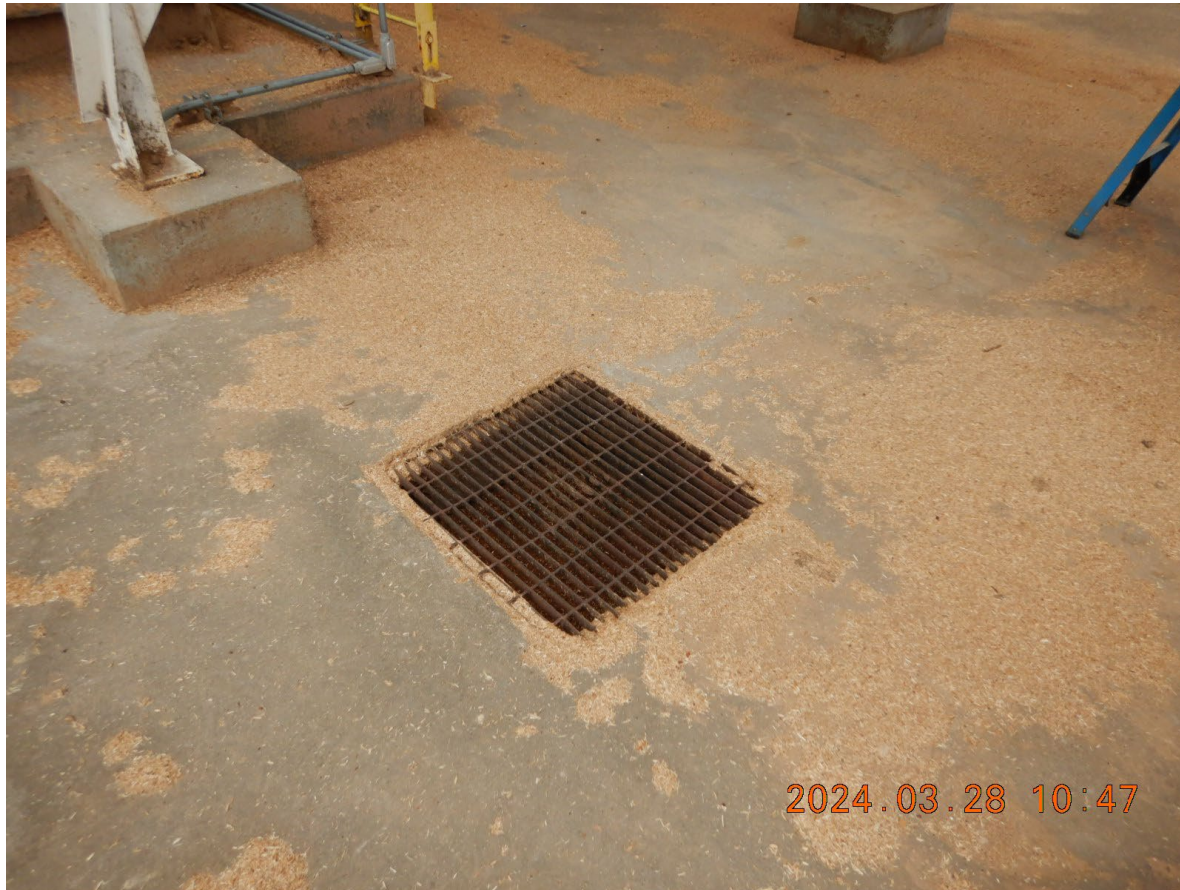
2. Part II.A.3 of the Permit states that the owner or operator must minimize pollutant discharges and achieve the effluent limitations in this permit, all industrial equipment and systems and control measures must be maintained in effective operating condition. EPA observed catch basins in need of maintenance. For example, photo 2754 shows a storm inlet with a large amount of wood chips and mulch within it, and photo 2662 shows a storm inlet partially blocked with vegetation (Attachment 1; DSCN2662, DSCN2671, DSCN2753, DSCN2754, DSCN2756).

DSCN2753 - Catch basin #3 on S corner pellet manufacturing building

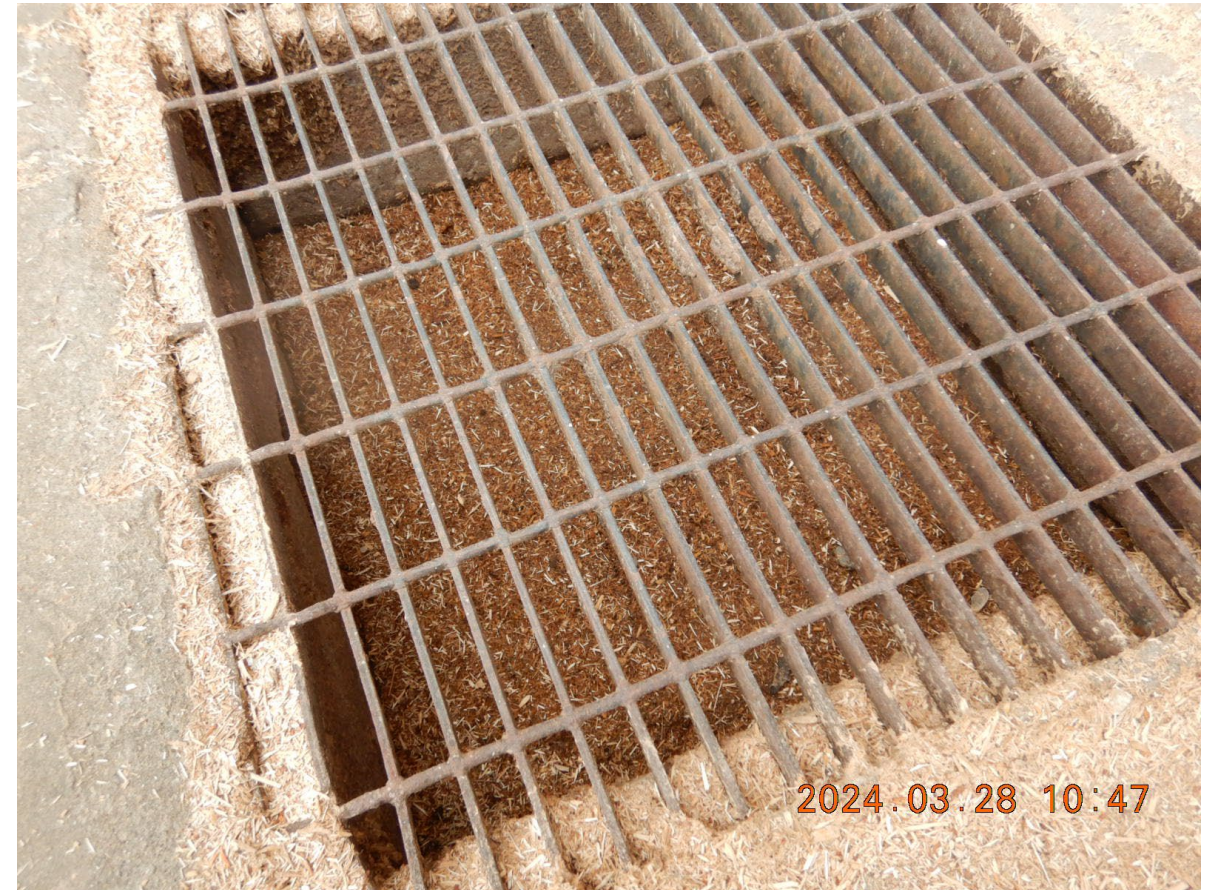
DSCN2754 - Catch basin #3 on S corner pellet manufacturing building – material seen in the catch basin

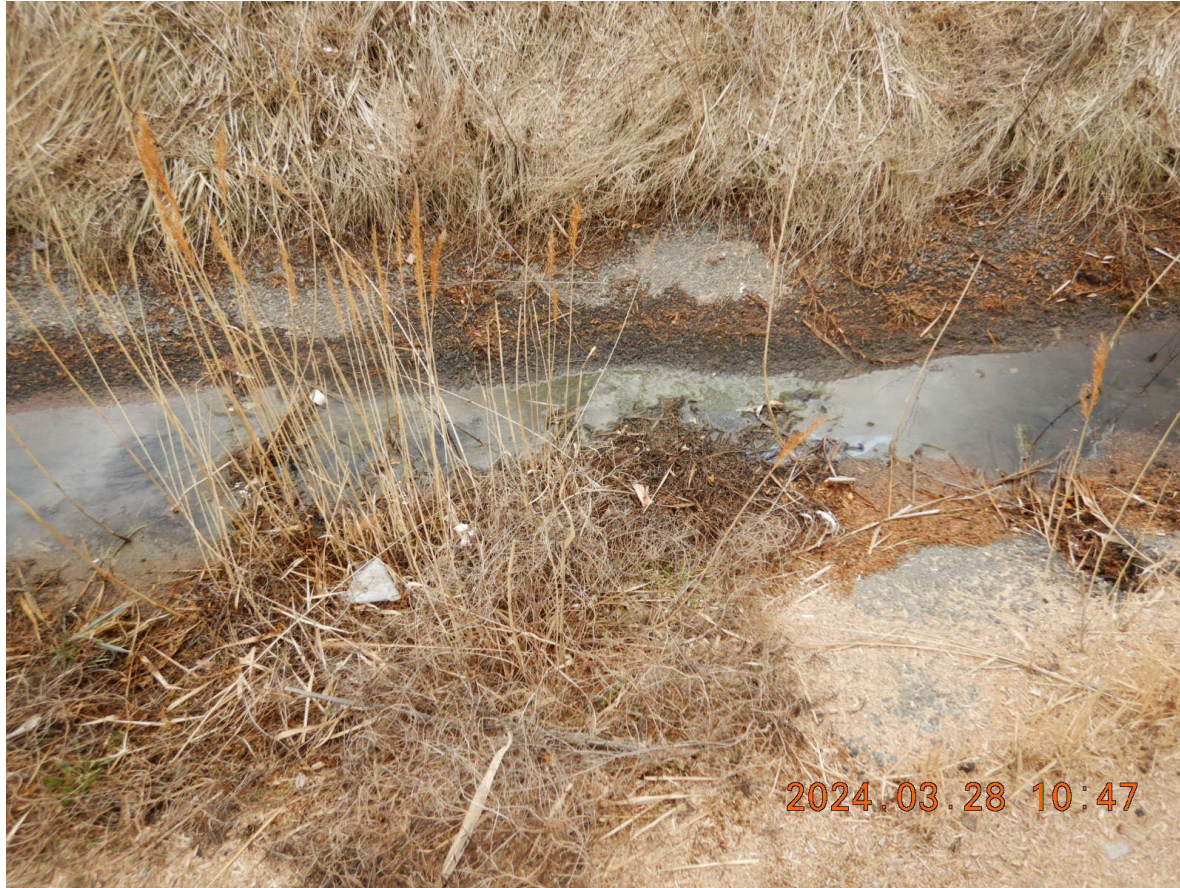
DSCN2673, DSCN2691, and DSCN2693). A retention pond and a gravel drive built over the stormwater channel was also observed by EPA representatives (Attachment 1, DSCN2674, DSCN2675 and DSCN2676). In addition to the collection of water on the west side of the Site, EPA observed water collected and flows from the central stockpile area and South stockpile lot (Attachment 1; DSCN2665, DSCN2667, DSCN2703, DSCN2707, DSCN2708, DSCN2709, DSCN2710, DSCN2716, DSCN2717, and DSCN2719). Mr. Measheaw stated that waste ash (from burning wood in boilers) created during pellet manufacturing was collected into two (2) metal collection bins (Attachment 1; DSCN2724). These bins are then emptied outside at the most southern waste stockpile lot. At the time of the CEI, EPA representatives also observed runoff and condensate flows from industrial equipment at the Site (Attachment 1; DSCN2666, DSCN2748, DSCN2749, DSCN2750 and DSCN2751). EPA observed a catch basin near the south side of the pellet manufacturing building filled with woodchip and pellet debris. EPA observed that this catch basin emptied to the south side of the Site (Attachment 1; DSCN2753, DSCN2754, DSCN2752, DSCN2755, DSCN2756, DSCN2757 and DSCN2758).

DSCN2755 - Channel with water from outlet near Catch Basin #3

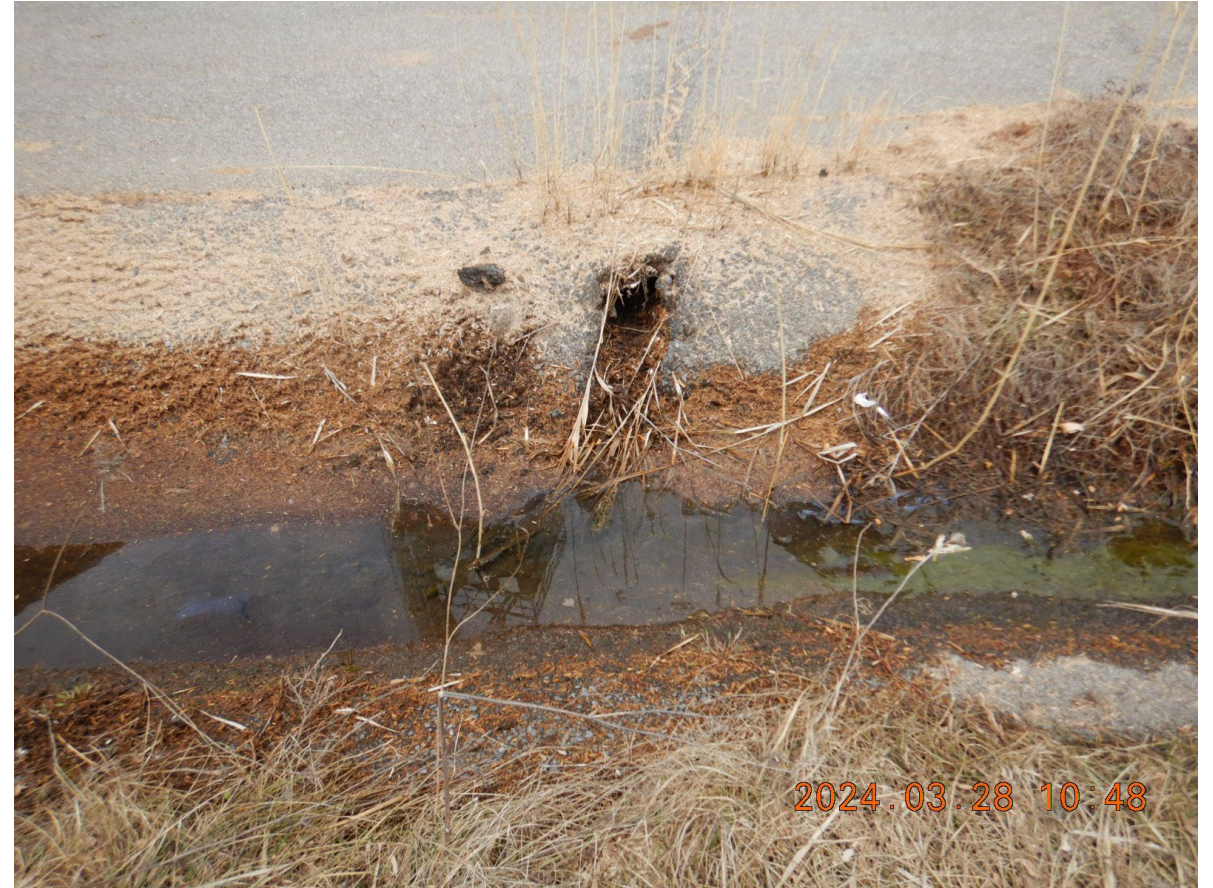
DSCN2756 - Stormwater outfall into channel near Catch Basin #3

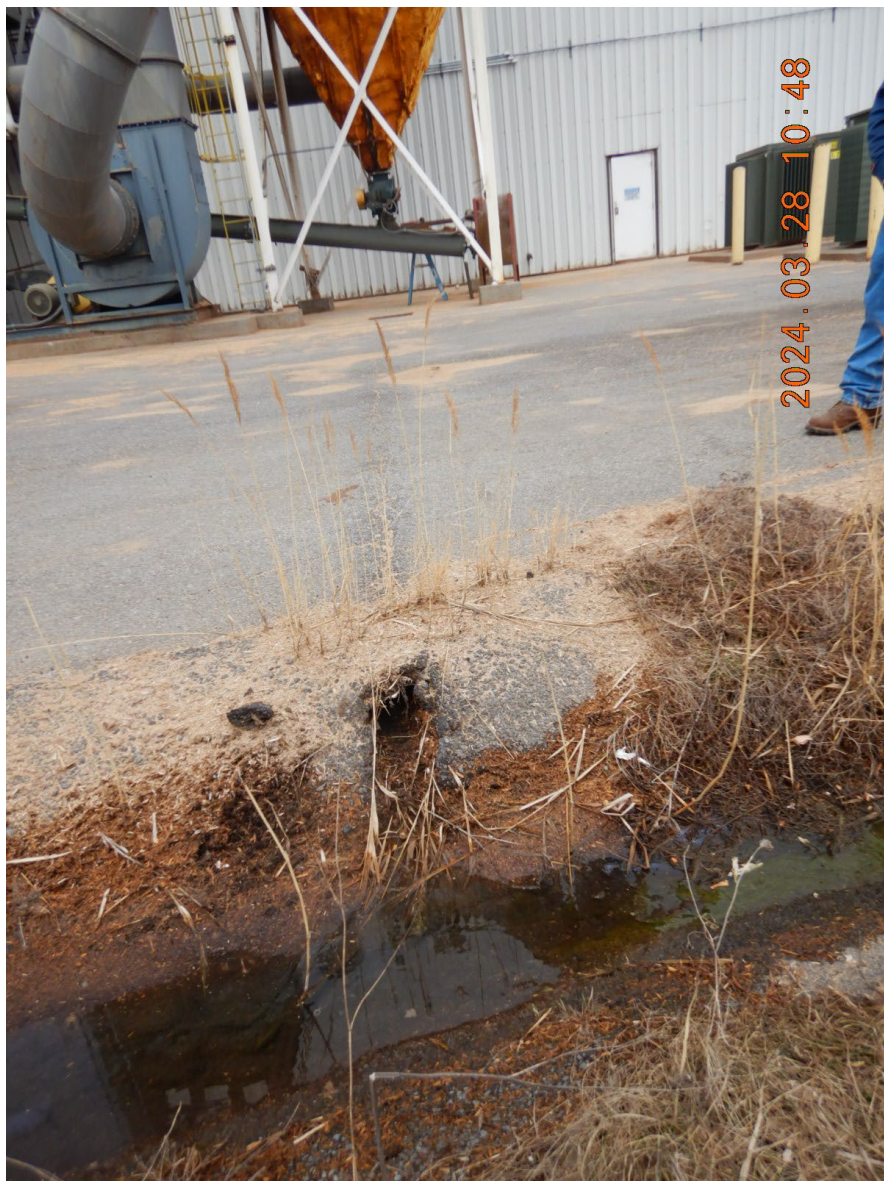
DSCN2757 - Drainage with water that gets flow from Catch Basin #3

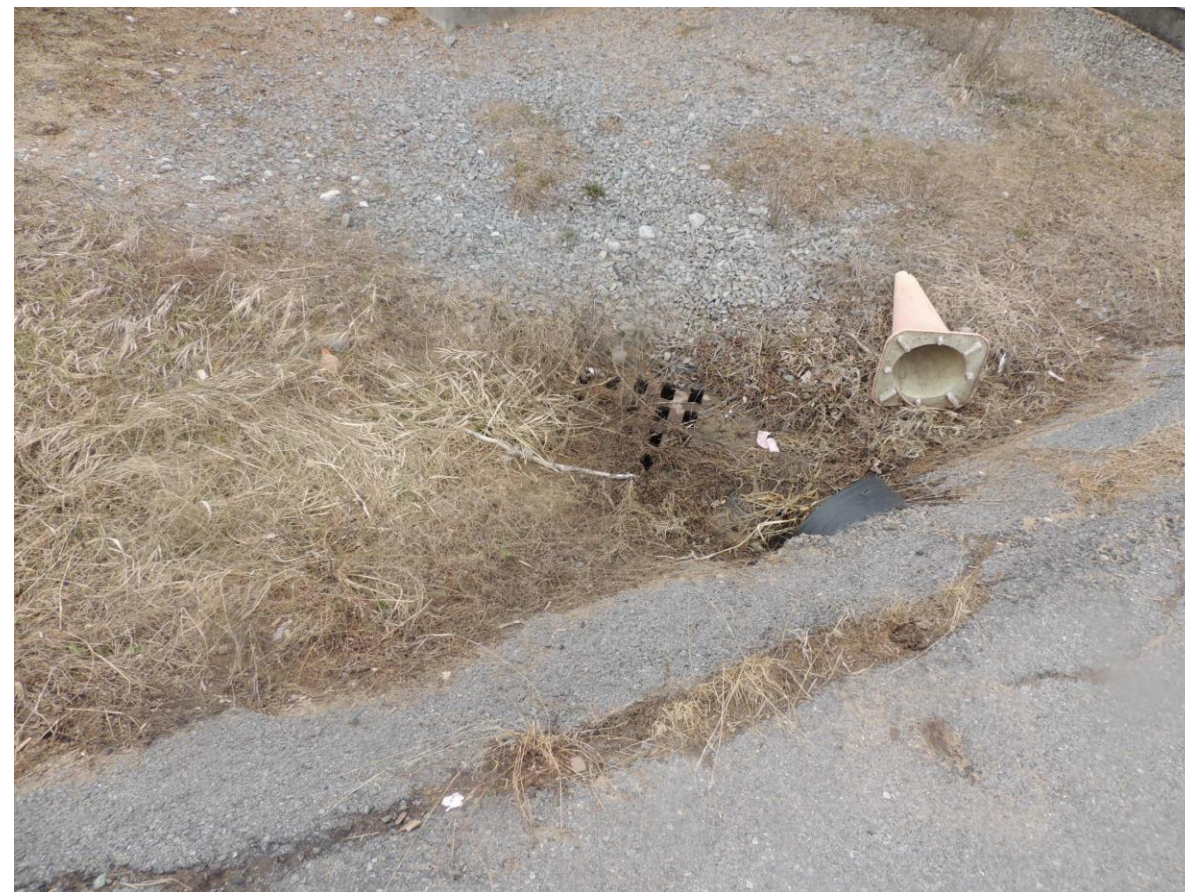
DSCN3987 – Storm inlet near southeast corner of packaging warehouse, that flows via pipe to the western edge of the Site

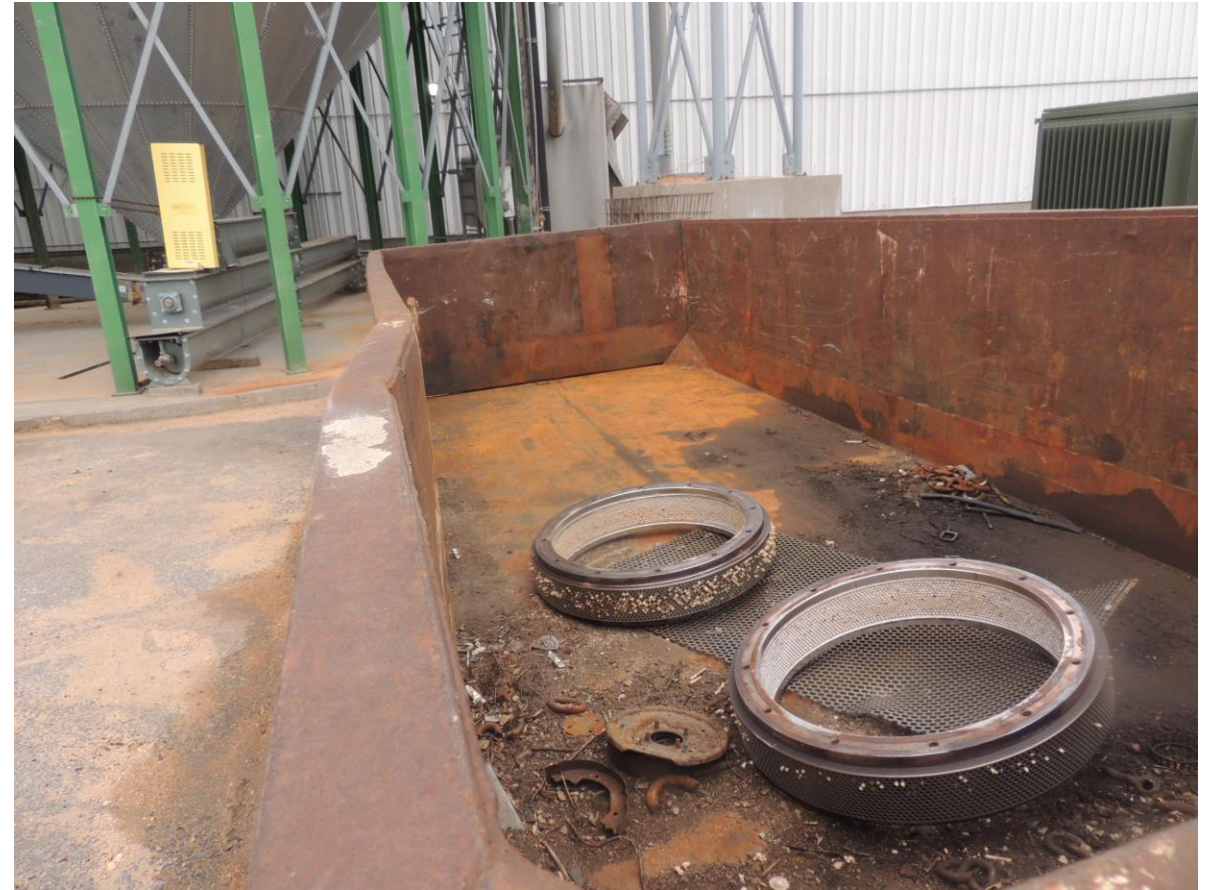
DSCN3989 – Scrap metal dumpster - uncovered

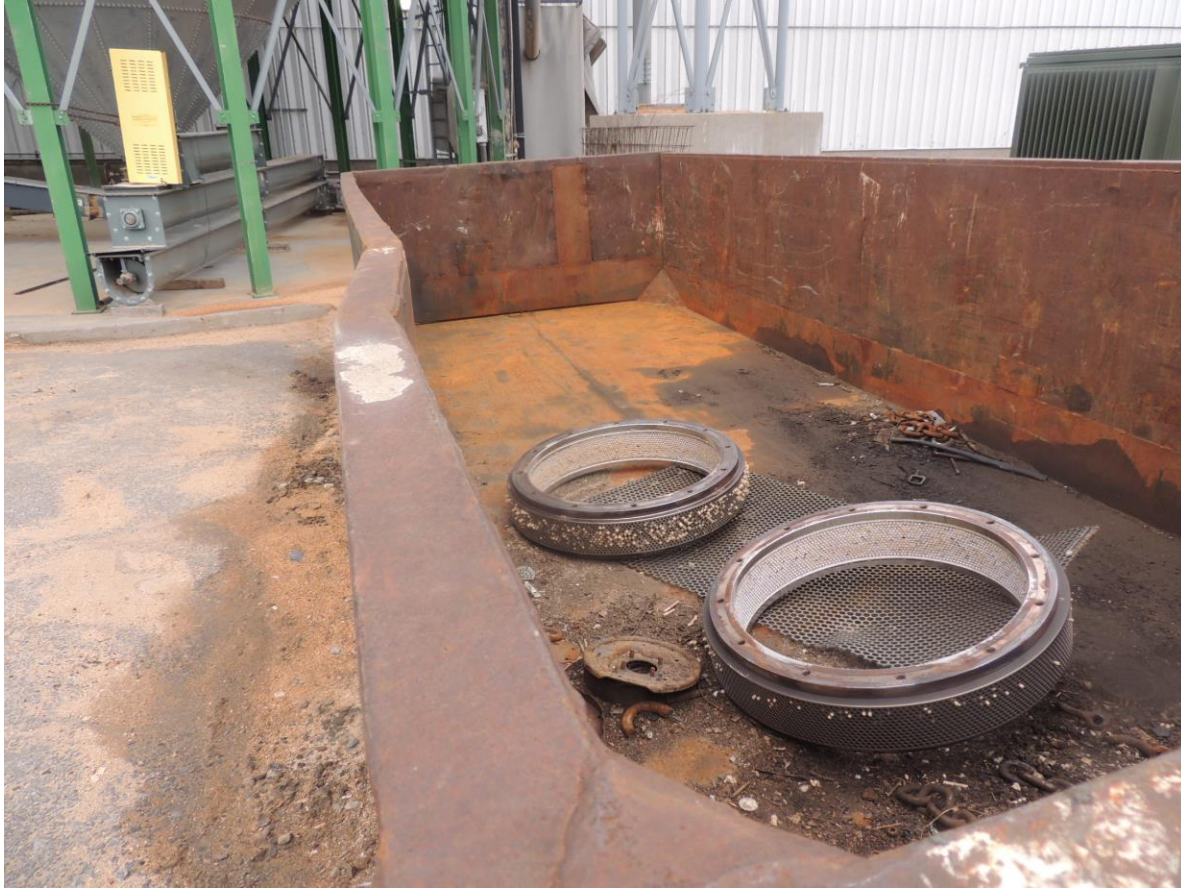
DSCN3990 – Scrap metal dumpster - uncovered

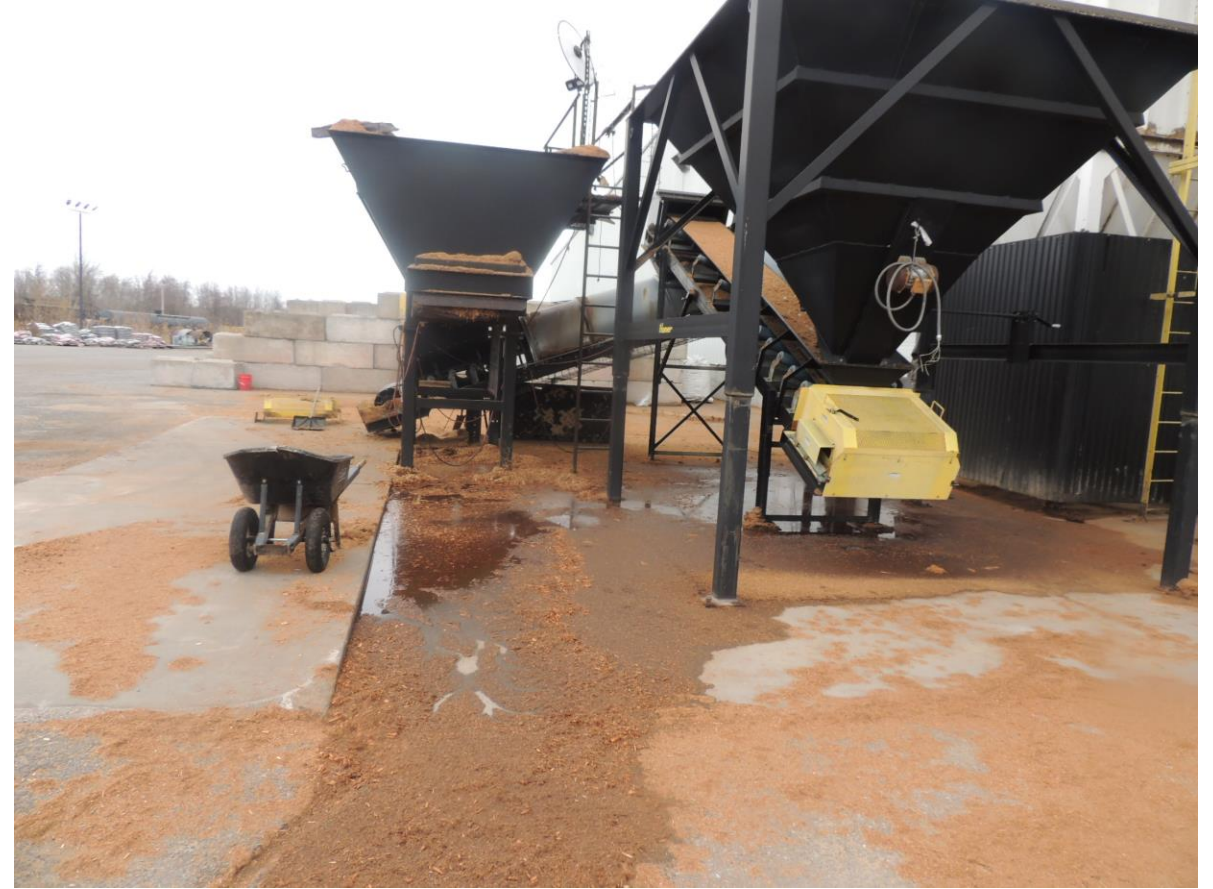
DSCN3991 – Puddles of water in and around material from mulch loading area/package warehouse and exposed mulch material

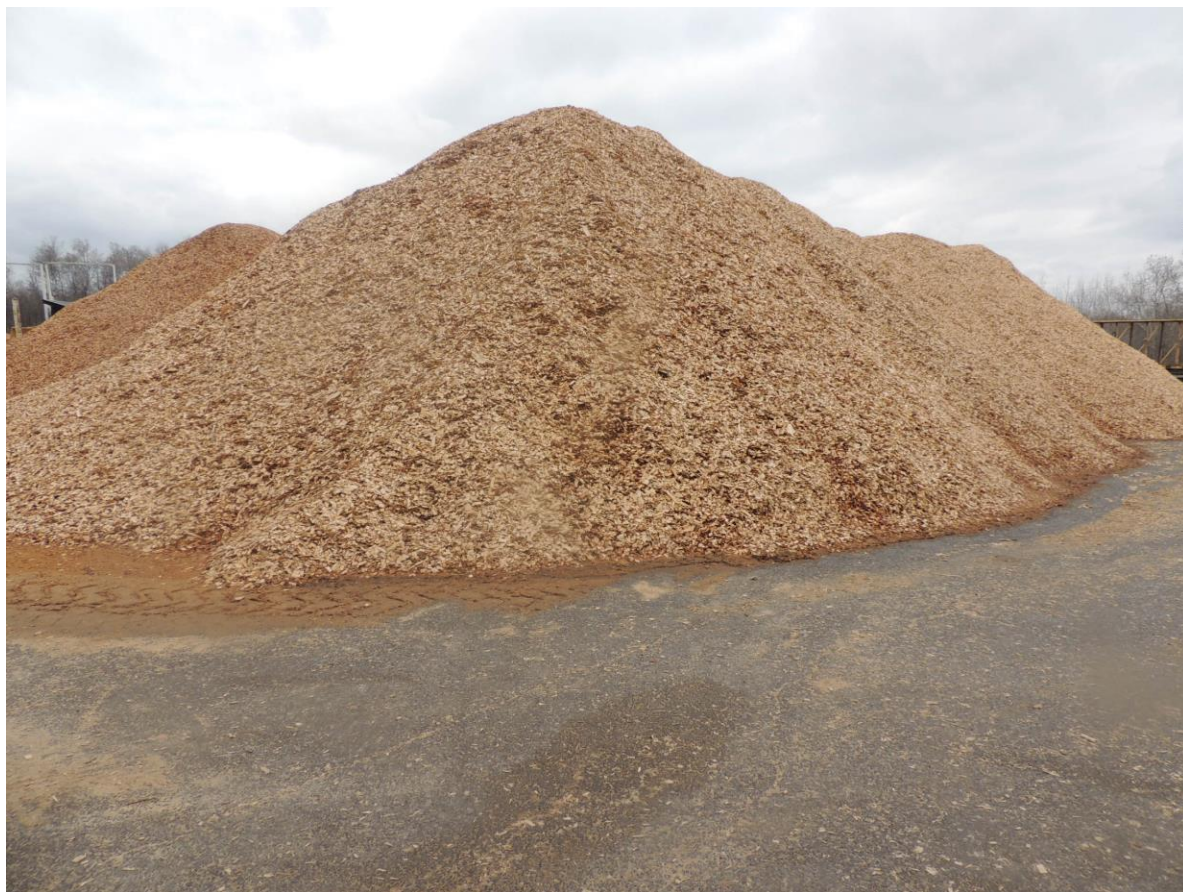
DSCN3992 – Exposed woodchip storage piles

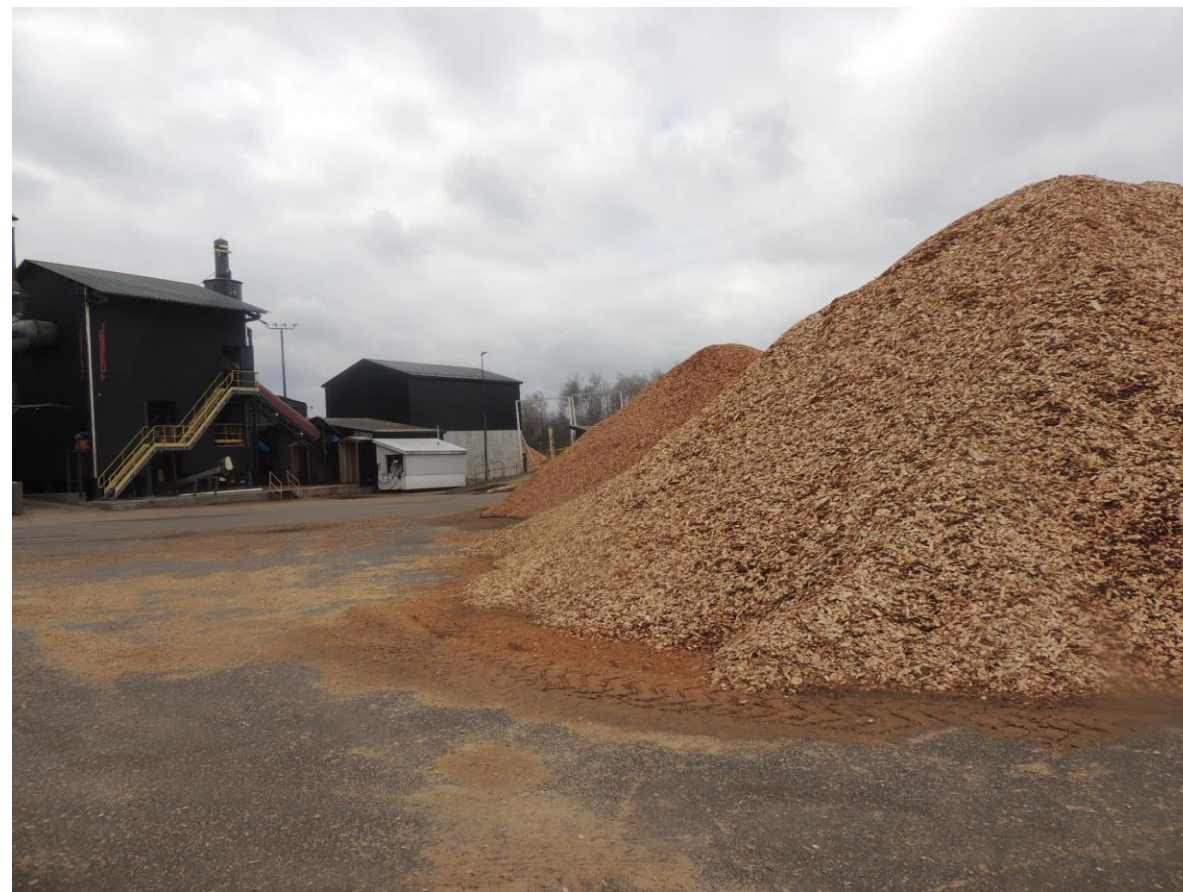
DSCN3993 – Exposed woodchip storage piles

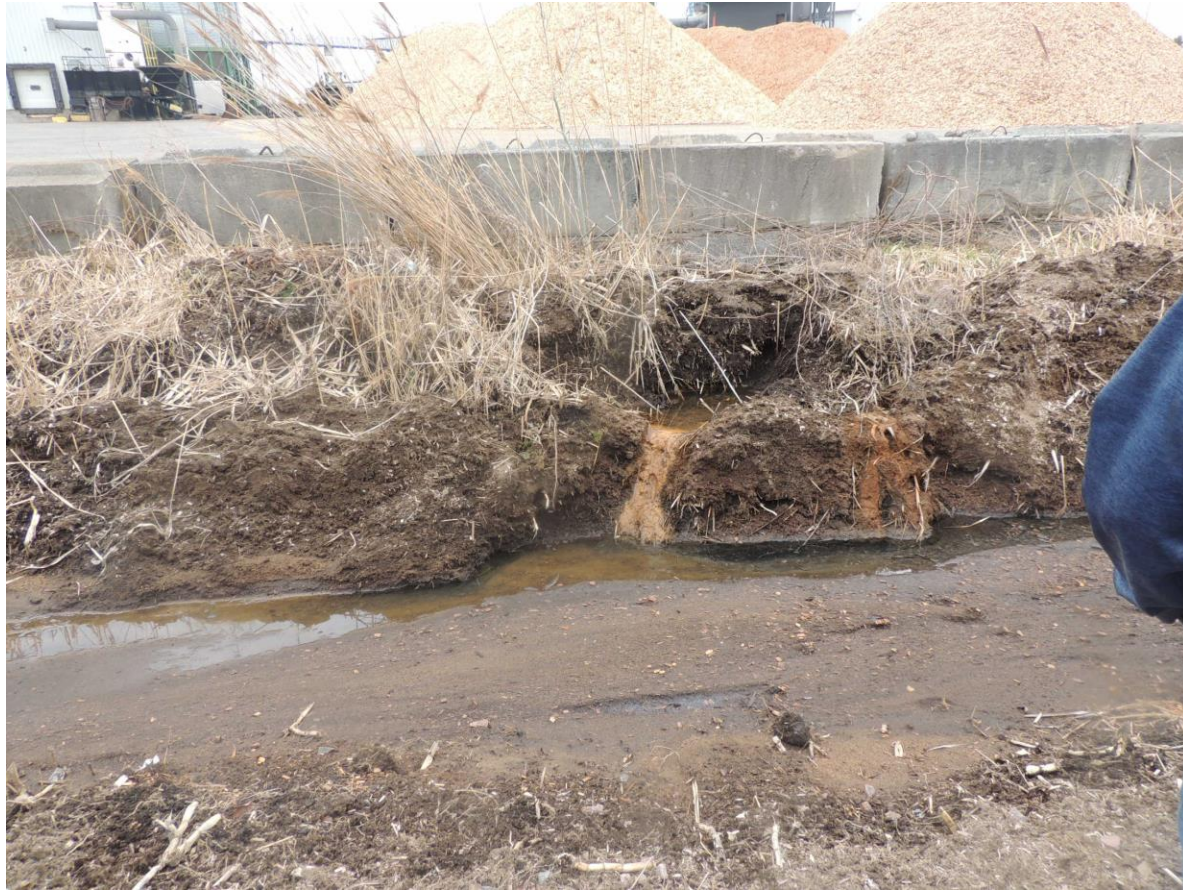
DSCN3994 - Stormwater outfall on the West of Site near CSX tracks; Stormwater from catch basin located near the South corner of the packaging warehouse. The outfall is not visible (and needs to be cleaned). Channel for stormwater flow also seen

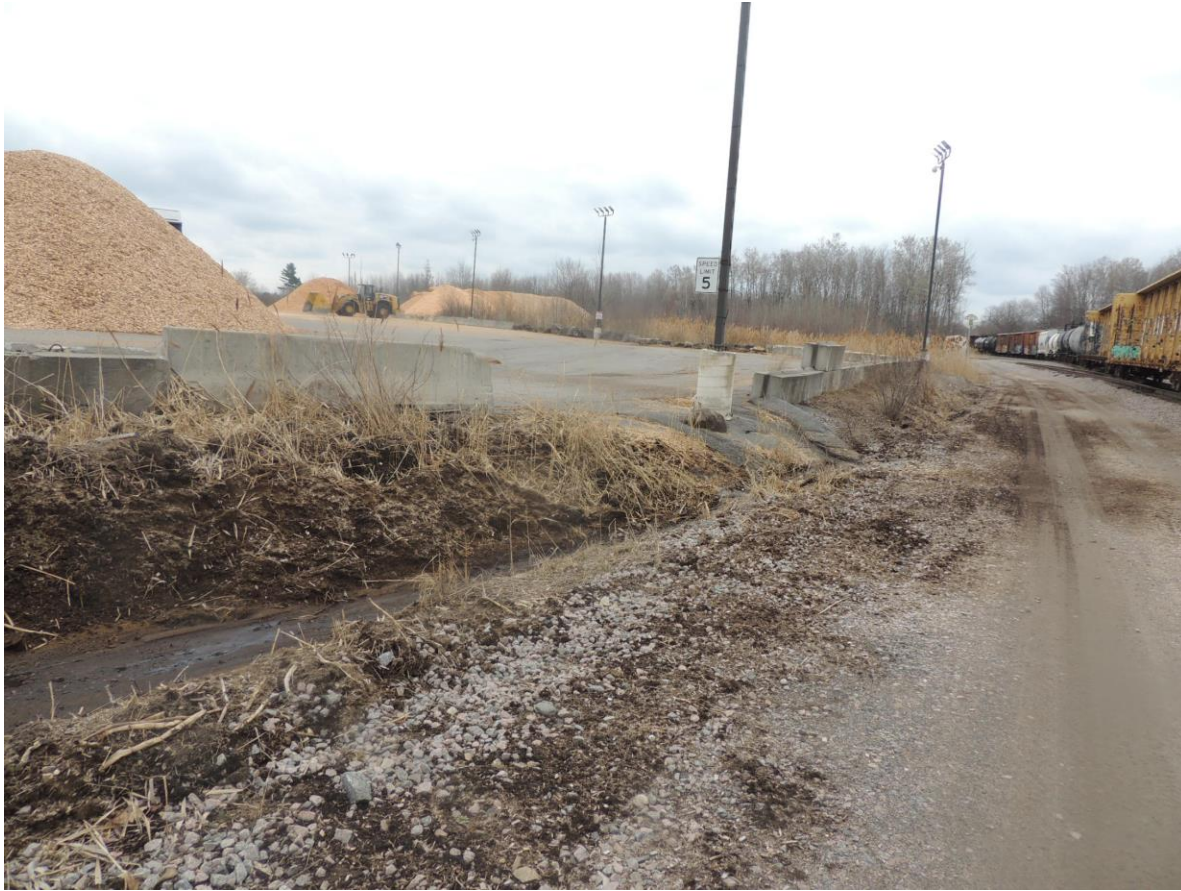
DSCN3996 – Storm channel along western portion of the Site adjacent to the CSX rail line and a break in block wall that would allow stormwater flow off the site.

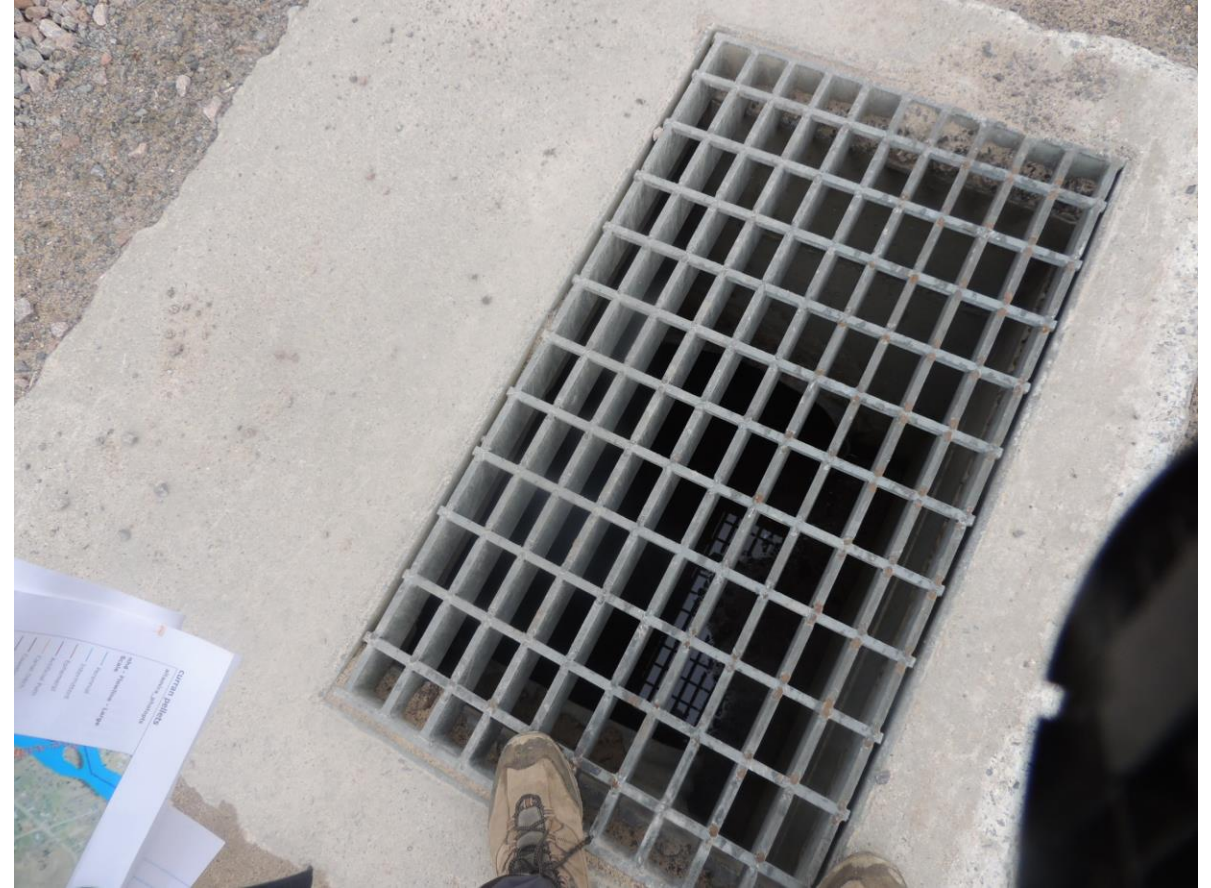
DSCN3999 - Catch basin located on railroad property along Western edge of Site, stormwater piping seen in the storm sewer

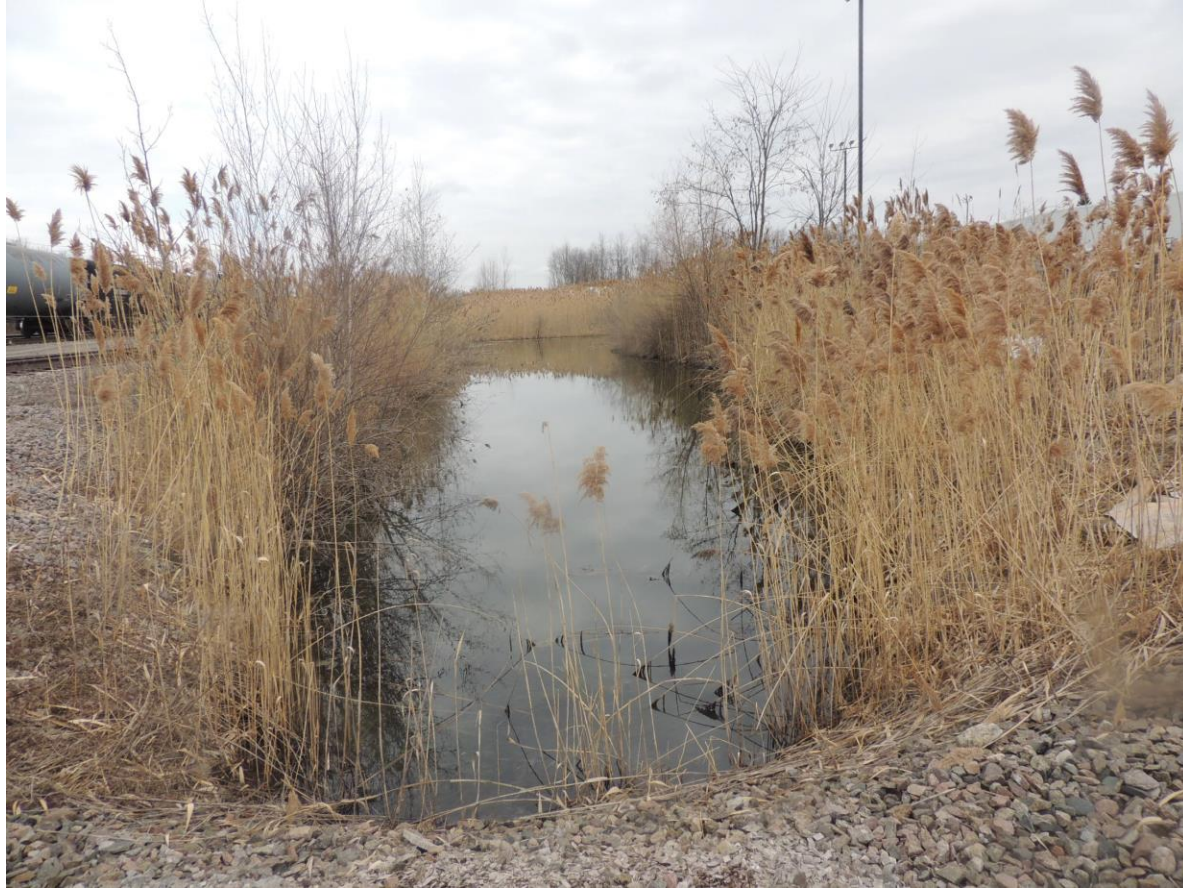
DSCN4000 – Stormwater pond (said to be a retention pond) on western edge of Site, adjacent to the CSX rail line

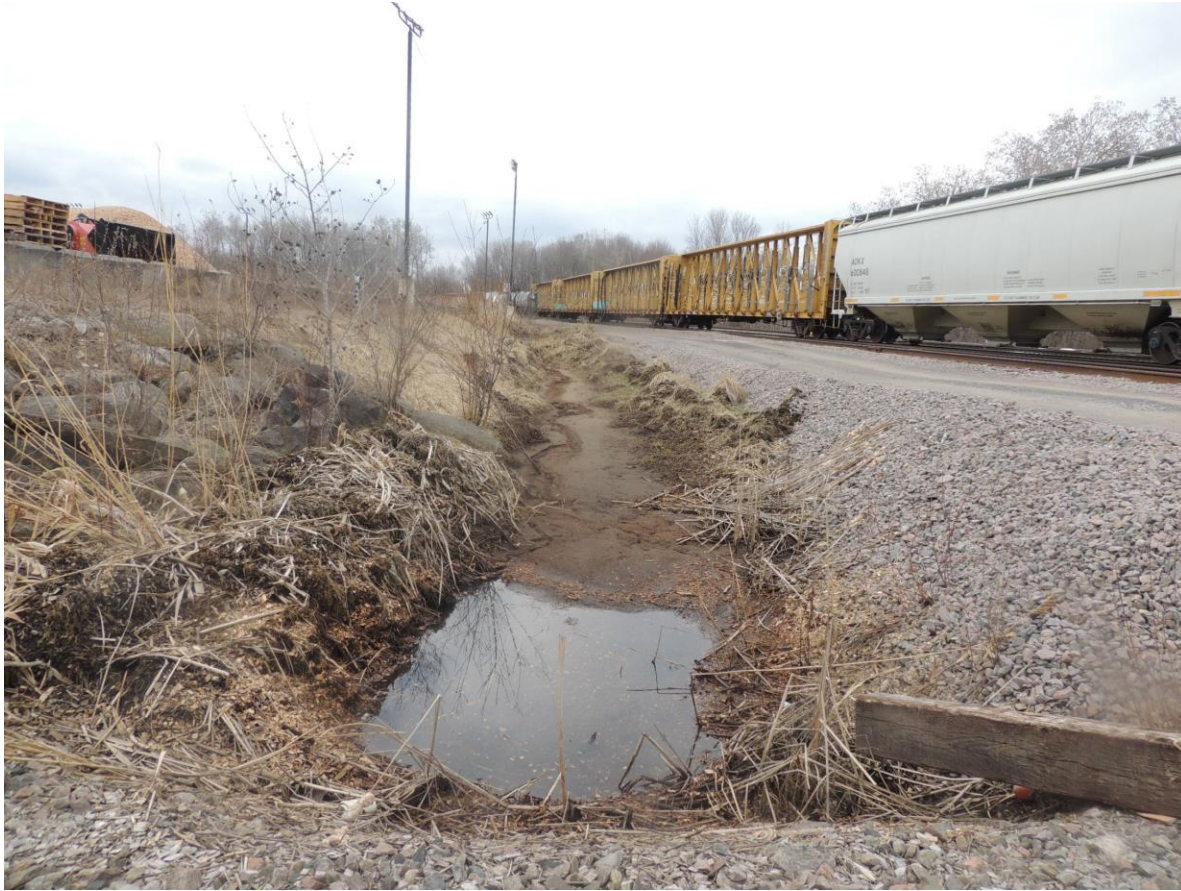
DSCN4002 – Stormwater channel, with water in it that is said to flow under the gravel roadway

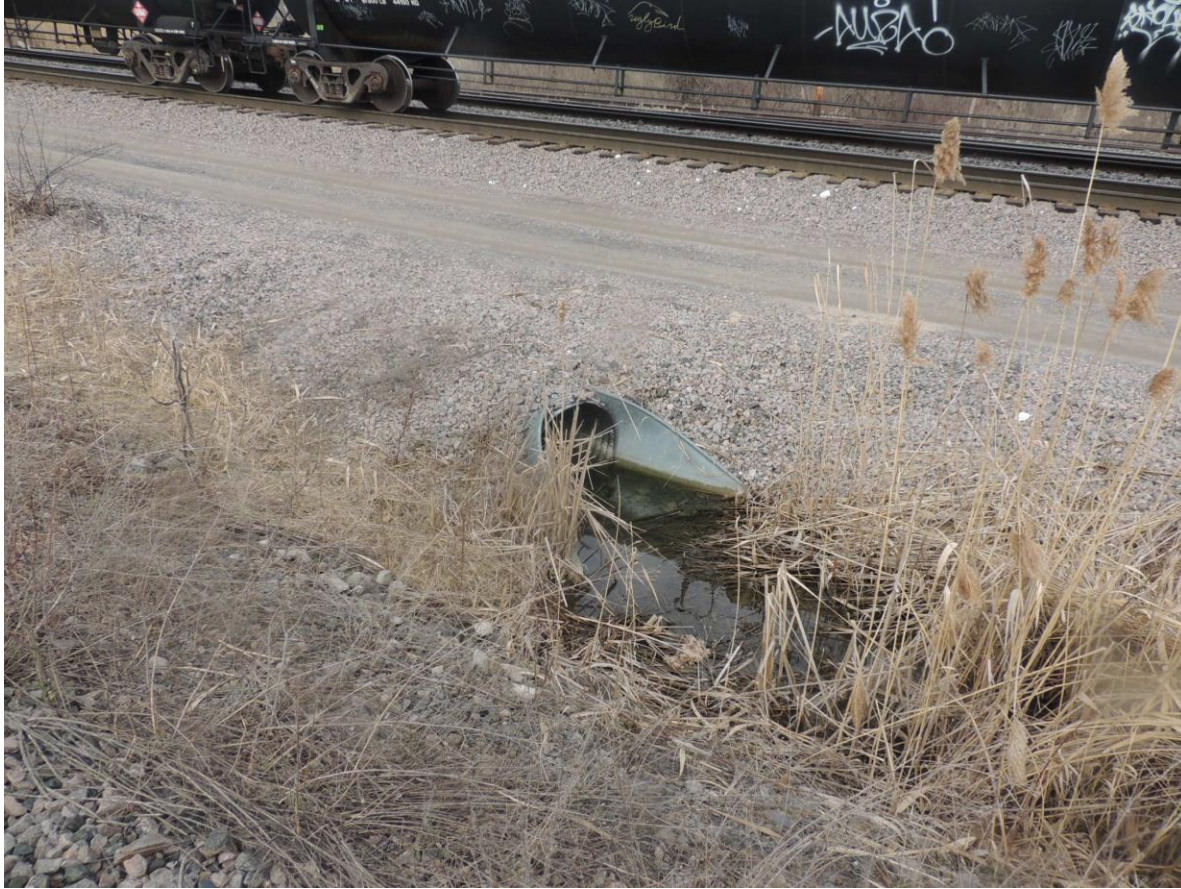
DSCN4008 – Pipe and channel with water adjacent to northwestern portion Curran Site next to CSX rail line

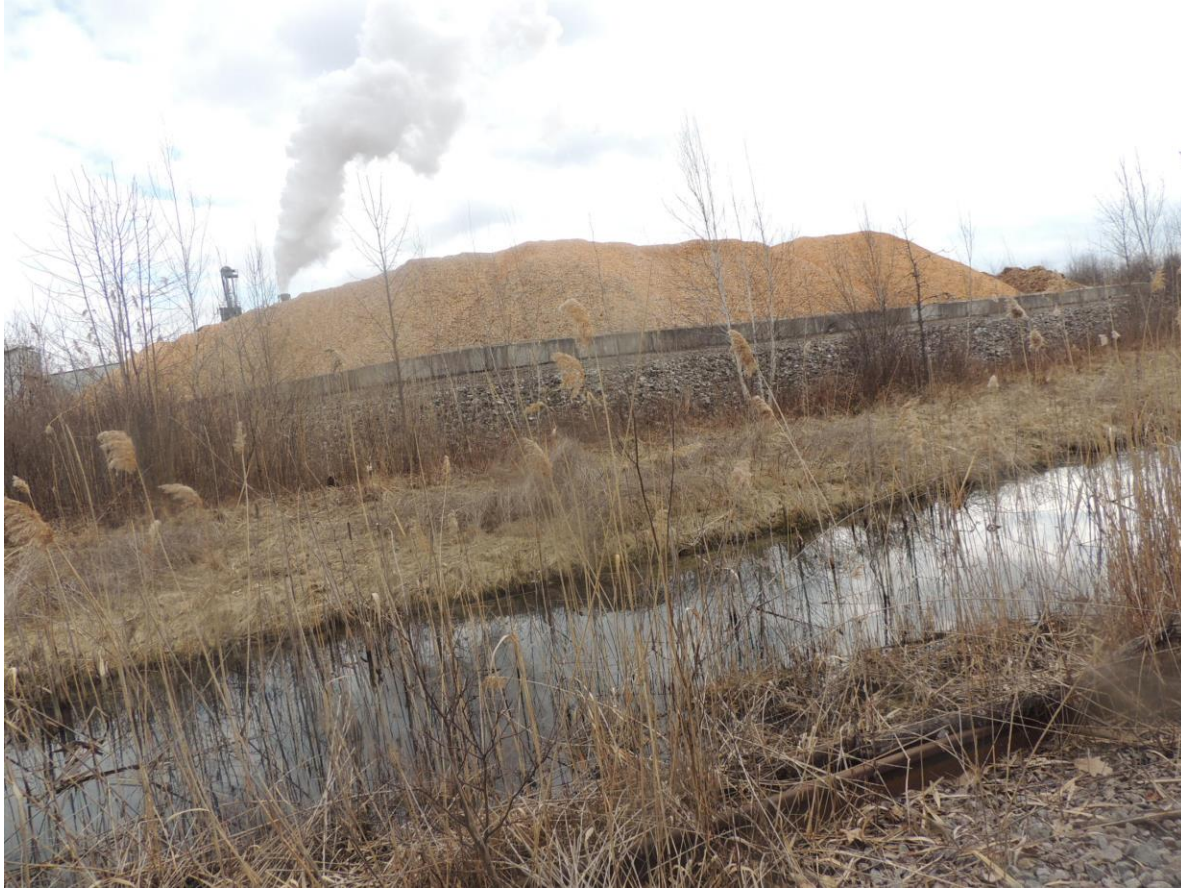
DSCN4017 - – drainage with water in it between railway and southwest portion of the Curran Site

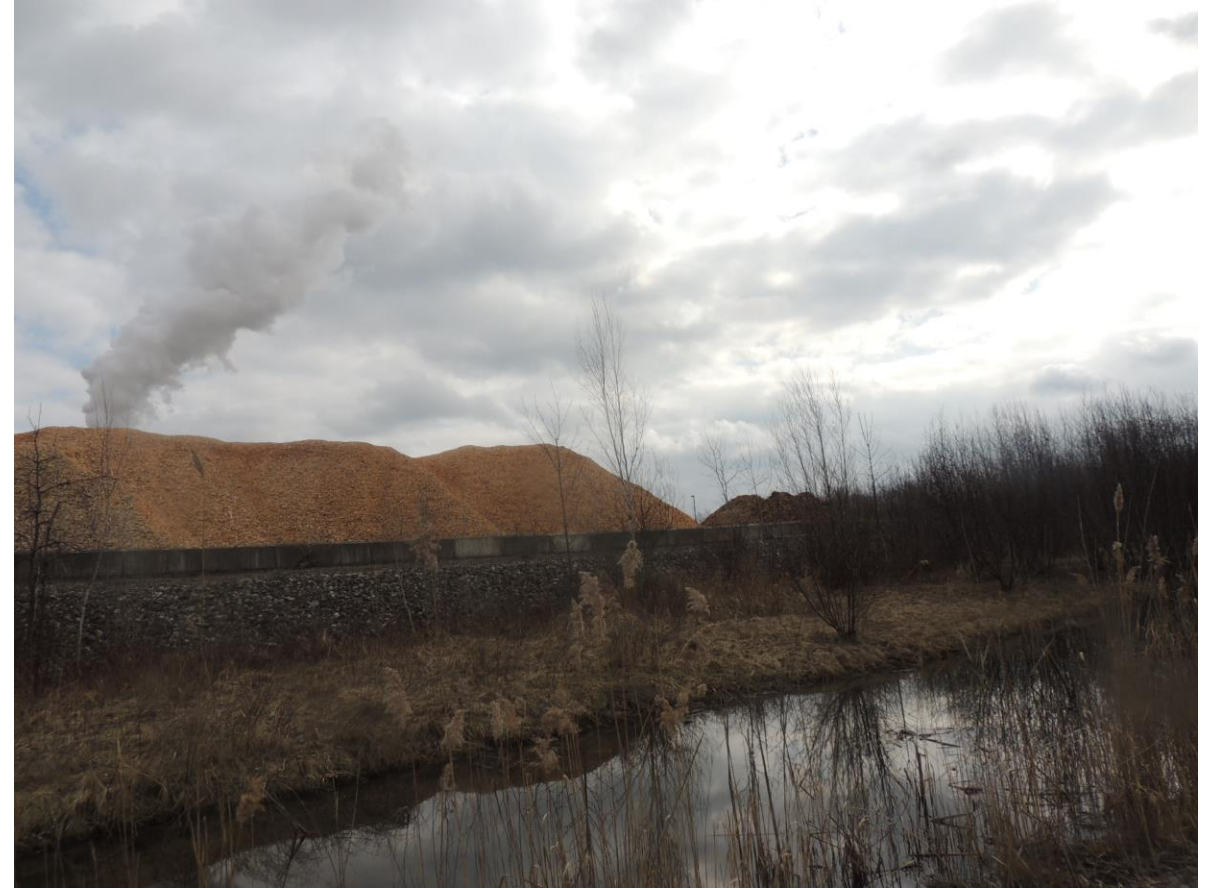
DSCN4018 – Wet area/drainage in the foreground and material storage piles and stack in background – southern portion of Curran Site

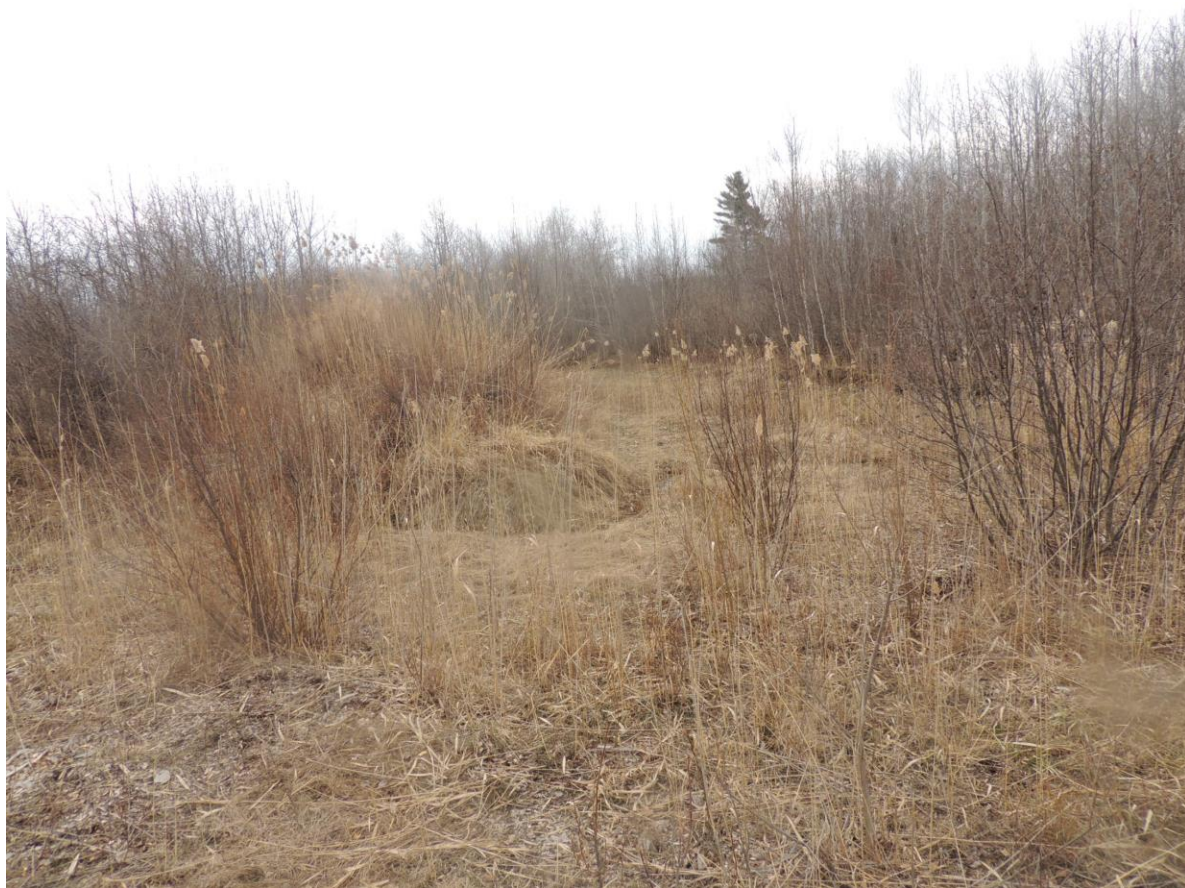
DSCN4023 - Vegetated area/potential drainage on the southwest portion of the Site
