**UNITED STATES ENVIRONMENTAL PROTECTION AGENCY, REGION 2**  
**Enforcement and Compliance Assurance Division Water**  
**Compliance Branch**

| <b>Clean Water Act (CWA) Inspection</b><br><b>Report Program:</b> Industrial Stormwater | <b>Inspection Type:</b> Compliance Evaluation Inspection |
| <b>Site Name:</b> Curran Renewable Energy LLC<br>(Does not have a permit) | <b>NPDES/ICIS No.:</b> NYU065324 |

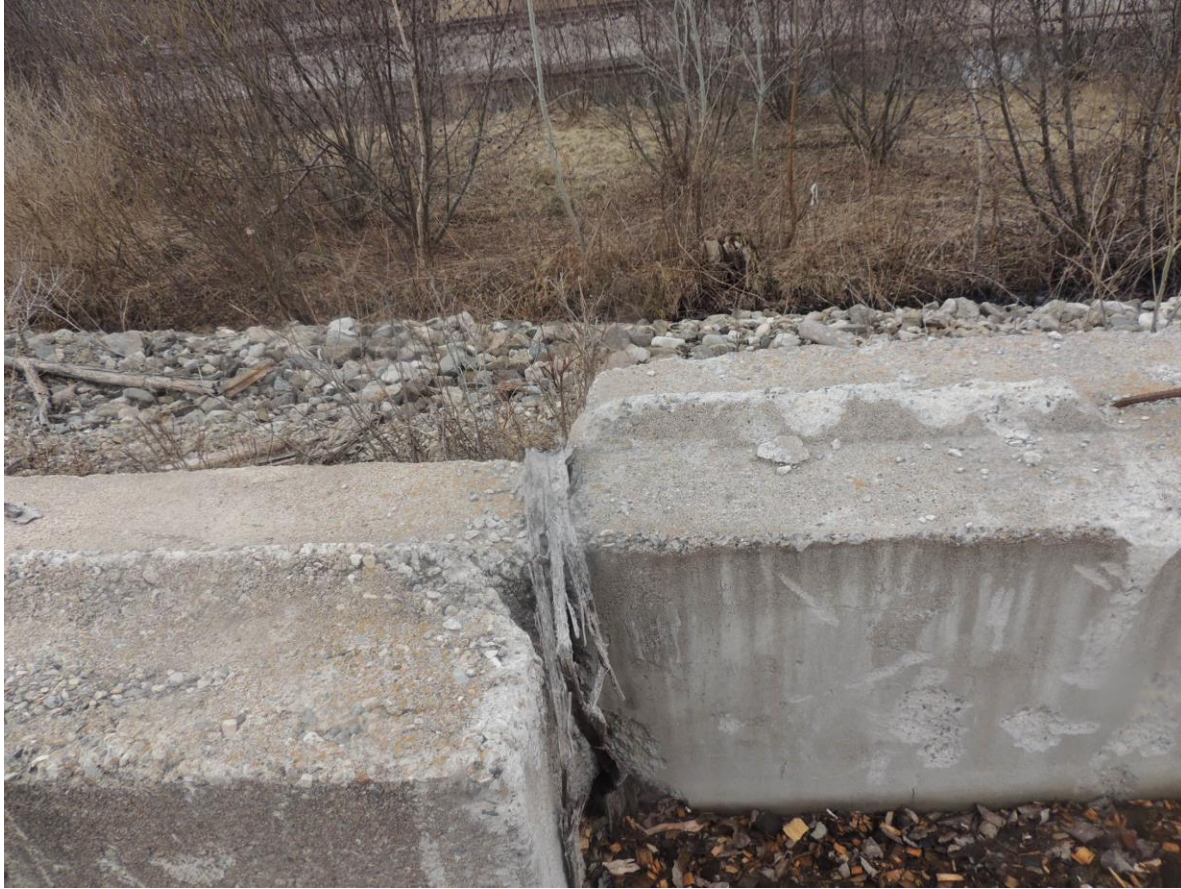
DSCN4025 - Outside of block walls south of the Curran Site

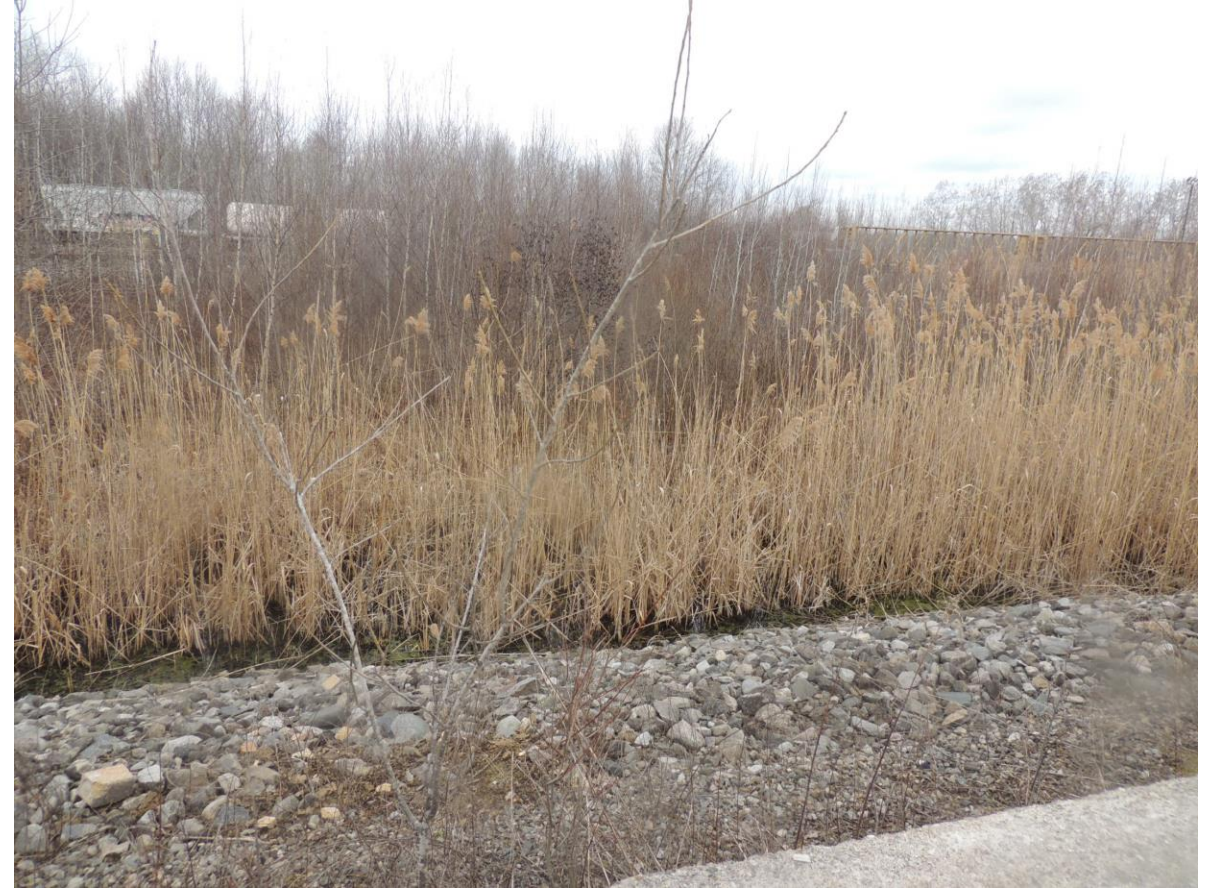
DSCN4030 – Block walls southwest portion of the Site – wet area with phragmites downgradient from the wall

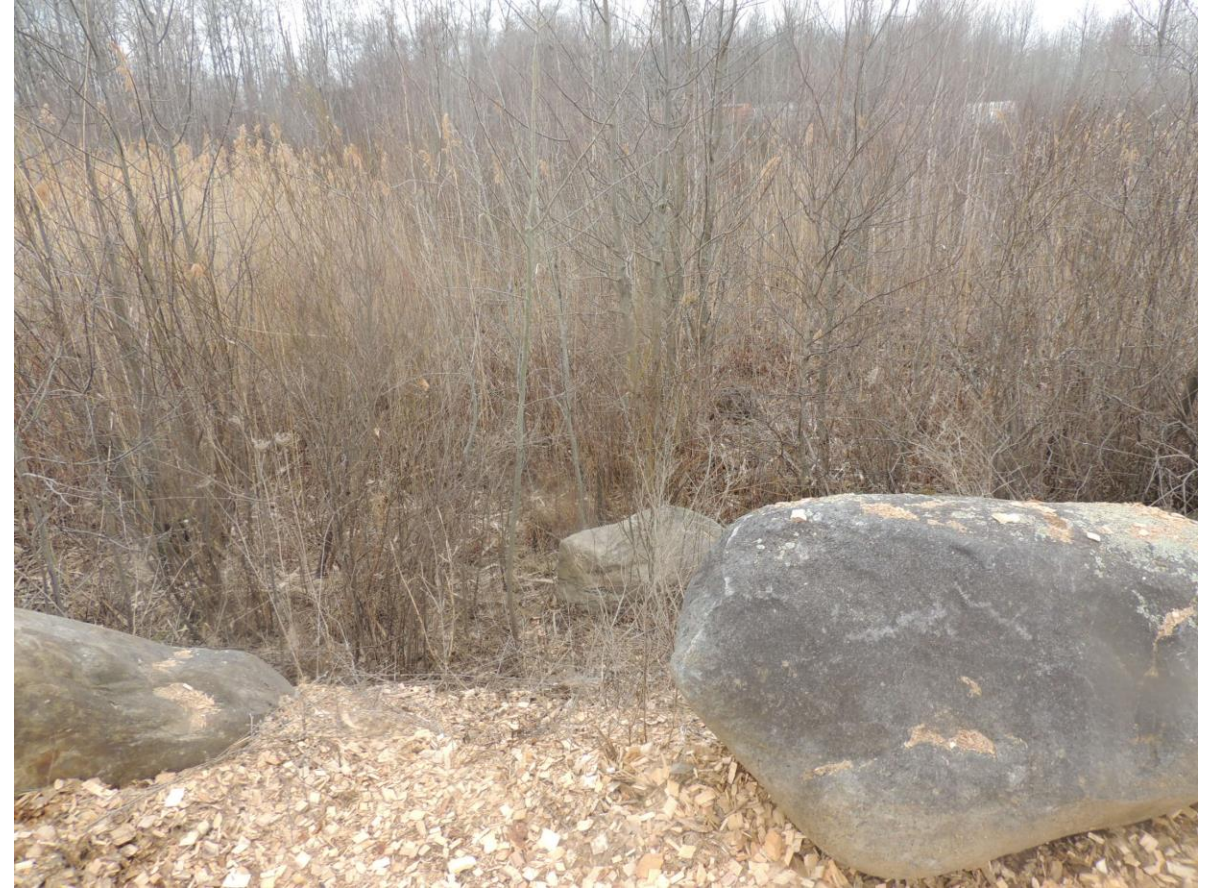
DSCN4032 – Exposed woodchips in the southwest portion of the Site.

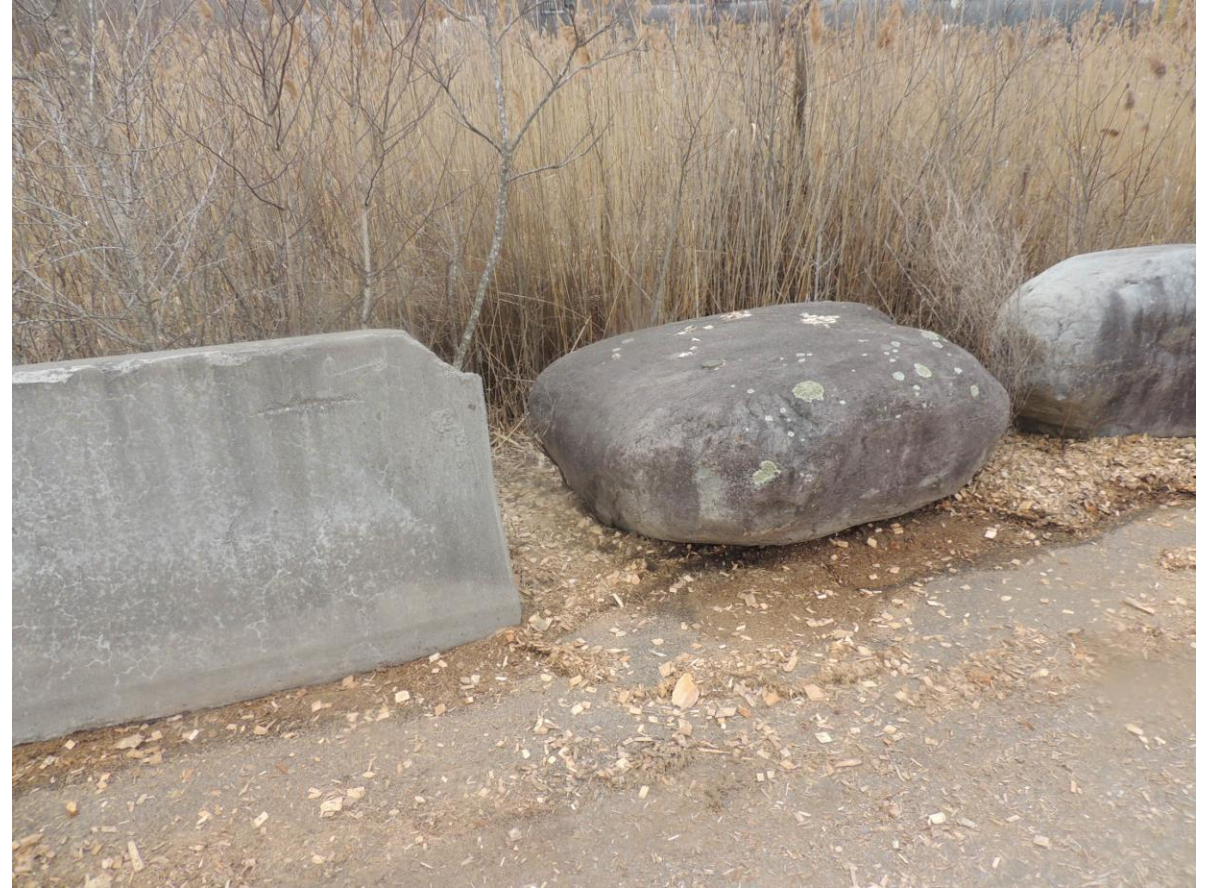
DSCN4034 - Exposed woodchips in the southwest portion of the Site with drainage downslope from it

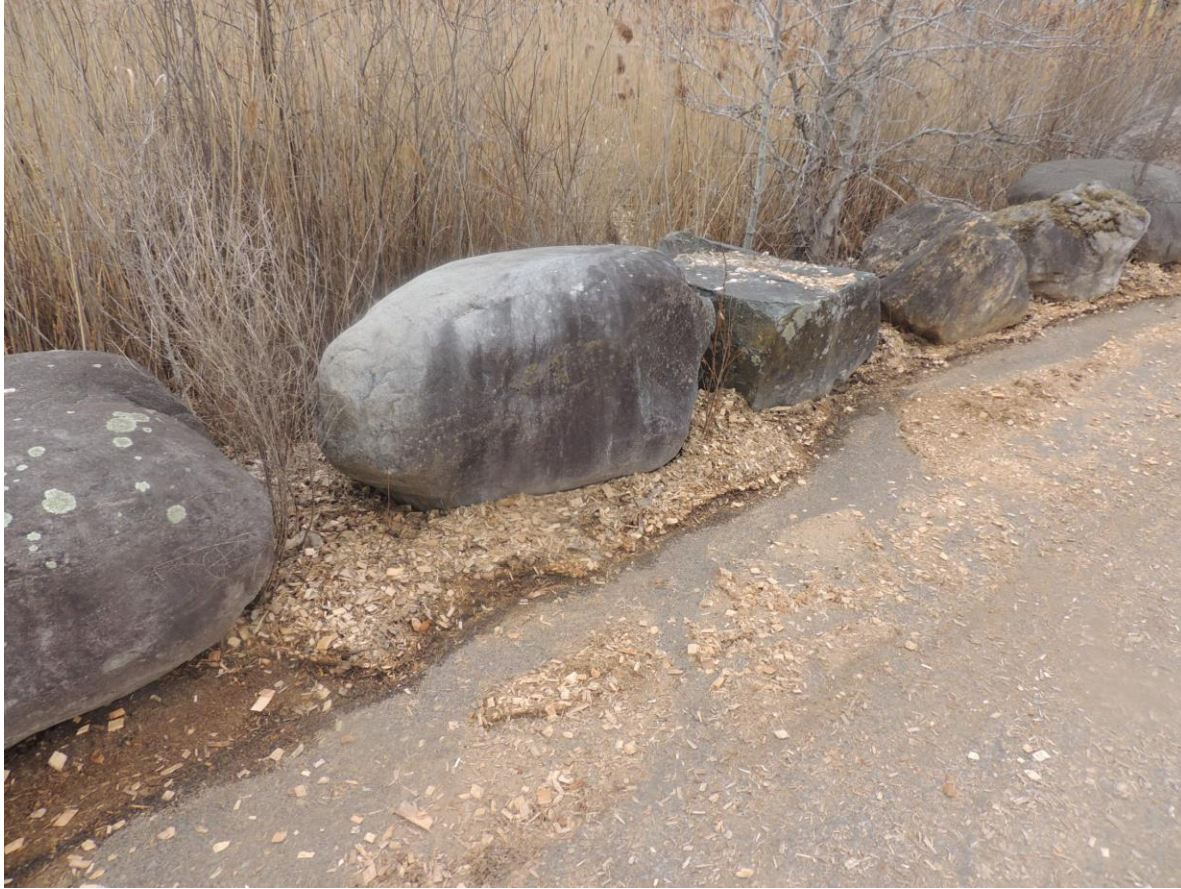
DSCN4035 – Gap in block wall. Southwest portion of the Site

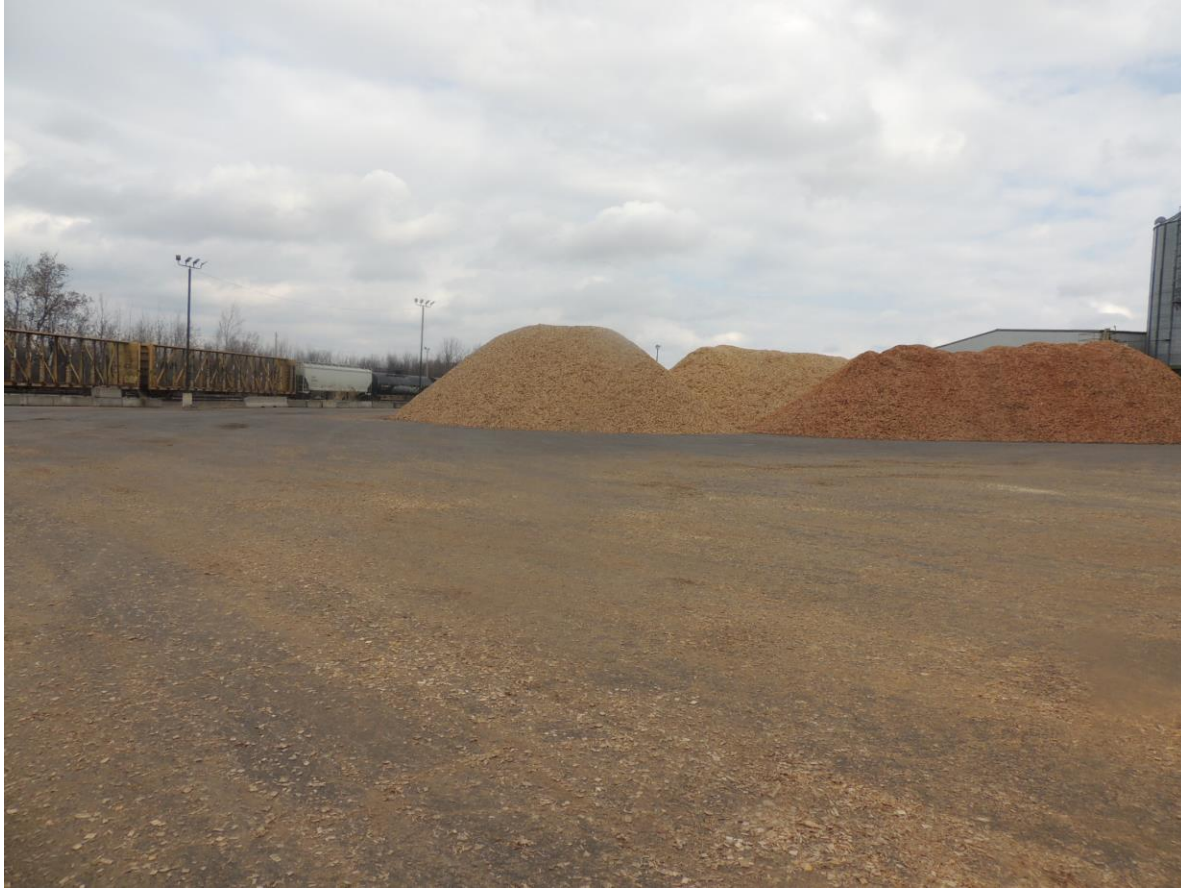
DSCN4037 – Gap in block wall on the southwest portion of the Site – with woodchip accumulation

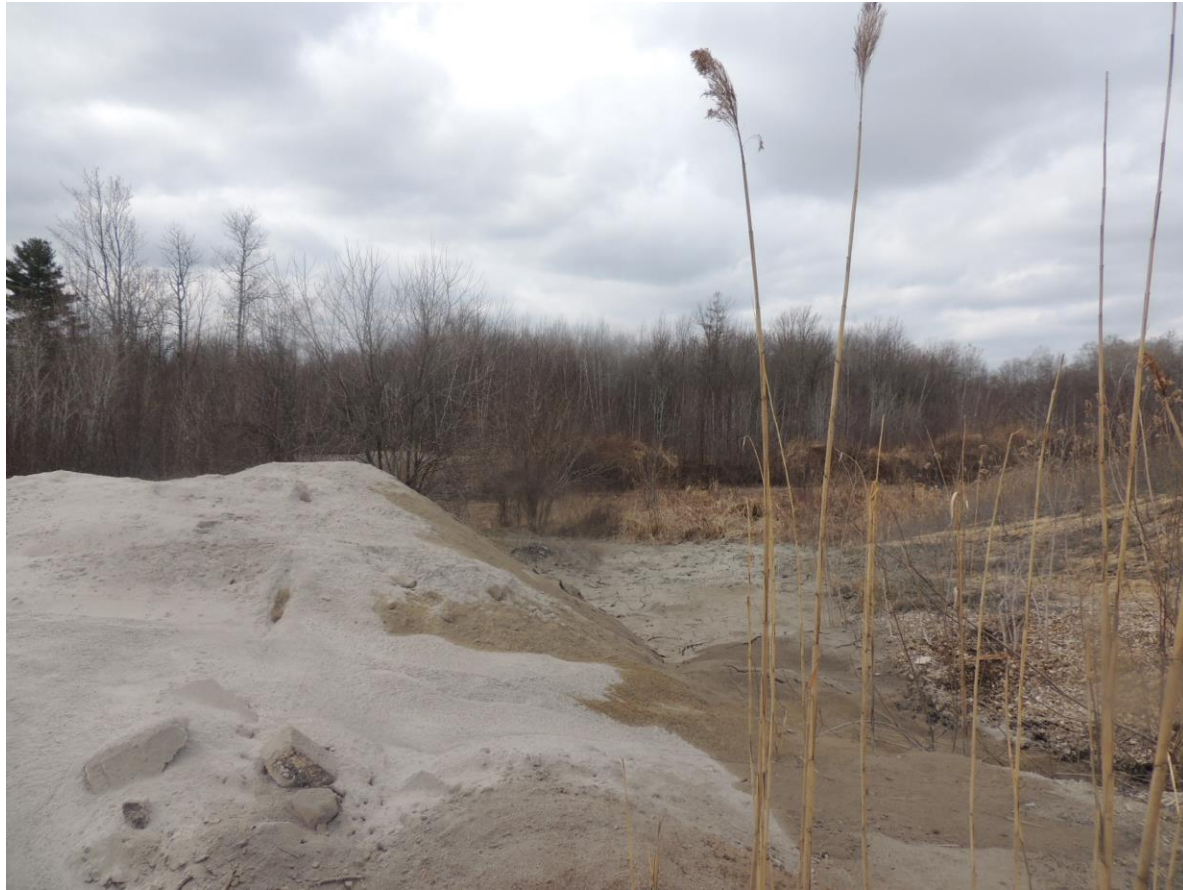
DSCN4046 – Boiler ash storage pile (uncovered), no BMPs in place

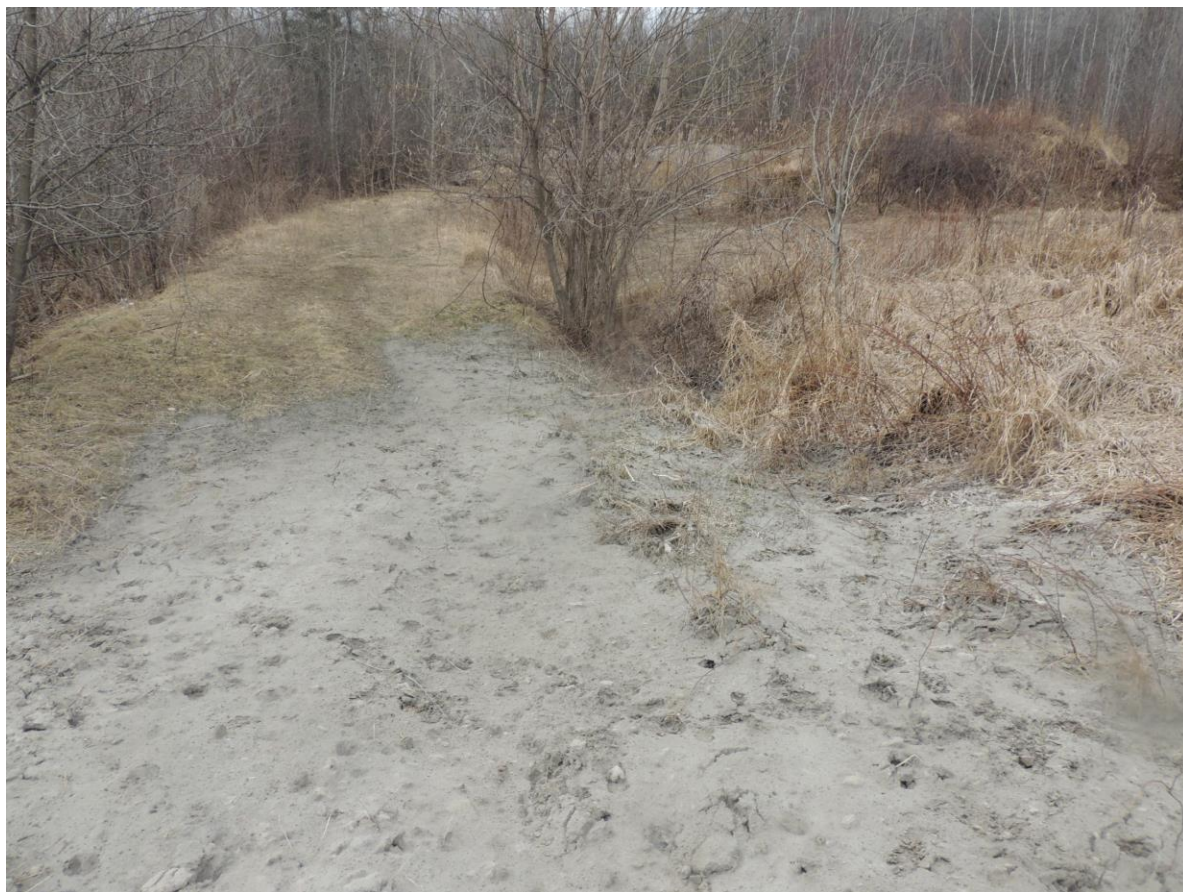
DSCN4048 – Boiler ash storage pile (uncovered), no BMPs in place

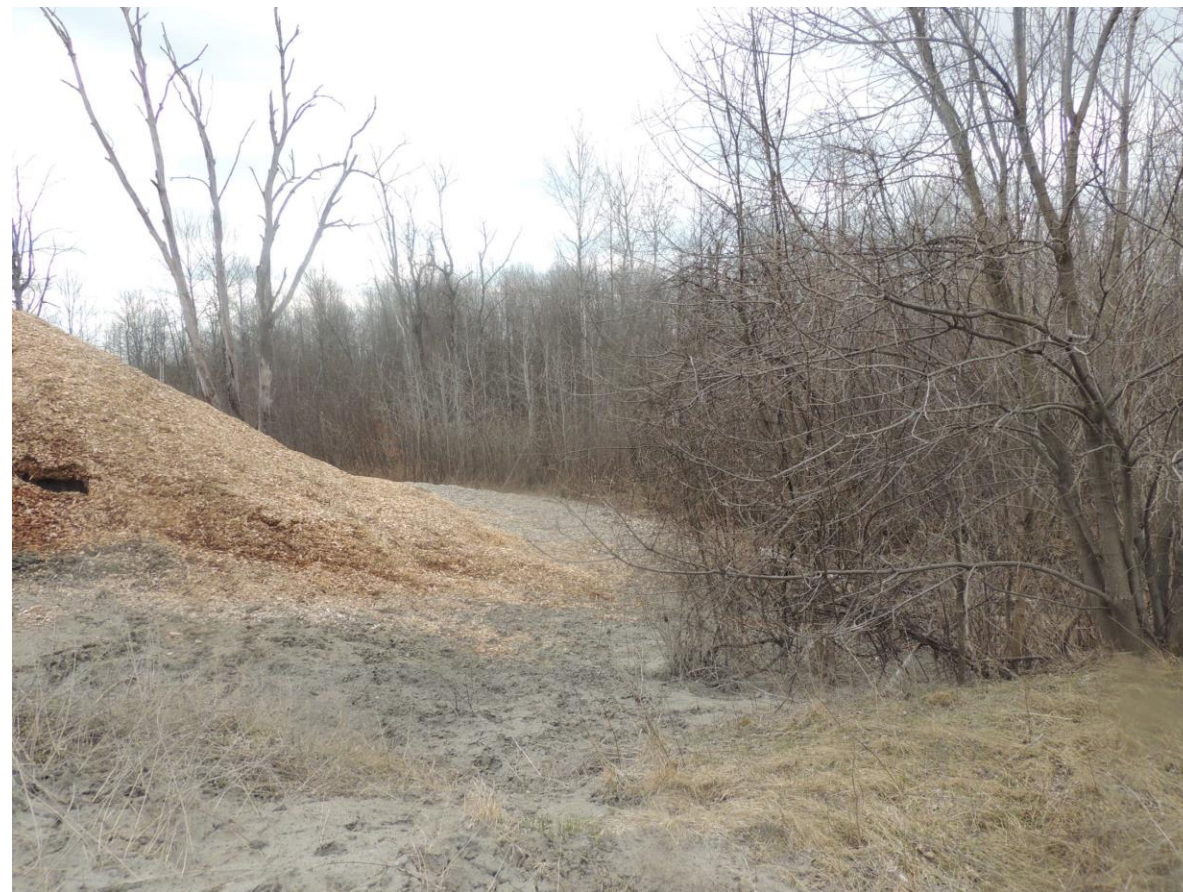
DSCN4049 – Flow path from boiler ash piles

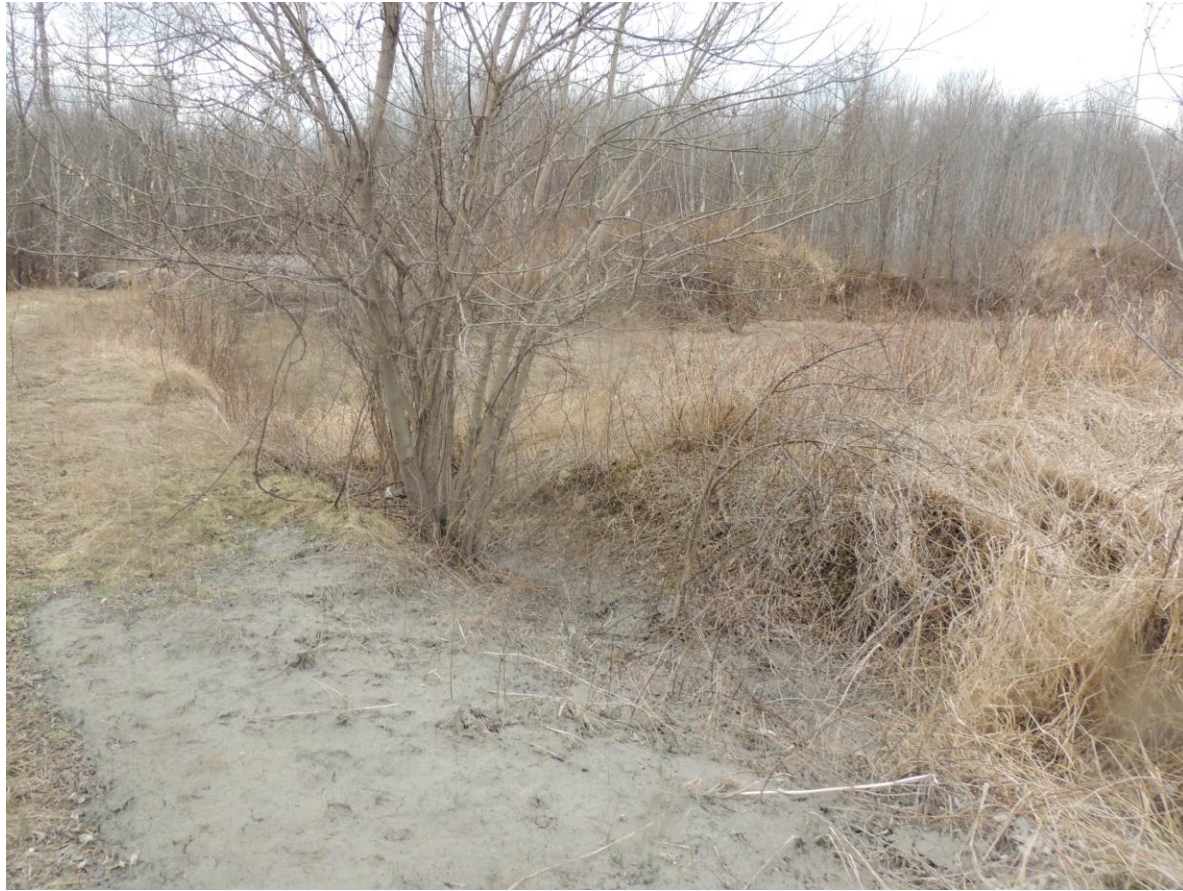
DSCN4050 – Flow path from boiler ash piles, material storage pile

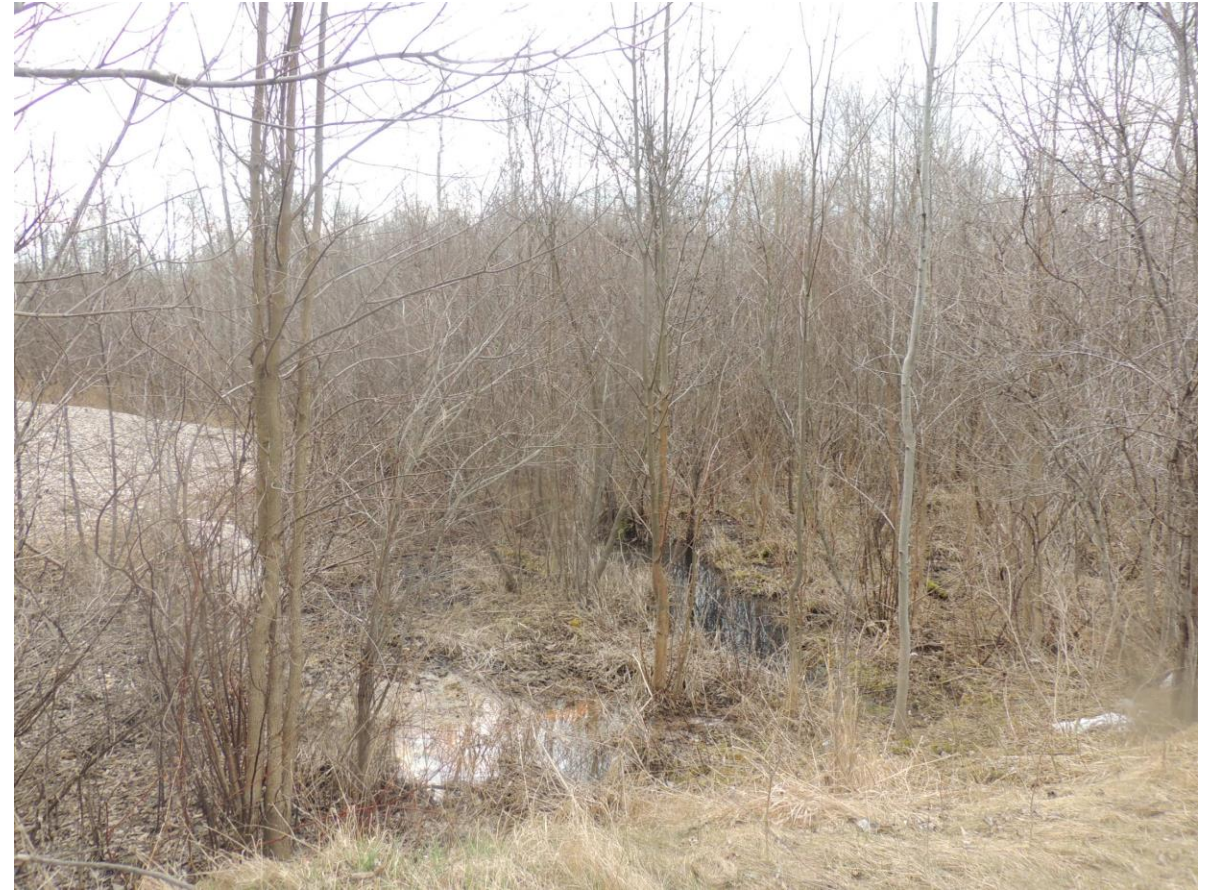
DSCN4051 – Flow path from boiler ash piles

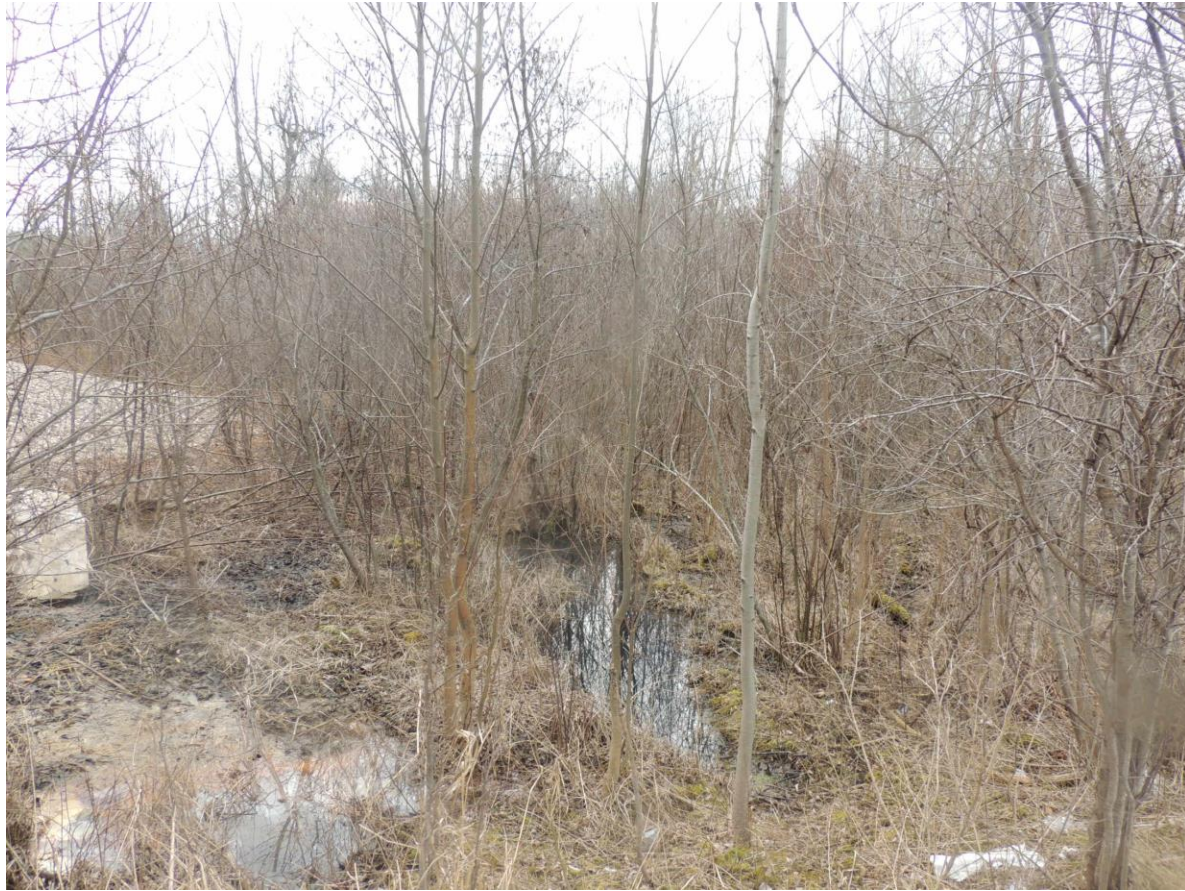
DSCN4052 – Wet area/drainage in vicinity of boiler ash piles

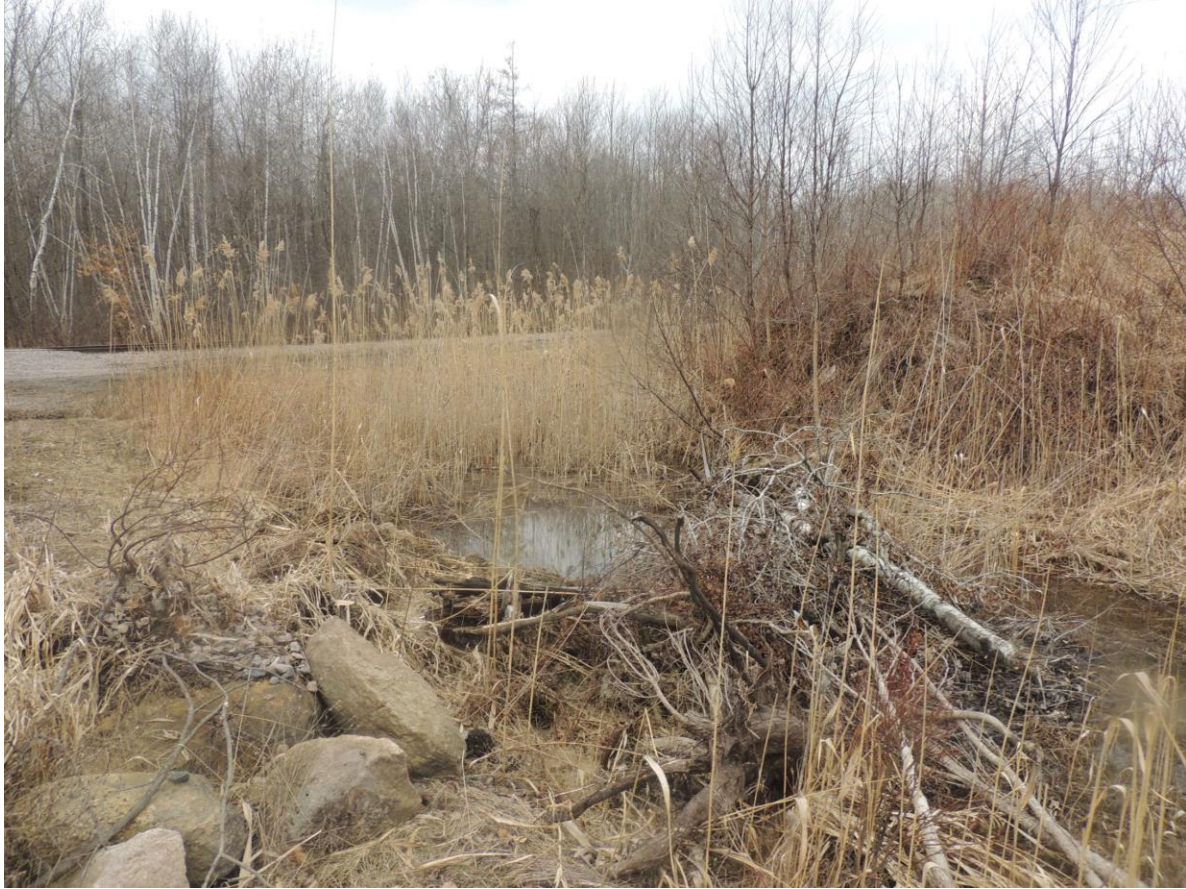
DSCN4055 – Drainage between rail line and southern portion of Facility

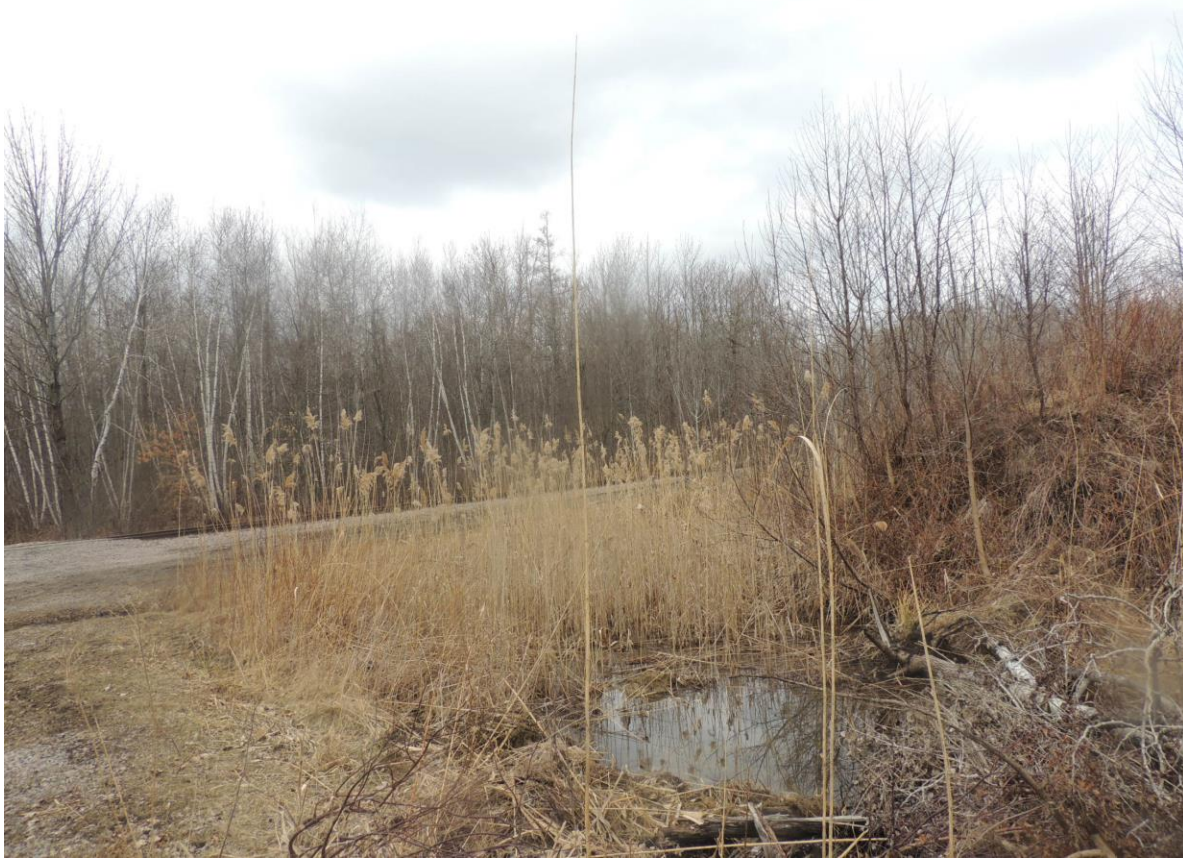
DSCN4056 - Drainage between rail line and southern portion of Facility

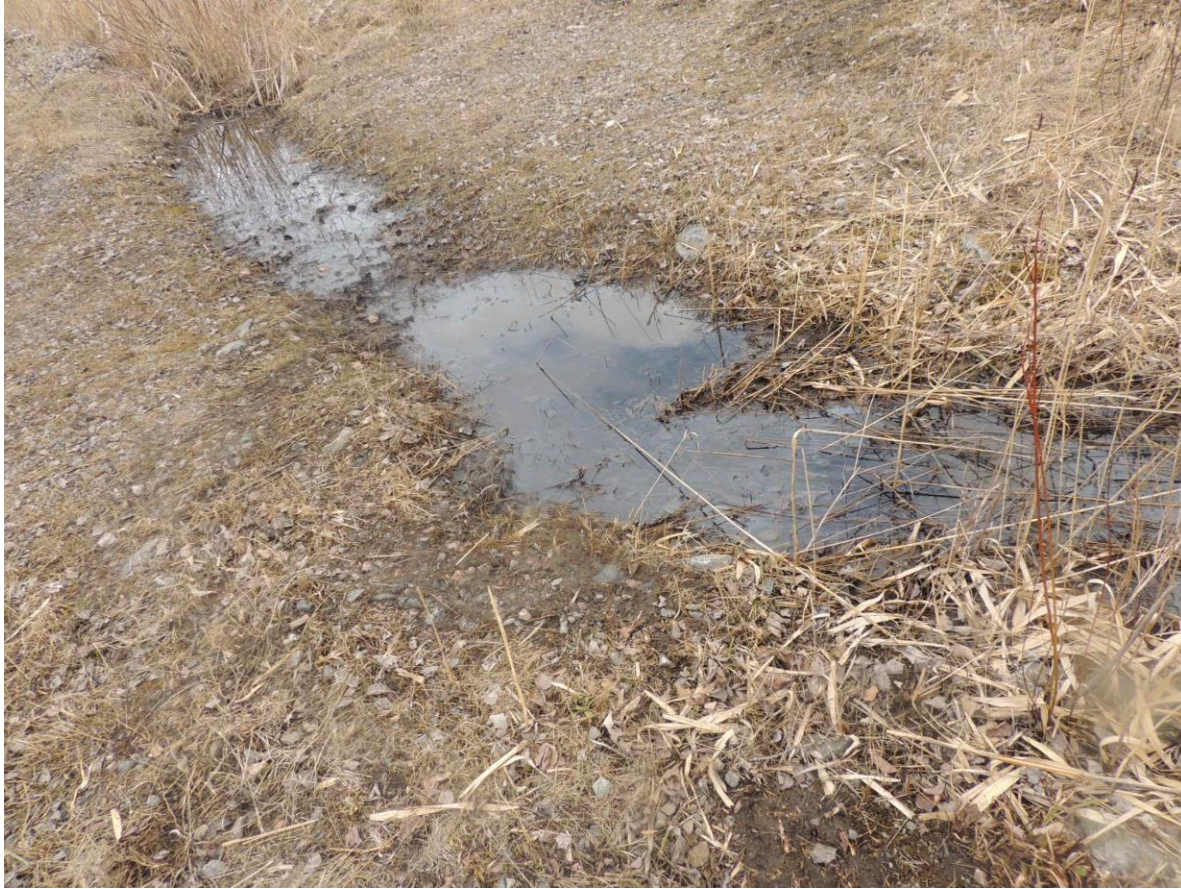
DSCN4058 – Flow path extending south into wooded area

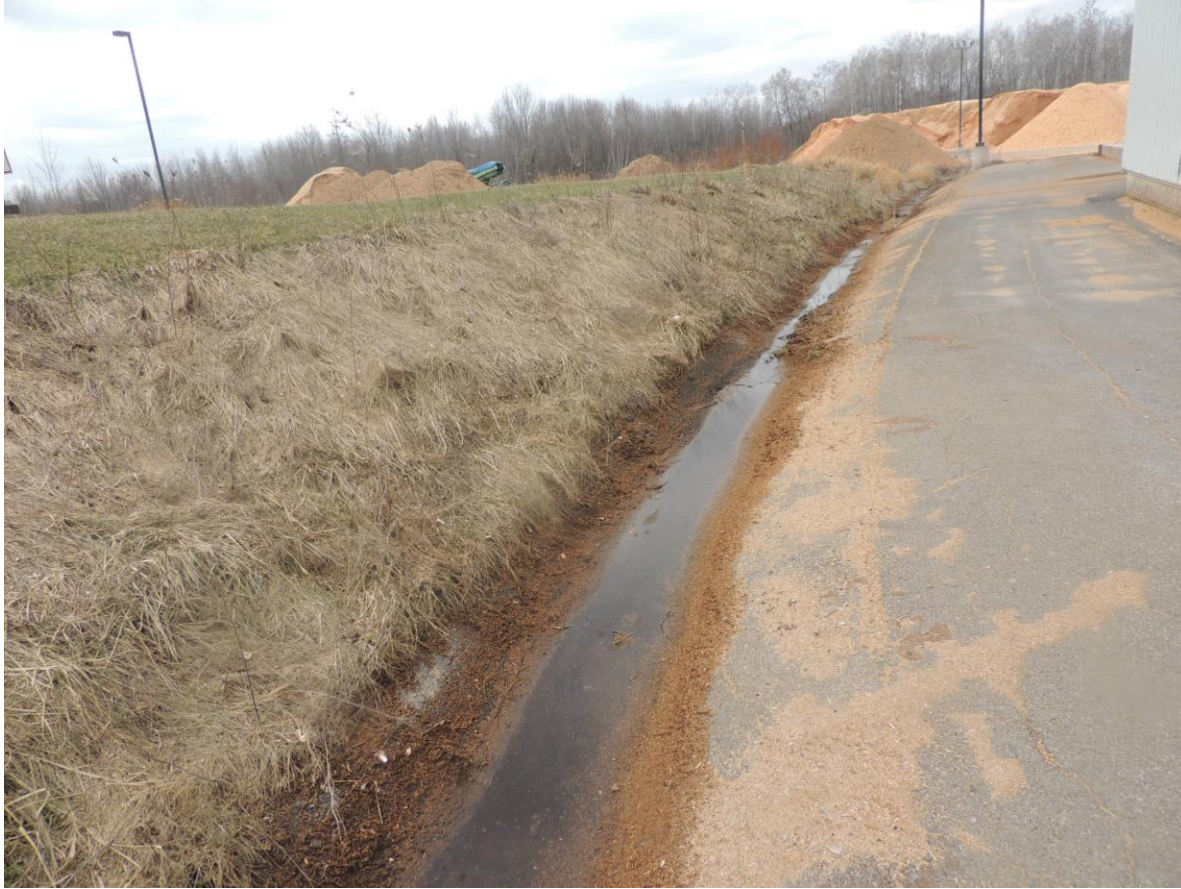
DSCN4063 - Swale with flow south of main building
