## Region 6 Compliance Assurance and Enforcement Division

### INSPECTION REPORT

| Company Name: | <b>Graphic Packaging International, LLC</b> | | |
| Facility Name: | <b>West Monroe Paper Mill</b> | | |

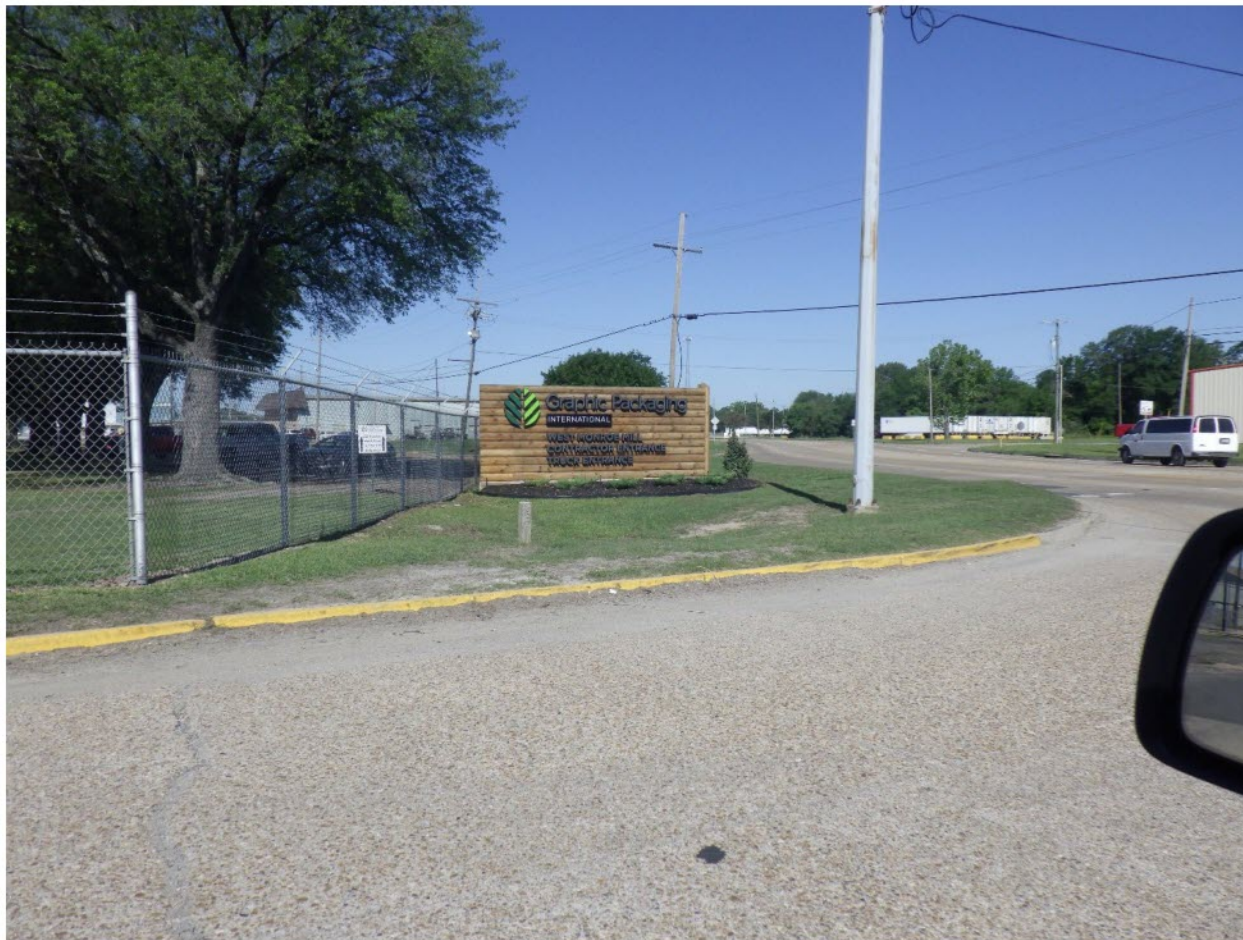
Photo No. 1

Photograph File Name: R0010826.JPG  
Date of Photograph: 04/23/2024  
Latitude and Longitude: 32.485205, -92.149951  
Orientation: E  
Map Datum: WGS-84  
Time of Photo: 09:35 AM  
Photographer: Jack Arias  
Description: This image shows the name and entrance of the facility.

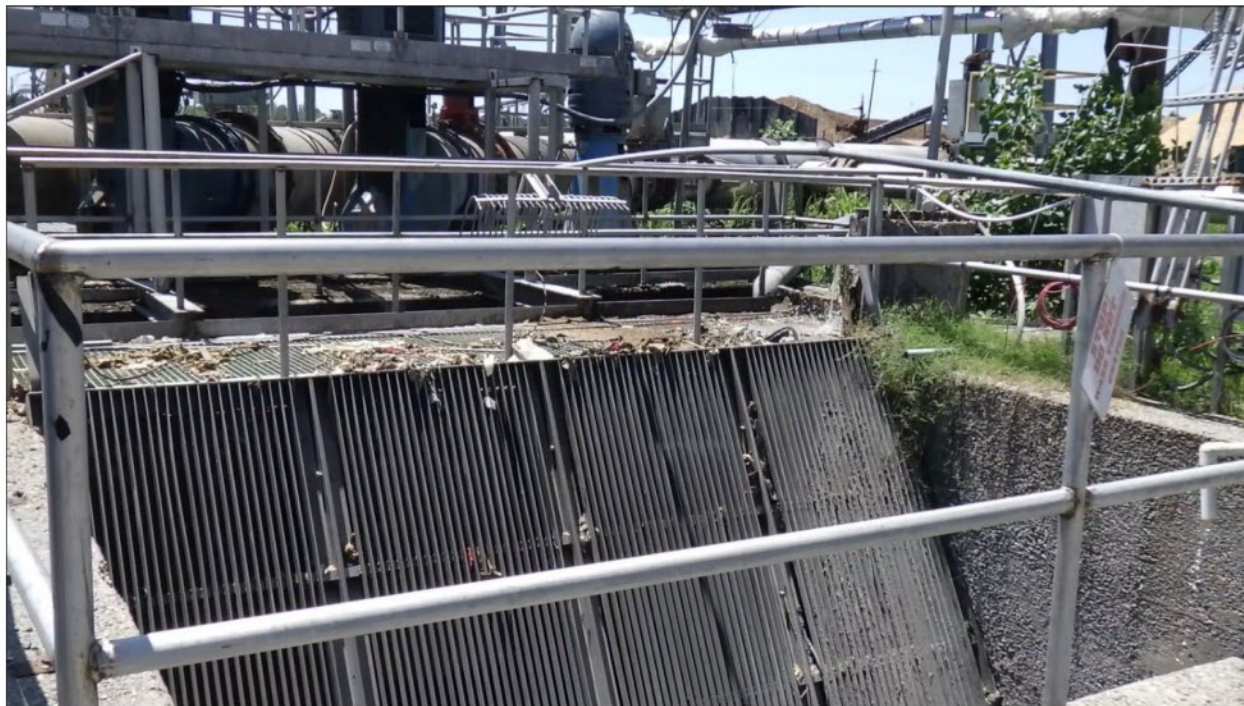
This image shows the mill pit which is a wastewater treatment system that collects all process wastewater through a system that drain to the mill effluent pit where the wastewater is then pumped through a pipe to the primary clarifier (basin processing area).

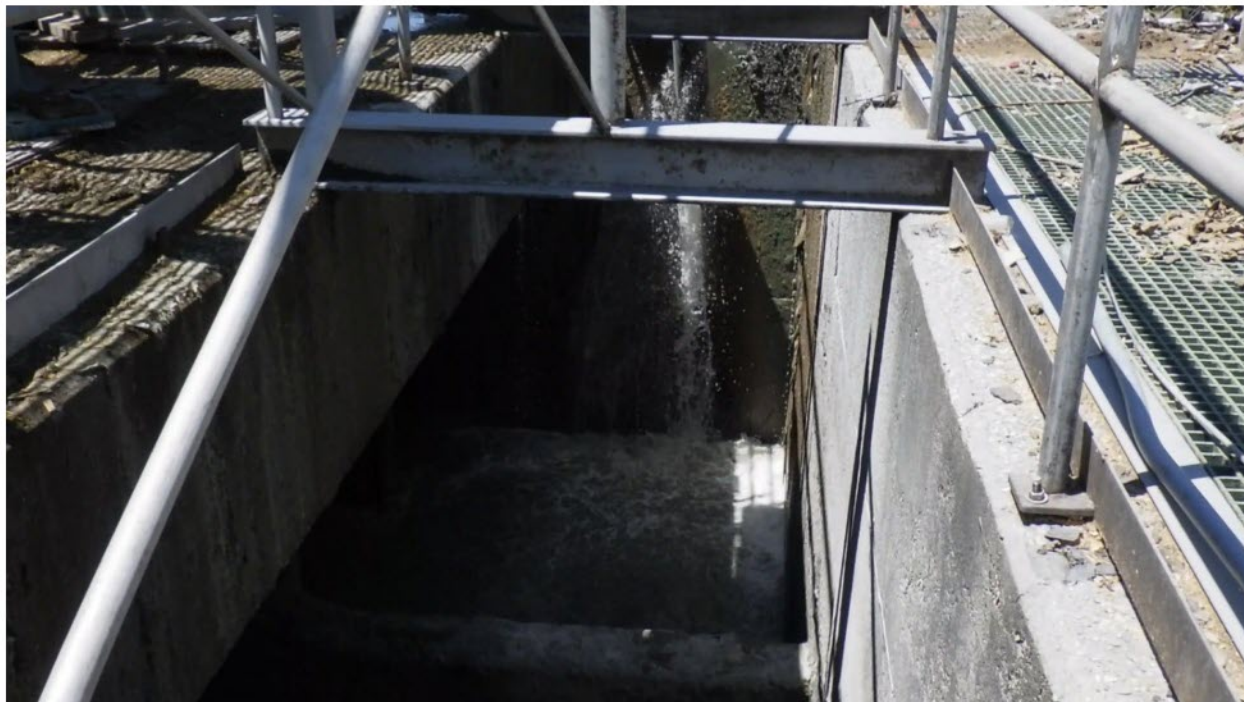
This image shows the mill pit collecting process wastewater and transferring wastewater through a pipe to the primary clarifier (basin processing area).

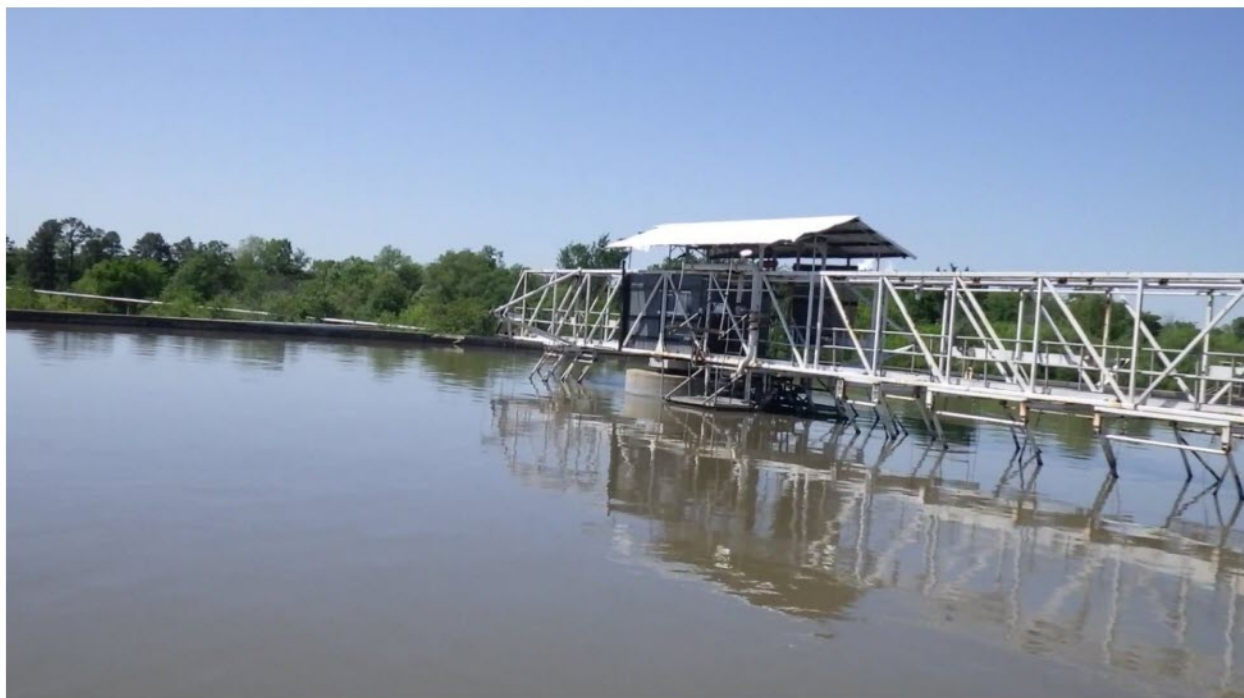
Photograph File Name: PClarifier.JPG  
Date of Photograph: 04/23/2024  
Latitude and Longitude: 32.473638 -92.146516  
Orientation: S  
Map Datum: WGS-84  
Time of Photo: 2:00 PM  
Photographer: Jack Arias  
Description: This image shows the primary clarifier. It removes heavy solids such as ash, grit, fiber, and lime and skim any oils from the surface.

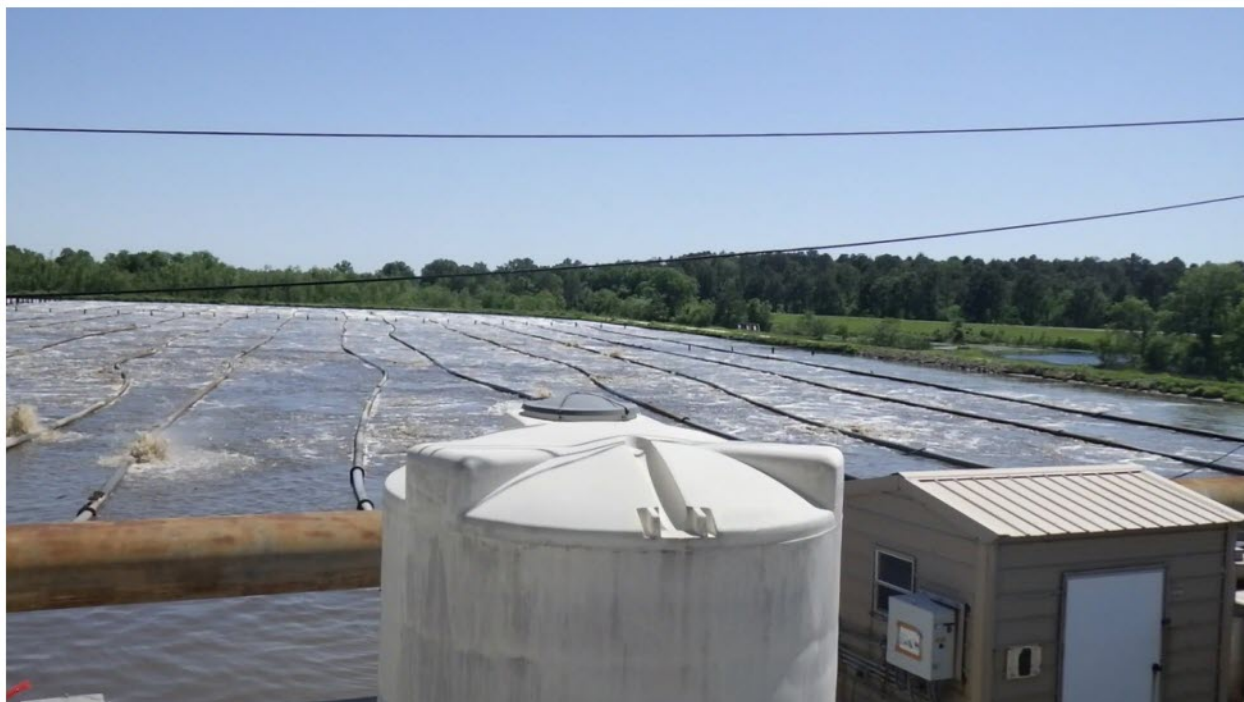
This image shows the aerated stabilization basin (ASB). The ASB is used for the biological treatment of soluble organics in the water from sources such as black liquor, starch, turpentine, methanol, and foul condensate.

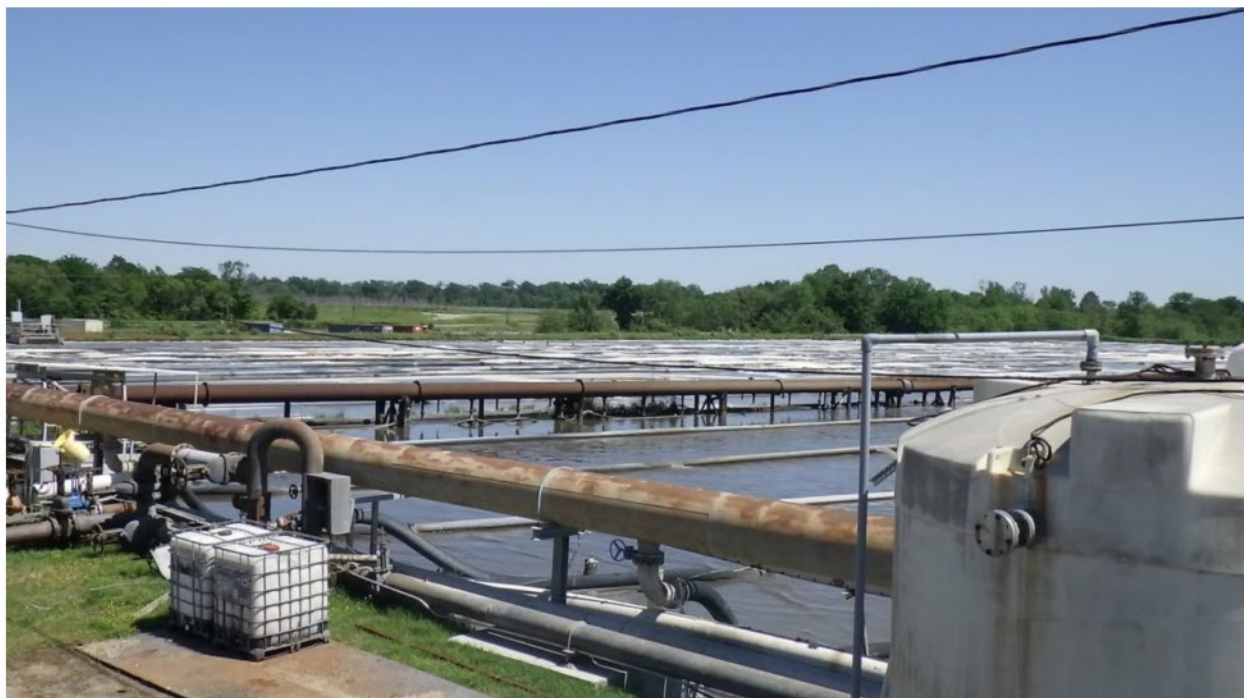
Photograph File Name: Basin2.JPG  
Date of Photograph: 04/23/2024  
Latitude and Longitud: 32.472344 -92.145314  
Orientation: S  
Map Datum: WGS-84  
Time of Photo: 2:15 PM  
Photographer: Jack Arias  
Description: This image shows the east part of aerated stabilization basin (ASB).

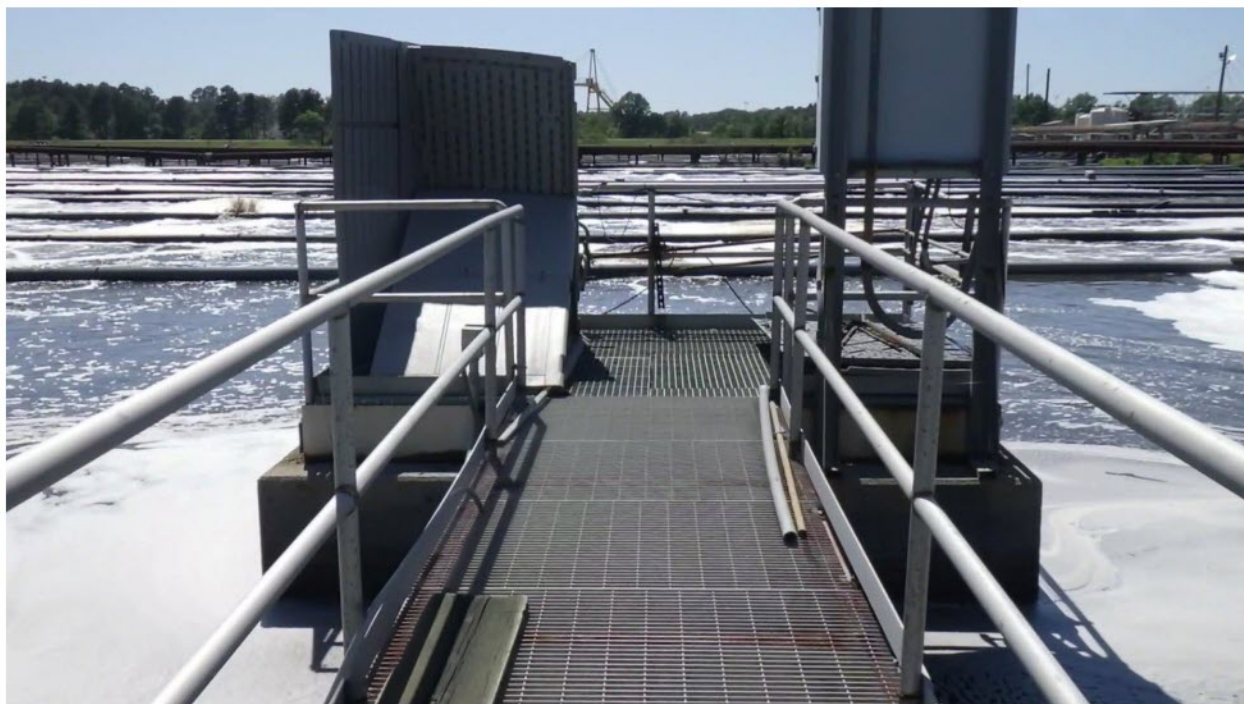
Photograph File Name: Sampling.JPG  
Date of Photograph: 04/23/2024  
Latitude and Longitud: 32.473438 -92.144849  
Orientation: S  
Map Datum: WGS-84  
Time of Photo: 2:20 PM  
Photographer: Jack Arias  
Description: This image shows the sampling point at the aerated stabilization basin (ASB).

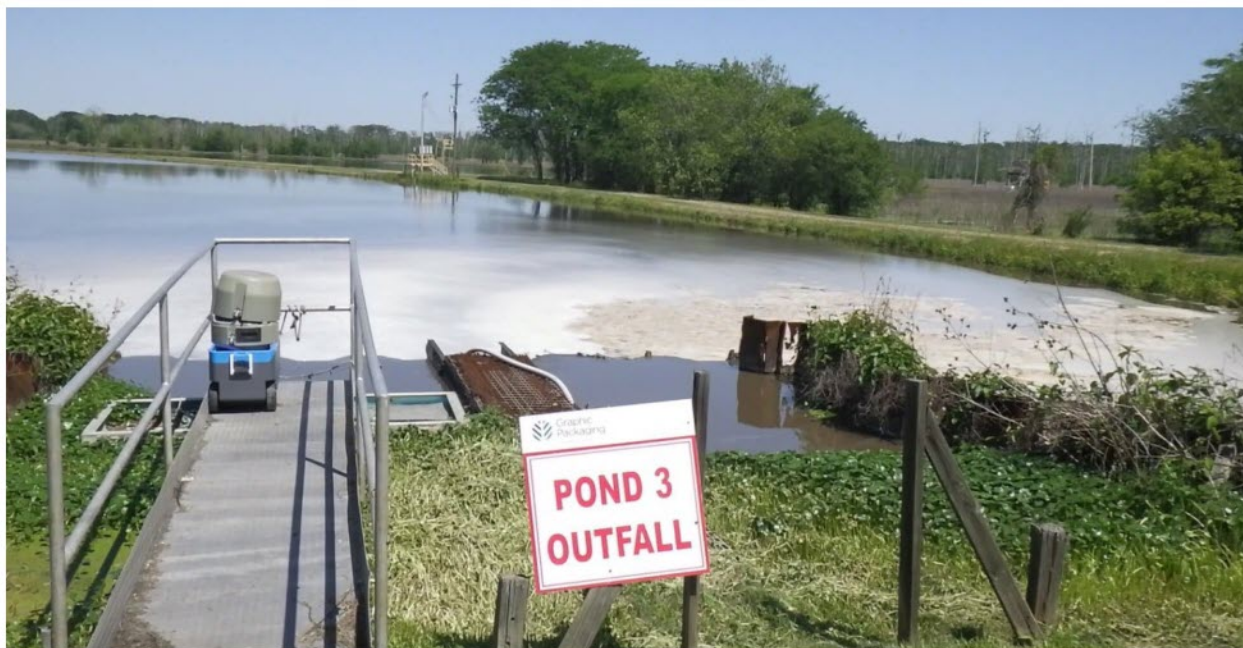
This image shows a settling pond. Solids are removed from the effluent through a series of three settling ponds before the effluent is discharged into the Ouachita River. Effluent is monitored to ensure compliance with LPDES Permit limits for pH, total suspended solids, and biochemical oxygen demand.

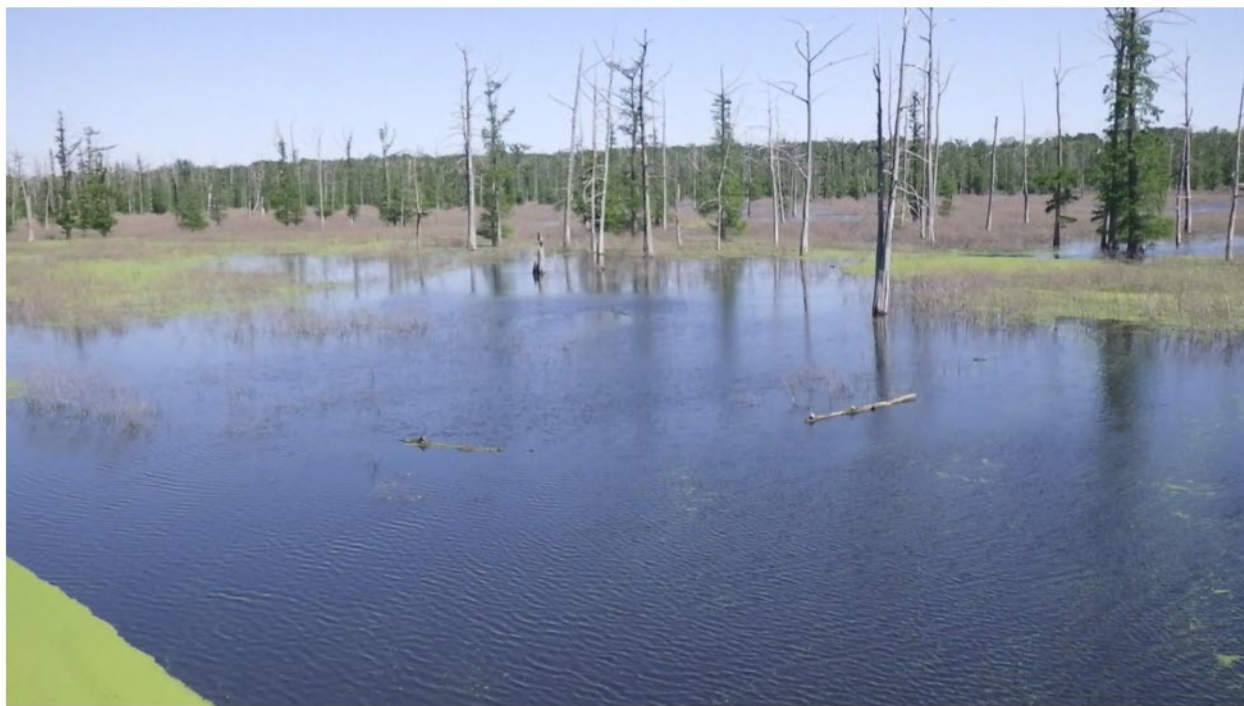
Photograph File Name: UnnamedTribuary.JPG  
Date of Photograph: 04/23/2024  
Latitude and Longitud: 32.448908      -92.130109  
Orientation: SE  
Map Datum: WGS-84  
Time of Photo: 3:20 PM  
Photographer: Jack Arias  
Description: This image shows the Outfall 401 discharging into an unnamed tributary, thence to Outfall 001, thence to the Quachita River.
