Former Frenchtown Mill	Observer: J. Peterson
Project 350.0065.001	Date / Time: 5/10/18 1340-1520
Clark Fork River Berm	Weather: Cloudy, 61 degrees F
Clark Fork Discharge at USGS Gage 12353000 (cfs): 45,200 – 42,700

**Clark Fork River Stage Monitoring Sites  
Former Frenchtown Mill Site  
Missoula County, Montana  
FIGURE 1**

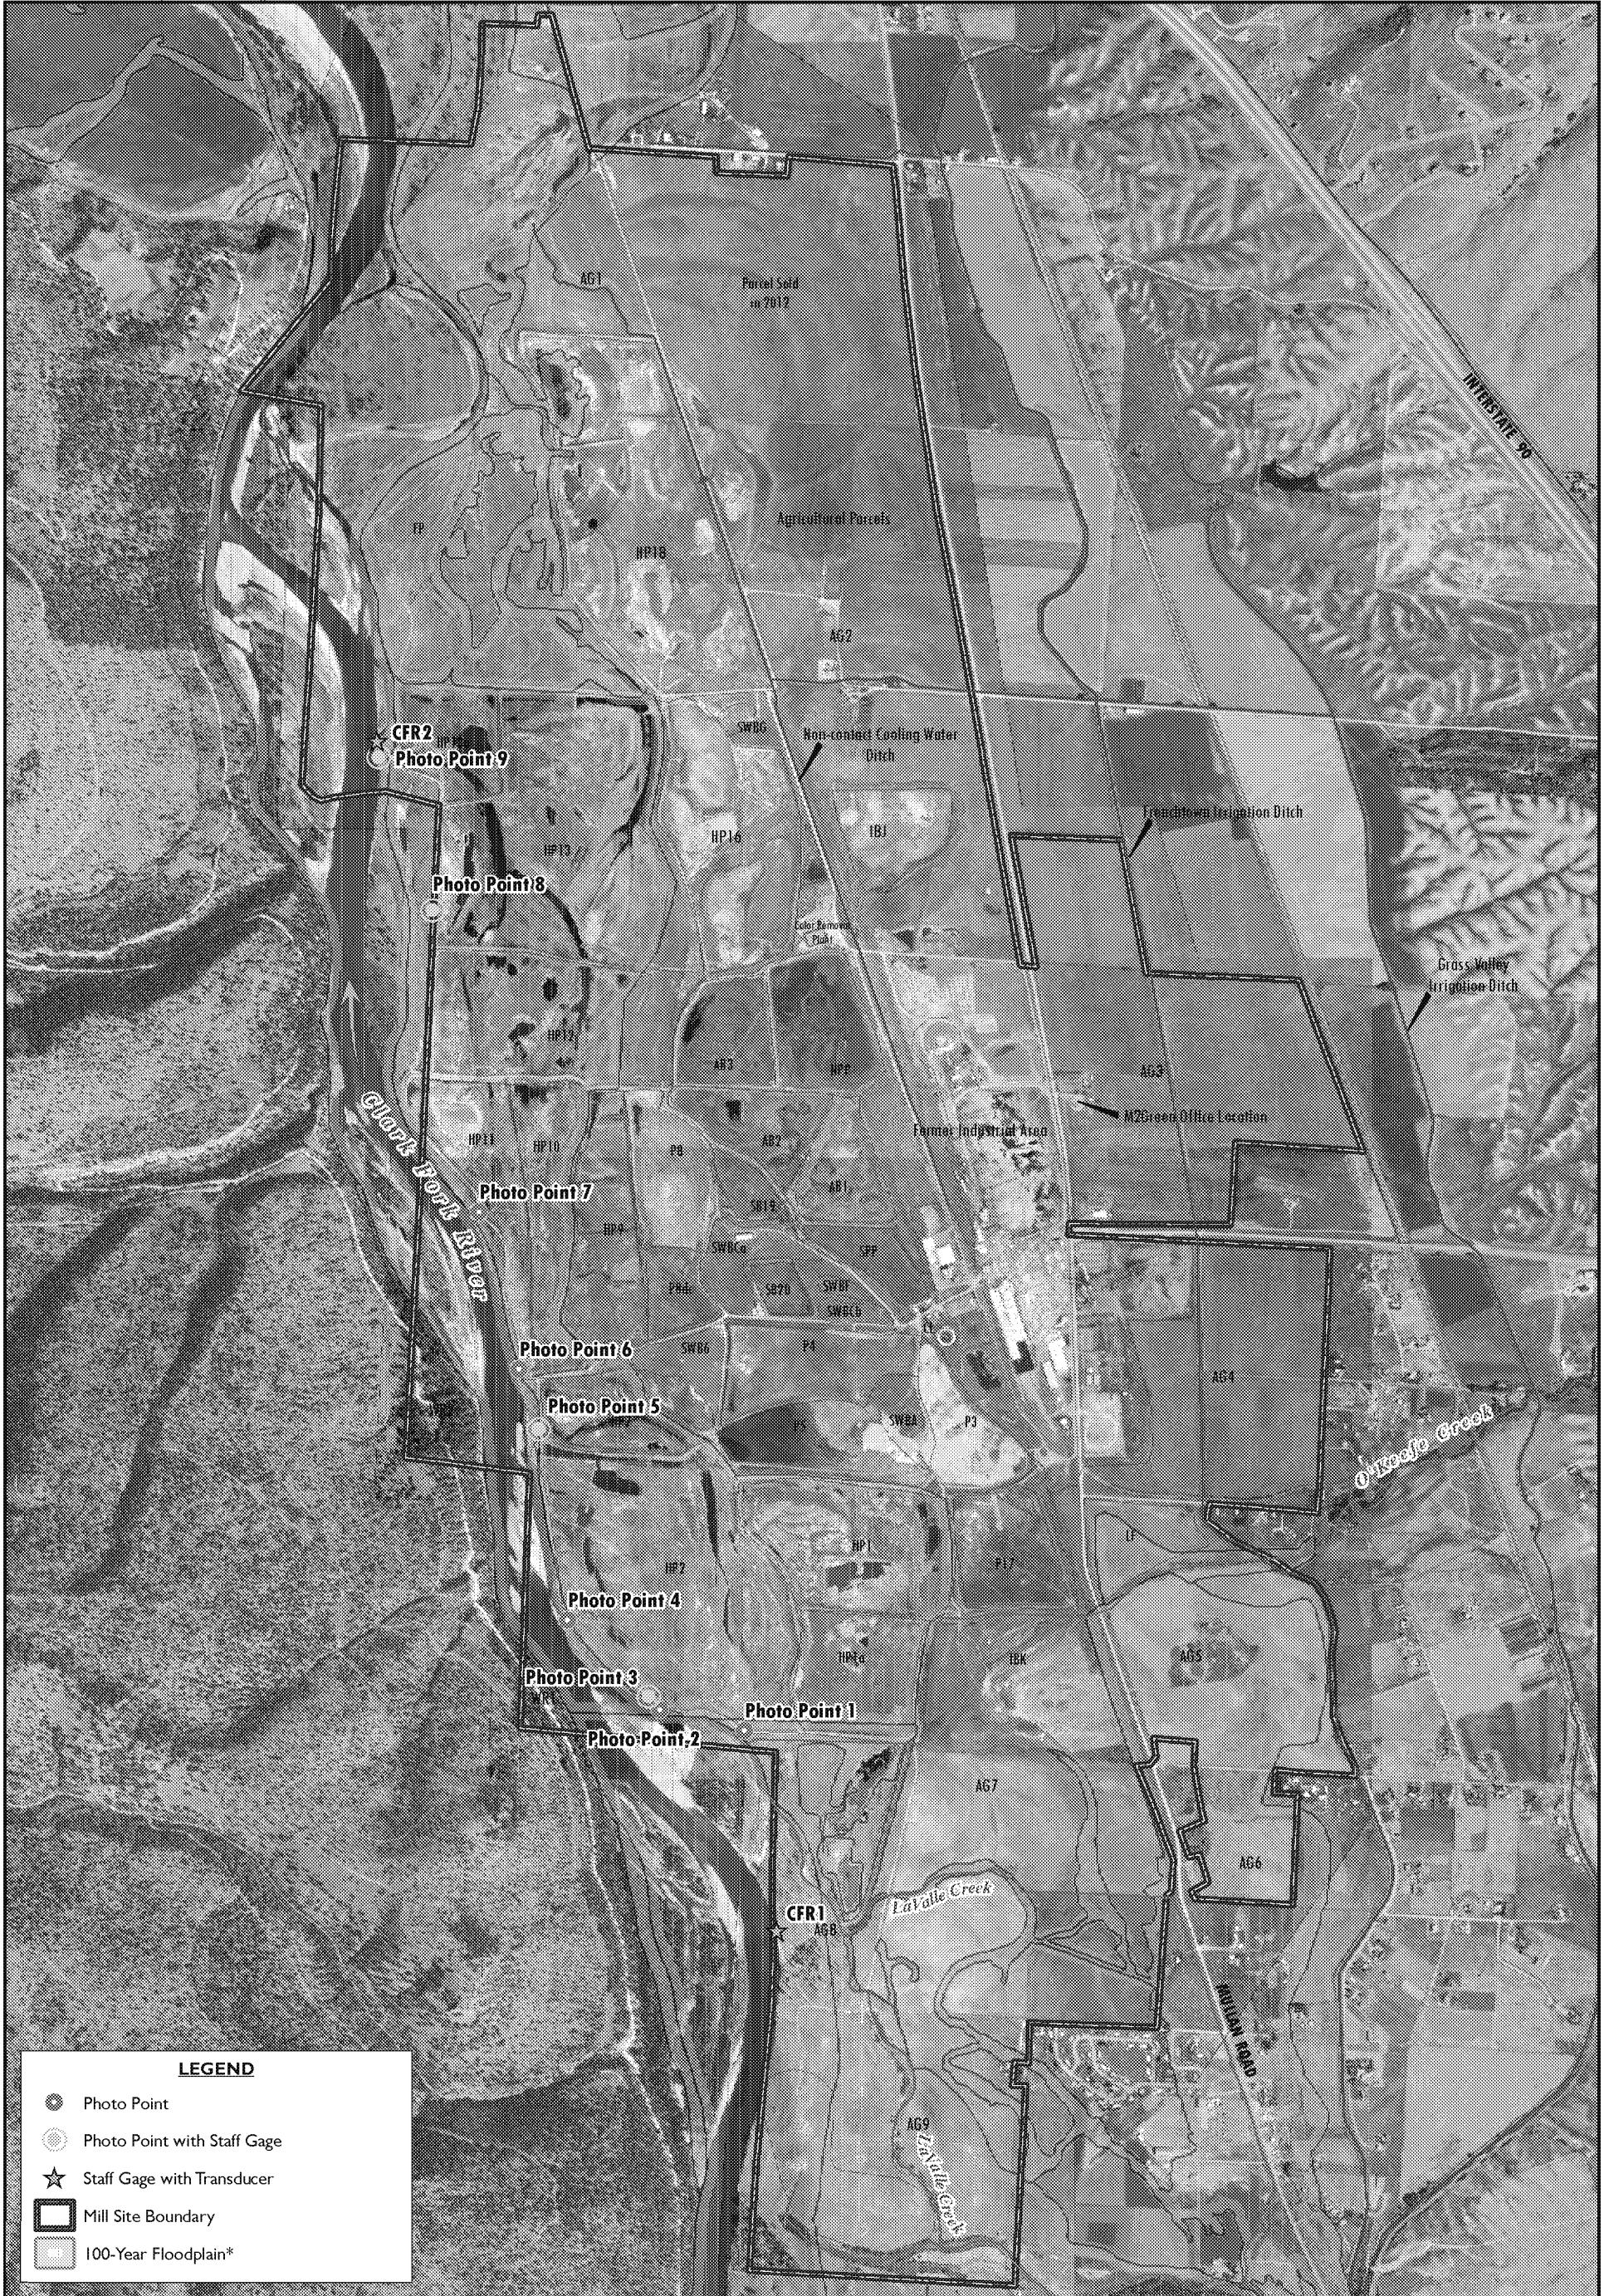
<b>Date/Time:</b> 5/10/2018 15:00	
<b>Staff Gage (ft):</b> above gage	
<b>Location:</b>	
N 46.97682	
W 114.22689	
<b>Comments:</b>	
Looking north. West side of HP13a. River gage submerged. A transducer is present at this gage site and stage data will be collected when the gage becomes accessible.
