# NPDES Compliance Inspection Report

## Copper River Seafoods Anchorage, AK

**NPDES Permit Tracking Number  
# AKU000398**

**Inspection Date: July 29 & 30, 2024**

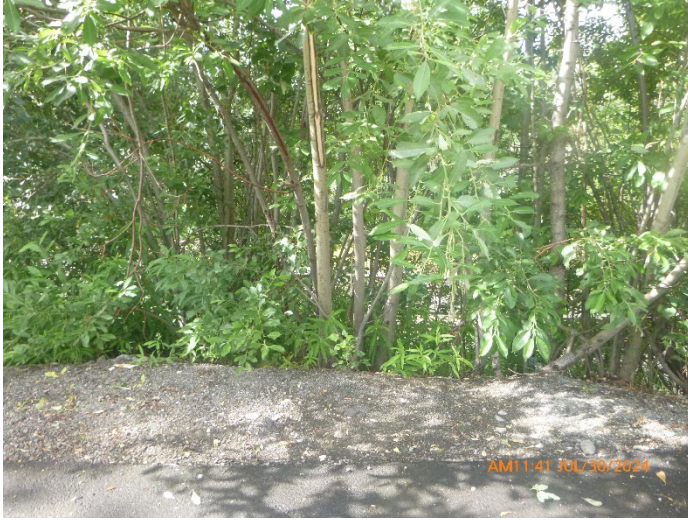
Photo #:25 (020)  
Description: Southwest corner of site.

Next, we walked to the southwest corner of the property to confirm there were no storm drains. No storm drain was observed, and Facility representatives confirmed there were no additional storm drains. We observed salmon roe on the ground located near the totes (see Photo 26). Facility representatives stated that the salmon roe got there from birds getting the salmon roe from the trash receptable.

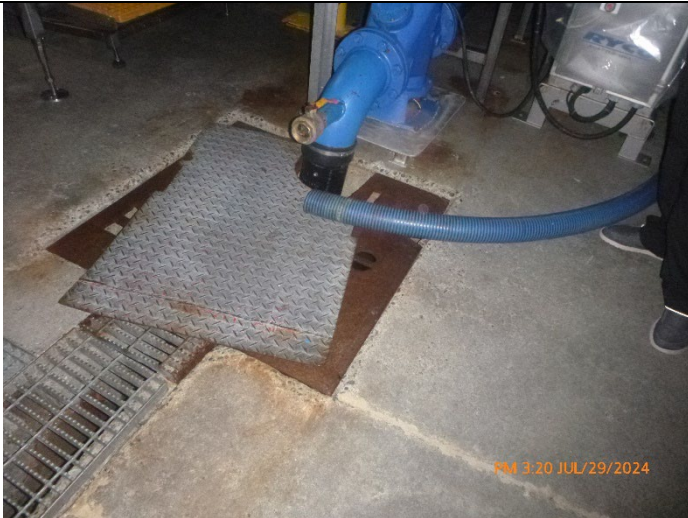
Photo #:27 (P1010185)  
Description: Main sump for processing waste before discharging to AWWU.
