Clean Water Act (CWA) Inspection Report

| <b>Type of Inspection</b> | CEI - Compliance Evaluation Inspection | | | |
| <b>Facility Name</b> | Pacific Steel and Recycling – Lewiston | | | |
| <b>NPDES Permit Tracking #</b> | IDR053088 | | | |

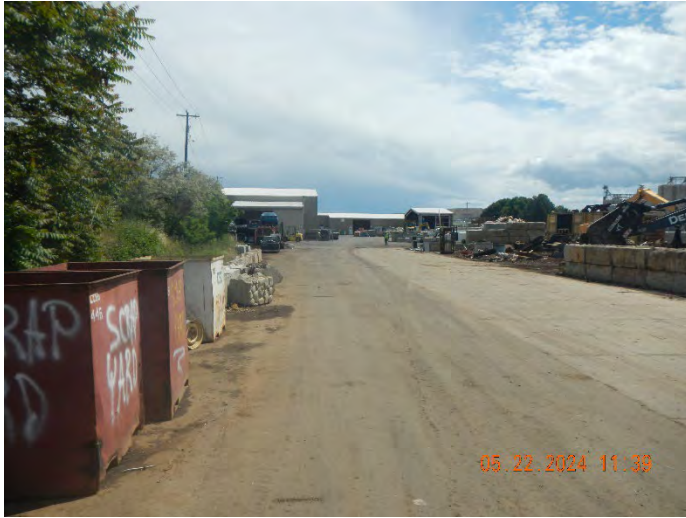
Photo #:13 (DSCN3752)

between the Facility's property and the vegetative marsh area. Concrete ecology blocks also extend across a portion the north perimeter, between the Facility's access road and the vegetative perimeter (**Photo 13**).

Description: Facing east, photo paved access road to crushing/processing area. Berm trench runs along the north end of the crushing/processing area.

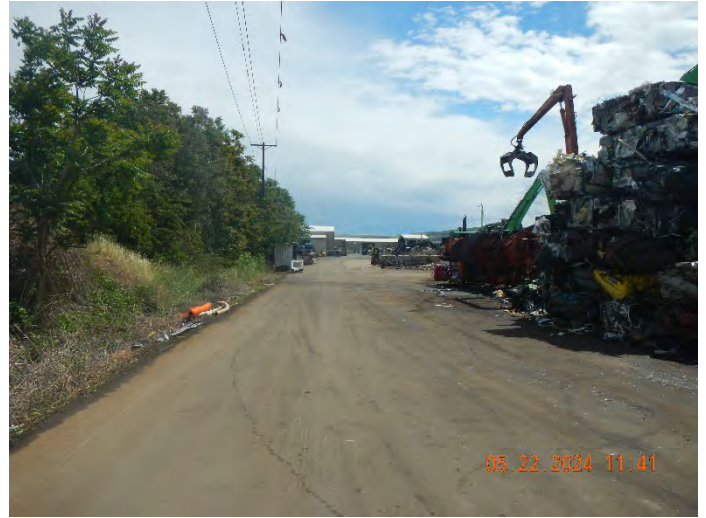
Photo #:14 (DSCN3753)

We continued west through the scrap processing area, where scrap metal sorted and compacted. It was discussed that processed scrap is ultimately delivered to Schnitzer Steel in Portland, Oregon. We observed the vegetated berm and swale throughout the northern perimeter (**Photo 14**), as well as the vegetated berm continuing across the western perimeter of the scrap processing area (**Photo 15**). We then observed the southern and central portions of scrap processing area. Southern portions of the scrap processing area were unpaved and stacked concrete ecology blocks extended across the southern property line and rail spur entrance (**Photo 16, Photo 17**). Primary/central scrap sorting and processing areas remain unpaved, and stormwater is designed to be infiltrated (**Photo 18, Photo 19**).

Description: Facing east, photo paved access road to crushing/processing area. Berm trench runs along the north end of the crushing/processing area.

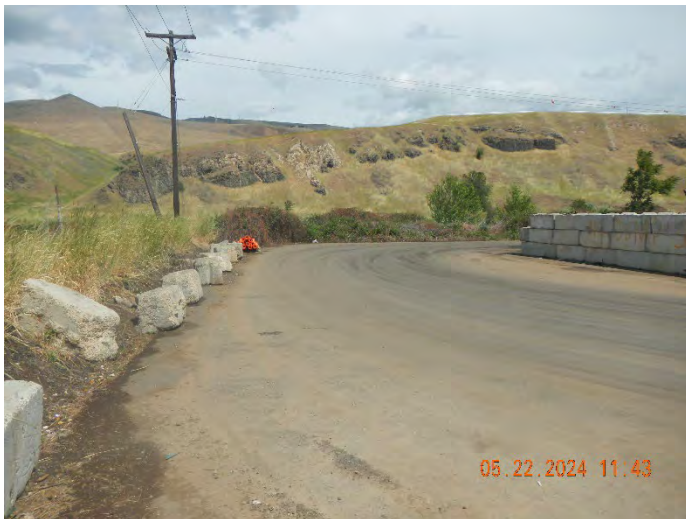
Photo #:15 (DSCN3754)

Description: Facing north, Photo of the bermed western perimeter of the Facility.

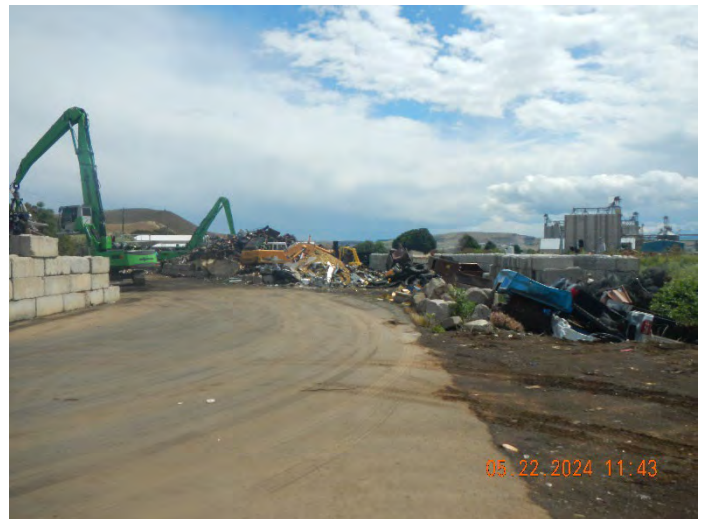
Photo #:16 (DSCN3755)

Description: Facing east, photo of the southwest perimeter of the Facility

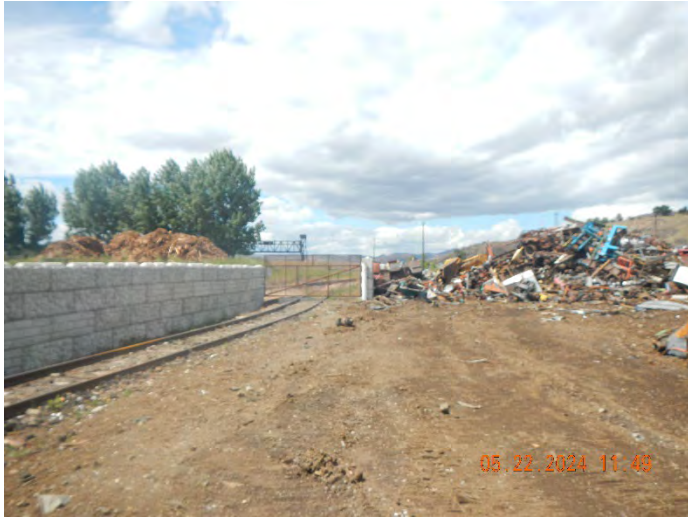
Photo #:17 (DSCN3756)  
Description: Facing west, photo of rail spur located along the south.

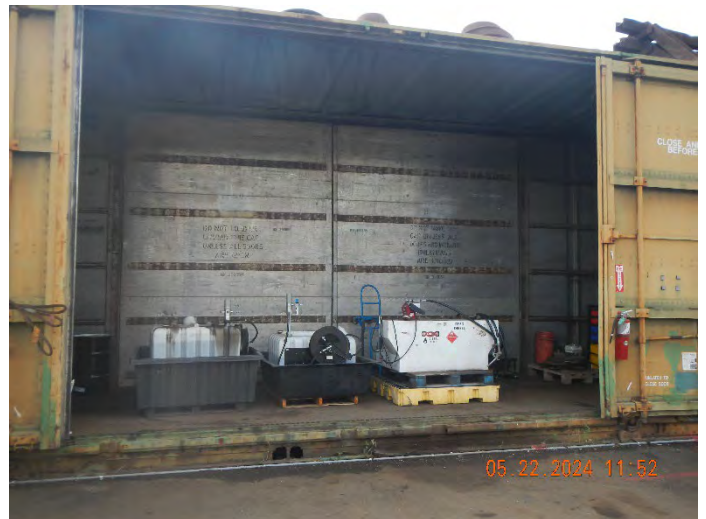
Following our time near within the scrap processing area, we continued along the southern perimeter to the Facility's enclosed fuel/lubricant storage area, contained within a repurposed rail car. Stored materials included diesel fuel, hydraulic oil, and engine oil (**Photo 20**). The diesel tank was double walled, and each product was within secondary containment. In general, the area appeared to be well maintained, stormwater is generally designed to flow south to a vegetated area along the rail spur. North of the fuel/lubricant storage area we observed/discussed a stockpile of absorbant material used for spill response. We also observed the Facility's sweeper attachment (**Photo 21**). It was discussed that in-house sweeping occurs once per week and as needed. In addition, the Facility utilizes Valley Sweeping for vacuum sweeping services every other week. Mr. Miller discussed that he would have to verify the contracted schedule Valley Sweeping.

Photo #:20 (DSCN3759)  
Description: Facing south, photo of covered fueling/lubricant area.

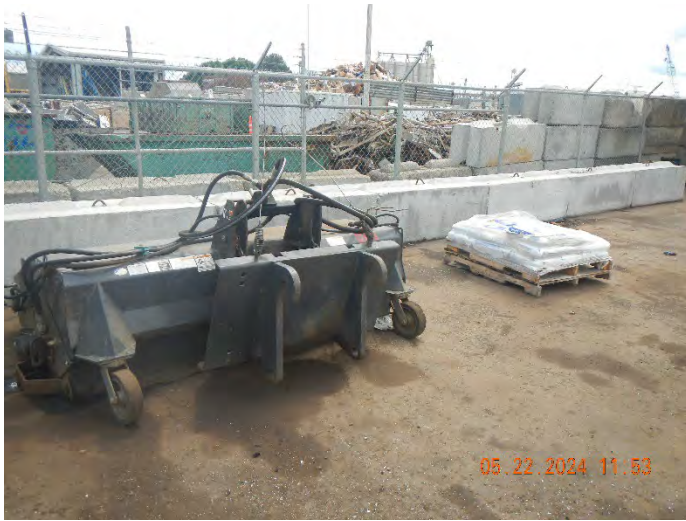
Photo #:21 (DSCN3760)  
Description: Facing east, photo of stockpiled absorbent materials and sweeper/broom attachment.

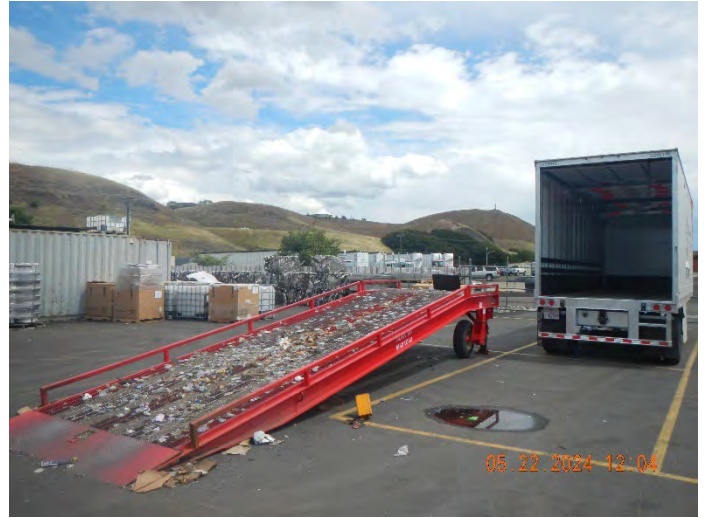
Photo #:26 (DSCN3765)

We continued to the shipping/loading areas within the southeast corner (**Photo 26**) and then then exited the

Description: Facing east, photo of shipping/loading area.

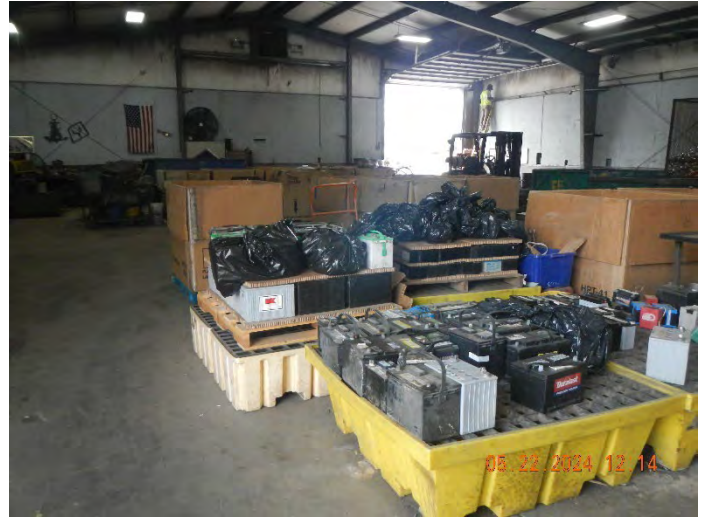
Photo #:30 (DSCN3769)

The walk-through concluded after observing the Facility's smaller receiving area typically used for smaller deliveries, including batteries, aluminum cans and copper wire (**Photo 30**).

Description: Facing south, photo from inside material receiving area.
