## EPA REGION 10 Enforcement Division

### INSPECTION REPORT

| Company Name | Alyeska Pipeline Service Company | |
| Facility or Site Name | Alyeska Taps Valdez Marine Terminal | |

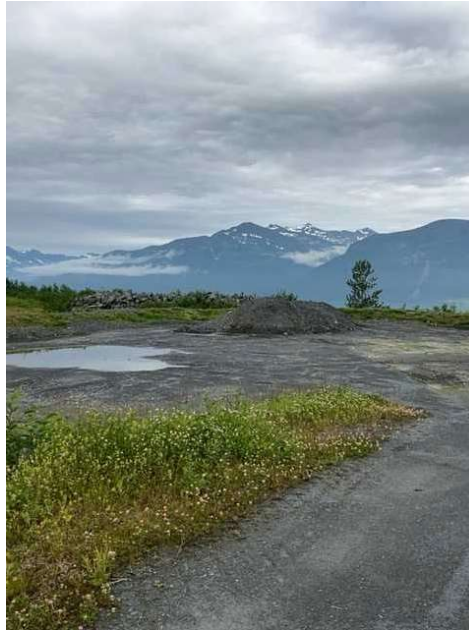
| Contaminated Soil Stockpile | | | IMG-202408061105015197774.jpg |

| Photo of the contaminated soil stockpile that ADEC approved. | | | |

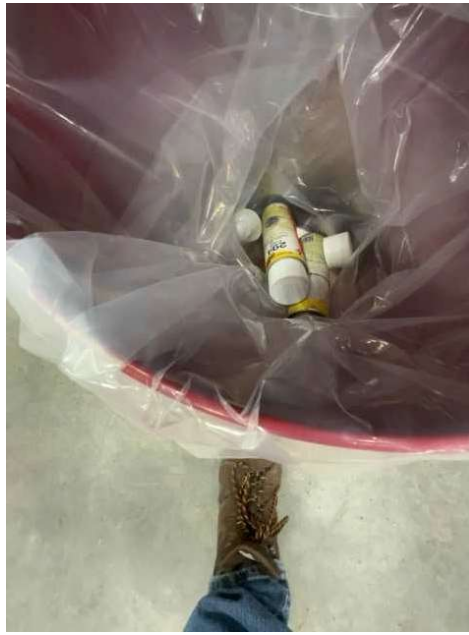
| Waste Aerosol Cans in 15-gal Container | | | IMG-20240806134034403457606.jpg |

| Top-down view of waste aerosol step-can in which the aerosol cans are contained was not labeled or marked clearly with any of the following phrases: "Universal Waste-Aerosol Can(s)," "Waste Aerosol Can(s)," or "Used Aerosol Can(s)." | | | |

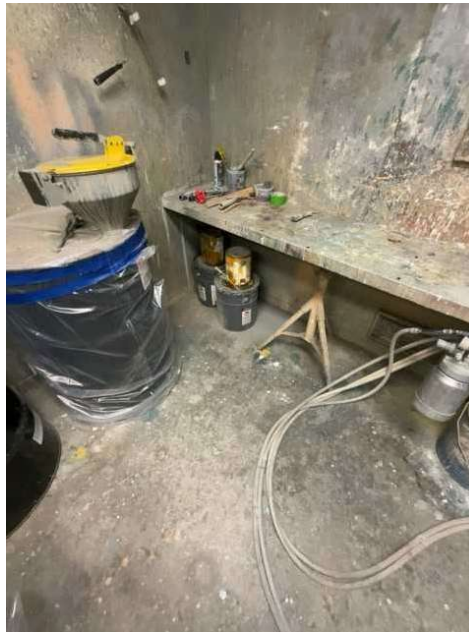
| Two, 5-gal Buckets of Paint | | | IMG-2024080614330833898491.jpg |

| View of two, 5-gallon buckets of paint that were still being utilized by the paint crew and were not waste. | | | |

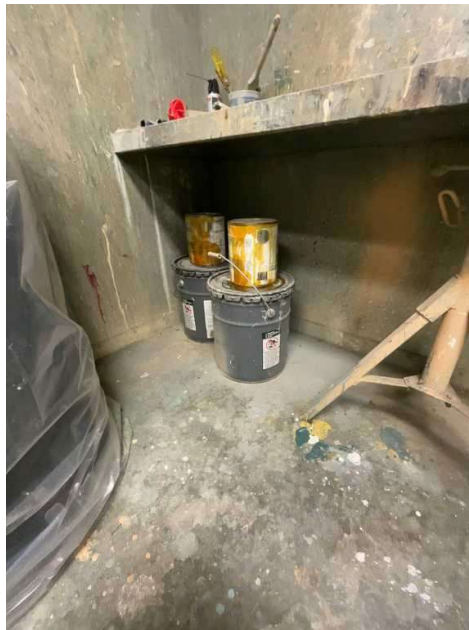
| Two, 5-gal Buckets of Paint | | | IMG-2024080614332233222061089.jpg |

| Close-up view of two, 5-gallon buckets of paint that were still being utilized by the paint crew and were not waste. | | | |
