**Region 6 - Enforcement & Compliance Assurance Division**  
**INSPECTION REPORT**

| Regulatory Program: | Water (CWA) Brine Program (Oil & Gas Inspection) | |
| Company Name: | Enerco Operating Corporation | |
| Facility Name: | Fouke D-3 SWD System; Goldman A, Goldman-Mariman, Hunter Collins Leases | |

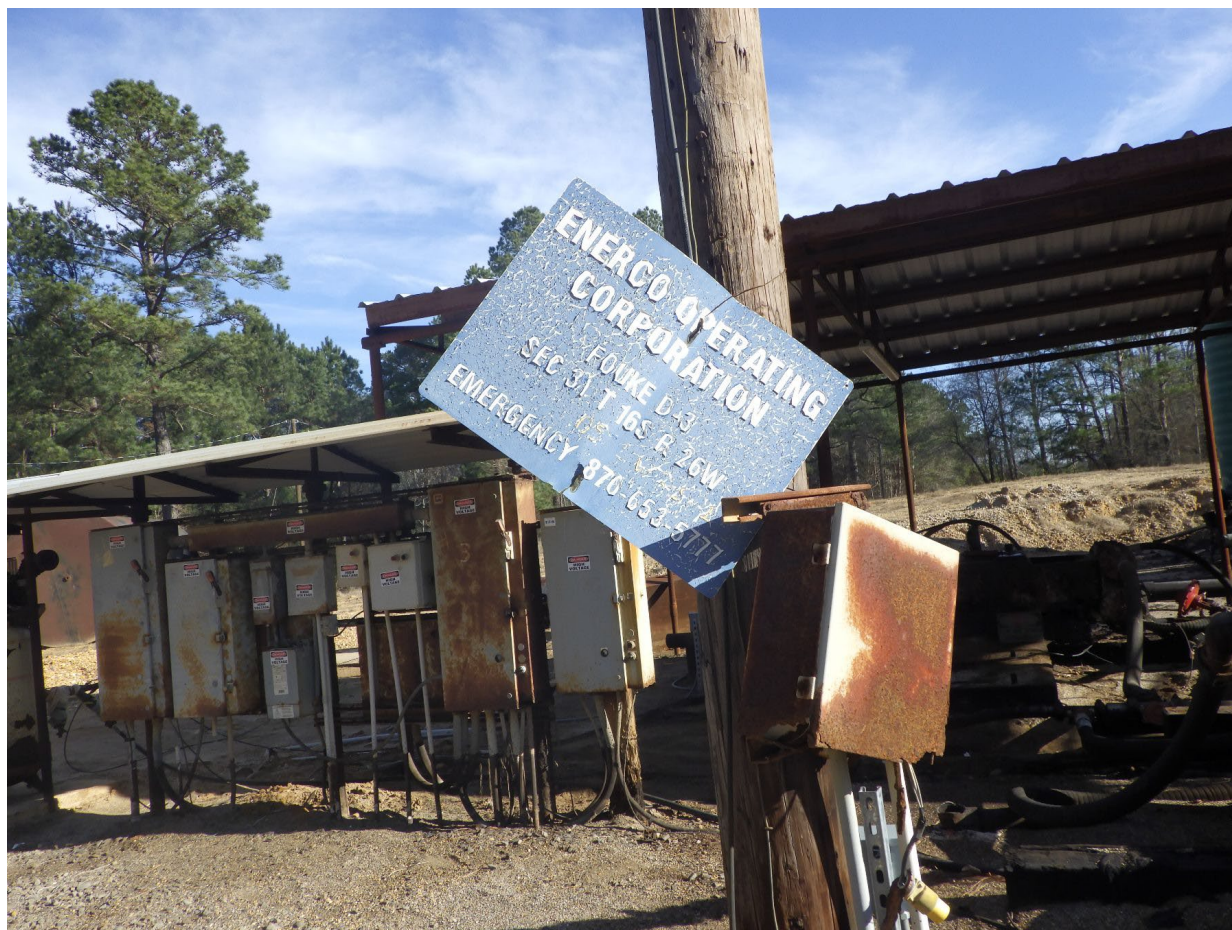
| Description: | This photo was taken facing south-southwest and shows the facility sign for Fouke D-3 SWD System. | | |

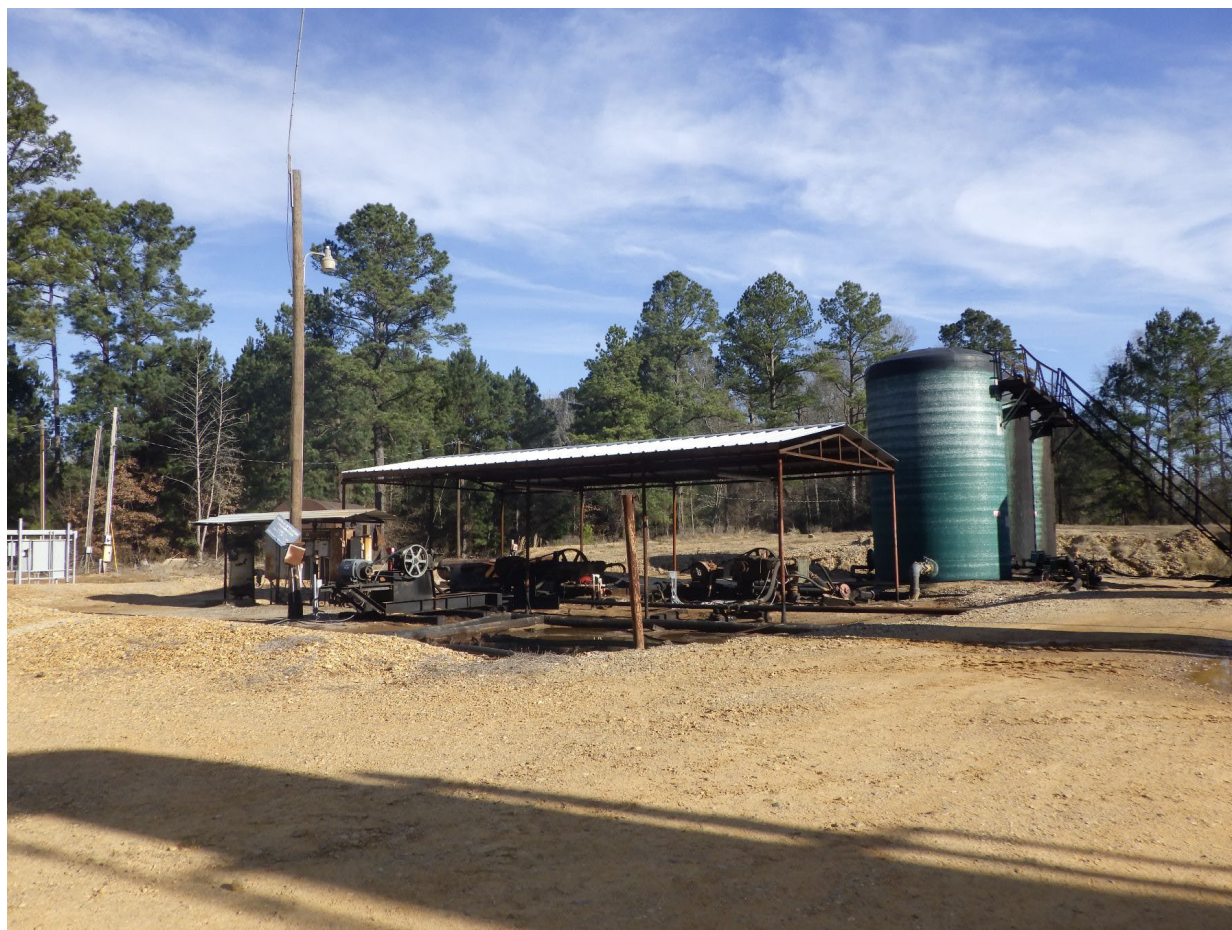
Photo No. 2

| Description: | This photo was taken facing south-southwest and shows an overview of the Fouke D-3 SWD System. | | |

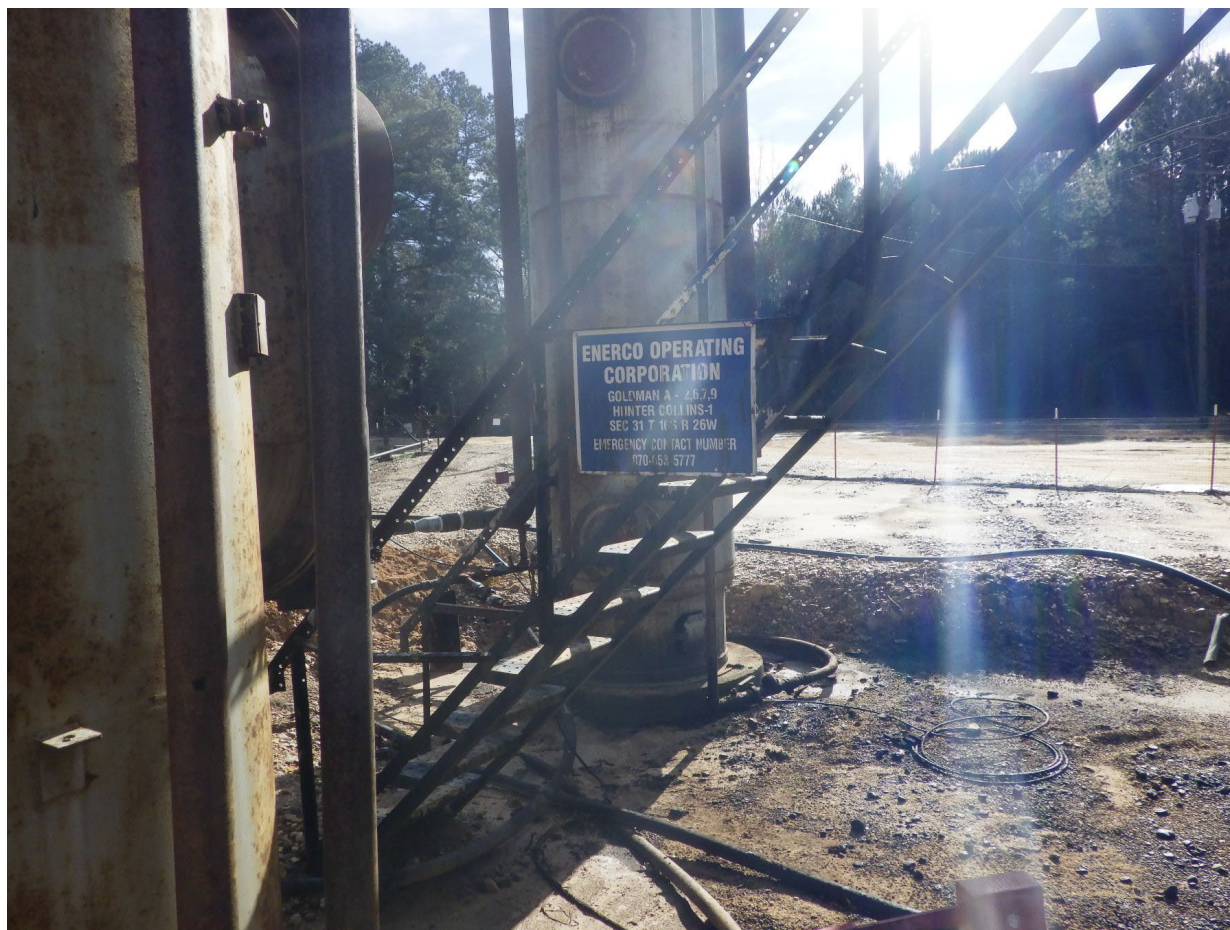
| Description: | This photo was taken facing south and shows a facility sign for the Goldman A, Goldman-Mariman, Hunter Collins Leases. | | |

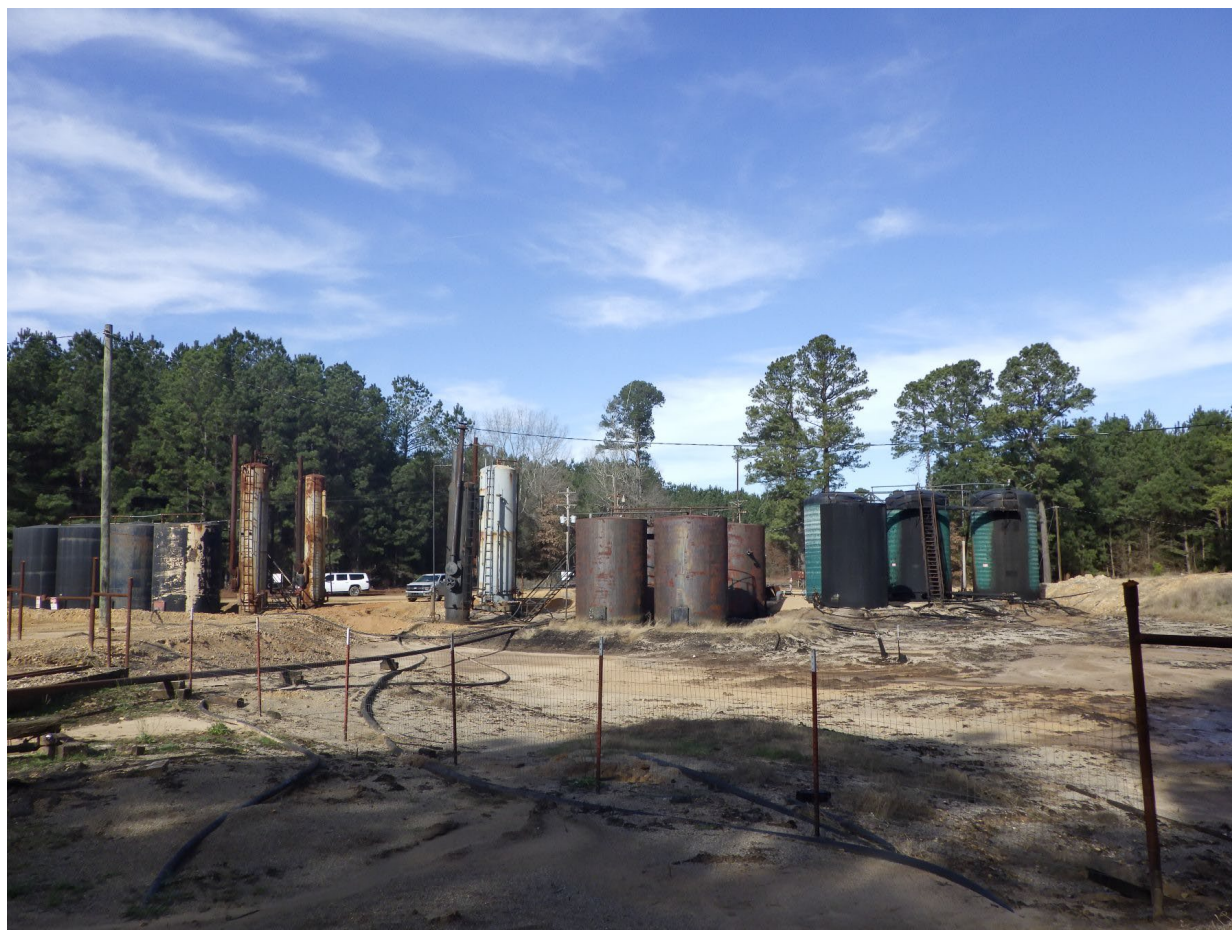
| Description: | This photo was taken facing southwest and shows an over of both the Fouke D-3 SWD System & Goldman A, Goldman-Mariman, Hunter Collins Leases. | | |
