**Region 6 - Enforcement & Compliance Assurance Division**  
**INSPECTION REPORT**

| Inspection Date(s): | 03/25/2024 | |
| Company Name: | <b>RS Livestock DBA Beaver County Stockyards</b> | |
| Facility Name: | <b>Beaver County Stockyards</b> | |

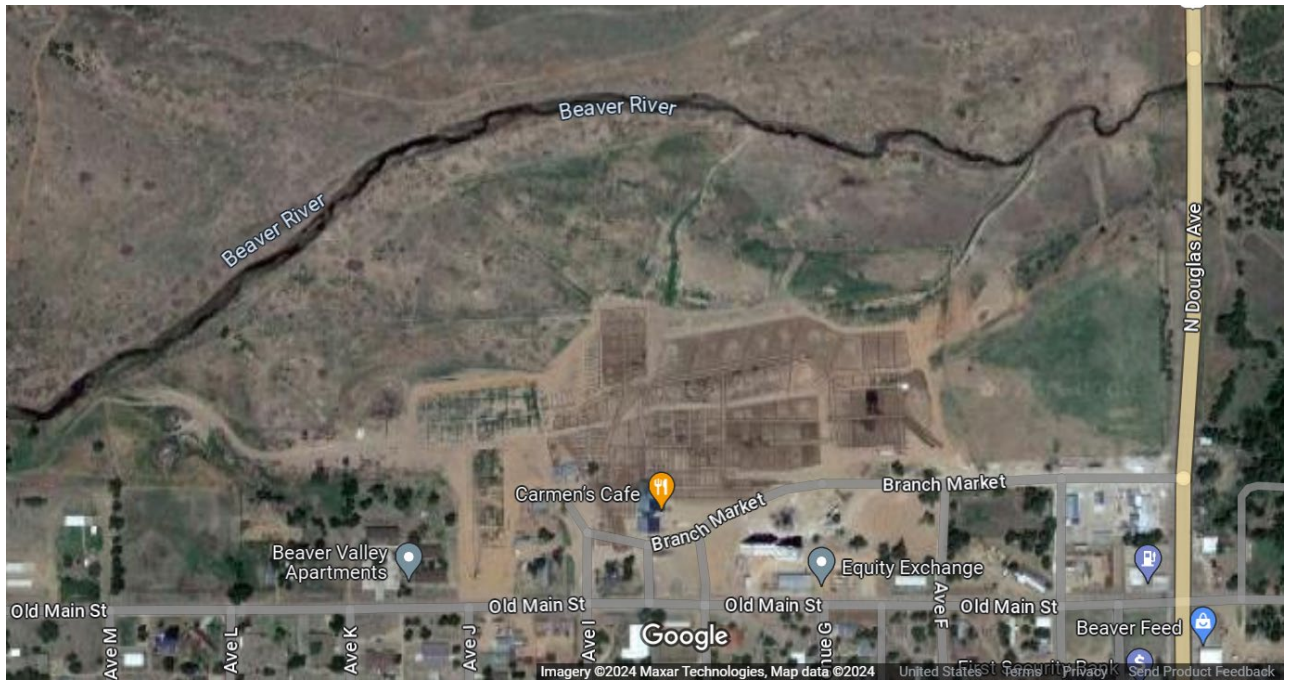
Photo 1: Aerial photo taken from Google Maps showing Beaver County Stockyards facility, Beaver River, and surrounding areas.
