**Region 6 - Enforcement & Compliance Assurance Division**  
**INSPECTION REPORT**

| Inspection Date(s): | August 22, 2023 | |
| Company Name: | Centurion Container, LLC. | |
| Facility Name: | <b>Houston Facility</b> | |

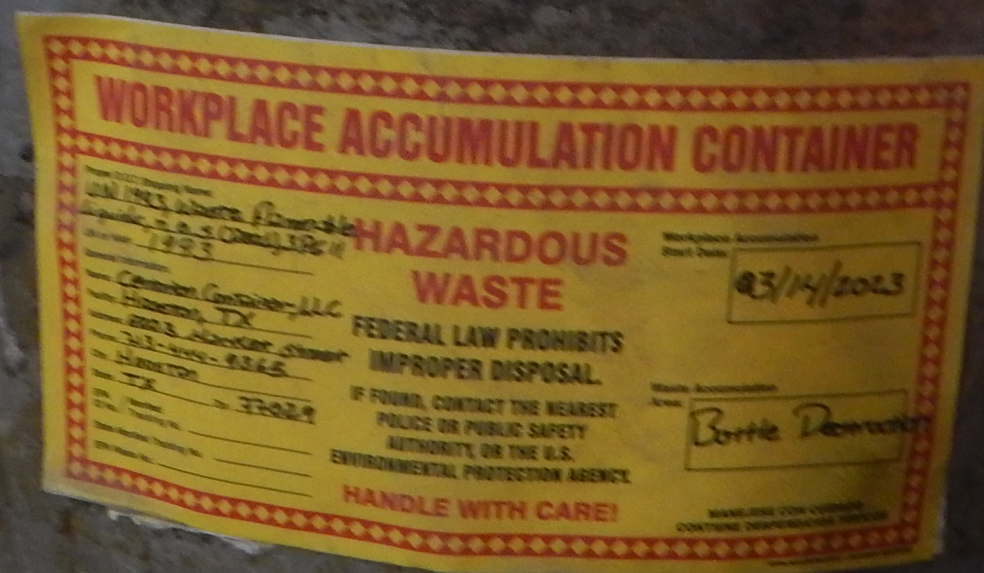
| Photo Number | File Name | | Date | Time | Photographer | Description |
|---|---|---|---|---|---|---|
| 1 | DSCN1127 | .JPG | 22-Aug-23 | 1028 | John Penland | Hazardous waste accumulation container located at the flammable liquids table in the IBC emptying and processing area. Label detail. Lid unsecured. |

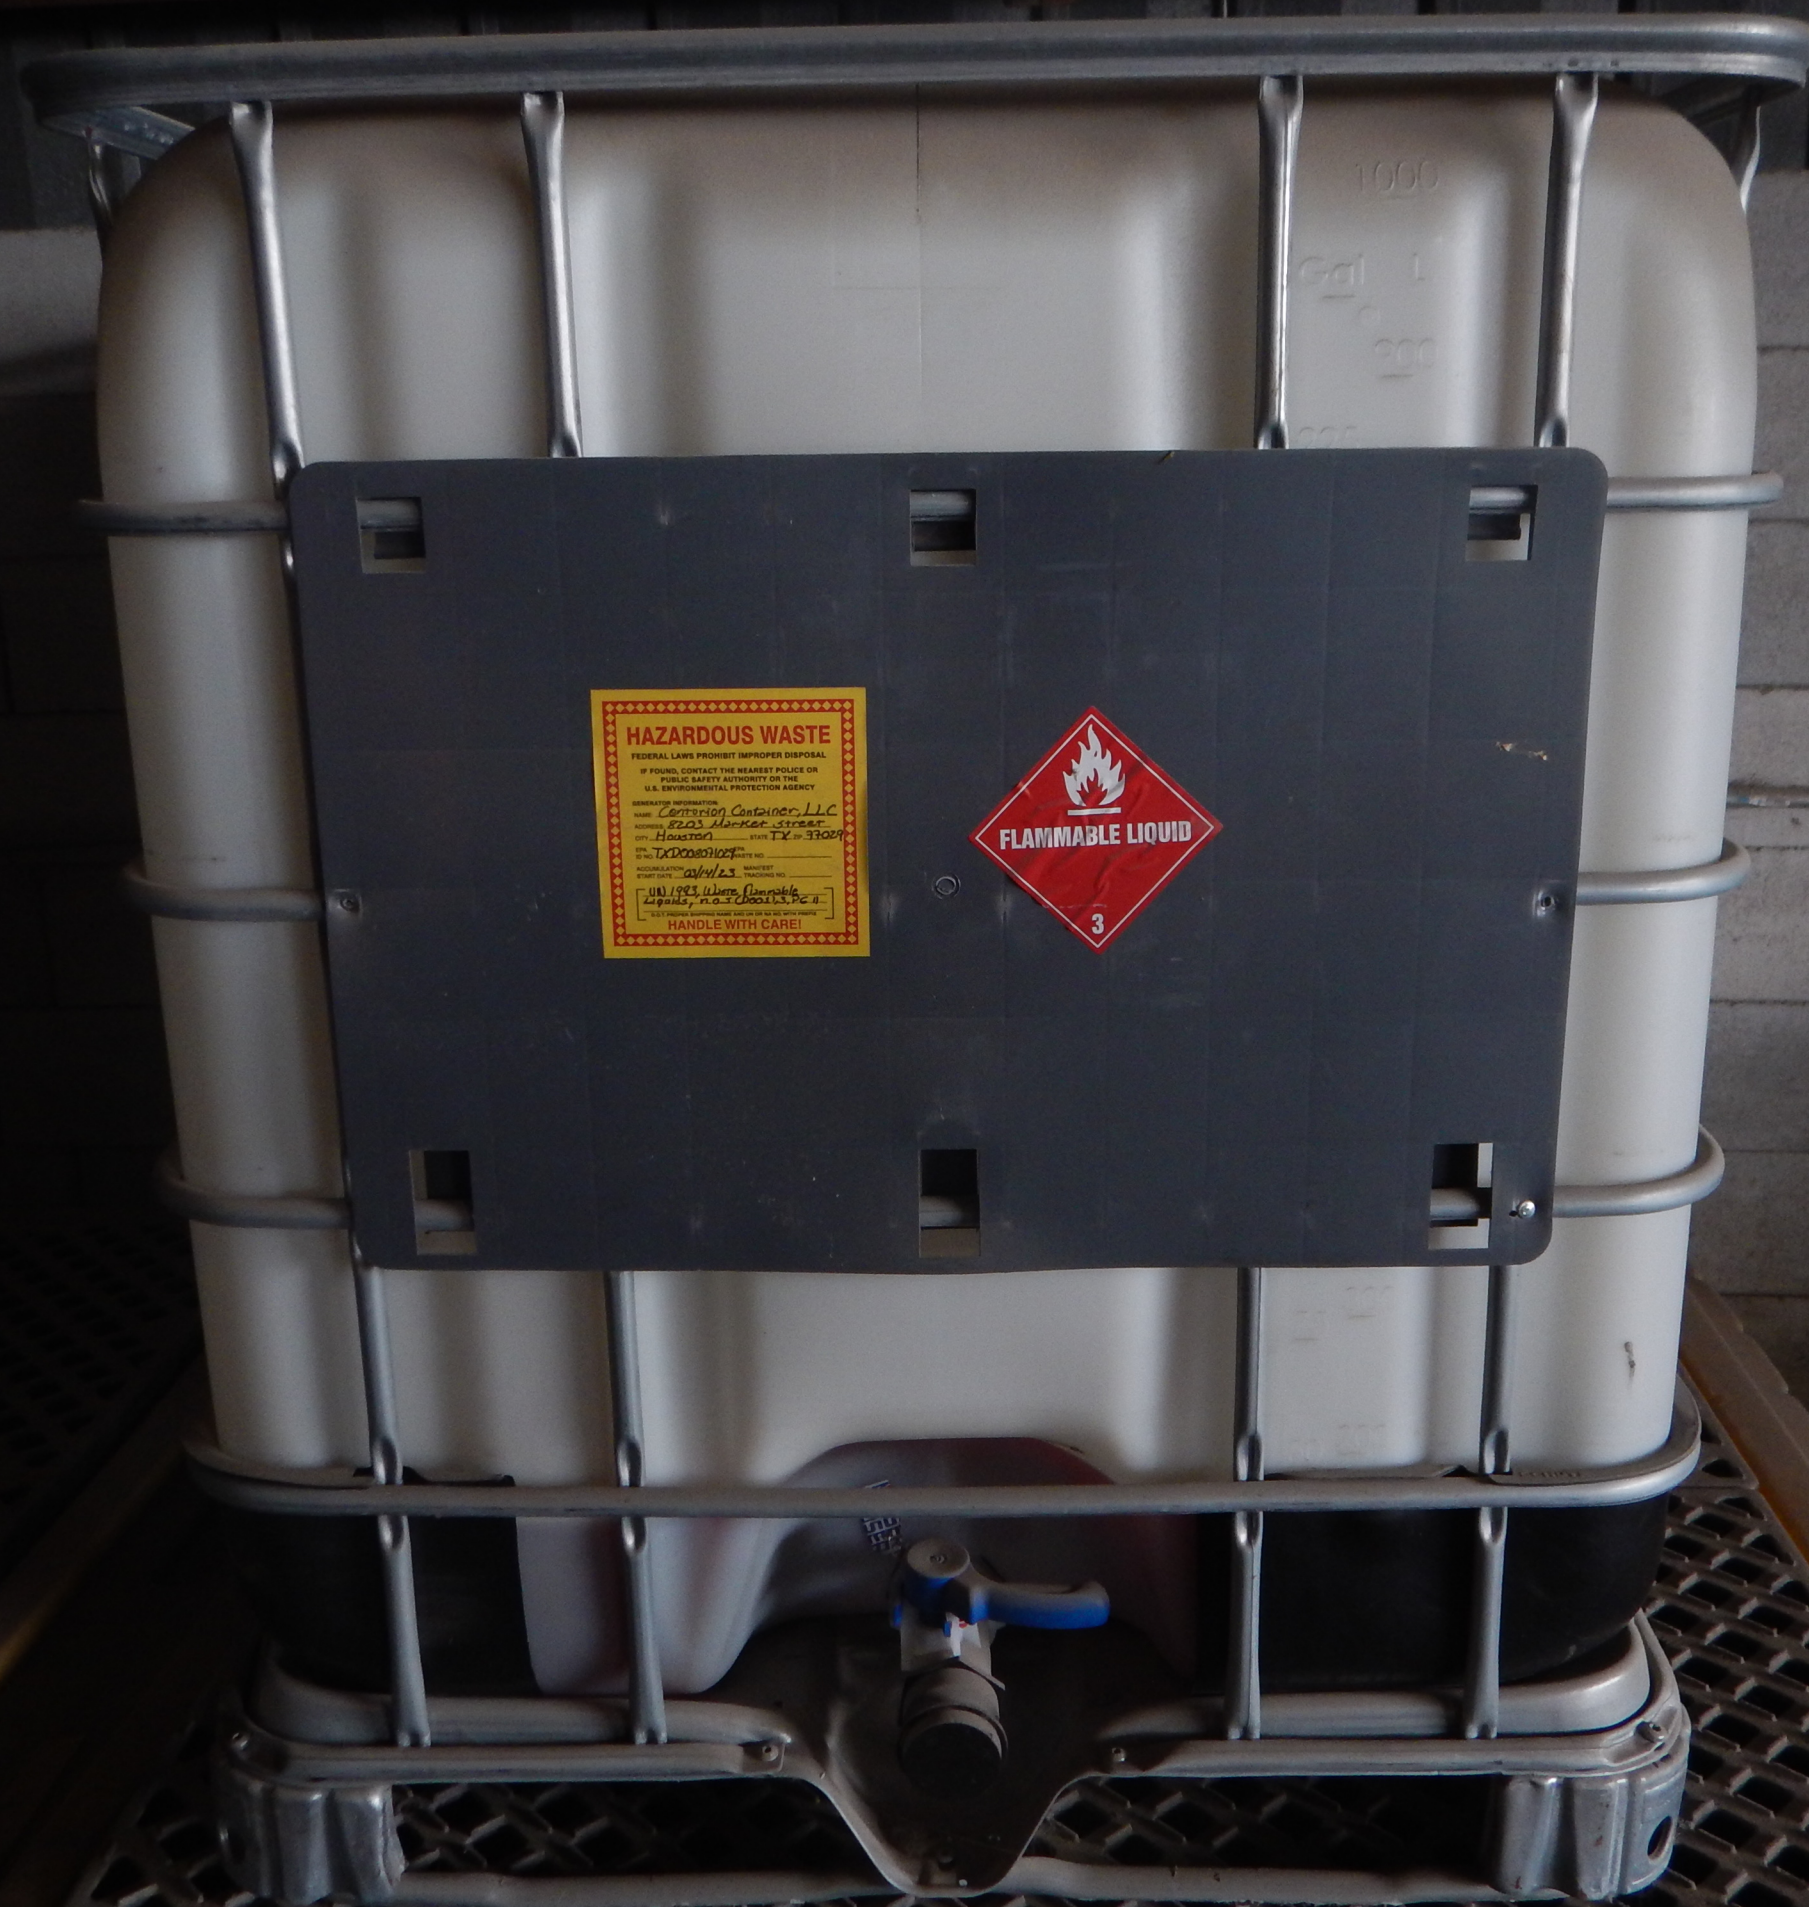
Photo 5

| Photo Number | File Name | | Date | Time | Photographer | Description |
|---|---|---|---|---|---|---|
| 5 | DSCN1131 | .JPG | 22-Aug-23 | 1040 | John Penland | Hazardous waste accumulation container (275-gallon IBC) located in the waste storage area. Used for the consolidation of flammable liquid waste from the container |
