**COMPLIANCE EVALUATION INSPECTION REPORT  
U.S. ENVIRONMENTAL PROTECTION AGENCY, REGION 5**

**Purpose:** NPDES Compliance Evaluation Inspection

Rantoul Foods, LLC  
205 East Turner Street  
Rantoul Illinois, 61866

**Date of Inspection:** July 3, 2023

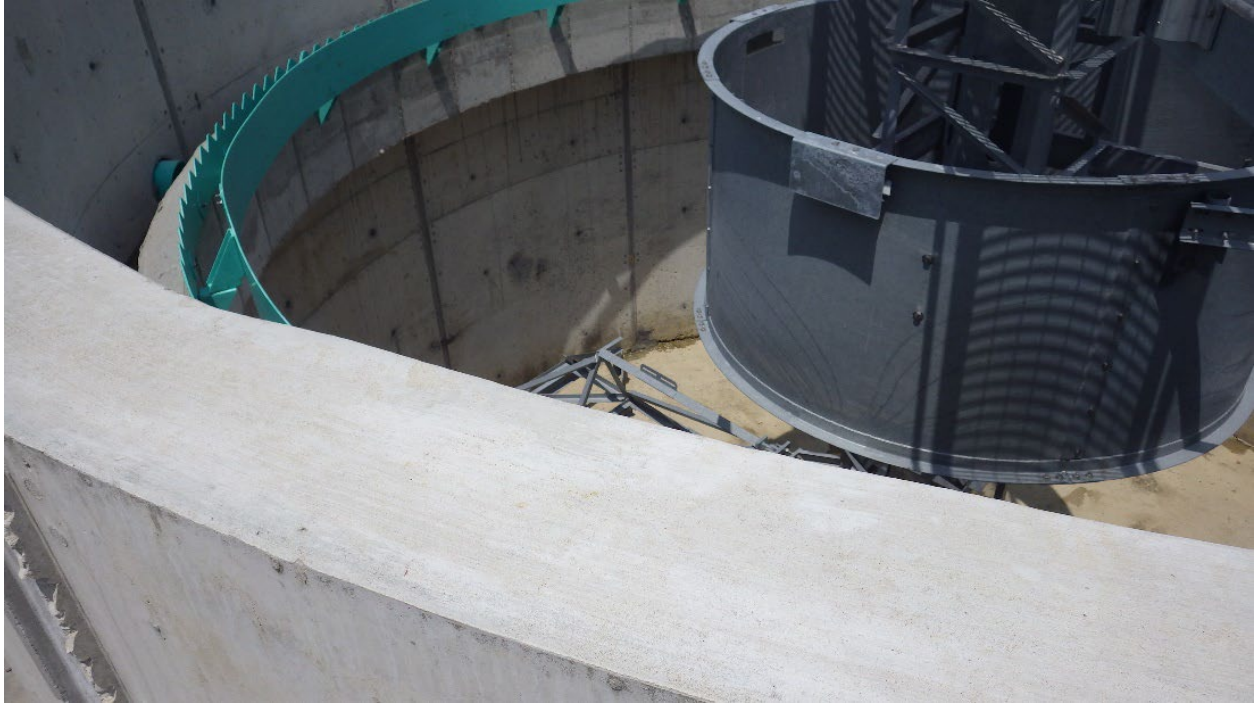
24. RIMG0024

I walked by two new empty 18-foot clarifiers (Photos 24 – 25). Mr. Ernst stated that stairs to the clarifier still had to be built. Sludge from the clarifiers will be pumped underground to the new pretreatment building. The existing sludge press will be moved to the new pretreatment building. A three-separation-chamber aeration basin was built and contained a small amount of water, pumped from the south stormwater pond, to protect the silicone diffusers from sunlight (Photos 26 – 27). The three basins can be run in series or separately. The aeration basin still needs sensors and a control box to be installed. The sensors can determine depth, but the valves are manually operated. So, operators can tell from the sensors which valves are open and which basins are operational based on depth. Mr. Ernst showed the Inspectors a winch for each basin that Rantoul Foods designed itself (Photo 28) and there is a valve that can isolate the lagoon if necessary.

Description: New clarifiers which have not yet been in use. The stairs to view the clarifier have not yet been installed.

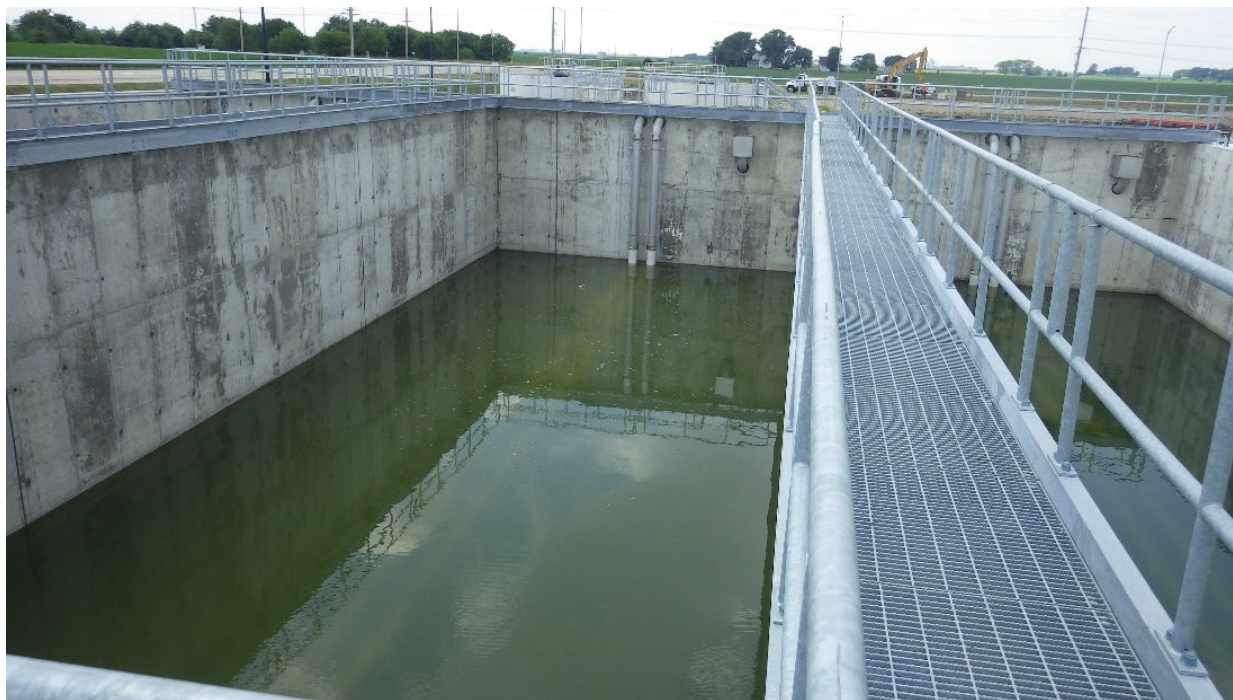
26. RIMG0026

Description: One of three aeration basins that are part of the new pretreatment system. The basin is not operational yet. A small volume of south stormwater pond water has been pumped into each aeration basin so the diffusers are not damaged by sunlight.

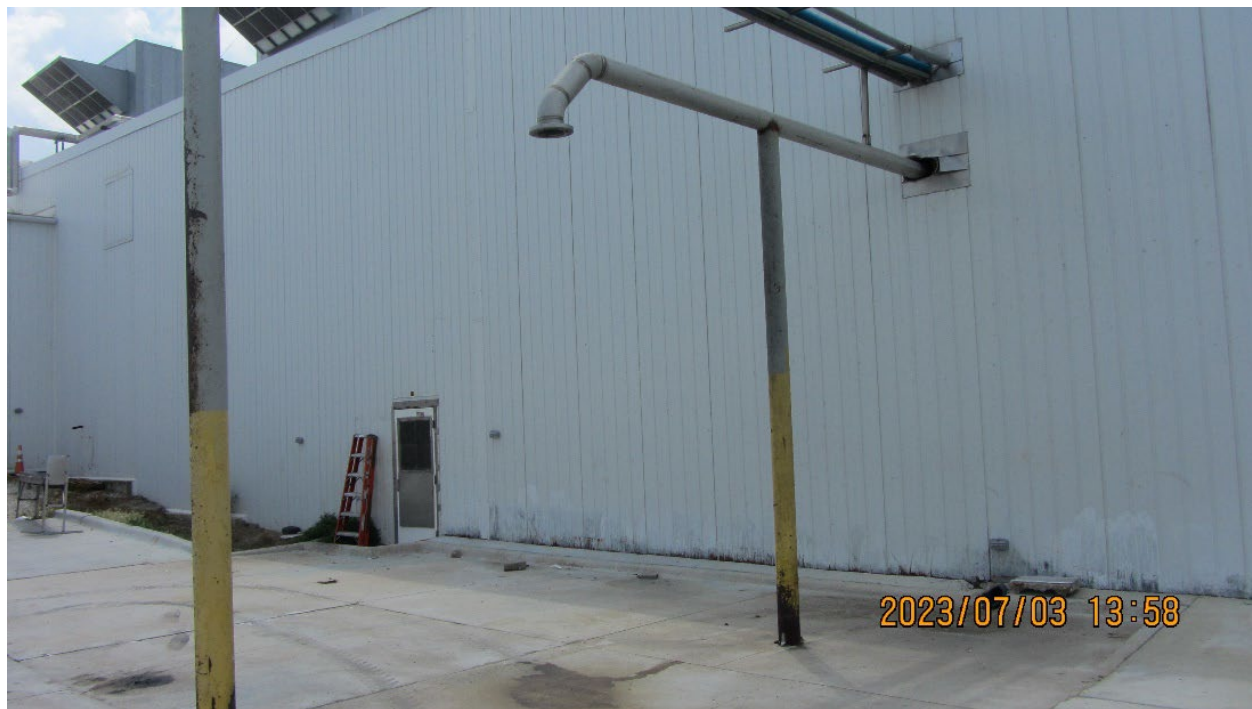
We then walked around the processing facility along the east then north towards the north stormwater pond. I noted that the stormwater inlet nearest the live animal unloading docks (Photo 36) appeared to be blocked and had foam and debris sitting on stagnant water (Photo 37). A stormwater drainage ditch ran along the north of the processing facility. EPA noted some trash and dried vegetative debris in the ditch area (Photos 38-40).

and hog hair were observed on the ground near the processing building. Trash and dried vegetation were observed in the stormwater channels leading to the north pond. Permit IL00 section F.2.iii states to clean up spills and leaks promptly and section F.2.c under Good Housekeeping and Pollution Prevention Practices requires the maintenance of clean, orderly facility areas that discharge stormwater. Section H.2.a lists cleaning up any contaminated surfaces so the material will not discharge in subsequent storm events.

Description: Open channel upstream of the inlet from Photo 39. Inspectors noted some floatables near the middle of the channel.

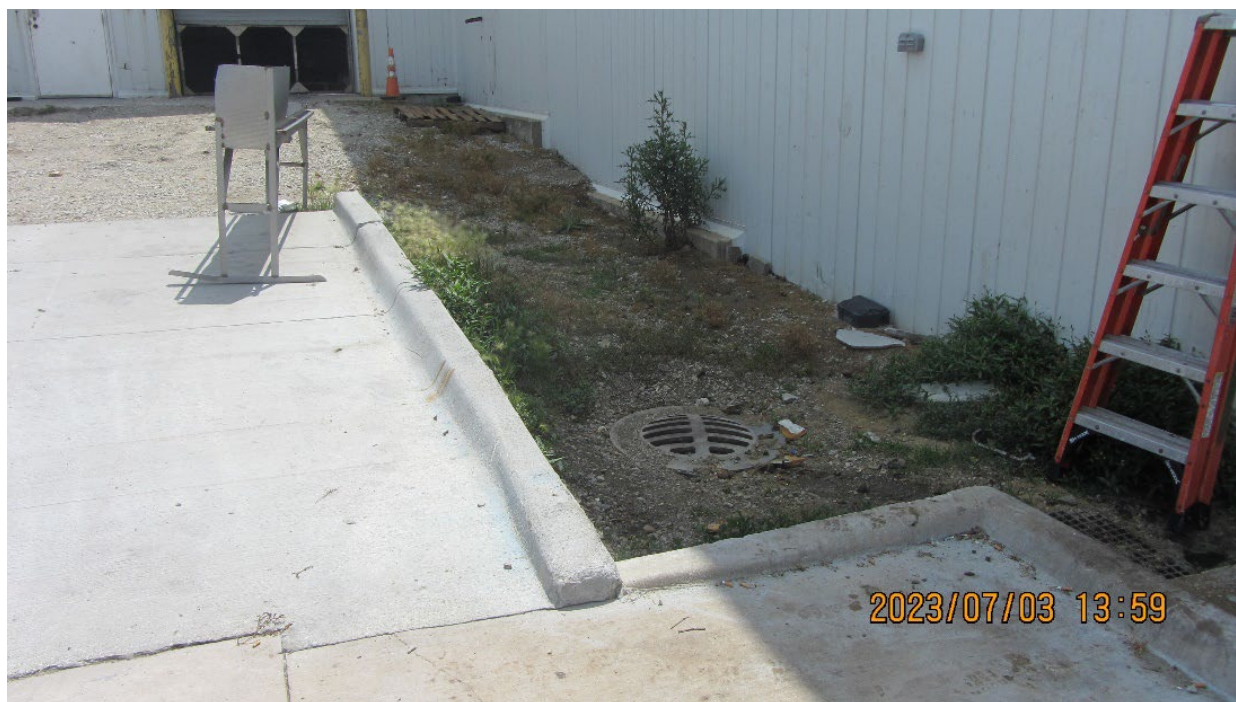
I noted that the hair and blood storage area on the north side of the processing facility appeared different than it was during the previous 2020 EPA Inspection (Photo 41). The loading area is paved and the storm drain is separated by a small berm at the edge of the pavement (Photo 43). Mr. Ernst stated that hair is mainly discarded through a hydrolysis process, which occurs indoors. On occasion hog hair could be removed from the facility via truck and the stormwater drain at this location is blocked to prevent any process wastewater, which would drip off the truck, from entering the stormwater system. I noted mats of hog hair on the ground outside of the paved area and some trash and hog hair at the blocked stormwater drain (Photos 42, 44).

5. Dried sludge from process wastewater was observed on the ground near the pretreatment facility and south stormwater pond. The secondary containment surrounding the Biotank had not been pumped down or cleaned out. Trash and process wastes such as blood spills

Description: Inspectors noted dried mats of hog hair on gravel near the concrete hair loading area.

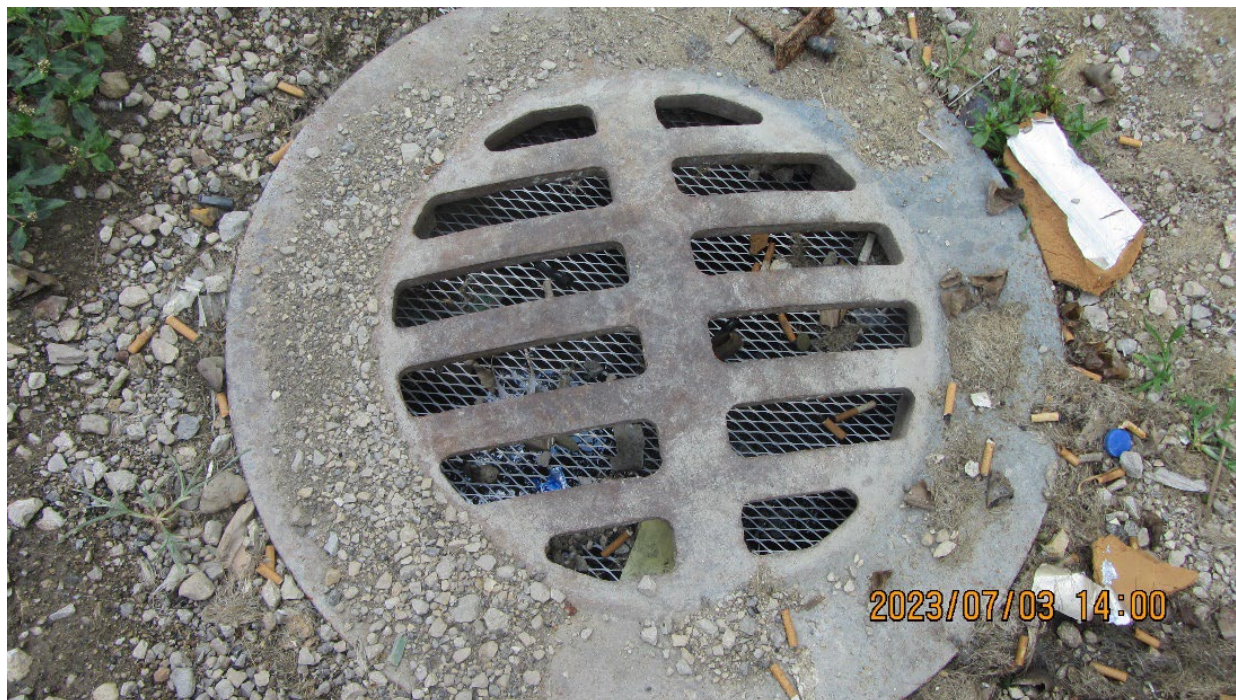
43. IMG\_0754

Description: Stormsewer inlet in hog hair production area from Photo 41. Mr. Ernst stated that this stormwater drain is blocked to prevent production wastewater entering the stormwater inlet. Note small concrete berm surrounding the inlet.

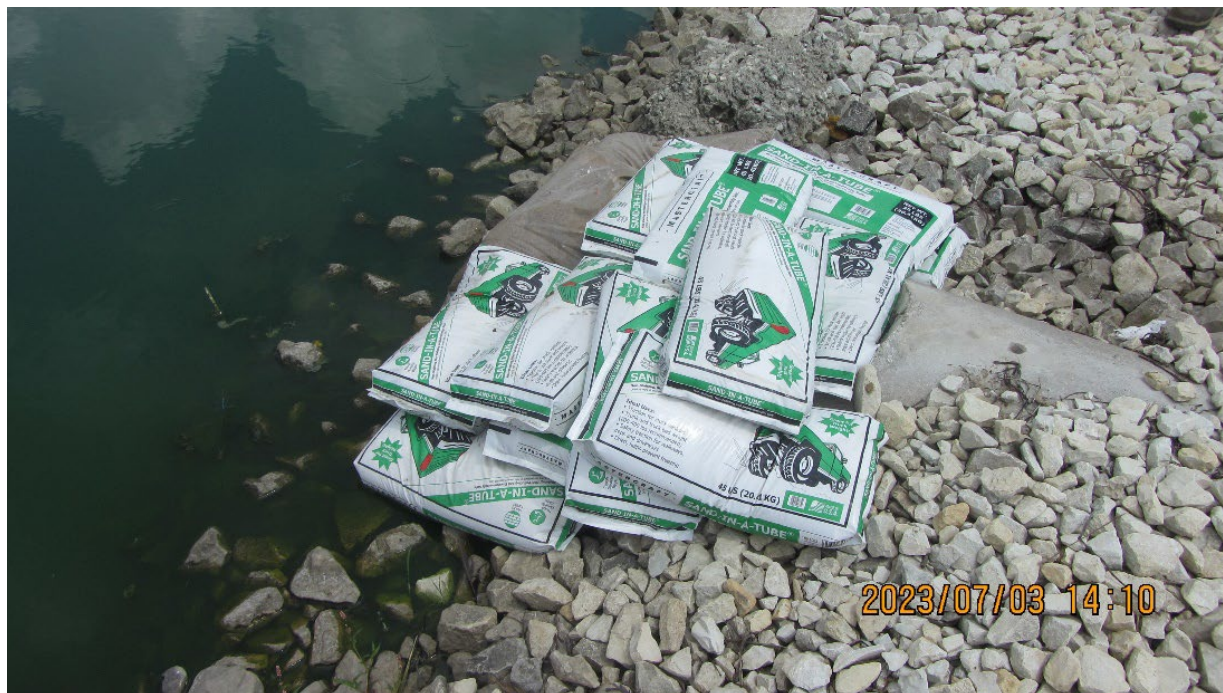
At the north pond, I noted that the water had an odor and had a turbid blue color (Photos 46-51). There was a floating mass of vegetation on the southeast corner of the pond and small dead fish floated on the surface. Mr. Ernst stated that the pond had an algae problem since springtime of this year, and he had blocked off the outfall with a metal plate and sandbags so the pond could not discharge (Photos 47 - 48). The quarterly inspection reports from first quarter visual

Description: North stormwater pond. Inspectors noted the pond water had an odor and appeared unnaturally turbid blue, as if blue-green algae was present.

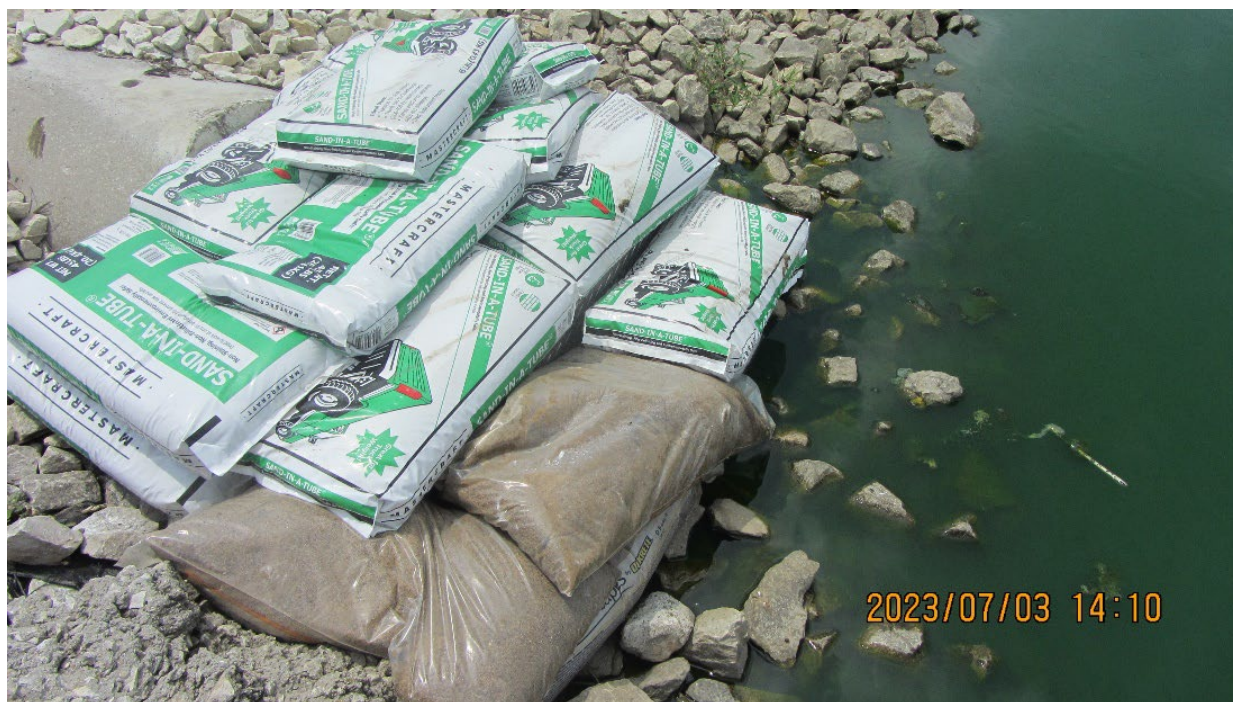
47. IMG\_0758

examination of stormwater quality indicate that on 3/23/23 the pond had green coloring with floating algae and the plate with sandbags was placed at that time. Second quarter inspections dated 6/22/23 noted similar issues.

Description: north stormwater outlet. Blocked by plate, held up by sandbags.

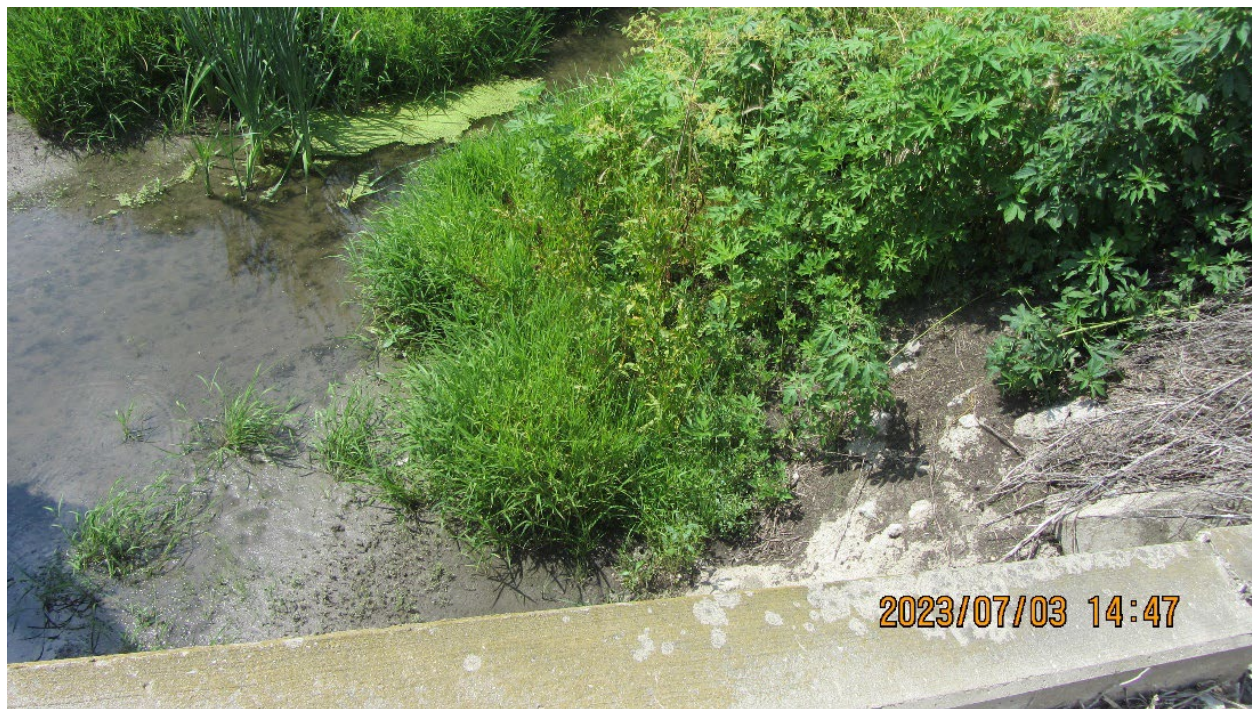
52. IMG\_0763

Description: Headwall for pipe located on the east bank of Big Ditch on the North of US 136. Inspectors did not see any discharge at the time of the inspection.

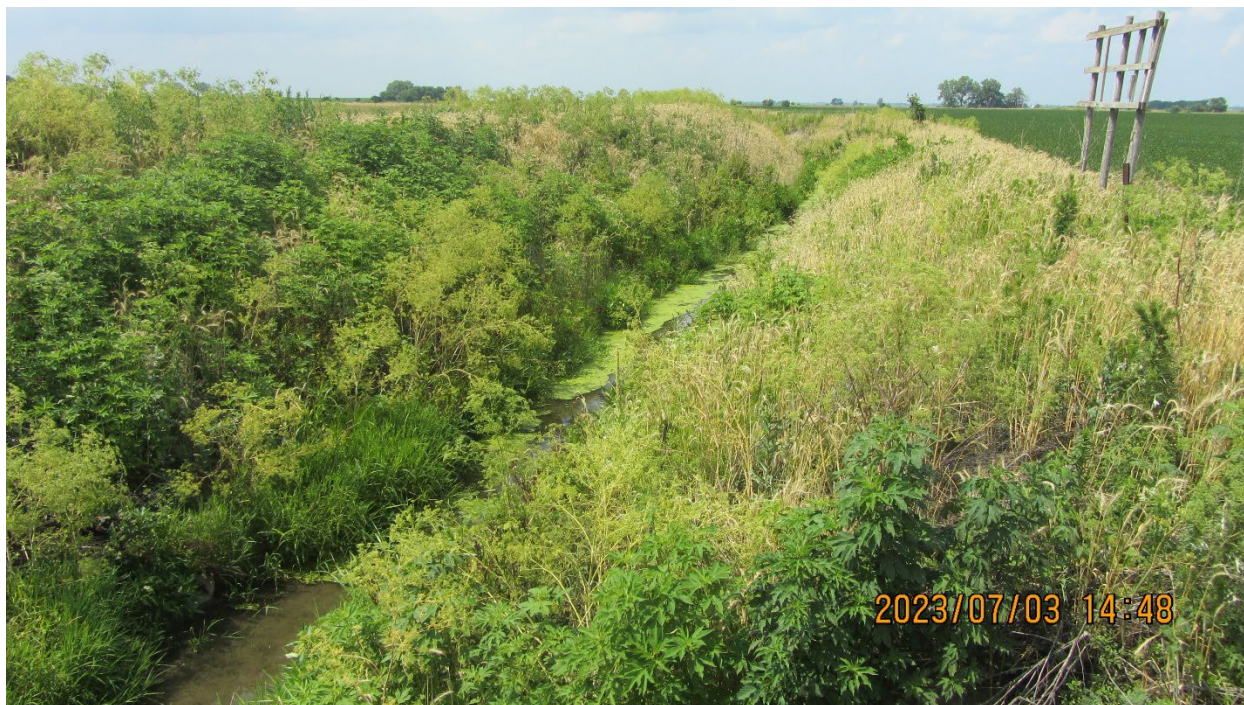
53. IMG\_0764

Description: Same location as Photo 52 but with a downwards view into the receiving waters of Big Ditch.  
Pipe is hidden from view by the cement.

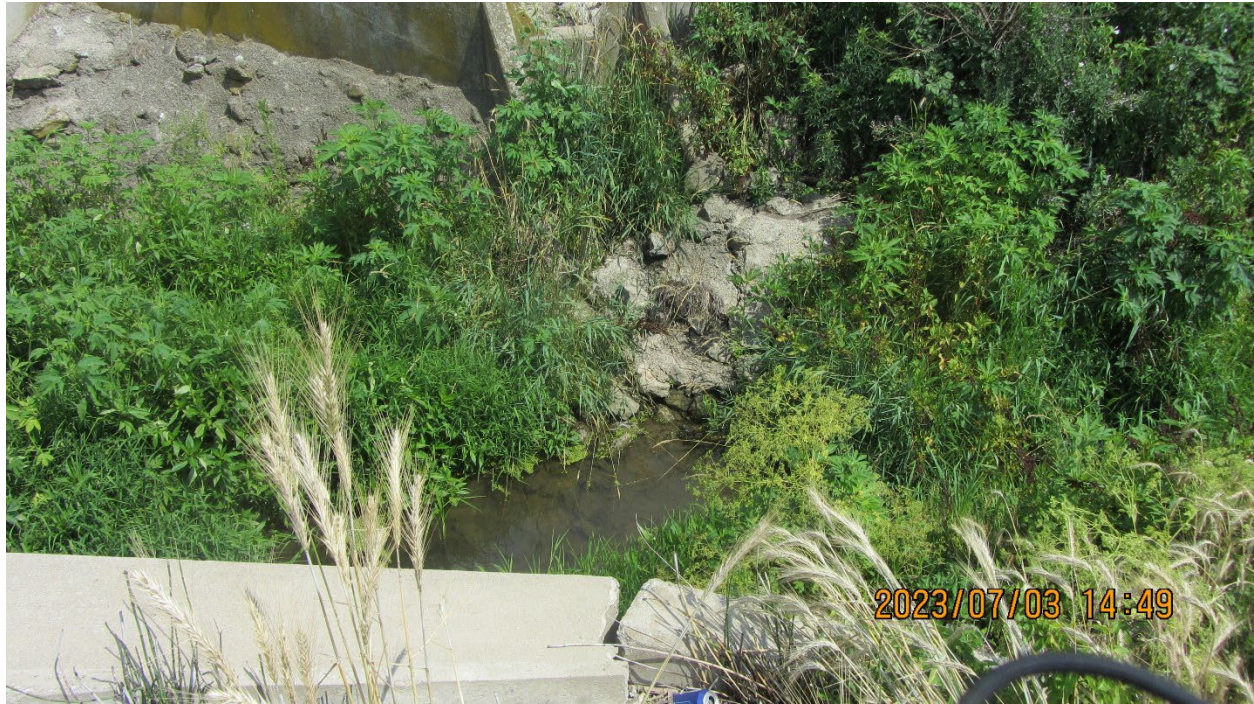
54. IMG\_0765

Description: View of Big Ditch to the north, downstream of outlet from Photos 52-53. Photo taken on the north side of US 136 and from the east of Big Ditch.

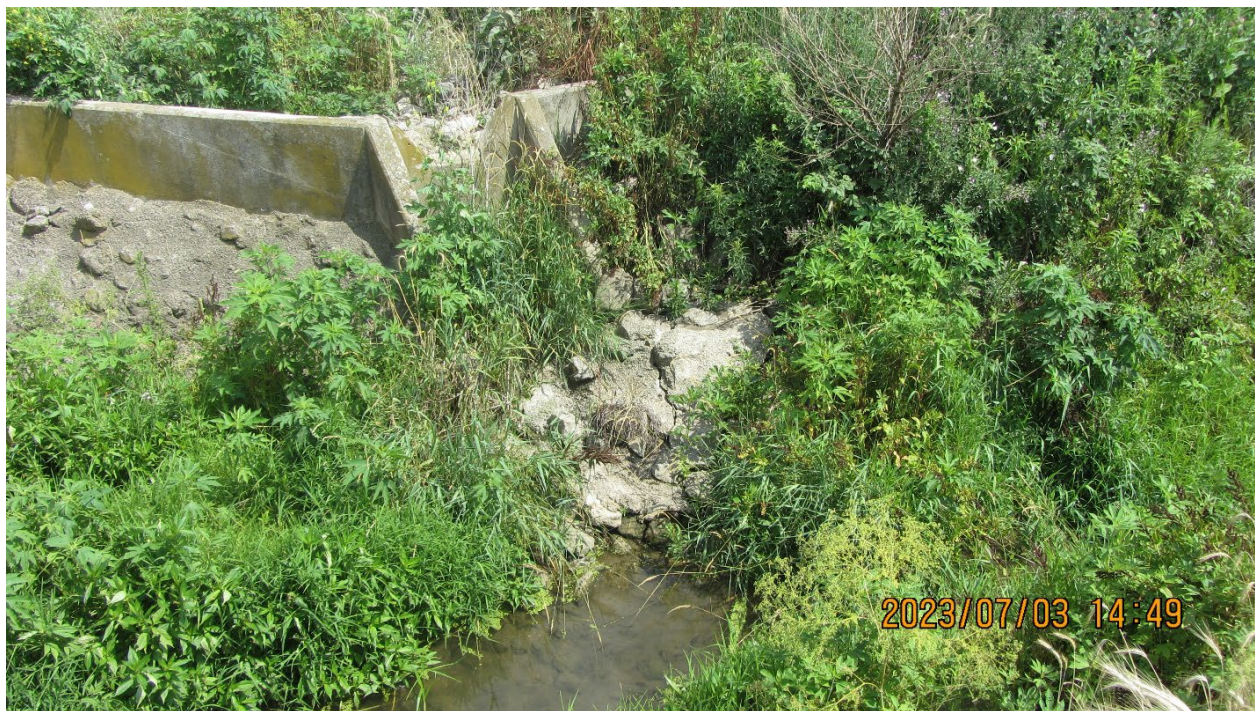
55. IMG\_0766

Description: West side of Big Ditch on showing headwall from south sewer.

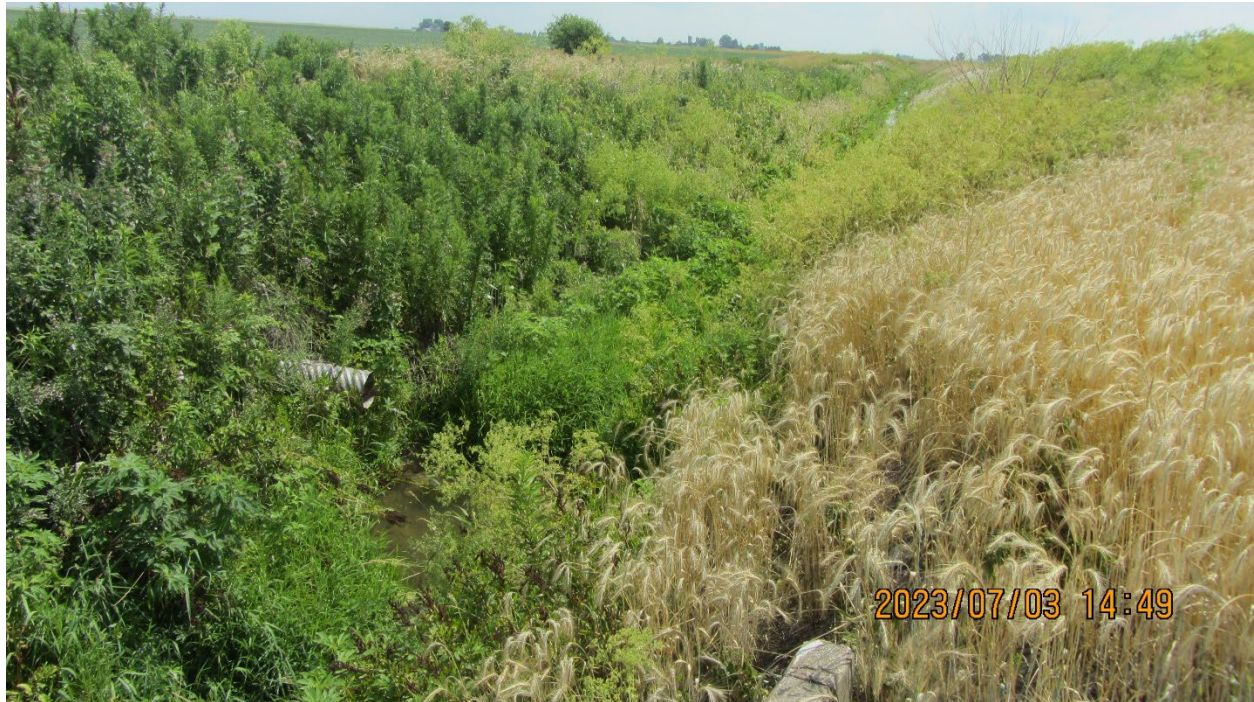
56. IMG\_0767

Description: West side of big ditch showing headwall from south sewer (Same as photo 55).

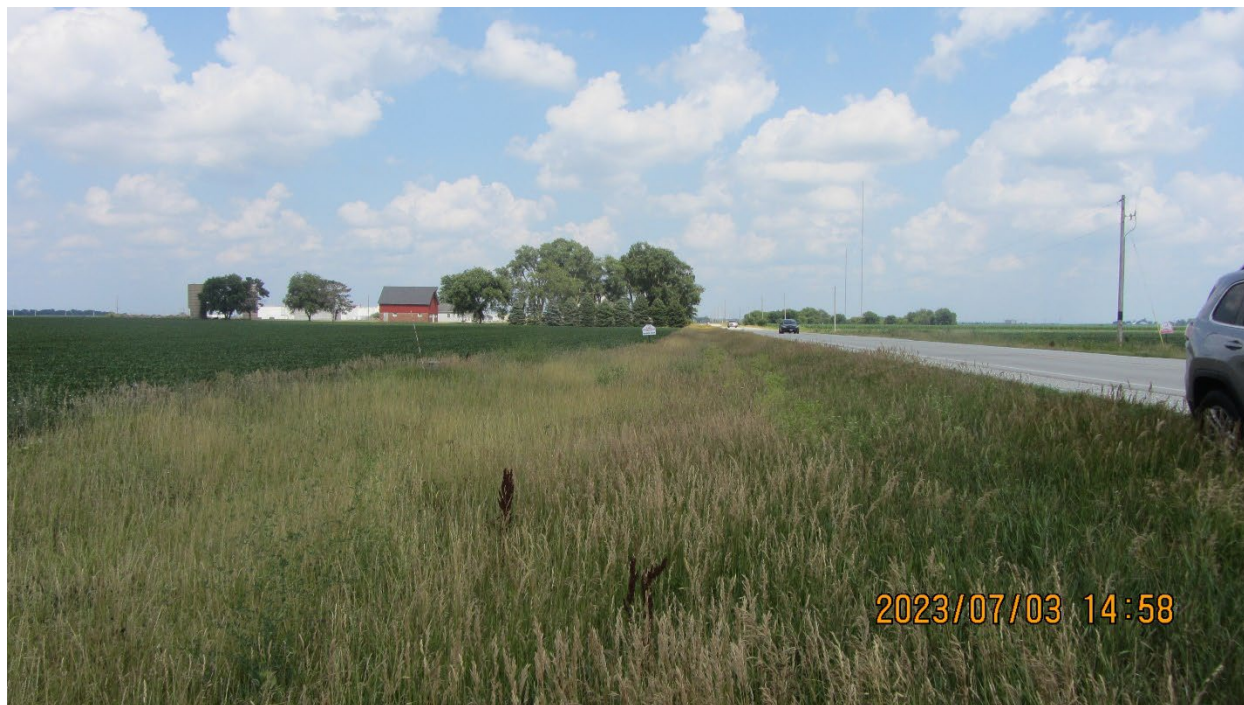
62. IMG\_0774

Description: Same as Photo 63. View facing eastward along the north of US 136 showing an aboveground open channel between stormwater excess flow outlet and Big Ditch.

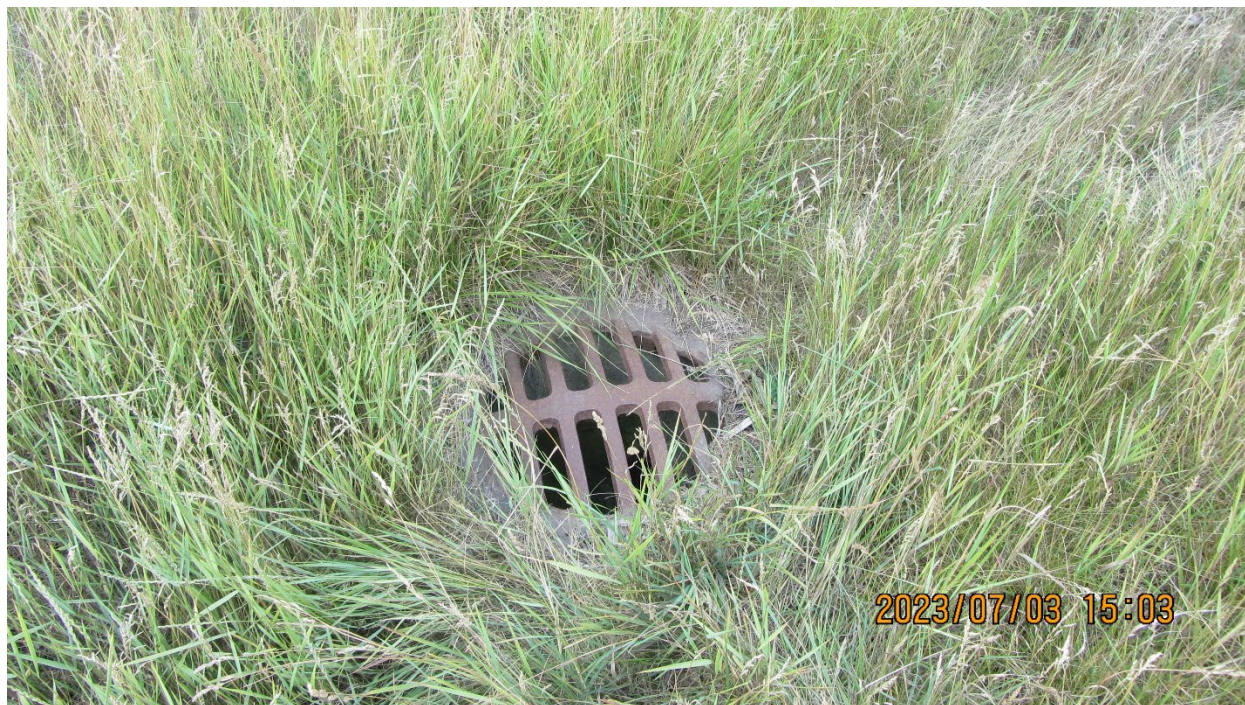
64. IMG\_0776

Description: Same location as Photo 65 Roadside stormwater drainage overflow point. Excess flow in the roadside stormwater drainage system would be able to flow onto the grassy ditch through this inlet. Pipe is approximately 12 - 18 inches below the inlet grate.
