STUDY & REPORT  
ON  
**TETE BAYOU WWTP  
EQUALIZATION BASIN  
LEVEE FAILURES**

Prepared For  
**The City of New Iberia  
&  
Iberia Parish Sewerage District No. 1**

December, 2017

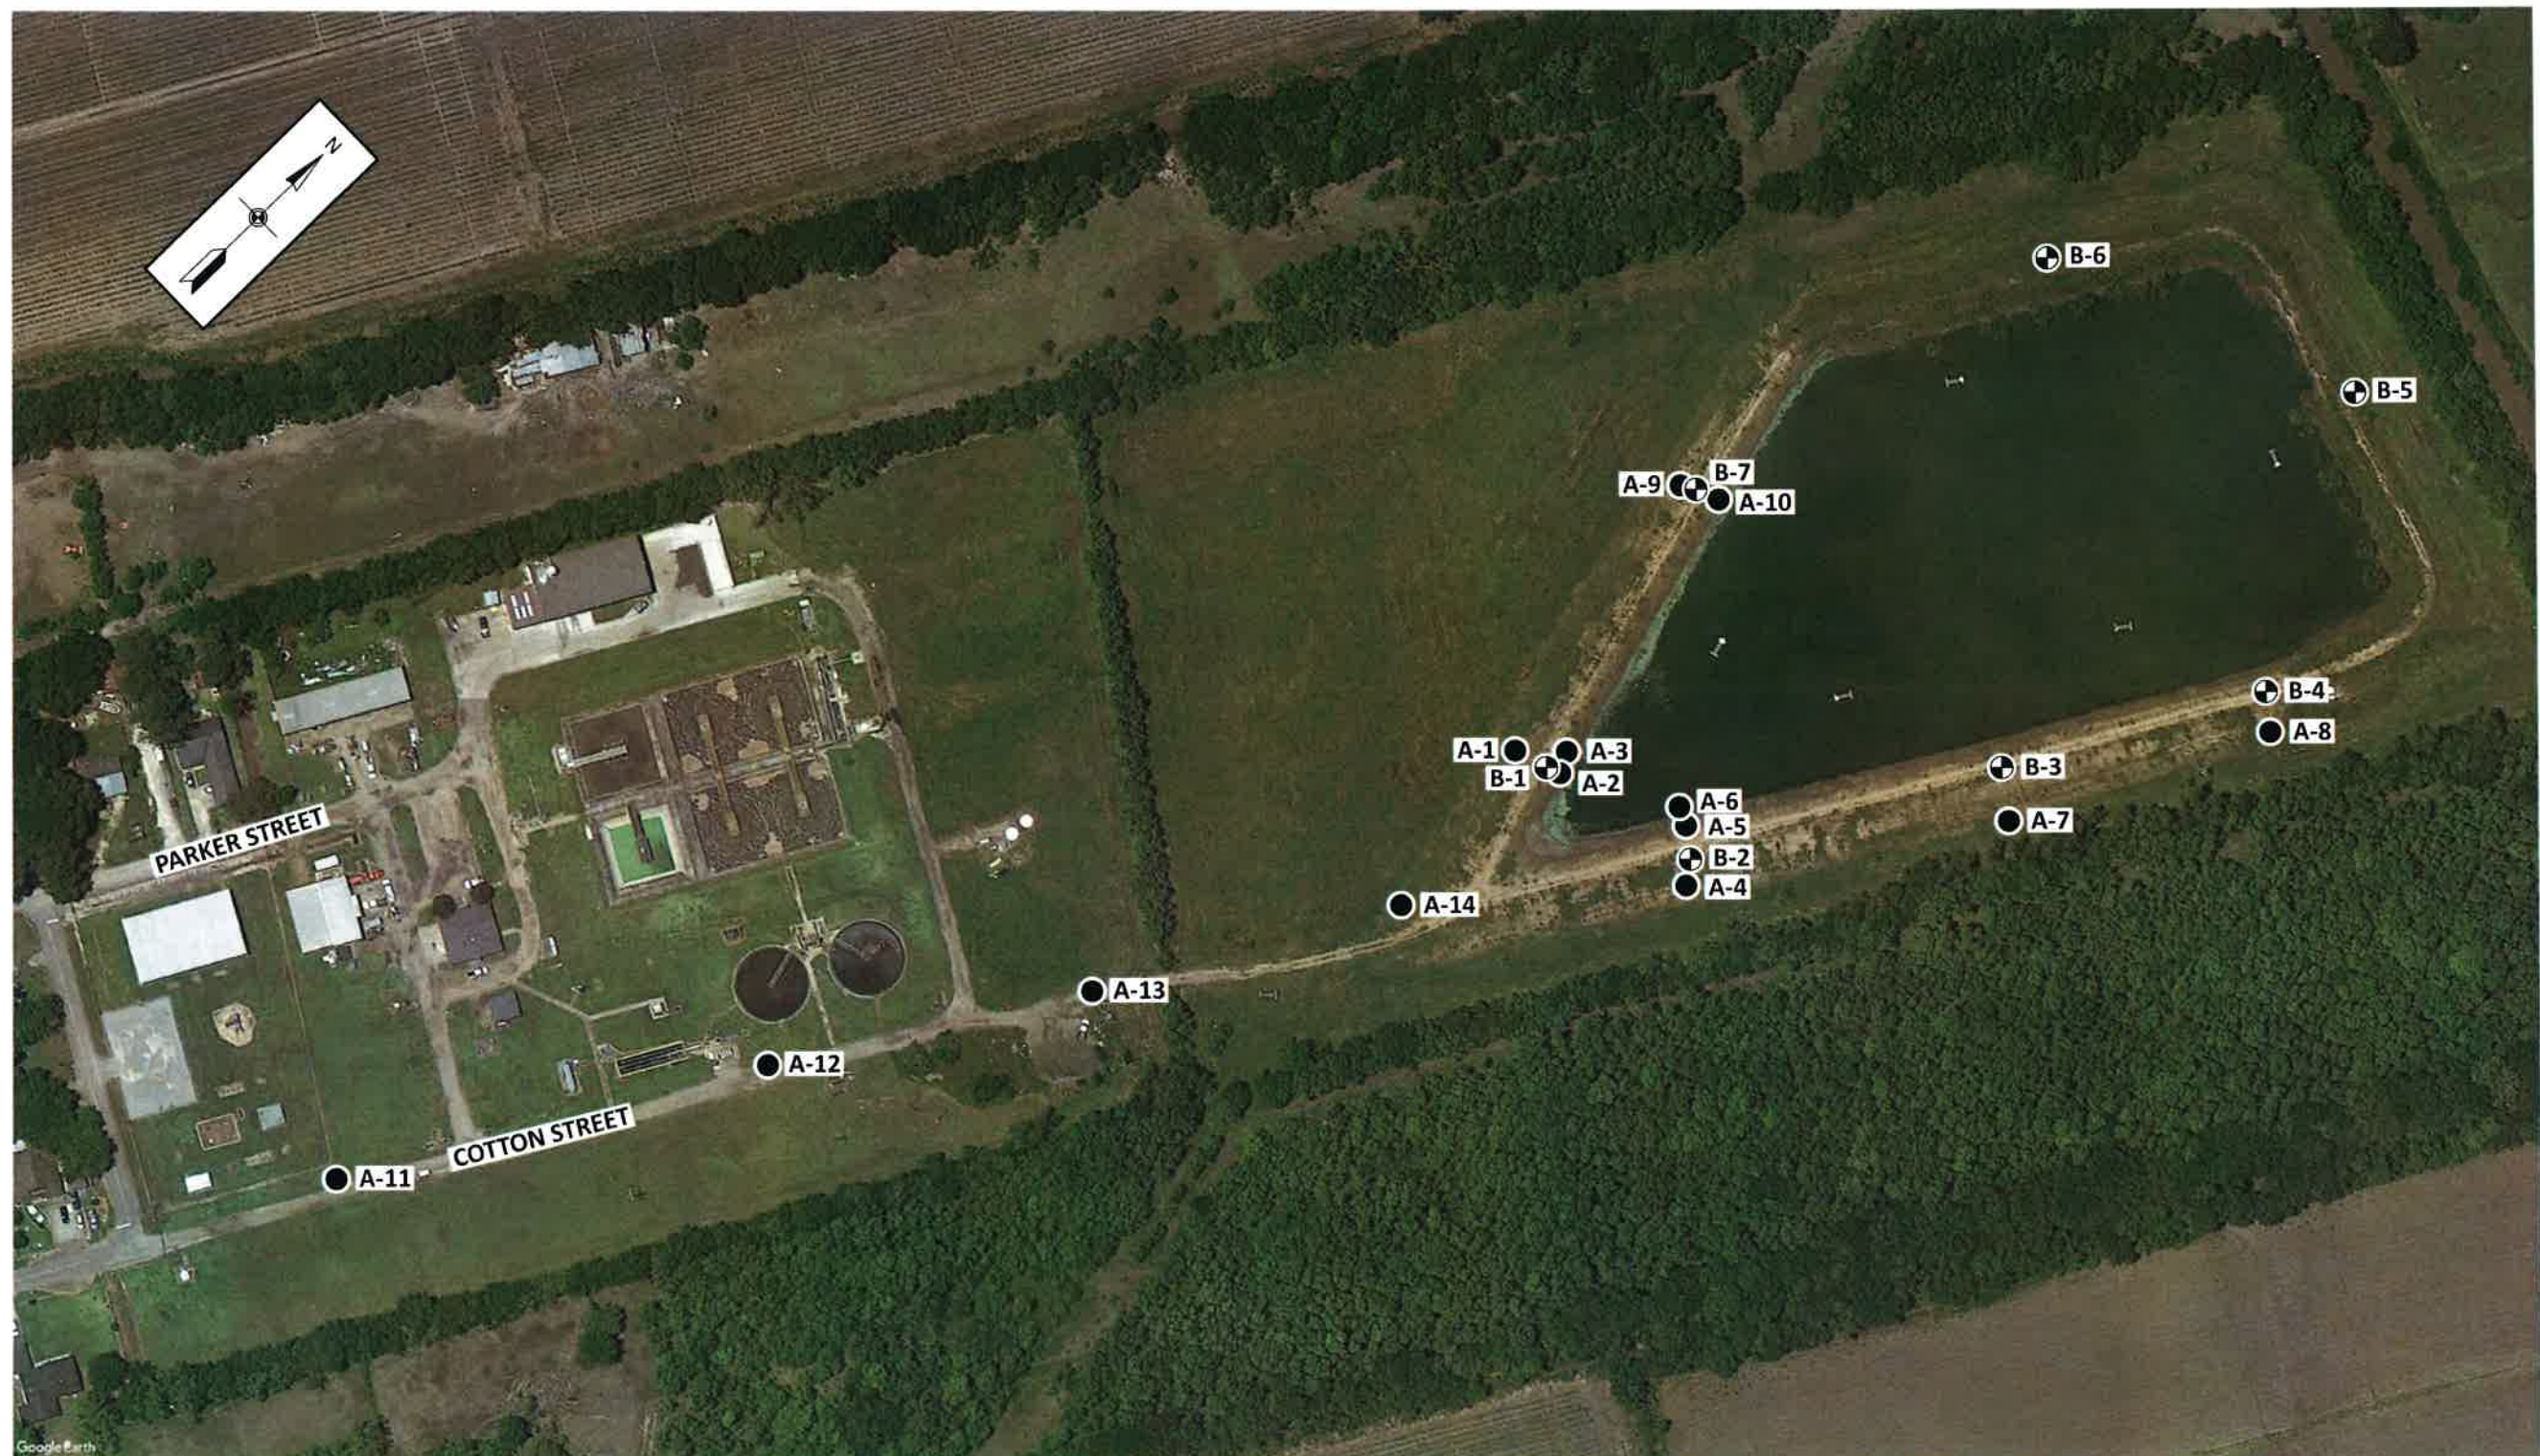
| CADD FILE:<br>LOCATION PLAN.DGN | FIGURE 1 |

3. Seven undisturbed soil test borings and 14 auger borings were taken at the project site between 12 and 20 December 2016. The undisturbed borings, designated as Borings B-1 through B-7, were made through the existing equalization pond levee crown to depths of 50 feet. Within the levee side slopes, ten auger borings, designated as Borings A-1 through A-10, were drilled to depths of 10 feet below the existing ground surface. Along the access driveway, four shallow auger borings were drilled to 8-ft depths for evaluation of the proposed pavements. The approximate locations of the borings are shown on Figure 1.

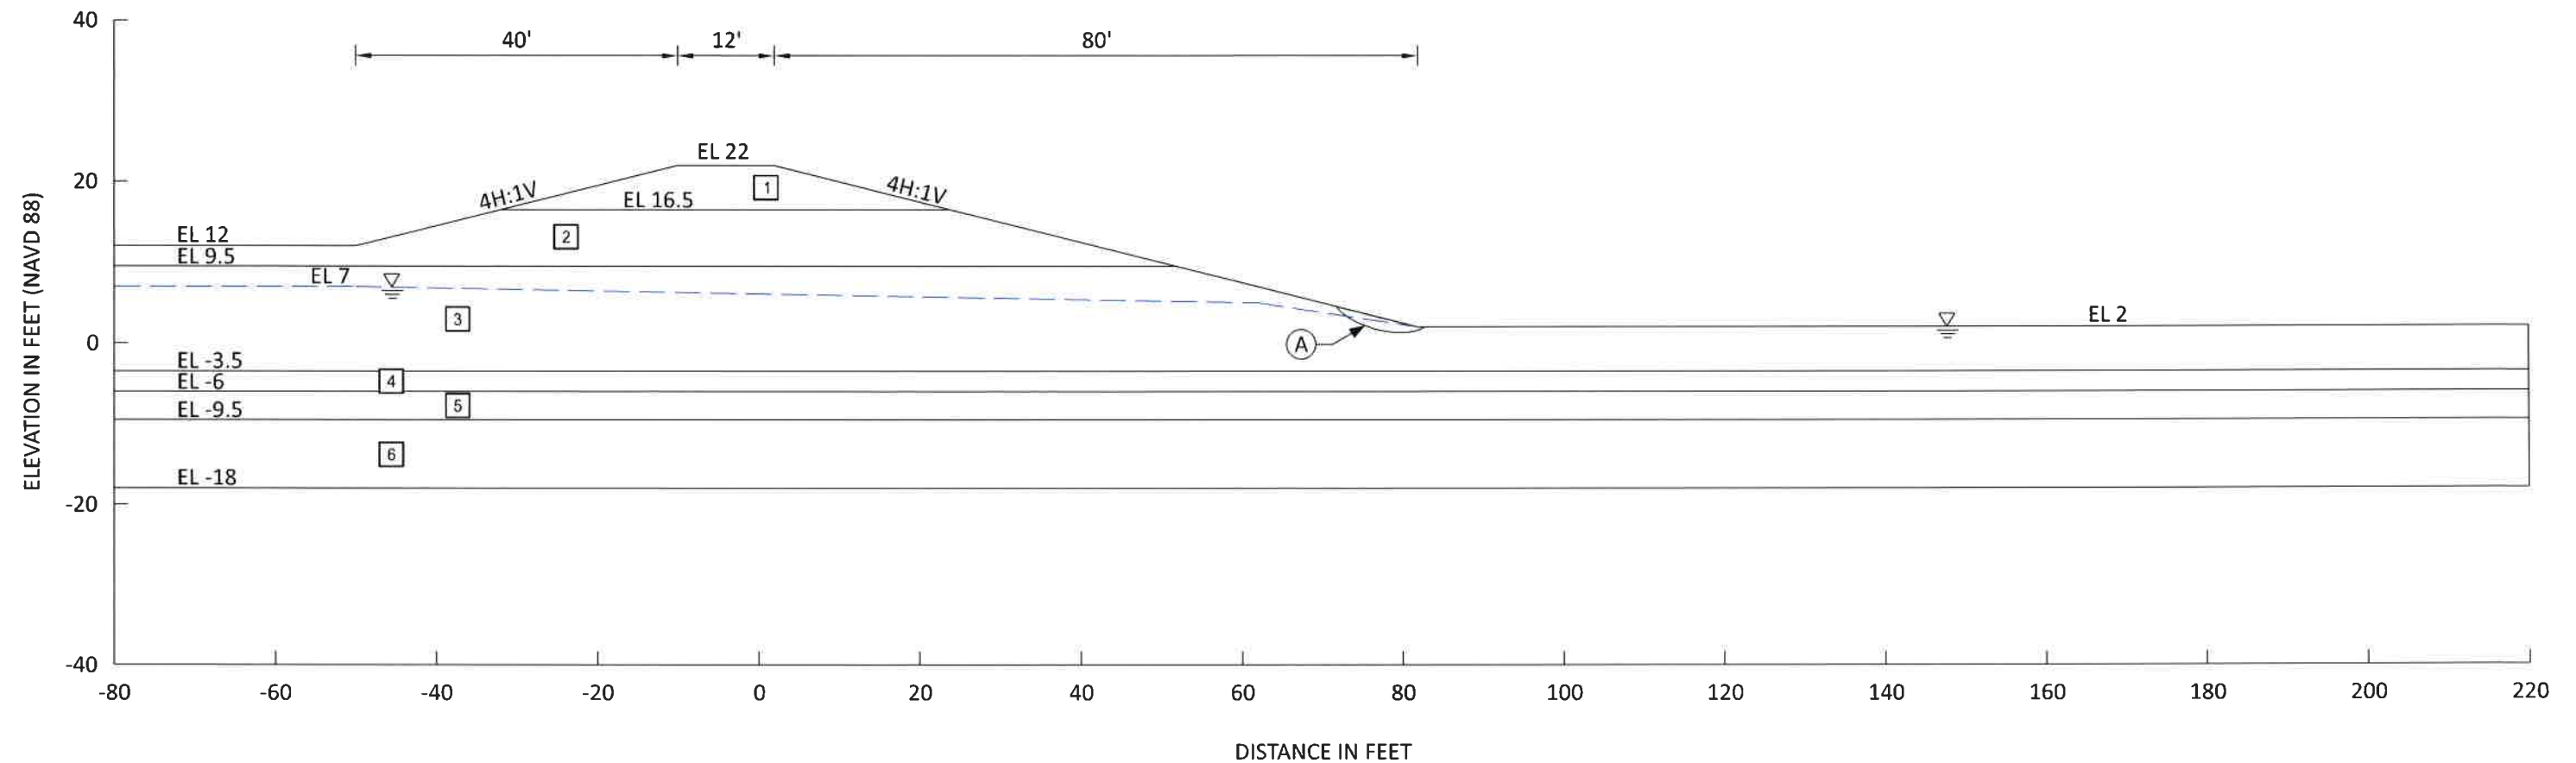
| CADD FILE: S-CASE_TOE.DGN | FIGURE 2 |

18. Figure 2 is for the initial toe failure. Figure 3 is for the larger failure that almost reaches the crown with a factor of safety of 1 (failure) and that has the shape closest to our visual observations.

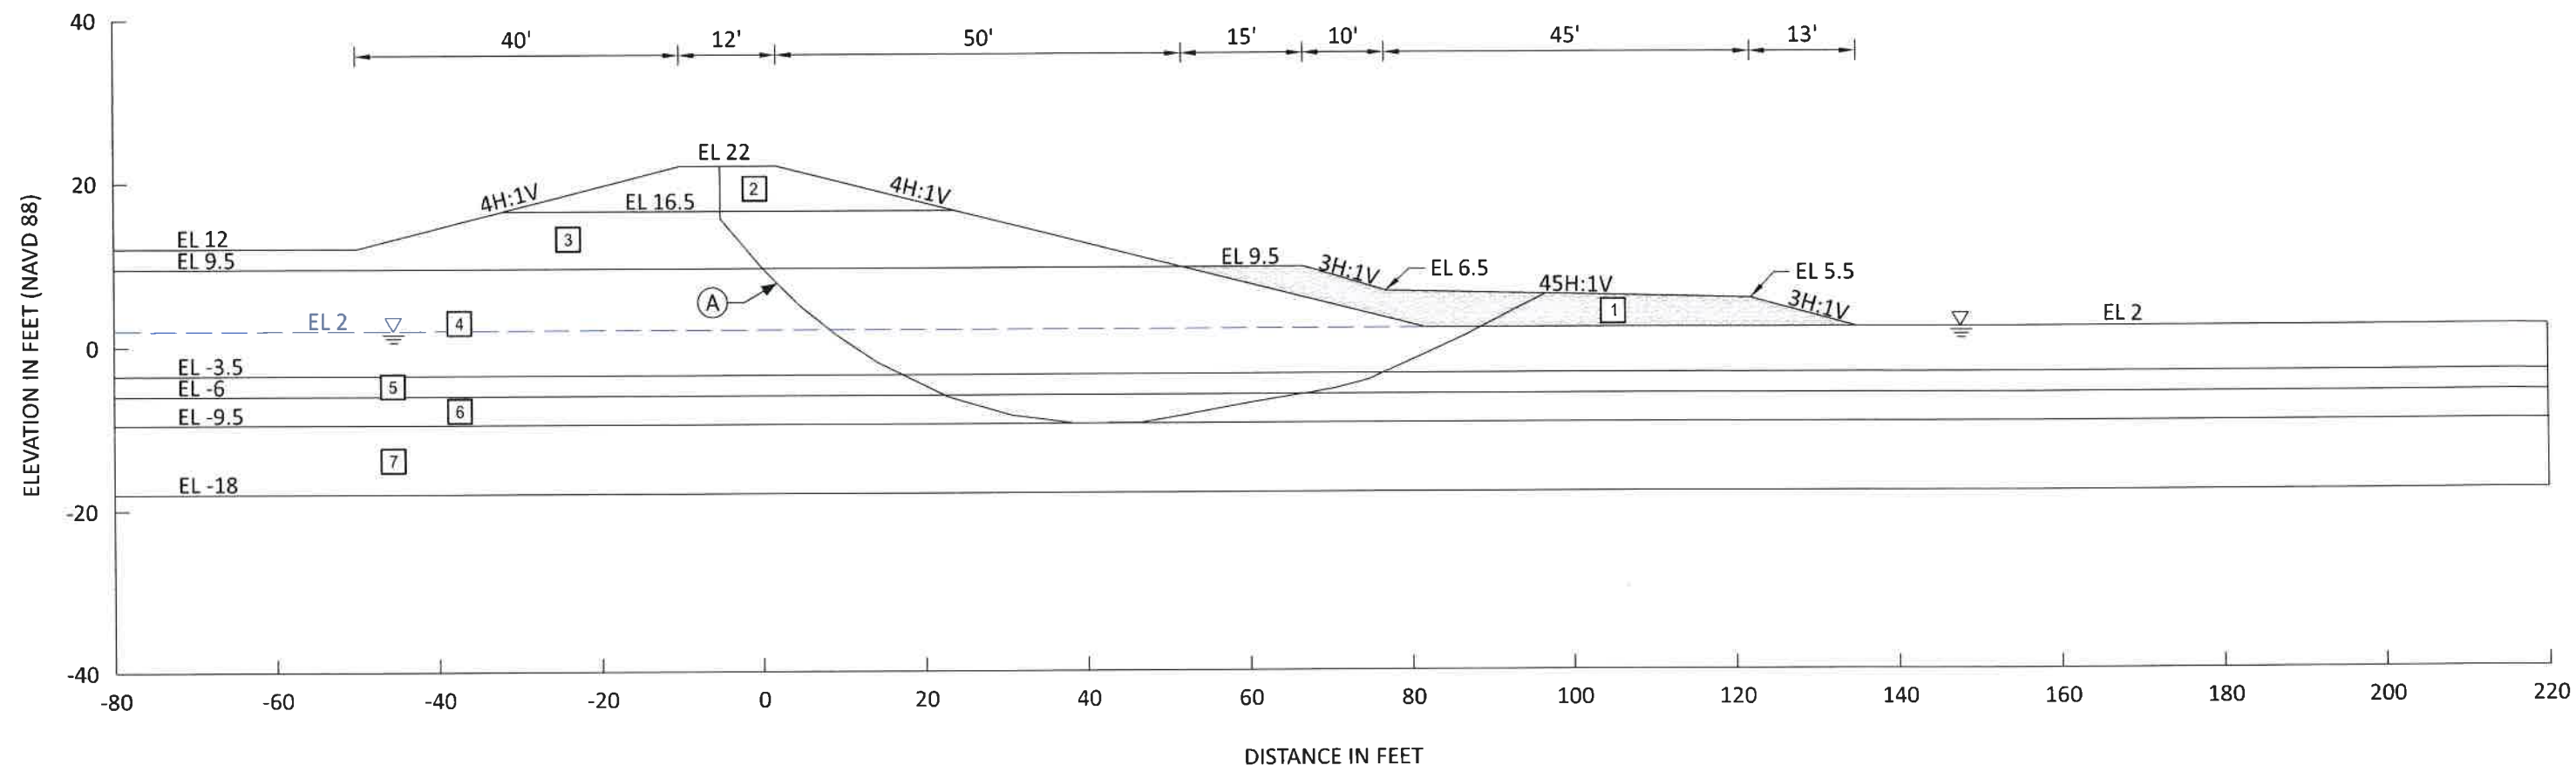
SLOPE STABILITY ANALYSES  
SPENCER'S METHOD, S-CASE  
DESIGN CONDITION WITH LIMESTONE BERM

Crushed Stone Stability Berms. In our referenced report, Eustis Engineering recommended a stability berm be constructed. This was illustrated on Figure 4 of our referenced report and assumed clay would be used as structural fill. Considering the use of crushed stone for constructing the berm, our analyses indicated an acceptable factor of safety would be provided. Our analyses assumed a minimum wet density of 135 pcf is provided by the crushed stone. The results of these analyses are shown on the Enclosure. Based on the current and previous analyses, a composite berm consisting of crushed stone at the bottom and clay on the top will also provide an acceptable factor of safety. Should a clay cover be desired for vegetation growth or maintenance, we recommend a minimum clay cover of 2 feet meeting the material requirements given in our referenced report. Material separation should be provided between the clay and crushed stone. We have assumed an over excavation of 2 feet for removal of soft muck.
