**CWA COMPLIANCE EVALUATION INSPECTION REPORT  
U.S. ENVIRONMENTAL PROTECTION AGENCY, REGION 5**

**Purpose:** Compliance Evaluation Inspection

**Facility:** Benton Dairy, LLC  
8444 South 900 West  
Ambia, Indiana 47917-003

**Date of Inspection:** April 28 and 29, 2021

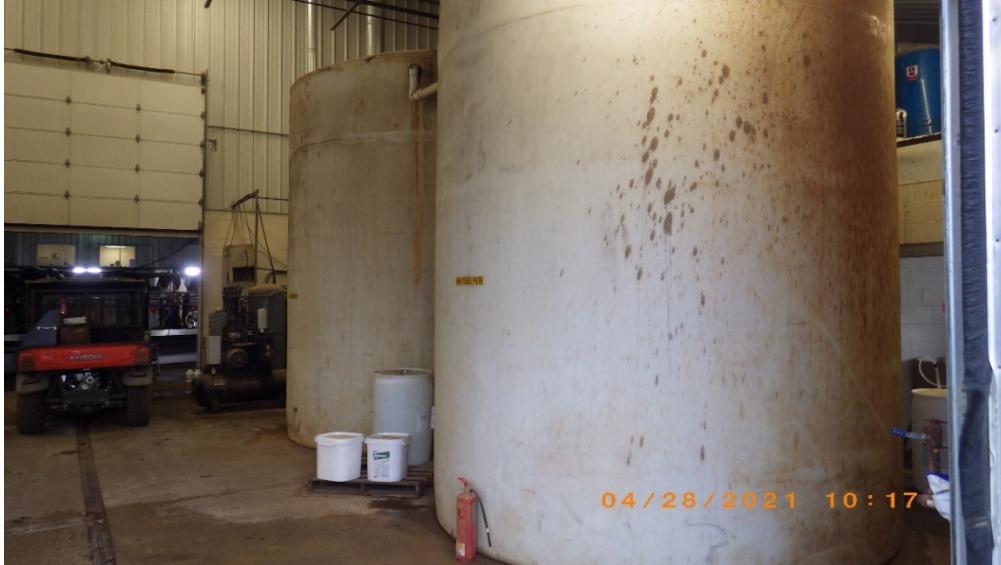
Photo Number: RIMG0068

Description: The noncontact cooling water tanks used to clean the Milking Parlor and provide water to the cows.

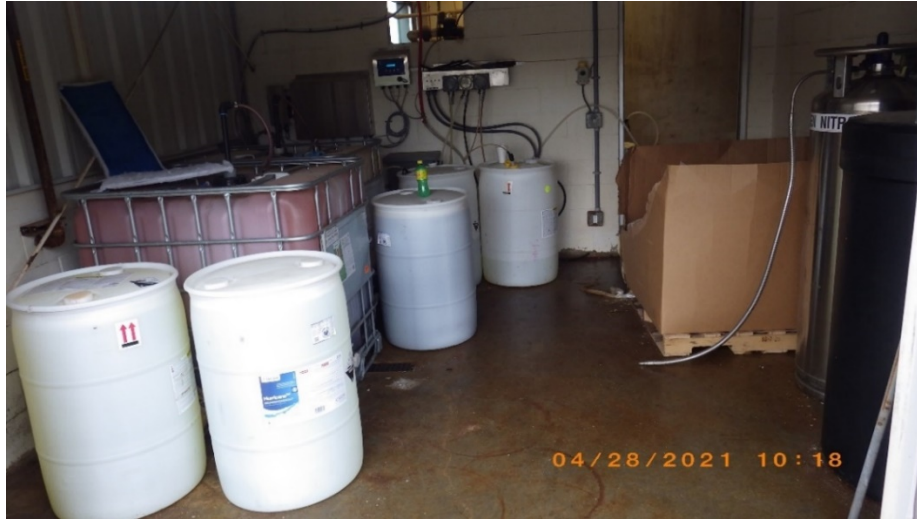
Photo Number: RIMG0070

Description: A second chemical storage Area with drains inside the building that convey any spill to the Recirculation Pit between Barns 2 and 3.

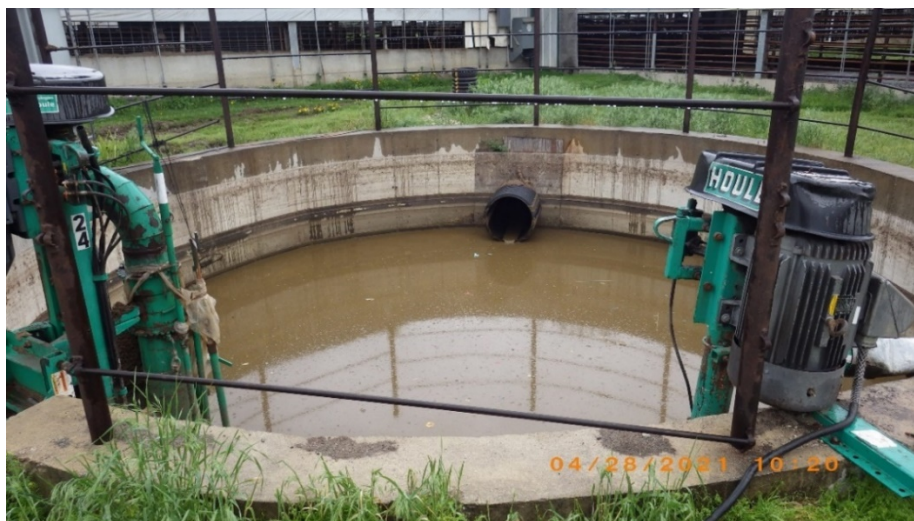
Photo Number: RIMG0071

Description: Recirculation Pit. Process wastewater from the clean out of the Milking Parlor gravity flows into the Recirculation Pit. The water within the Recirculation Pit is used to clean out the holding area for the cows.

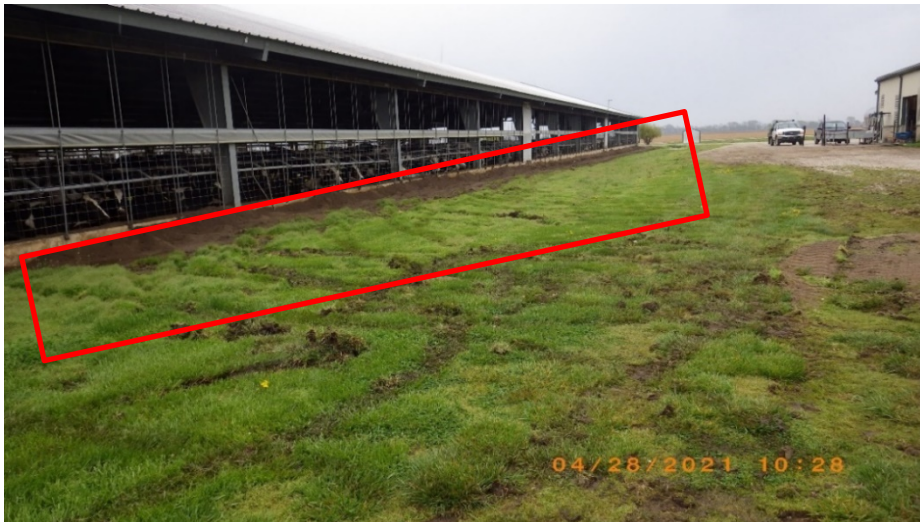
Photo Number: RIMG0072

We began walking between Barn 2 and Barn 3 where I observed used bedding and feed pushed from the barns and from the sides of the barns. According to Mr. Boerman, the stormwater that comes into contact with the used bedding, feed, and manure flows to the drainage tiles between each of the barns. The drainage tiles go under the East Access Road to the east side of the East Access Road and outlet into the East Drainage Channel (Photos 72 and 73). The East Drainage Channel flows, either by gravity to the Stormwater Pond, or to a depressional area at the northeast corner of the facility.

Description: Flow from between Barn 3 and Barn 2 flows to the east. Bedding from Barn 2 is pushed out of Barn 2 on the south side of the Barn 2. The red outlined box shows the bedding pushed out of Barn 2.

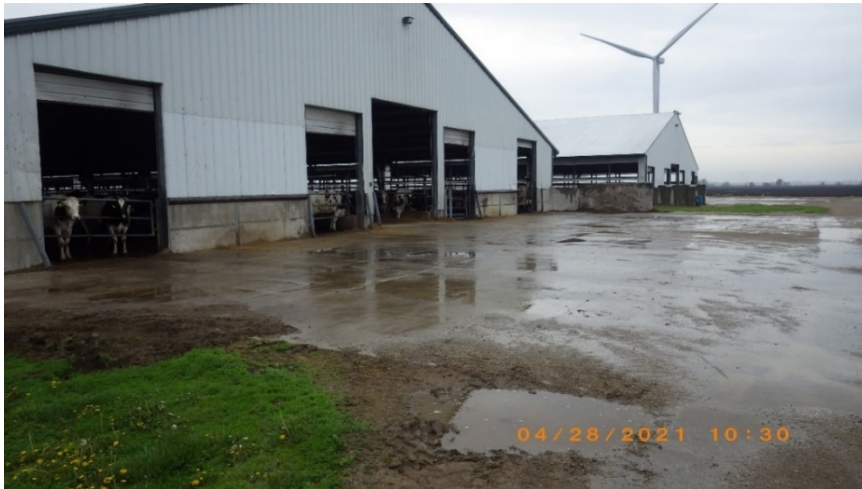
Photo Number: RIMG0073

Description: Barn 2 had some used bedding that was outside the doors on the east side of the barn and mixed with stormwater. The stormwater flows into drainage tile inlets between the Barns and outlets into the East Drainage Channel.

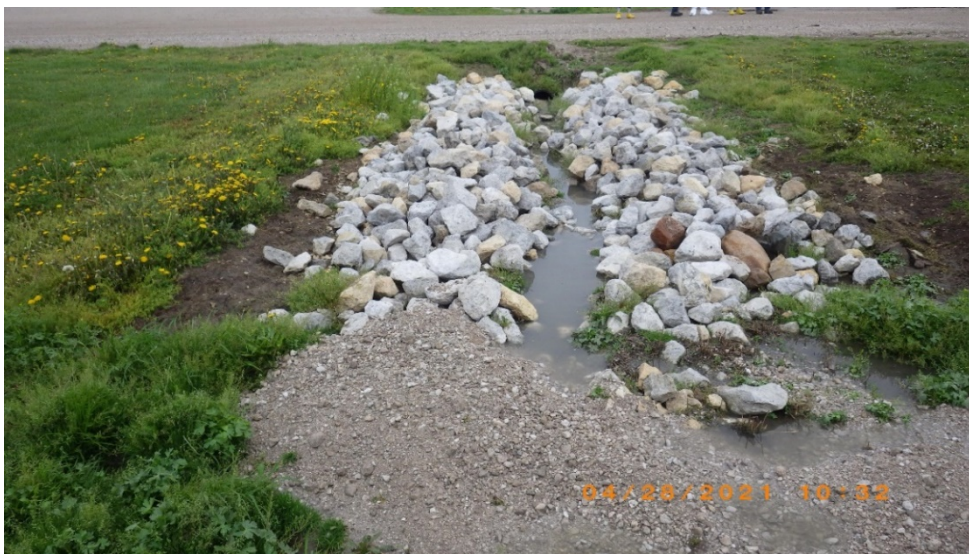
Photo Number: RIMG0076

Description: The drainage tile outlets the flow collected from between Barn 2 and Barn 3 through the drainage tile between Barn 2 and Barn 3 and conveys flow under the East Access Road into the East Drainage Channel.

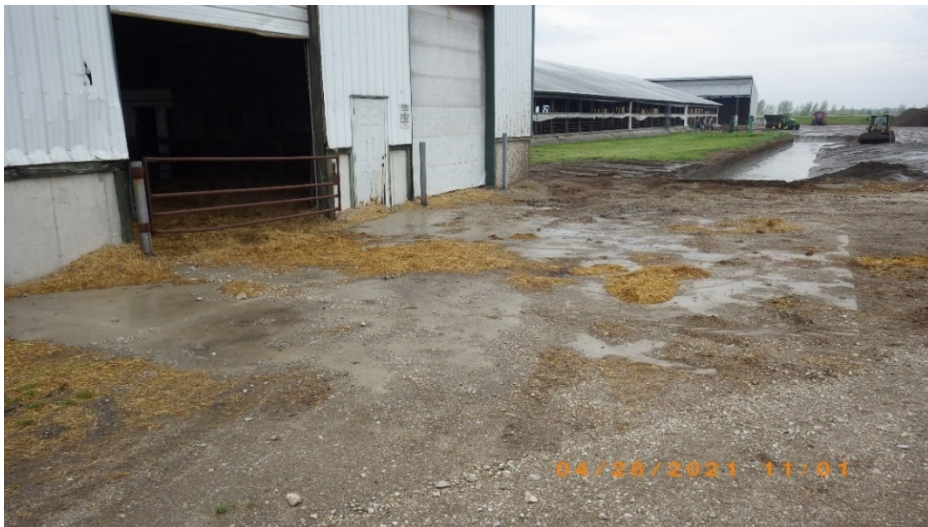
Photo Number: RIMG0085

EPA observed on the north side of Barn 5 that used bedding and feed had been pushed out the door (Photos RIMG0085 and RIMG0086). Mr. Boerman explained that when stormwater comes into contact with any track out on the north side, it surface flows by gravity into the Sand Separation Lane. We also observed the outlet into the Sand Separation Lane. The outlet is from the trenches that collect used bedding, manure, and process wastewater in the barns and flow by gravity into the Sand Separation Lane (Photo RIMG0087).

Description: Used bedding pushed out of the door of Barn 1.

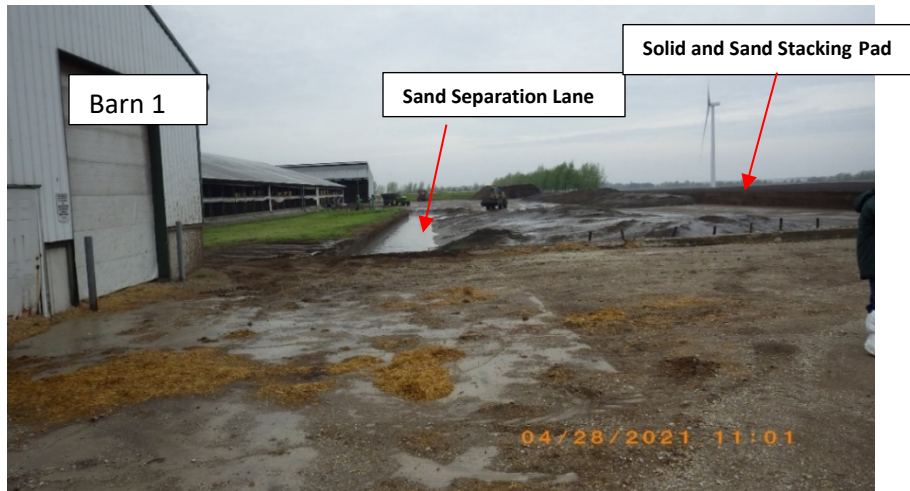
Photo Number: RIMG0086

Description: Used bedding and feed pushed out of Barn 1, the Sand Separation Lane and Solid and Sand Stacking Pad which are labeled in the photo above.

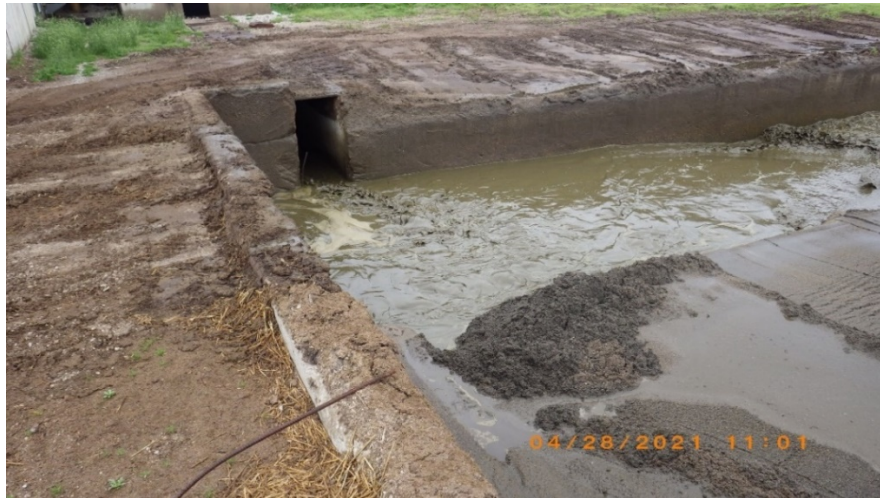
Photo Number: RIMG0087

Description: All the used bedding, manure, and process wastewater from Barns 1-5 is flushed with process wastewater from the Recirculation Pit and the 3<sup>rd</sup> Stage Lagoon and flows by gravity in the trench into the Sand Separation Lane.

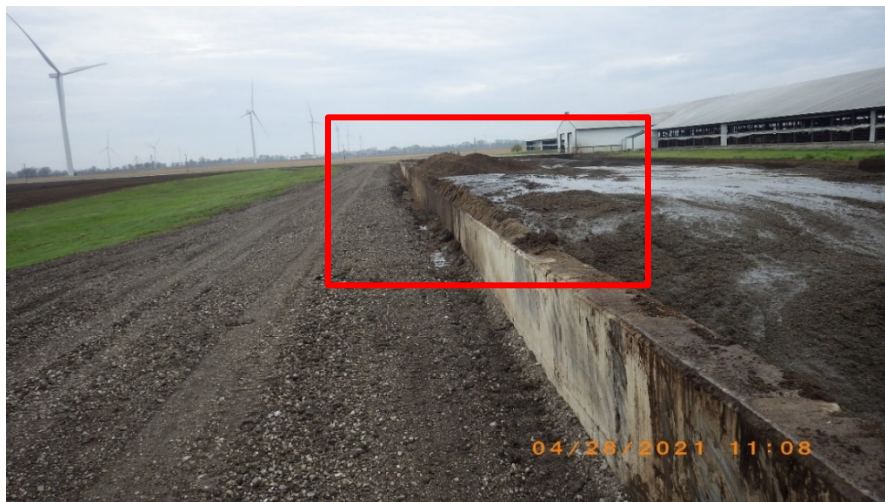
Photo Number: RIMG0091

EPA continued walking west on the north side of the facility and observed solids pushed over the concrete wall of the Solid and Sand Stacking Pad. Mr. Boerman explained that any stormwater that comes into contact with the solids been pushed over the wall would flow to the Stormwater Pond (Photo RIMG0091). We walked on the Solid and Sand Stacking Pad to observe how the process wastewater is pumped into the 1<sup>st</sup> Stage Lagoon (Photos RIMG0095 and RIMG0096).

Description: In the red outline box in the photo above, some solids from the Solid and Sand Stacking Pad spilled over the concrete wall onto the North Access Road.

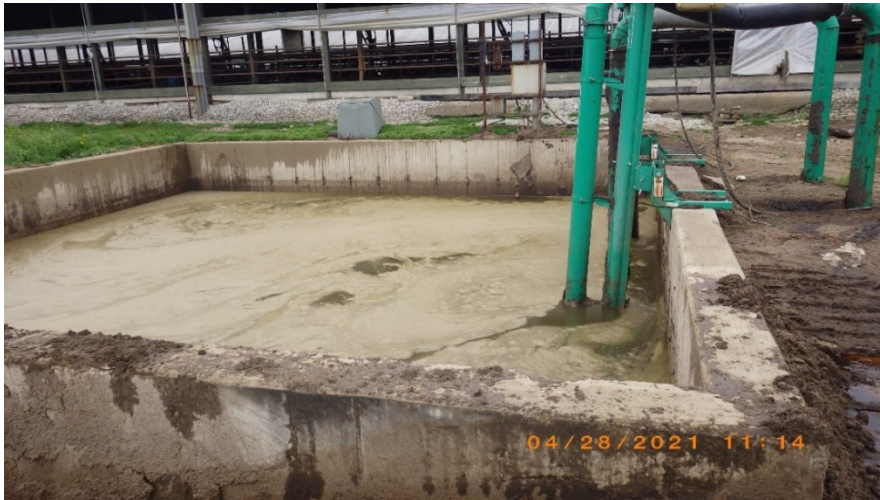
Photo Number: RIMG0096

Description: This is where the process wastewater from the Sand Separation Lane is pumped to the 1<sup>st</sup> Stage Lagoon.

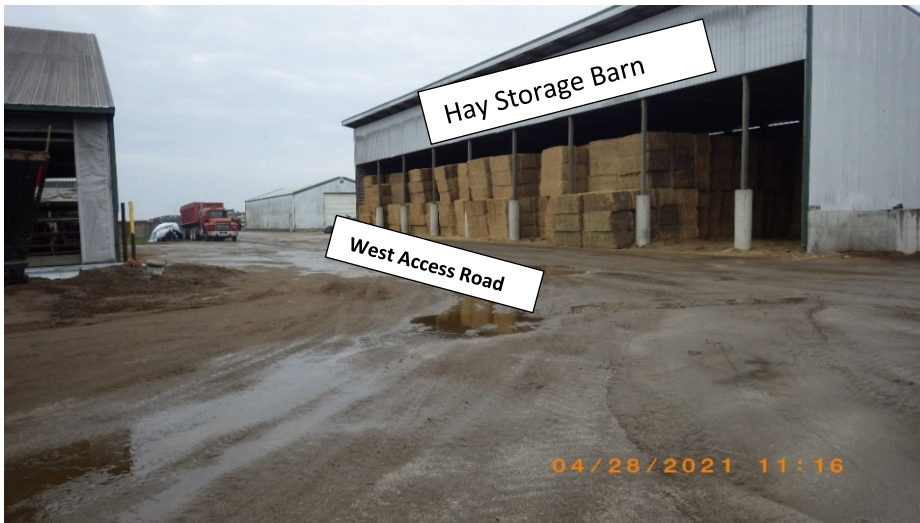
Photo Number: RIMG0097

Description: Any process wastewater on the West Access Road flows into the Stormwater Pond. The Hay Storage Barn is labeled in the photo along with the West Access Road.

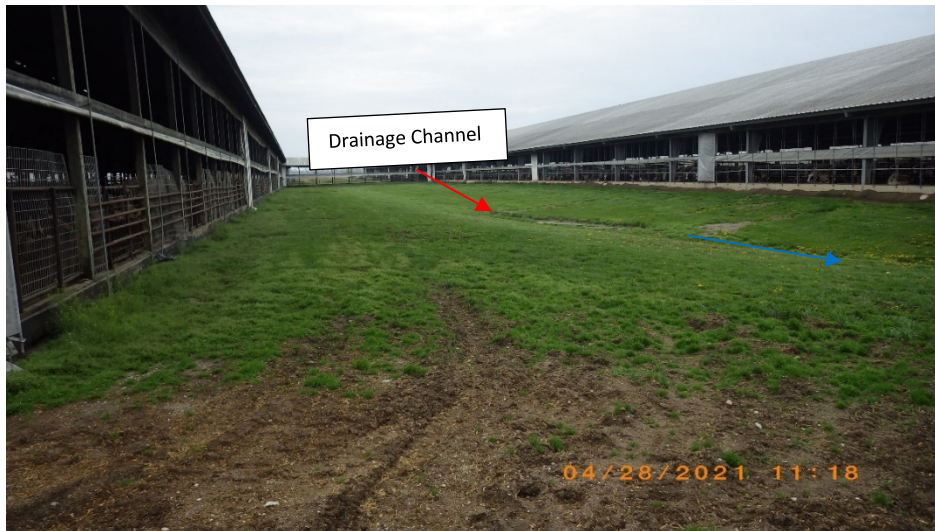
Photo Number: RIMG0098

Description: The drainage channel between Barn 1 and Barn 2 is labeled with the arrow showing the direction of flow. The flow within the drainage channel conveys flow to a drainage inlet pipe that conveys flow to the Stormwater Pond.

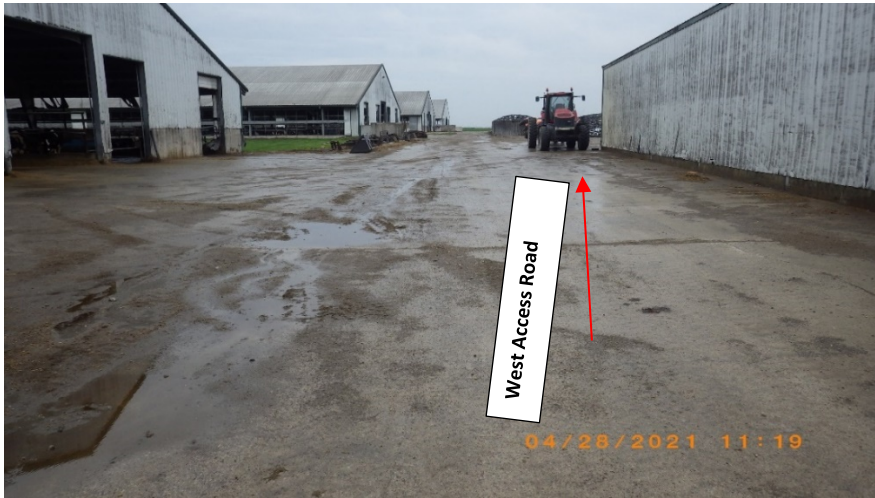
Photo Number: RIMG0100

Description: The overall view of the West Access Road. Flow is to the south (as shown in the photo by the red arrow) into a drainage tile that conveys flow to the Stormwater pond.

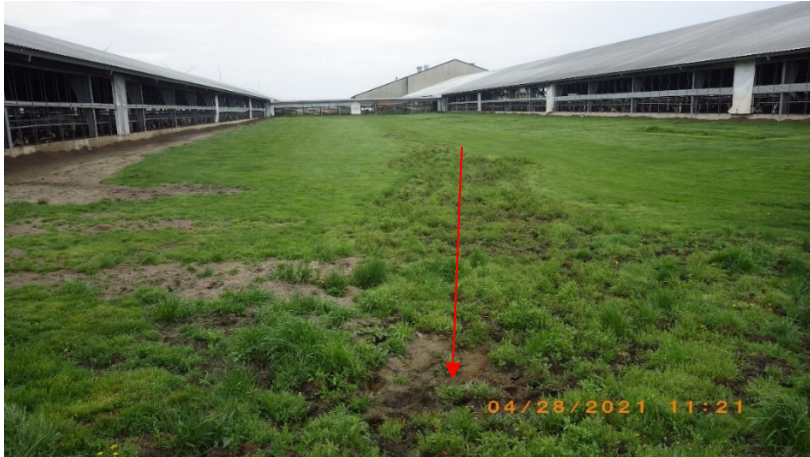
Photo Number: RIMG0104

Description: The red arrow in the photo above shows the direction of flow within the drainage pathway between Barn 2 and Barn 3.

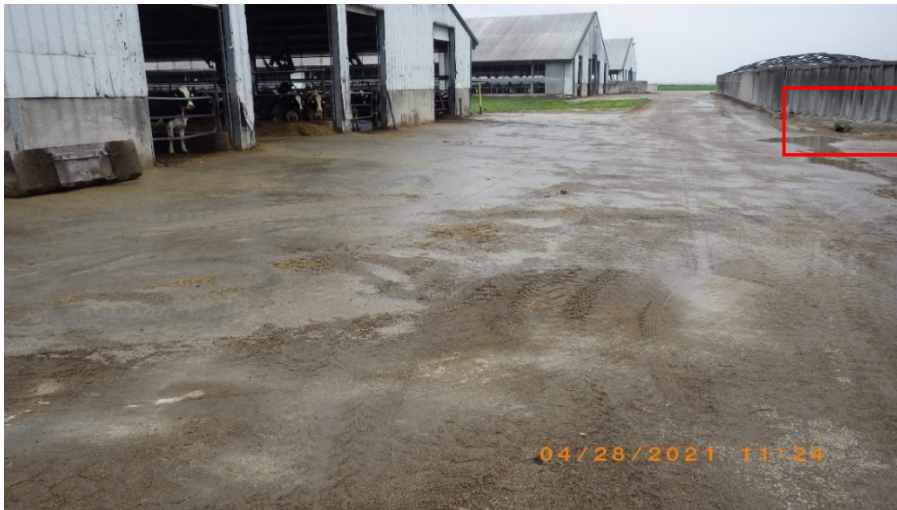
Photo Number: RIMG0105

Description: The feed and used bedding pushed out of the Barn 2 and Barn 1 and drains to the southwest and drains to Stormwater Pond through tile inlets. One of the tile inlets is in the red box.

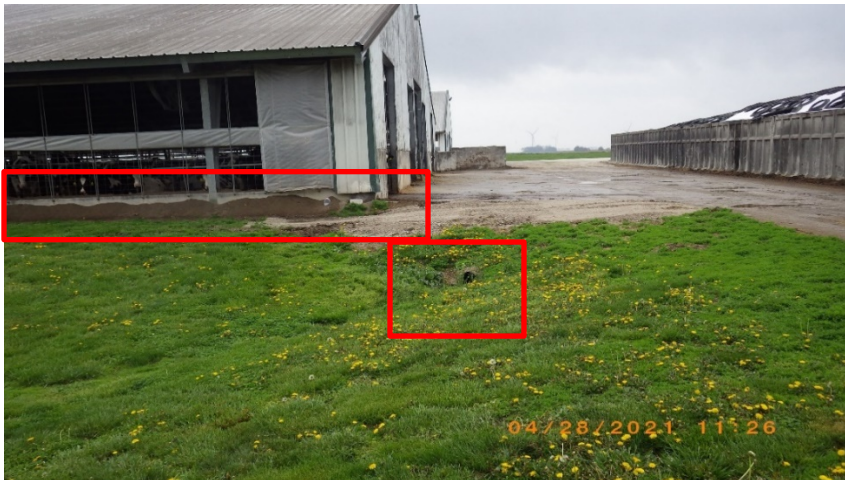
Photo Number: RIMG0109

Description: The drainage tile inlet near the northwest corner of Barn 3 and used bedding being pushed out of Barn 3 shown inside the red outlined boxes in the photo above.

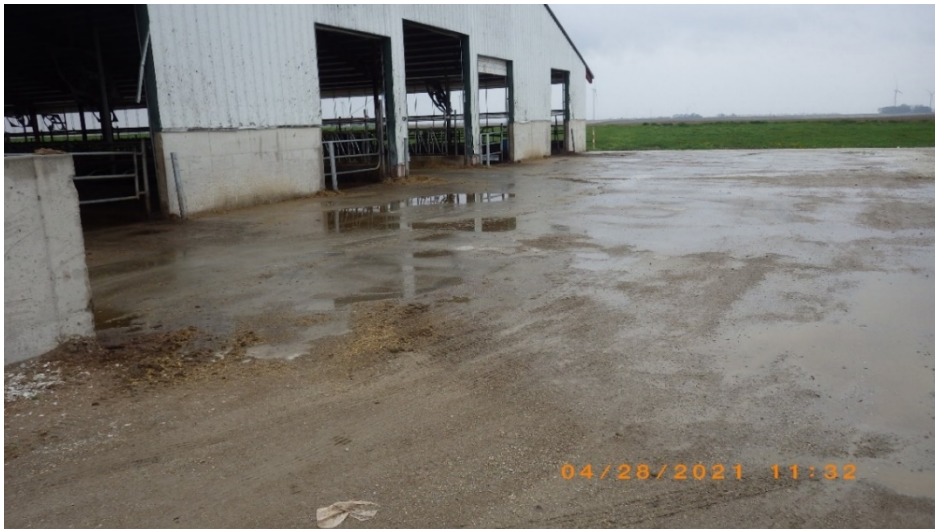
Photo Number: RIMG0115

We continued to the west side of the barns on the West Access Road (Attachment B). EPA observed the Hay Storage Barn on the west side of the facility and observed used bedding, feed, and manure on the West Access Road tracked out of Barn 1.(Photos RIMG0098 and RIMG0099). Mr. Boerman stated that any stormwater that comes into contact with solids tracked out of Barns 1, 2, or 3 flows either into the tile inlets between these barns or surface flows east along the West Access Road to the Solid and Sand Stacking Pad. Mr. Boerman stated that when stormwater comes into contact with solids on the West Access Road west of the Barn 4 and Barn 5, it surface flows to the South Drainage Ditch (Attachment B) and into the Stormwater Pond (Photos RIMG0115, RIMG0116, and RIMG0117).

Description: Used feed and bedding coming out of the doors on the west side of Barn 5 flows west into the Stormwater Pond.

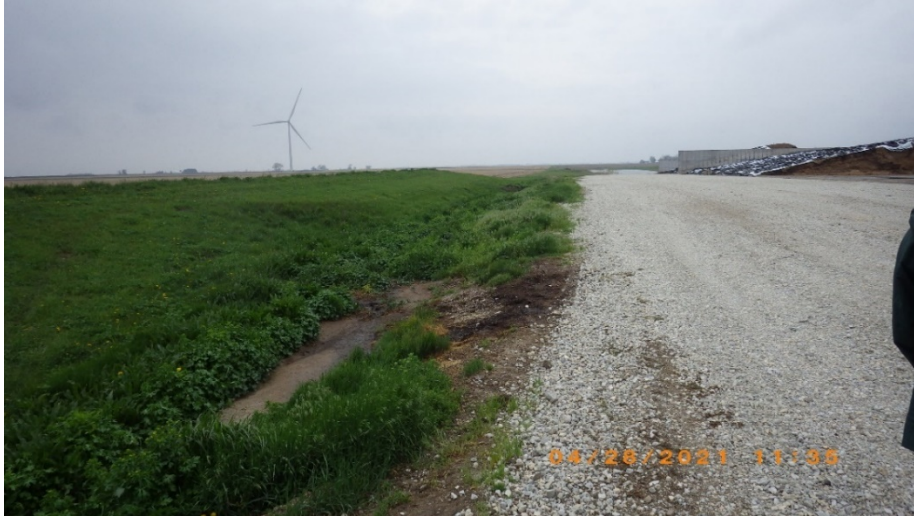
Photo Number: RIMG0118

Description: The South Drainage ditch surface flows to the west into the Stormwater Pond.

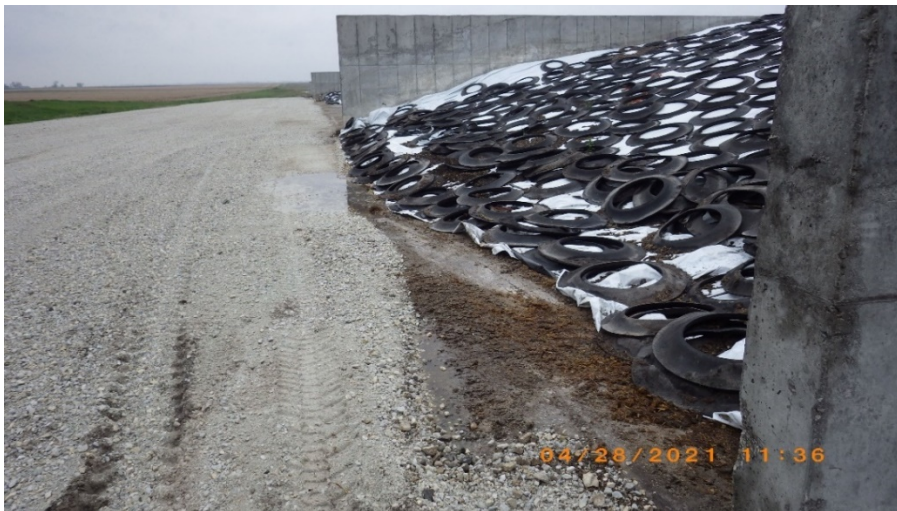
Photo Number: RIMG0119

We continued our walk-through to the south side of the Stormwater Pond and observed leachate from the silage stored in the silage bunkers. Any leachate, stormwater, and/or stormwater that comes into contact with the feed in the bunkers flows either into the South Drainage Ditch (Attachment B) or along the South Access Road (Attachment B) and into the Stormwater Pond (Photos RIMG0119 through RIMG0128).

Description: Feed exposed on the ground outside of the Silage Bunkers.

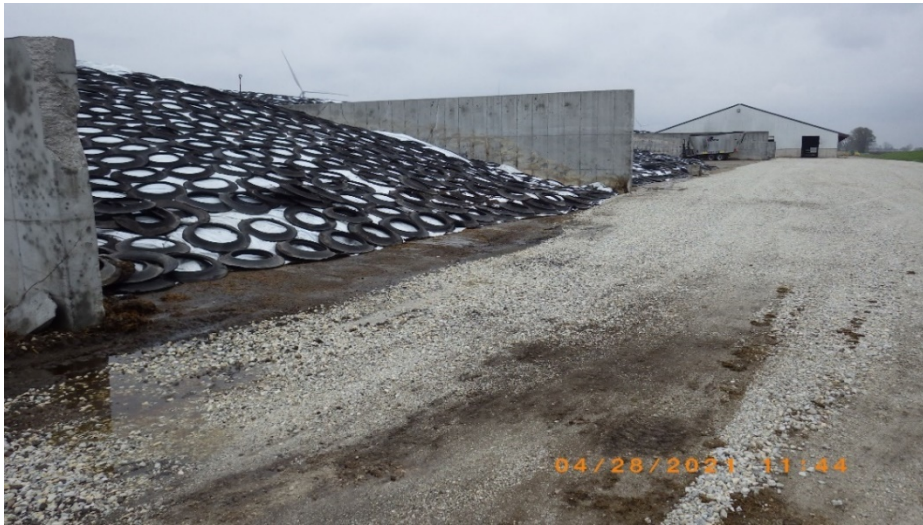
Photo Number: RIMG0122

Description: Process wastewater drains to the west into the Stormwater Pond.

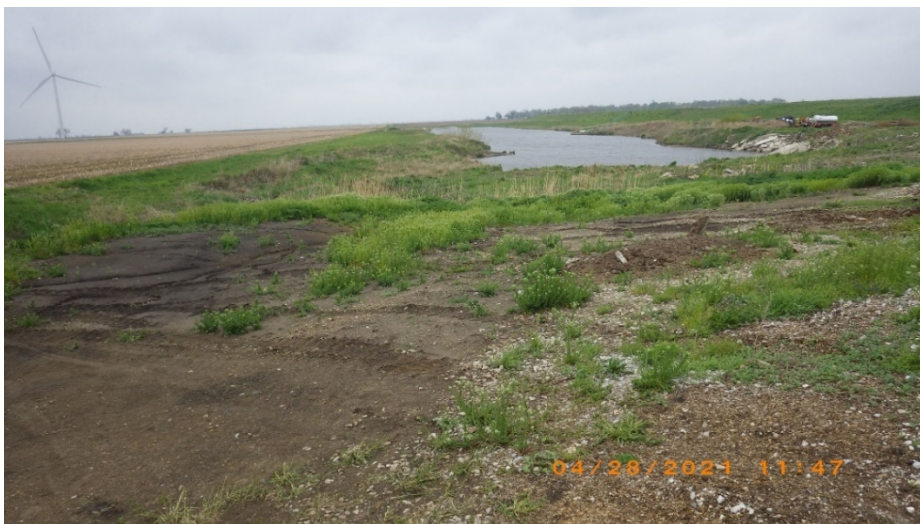
Photo Number: RIMG0125

Description: The feed outside of the Storage Bunkers, which mixes with stormwater and flows into the Stormwater Pond.

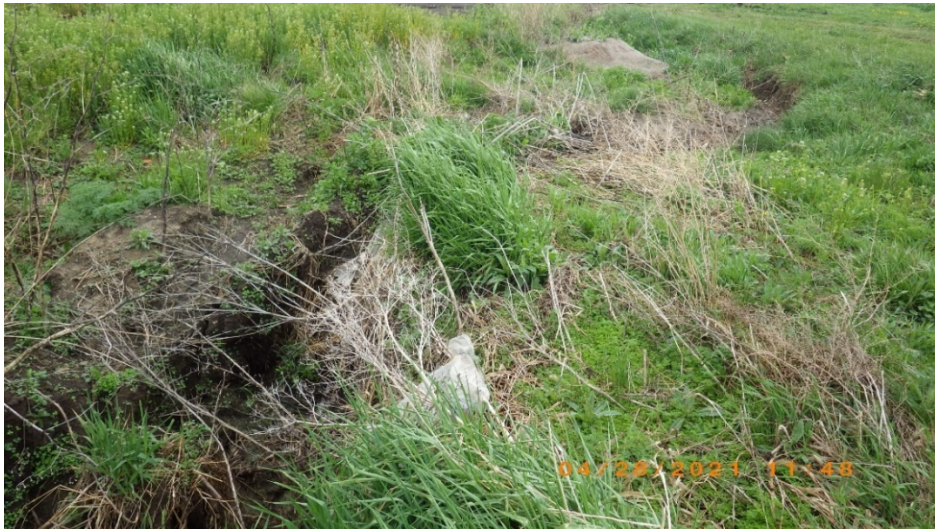
Photo Number: RIMG0126

Description: The eroded drainage channel that flows into the Stormwater Pond.

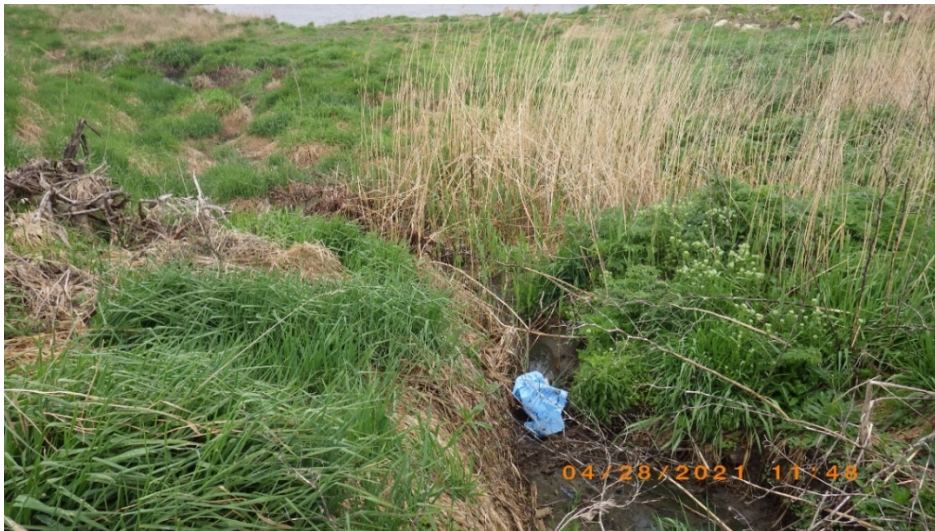
Photo Number: RIMG0127

Description: The continuation of the eroded drainage channel that carries flow into the Stormwater Pond.

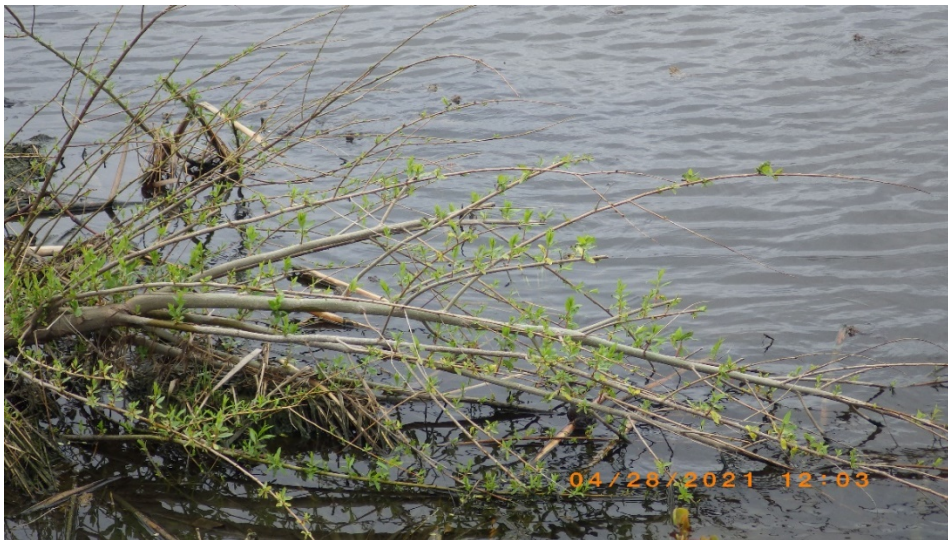
Photo Number: RIMG0131

As we were walking on the south side of the Stormwater Pond, we observed approximately one hundred frogs/toads within the Stormwater Pond (Photos RIMG0129 through RIMG0132). We continued to the southwest side of the Stormwater Pond where we observed the tile outlet into the Stormwater Pond. Mr. Boerman explained that the

Description: Trying to show the frogs within the Stormwater Pond.

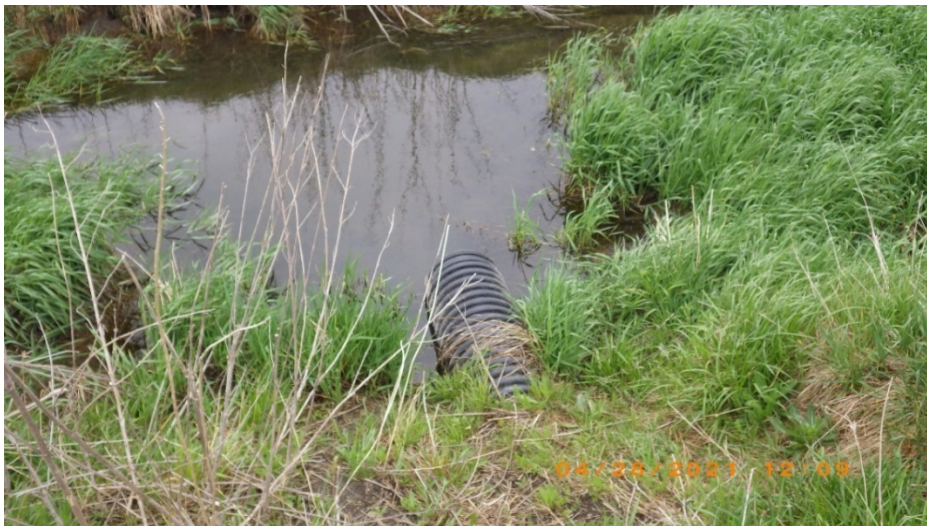
Photo Number: RIMG0135

agricultural field to the south was tiled to flow into Prudential Ditch (Photos RIMG0135 and RIMG0136), but this tile has been plugged and is now tiled to flow into the Stormwater Pond (Photo RIMG0133). We observed an access ramp into the Stormwater Pond, which Mr. Boerman explained farmers use to access the Stormwater Pond for irrigating their crops (Photo RIMG0134).

Description: The drainage tile outlet into Prudential Ditch was plugged. The drainage has been rerouted into the Stormwater Pond.

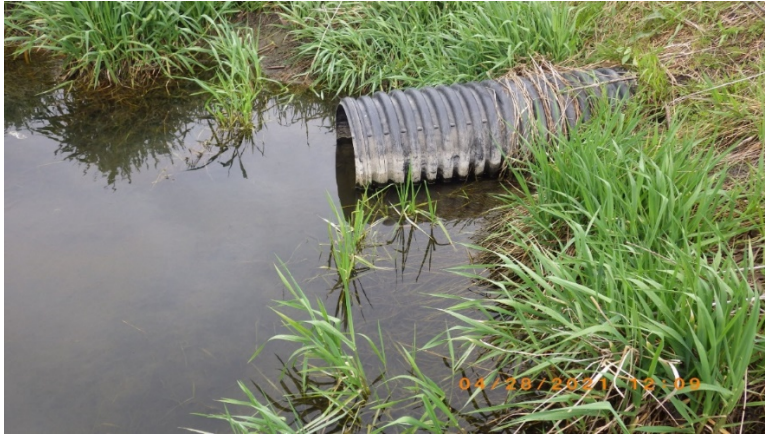
Photo Number: RIMG0136

Description: The close-up of the tile outlet into Prudential Ditch that has been plugged and rerouted to drain into the Stormwater Pond.

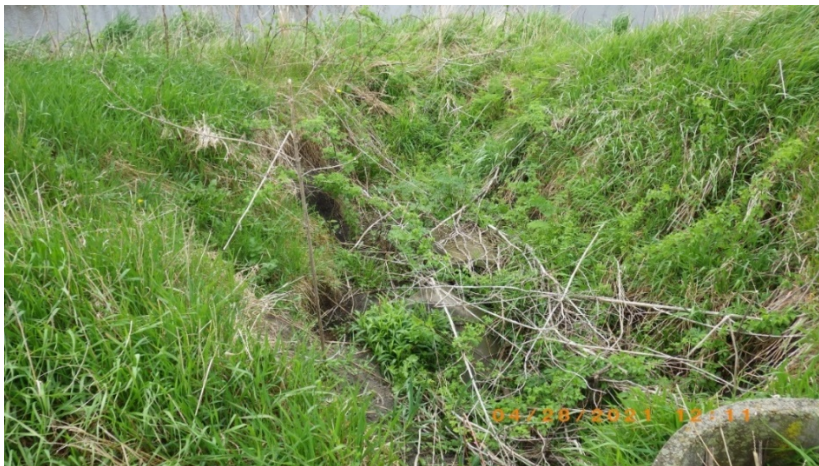
Photo Number: RIMG0137

Description: The erosion channel into Prudential Ditch, west of the Stormwater Pond.

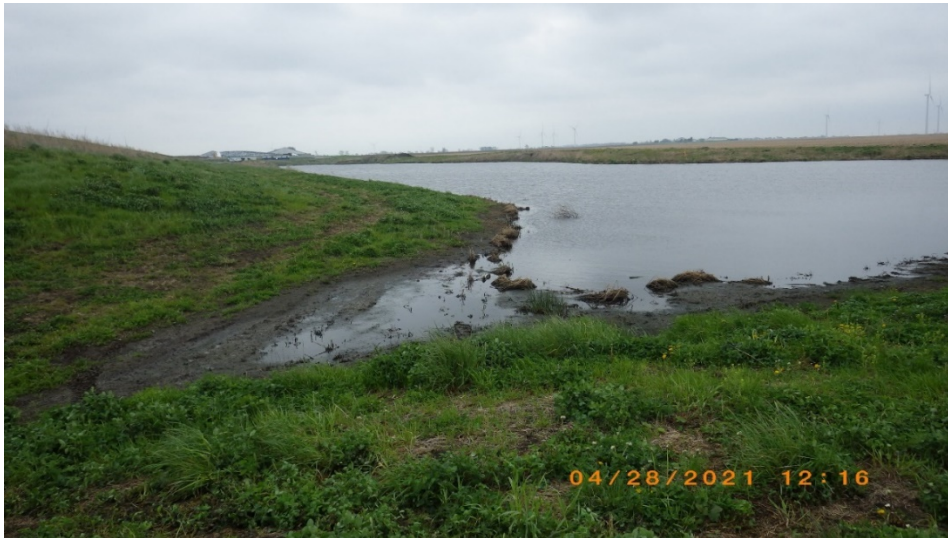
Photo Number: RIMG0138

Description: The flow drains from the north to the south into the Stormwater Pond.

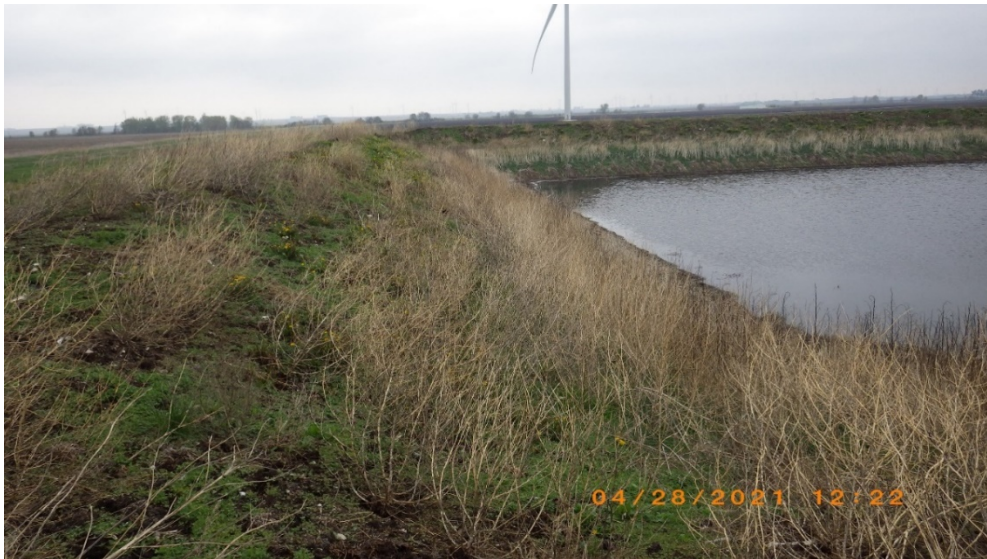
Photo Number: RIMG0139

Description: The west berm of the 5<sup>th</sup> Stage Lagoon.

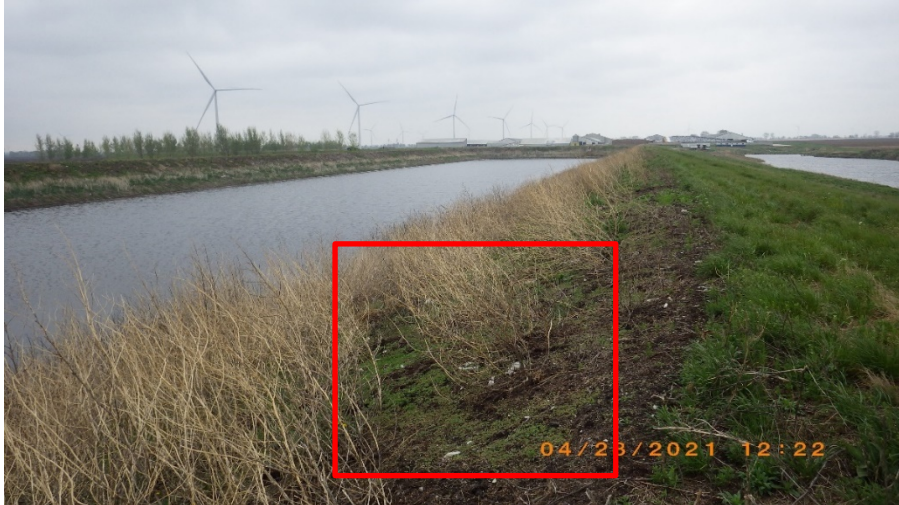
Photo Number: RIMG0140

We continued to the 5<sup>th</sup> Stage Lagoon to observe the berms. We observed vegetation that at first appeared to possibly be impacting the berm. Mr. Boerman and Mr. Severson showed that the vegetation was not rooted to the liner but was in the compost that was used as additional protection of the berms (Photo RIMG0139). The compost on the berms contained bones from the cows that were composted in the mortality pile (Photo RIMG0140).

Description: Mortality compost is used on top of the clay liner of the 5<sup>th</sup> Stage Lagoon. In the red outlined box, there are white cow bones.

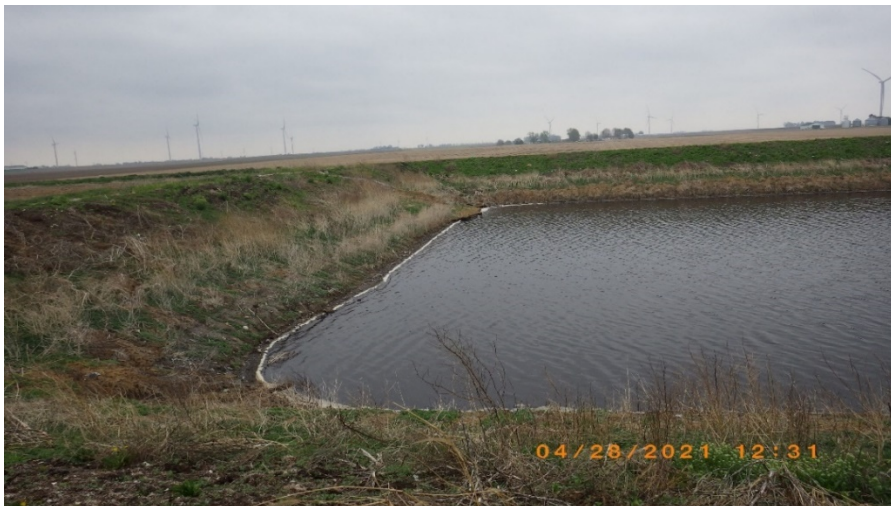
Photo Number: RIMG0141

Description: The east berm of the Stormwater Pond.

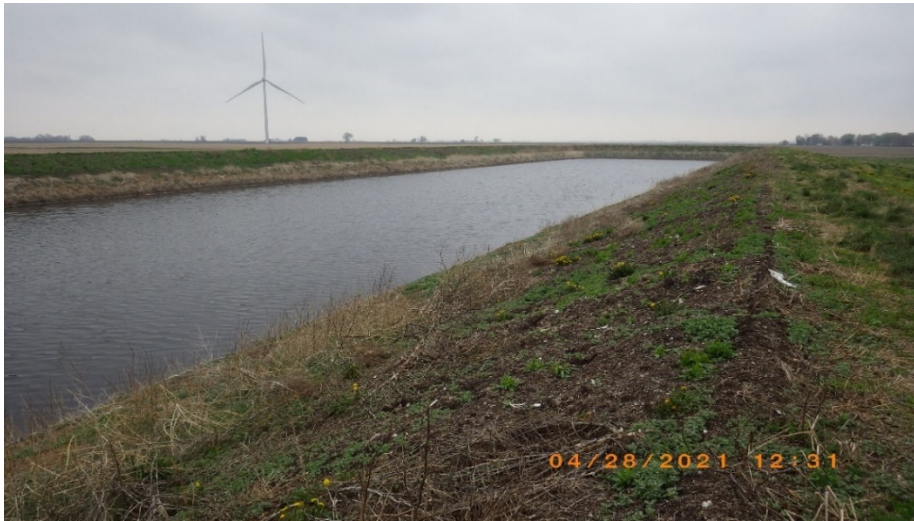
Photo Number: RIMG0142

Description: The north berm of the 5<sup>th</sup> Stage Lagoon.

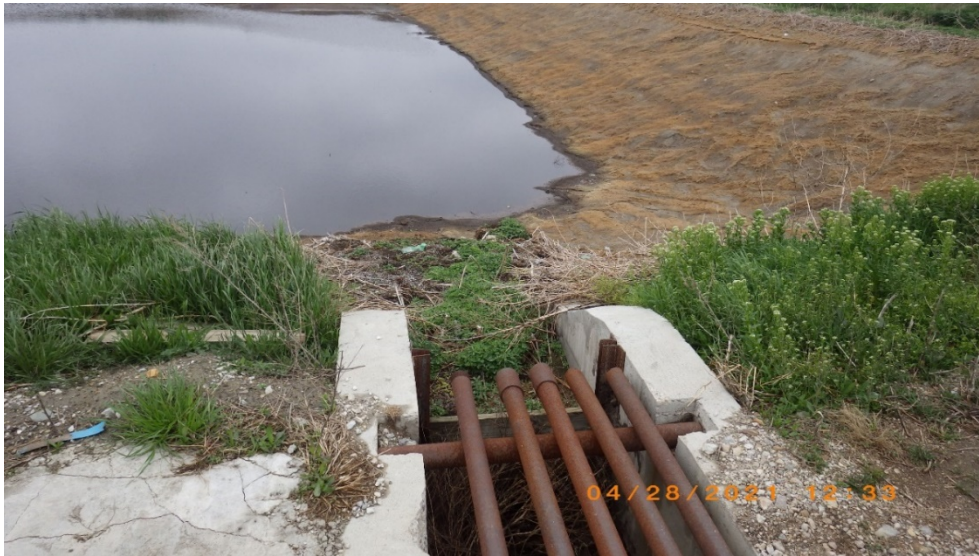
Photo Number: RIMG0144

Description: The concrete overflow between the 4<sup>th</sup> Stage Lagoon and the 5<sup>th</sup> Stage Lagoon.

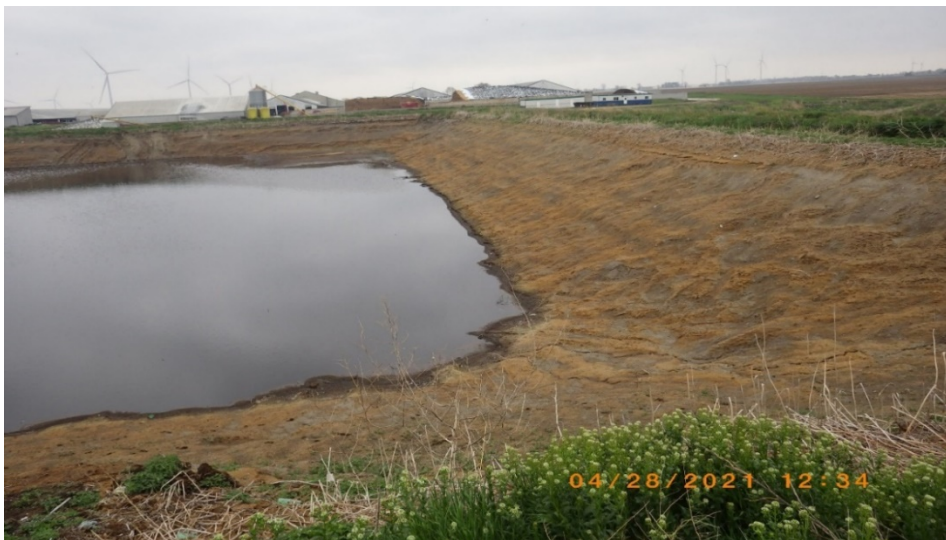
Photo Number: RIMG0145

Description: Looking at the west and the south berms on the 4<sup>th</sup> Stage Lagoon.

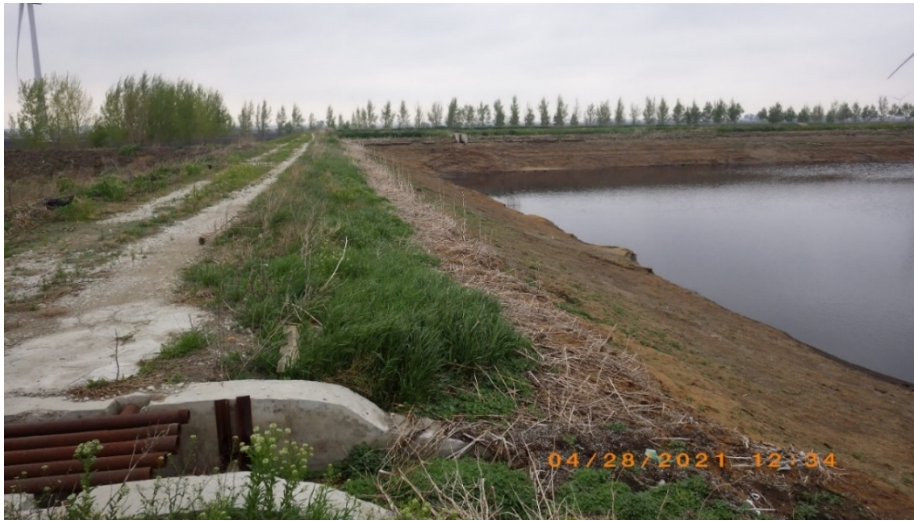
Photo Number: RIMG0146

Description: The west and north berms of the 4<sup>th</sup> Stage Lagoon

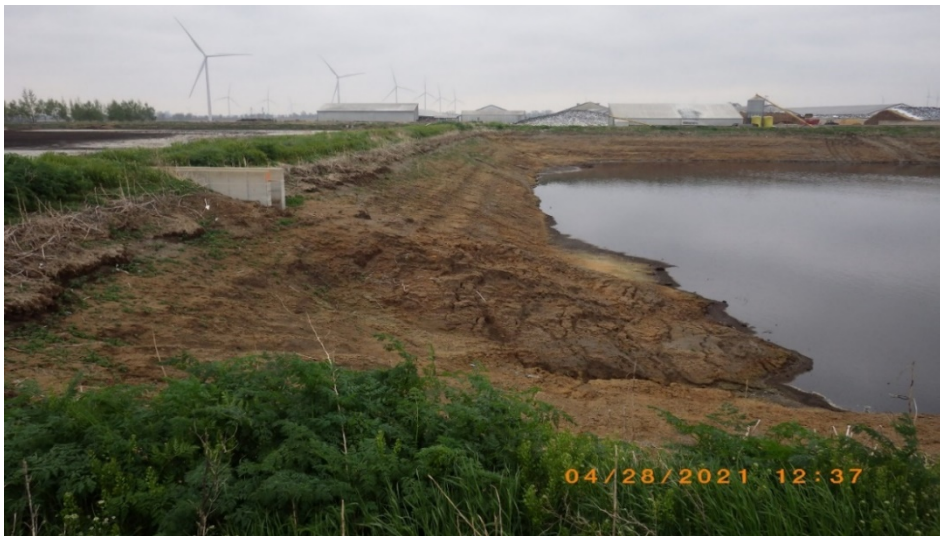
Photo Number: RIMG0147

Description: The concrete overflow from the 3<sup>rd</sup> Stage Lagoon into the 4<sup>th</sup> Stage Lagoon.

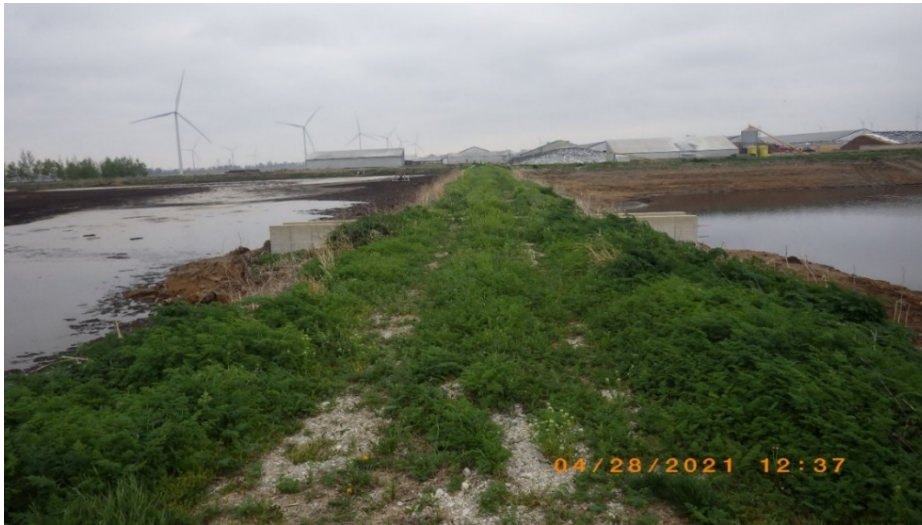
Photo Number: RIMG0148

Description: The concrete overflow that conveys wastewater from the 3<sup>rd</sup> Stage Lagoon to the 4<sup>th</sup> Stage Lagoon.

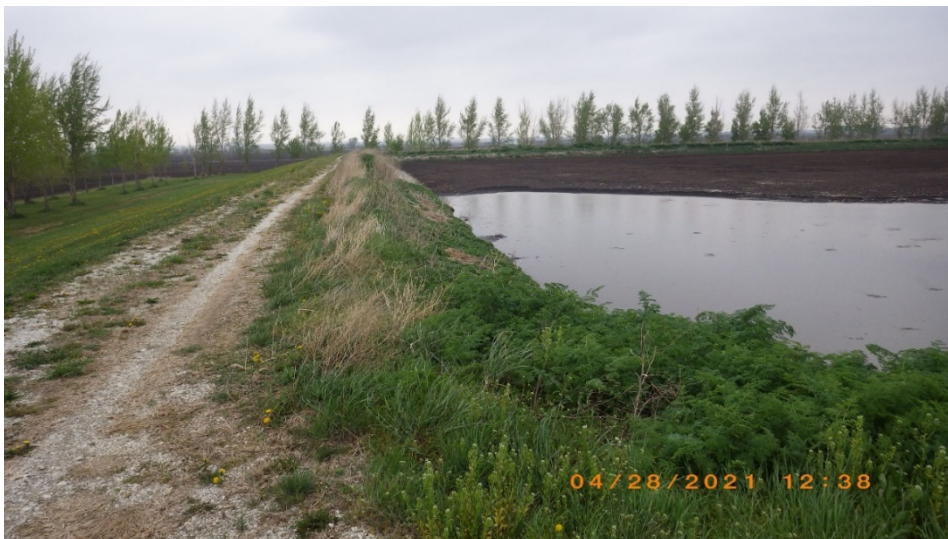
Photo Number: RIMG0149

Description: The 3<sup>rd</sup> Stage Lagoon.

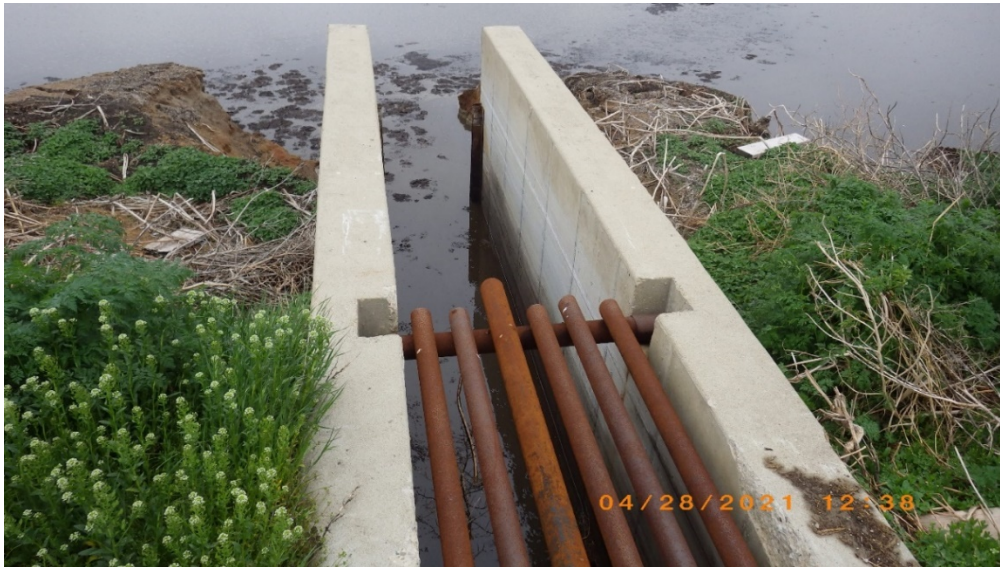
Photo Number: RIMG0150

Description: The concrete overflow from between the 2<sup>nd</sup> Stage Lagoon and the 3<sup>rd</sup> Stage Lagoon.

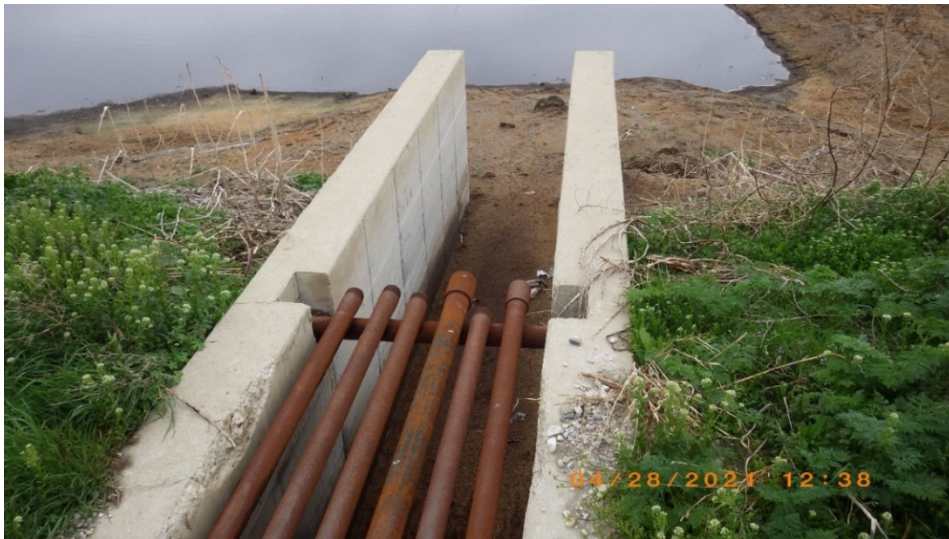
Photo Number: RIMG0151

Description: The concrete overflow from between the 3<sup>rd</sup> and 2<sup>nd</sup> Stage Lagoon.

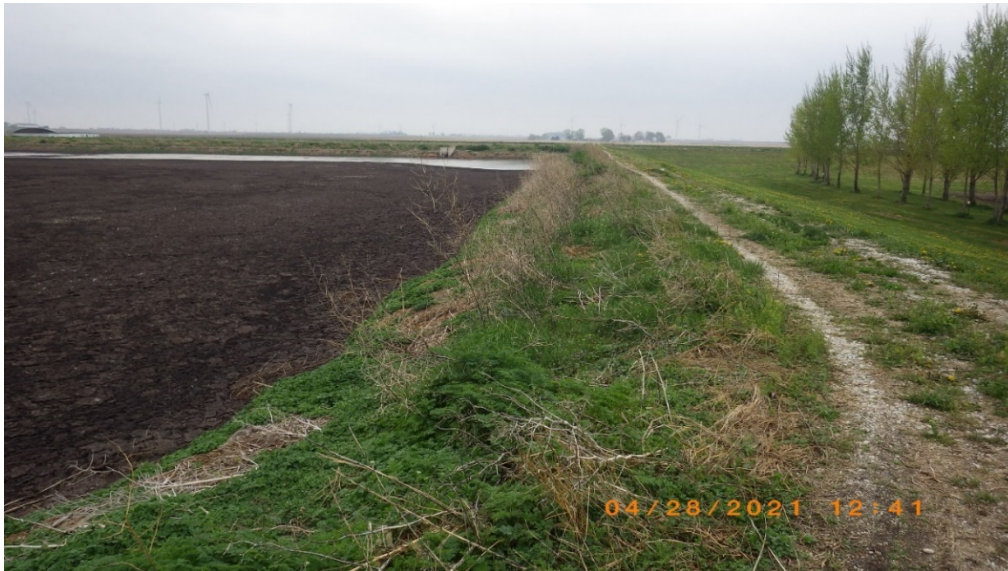
Photo Number: RIMG0152

Description: The north berm of the 3<sup>rd</sup> Stage Lagoon.
