**CWA COMPLIANCE EVALUATION INSPECTION REPORT  
U.S. ENVIRONMENTAL PROTECTION AGENCY, REGION 5**

**Purpose:** Compliance Evaluation Inspection

**Facility:** Benton Dairy, LLC  
8444 South 900 West  
Ambia, Indiana 47917-003

**Date of Inspection:** April 28 and 29, 2021

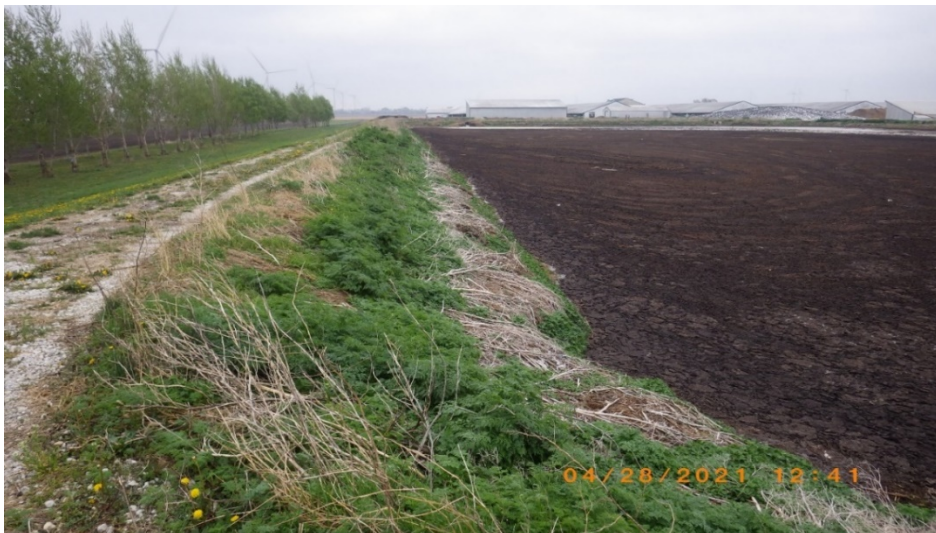
Photo Number: RIMG0153

Description: The north berm of the 3<sup>rd</sup> Stage Lagoon.

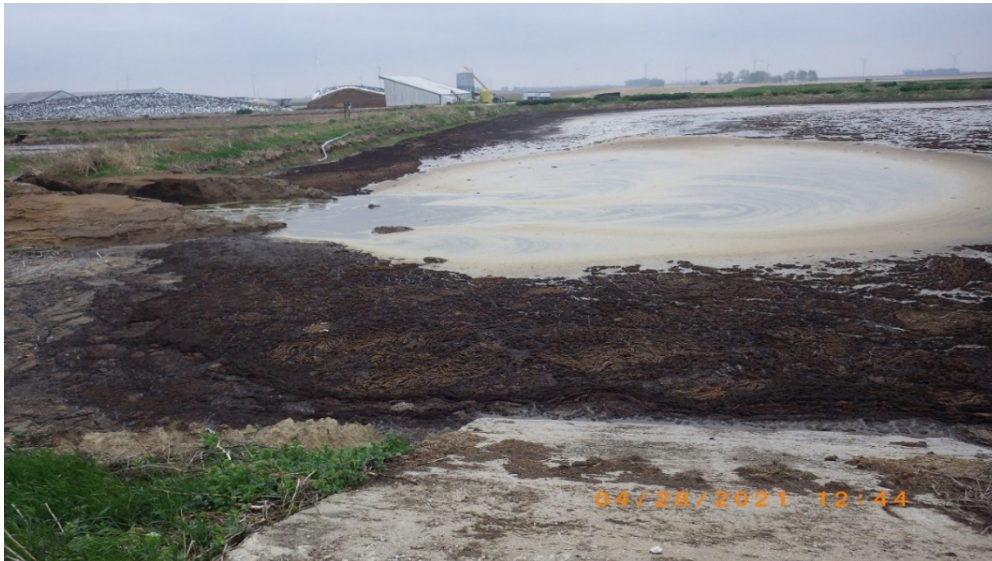
Photo Number: RIMG0154  
Description: Access pad to the 3<sup>rd</sup> Stage Lagoon.  
Location: North side of the 3<sup>rd</sup> Stage Lagoon.  
40.48688, -87.499627  
Facing: West.  
Date/Time: 4/28/2021 12:44 p.m.

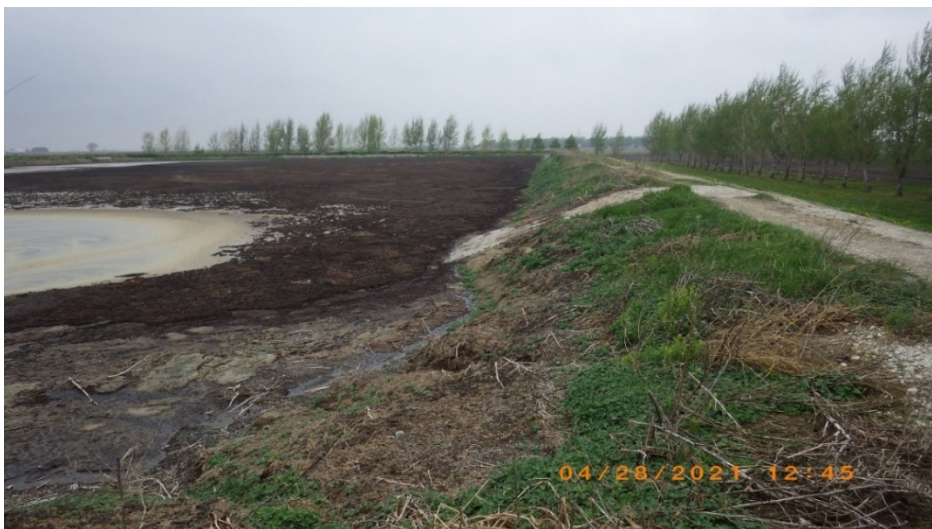
Photo Number: RIMG0155  
Description: North berm of the 3<sup>rd</sup> Stage Lagoon.  
Location: On the northeast corner of the 3<sup>rd</sup> Stage Lagoon.  
40.487375, -87.498103  
Facing: West.  
Date/Time: 4/28/2021 12:45 p.m.

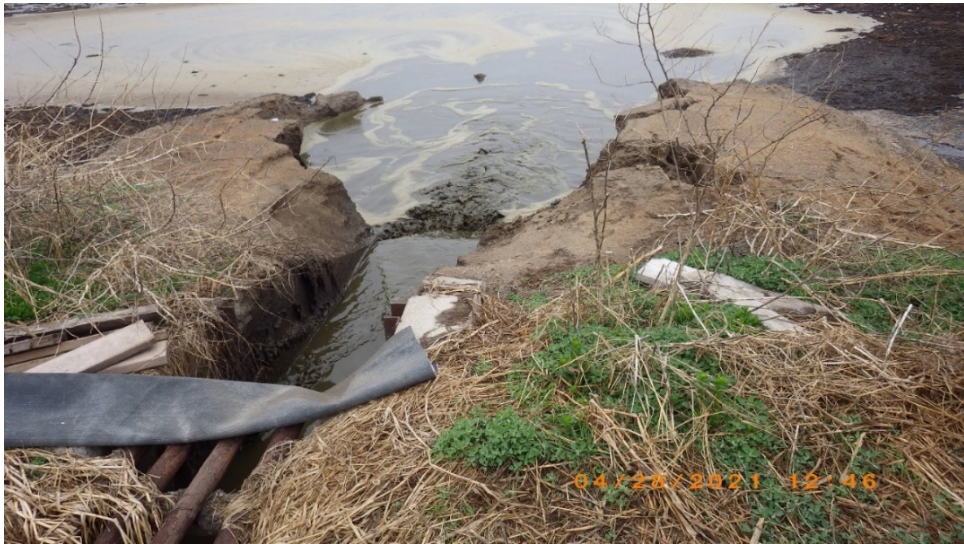
Photo Number: RIMG0156

Description: The concrete overflow from the 2<sup>nd</sup> Stage Lagoon into the 3<sup>rd</sup> Stage Lagoon.

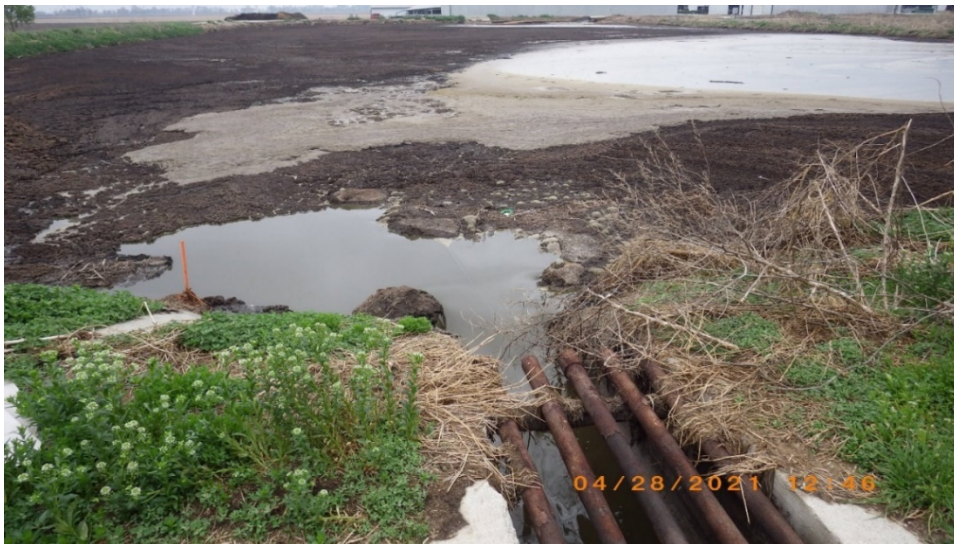
Photo Number: RIMG0157

Description: The depth marker within the 3<sup>rd</sup> Stage Lagoon.

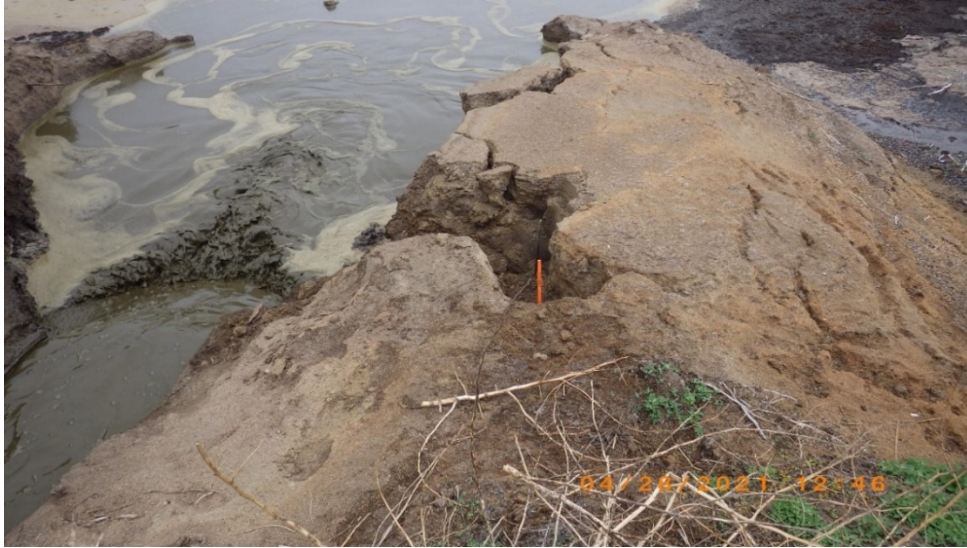
Photo Number: RIMG0158

Description: The depth marker within the 2<sup>nd</sup> Stage Lagoon.

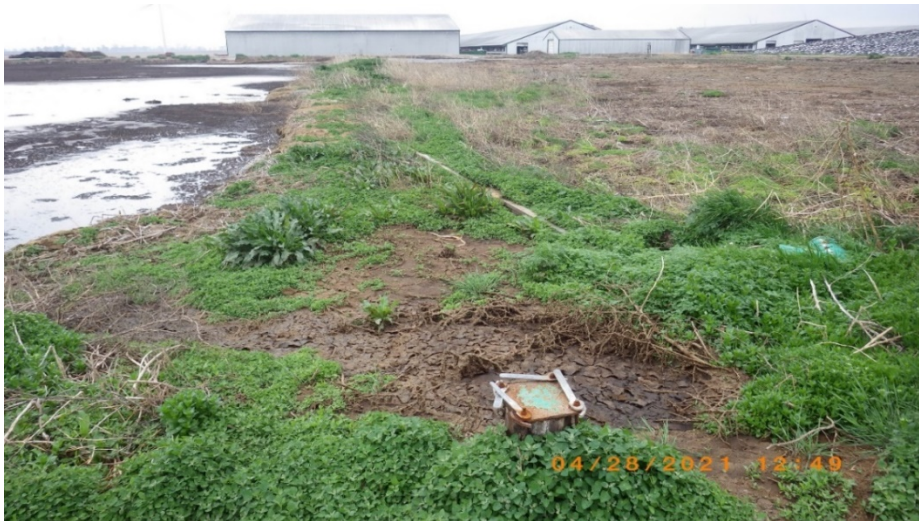
Photo Number: RIMG0159

Description: Berm between the 1<sup>st</sup> and 2<sup>nd</sup> Stage Lagoons.

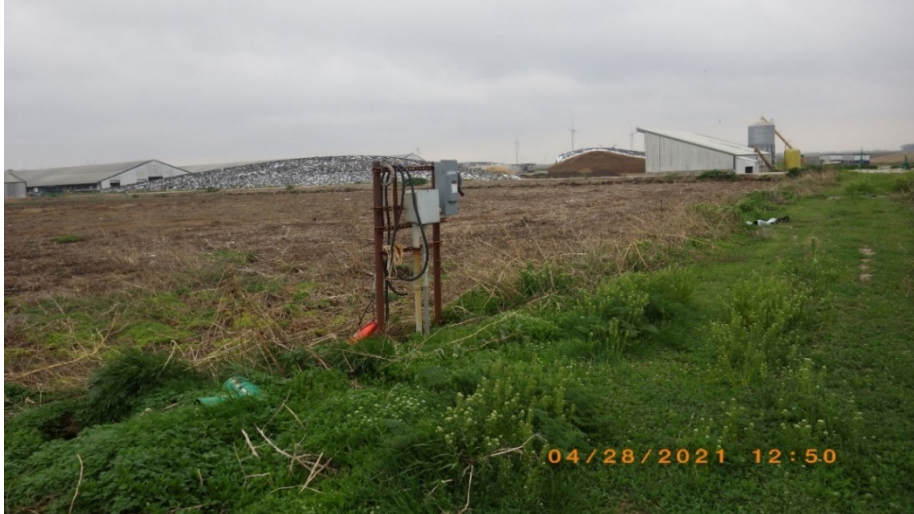
Photo Number: RIMG0160

Description: The pump within the 1<sup>st</sup> Stage Lagoon.

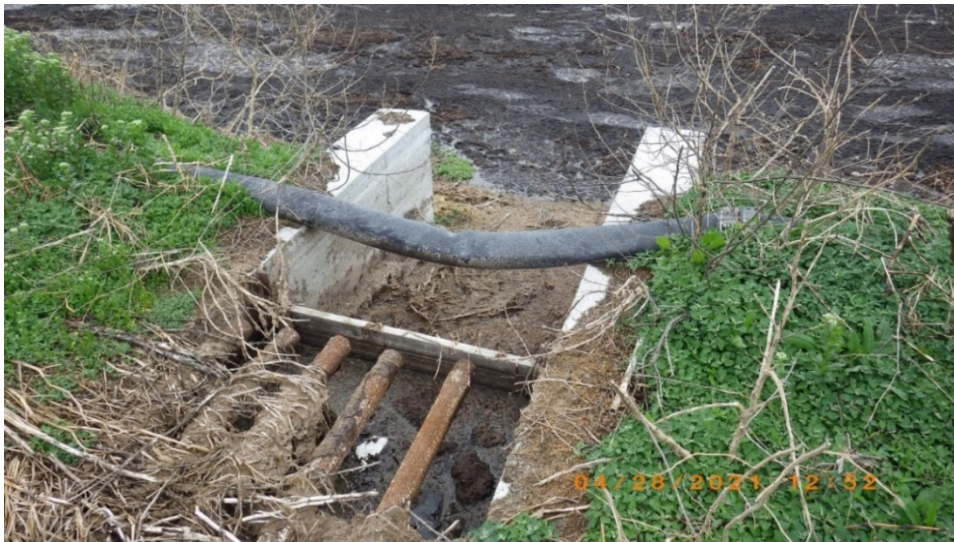
Photo Number: RIMG0161

Description: The concrete overflow from the 1<sup>st</sup> Stage Lagoon into the 3<sup>rd</sup> Stage Lagoon.

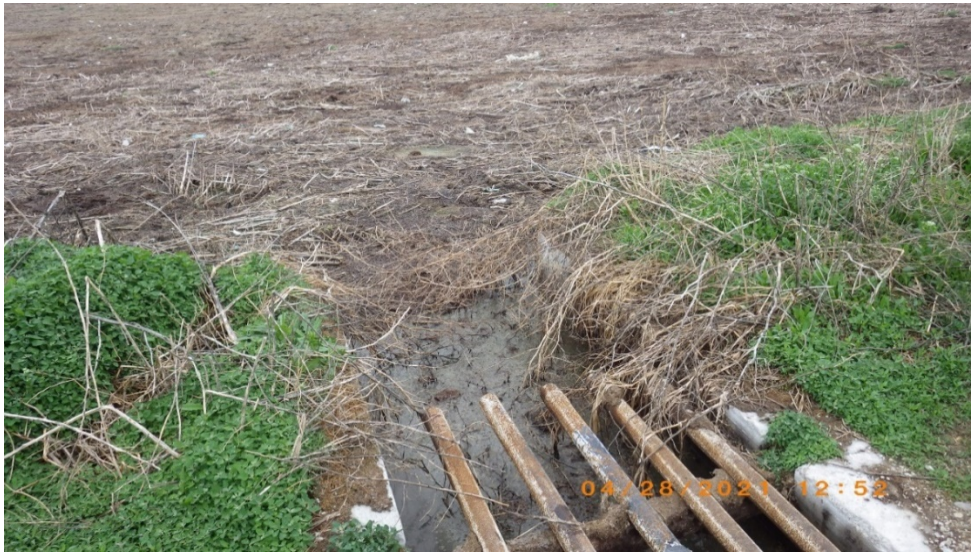
Photo Number: RIMG0162

Description: The concrete overflow from the 1<sup>st</sup> Stage Lagoon into the 3<sup>rd</sup> Stage Lagoon.

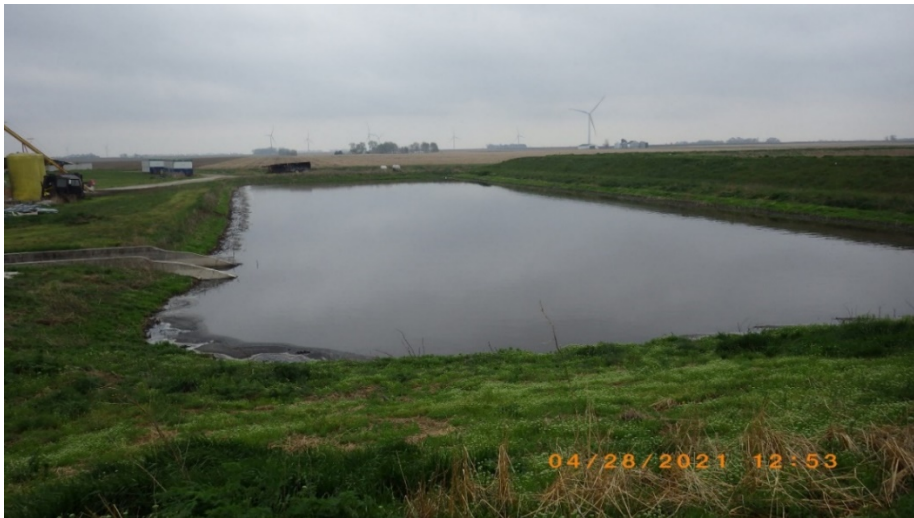
Photo Number: RIMG0163

We observed the Silage Leachate Collection Pond. Stormwater that comes into contact with feed within the concrete Feed Storage Area is collected and flows to the Silage Leachate Collection Pond.

Description: Silage Leachate Collection Pond for the collection of the leachate from the Concrete Feed Storage Area.

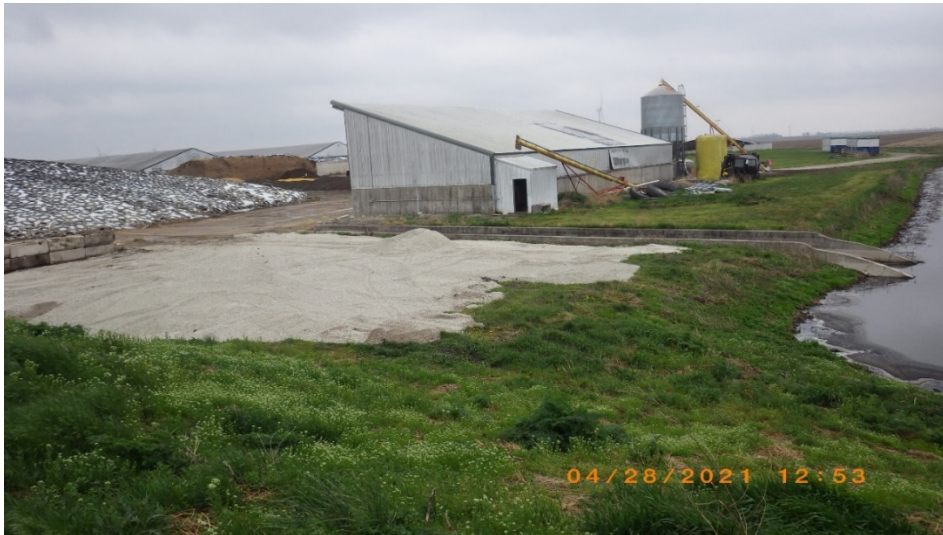
Photo Number: RIMG0164

Description: The concrete conveyance from the concrete feed storage area into the Silage Leachate Collection Pond.

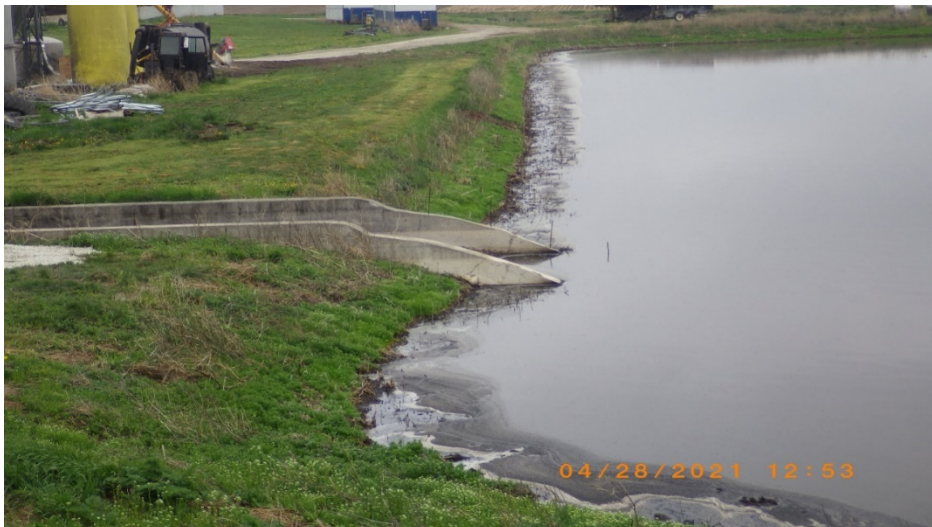
Photo Number: RIMG0165

Description: Close-up of the concrete conveyance from the concrete Feed Storage Area into the Silage Leachate Collection Pond.

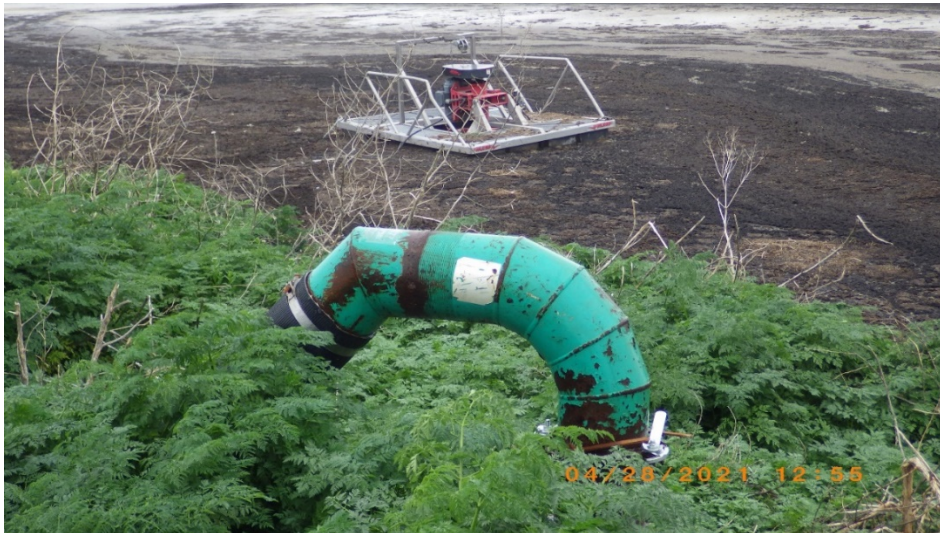
Photo Number: RIMG0166

Description: The aerator or pump within the 3rd Stage Lagoon.

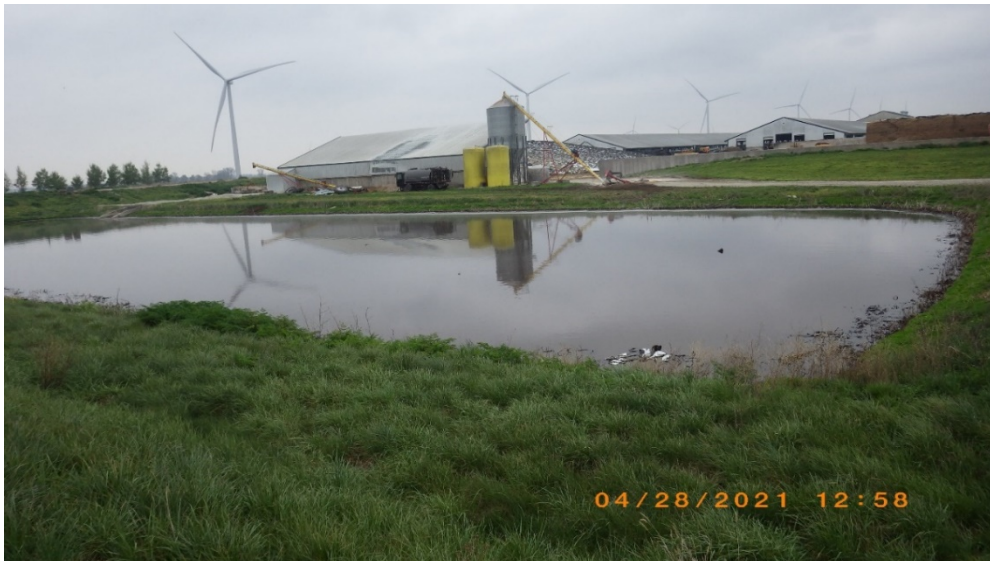
Photo Number: RIMG0167

Description: Silage Leachate Collection Pond.

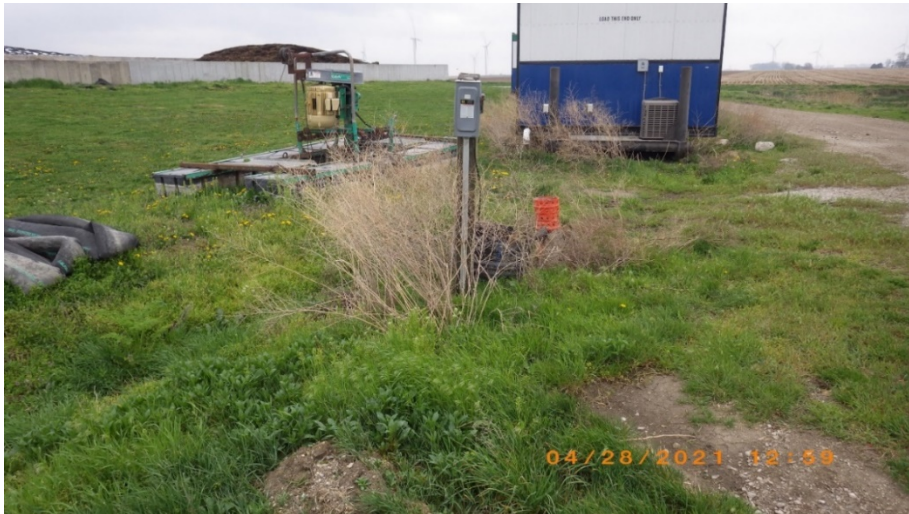
Photo Number: RIMG0168

Description: The perimeter tile pump into the Stormwater Pond.

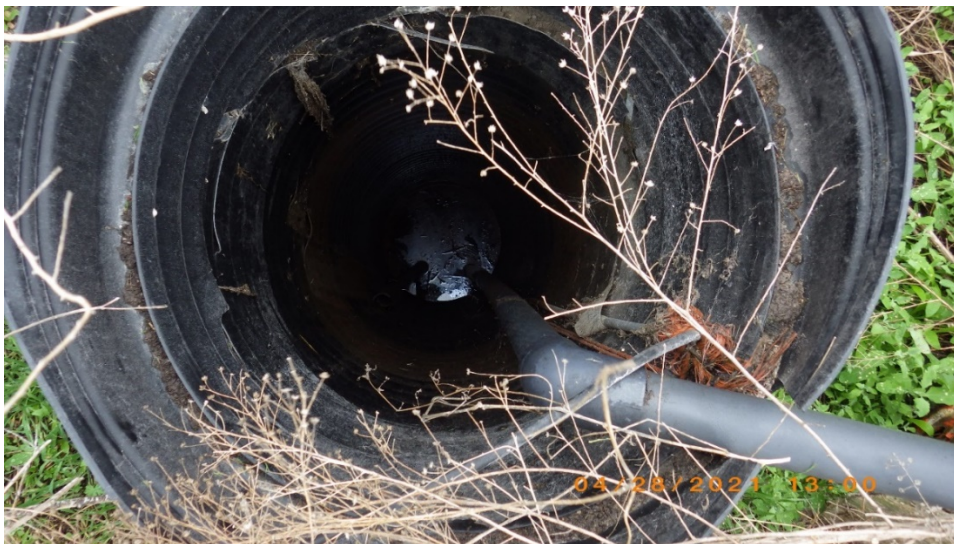
Photo Number: RIMG0169

Description: The perimeter tile pump into the Stormwater Pond.

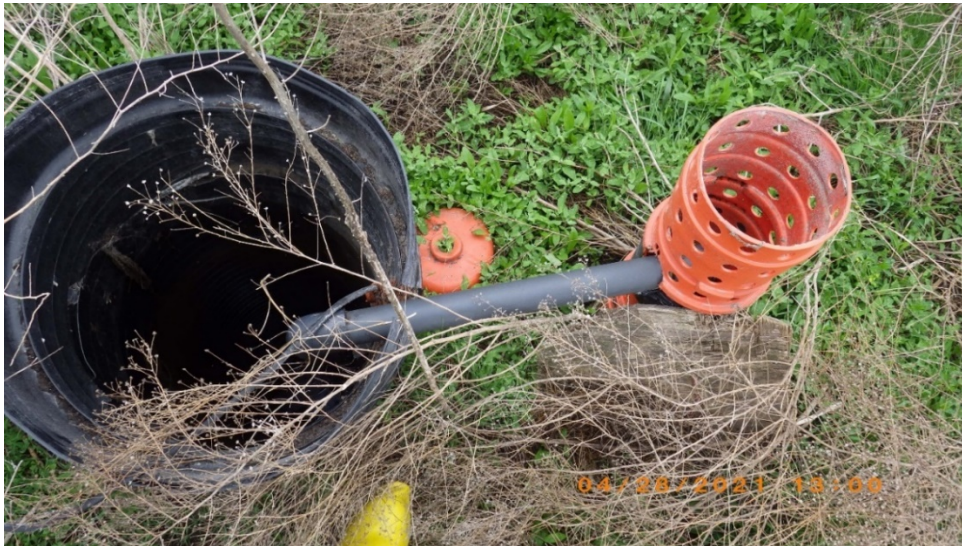
Photo Number: RIMG0170

Description: The perimeter tile pump into the Stormwater Pond.

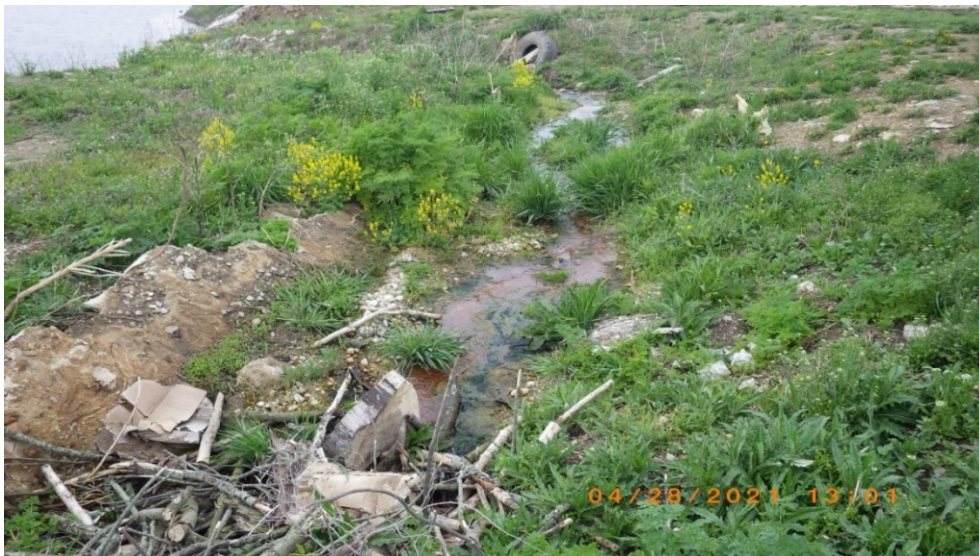
Photo Number: RIMG0171

Description: An eroded channel that conveys surface flow into the Stormwater Pond.

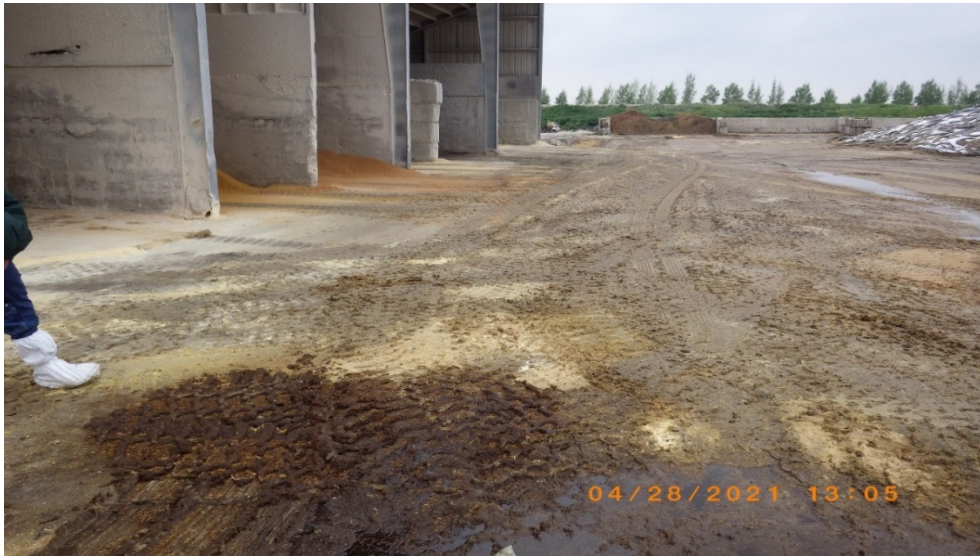
Photo Number: RIMG0172

Description: The commodity shed on the northwest side of the concrete Feed Storage Area.

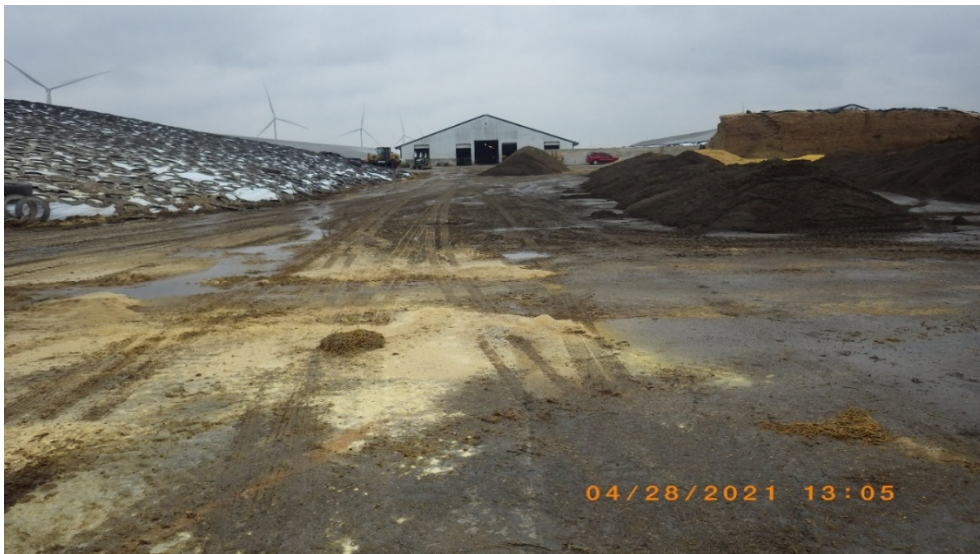
Photo Number: RIMG0173

Description: Concrete Feed Storage Area.

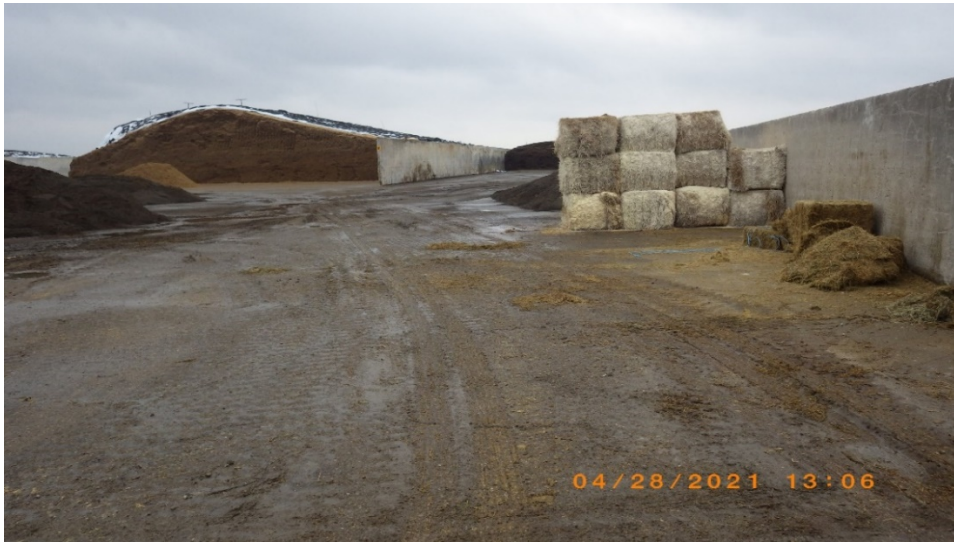
Photo Number: RIMG0174

Description: The concrete Feed Storage Area.

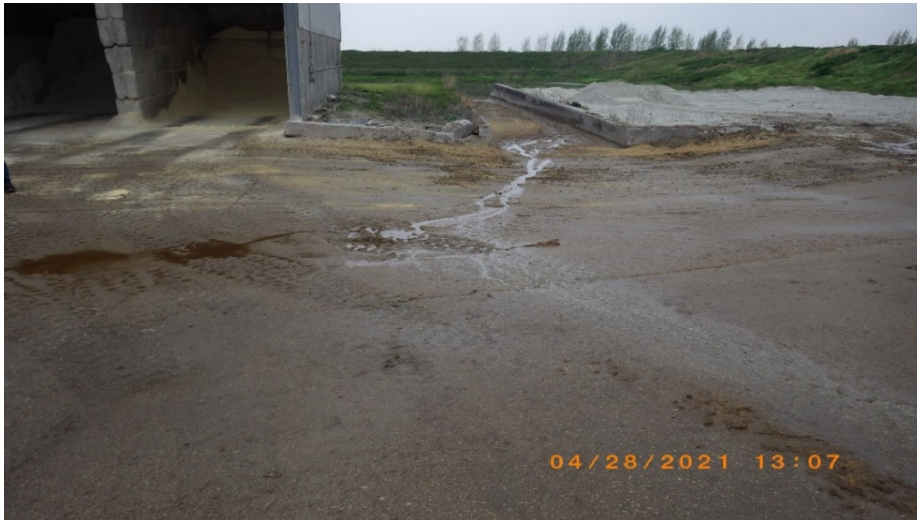
Photo Number: RIMG0175

We observed a few of the manholes within the concrete Feed Storage Area and observed flow into the manholes. These manholes are connected to the Sileage Leachate Collection Pond.

Description: The manhole on the concrete Feed Storage Area that conveys flow to the Silage Leachate Collection Pond.

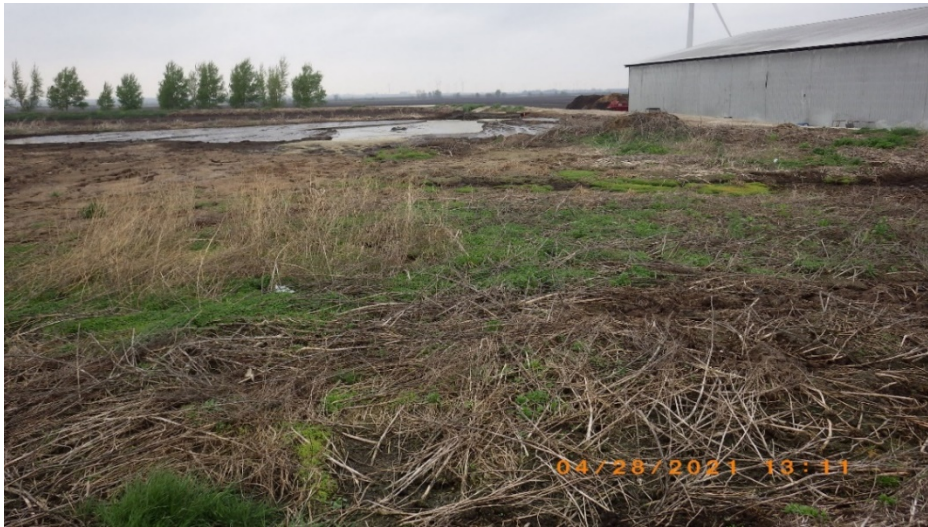
Photo Number: RIMG0176  
Description: The 1<sup>st</sup> Stage Lagoon and Commodity Shed.  
Location: Southwest corner of the Commodity Shed.  
40.485617, -87.496863  
Facing: North.  
Date/Time: 4/28/2021 1:11 p.m.

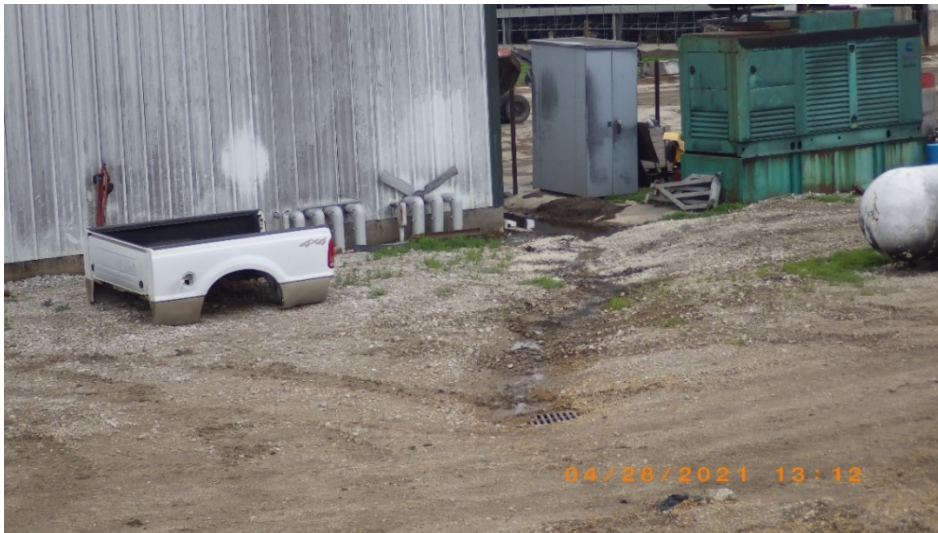
Photo Number: RIMG0176  
Description: The pump to the 1<sup>st</sup> Stage Lagoon from the Sand Separator and drains flow to the Stormwater Pond.  
Location: West of Feed Storage Area and south of commodity shed.  
40.486248, -87.497026  
Facing: Southeast.  
Date/Time: 4/28/2021 1:12 p.m.

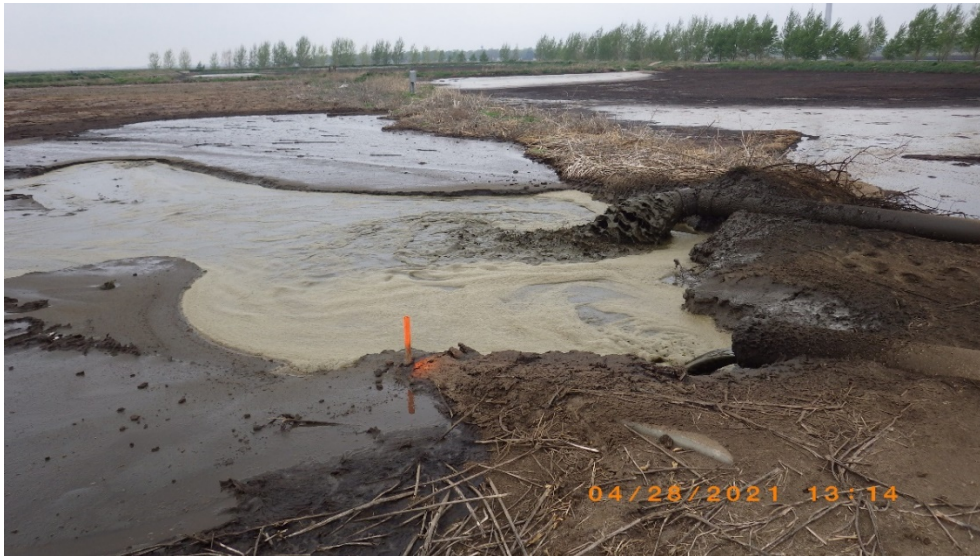
Photo Number: RIMG0178

Description: The depth gage for the 1<sup>st</sup> Stage Lagoon.

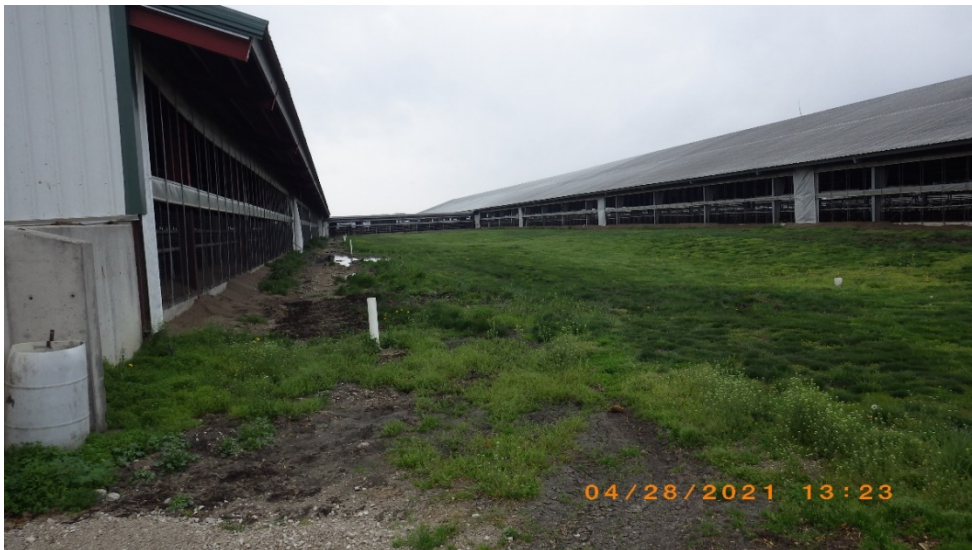
Photo Number: RIMG0179

Description: The drain pipe between Barn 4 and Barn 5.

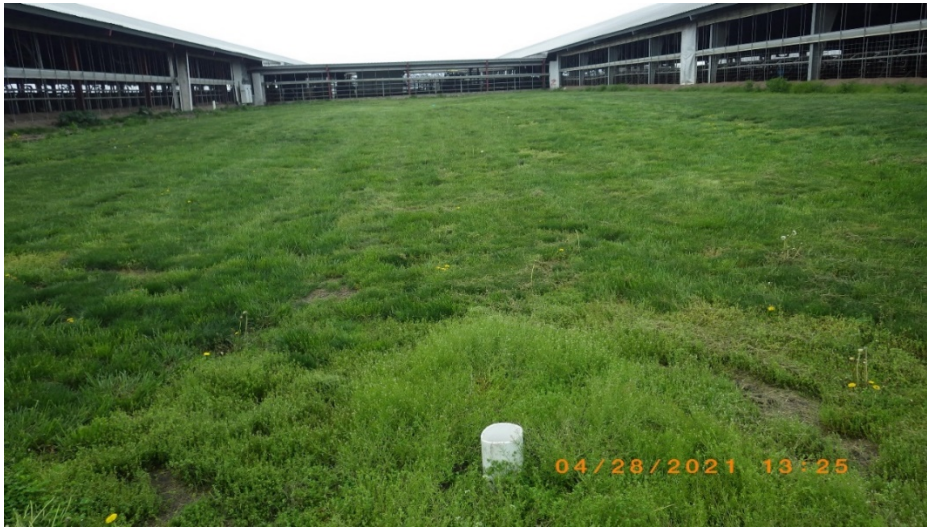
Photo Number: RIMG0180

Description: The drainage tile inlet between Barn 4 and Barn 5 on the east side of the barns.

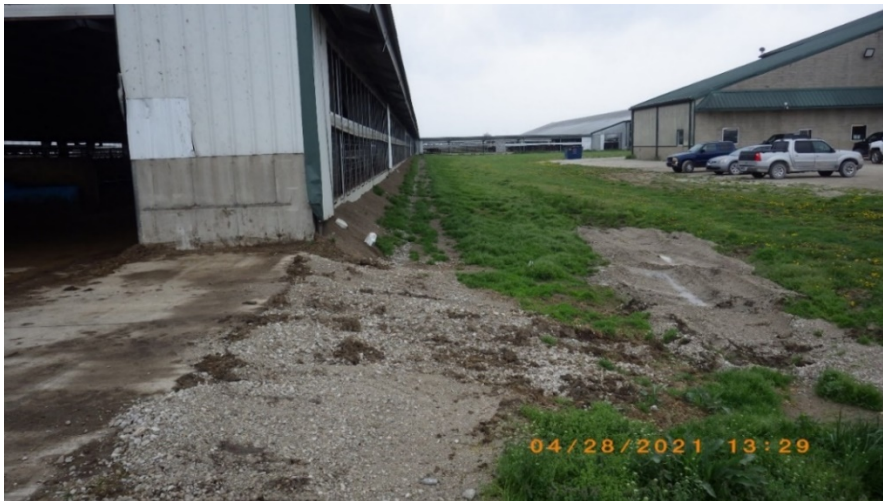
Photo Number: RIMG0181

Description: Stormwater that comes into contact with used bedding and feed pushed out of Barn 4 flows to the north and to the east through the drainage tile inlet that runs under the East Access Road and outlets into the East Drainage Channel that flows into the Stormwater Pond.

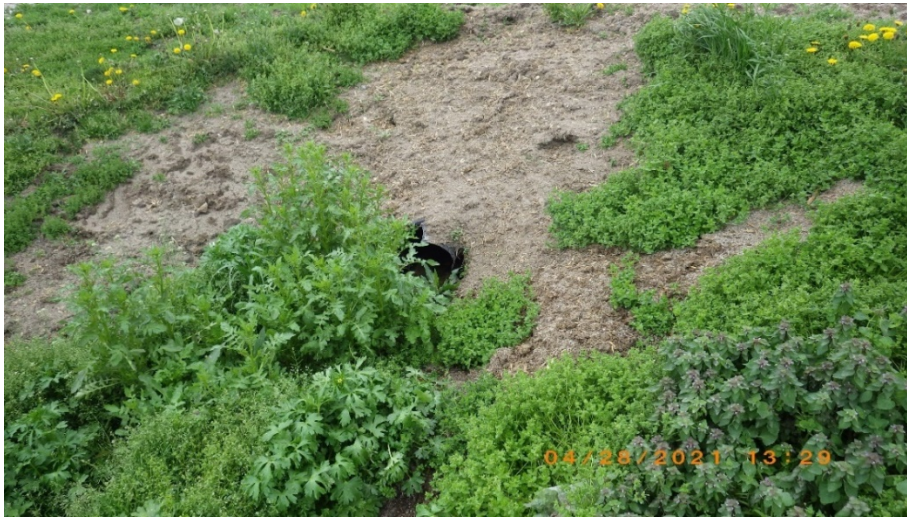
Photo Number: RIMG0182

Description: The drainage inlet from between Barn 4 and Barn 3.

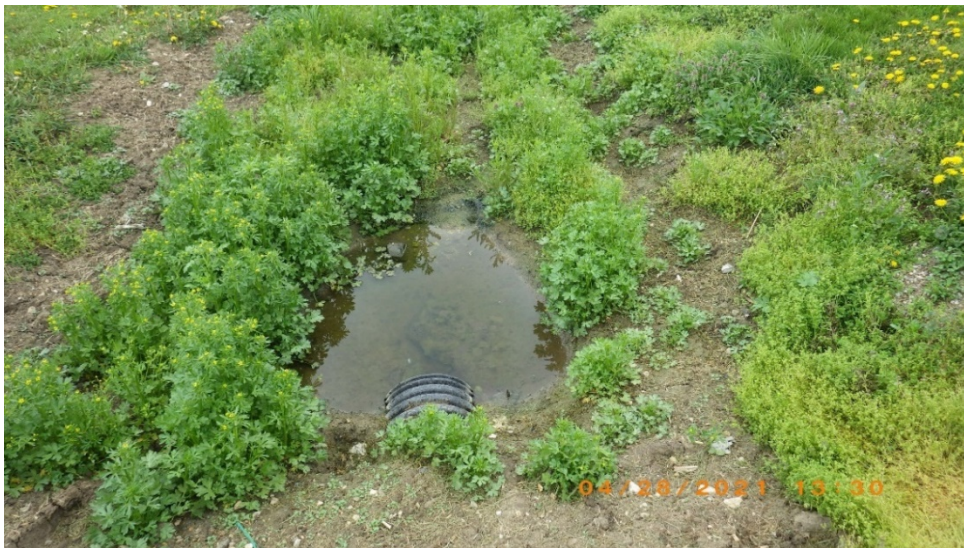
Photo Number: RIMG0183

Description: The drainage outlet from between Barn 4 and Barn 3 into the East Drainage Channel east of the East Access Road.

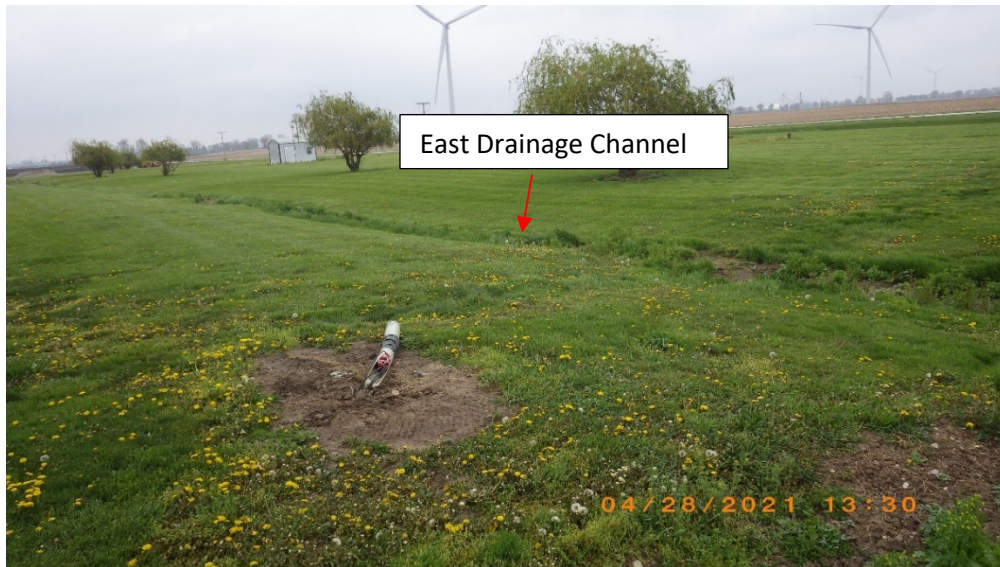
Photo Number: RIMG0184

Description: The East Drainage Channel on the east side of the facility east of the east access road.

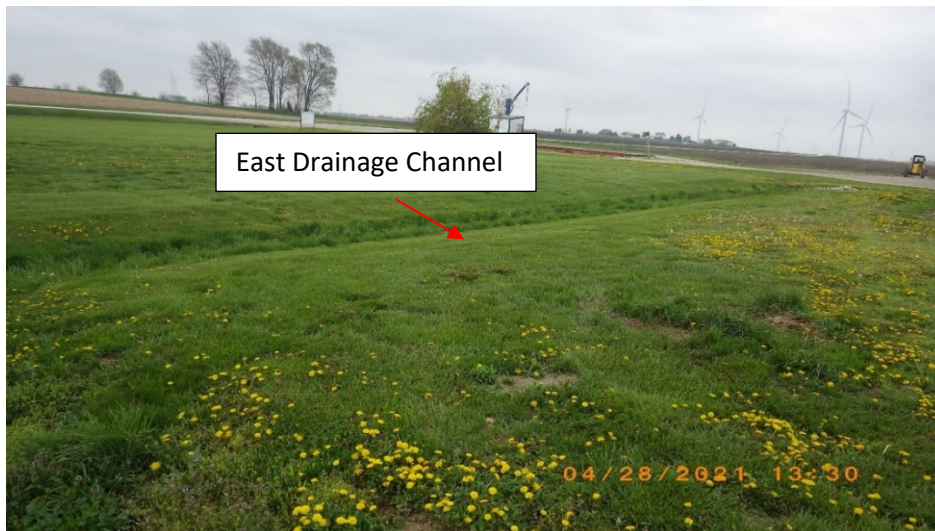
Photo Number: RIMG0185

Description: The East Drainage Channel that collects frow from between the barns.

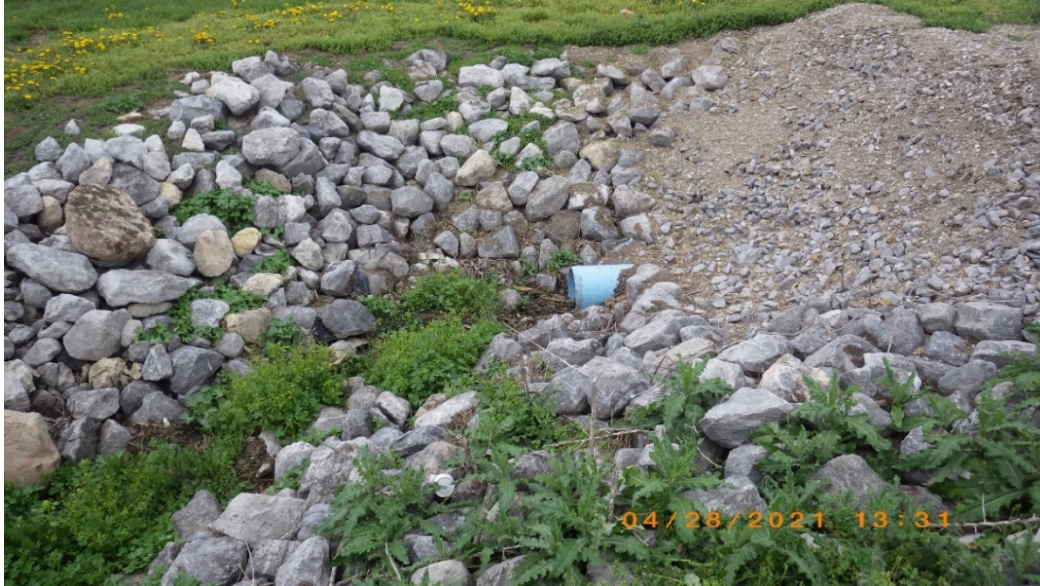
Photo Number: RIMG0186

Description: The drainage outlet conveys the stormwater and process wastewater from what is pushed out of the barns and conveys it under the East Access Road to the East Drainage Channel into the Stormwater Pond.
