Region 10 Enforcement and Compliance Assurance Division

INSPECTION REPORT

| <b>Regulatory Program:</b> | CWA NPDES/Industrial Stormwater | |
| <b>Facility Name:</b> | Notus, Boise River Rd. Facility | |

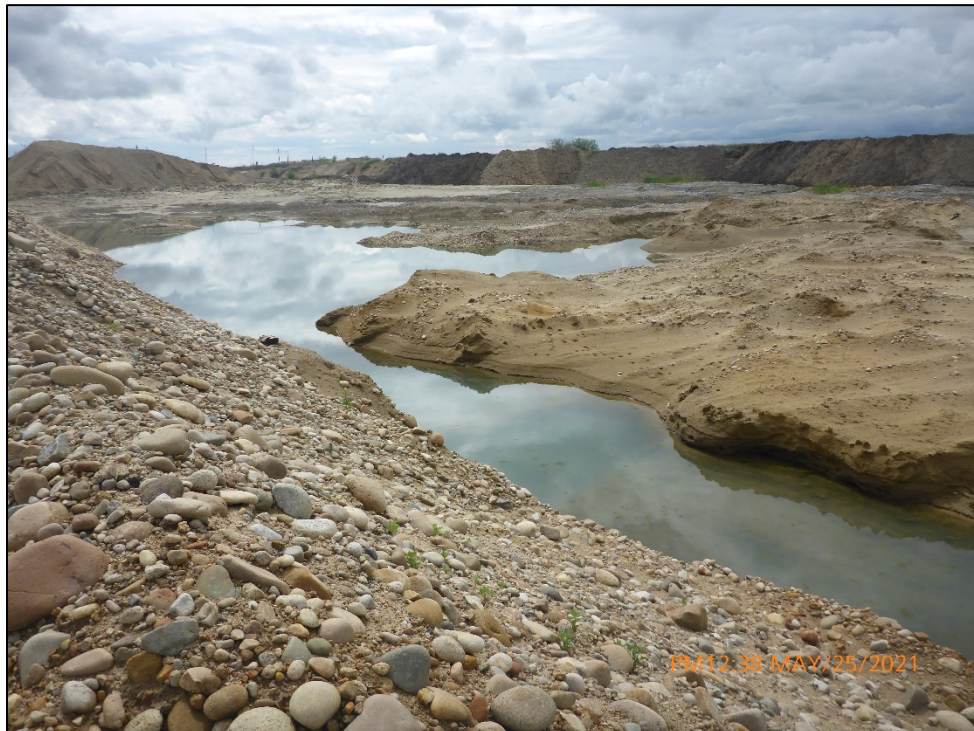
**Photograph 2.** View, facing southeast, of the low point in the pit area which Mr. Kalmbach identified as a groundwater accumulation area and which the SWPPP site map identifies as Sediment Pond (refer to Exhibit 3).

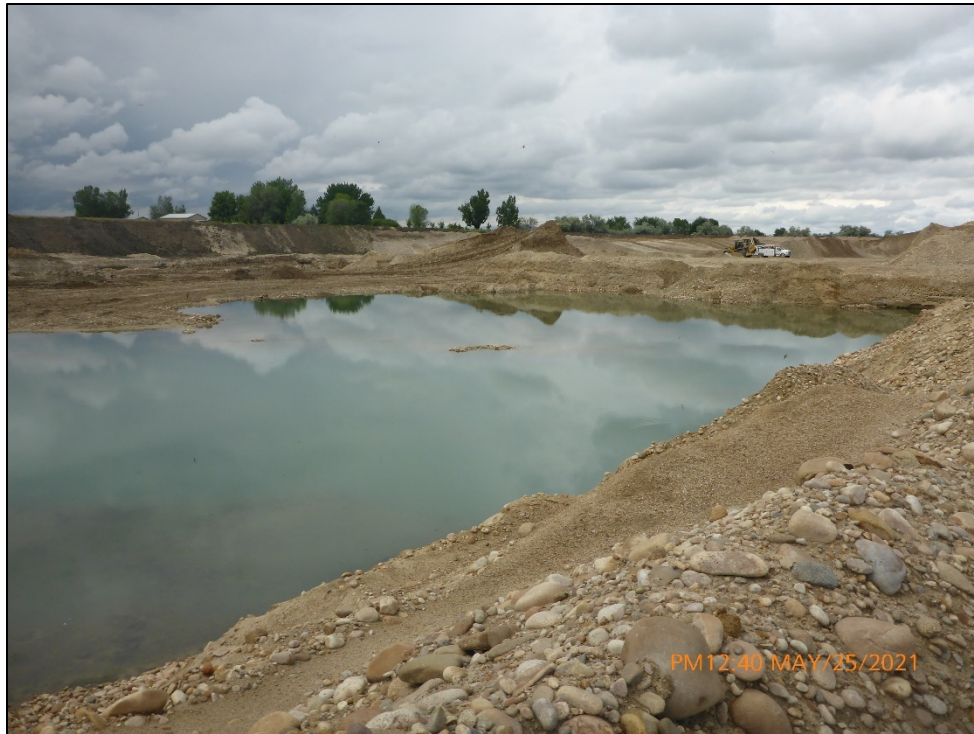
**Photograph 3.** View, facing southwest, of the low point in the pit area which Mr. Kalmbach identified as a groundwater accumulation area and which the SWPPP site map identifies as Sediment Pond (refer to Exhibit 3).

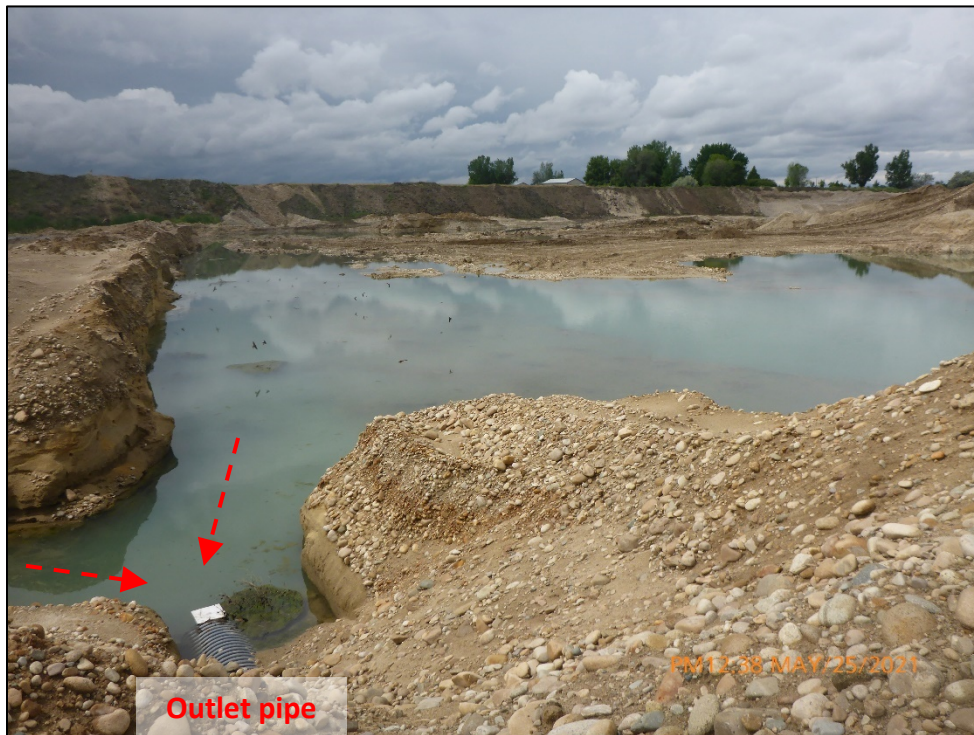
**Photograph 4.** Additional view, facing southwest, of the Sediment Pond and exposed groundwater shown in Photographs 2 and 3. Note the outlet pipe which conveys groundwater north, into a channel, and ultimately to the dewatering pumps shown in Photograph 5 and 6.

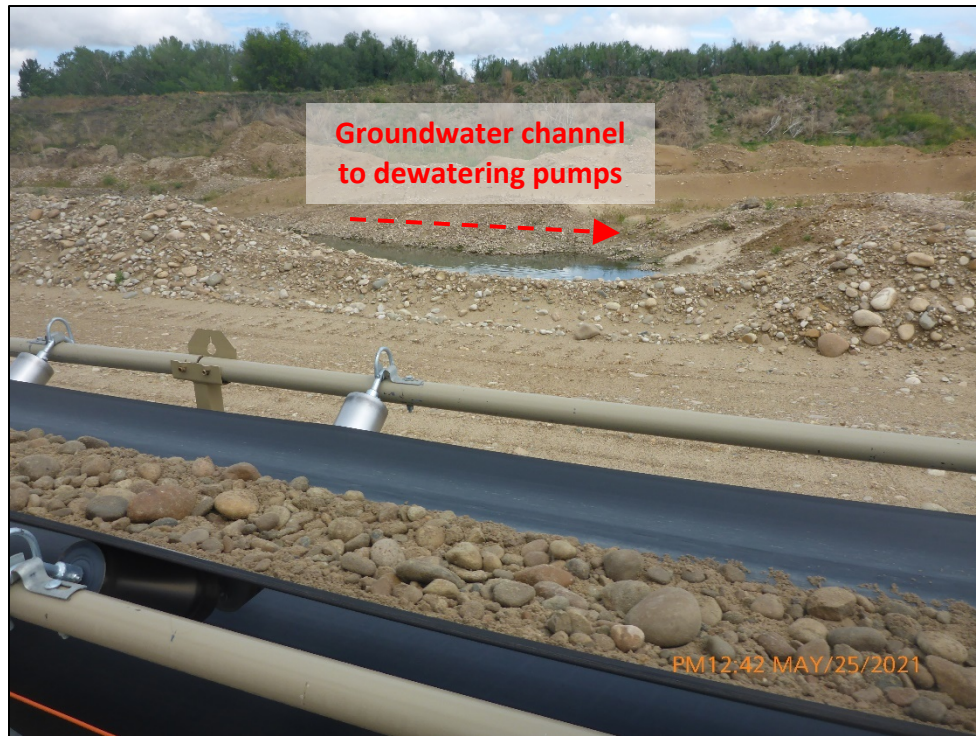
**Photograph 5.** View, facing north, of the approximate location where groundwater from the Sediment Pond is piped north under the main pit access road and aggregate conveyor into the channel that flows east to the dewatering pumps shown in Photograph 5.

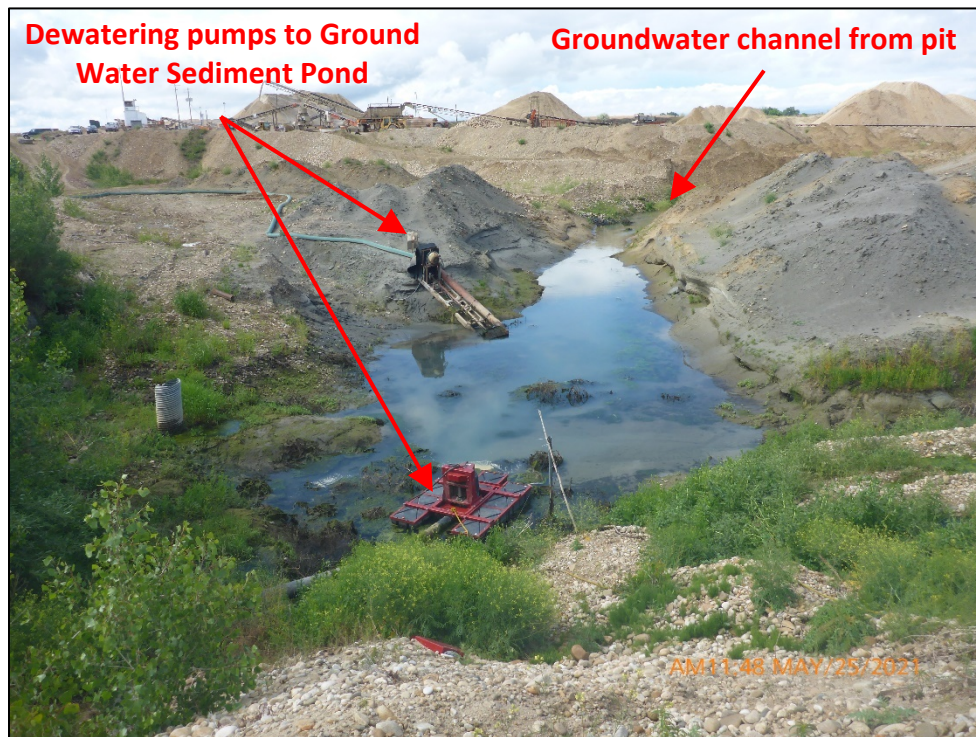
Mr. Kalmbach explained that groundwater collects in a low point in the central portion of the excavated pit area, referred to on the SWPPP site map as Sediment Pond (Exhibit 3). He added that mining operations are occurring on the far western pit wall and that stormwater runoff from that area is typically contained. This area was unable to be viewed due to active mining operations occurring. An earthen berm was constructed along the western edge of the groundwater accumulated in this low point (refer to Photographs 2, 3, and 4). Mr. Kalmbach further explained that from this low point, groundwater is piped north, under the pit access road and aggregate conveyer belt, into a channel that flows to the surface water collection point in the northeastern portion of the pit. This channel was inaccessible due to the operating aggregate conveyer belt that spans the pit from west to east along the main pit access road (refer to Photographs 4 and 5). This channel flows to the dewatering pumps in the northeastern portion of the mining pit which pump to the Ground Water Sediment Pond (refer to Photograph 6).

**Photograph 6.** View, facing south, of the groundwater dewatering pumps in the northeast corner of the mining pit area. Groundwater is pumped via one permanent pump and one secondary pump (only used during wet season) to the Ground Water Sediment Pond shown in Photographs 7, 8, and 9.

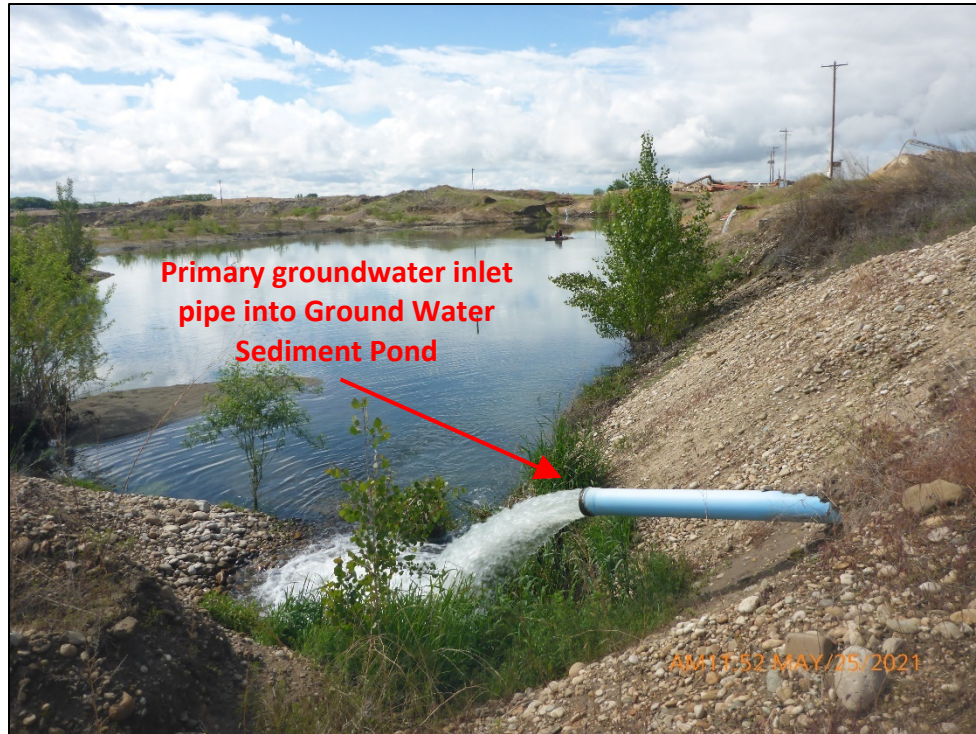
**Photograph 7.** View of the primary (year-round) inlet pipe that conveys groundwater into the Ground Water Sediment Pond.

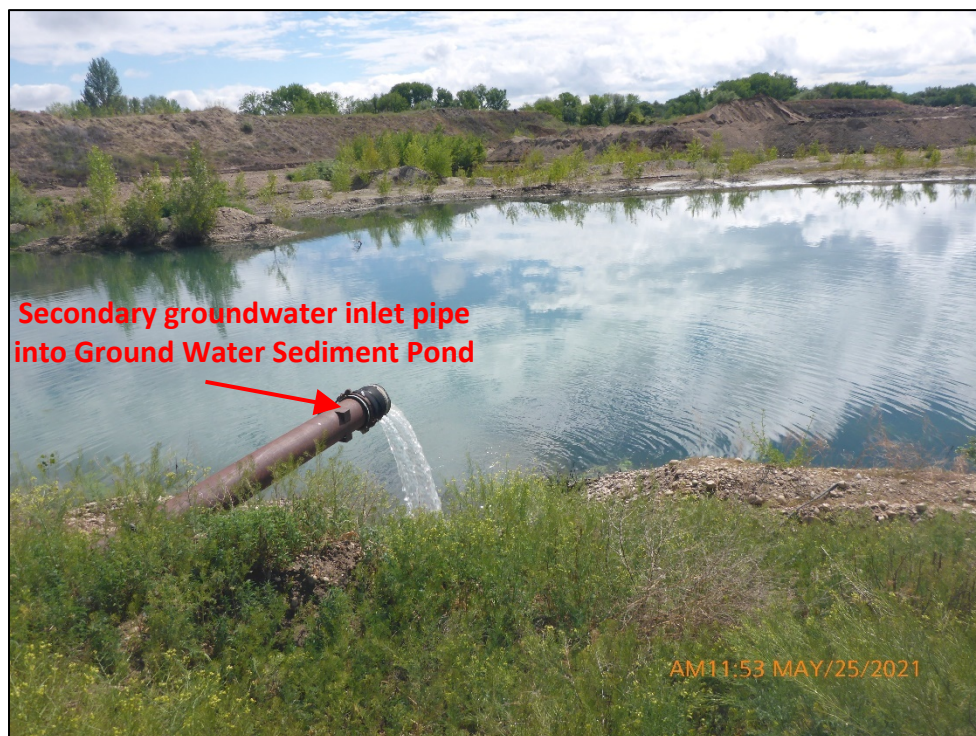
**Photograph 8.** View of the secondary inlet pipe (during wet season) into the Ground Water Sediment Pond.

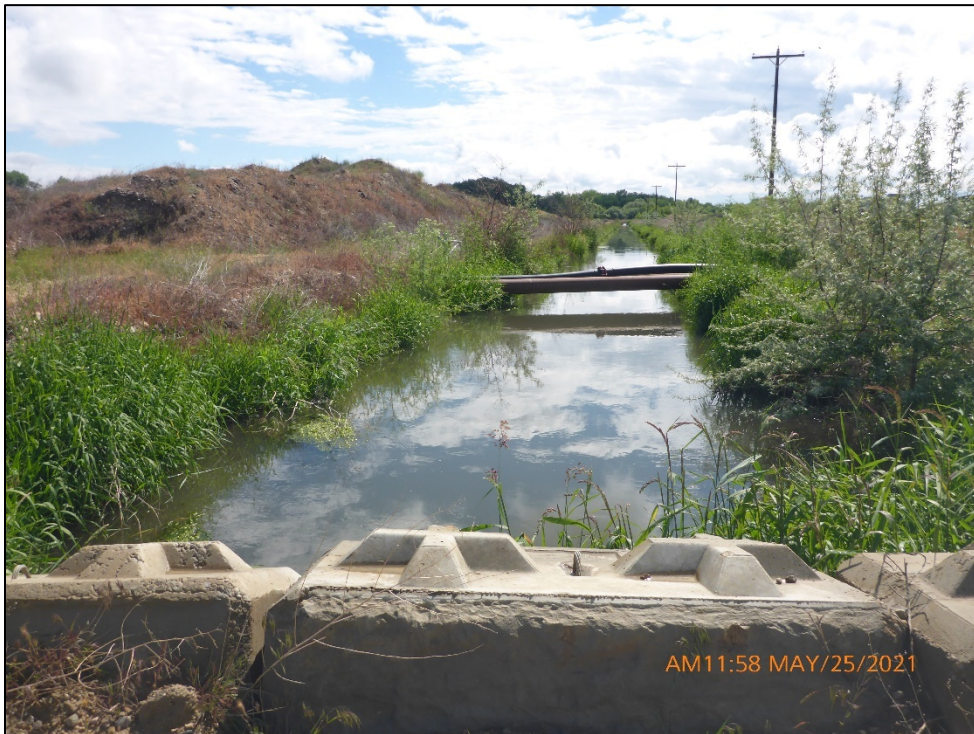
**Photograph 10.** View, facing east (upstream), of the tributary of the Center Point Canal that flows from east to west through the Facility. The Facility does not have outfalls that discharge into this waterbody.

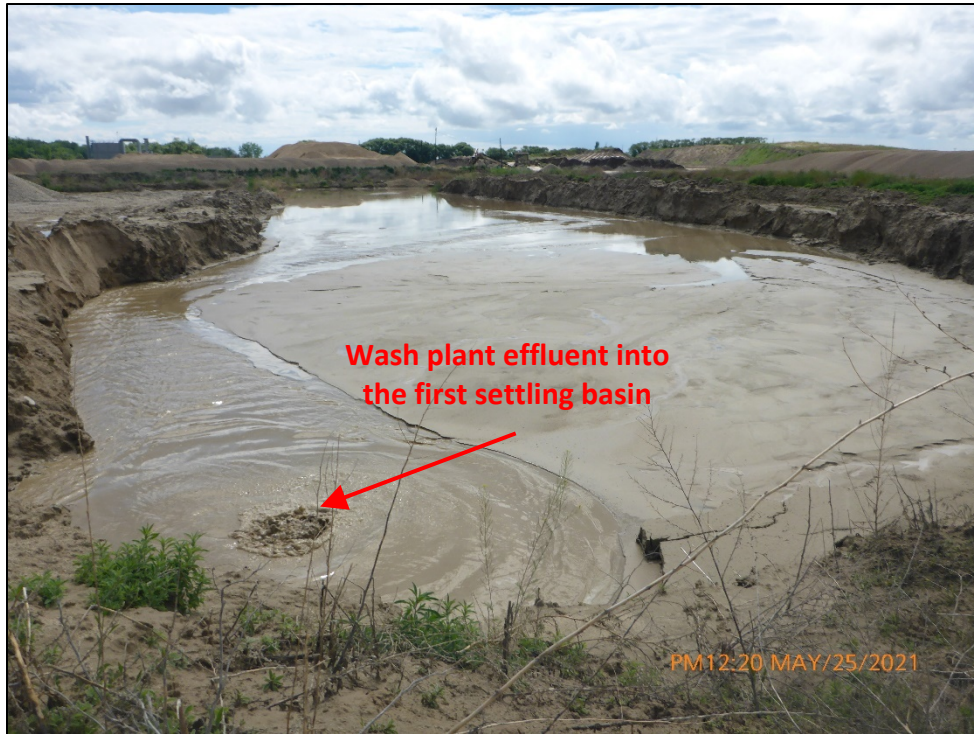
**Photograph 17.** View, facing southeast, of the aggregate wash water discharge point into the first of six onsite wash water settling ponds.

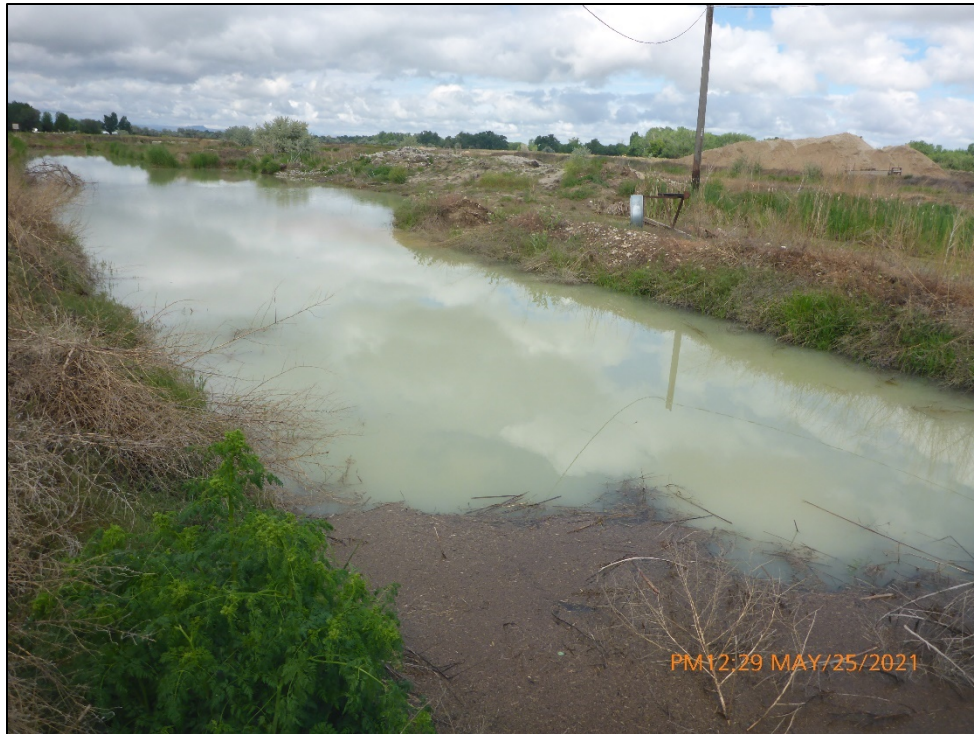
**Photograph 21.** View of the sixth and final wash water settling pond. Mr. Kalmbach stated that this pond does not discharge offsite. Freeboard in this basin appeared sufficient and the downgradient berm was intact and vegetated.

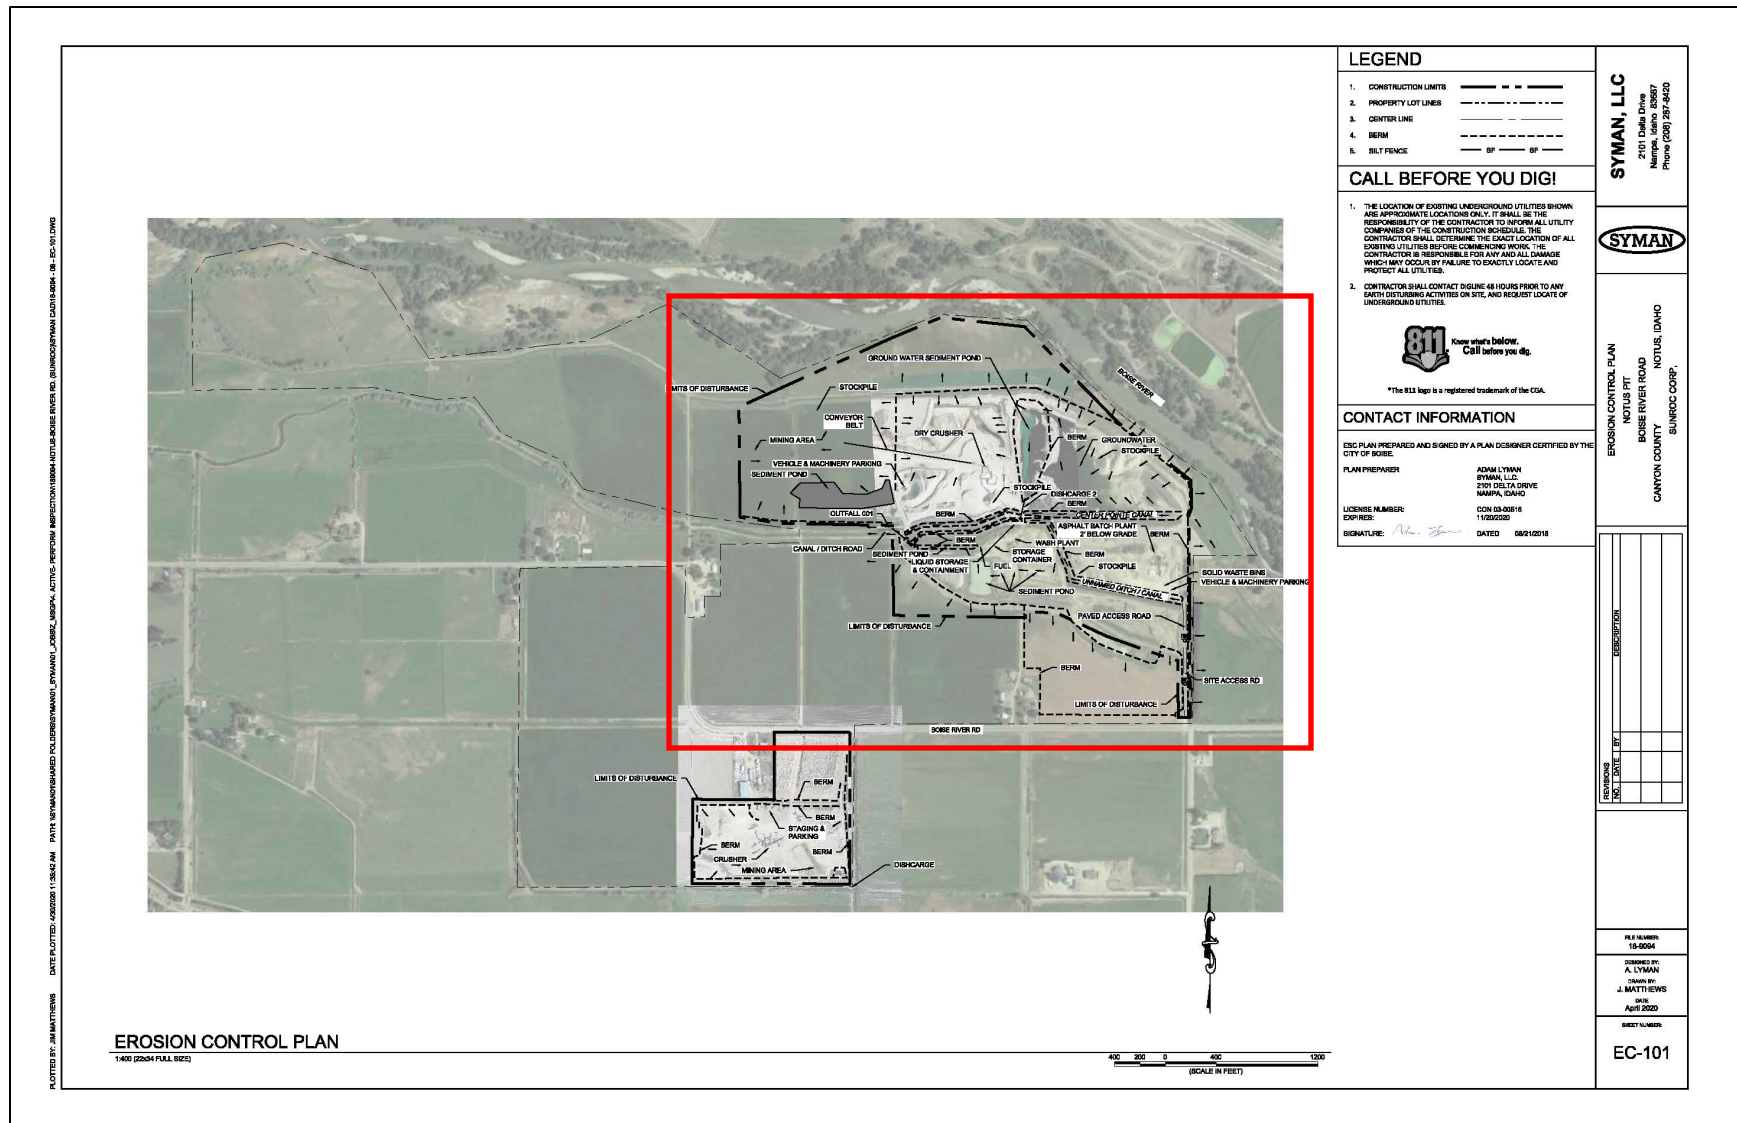
The SWPPP site map did not identify all stormwater discharge and monitoring points at the Facility. The Inspection Team noted that the SWPPP site map identifies two discharge points: 'Outfall 001' where the unnamed ditch leaves the property and 'Discharge 2' (refer to Exhibit 3). These points were indicated by an arrow pointing near where the two pipes from the groundwater retention basin discharge into the unnamed irrigation ditch, which was observed during the Facility walk-through. While it was unclear which discharge point was indicated by 'Discharge 2', the Inspection Team noted that at least one of the two discharge points was not identified on the site map. The site map also does not indicate whether Outfall 001 or Discharge 2 is a stormwater monitoring point. As stated above, the Permittee conducts sampling at the downstream discharge pipe (main discharge point) into the unnamed ditch (refer to Photographs 12 and 13).

The SWPPP site map did not clearly identify groundwater conveyances in the pit area. Since the SWPPP was developed, the pit has expanded within its limits of disturbance (refer to Exhibit 2). As such, flow paths and conveyance locations had changed slightly. Of note, the conveyance of groundwater from the groundwater low point identified by Mr. Kalmbach (referred to as Sediment Pond on SWPPP Site Map), through a pipe, and into the channel that flows to the northeastern dewatering pumps shown in Photograph 6 is not clearly identified (refer to Exhibit 3). The SWPPP Site Map also does not identify any structural controls (berm) used by the Facility to segregate stormwater and groundwater.

- Area of Concern 7b – The SWPPP site map did not clearly identify groundwater conveyances or structural controls in the mining pit area.
- Area of Concern 8 – The Facility’s NOI and SWPPP only identify one outfall; however, the Inspection observed two discharge points from the Facility into the unnamed irrigation ditch.

Exhibit 3. General View: SWPPP Site Map. Red box indicates the close-up shown on next page.
