**Report Title:** Clean Water Act, Section 404 Inspection Report for Susquehanna Union Green

**Inspection Date(s):** 05/23/2024

**Site Name:** Susquehanna Union Green

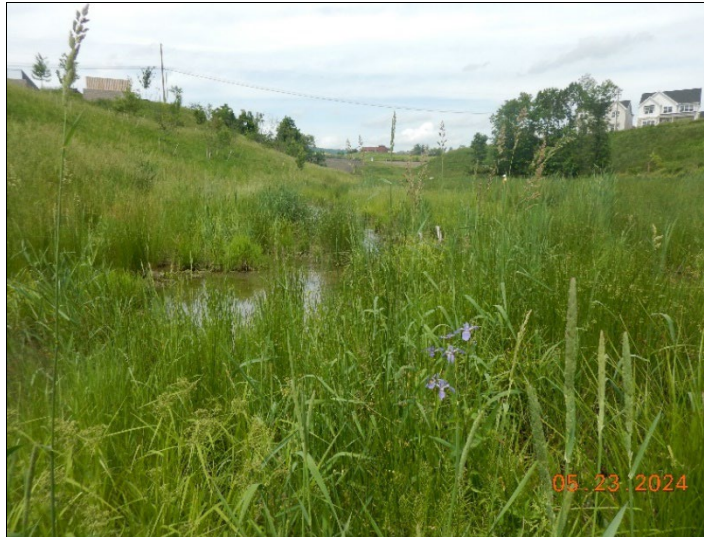
Susquehanna Union Green  
Date: 23 May 2024  
Photo ID: DSCN5408.JPG  
Photo taken by: Katelyn Almeter

The inspection continued upstream, most of the restored area was densely vegetated with herbaceous vegetation (DSCN5408, DSCN5411, DSCN5412, DSCN5414, DSCN5421, and DSCN5422), with some sparsely vegetated areas observed along the stream banks with exposed matting

Notes: View farther upstream of Black Run Creek and surrounding areas.

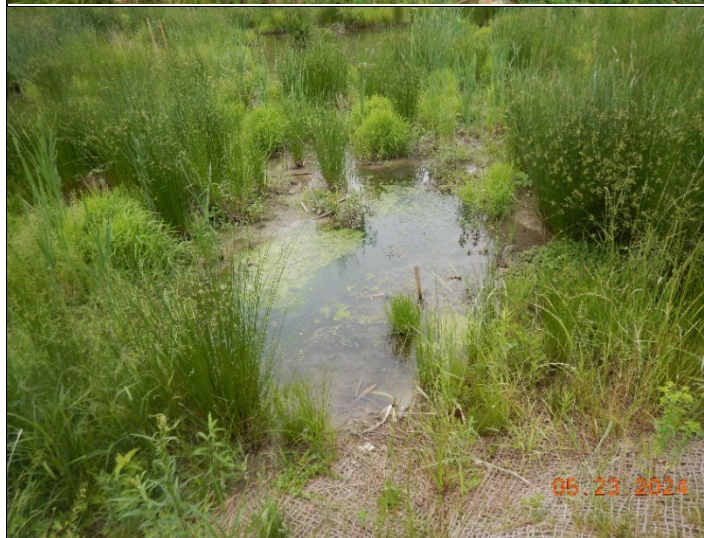
Susquehanna Union Green  
Date: 23 May 2024  
Photo ID: DSCN5410.JPG  
Photo taken by: Katelyn Almeter

Notes: View of Black Run Creek with the presence of herbaceous vegetation throughout.

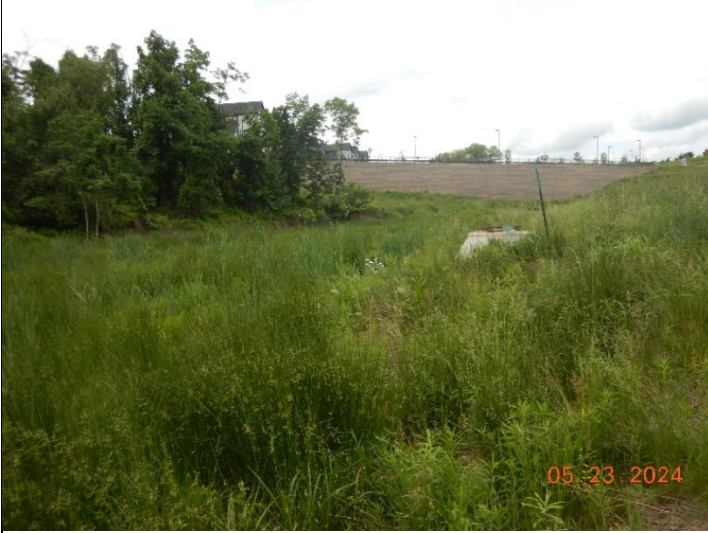
| <p>05.23.2024</p> | <p>Susquehanna Union Green<br/>Date: 23 May 2024<br/>Photo ID: DSCN5411.JPG<br/>Photo taken by: Katelyn Almeter</p> <p>Notes: North facing view of the floodplain farther upstream along Black Run Creek with a retention wall for residential development in the background.</p> |

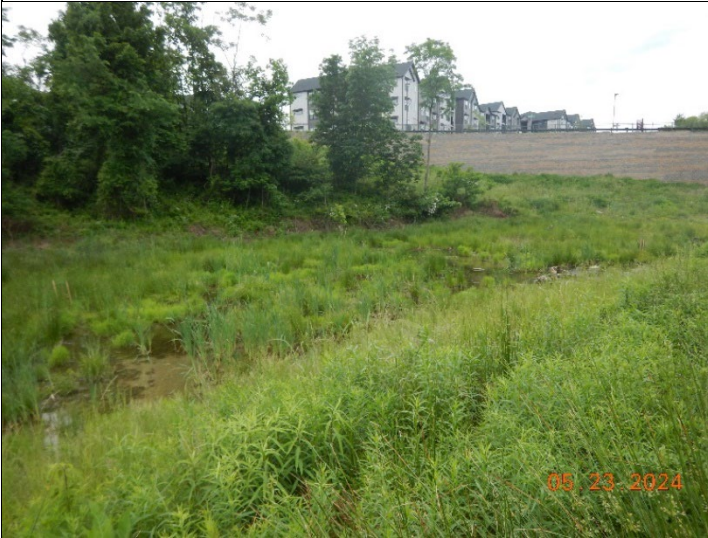
| <p>05.23.2024</p> | <p>Susquehanna Union Green<br/>Date: 23 May 2024<br/>Photo ID: DSCN5412.JPG<br/>Photo taken by: Katelyn Almeter</p> <p>Notes: View facing north/northwest of Black Run Creek with residential development in the background.</p> |

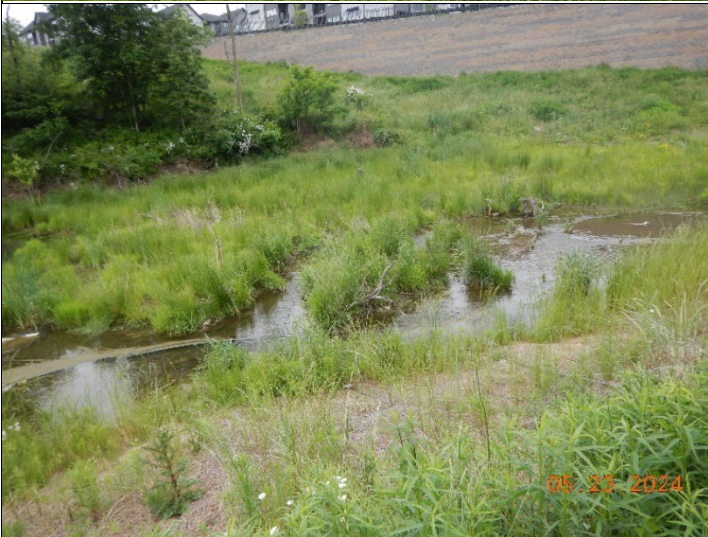
| <p>05.23.2024</p> | <p>Susquehanna Union Green<br/>Date: 23 May 2024<br/>Photo ID: DSCN5413.JPG<br/>Photo taken by: Katelyn Almeter</p> <p>Notes: Another view of Black Run Creek.</p> |

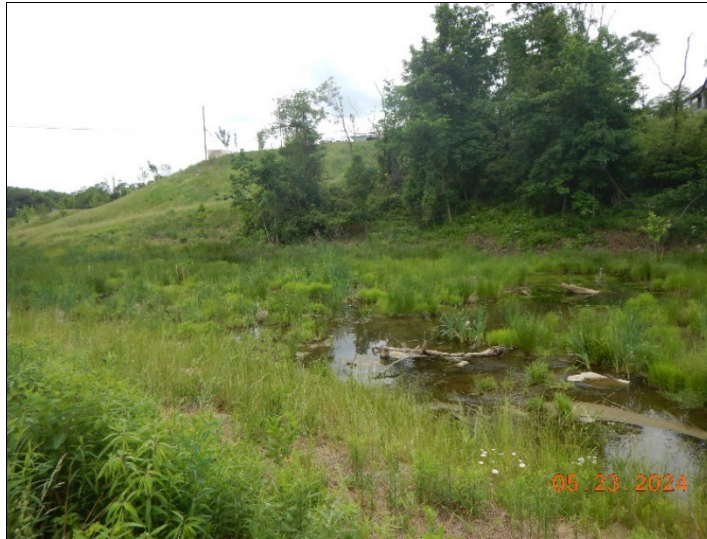
Susquehanna Union Green  
Date: 23 May 2024  
Photo ID: DSCN5414.JPG  
Photo taken by: Katelyn Almeter

Notes: Downstream view of Black Run Creek.

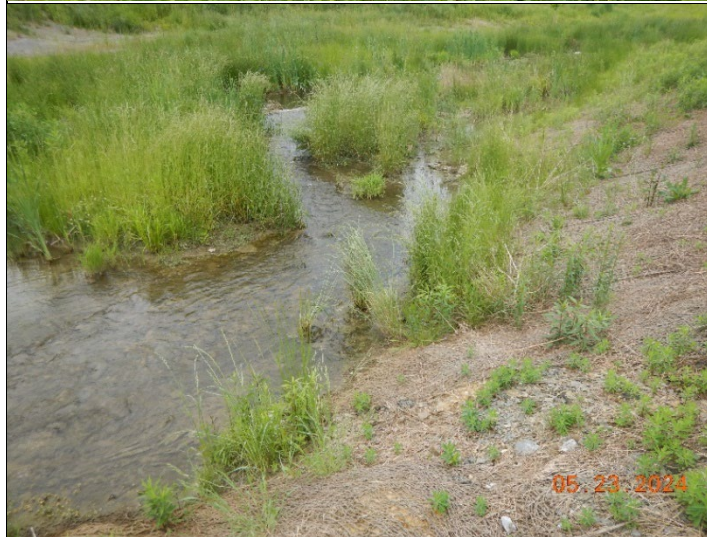
Susquehanna Union Green  
Date: 23 May 2024  
Photo ID: DSCN5416.JPG  
Photo taken by: Katelyn Almeter

Notes: View showing the meandering of Black Run Creek.

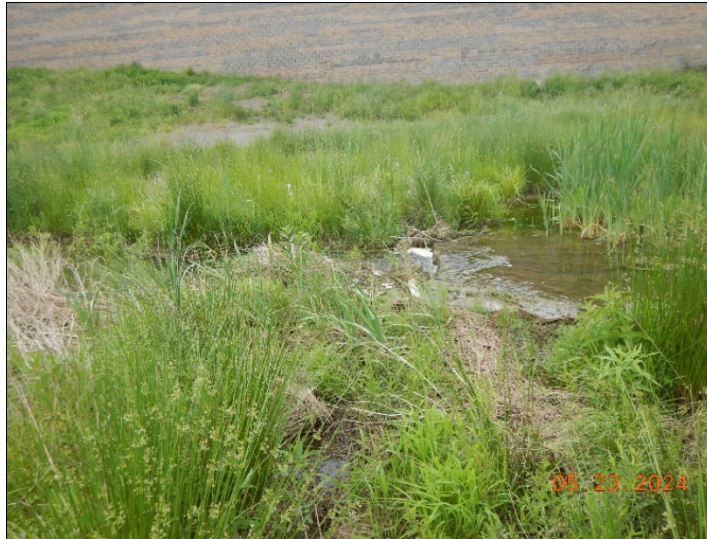
Susquehanna Union Green  
Date: 23 May 2024  
Photo ID: DSCN5417.JPG  
Photo taken by: Katelyn Almeter

Notes: Another view farther upstream of Black Run Creek.

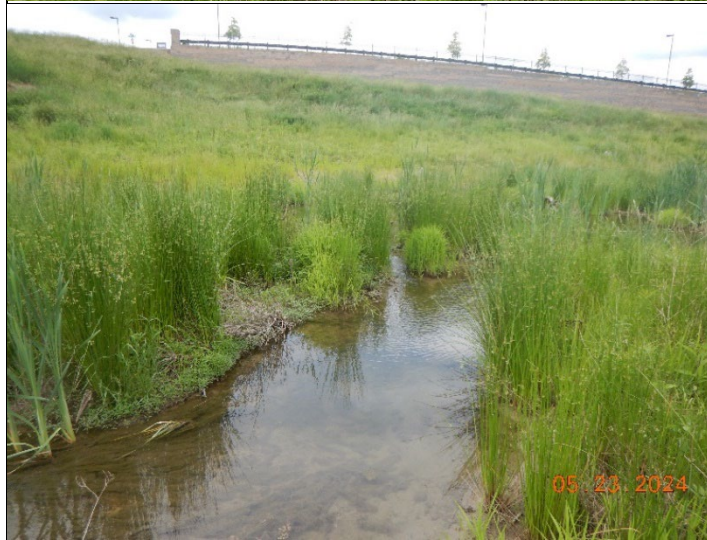
Susquehanna Union Green  
Date: 23 May 2024  
Photo ID: DSCN5418.JPG  
Photo taken by: Katelyn Almeter

Notes: Another view of Black Run Creek as the inspection moved upstream.

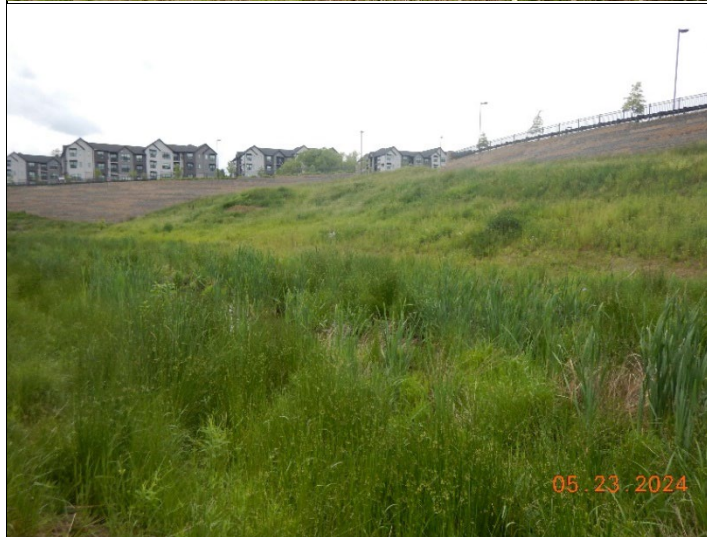
Susquehanna Union Green  
Date: 23 May 2024  
Photo ID: DSCN5421.JPG  
Photo taken by: Katelyn Almeter

Notes: East facing view of the restored floodplains with residential development in the background.

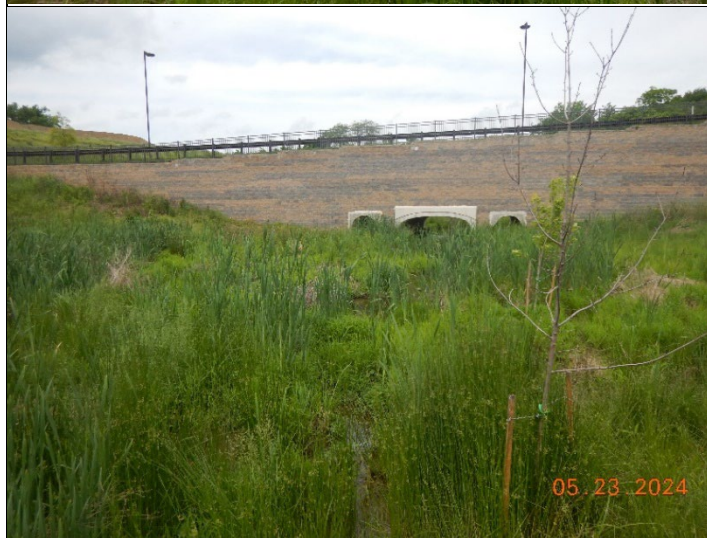
Susquehanna Union Green  
Date: 23 May 2024  
Photo ID: DSCN5422.JPG  
Photo taken by: Katelyn Almeter

Notes: View facing upstream of Black Run Creek and surrounding area.

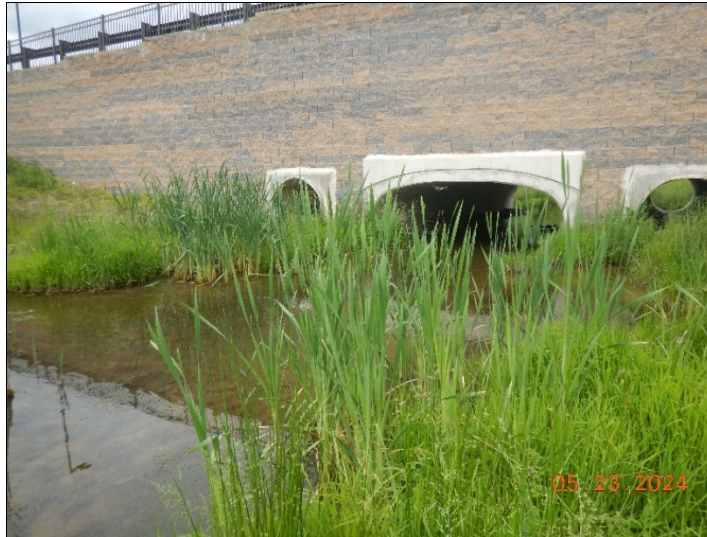
Susquehanna Union Green  
Date: 23 May 2024  
Photo ID: DSCN5423.JPG  
Photo taken by: Katelyn Almeter

The inspection moved upstream where Black Run flows through a culvert under Hawthorne Drive (DSCN5423). Two overflow pipes were observed on either side of the culvert (DSCN5424), and the area was densely vegetated with broadleaf cattails (*Typha latifolia*), rice cutgrass (*Leersia oryzoides*), soft rush (*Juncus effusus*), soft-stem bulrush (*Scirpus validus*), and foxtail (*Alopecurus aequalis*). The inspectors moved up the slope on the left side of Black Run towards Hawthorne Dr and noted a retention basin near the toe of the slope (DSCN5424). The inspectors then noted that the Black Run floodplain upstream of the culvert was densely vegetated (DSCN5429) prior to flowing through the culvert under the road (DSCN5427 and DSCN5430). A portion of a black drainpipe was noted in the hillslope along the stream. It appeared that a portion of streamflow was being captured and transported through the pipe (DSCN5428).

Notes: View of Black Run Creek on the downstream side of the culvert.

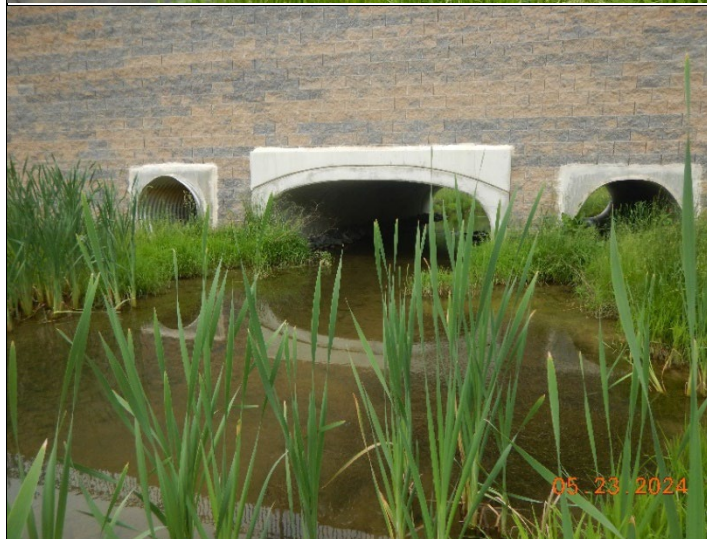
Susquehanna Union Green  
Date: 23 May 2024  
Photo ID: DSCN5424.JPG  
Photo taken by: Katelyn Almeter

Notes: Another view of Black Run Creek on the downstream side of the culvert.

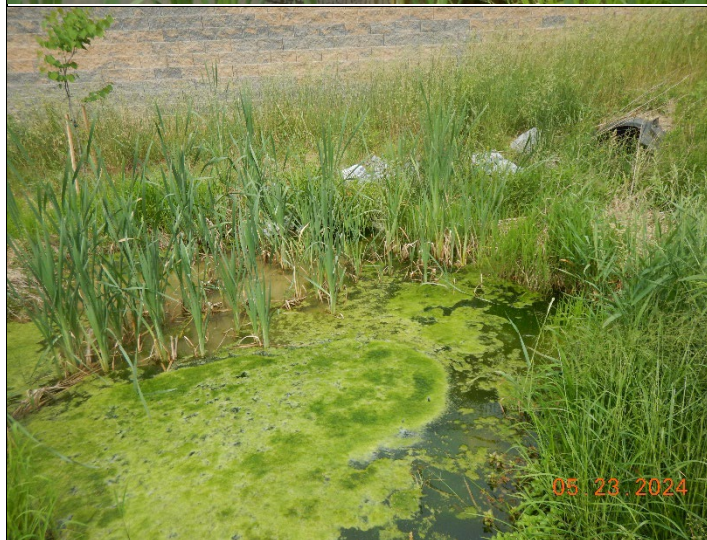
Susquehanna Union Green  
Date: 23 May 2024  
Photo ID: DSCN5425.JPG  
Photo taken by: Katelyn Almeter

Notes: View of Black Run Creek near the culvert.

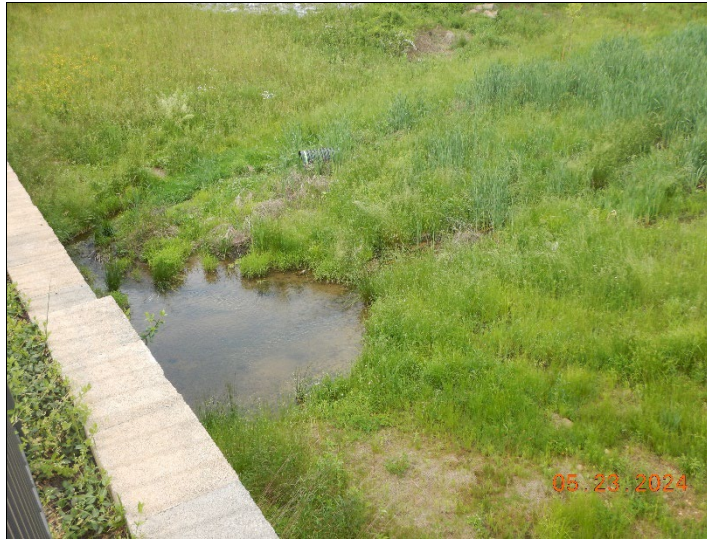
Susquehanna Union Green  
Date: 23 May 2024  
Photo ID: DSCN5427.JPG  
Photo taken by: Katelyn Almeter

Notes: View of Black Run Creek upstream of the culvert.

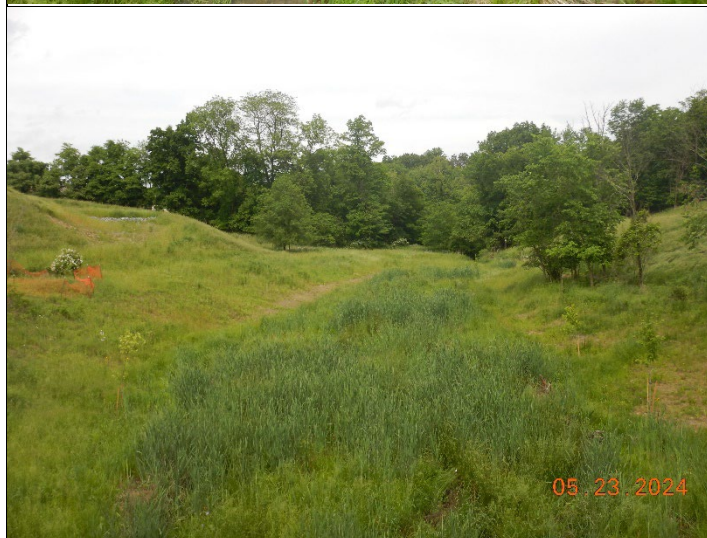
Susquehanna Union Green  
Date: 23 May 2024  
Photo ID: DSCN5429.JPG  
Photo taken by: Katelyn Almeter

Notes: View of Black Run Creek and the surrounding areas upstream of the culvert.
