**Region 6 - Enforcement & Compliance Assurance Division**  
**INSPECTION REPORT**

| Inspection Date(s): | 12/12/2023 | |
| Company Name: | <b>Jamie Oil, Inc.</b> | |
| Facility Name: | <b>Frost F#3, F#4, and F#5 Tank Battery</b> | |

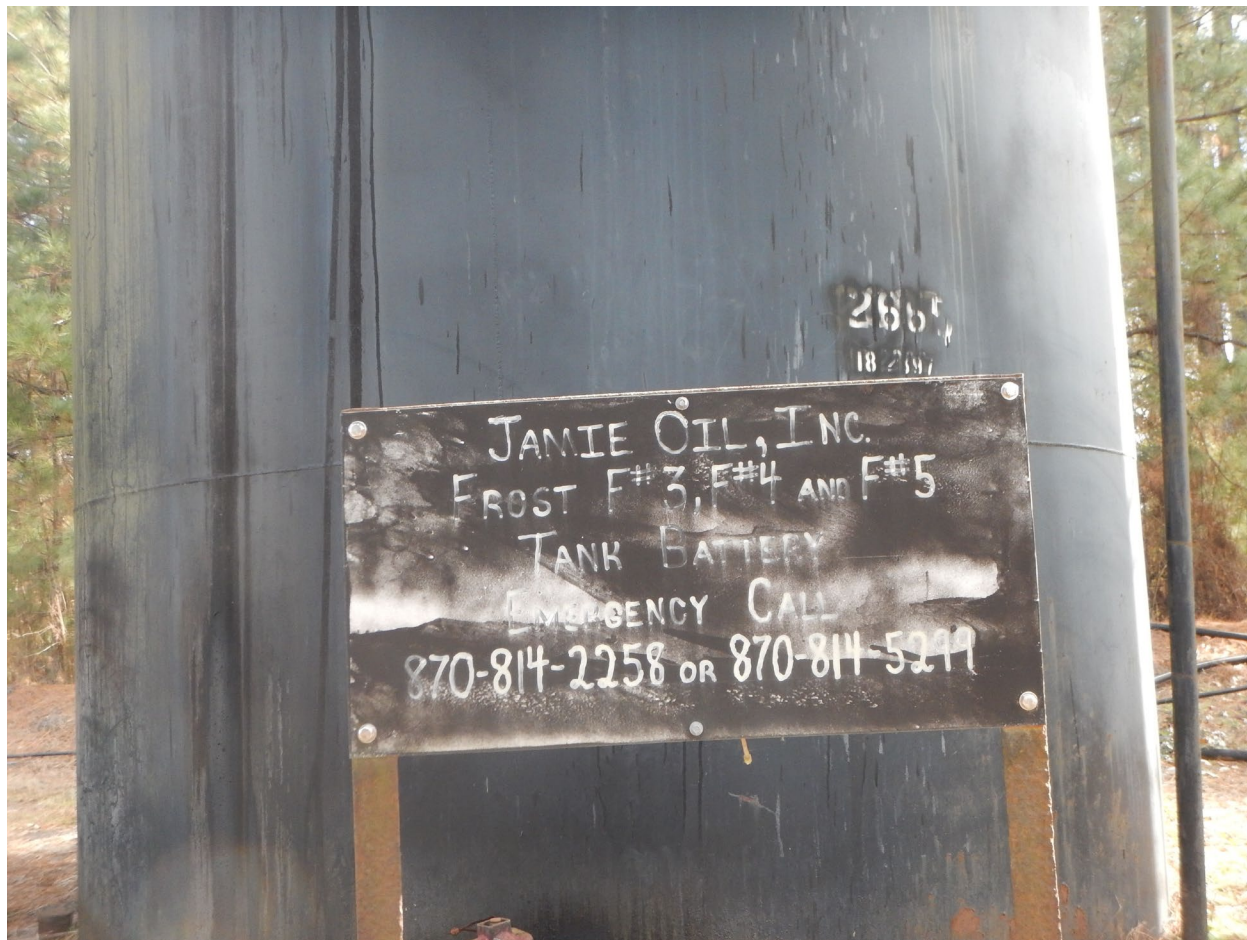
**Photo File Name:** 6190

I observed the facility sign, secondary containment, oil tanks, oil separator, heater treater, and pipes located at the facility, see Appendix 1 (photo log), photo No. 1 for additional GPS location and photo metadata, see Appendix 1.
