Region 2 Enforcement & Compliance Assurance Division  
Air Compliance Branch  
CAA Inspection Report

Inspection Date: 10/16/2024  
Facility Name: 49 Gingerbread Castle Rd  
Facility Address: 49 Gingerbread Castle Rd, Hamburg NJ  
ICIS-Air ID #: 3601694258  
EPA Lead Inspector: Christopher Collins, EPA Inspector, Collins.Christopher.W@epa.gov  
EPA Asst. Inspector: Victor Tu, EPA Inspector, tu.victor@epa.gov  
Facility Contact: Joseph Park, Owner, [joseph@selininy.com](mailto:joseph@selininy.com)  
State Inspector(s): James Harris, NJDOL, james.harris@dol.nj.gov  
State Inspector(s): Ray Djurin, NJDOL, radovan.djurin@dol.nj.gov

40 CFR Part 61 Subpart M – Asbestos NESHAPs

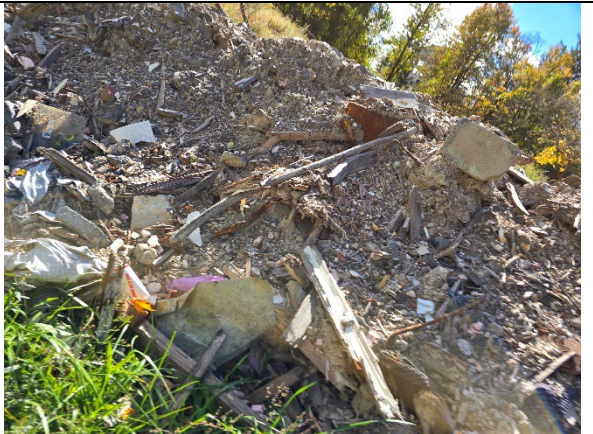
20241016\_124006.jpg

At approximately 12:30 PM, EPA inspectors start looking at the debris said to be dumped by unknown parties in the debris storage area at the entrance of 30 Gingerbread castle road. The material appears to have same consistency as material found in pile in the processing area.
