DOCUMENT DESCRIPTION: Draft of Investigation Report - U.S. Chemical Safety and Hazard Investigation Board RE E.I. DuPont de Nemours & Co., Inc.

# **INVESTIGATION REPORT**

## **E.I. DUPONT DE NEMOURS & CO., INC.**

**BELLE, WEST VIRGINIA**

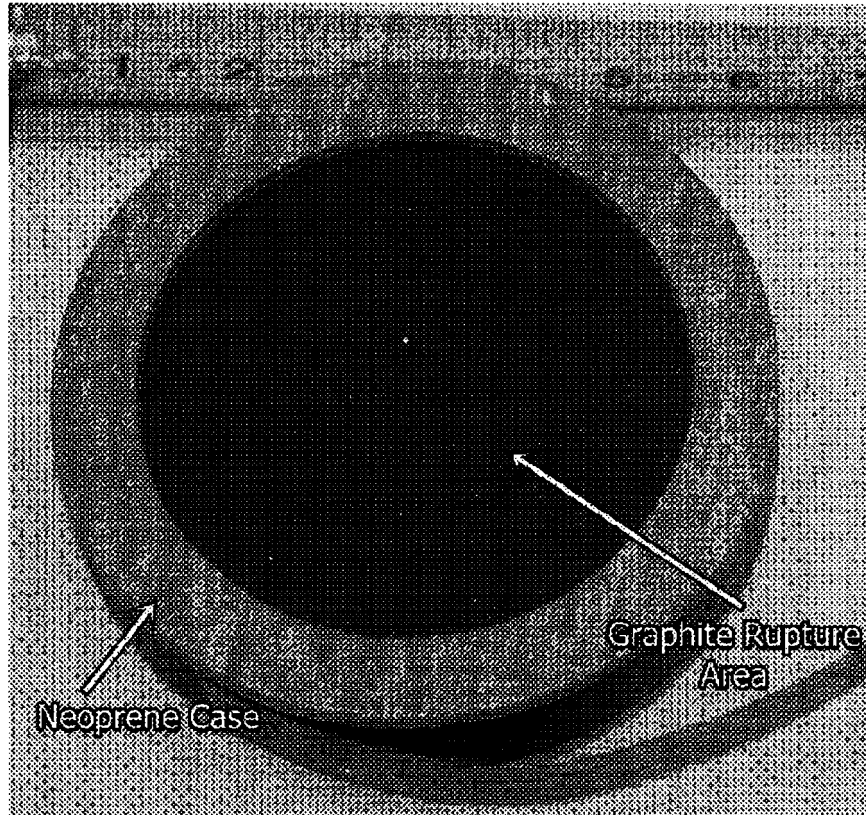
Figure 6. New rupture disc

The rupture disc involved in the incident was a 4-inch diameter graphite rupture disc, designed to rupture at 15 psig, and mounted in neoprene casing (Figure 6). While the rupture disc is on a preventive maintenance (PM) schedule, the annual frequency was so infrequent that the disc is only replaced when it has activated or when it is removed for certain processes. Operators told CSB investigators that once removed, the rupture discs, intact or compromised, are thrown away and are replaced with new ones.

Even without a burst sensor, all overpressure protection devices, including rupture discs, should be routinely checked on an effective PM schedule as a layer of protection.<sup>16</sup>

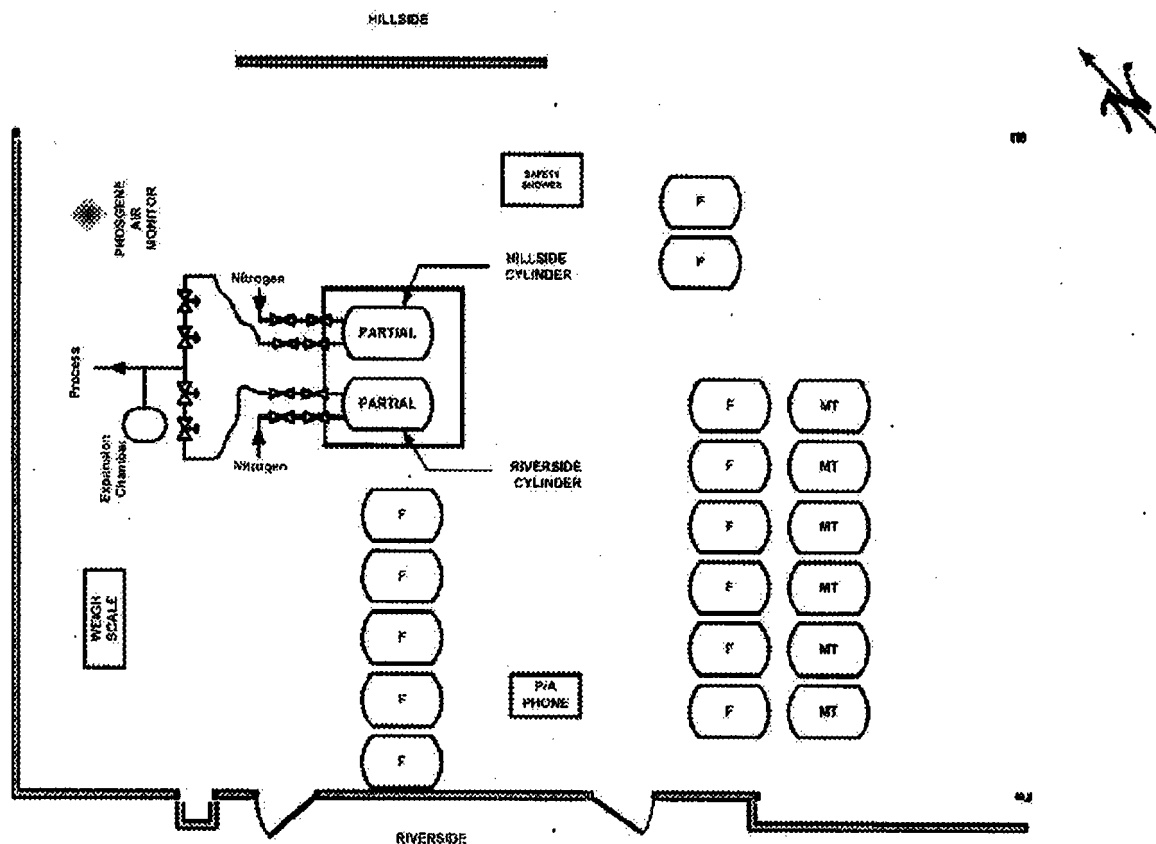
Figure 12. Phosgene shed and full (F) and empty (MT) cylinder locations on day of incident (not to scale)

During normal operation, two cylinders are staged on weigh scales and each is connected to the process with two, 0.25-inch diameter by 48-inch long PTFE-lined, 304 stainless steel overbraid hoses. One hose transfers liquid phosgene to a steam vaporizer and one provides 70-psig nitrogen to the cylinder. The scales record the weight of the in-service cylinder and when the container is nearly empty, an alarm notifies the board operator, who then directs the plant operators to switch to a full cylinder. This switch is completed by opening valves to the full cylinder and closing valves to the empty cylinder. The hoses remain coupled in this operation and plant SOPs do not require enhanced PPE such as a fully encapsulated suit and breathing air. Under normal operating conditions, the process consumes two to three cylinders of phosgene per day.

NFPA 55 includes guidelines for controls in buildings that store compressed gas cylinders, and classifies the phosgene shed structure as an indoor storage area because the walls comprise more than 25 percent of the shed perimeter (Figure 12). Indoor storage for the use of highly toxic gases must have a gas cabinet, exhausted enclosure, or a gas room, according to NFPA 55. Exhausted enclosures, gas cabinets, or gas rooms fully enclose cylinders and associated process equipment and are equipped with ventilation systems to capture and treat hazardous vapors. The phosgene shed at Belle, though considered indoor storage by NFPA, did not contain a ventilation system; instead, DuPont relied on natural ventilation from the outside to decrease concentrations of phosgene, which allowed phosgene vapors to travel downwind,

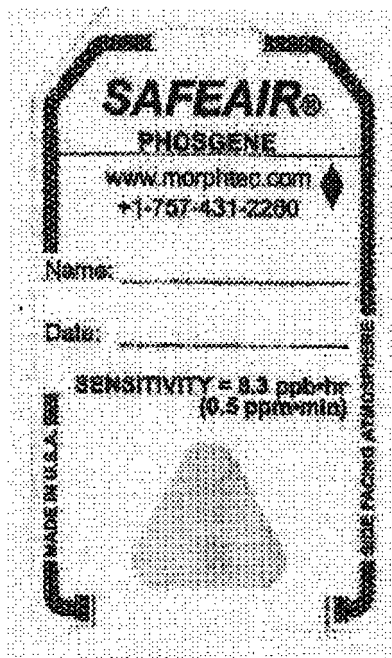
Figure 13. SafeAir Phosgene Dosimeter Badge<sup>37</sup>

<sup>37</sup> The badge in Figure12 has a range of 0.5 to 450 ppm-min. The SafeAir badge worn by the exposed employee had a range of 0.9 to 100 ppm-min.

Immediately after the operator was sprayed, he called for assistance on the SLM unit public address phone in the phosgene shed. A co-worker who responded to the call for assistance noticed the victim's phosgene dosimeter badge (Figure 13) was discolored, indicating an exposure. The co-worker directed the exposed worker to a plant truck to transport him to the plant's medical center for assessment and treatment. As they drove to the medical center, the two workers were met by the Shift Supervisor and the exposed worker was transferred to the shift supervisor's vehicle to complete the trip. While en route to the plant's medical center, the front gate guard was radioed and advised to call Metro 9-1-1 and request that an ambulance respond for a medical emergency. The exposed worker, while at the medical center waiting for the ambulance, chose to wash his face and hands, but there is no evidence or record that he was placed in a safety shower to wash off, as instructed by the emergency procedures, or that any decontamination activity took place beyond his washing his face and hands. He was given a change of coveralls to put on in exchange for the work clothes he was wearing at the time of exposure. The gate guard called Metro 9-1-1 at 1:59 p.m., requesting transport for a medical emergency patient to the hospital. The 9-1-1 dispatcher asked if there was a chemical release; however, the gate guard, who was unaware of the situation, responded that there was no release and that the response was for a medical emergency. As part of the Metro 9-1-1 emergency response protocol, the dispatcher asks for specific information to ensure that responders are as informed as possible prior to arrival at the scene. At 2:03 p.m., an ambulance was dispatched from the Kanawha County Emergency Ambulance Authority (KCEAA).

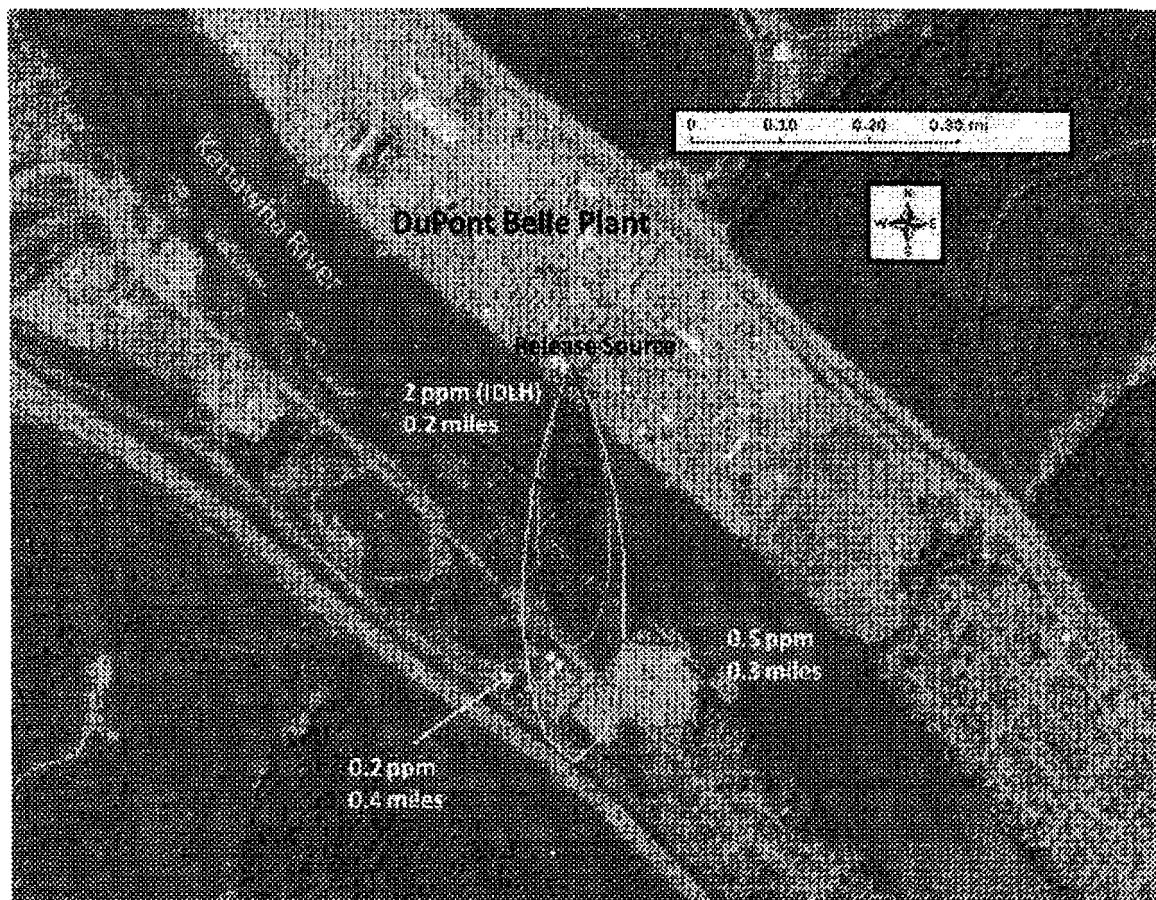
Figure 19. ALOHA estimate of phosgene concentrations with MARPLOT GIS overlay

The ALOHA program generated a display of concentration “threat zones” over a distance downwind from the source of the release. Using the U.S. EPA MARPLOT program, threat zones are displayed over a satellite map of the area using a graphical information system (GIS) interface (Figure 19).

The release estimates from the ALOHA program are based on the weather conditions recorded at the Charleston Yeager Airport around the time of the January 23, 2010 phosgene release, but may not accurately represent atmospheric conditions at the plant. The ALOHA program also does not consider the topography or terrain surrounding the plant. The fence line monitors south and southwest of the phosgene shed recorded phosgene concentrations between 0 and 0.27 ppm, suggesting phosgene vapor may have traveled south of the DuPont Belle plant fence line toward the river. The ALOHA threat-zone overlay in Figure 19 displays a model of the worst case release conditions indicating IDLH concentrations of phosgene could have been present on the Kanawha River shortly after the release and lower concentrations could have traveled across the river. There were no reports of odors or exposure symptoms from the community on the afternoon of the phosgene release incident.
