**CWA COMPLIANCE EVALUATION INSPECTION REPORT
U.S. ENVIRONMENTAL PROTECTION AGENCY, REGION 5**

Purpose: Compliance Evaluation Inspection

Facility: Befesa Zinc US Inc.
2701 East 114th Street
Chicago, Illinois 60617
41.68482160845534, -87.54572106929497

Date of Site Inspection: 11/05/2024

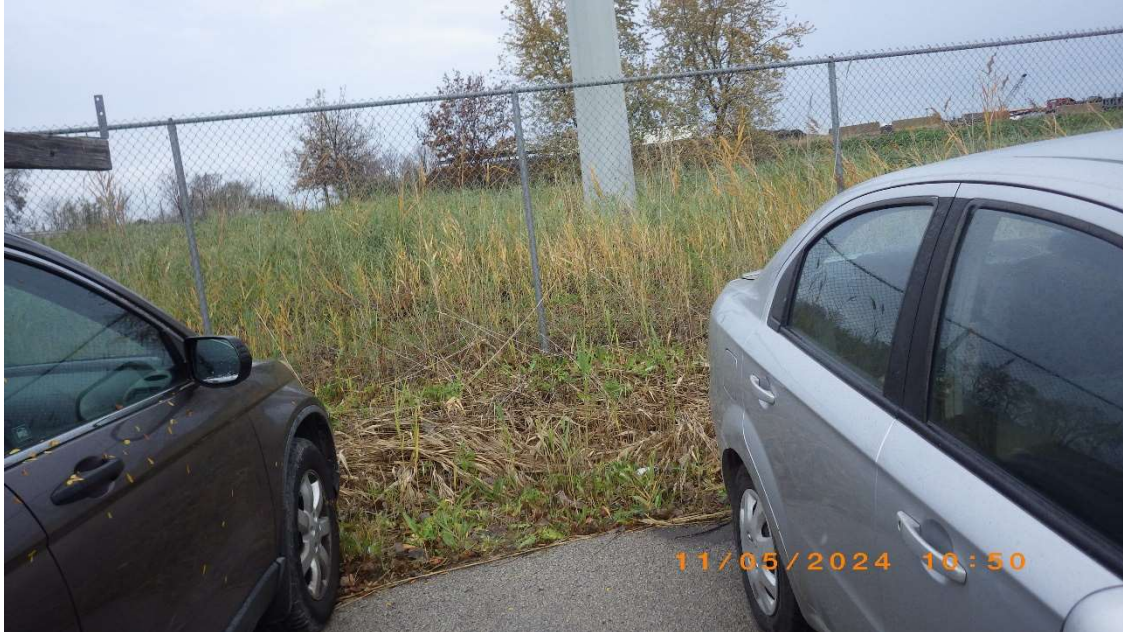
1: RIMG0001

Description: Looking north between cars parking on E 114th Street toward drainage swale north of the Facility.

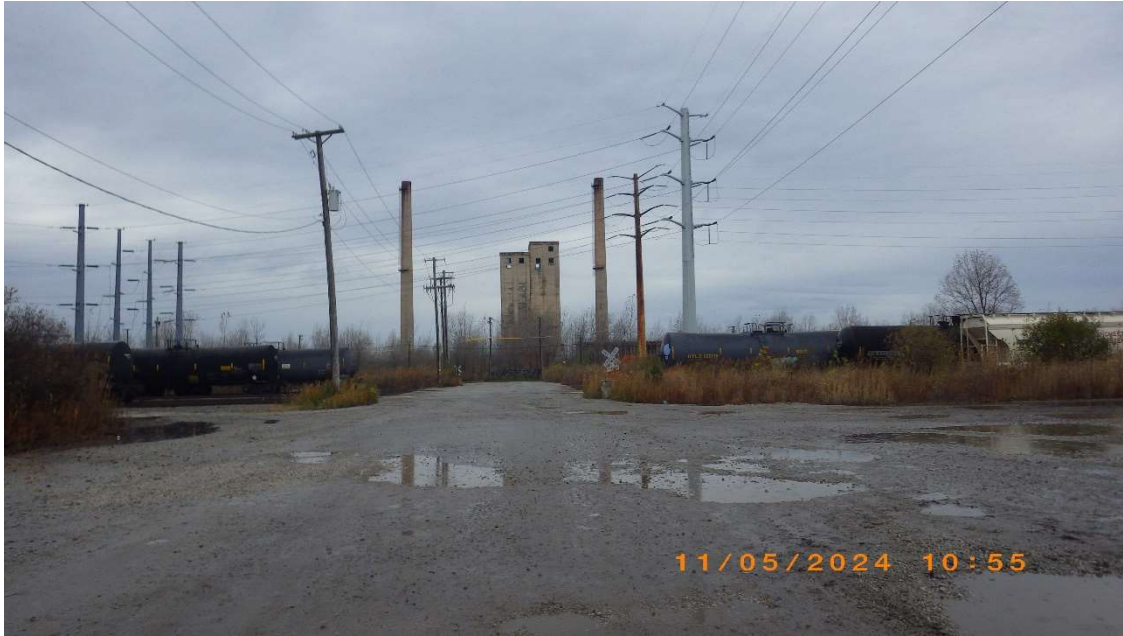
2: RIMG0002

Description: Looking west along E 114th Street from the northwest corner of the Facility.

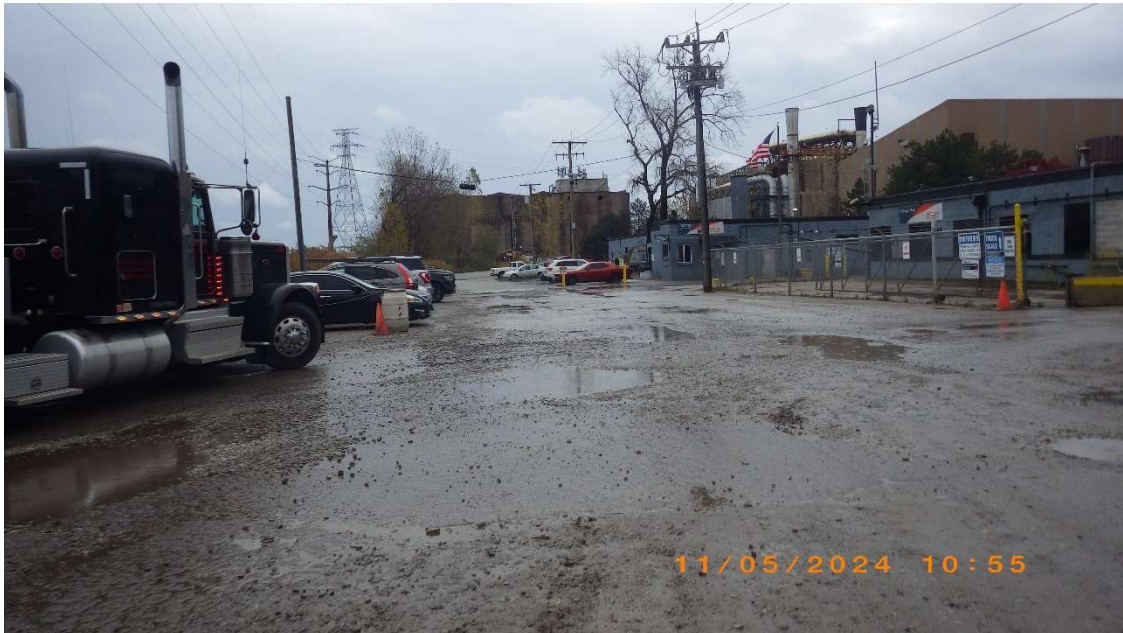
3: RIMG0003

Description: Looking east along E 114th Street. The Facility uses this area as parking.

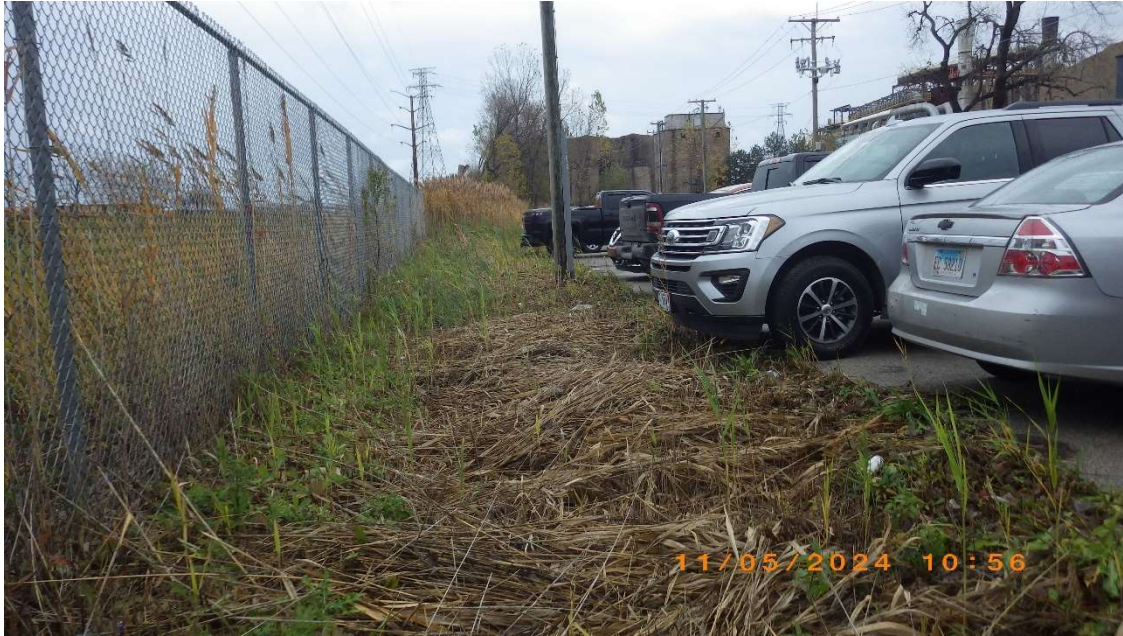
4: RIMG0004

Description: Looking east along the north side of E 114th street (right) and the drainage ditch (left).

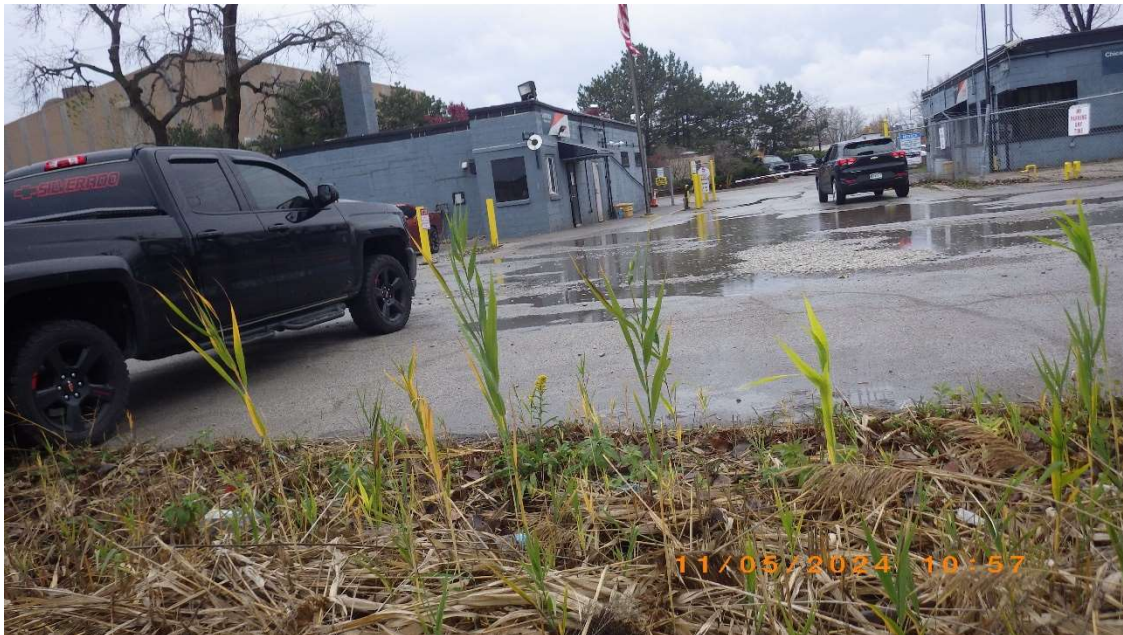
5: RIMG0005

Description: Looking south toward the northern entrance to the Facility from the north side of E 114th Street.

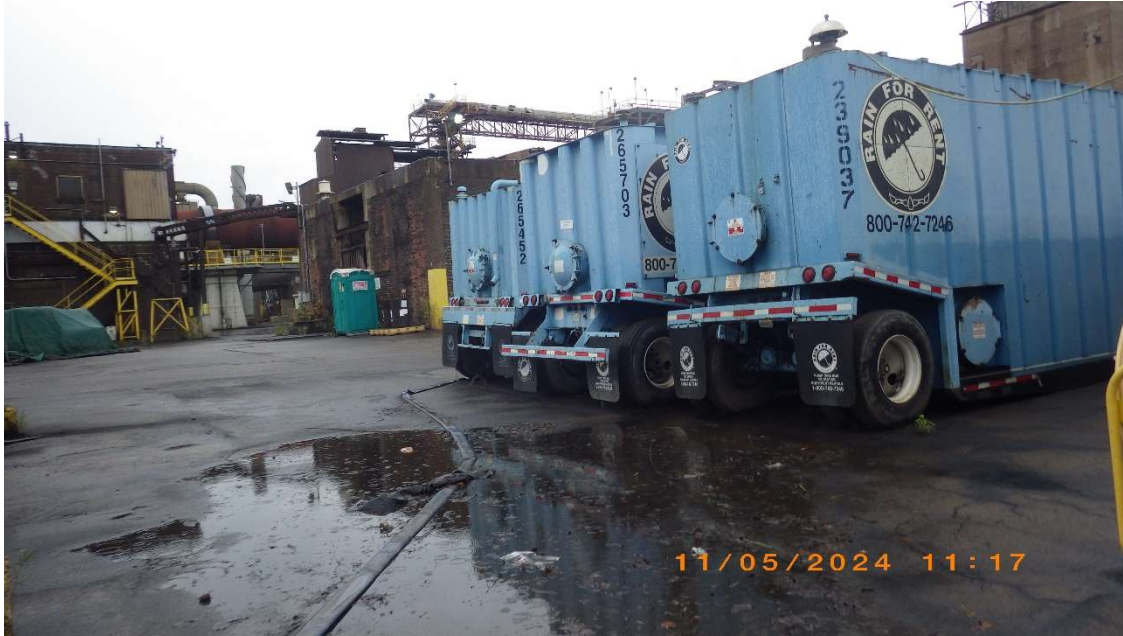
13: RIMG0013

The Inspectors continued east and observed the diked area including the reception/pump pit and temporary frac tanks (photos 12 and 13). The Inspectors walked around the north end of the diked area and observed the concrete berm along the north side of the Facility. The Inspectors observed that there was standing water on the south side of the berm but no observed water on the north side (photo 14).

Description: Frac tanks adjacent to the diked area.

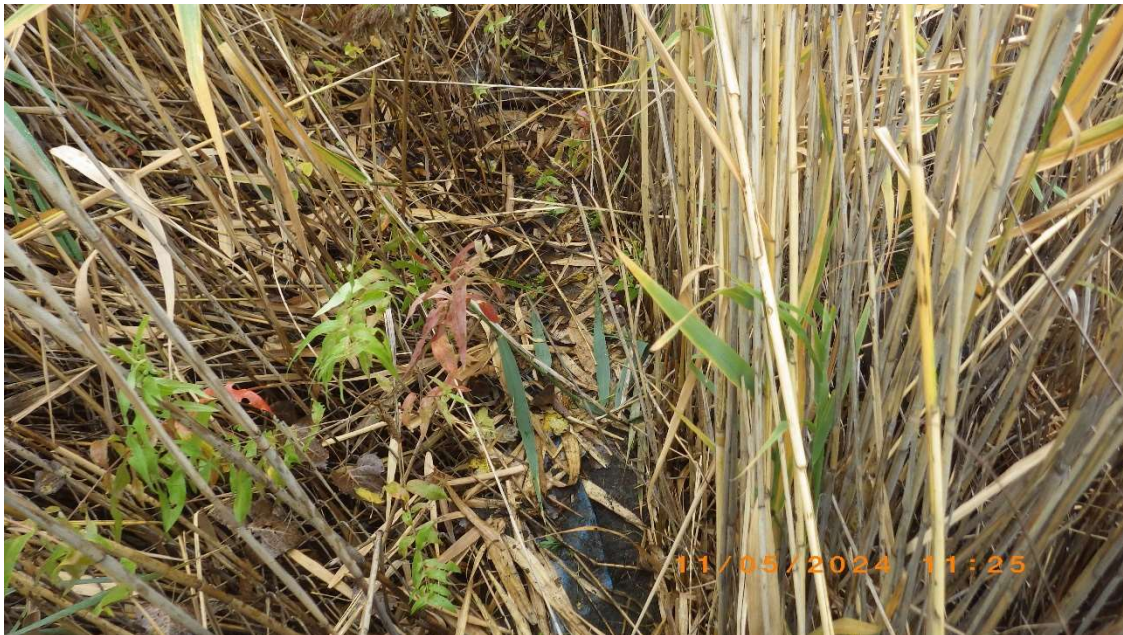
16: RIMG0016

Description: Concrete berm along the north side of the Facility.

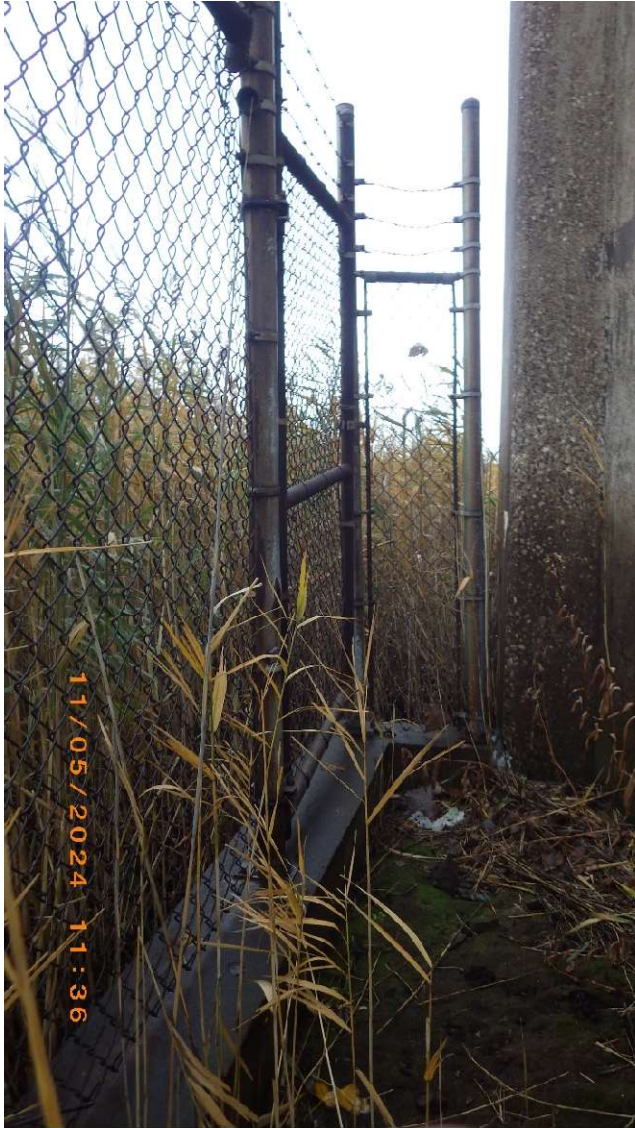
23: RIMG0023

The Inspectors walked east to the east end of the concrete berm (photo 23). The Inspectors then walked south and observed IRM being stored on the southwest side of the unused concrete silos (photo 24). The Inspectors then walked around the silos and north along east edge of the Facility along the Calumet River and observed the area where the stormwater swale north of the Facility would flow into the Calumet River (photo 26). No flow was observed at the time of the Inspection. The Inspectors then walked south along east side of the Facility and observed the asphalt berm along the eastern edge of the Facility (photos 25 and 27). EPA observed a structure extending out over the bank of the Calumet River which appeared to contain a pump and electrical equipment (photos 27-32). The Facility personnel stated that the structure was a remnant from previous owners of the site and was not used by the Facility. The Inspectors continued to walk south along the east side of the Facility and observed the asphalt berm, a concrete barrier in the barge loading area, and the large berm along the east side of the Facility south of the concrete barrier (photos 33-42). At the sound end of the barge loading area where the asphalt berm and concrete barrier end and the large berm begins, the Inspectors observed that there was area between the berms where stormwater may have a potential to flow toward the Calumet River.

Description: East end of the concrete berm on the north side of the Facility.

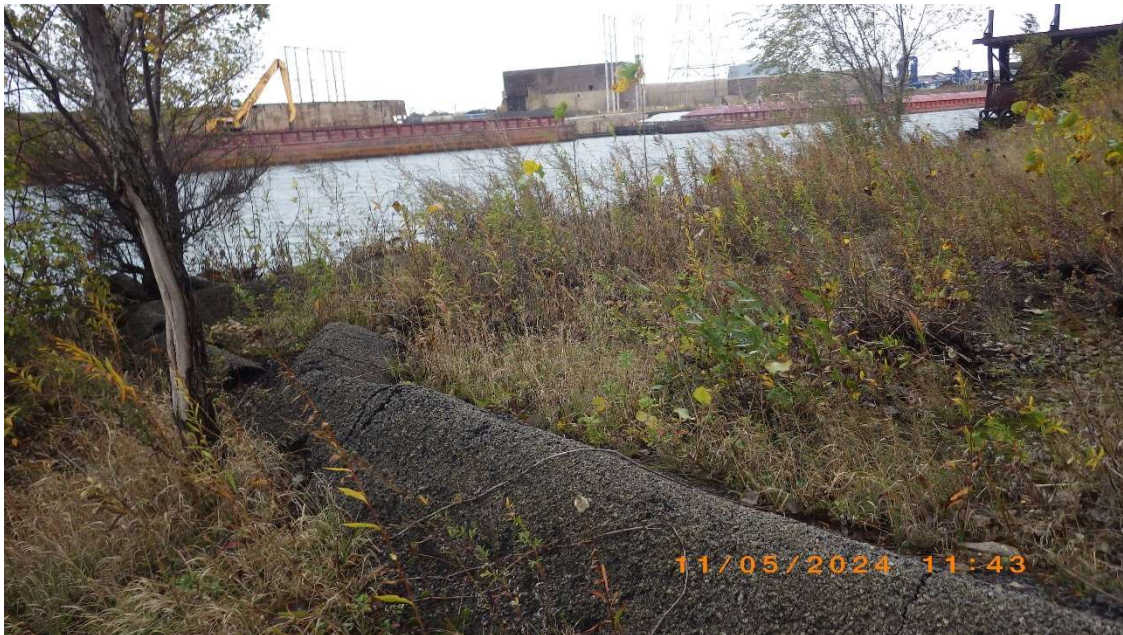
25: RIMG0025

Description: North end of asphalt berm located along the northeast side of the Facility.

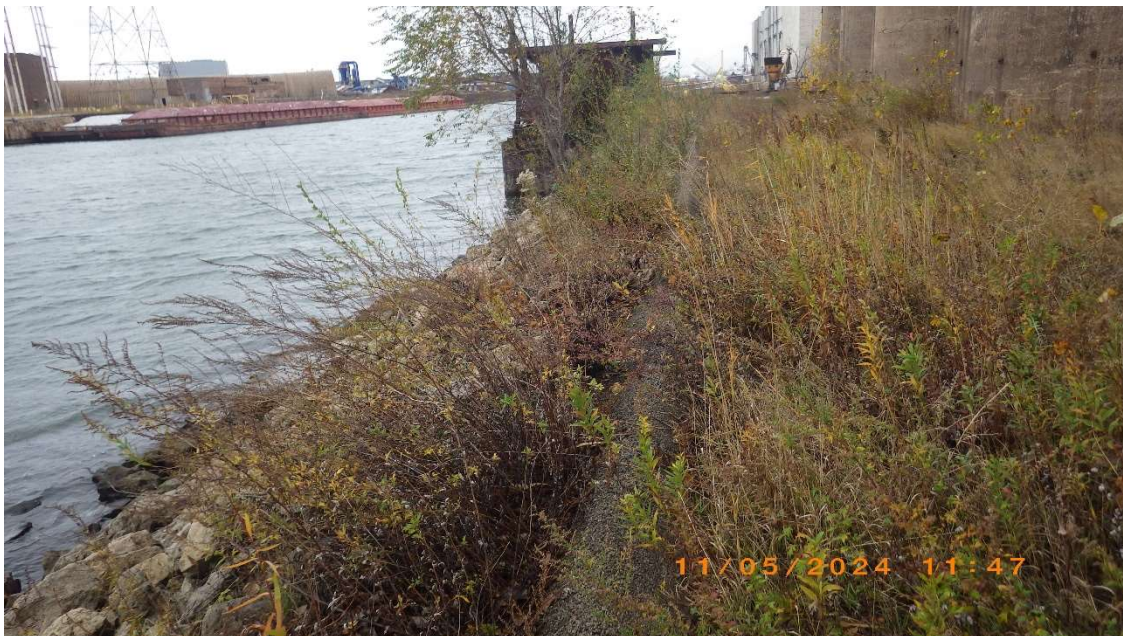
27: RIMG0027

Description: Looking south along the asphalt berm along the northeast side of the Facility.

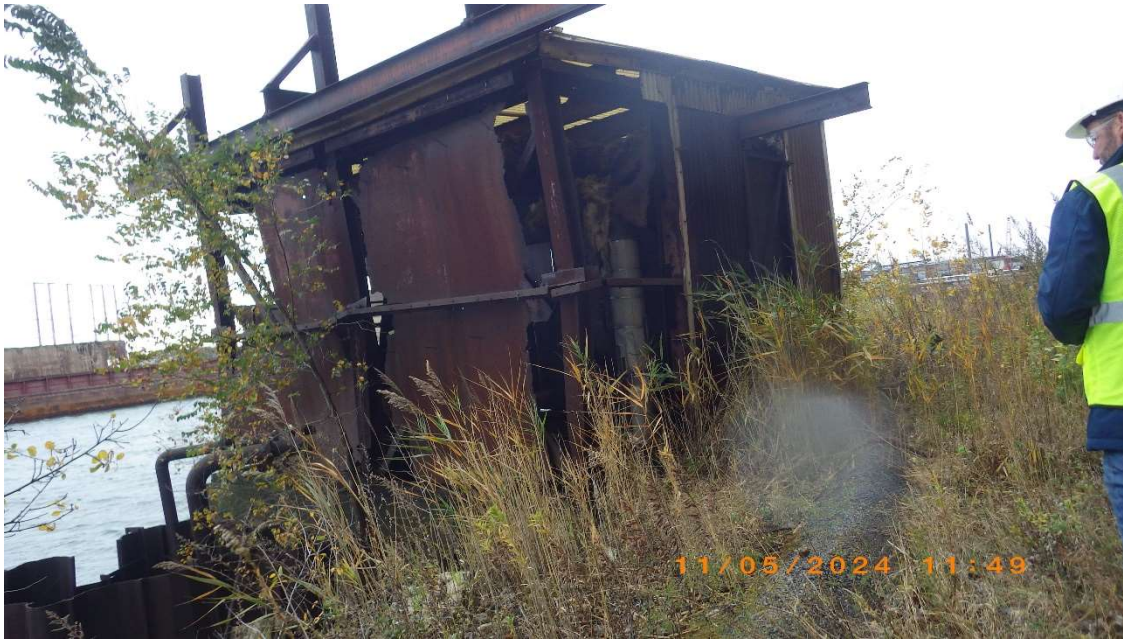
28: RIMG0028

Description: Structure on the bank of the Calumet River on the northeast side of the Facility.

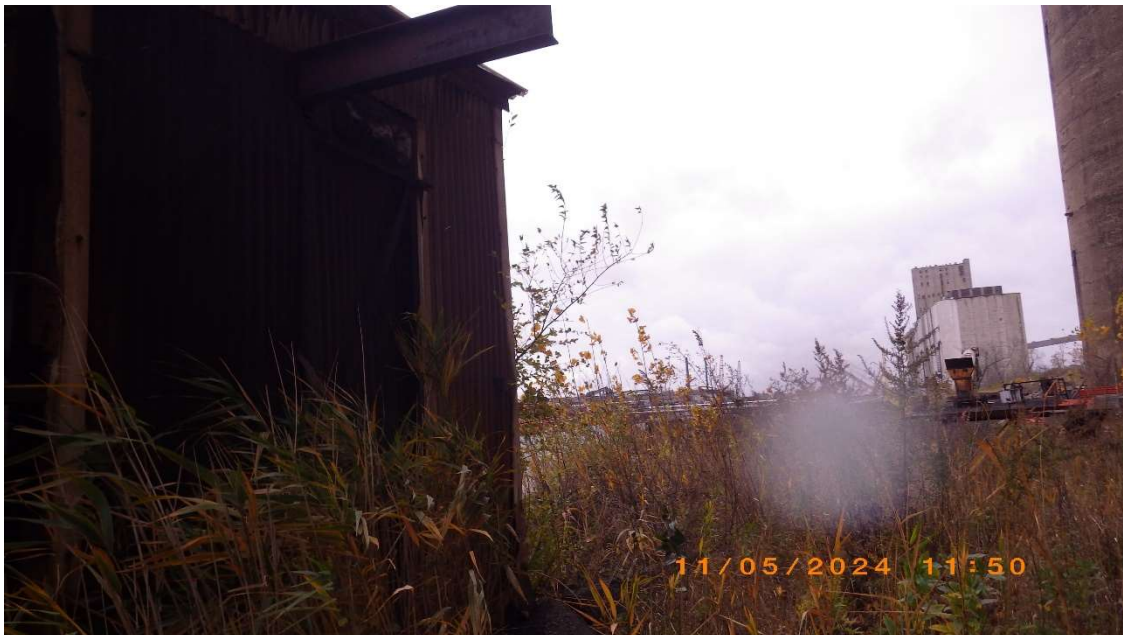
29: RIMG0029

Description: Looking southeast along the east side of the Facility.

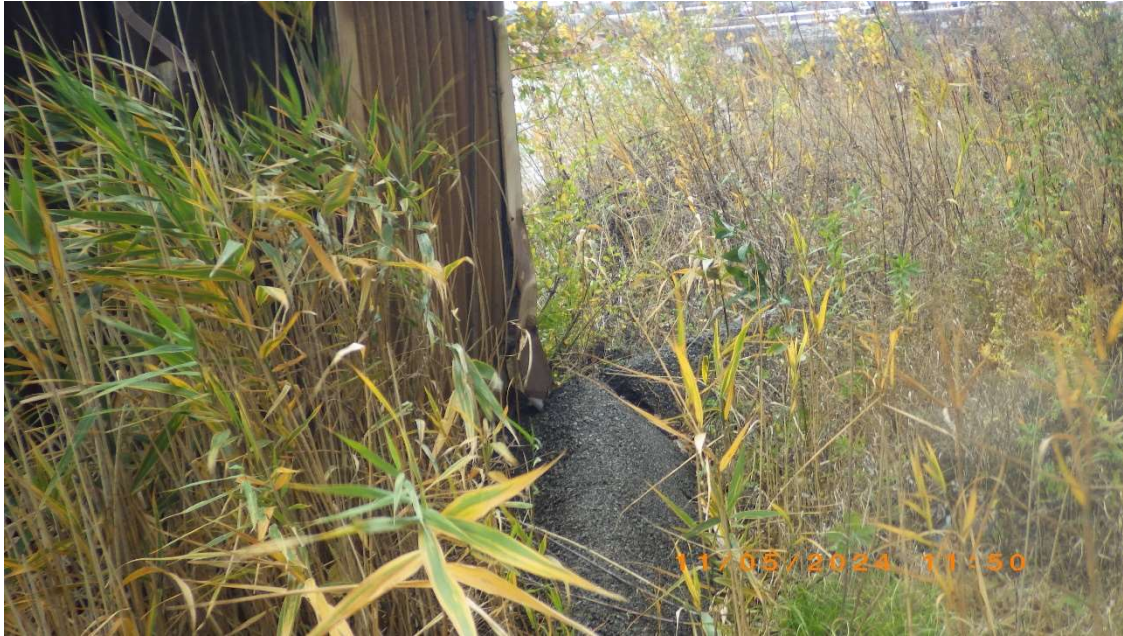
30: RIMG0030

Description: The asphalt berm adjacent to the structure on the bank of the Calumet River.

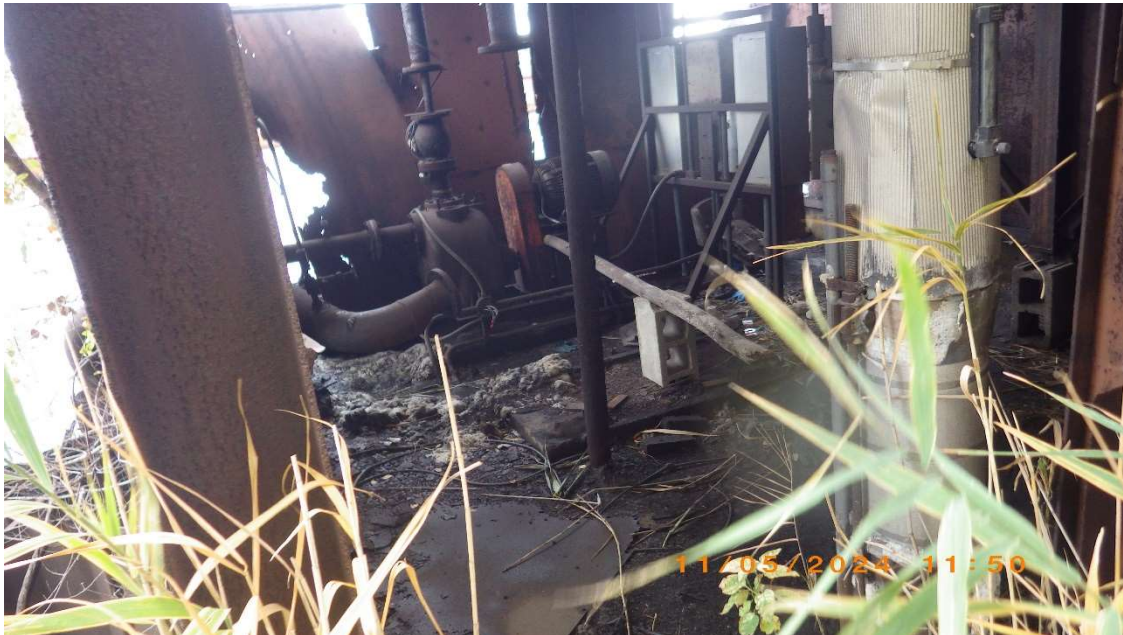
31: RIMG0031

Description: Interior of the structure on the Bank of the Calumet River on the northeast side of the Facility.

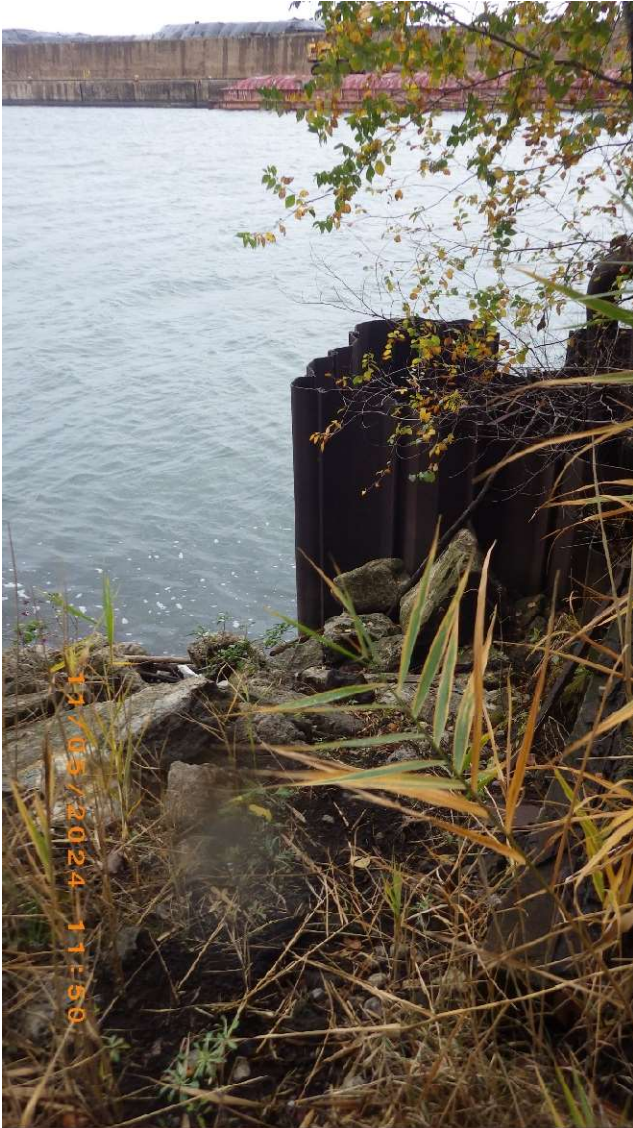
32: RIMG0032

Description: North side of the structure on the Calumet River.

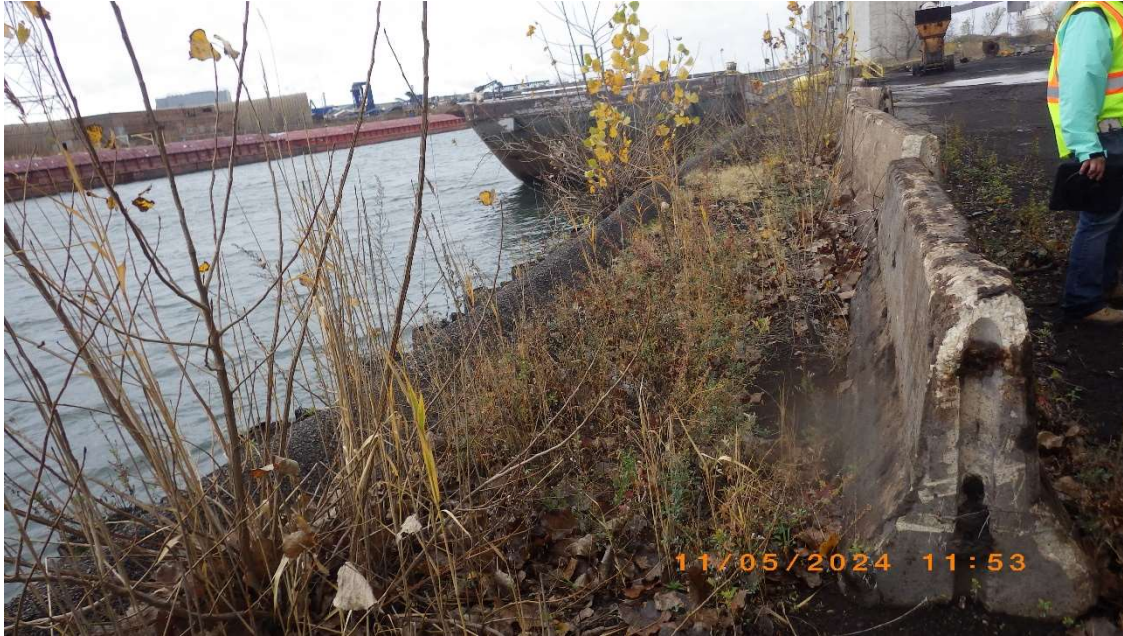
33: RIMG0033

Description: Looking south along the east side of the Facility. Note the asphalt berm between the concrete barrier and corrugated metal wall along the Calumet River.

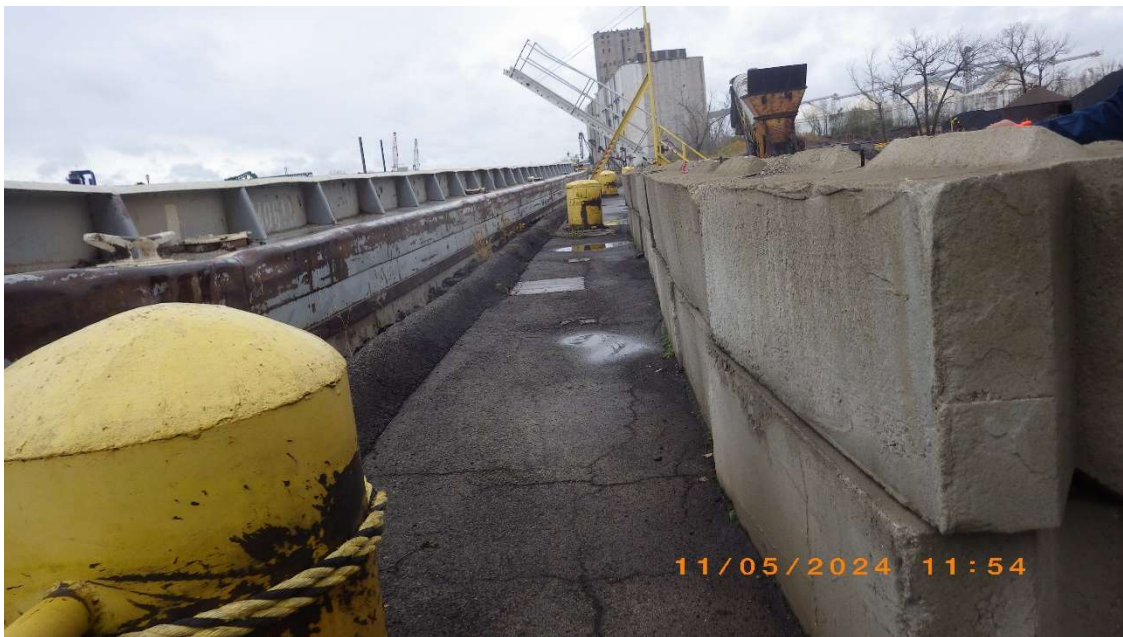
34: RIMG0034

Description: Looking south along the east side of the Facility between the concrete barrier and the asphalt berm.

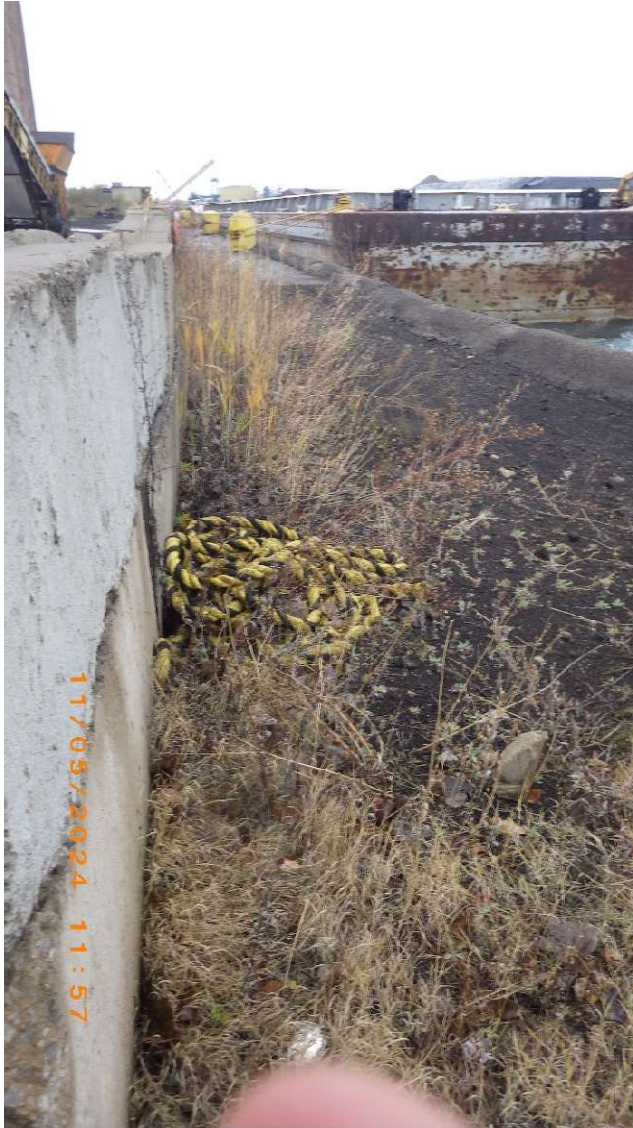
35: RIMG0035

Description: Looking northeast along the east side of the Facility between the concrete barrier and asphalt berm.

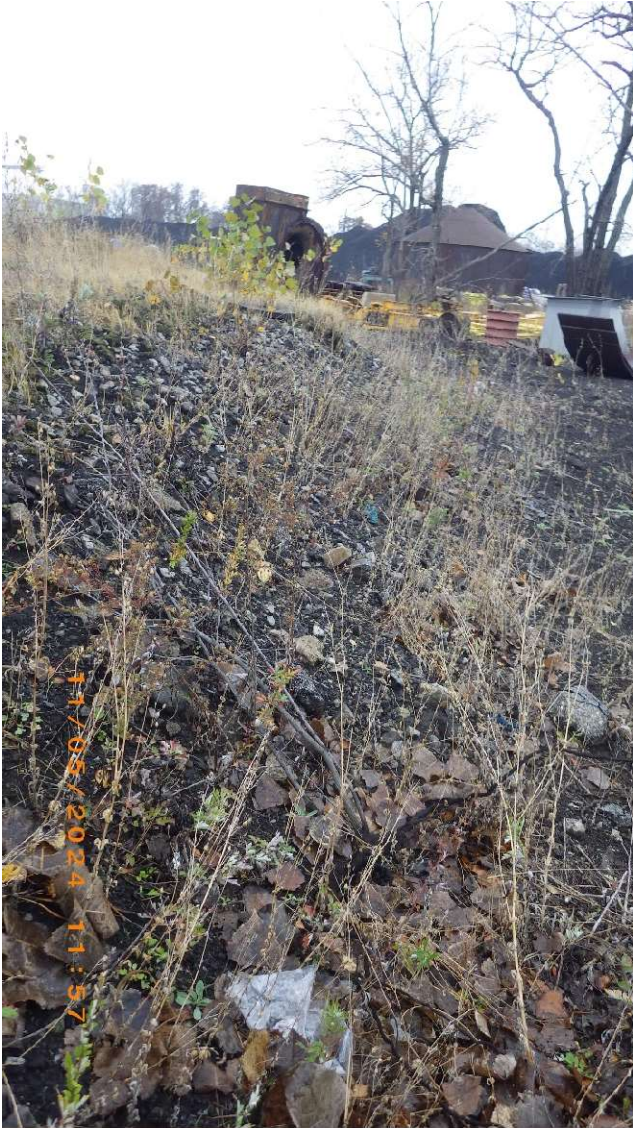
36: RIMG0036

Description: Looking south along the berm on the southeast side of the Facility, south of the concrete barrier.

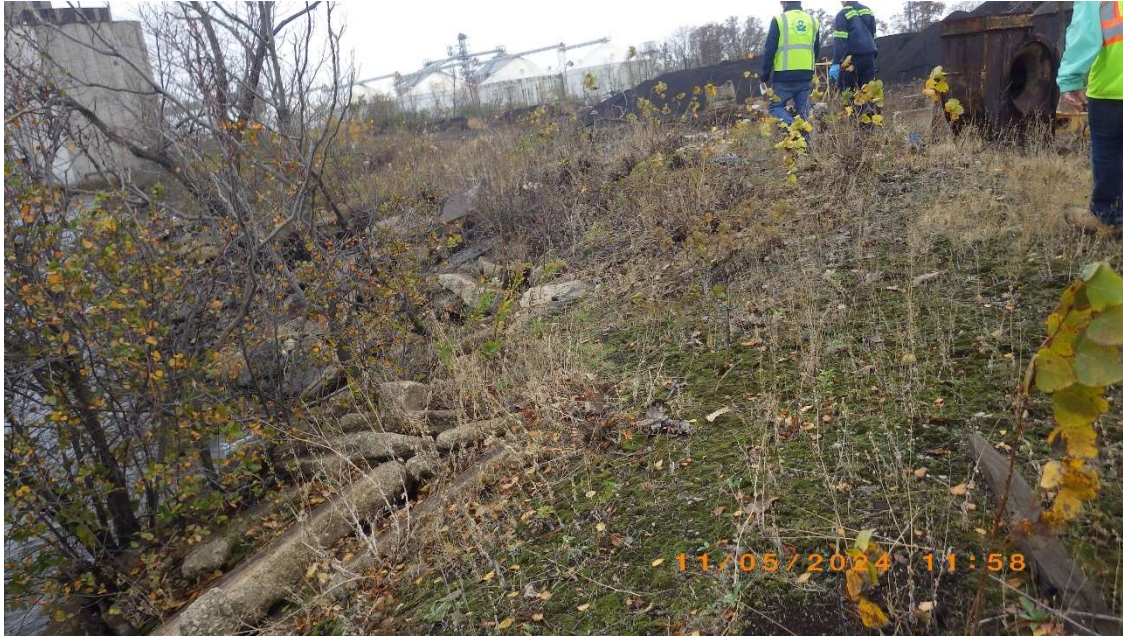
37: RIMG0037

Description: Looking south along the top of the berm on the southeast side of the Facility. The Calumet River is to the left.

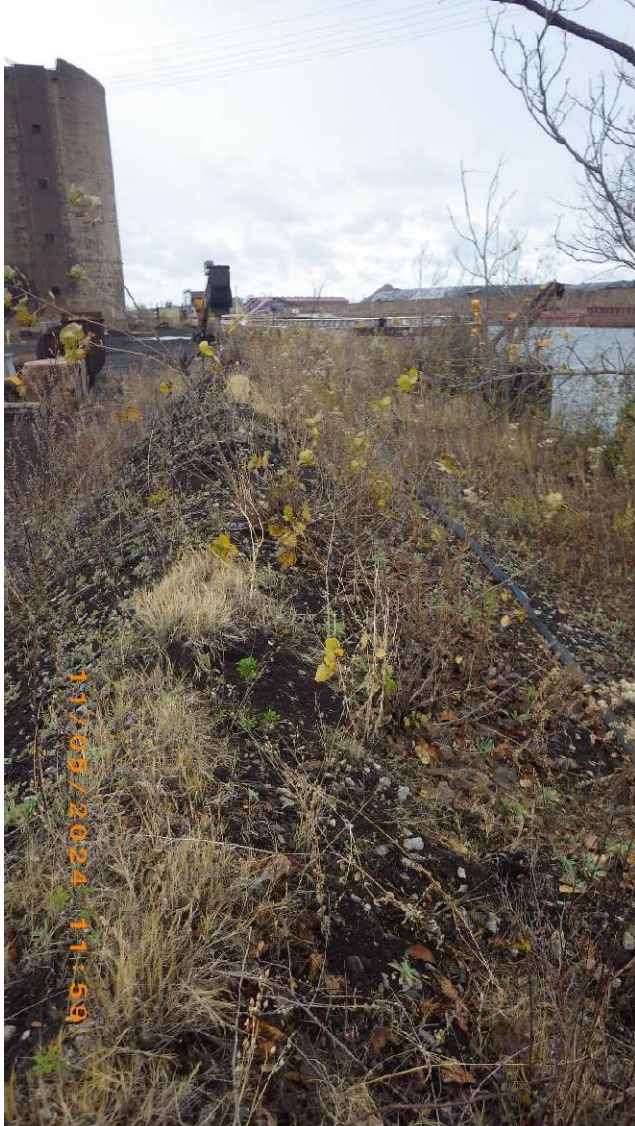
38: RIMG0038

Description: Looking north along the top of the berm on the southeast side of the Facility. The Calumet River is to the right.

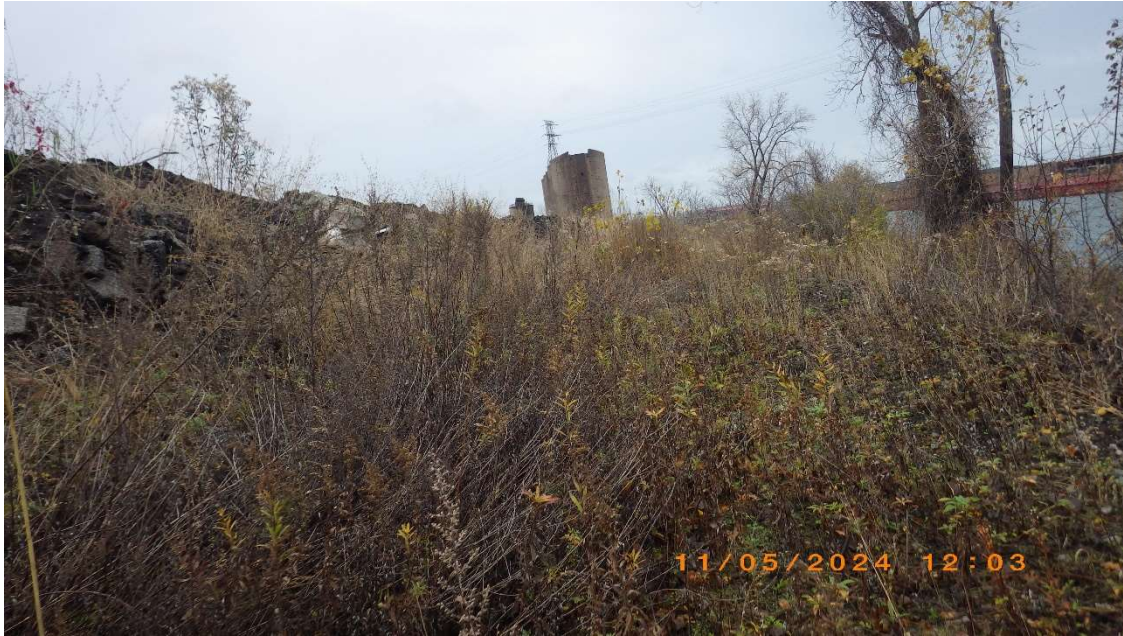
39: RIMG0039

Description: Looking north between the berm on the southeast side of the Facility (left) and the bank of the Calumet River (right).

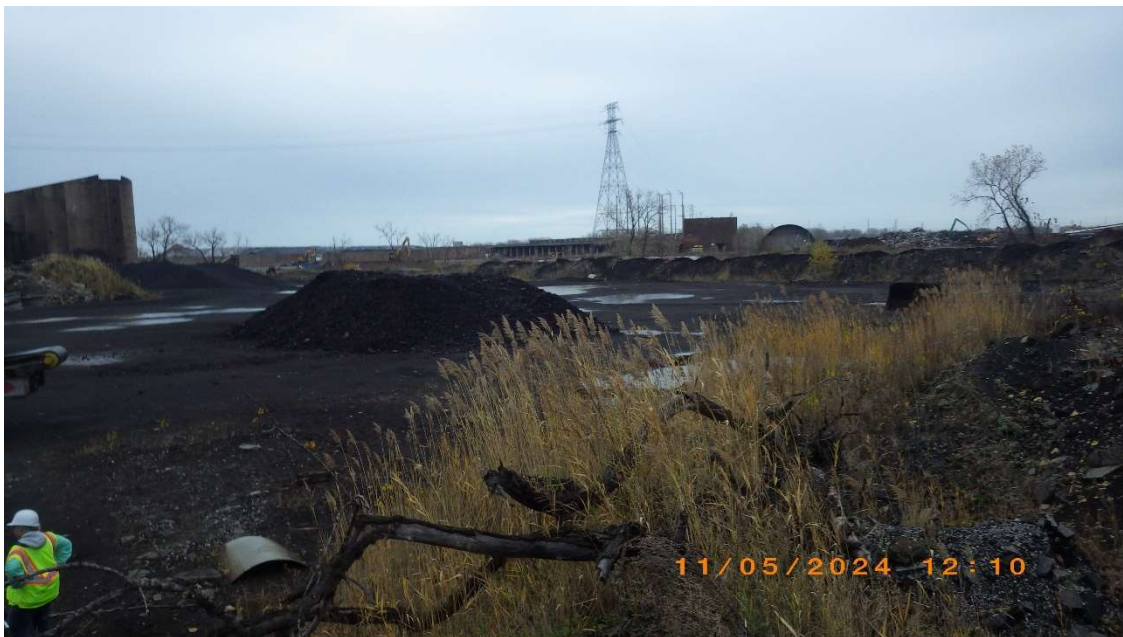
40: RIMG0040

Description: Looking northeast from the top of the berm at the southeast corner of the Facility.

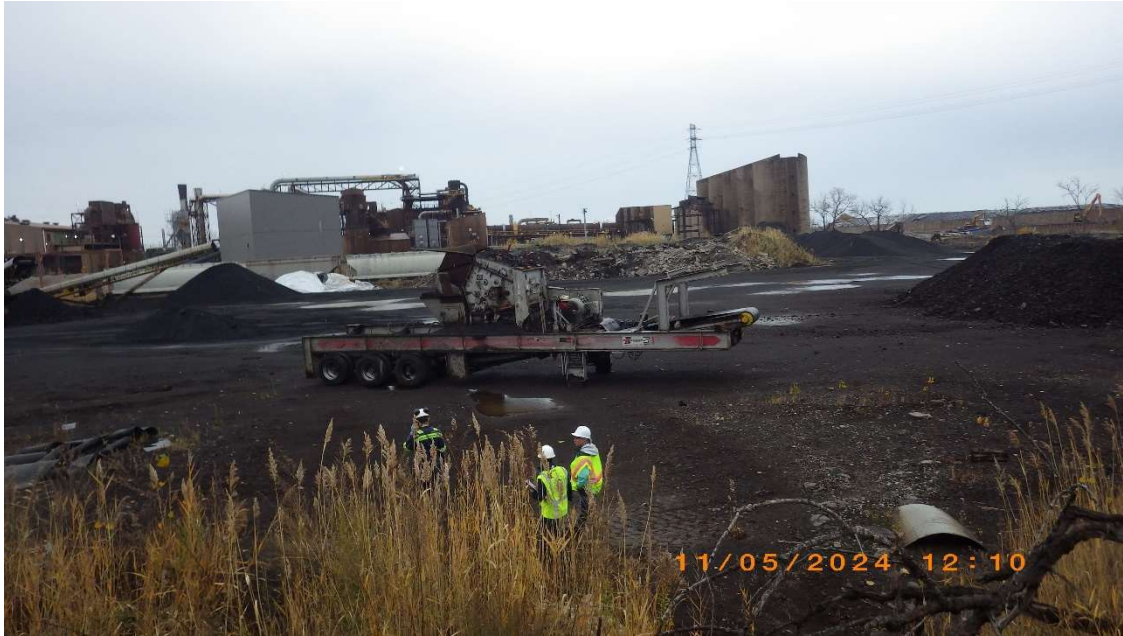
41: RIMG0041

Description: Looking north from the top of the berm at the southeast corner of the Facility.

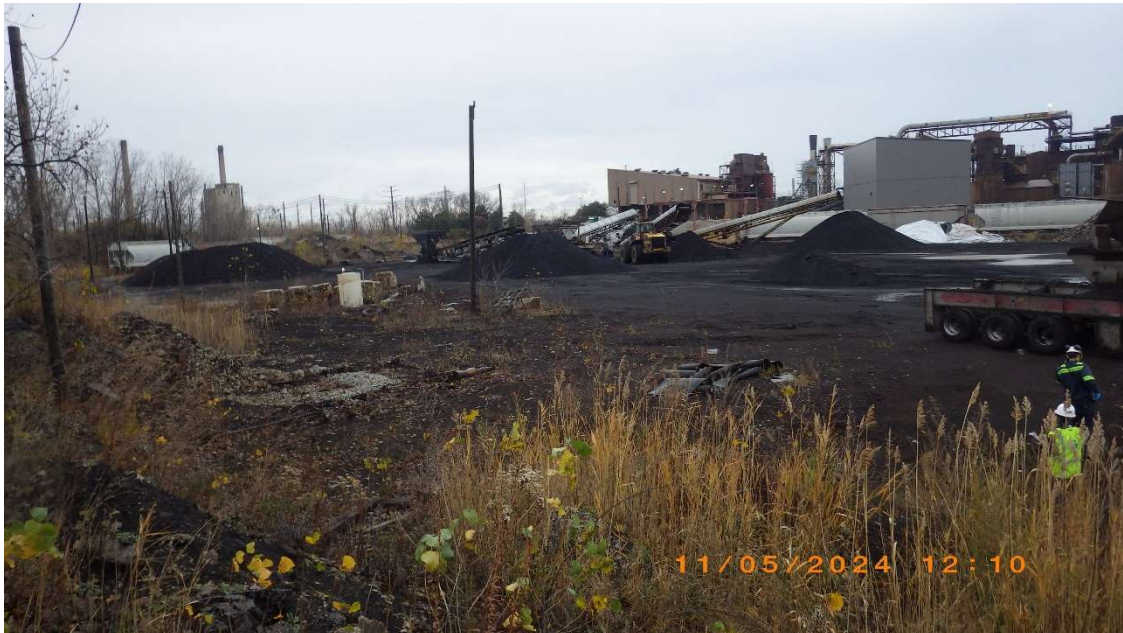
42: RIMG0042

Description: Looking northwest from the top of the berm at the southeast corner of the Facility.

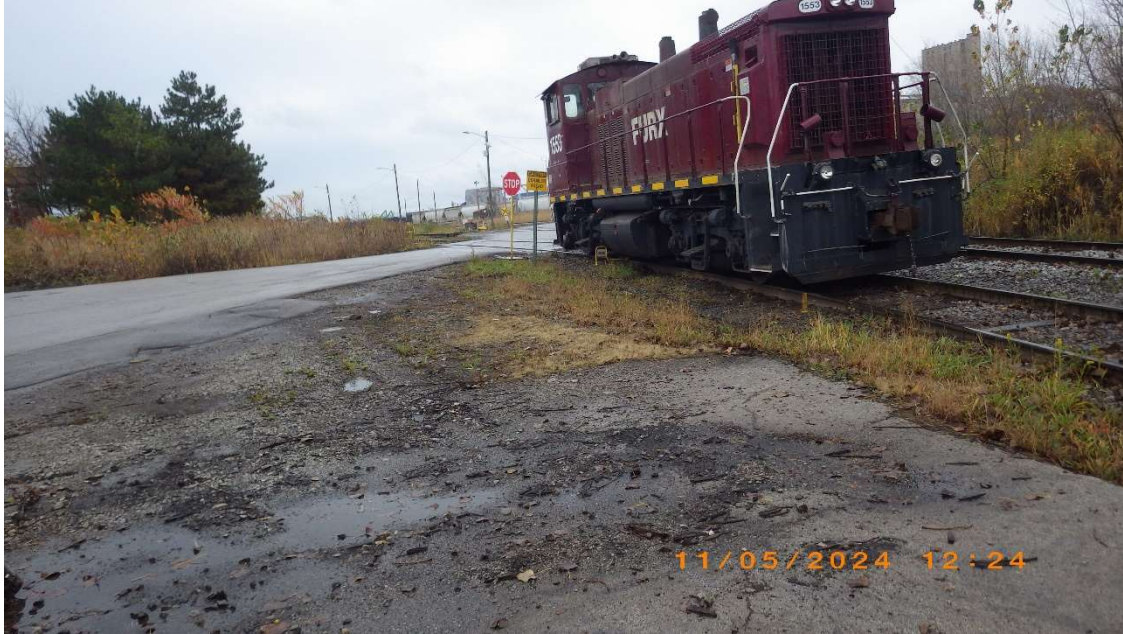
46: RIMG0046

Description: Looking southeast from the north side of the train tracks where the rails enter the Facility.

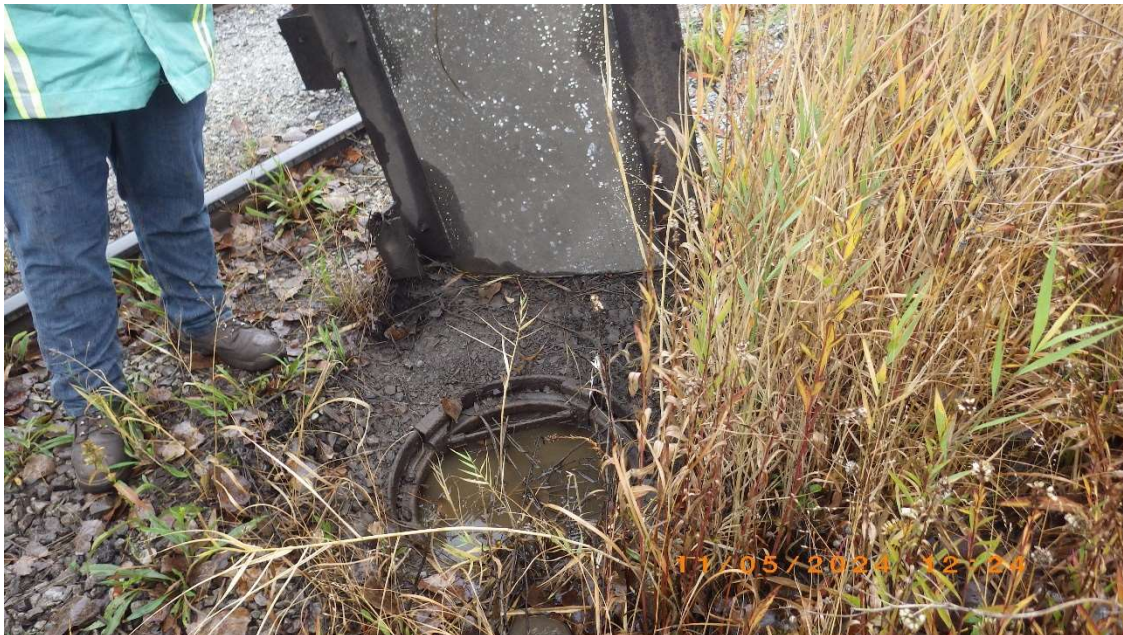
47: RIMG0047

The Inspectors walked west to where rail lines entered the Facility and observed a collection pit with a hose protruding out of it (photos 45-47). The Facility personnel stated that were stormwater to accumulate in this area, a pump could be attached to the hose to pump water out of the area into the stormwater management system. The Inspectors also observed perforated black corrugated pipe under the rail lines to allow stormwater to flow under the tracks to the north (photo 48). The Inspectors walked east and observed the low area with standing stormwater as well as the other end of the hose observed in Photo 44 and other flat hoses (photo 49).

Description: Looking down into the stormwater collection location.

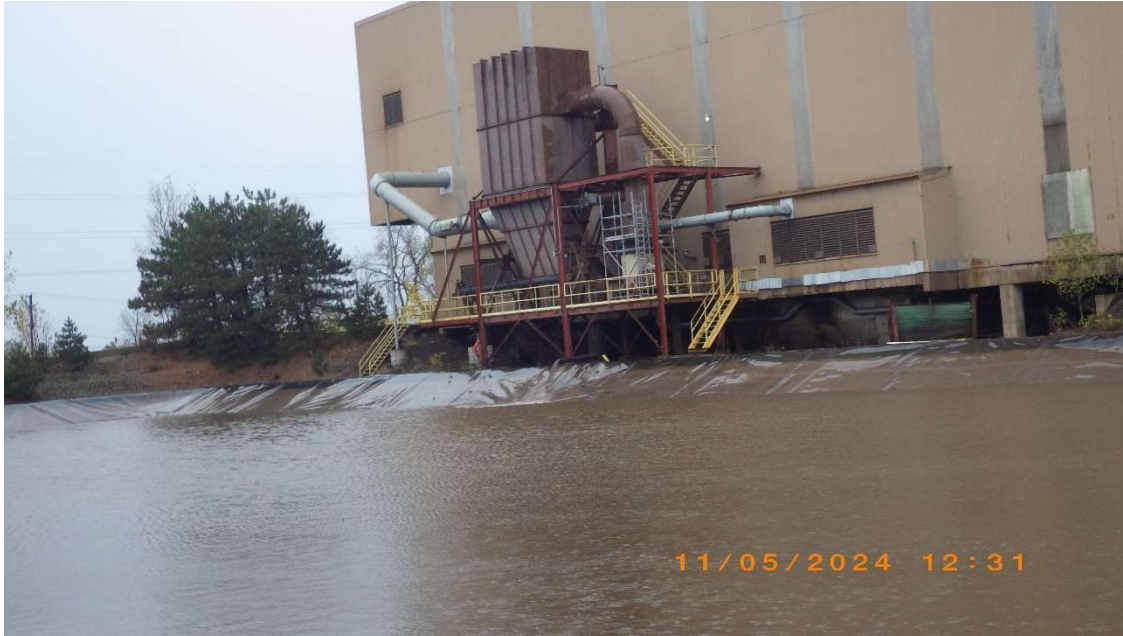
50: RIMG0050

The Inspectors then walked to the south side of Pond and observed a pipe on the east side discharging into the Pond (photo 50). The Inspectors then walked west, north, east, and then south around the Pond to the northeast side and observed the pipe discharging into the Pond again (photos 51 and 52). The Inspectors then continued walking around the Pond to the south side and walked north along the west access road on the west side of the Pond. The Inspectors observed stormwater flowing north along the access road to a stormwater drain (photos 53-55). The Facility personnel stated that this drain was connected to the stormwater management system and pumped to the Pond.

Description: Looking northeast across the Pond.

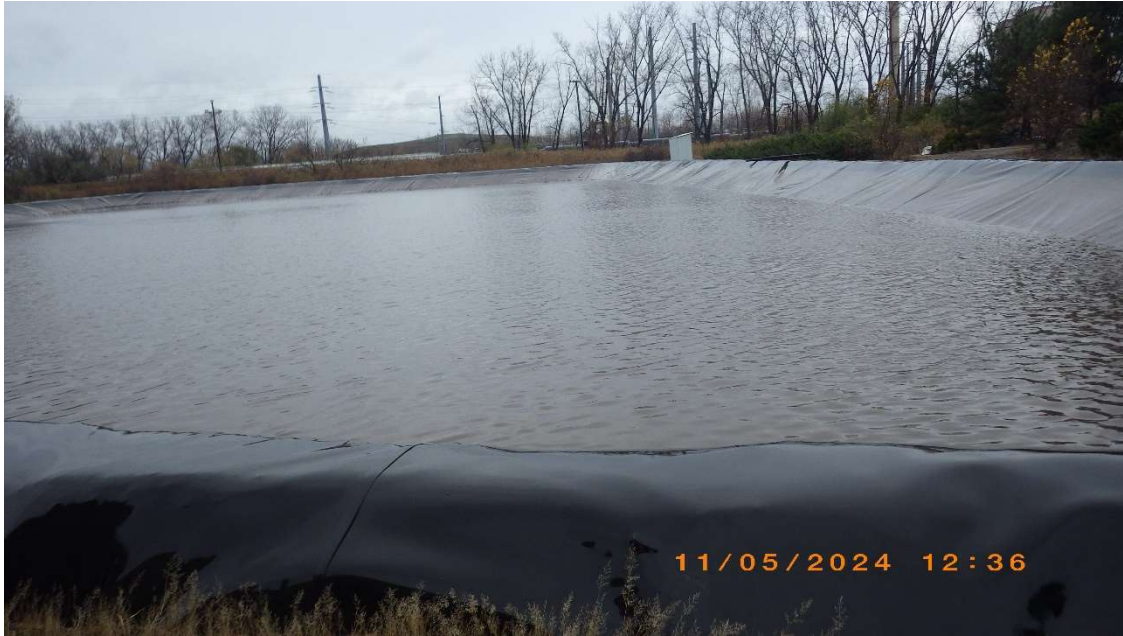
52: RIMG0052

Description: Looking west across the Pond from the north end of the east side of the pond.
