**CWA COMPLIANCE EVALUATION INSPECTION REPORT
U.S. ENVIRONMENTAL PROTECTION AGENCY, REGION 5**

Purpose: Compliance Evaluation Inspection

Facility: Befesa Zinc US Inc.
2701 East 114th Street
Chicago, Illinois 60617
41.68482160845534, -87.54572106929497

Date of Site Inspection: 11/05/2024

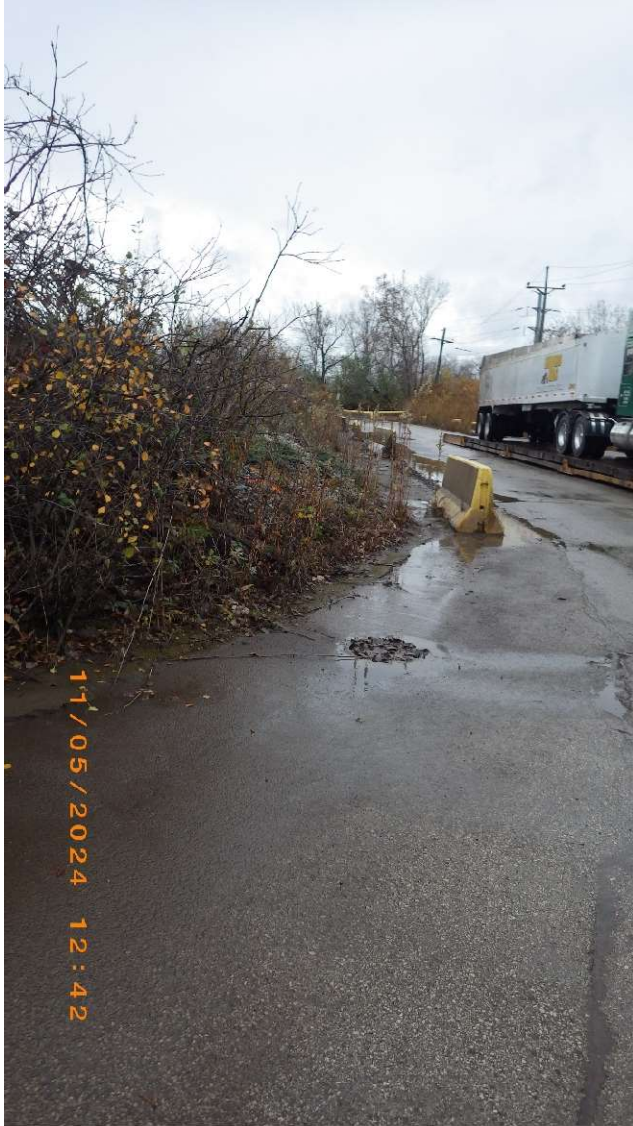
55: RIMG0055

Description: Looking south along the access road on the west side of the Pond.
