# Clean Water Act Section 404: Site Visit/Case Development

Site Name	SVG Holdings Property	Start Date	September 9, 2022
		End Date	September 9, 2022
Inspection Purpose	Initial site visit		
<b>Opening Conference</b>			
<input checked="" type="checkbox"/> Presentation of Inspector Credentials			
Name and Title (Use N/A if owner/operator not available to join the inspection)			
Credentials were presented to Mr. Seamus Glynn, owner of SVG Holdings			
<input checked="" type="checkbox"/> Opening Conference			
Name of person authorizing access if applicable			
I corresponded with Mr. Glynn via phone and e-mail to arrange the inspection.			
Notes from Opening Conference			
Mr. Glynn explained that the property was a working farm when he purchased it 5-6 years ago. While developing the farm, he worked under the advisement of the Ulster County SWCD.			
<input type="checkbox"/> Access Issues if Any			
Describe			
N/A			
<b>Inspection Observations and Sample Collection</b>

CWA 404 Inspection  
SVG Holdings Property  
260 Bruyn Turnpike  
Wallkill, Ulster County, NY

September 9, 2022

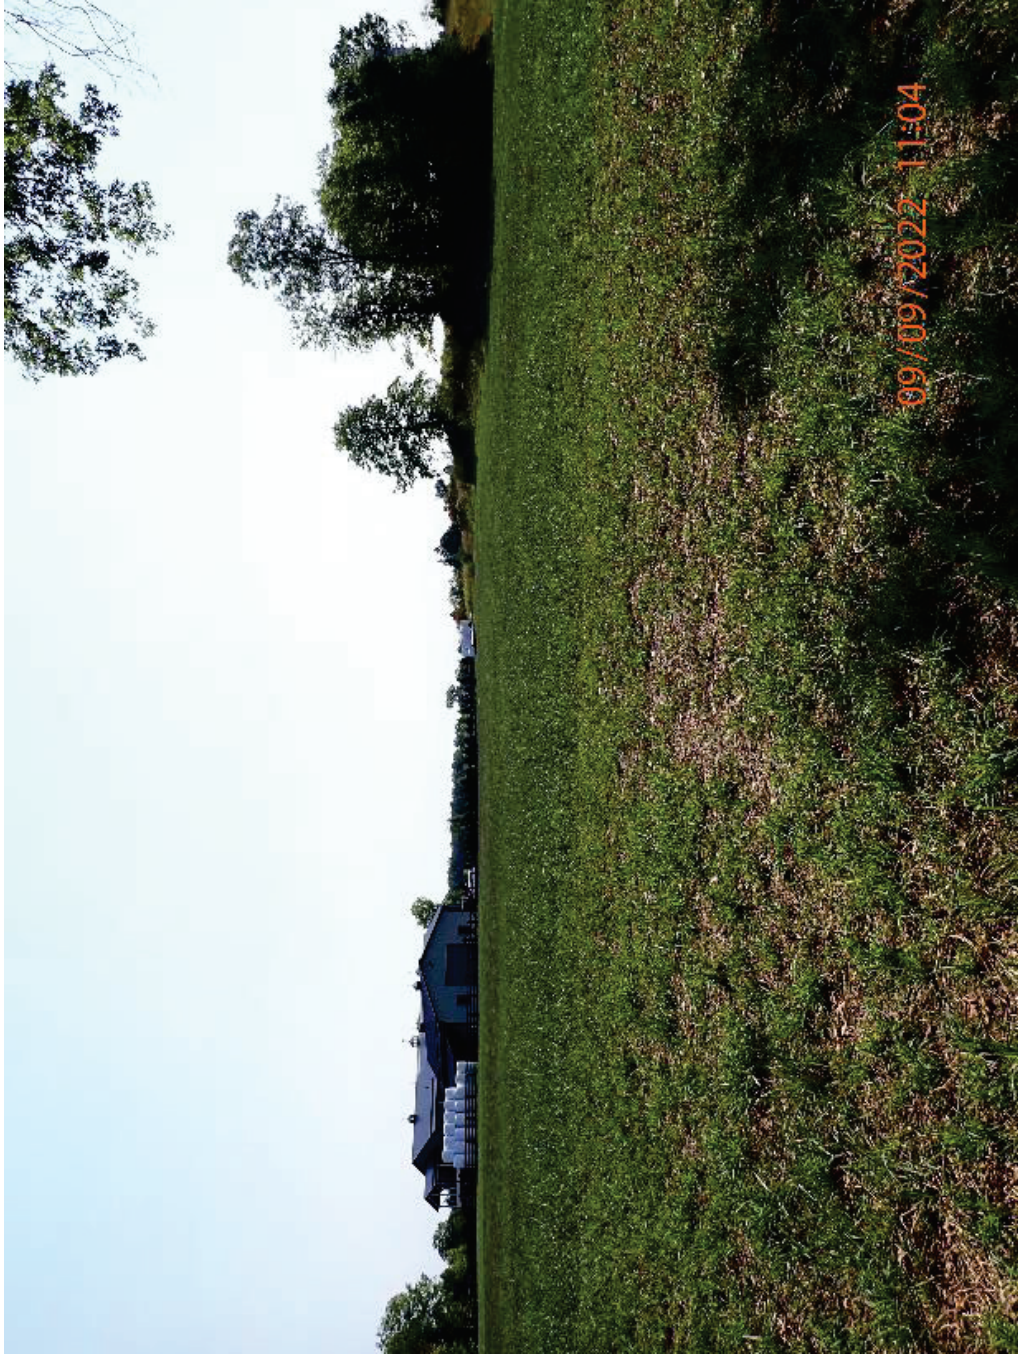
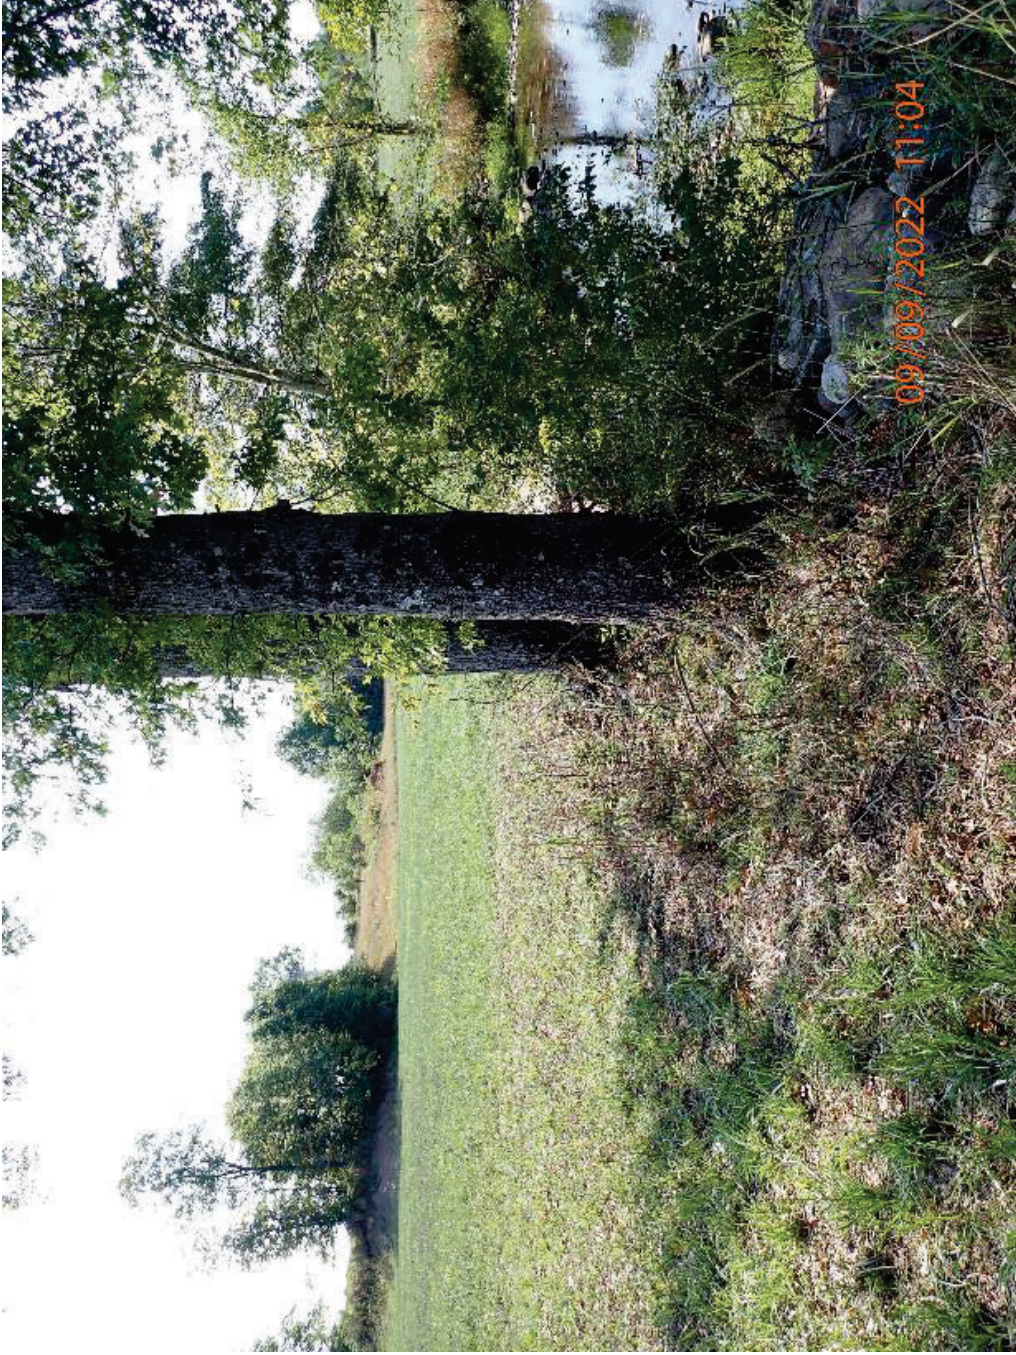
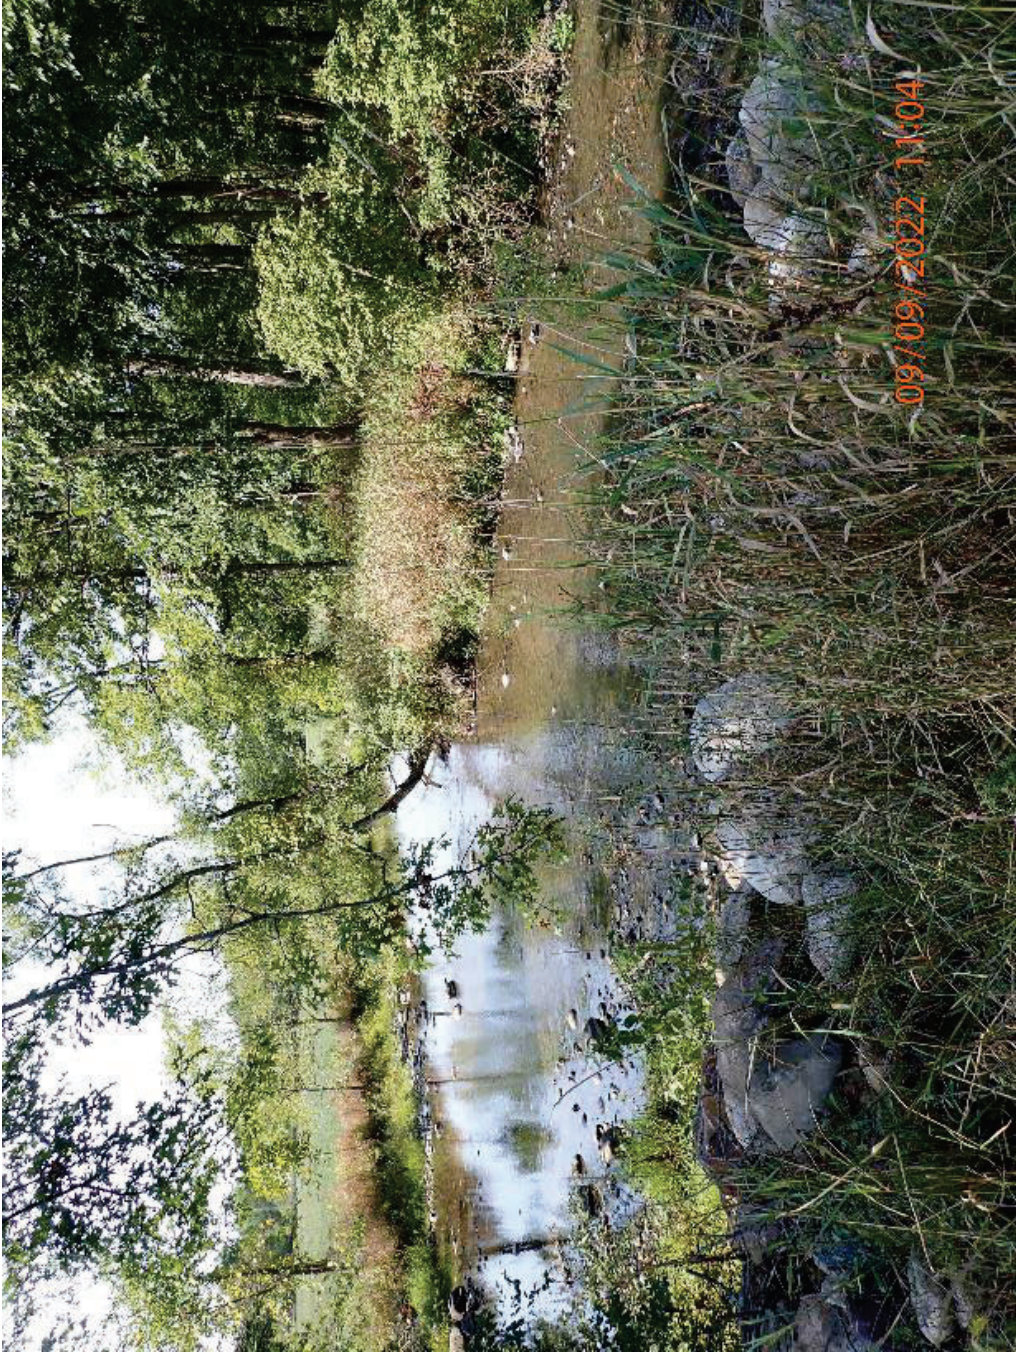
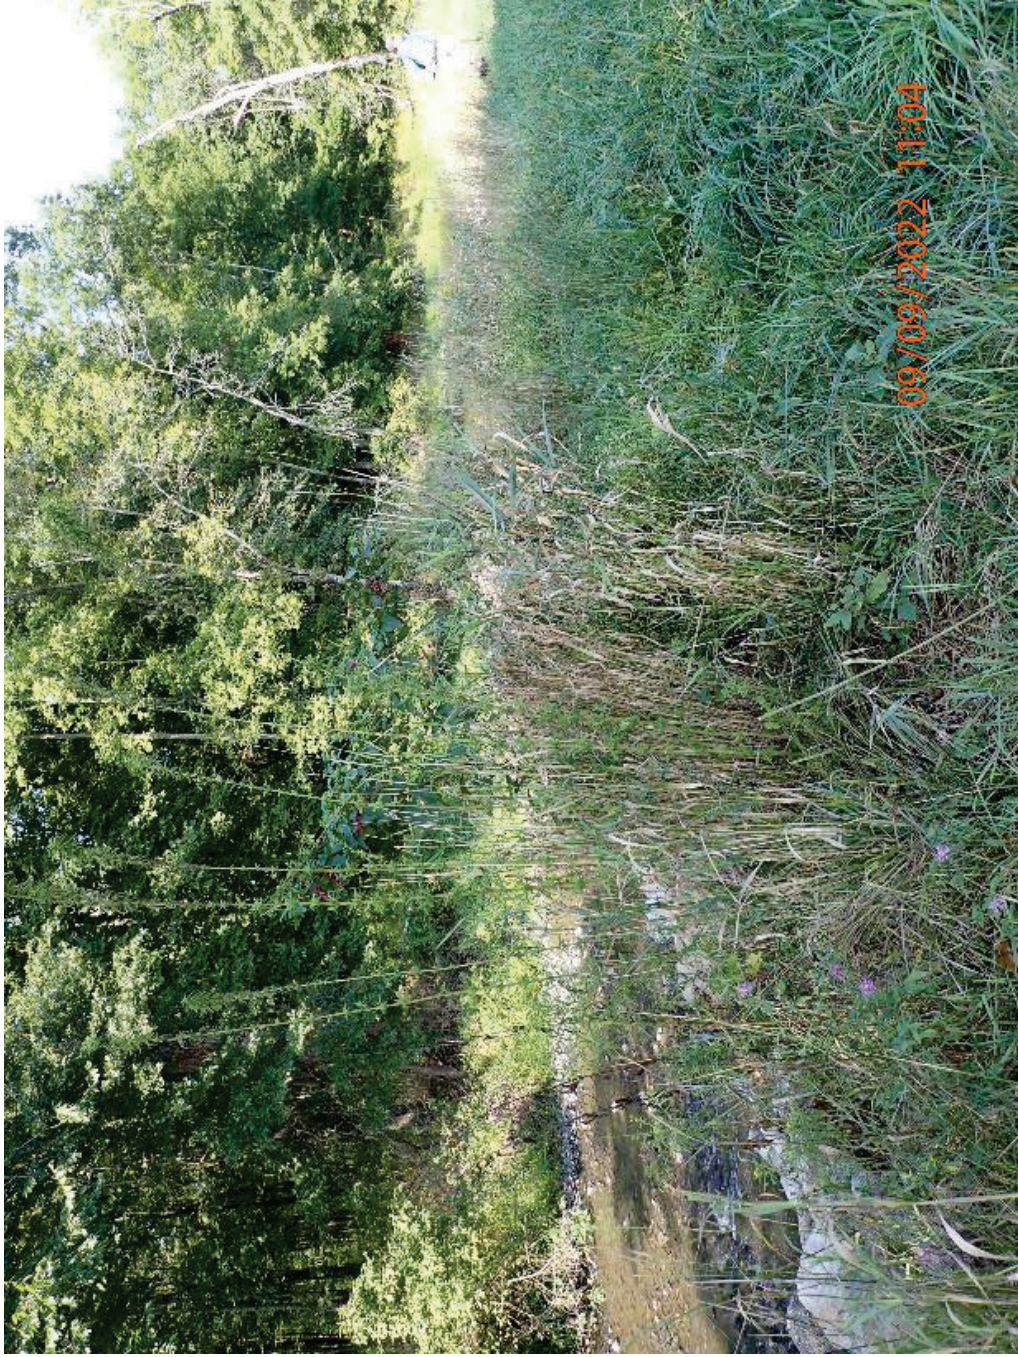
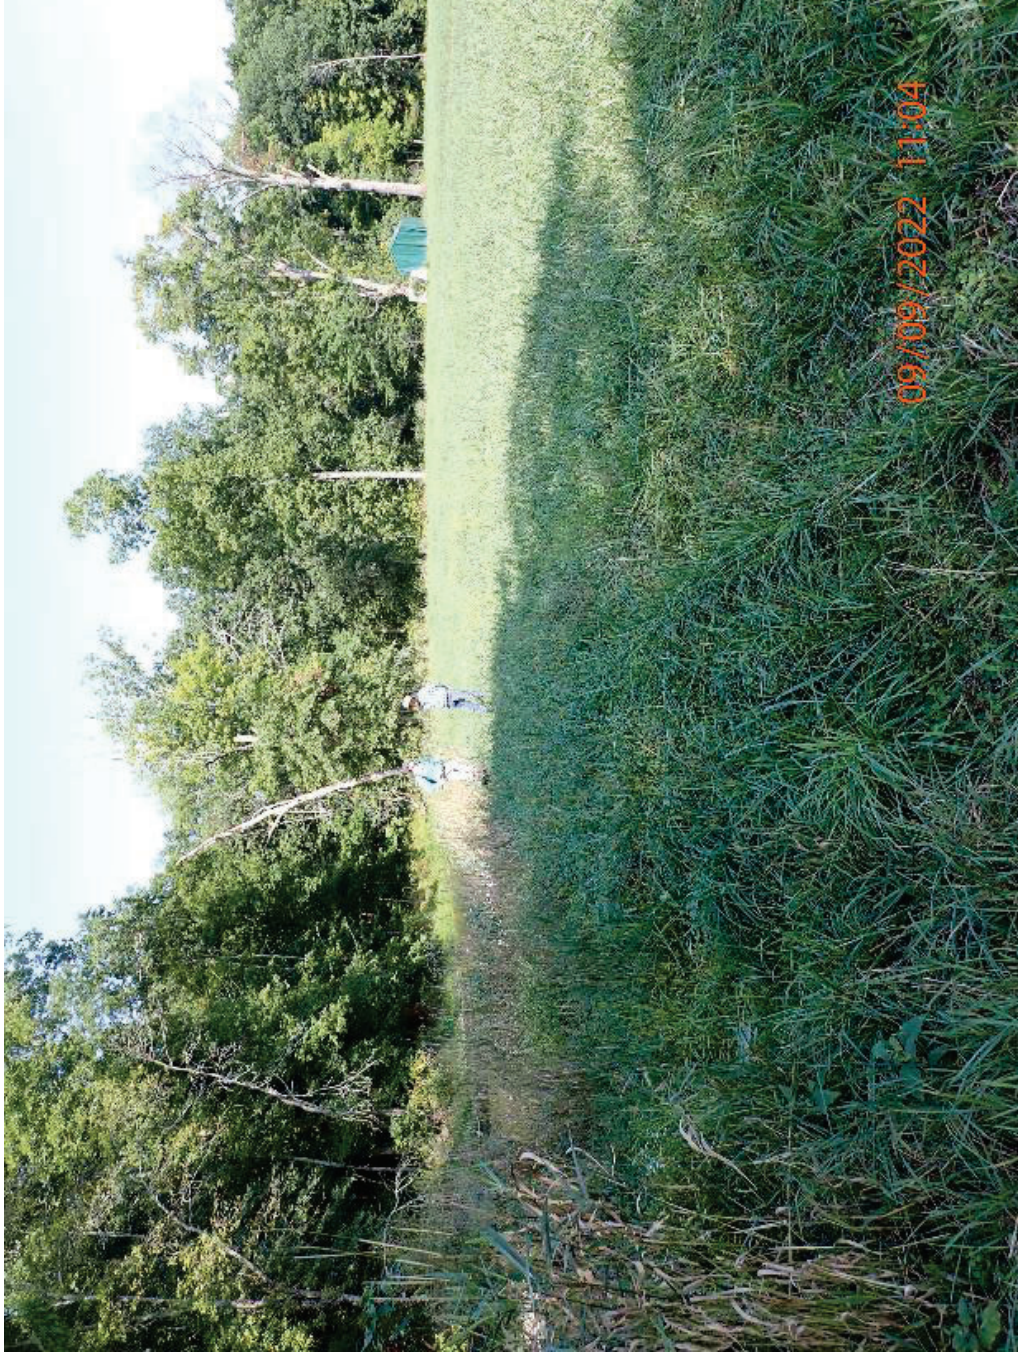
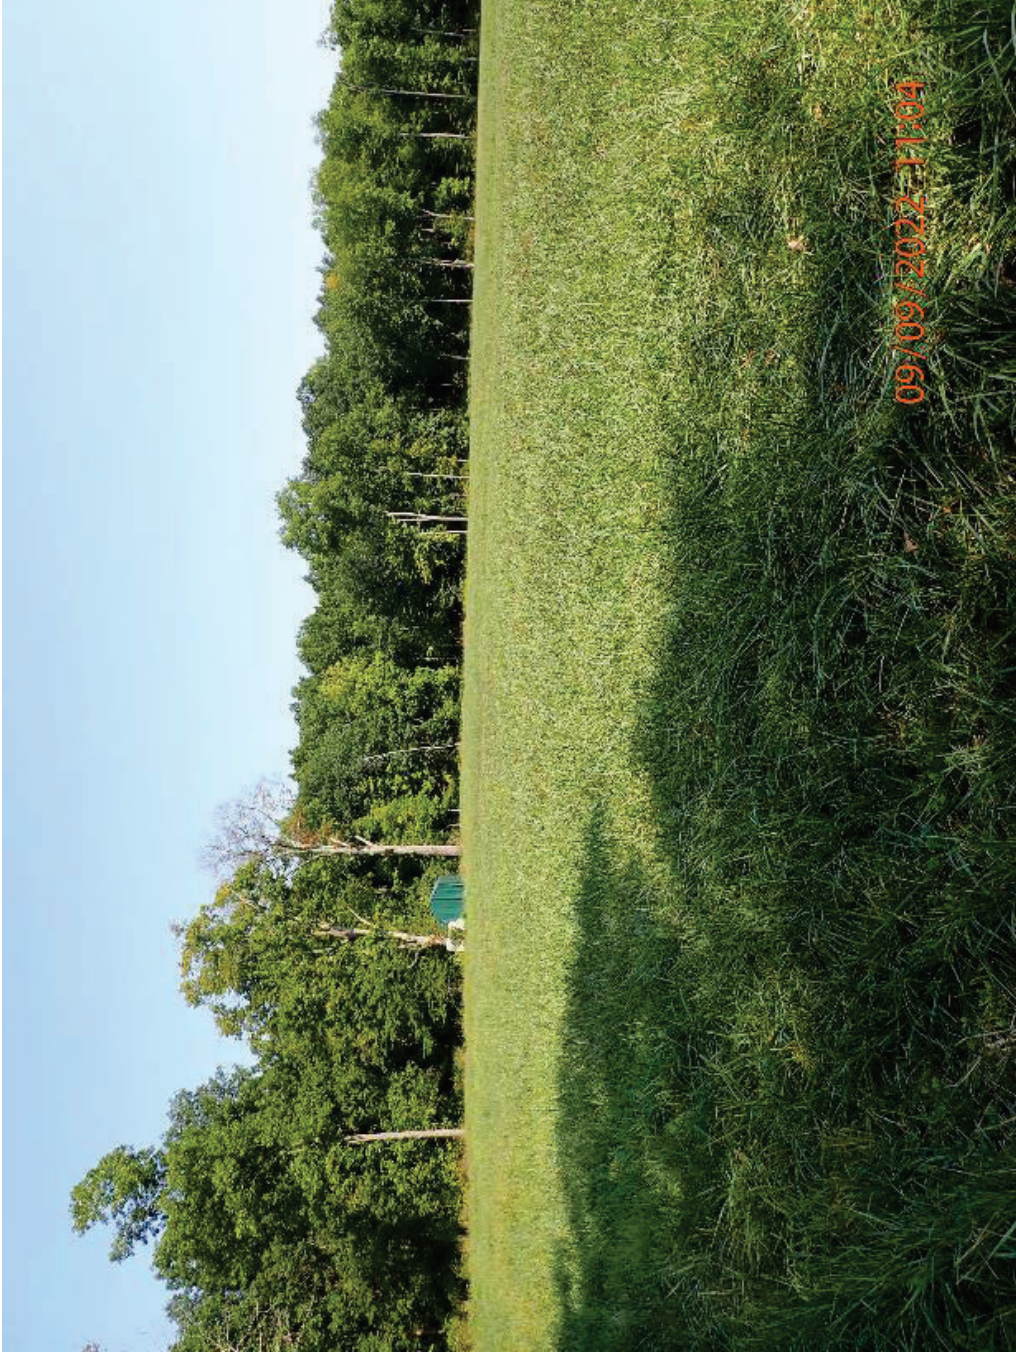
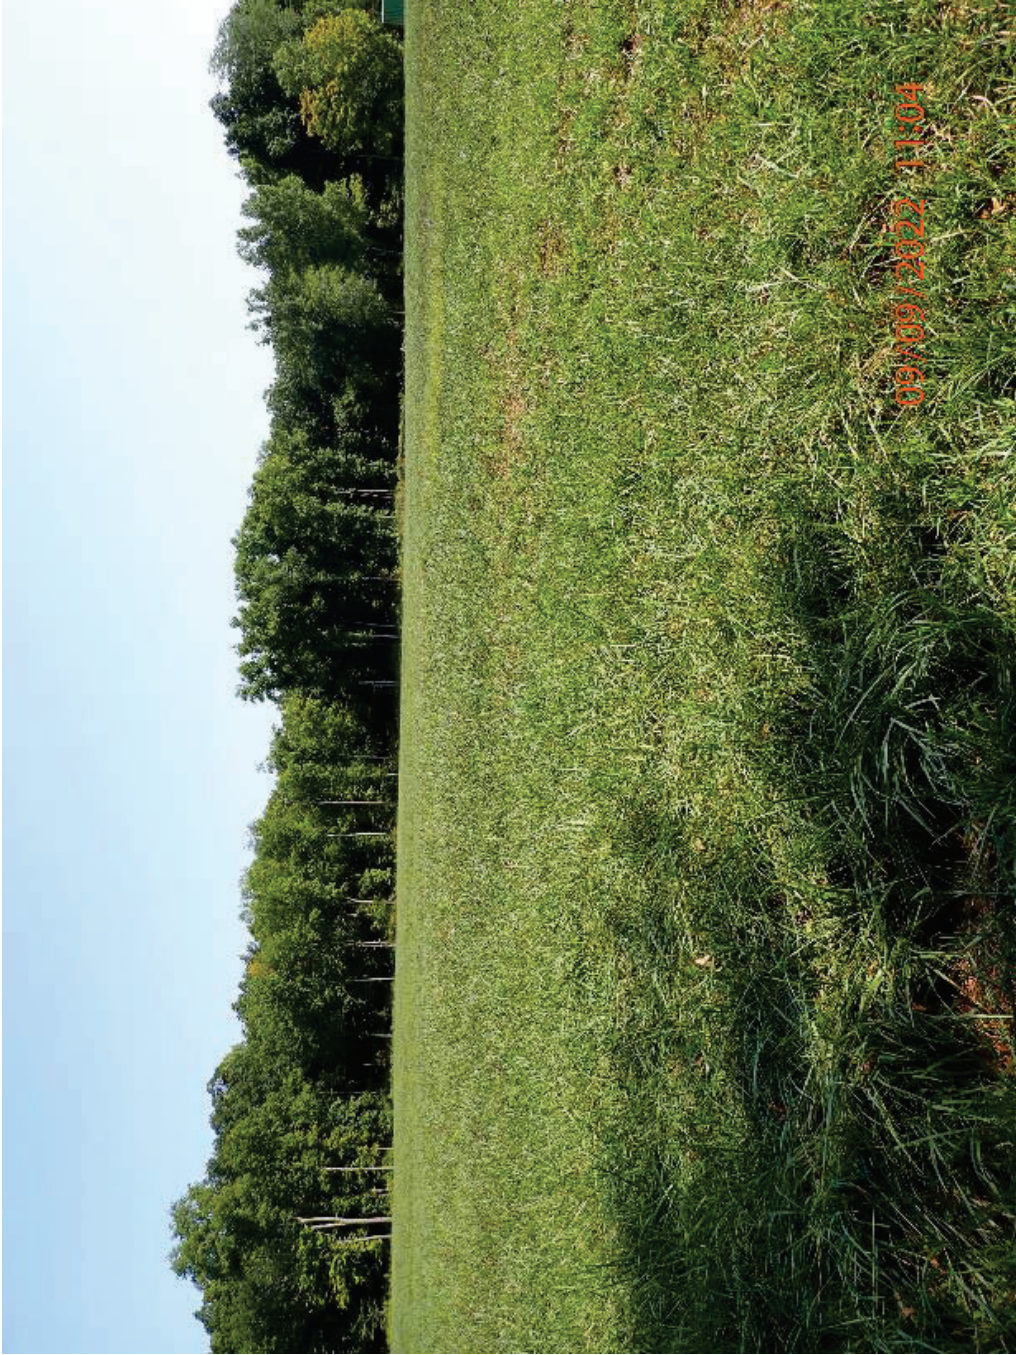
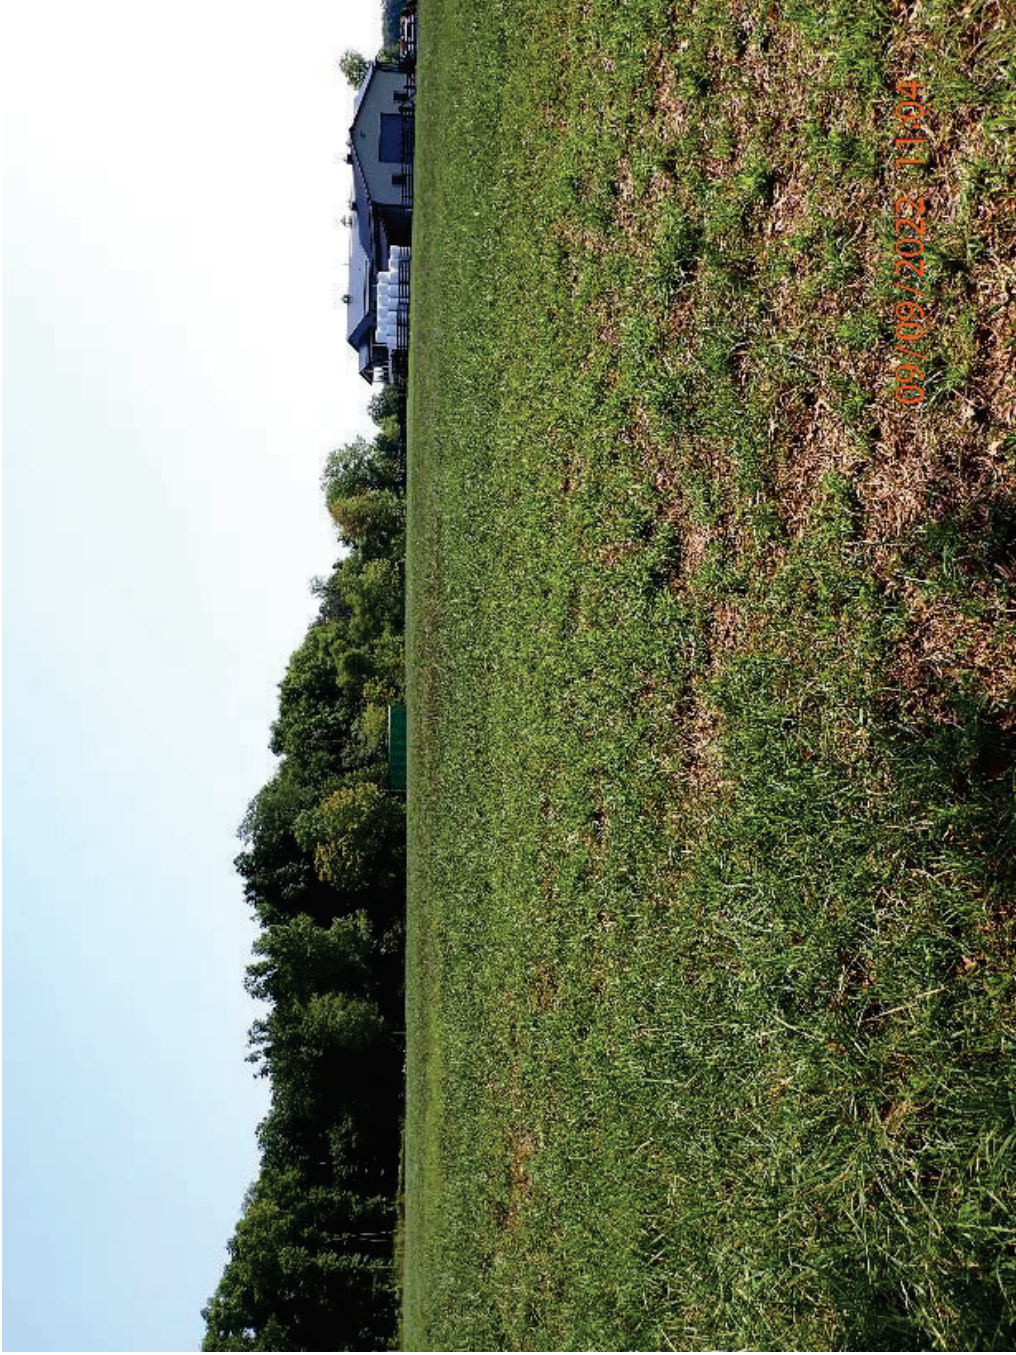
**Description:**  
(1/8) Panorama of property

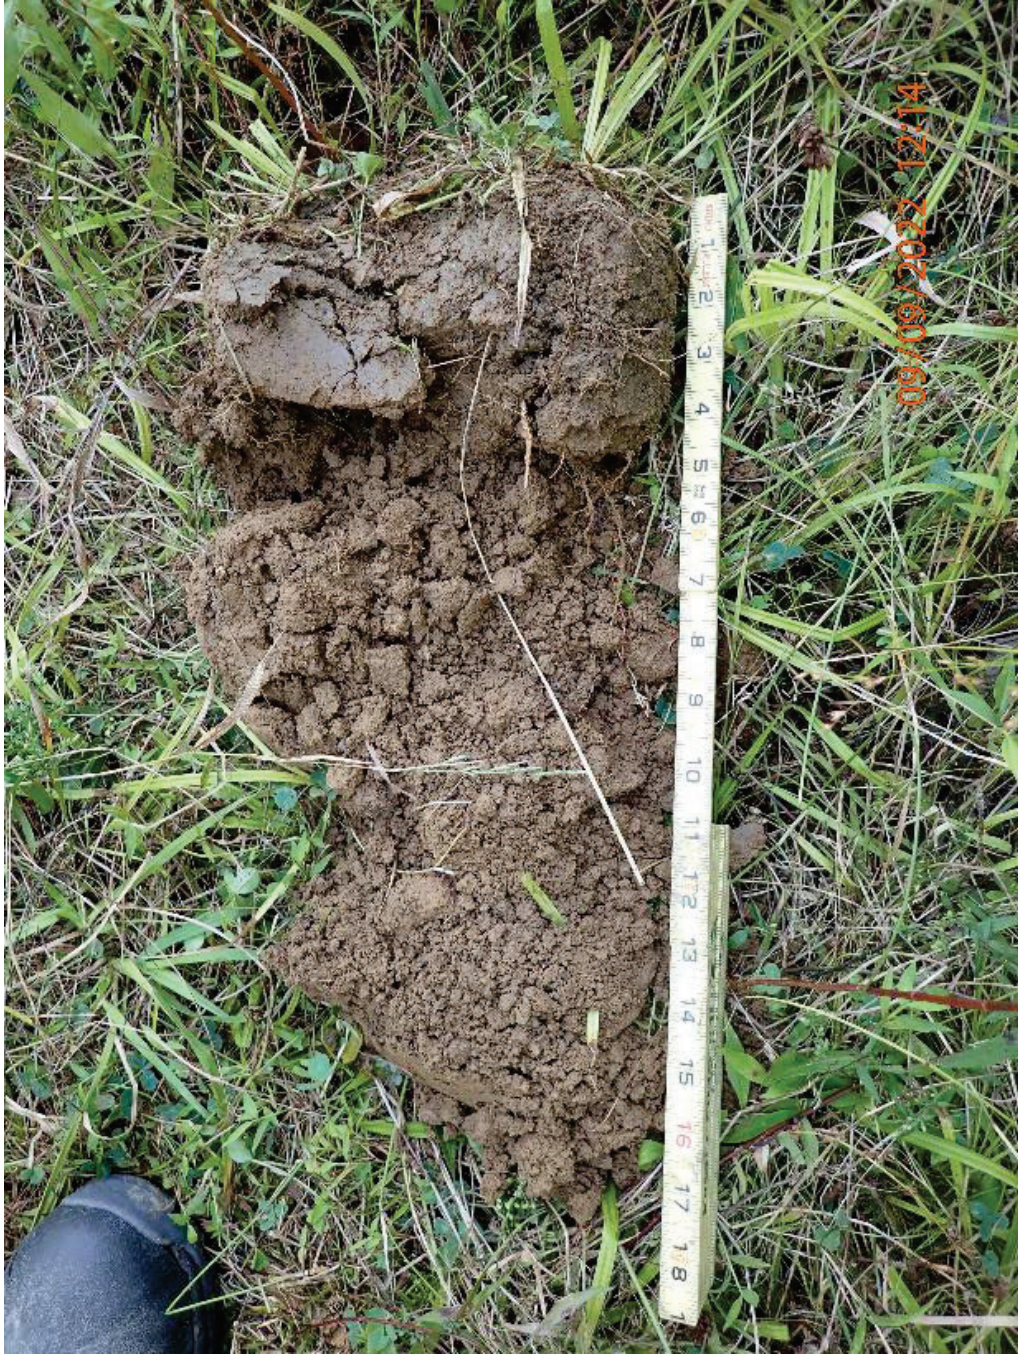
**Date:** 9/9/2022  
**Time:** 12:14 PM  
**Photographer:** SSA  
**Photo ID:** 15 – P9090478

From the first soil sample location, EPA walked east along the Dwaar Kill and took a GPS point at a low spot in the hayfield that had boulders in it. EPA then continued to walk east to an undisturbed forested/scrub shrub area to take a second soil sample. This soil sample was found to be in upland.

**Description:**  
SS2 soil profile

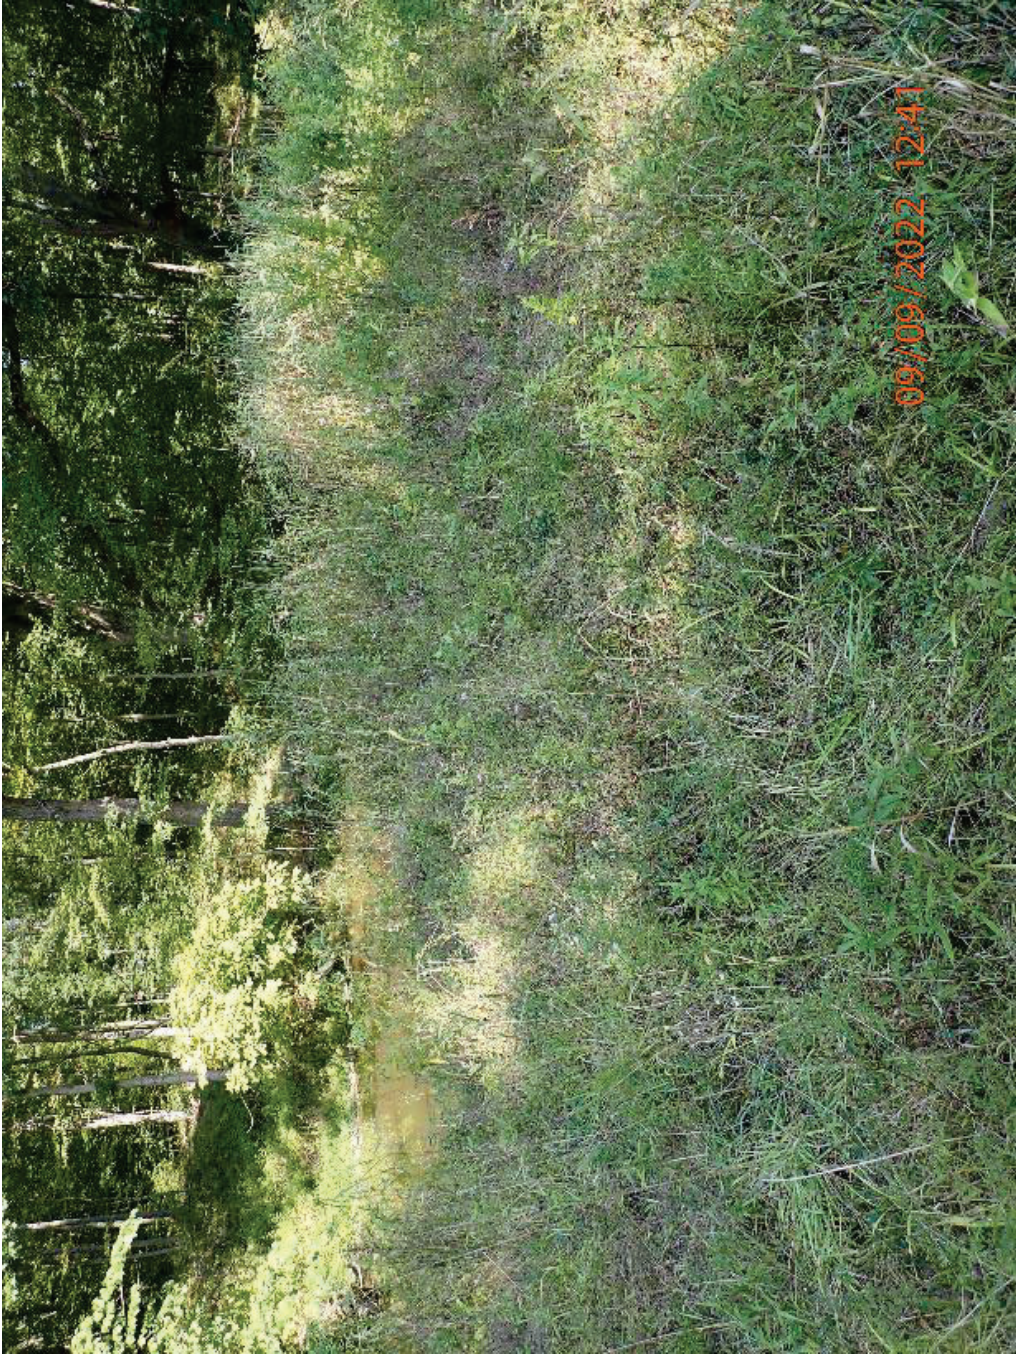
**Date:** 9/9/2022  
**Time:** 12:41 PM  
**Photographer:** SSA  
**Photo ID:** 16 – P9090479

**Description:**  
Vicinity of SS2

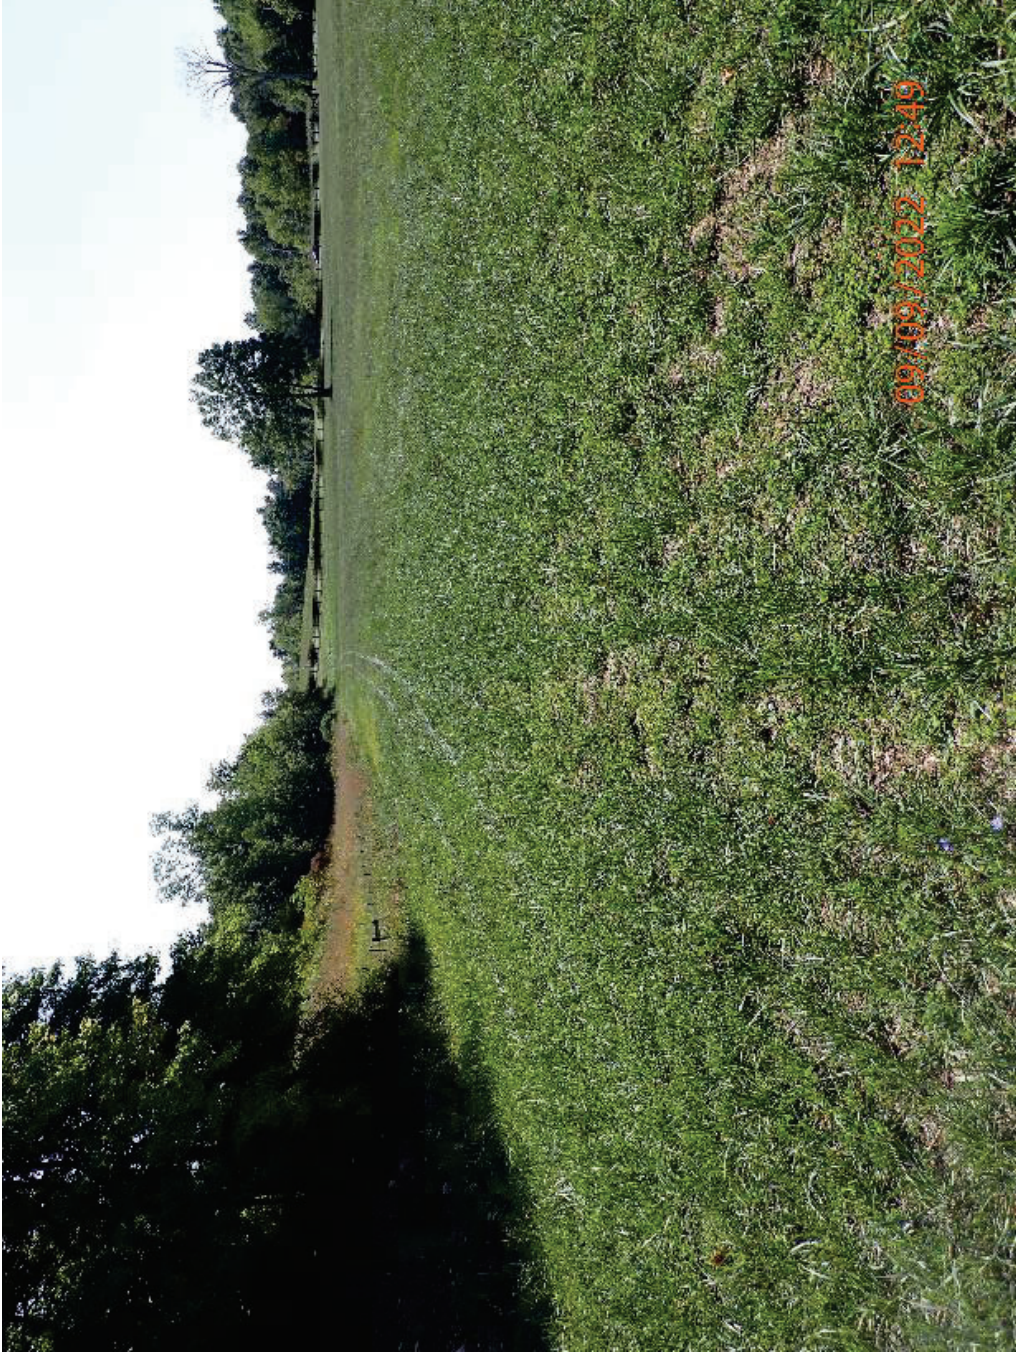
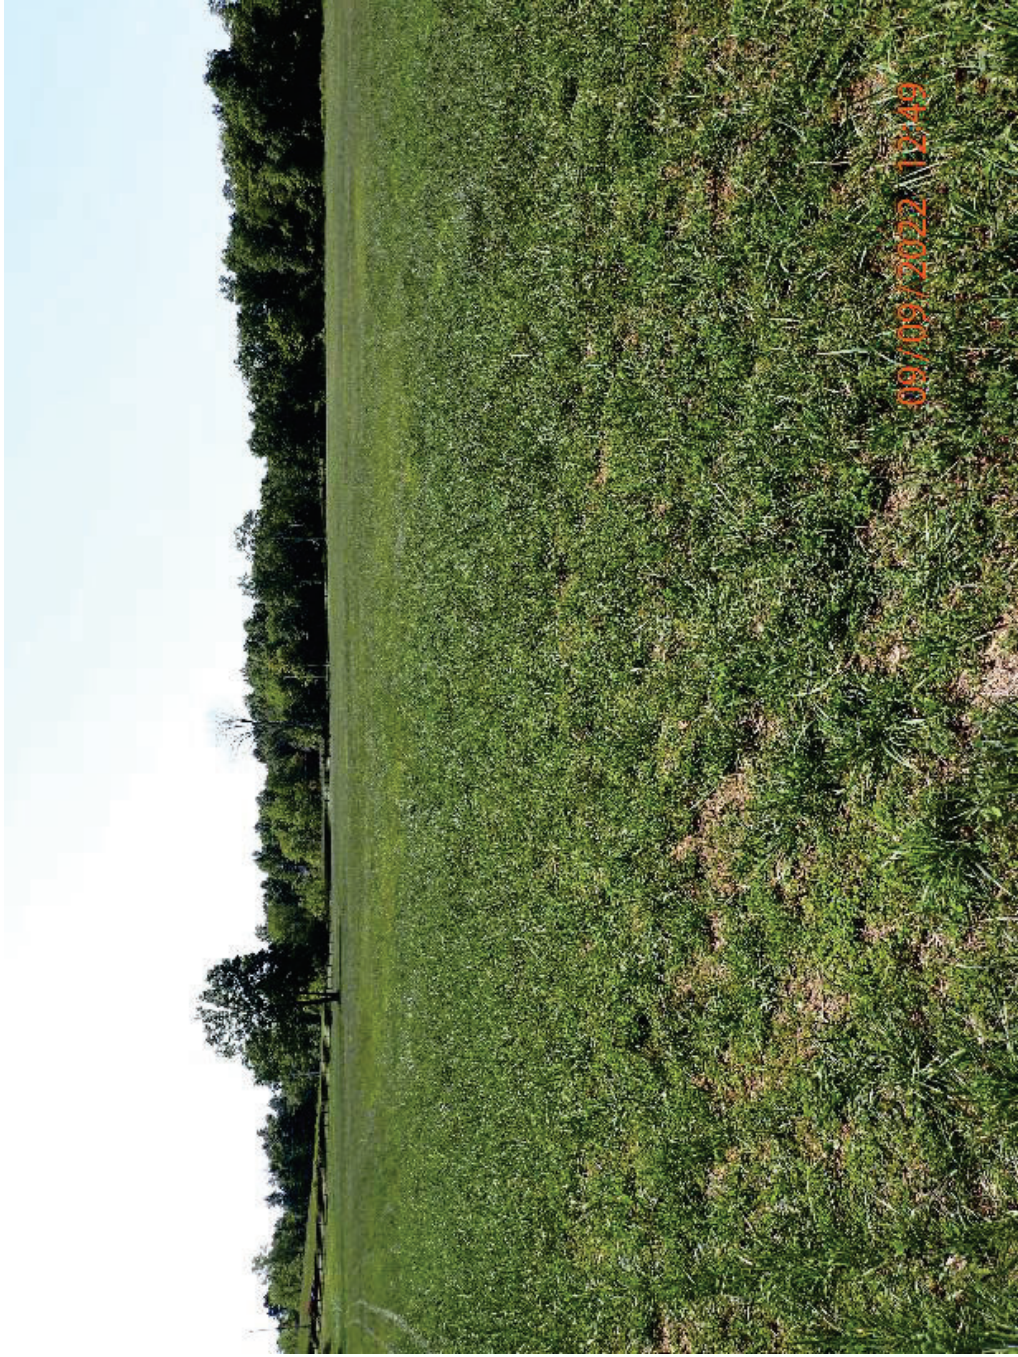
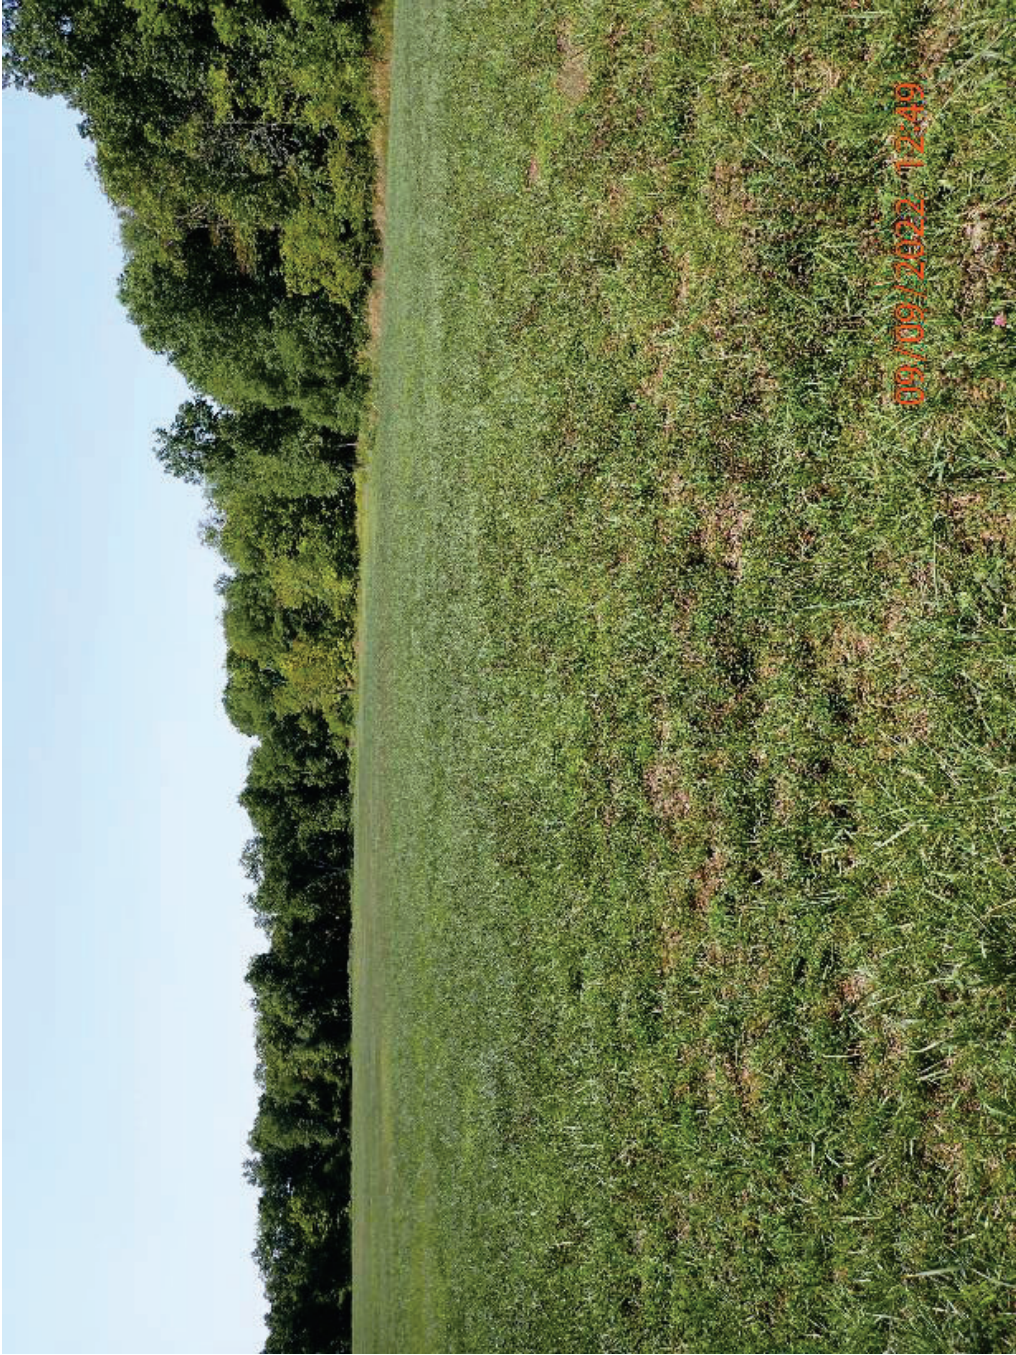
**Description:**  
(1/3) Panorama of southwestern hayfield, eastern side

**Description:**  
(2/3) Panorama of southwestern hayfield

**Description:**  
(3/3) Panorama of southwestern hayfield
