COMPLIANCE EVALUATION INSPECTION REPORT  
U.S. ENVIRONMENTAL PROTECTION AGENCY, REGION 5

**Purpose:** NPDES Compliance Evaluation Inspection

**Facility:** Leesville Land LLC  
86900 Sinfield Road  
Hopedale, Ohio 43976

**NPDES Permit:** OH0011827

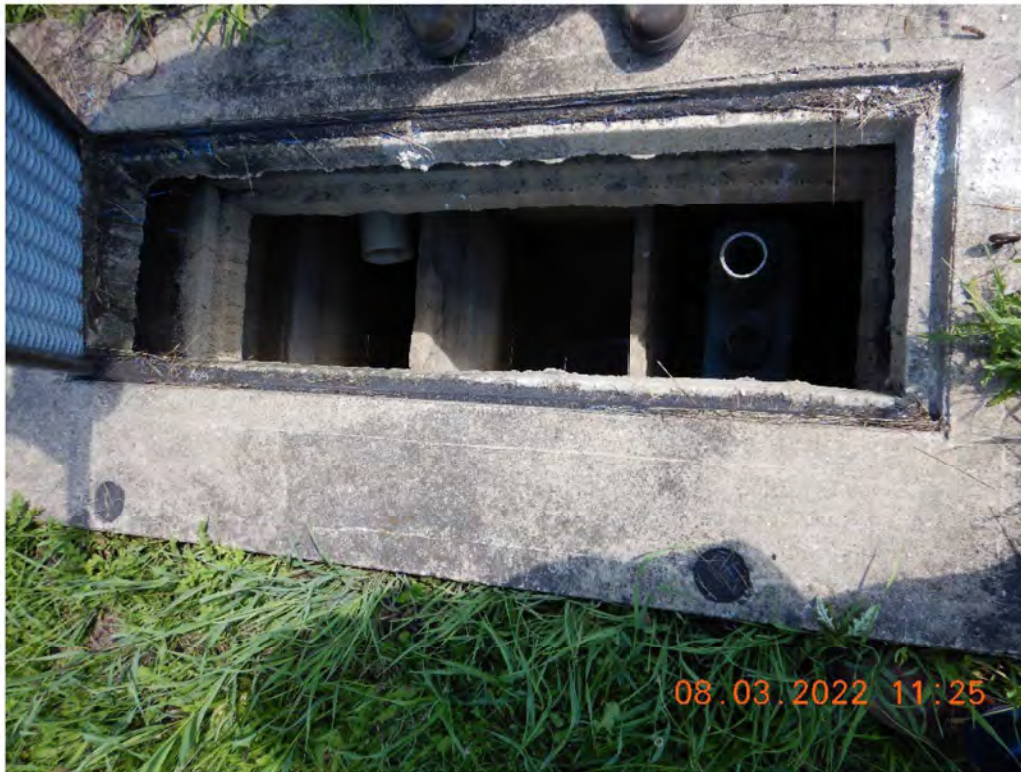
5: DSCN3869

Description: Final stage chlorination well for the preparation plant sewage treatment plant.

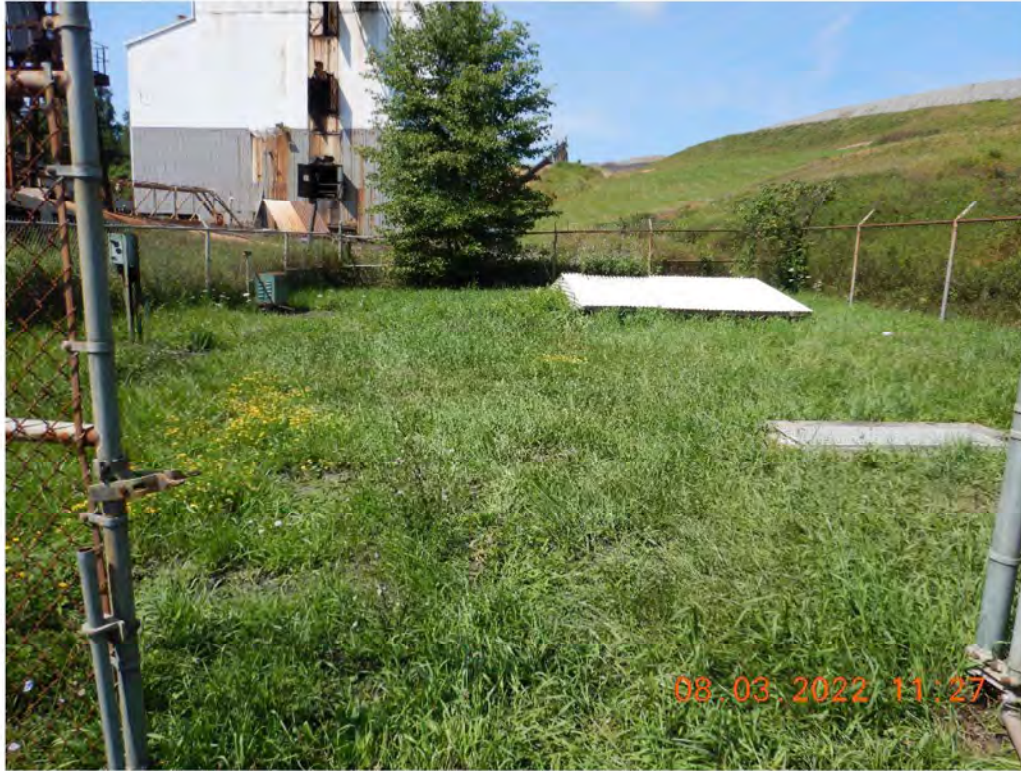
6: DSCN3870

Description: View looking across the preparation plant sewage treatment plant. Domestic sewage from preparation plant office showers and toilets is treated here. Aerated underground tanks are located to the left of the photograph view. The covered sand filtration beds (roofed structure) and grated cover to the chlorination well are visible to the right side of the photograph.

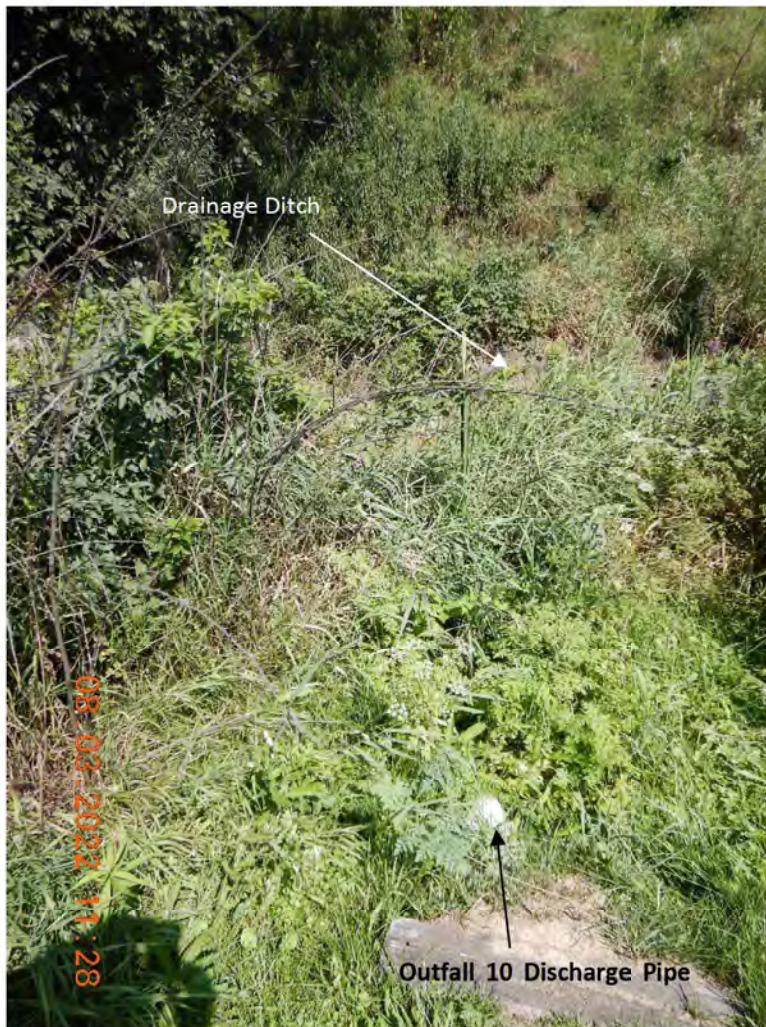
7: DSCN3871

Description: The preparation plant sewage treatment plant discharges through a white plastic pipe to the drainage ditch that collects stormwater run-off and underdrains from the mine refuse impoundment.

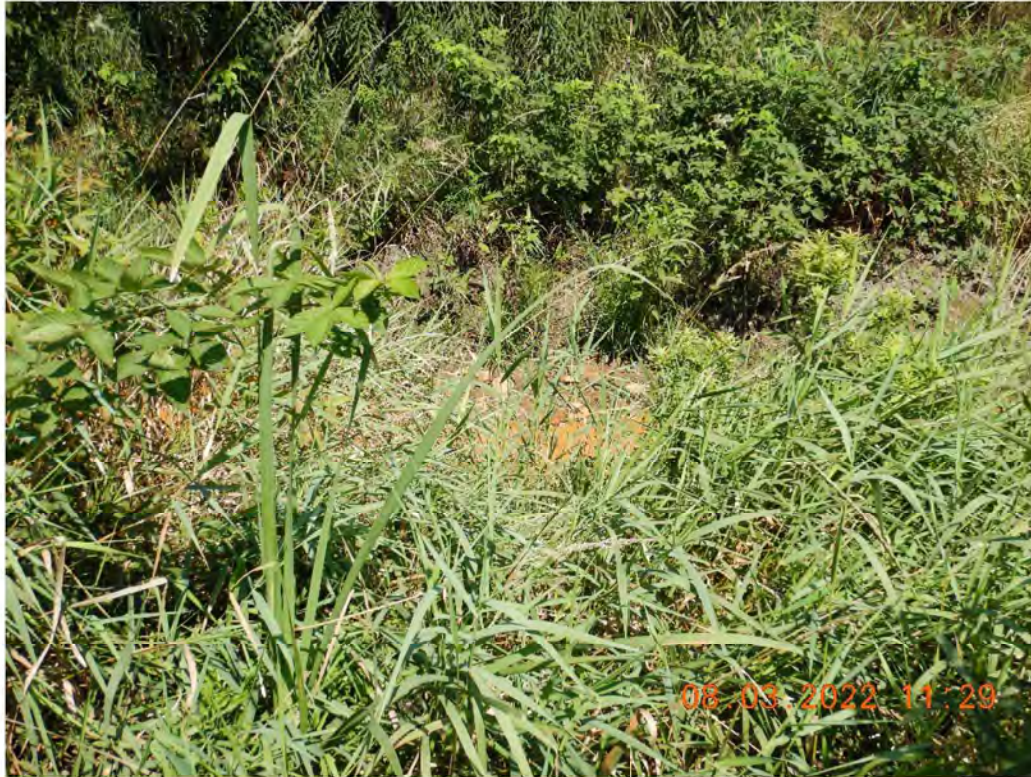
9: DSCN3873

Acid mine drainage (Photos 9-11) from the wet impoundment drains into three ponds, ponds A, B and 11 (Appendix C, Image 1) which then flow into the drainage ditch. The drainage ditch is dammed at the outlet to flow into a treatment basin which then flows into the system of settling ponds: all settling ponds are operated in series. Cell 1 is the primary settling pond, Cell 2 is the secondary settling pond and Pond 9 is the polishing pond. North Pond 9 discharges to a pipe via an overflow into a wetland area prior to merging with the tributary of Cross Creek.

Description: Close-up view of drainage ditch that receives flow from Outfall 10 as well as stormwater run-off and flow from the underdrains for the mine refuse impoundment.

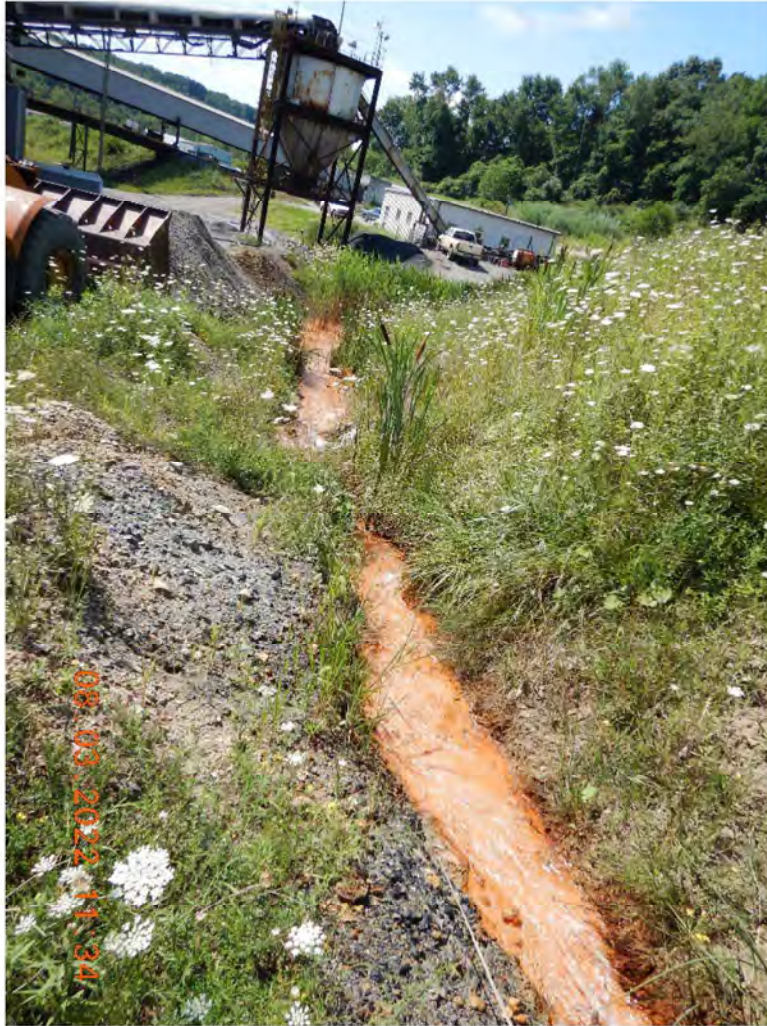
10: DSCN3874

Description: Flow observed in the drainage ditch at the base of the mine refuse impoundment, north east of the Preparation Plant. The offices for the Preparation Plant are visible in the background of the photograph.

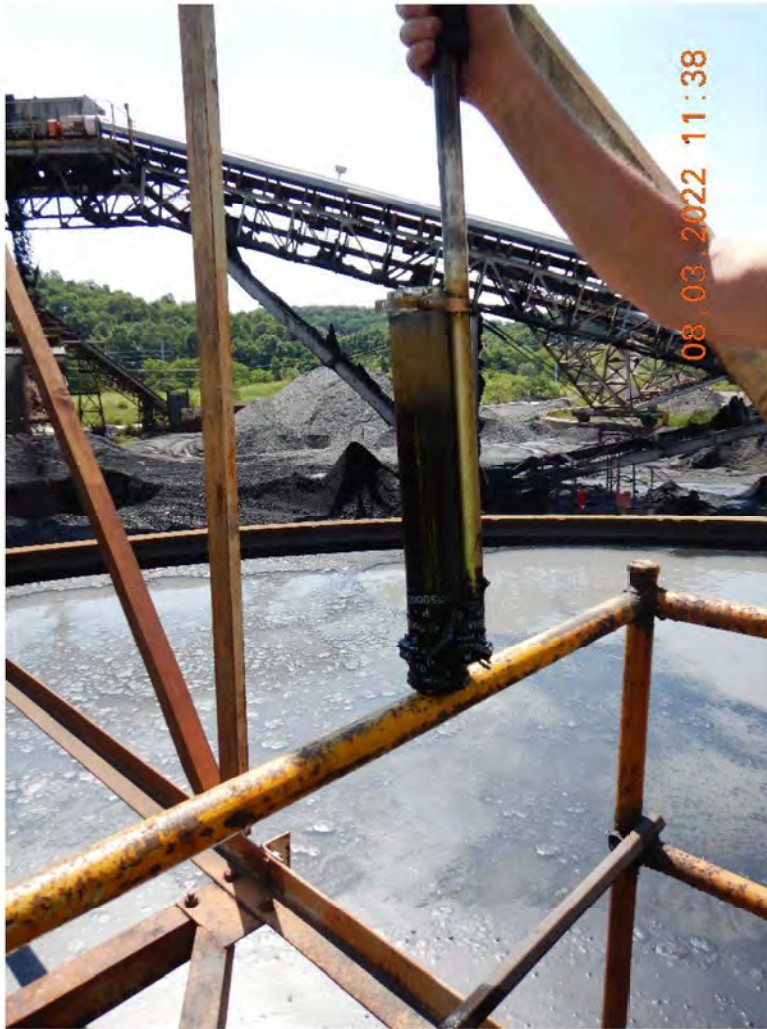
12: DSCN3876

Next, EPA viewed the sludge thickener and Mr. Henderson described the process to determine sludge depth and settleability (Photos 12-17). Flocc is added during the process and sodium hydroxide is added to keep the pH neutral. A sludge judge measures the amount of sludge and when necessary, the sludge slurry is sent to the wet impoundment using two tandem pumps. Next, EPA viewed the sludge slurry pump house and noted a sump pump discharging from the pump house onto the ground. The ground in this area is sloped towards the drainage ditches (Photos 18 and 41).

Description: Example of sample collection by site personnel to determine settling time of the slurry in preparation plant thickener.

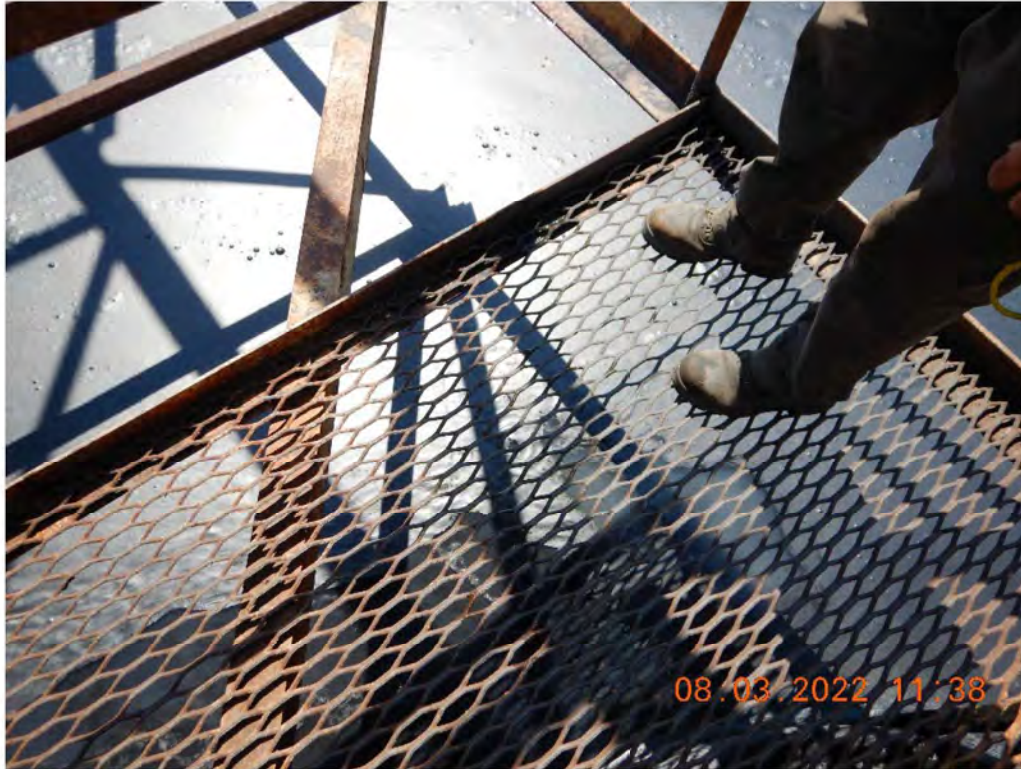
13: DSCN3877

Description: View into thickener unit below the walkway.

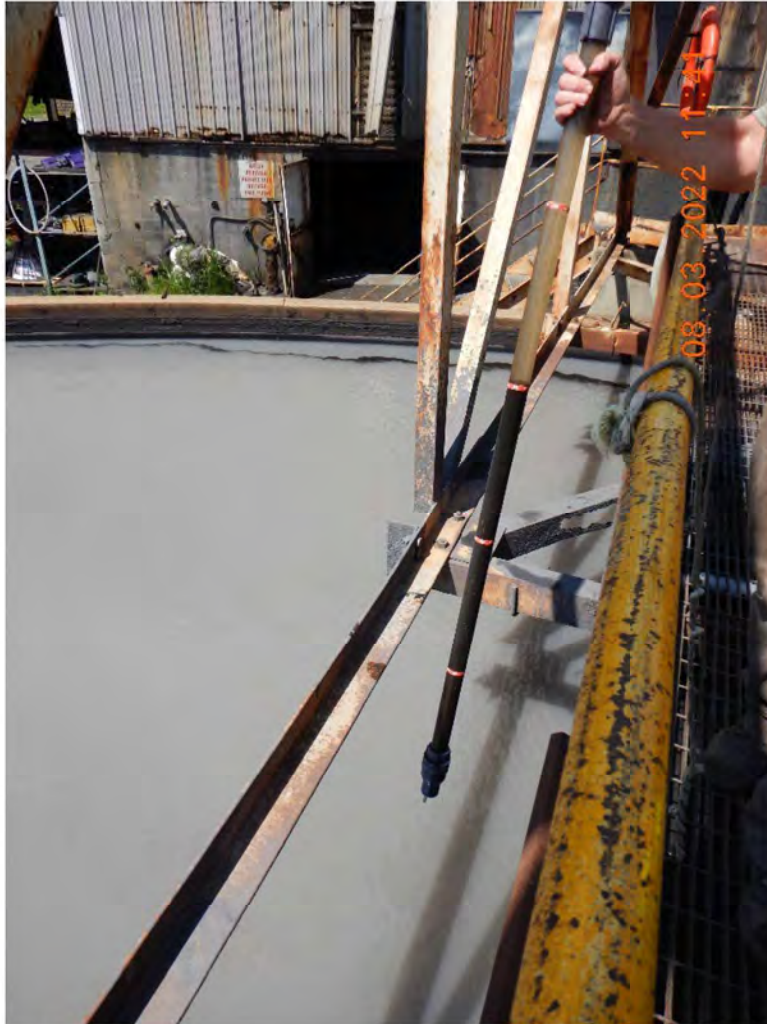
16: DSCN3880

Description: Sludge judge sample from thickener pulled as an example during the inspection.

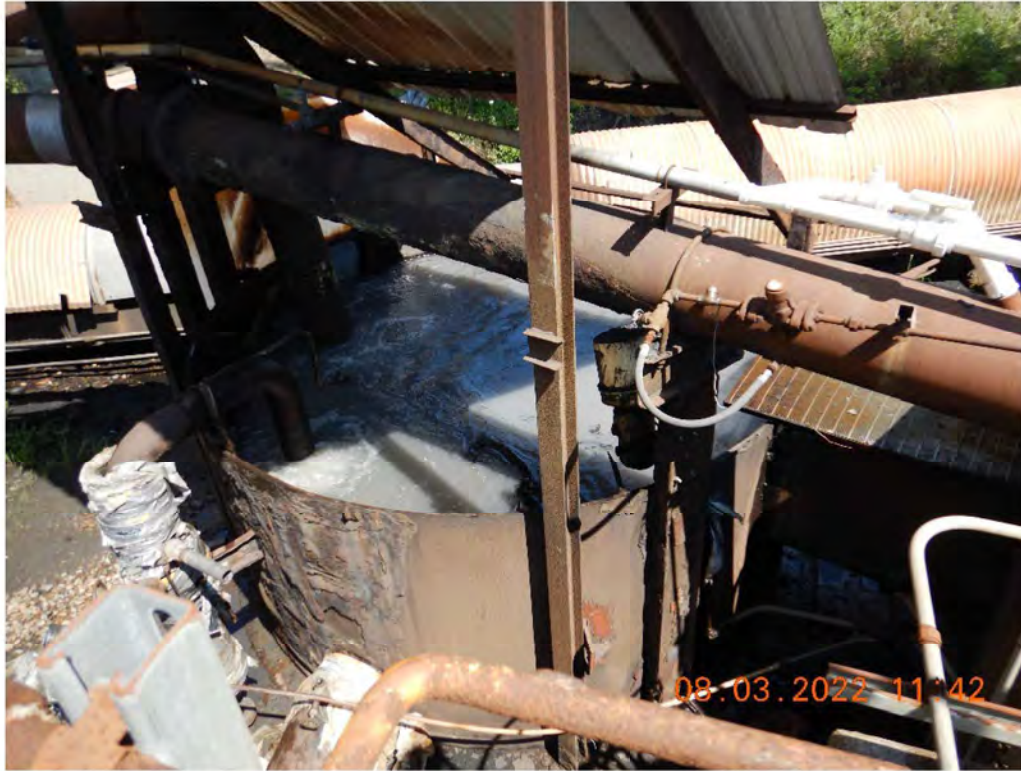
17: DSCN3881

Description: Clarified water tank. This water is reused in the wash plant/preparation plant.

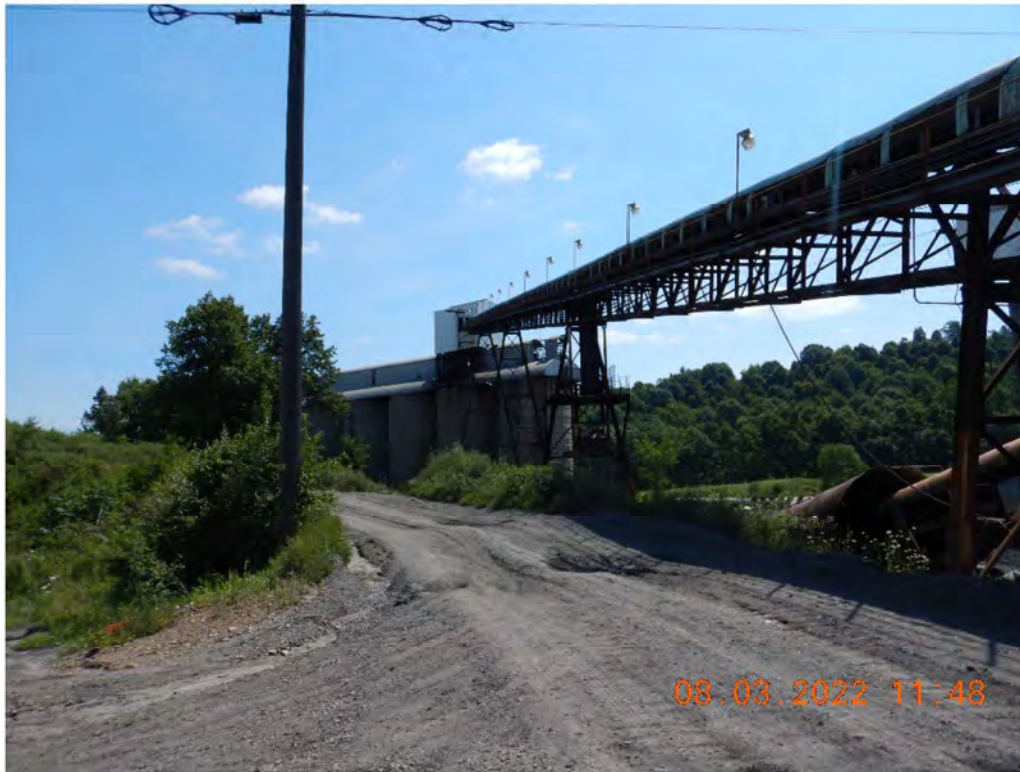
18: DSCN3882

Description: Coal conveyor and washed coal product storage silos.

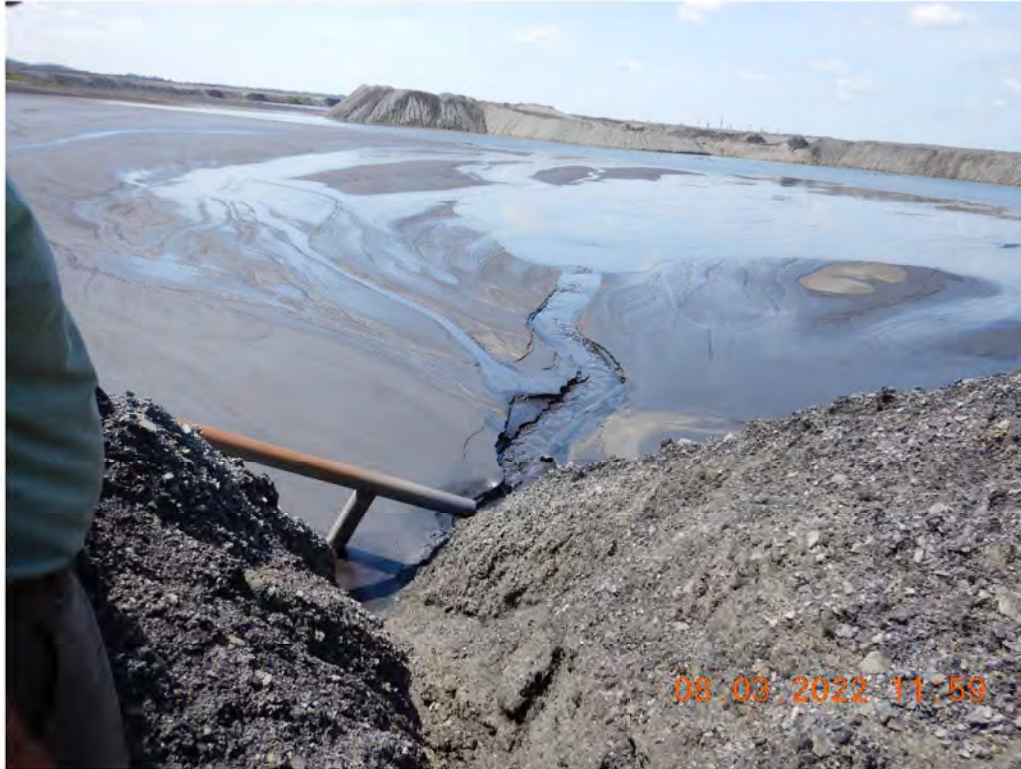
19: DSCN3883

At 12:00 pm, EPA and Mr. Henderson drove to the top of the wet impoundment. A delta has formed under the discharge from the pipe which pumps sludge slurry from the sludge thickener. (Photo 19-20). Mr. Henderson stated that the pipe must be moved when the buildup gets too high to maintain head. EPA noted waterfowl residing on the top of the impoundment. EPA noted pipes periodically built into the side of the impoundment and Mr Henderson stated that they are used to check the water table in the impoundment.

Description: Standing at the top of the northeast quadrant of the mine refuse impoundment. Current location of the discharge pipe where preparation plant thickener slurry is pumped into the impoundment. Pipe was observed discharging the slurry into the impoundment.

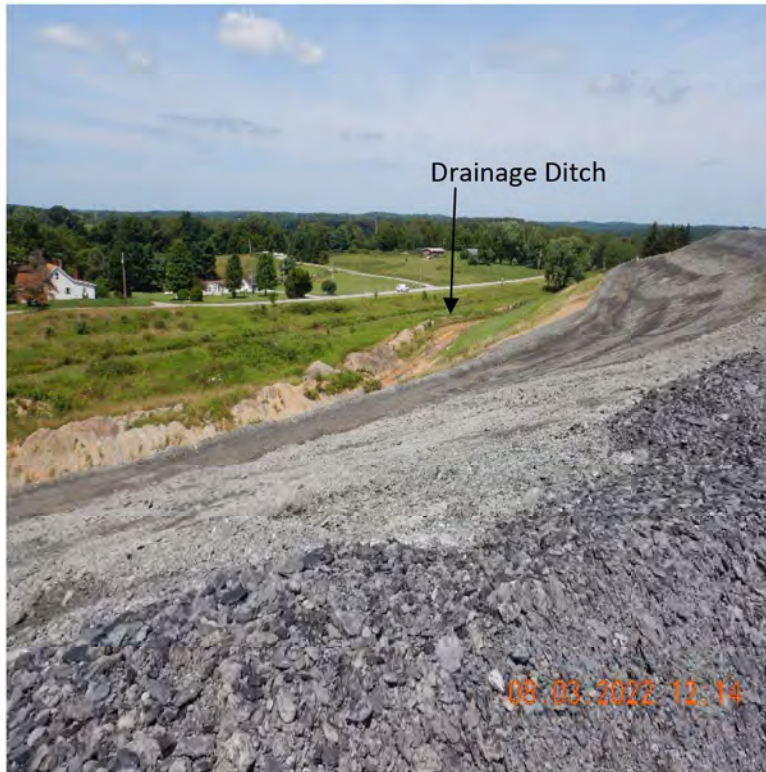
21: DSCN3885

Description: Standing at the top of the southwest quadrant of the mine refuse impoundment. View of drainage ditch along west side of impoundment.

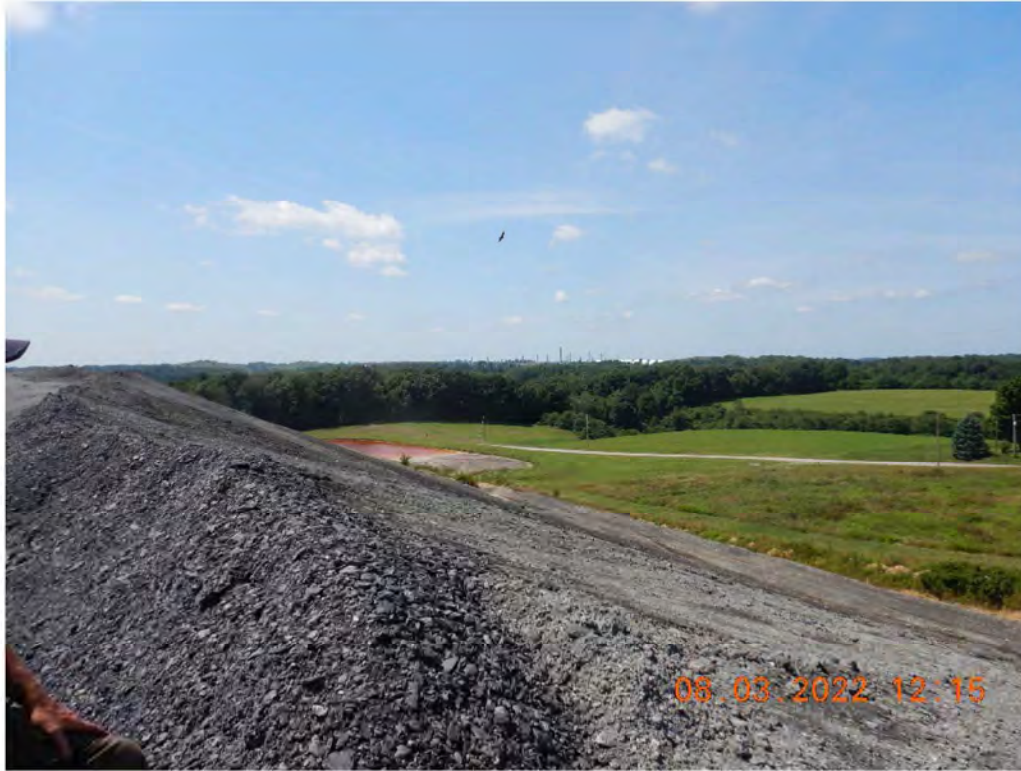
22: DSCN3886

Description: Standing at the top of the southwest quadrant of the mine refuse impoundment. View of drainage ditch along west side of impoundment and the north end of Pond B.

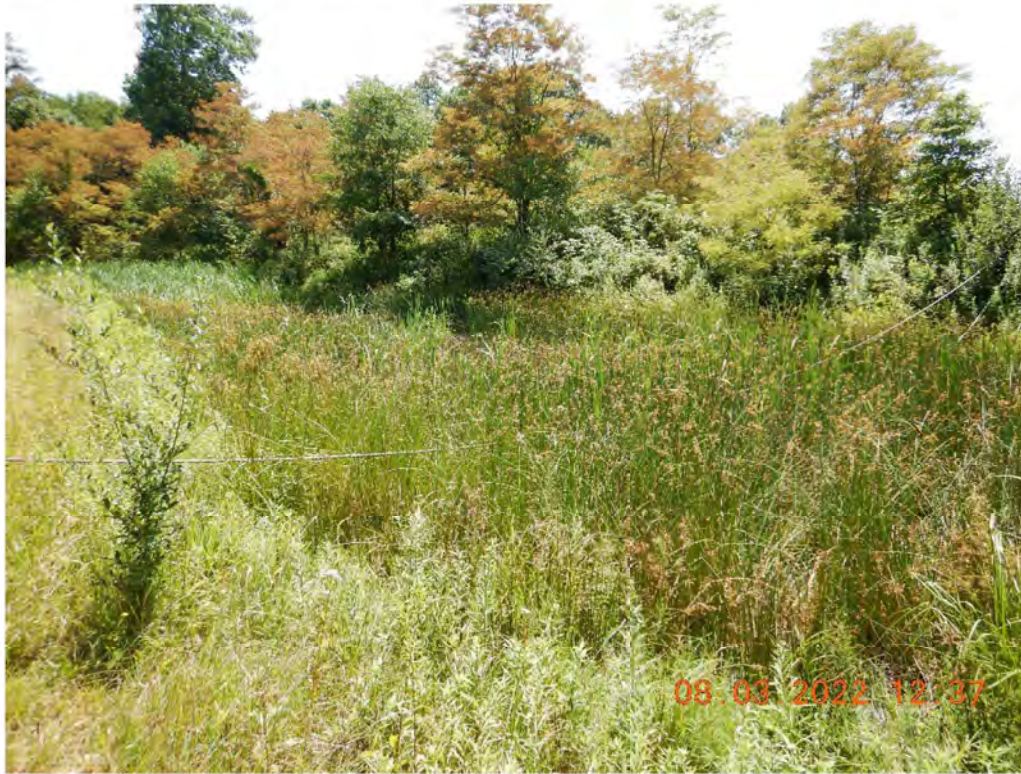
23: DSCN3887

Description: Unnamed Pond which is not covered under the Permit. Minimal water level present.

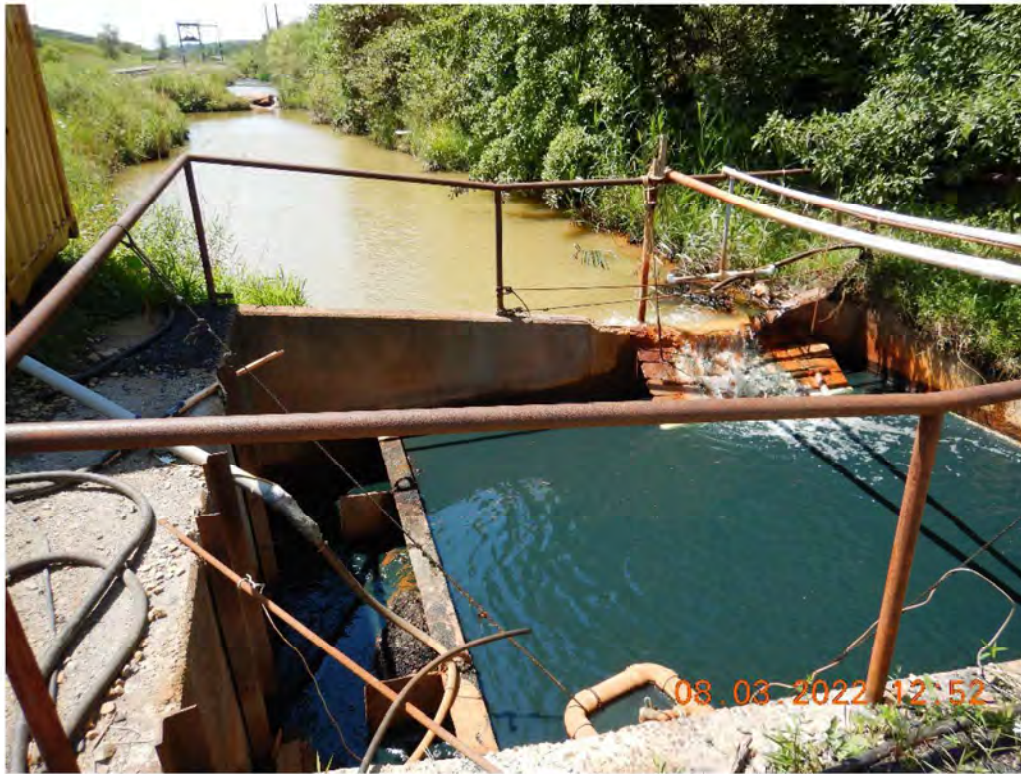
25: DSCN3889

Description: Overview of the treatment basin at the end of the final collection ditch prior to the settling ponds. The washed coal storage silos are to the right (west) of the ditch.

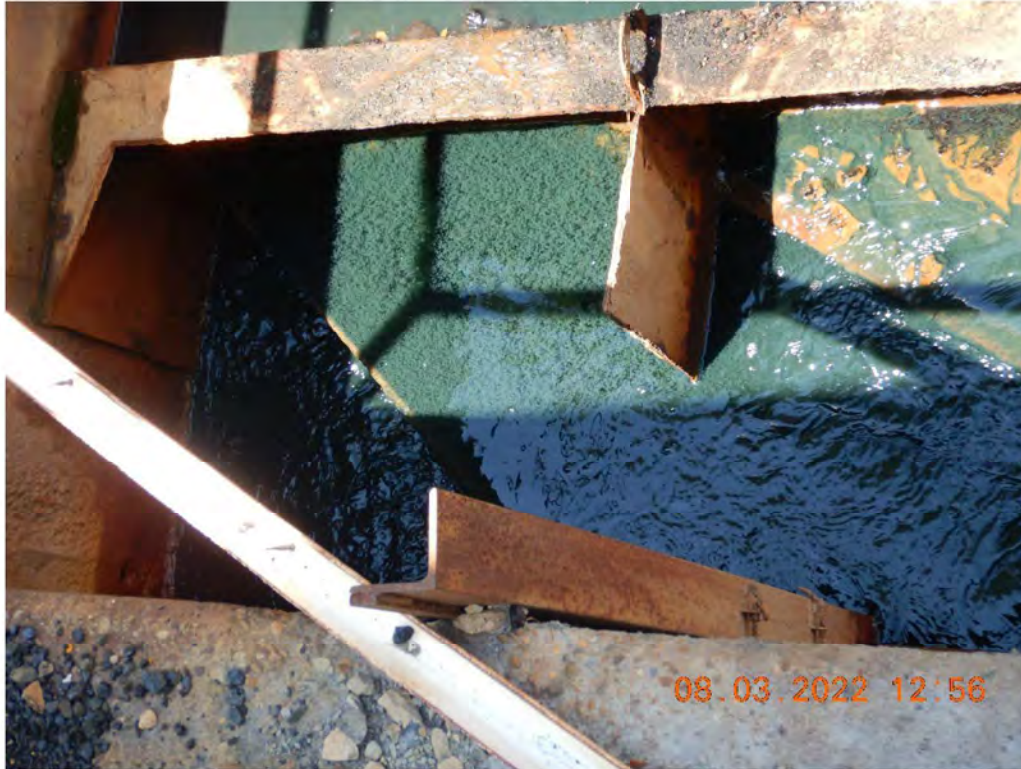
26: DSCN3890

Description: Close-up view of the flocculant (ECOFloc – 270+) in the southeast corner of the treatment basin.

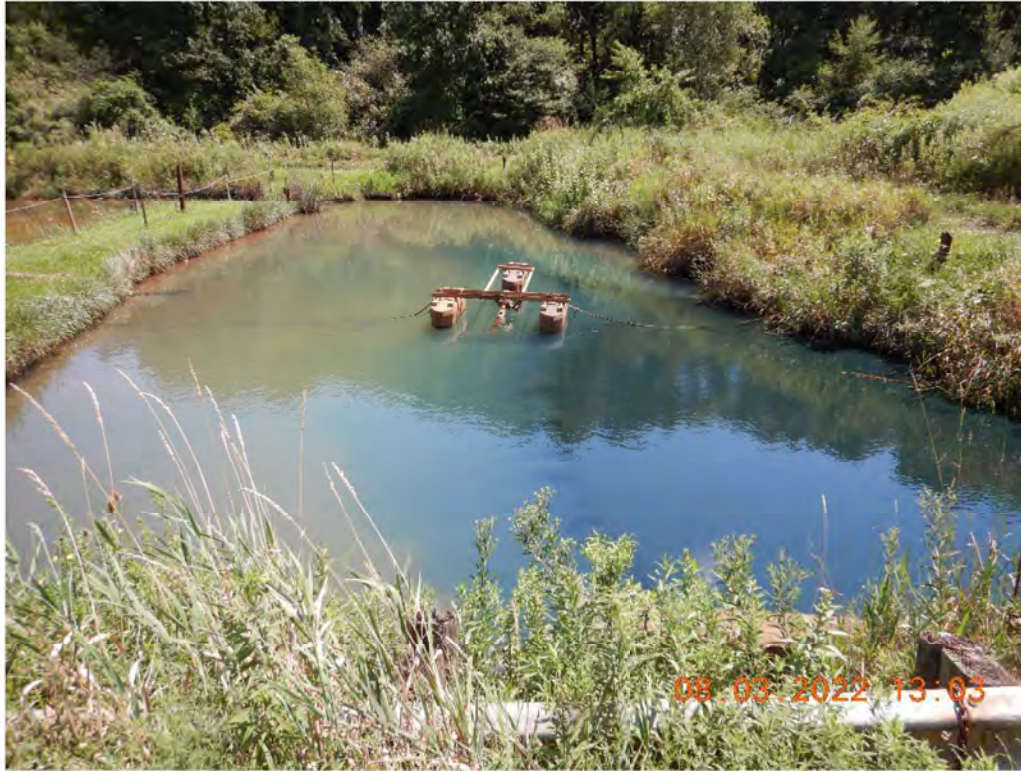
27: DSCN3891

Description: Cell 1 (primary settling pond) used to drop out as much of the solids as possible.

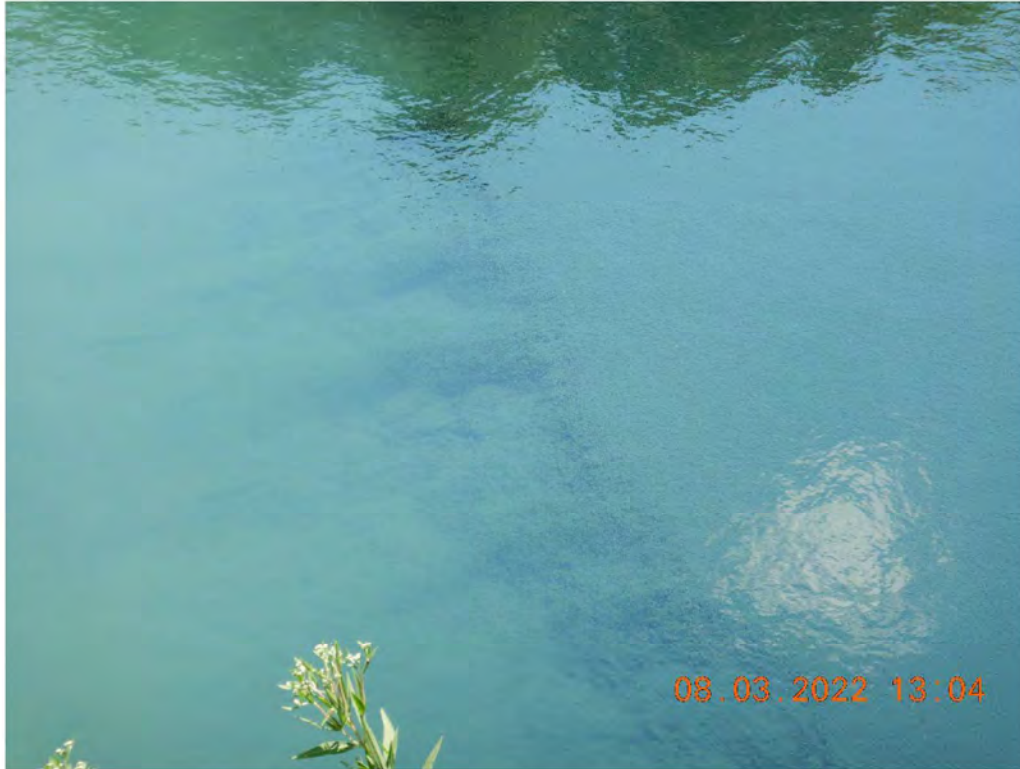
28: DSCN3892

Description: Close-up view of the flocculated solids in Cell 1 of the settling pond system.

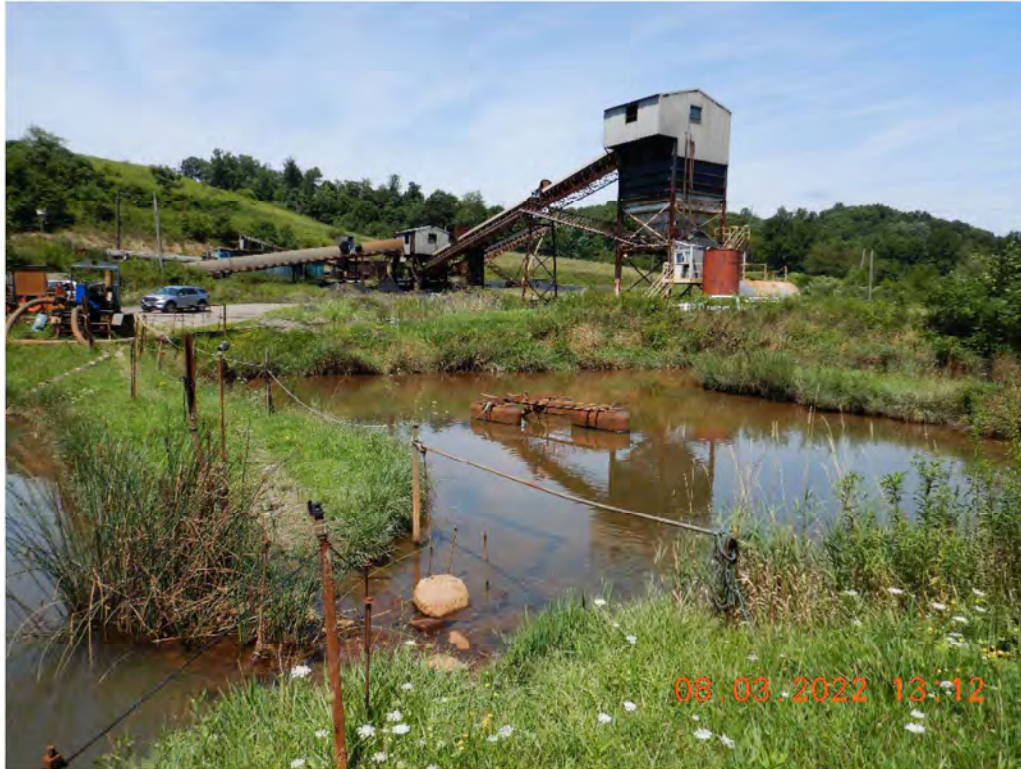
29: DSCN3893

Following the treatment basin after the dam, the water flows into the primary settling pond, Cell 1 and the secondary settling pond, Cell 2 (Photo 29). Mr. Henderson stated that the facility is operating now to intentionally drop as many solids into Cell 1 as possible. EPA noted visible blue solids in the first quarter of Cell 1, after flow enters from the treatment basin (Photo 27-28). A 100-hp pump with a hose is used to move solids from the two settling ponds to the wet impoundment. There is a mixer/aerator on a float in Cell 1 which used to be used for treatment but is not currently used.

Description: Overview of Cell 2 in the settling pond system. The hydraulic connection from Cell 1 into Cell 2 is visible in the lower left quadrant of the photograph.

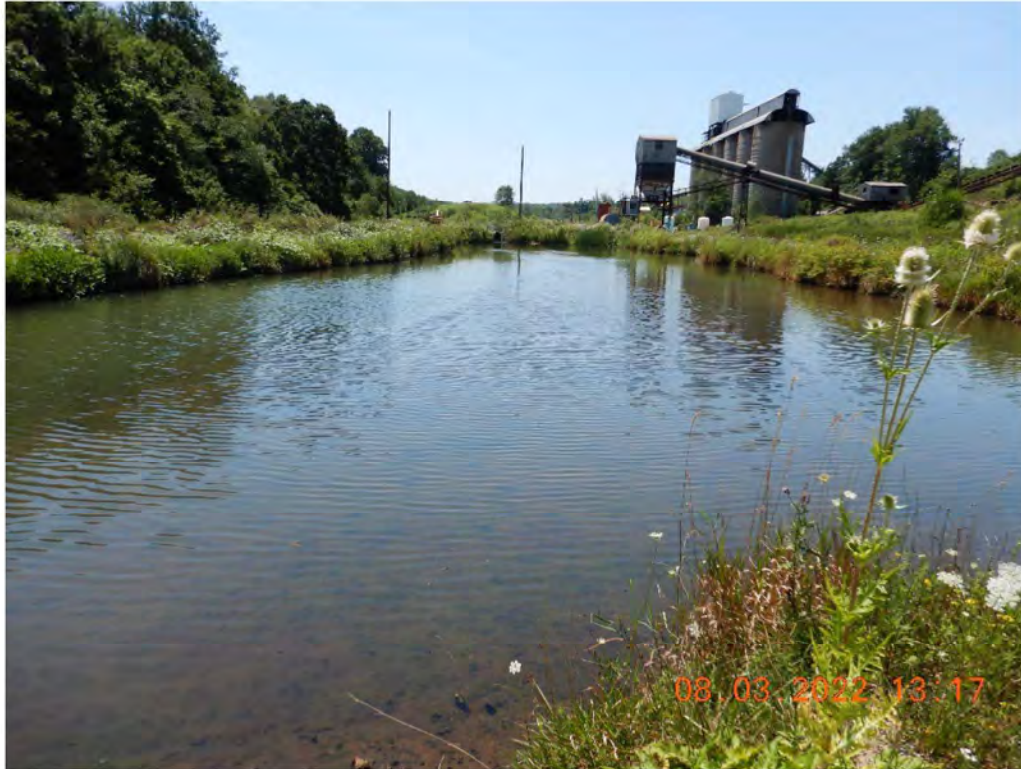
30: DSCN3894

There is a north and south portion to Pond 9. South Pond 9 was last cleaned out when a long reach excavator could scoop out solids on either side of the bank, but the long boom excavator does not reach the center of the pond. EPA noted visually on site and on satellite imagery (Photo 30 and Appendix B, Image 1) that there is a buildup of solids in the center of the pond where the excavator could not reach. According to Mr. Henderson, at the North Pond 9 an excavator would not have the necessary boom reach to clean up solids in this pond and a vacuum dredge would be needed to do that. A pH meter is on a float at the North Pond 9, but Mr. Henderson stated that it is not used. He daily tests pH and iron using an Oakton pH meter and Hach color disc test kit and records the results on the daily rounds, but this measurement is only used internally. There are sodium hydroxide briquettes at the causeway between North and South Pond 9 where pH adjustment can occur if necessary.

Description: Southern section of Pond 9. Washed coal storage silos visible in background.

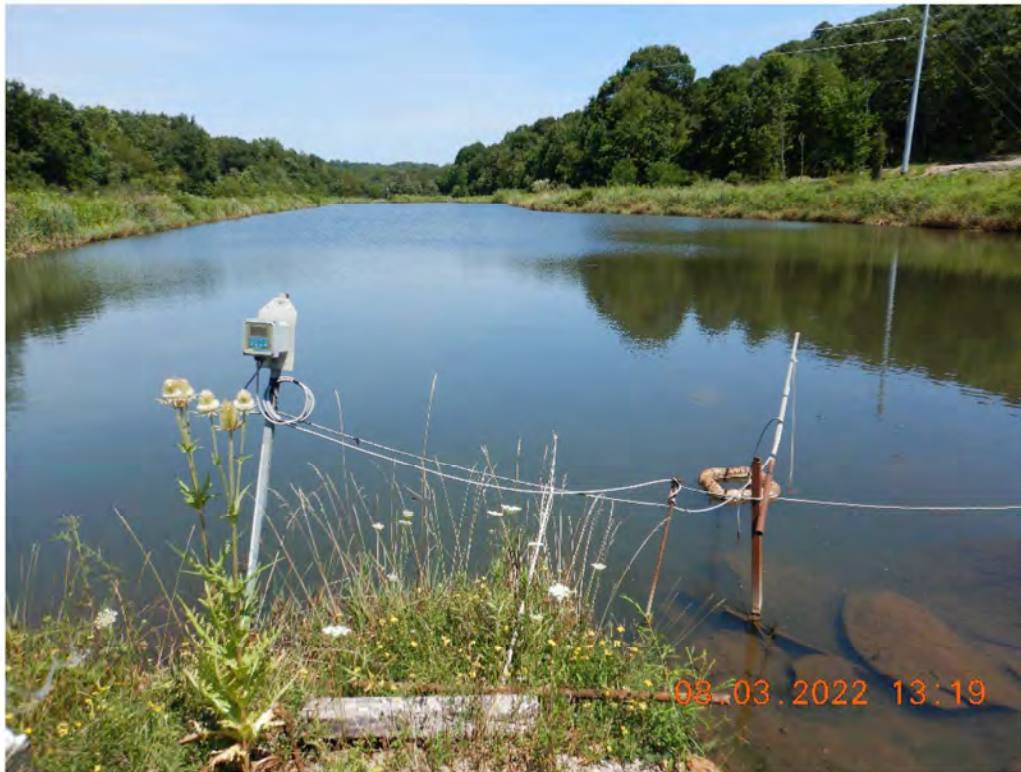
31: DSCN3895

Description: Northern section of Pond 9

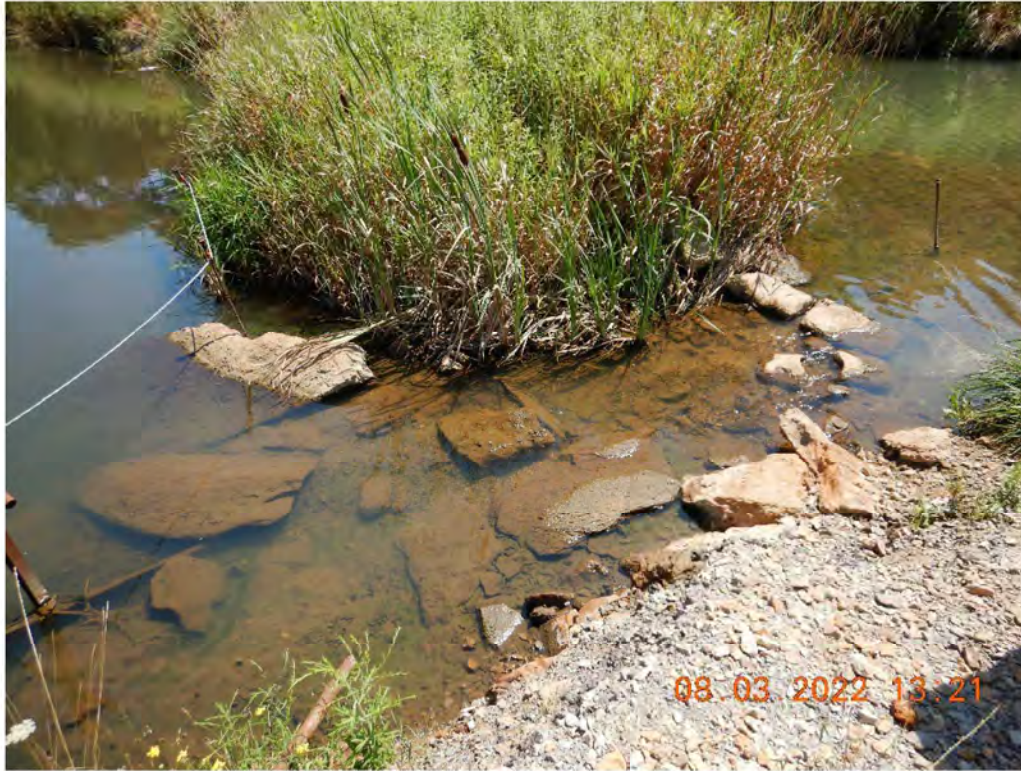
32: DSCN3896

Description: Overflow connection from the southern section of Pond 9 (to the right) into the northern section of Pond 9 (to the left).

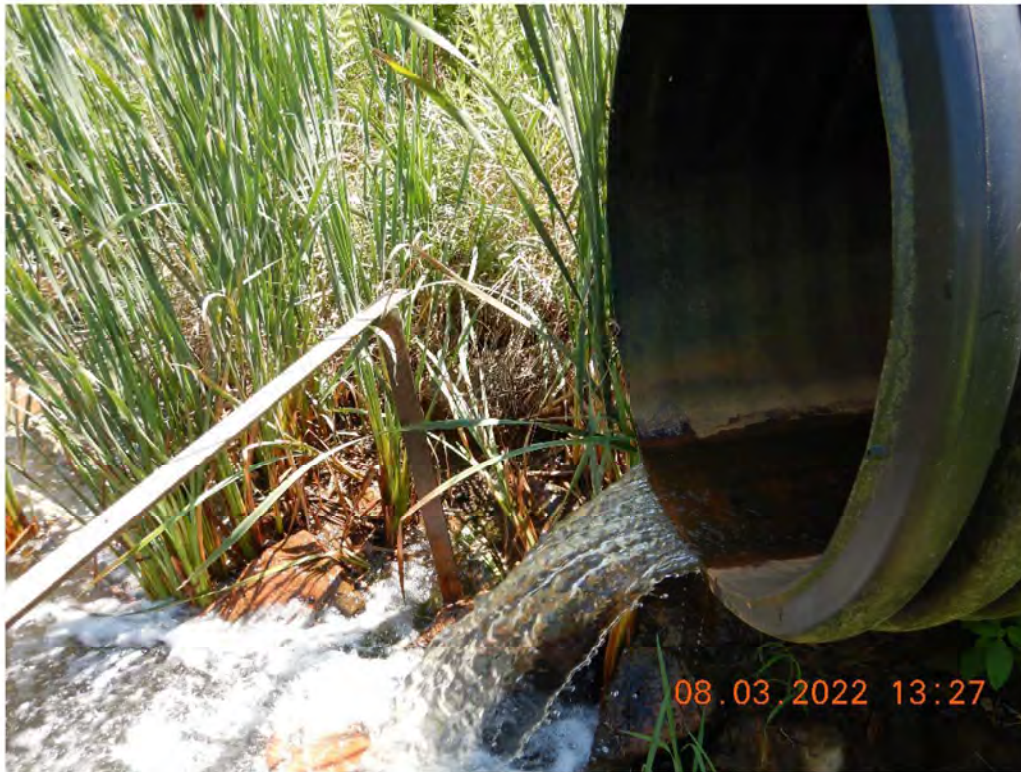
33: DSCN3897

North Pond 9 discharges to a pipe via an overflow. Mr. Henderson takes a daily flow measurement by visually estimating depth of water in the discharge pipe. At the time of inspection, he noted that there was approximately 1" of flow in the pipe (Photo 33). This measurement is used to calculate flow that is submitted on daily discharge monitoring reports sheets. At the discharge pipe, EPA noted a sign identifying as the discharge point (Photo 35). EPA noted floating scum in orange color after the effluent discharged from the pipe (Photo 34 - 35). According to Mr. Henderson, QES collects Permit samples which are submitted on daily discharge monitoring reports sheets, not at the pipe, but in the wetland area, prior to merging with the unnamed tributary of Cross Creek. EPA and Mr. Henderson walked along the Columbus & Ohio River Railroad Company railroad spur to the location on the tracks just above the heavily vegetated wetland area where the discharge merges with the tributary of Cross Creek (Photo 37 - 38).

Description: Pond 9 outlet discharging.

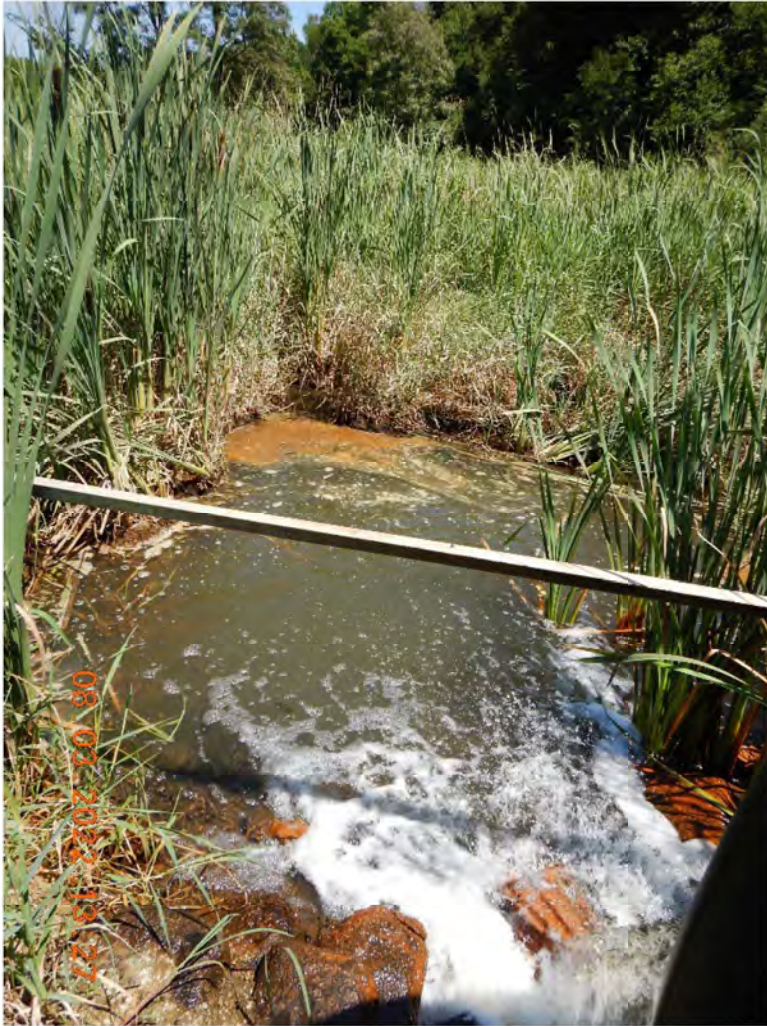
34: DSCN3898

Description: Discharge from pond 9 outlet (see previous photo) into adjacent marsh/wetland area. Flow meanders through the vegetated area to the Outfall 009 sample collection point.

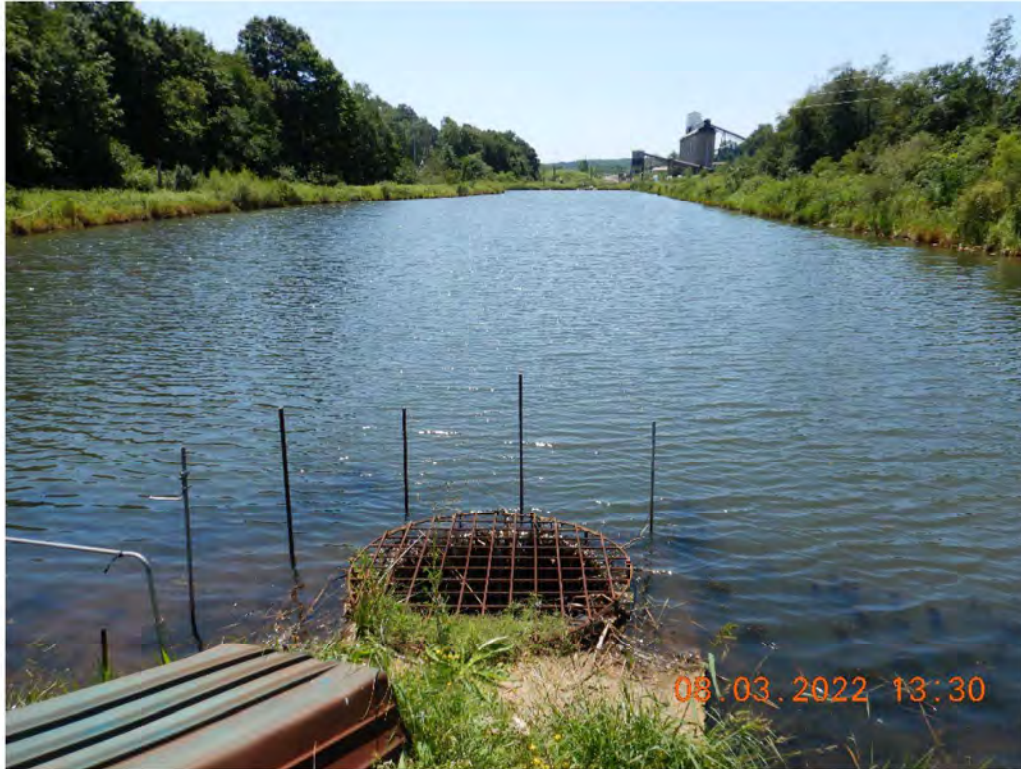
36: DSCN3900

Description: Overflow point for the Pond 9 discharge seen in photographs 33 and 34.

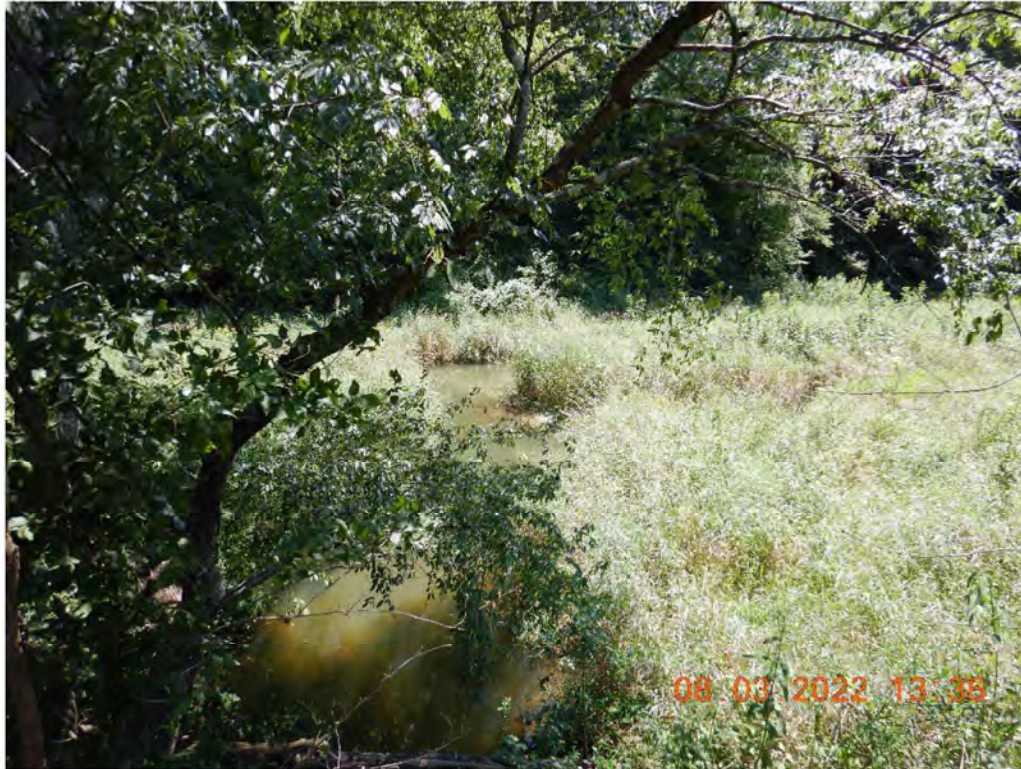
37: DSCN3901

Description: Location where the unnamed tributary curves to the west, joins with the flow from the marsh/wetland that receives the Outfall 009 discharge and the combined flow travels under the Columbus & Ohio River Railroad Company tracks before its confluence with Cross Creek.
