COMPLIANCE EVALUATION INSPECTION REPORT  
U.S. ENVIRONMENTAL PROTECTION AGENCY, REGION 5

**Purpose:** NPDES Compliance Evaluation Inspection

**Facility:** Leesville Land LLC  
86900 Sinfield Road  
Hopedale, Ohio 43976

**NPDES Permit:** OH0011827

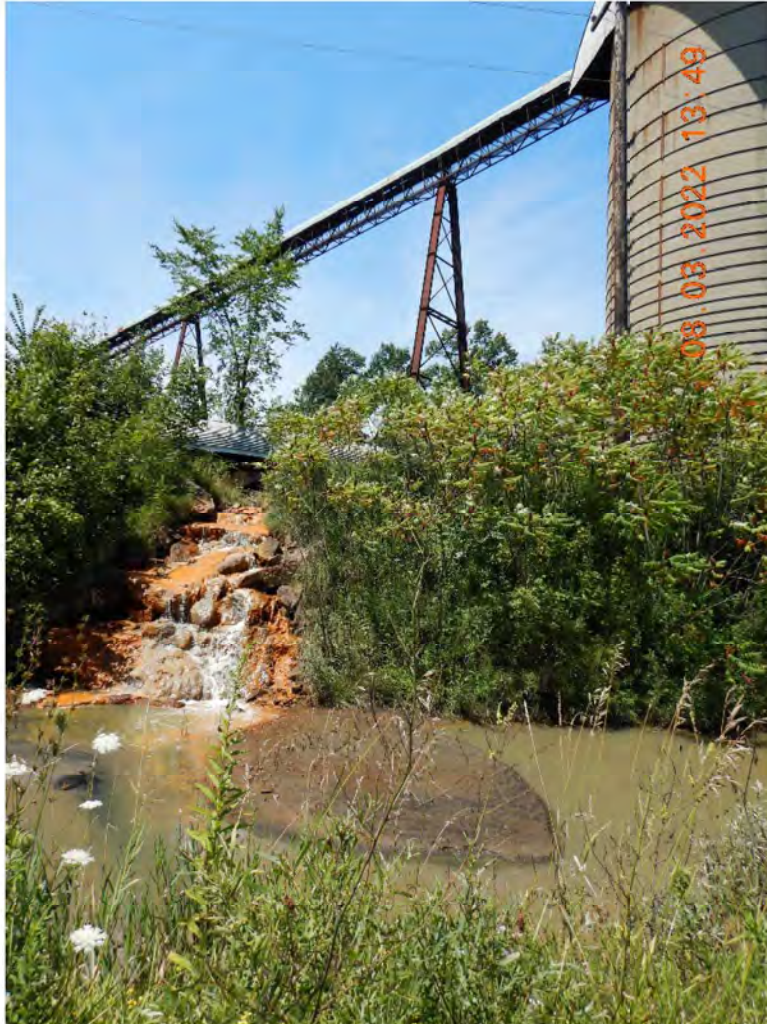
39: DSCN3903

Description: This is the location where drainage flow from on site ditches on the north and east sides of the mine refuse impoundment is directed to discharge into the final collection ditch. Ditch drainage includes flow from stormwater run-off; discharges from the sewage treatment system for the preparation plant offices; and, flow from the mine refuse impoundment underdrains.

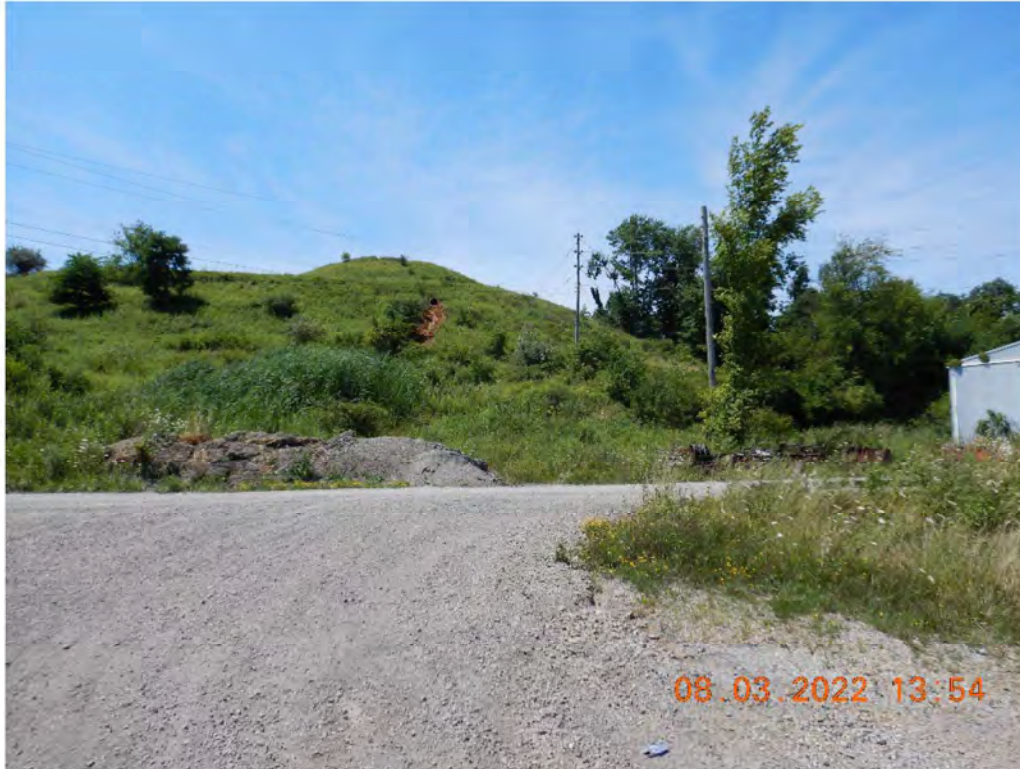
40: DSCN3904

Description: Pond A, the kidney bean-shaped pond, is located at the top of the hill. Drainage from the culvert pipe from Pond A flows downslope, under the driveway to a drainage ditch located to the south/southeast of the impoundment and preparation plant. This ditch flows northeast and becomes the final collection ditch (photograph 39) that flows to the treatment basin (photograph 25).

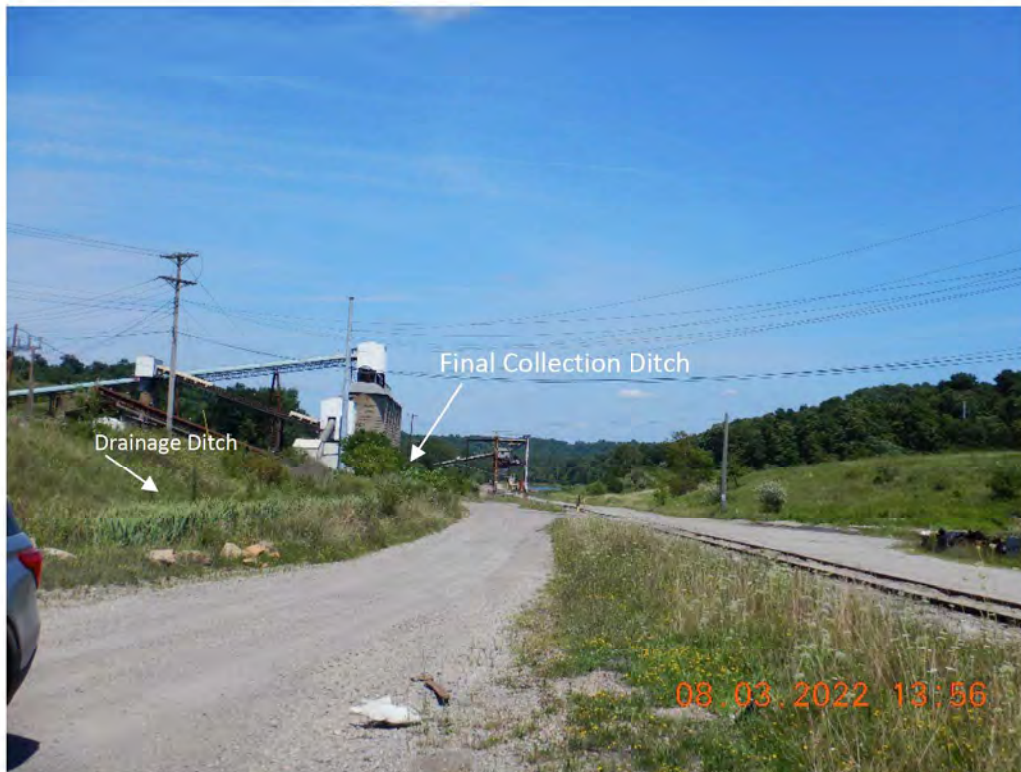
41: DSCN3905

Description: View looking northeast towards the final collection ditch for drainage waters and the washed coal storage silos. The settling ponds and Pond 9 are located in the background towards the center of the photograph.

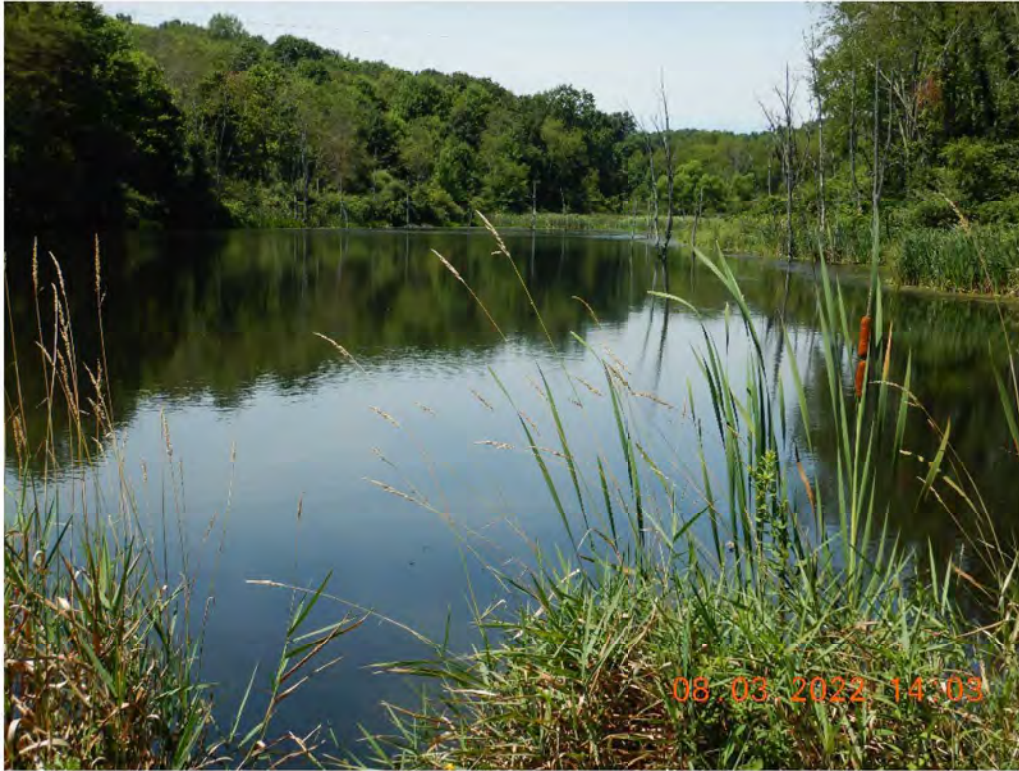
42: DSCN3906

Description: View looking across stormwater pond located off Sinfield Road, located south of the sewage treatment plant for the deep mine bathhouse and offices.

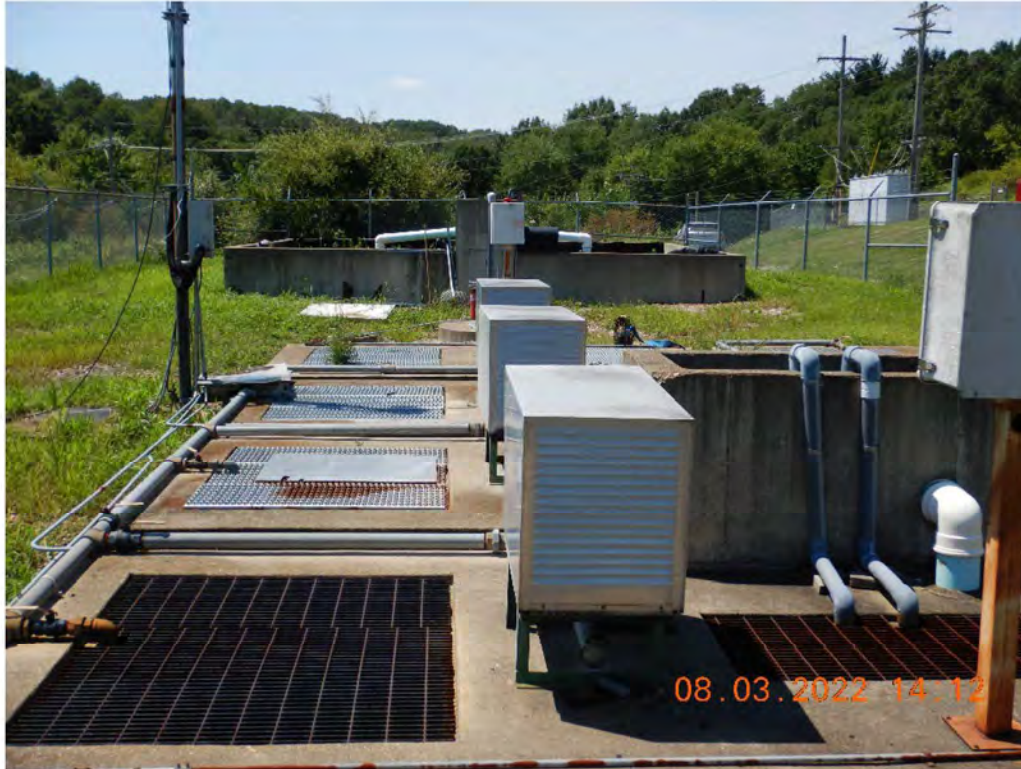
44: DSCN3908

Description: Overview of the Deep Mine Bathhouse and Office Sewage Treatment Plant.

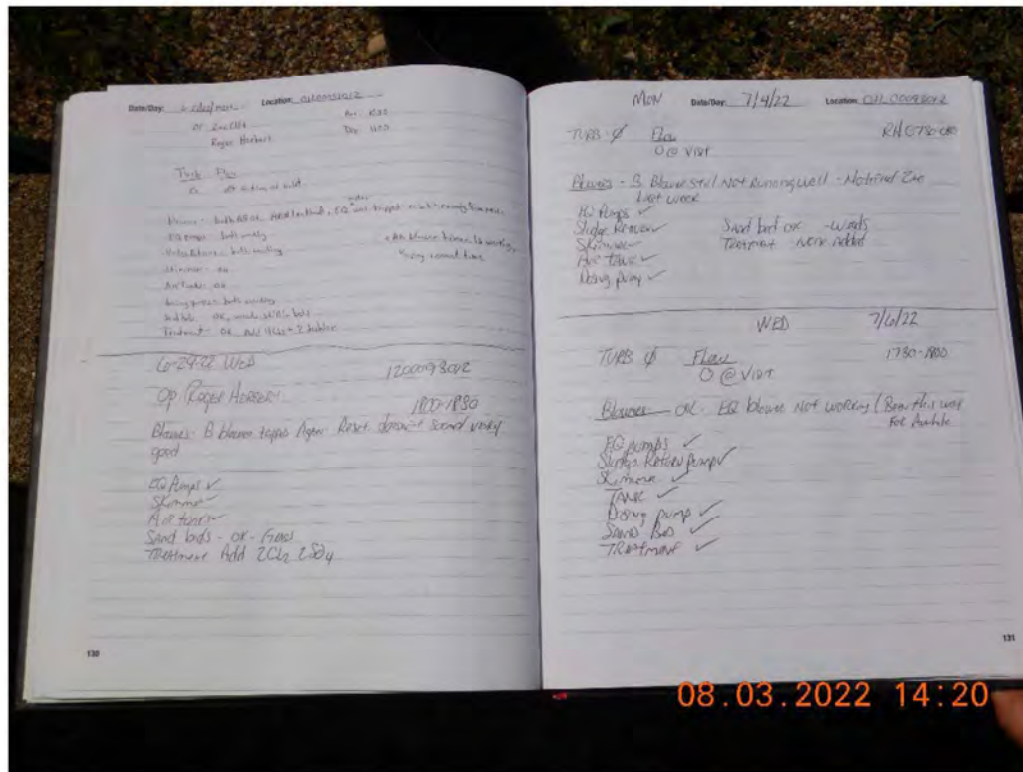
45: DSCN3909

Description: Operator logbook pages for the Deep Mine Bathhouse and Office Sewage Treatment Plant for June 27, 2022 through July 6, 2022.

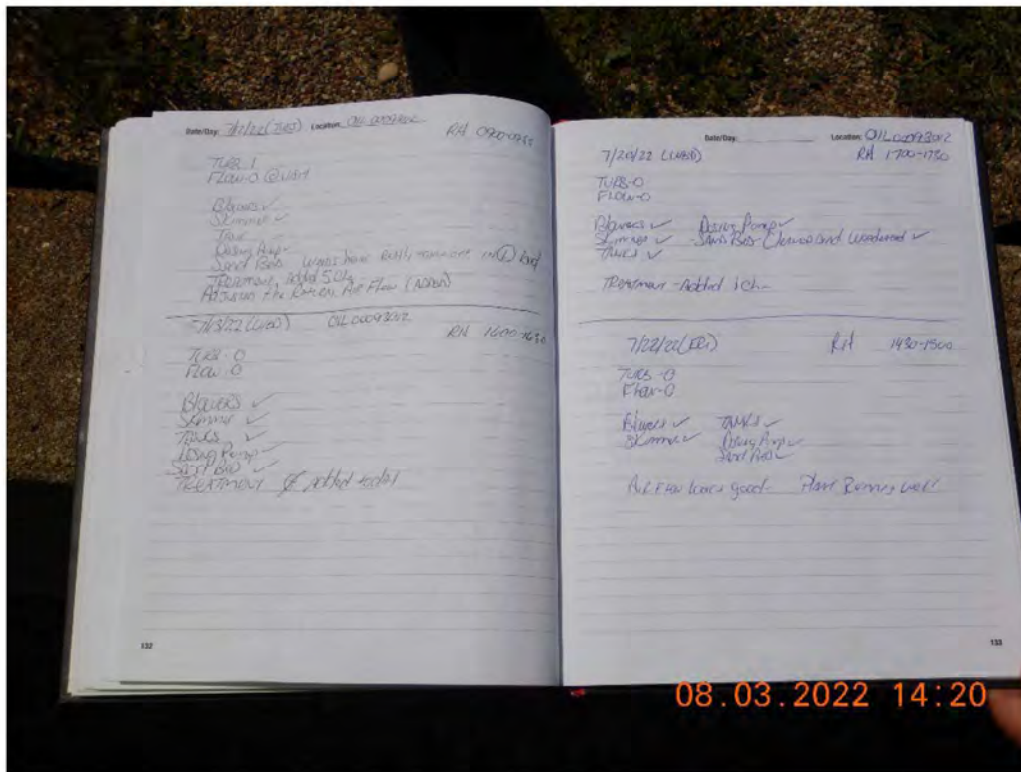
46: DSCN3910

Description: Operator logbook pages for the Deep Mine Bathhouse and Office Sewage Treatment Plant for July 12, 2022 through July 22, 2022.

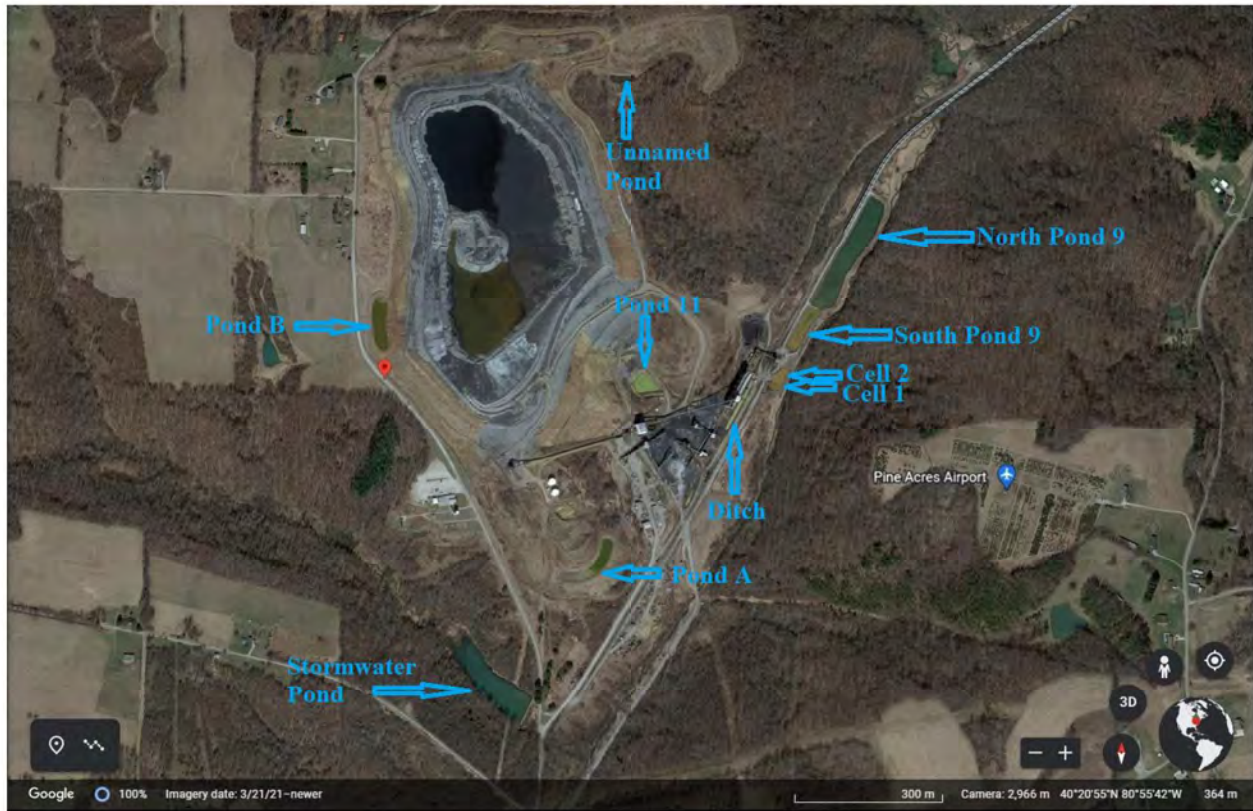
Image 1. Aerial image of the Facility with collection ponds, treatment ponds and stormwater ponds labeled.

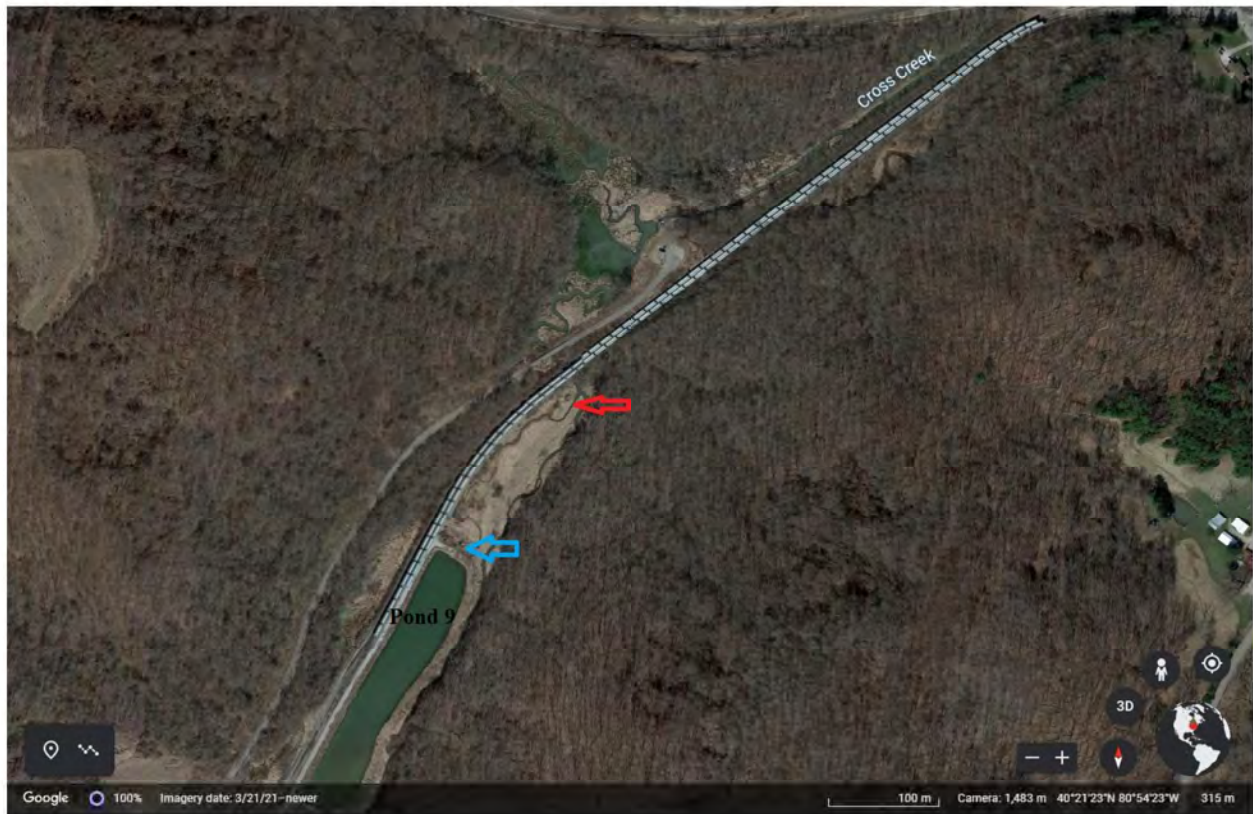
According to Ms. Snyder, after a discussion with Scott Foster of the EPA in May 2020, the location of Outfall 009 was moved from the point at the discharge pipe to a downstream location where the wetlands discharged into the unnamed tributary (Appendix B, Image 2). Mr. Vah and

Image 2. Aerial image of Pond 9 leading to Outfall 009. In 2020, Outfall 009 was moved from the location at the blue arrow at the end of the discharge pipe to the location at the red arrow prior to merging with Cross Creek in order to prevent TDS.

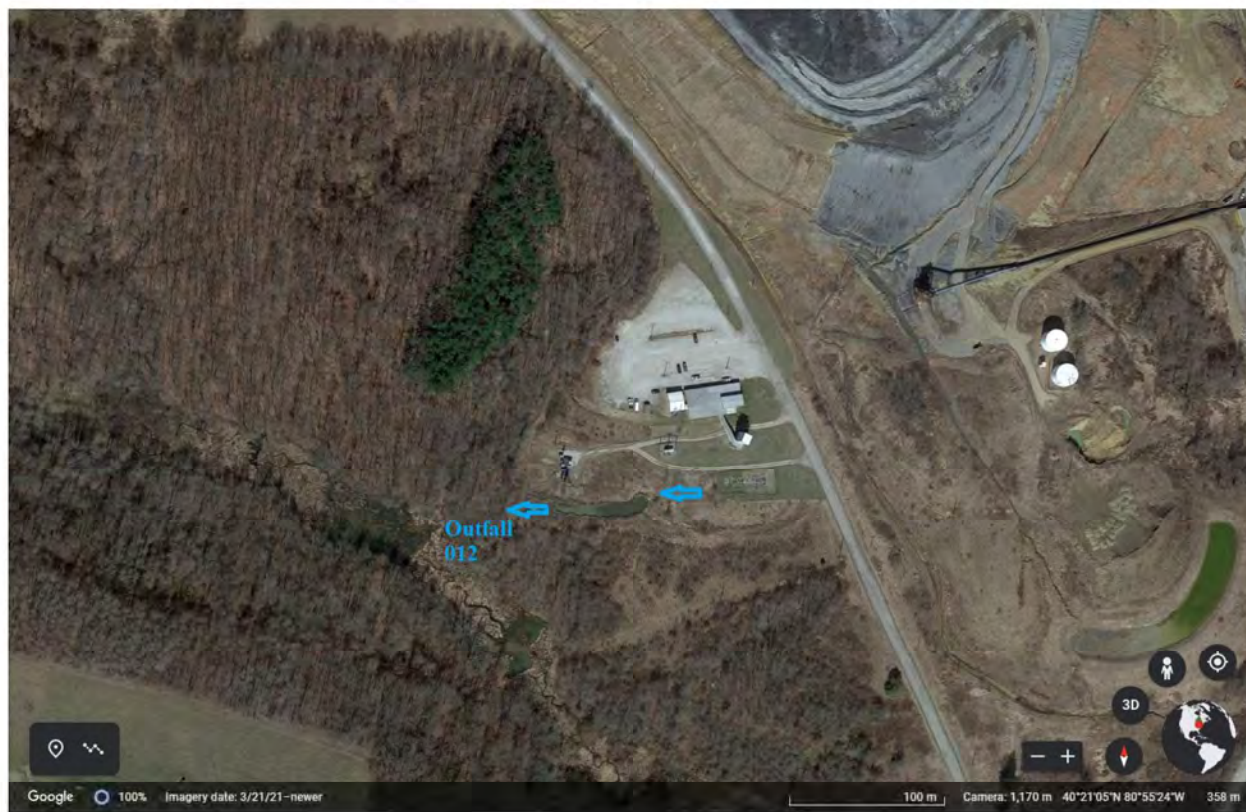
Image 4. Aerial image of the office and deep mine bathhouse WWTP discharging to a pond first prior to discharging to the Outfall 012.
