# NPDES Compliance Inspection Report

## Nisqually Clear Creek Fish Hatchery

**NPDES Permit Tracking Number  
# WAG130015**

**Inspection Date: August 8, 2023**

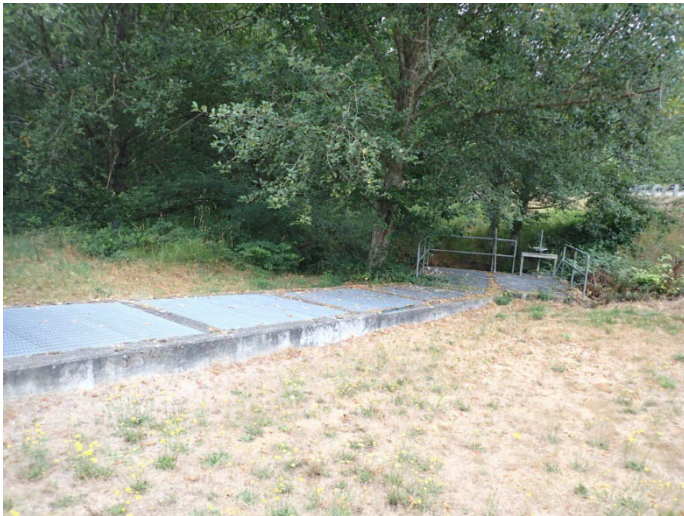
Photo #:03 (P8080010)

Description: Facing North, photo of the Facility's fish ladder leading to Outfall 001.

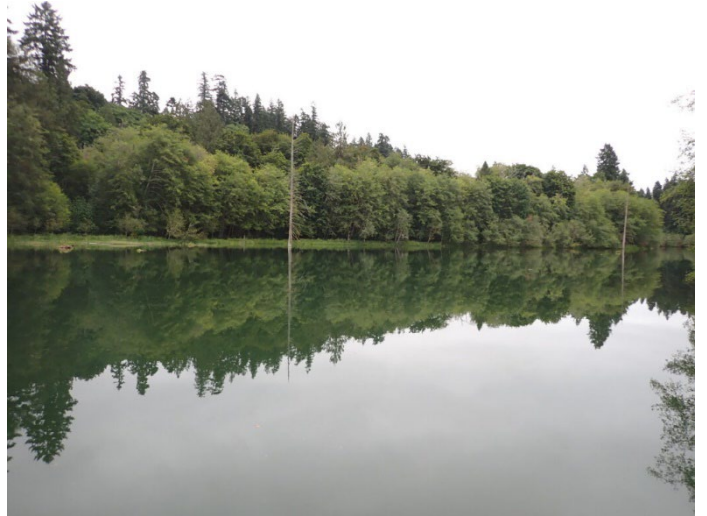
Photo #:04 (P8080011)

Description: Facing Southeast, photo of the Facility's Lower Forebay.

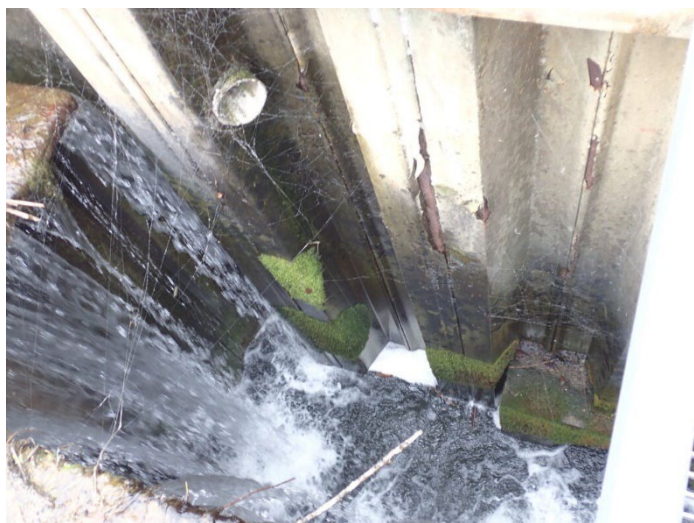
Photo #:05 (P8080016)

Description: Photo of the Lower Forebay's dam spillway that would discharge overflow to Clear Creek via Outfall 001.

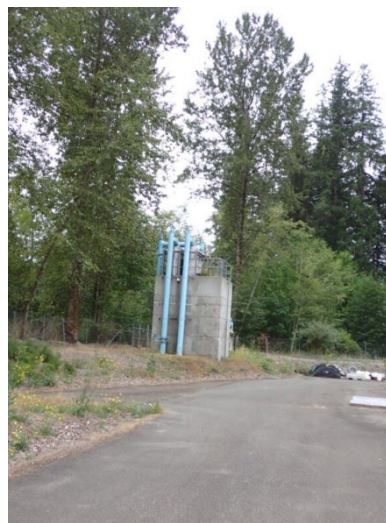
Photo #:06 (P8080020)

Description: Facing Southwest, photo of the Facility's main water distribution tower.

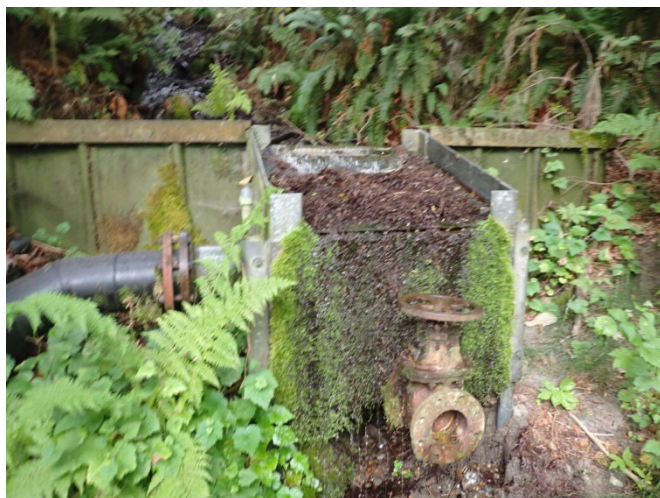
Photo #:07 (P8080027)

Description: Photo of spring #2, one of the Facility's intake sources for the upper hatchery complex.

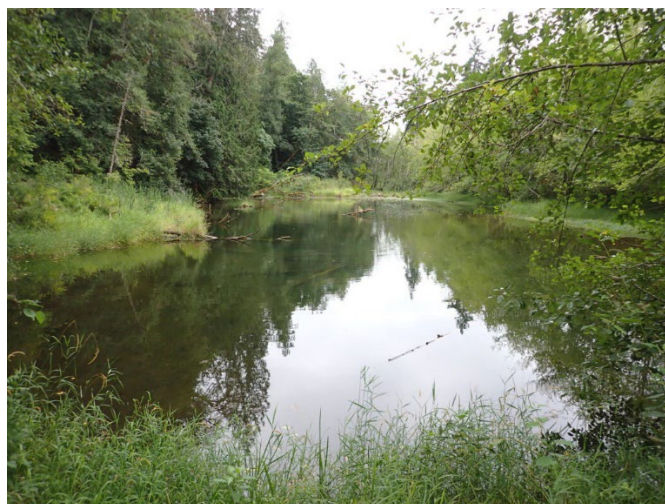
Photo #:08 (P8080028)

Description: Facing Southeast, photo of the Upper Forebay near the spring intake sources.

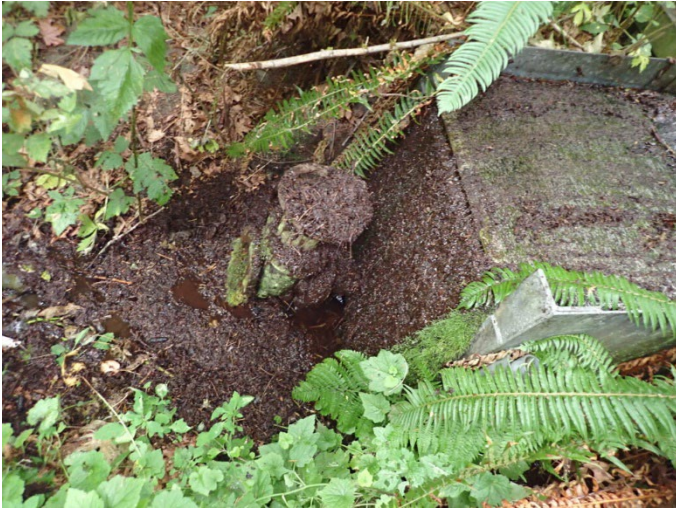
Photo #:09 (P8080029)

Description: Photo of spring #1, another one of the Facility's intake sources for the upper hatchery complex.

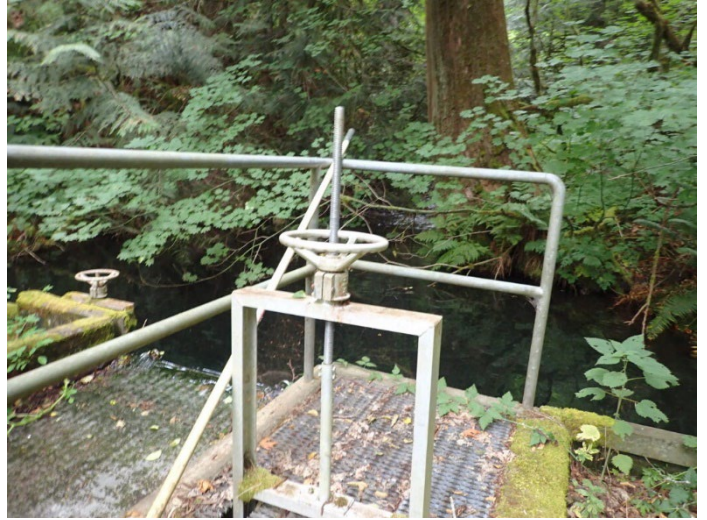
Photo #:10 (P8080032)

valve to pipe spring water to the main water distribution tower (**Photo 10**).

Description: Photo of the Clear Creek Springs valve that pipes this intake source to the Facility's main water tower.

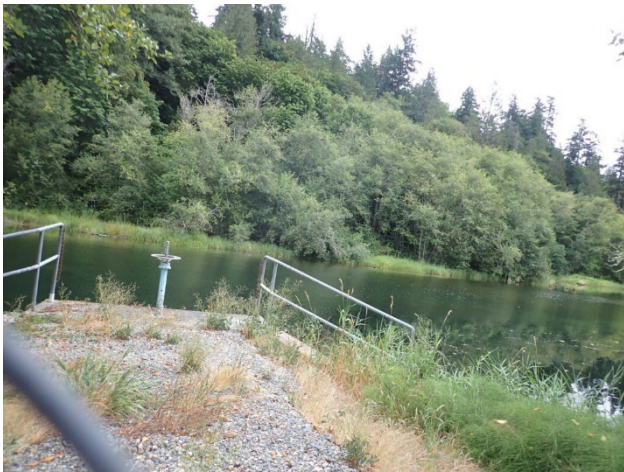
Photo #:11 (P8080035)

On our way back to the main upper hatchery complex, we observed the mechanism for the Facility to draw water from the Forebay into the upper hatchery complex raceways and into Pond #11 (**Photo 11**). As we walked North, we observed a dam dividing the Upper Forebay and Lower Forebay with a release pipe (**Photo 12**).

Description: Facing West, photo of the valve the Facility uses to draw Upper Forebay water into upper hatchery complex raceways and pond #11.

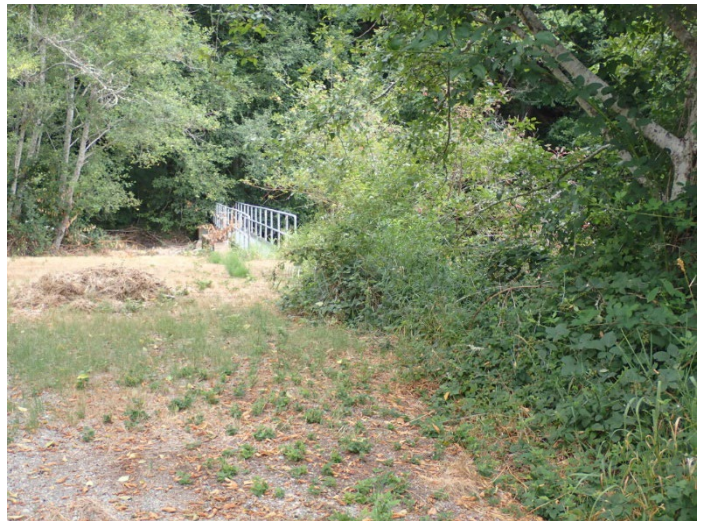
Photo #:12 (P8080038)

Description: Facing West, photo of a dam that divides the Upper Forebay and Lower Forebay with a release pipe.

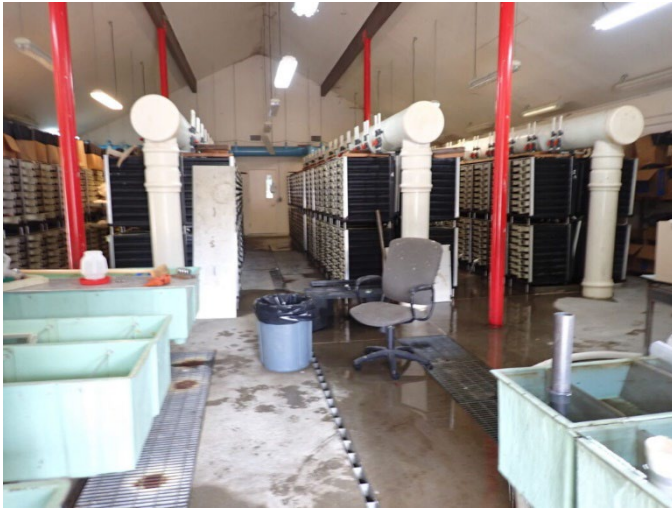
Photo #:15 (P8080053)

Description: Photo of inside the Facility's inactive egg incubation building in the upper hatchery complex.

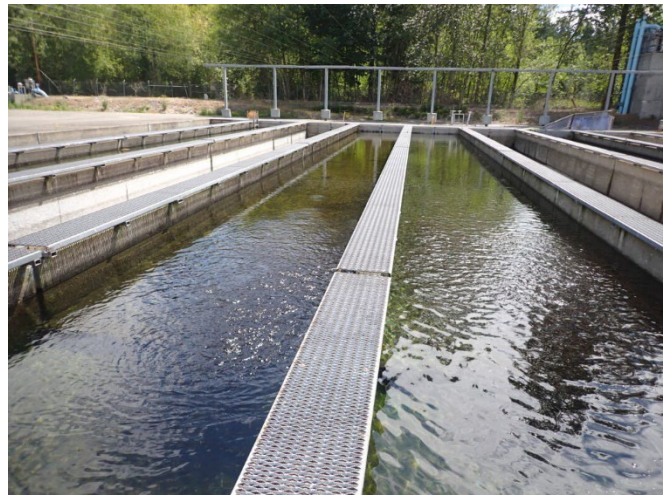
Photo #:16 (P8080057)

Next, we walked to the upper hatchery complex's raceways (**Photo 16**). Some of the raceways contained fish at the time of inspection. Raceways not in use are cleaned using a vacuum and then wastewater is pumped to the offline settling basin (OLSB). Flow for each raceway is measured by hand using the crest weir. Raceway water can also be pumped to pond #11 (**Photo 17**) which can be discharged back into the Forebay. When fish in these raceways achieve adequate growth, they are transferred to rearing ponds in the lower hatchery complex. We then observed the OLSB (**Photo 18**) where vacuumed waste is settled. OLSB solids are pumped into the woods a few yards North of the OLSB (**Photo 19**) and remaining water decants and subsequently discharges into Clear Creek through Outfall 001.

Description: Facing Southwest, photo of the Facility's upper hatchery complex raceways.

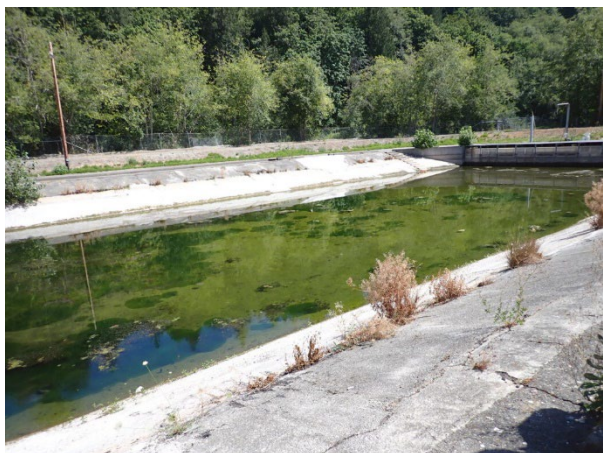
Photo #:17 (P8080061)

Description: Facing Southwest, photo of pond #11 of the Facility's upper hatchery complex containing water pumped from the raceways.

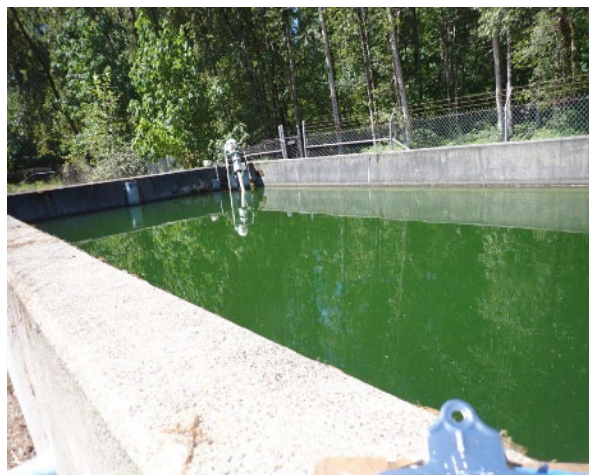
Photo #:18 (P8080065)

Description: Facing East, photo of the Facility's upper hatchery complex offline settling basin in which solids are subsequently pumped into the woods in the background.

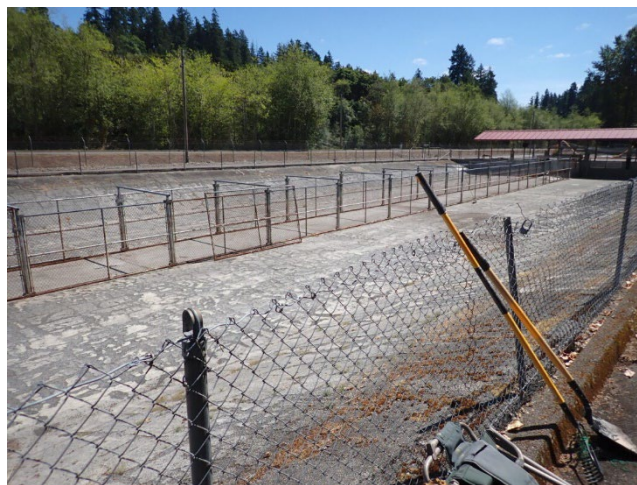
Photo #:20 (P8080074)

Description: Facing South, photo of the Facility's inactive pond #15 in the lower hatchery complex.

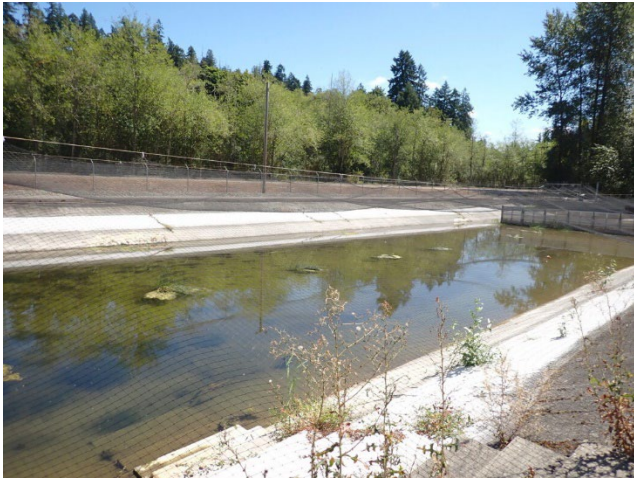
Photo #:23 (P8080083)

Description: Facing South, photo of the Facility's pond #13 in active use to move straggling Coho salmon from the Lower Forebay.

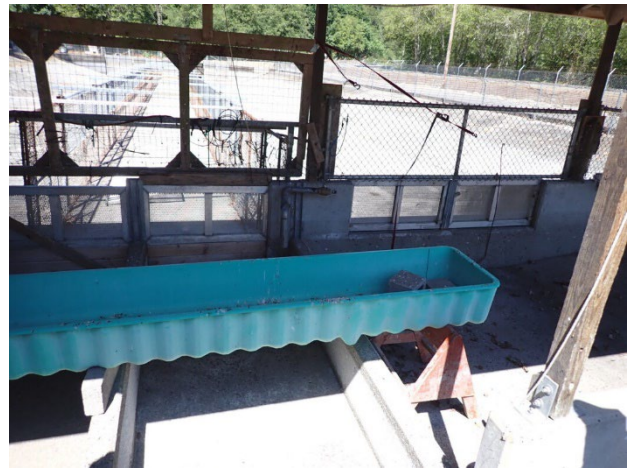
Photo #:24 (P8080086)

Description: Facing North, photo of the Facility's spawning area in the lower hatchery complex with a trough that has a drain connecting to the offline settling basin.

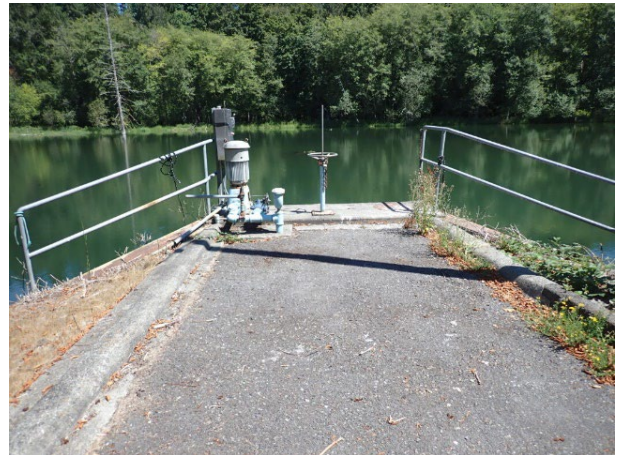
Photo #:26 (P8080090)

Description: Facing West, photo of inside the Facility's intake from the Lower Forebay into pond #15 in the lower hatchery complex.

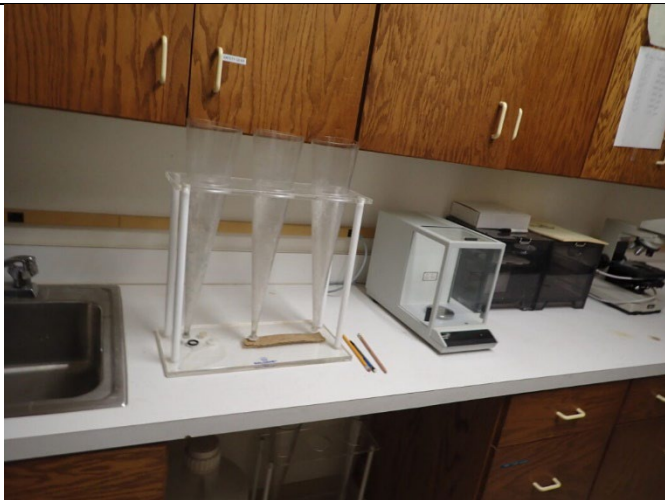
Photo #:27 (P8080092)

We concluded the site walkthrough going through the Facility's in-house laboratory, located in the same main administration building, where all sampling analyses are conducted. Cones were used in settleable solids analysis (**Photo 27**), and disks were also used to bake samples in the lab's oven before measuring required parameters. Results are recorded in internal Facility bench sheets (**Photo 28**) and then reported in DMRs. We proceeded back to the Facility's conference room of the administration building.

Description: Photo of inside the Facility's laboratory illustrating the cones used to analyze settleable solids.
