**CLEAN WATER ACT COMPLIANCE EVALUATION INSPECTION REPORT
U.S. ENVIRONMENTAL PROTECTION AGENCY
REGION 5**

Purpose: Stormwater Inspection

Facility: Midstates Rail LLC (Midstates Rail)
13830 Brainard Avenue
Burnham, Illinois 60633

Date of Inspection: April 13, 2022

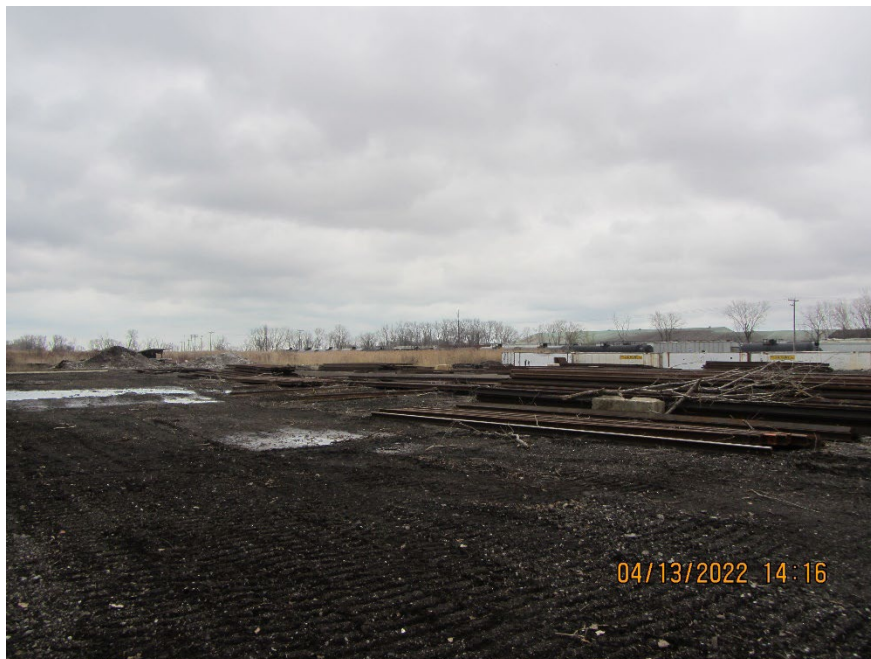
9: IMG_0234

Description: Piles of rails

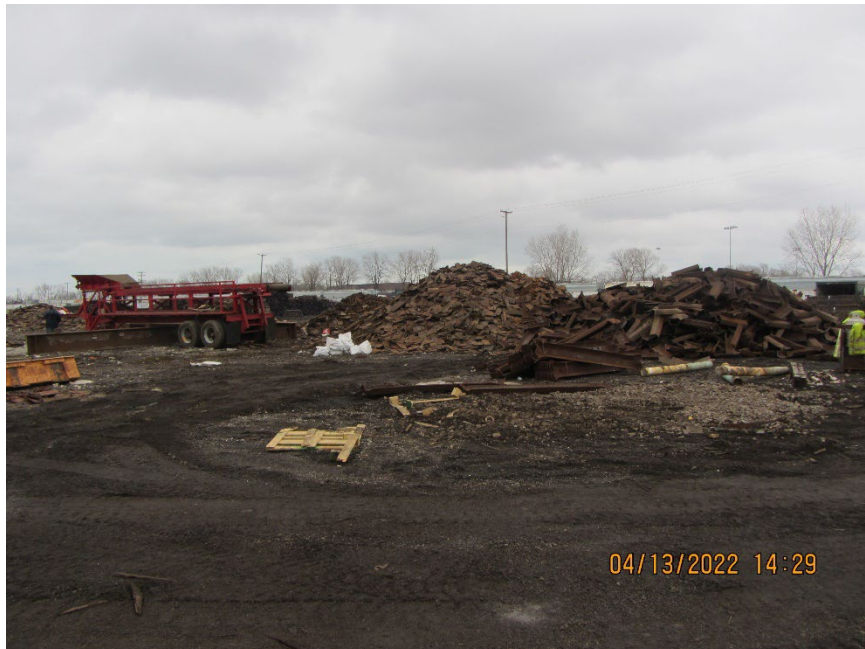
15: IMG_0240

Description: Piles of scrap

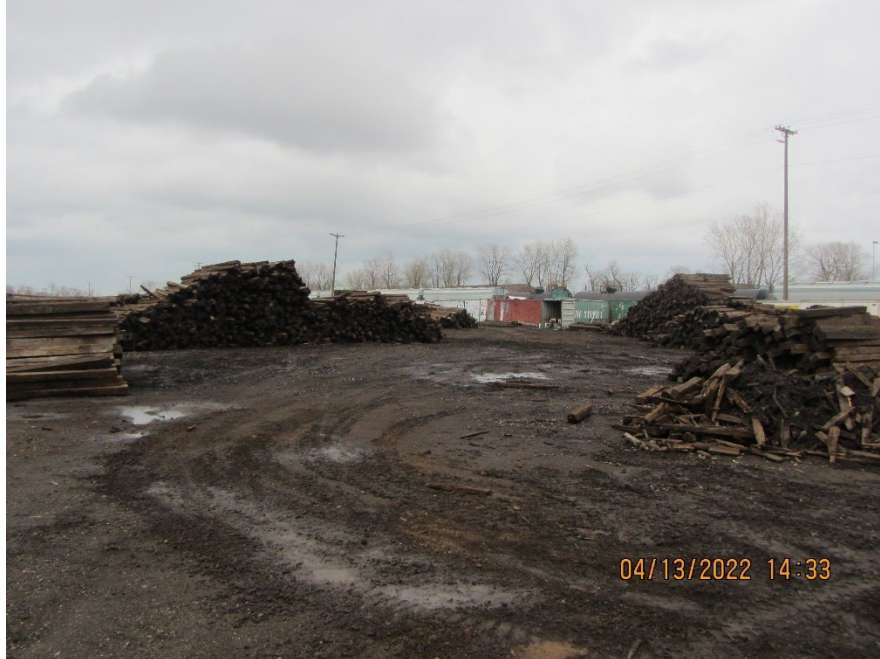
16: IMG_0241

On the northeast side of the site, about 25 railcars line the perimeter. There is an opening, near a pile of railroad ties, between two of these cars (Photos 16-18). To the south, next to piles of railroad ties, is a chain link fence (Photos 20-23). In this area, in the southeast corner of the site is a large pool of water next to the fence that appears to have oil staining on the ground.

Description: Piles of railroad tie scrap

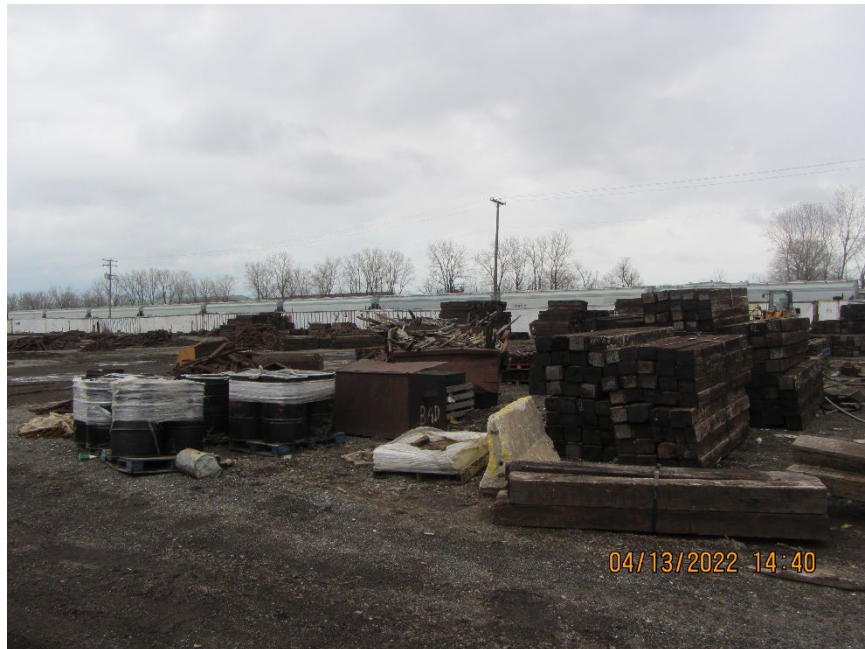
19: IMG_0244

Description: Piles of railroad tie relay and other track material

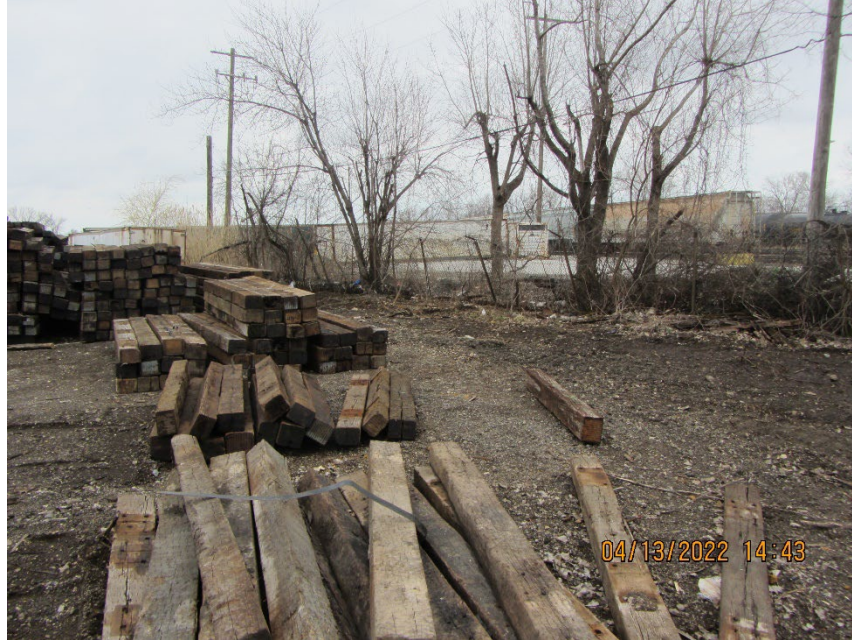
20: IMG_0245

Description: Piles of railroad ties near chain link fence along eastern border of site
Location: East side, near middle of site
Camera Direction: Northeast
Date/Time: 4/13/22, 2:43 p.m.

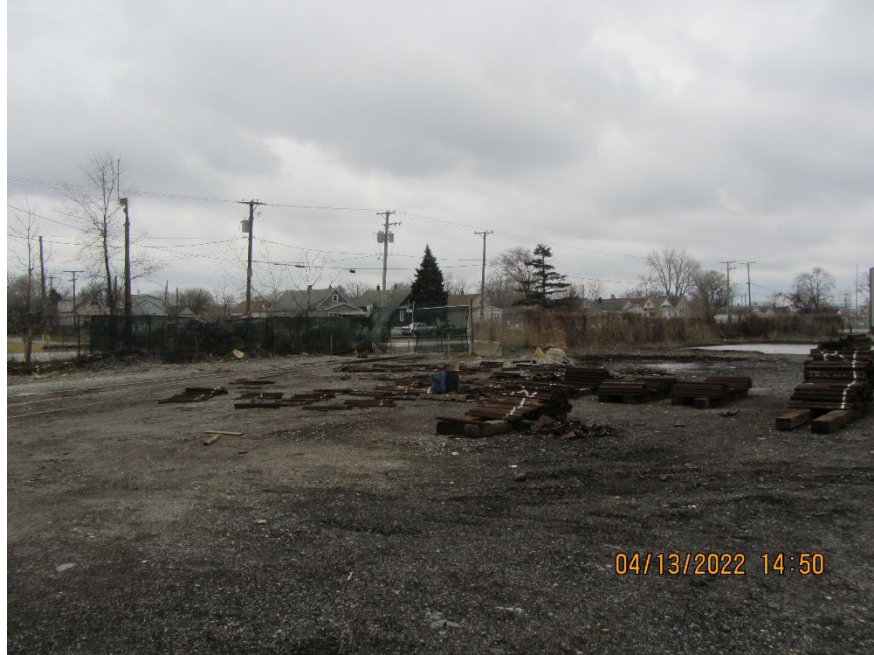
22: IMG_0247

Description: Piles of railroad material

Description: What appears to be oil staining by the small pond shown in Photo 22
