## Region 6 - Enforcement & Compliance Assurance Division

### INSPECTION REPORT

| Inspection Date(s): | 05/07/2025 | |
| Company Name: | <b>City of Monroe</b> | |

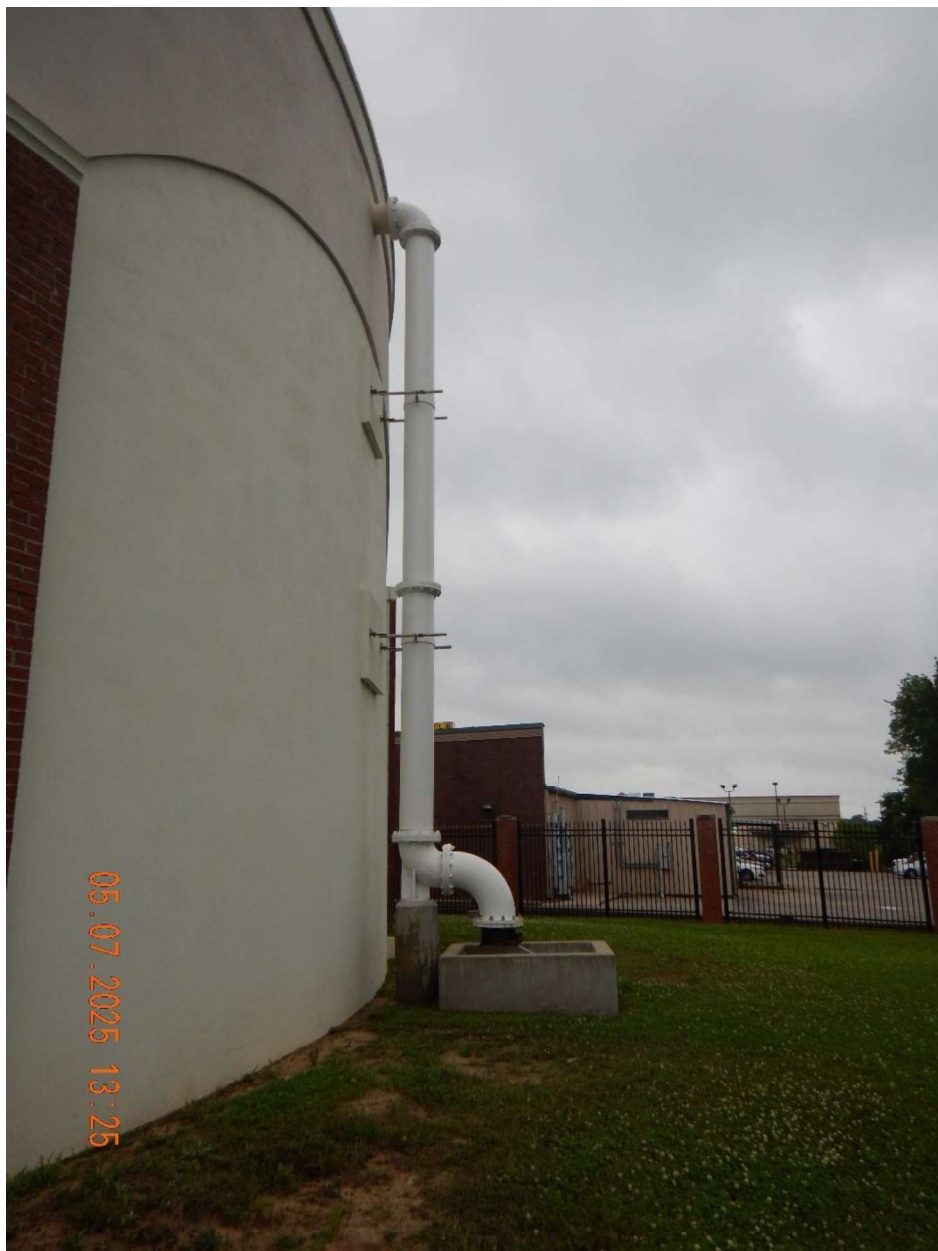
The Chauvin Tank has a capacity of one MG and was built in 2018 for expansion. The overflow of the tank was observed to have a flap that flows out to the bayou. The tank was inspected in 2023. The total chlorine reading was observed to be 1.85 mg/L on the chlorine analyzer in the pump station. The station has its own generator.

**Chauvin Tank** Chauvin tank overflow pipe.

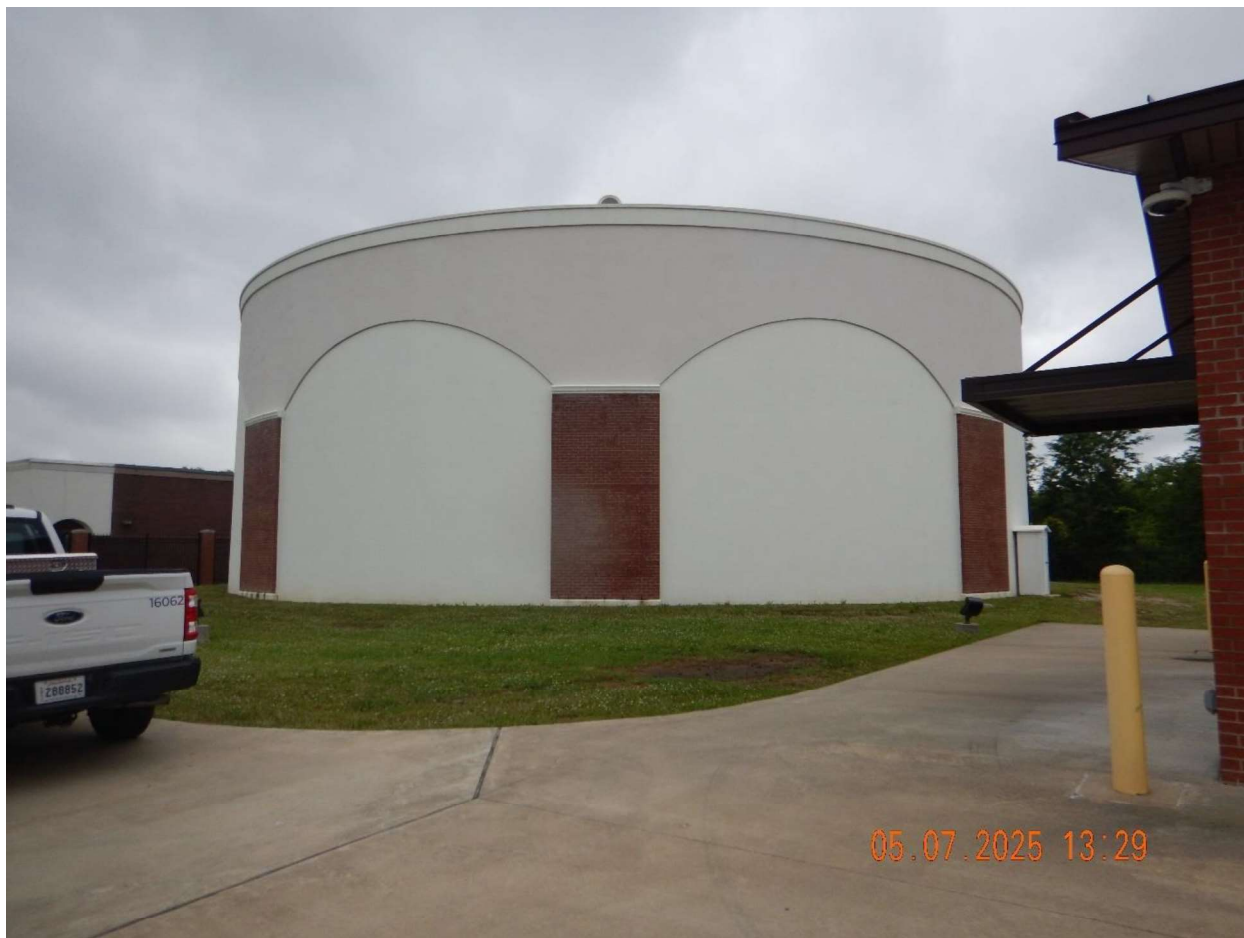
The Chauvin tank has a capacity of 3.1 MG. Vegetation was observed next to the fencing, with a tree above the fencing. The system representative discussed that the tank was inspected in 2022, during which thin areas observed on the tank. About 2-3 inches of sediment was removed at the time of the tank inspection. The tank is scheduled to be rehabilitated.

**Chauvin Tank** View of Chauvin Tank.

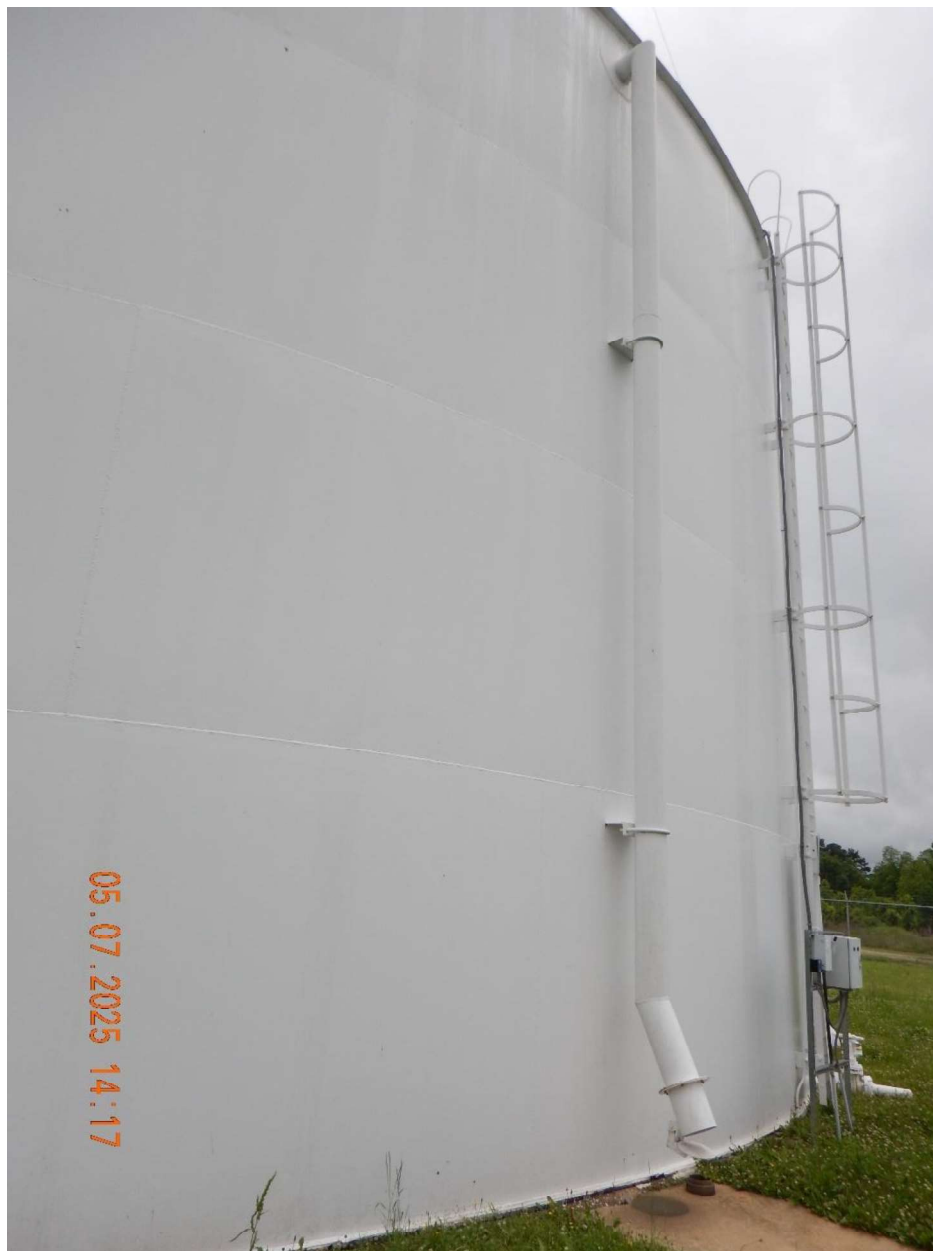
The Thomas tank is a 1.5 MG tank that was built in 1950. The overflow was screened and discharged into the storm drain. According to the system representatives, the tank was last inspected three years ago. It was observed that the pH at the station was 7.86, the turbidity was 0.151 NTU, and the chlorine residual was 2.18 ppm. A room containing liquid aluminum sulfate was observed, as well as a chlorine room with a chlorine detector, ventilation, chained cylinder gas tanks, and an entry door with a knob.

**Thomas Tank** View of overflow pipe at Thomas Tank.

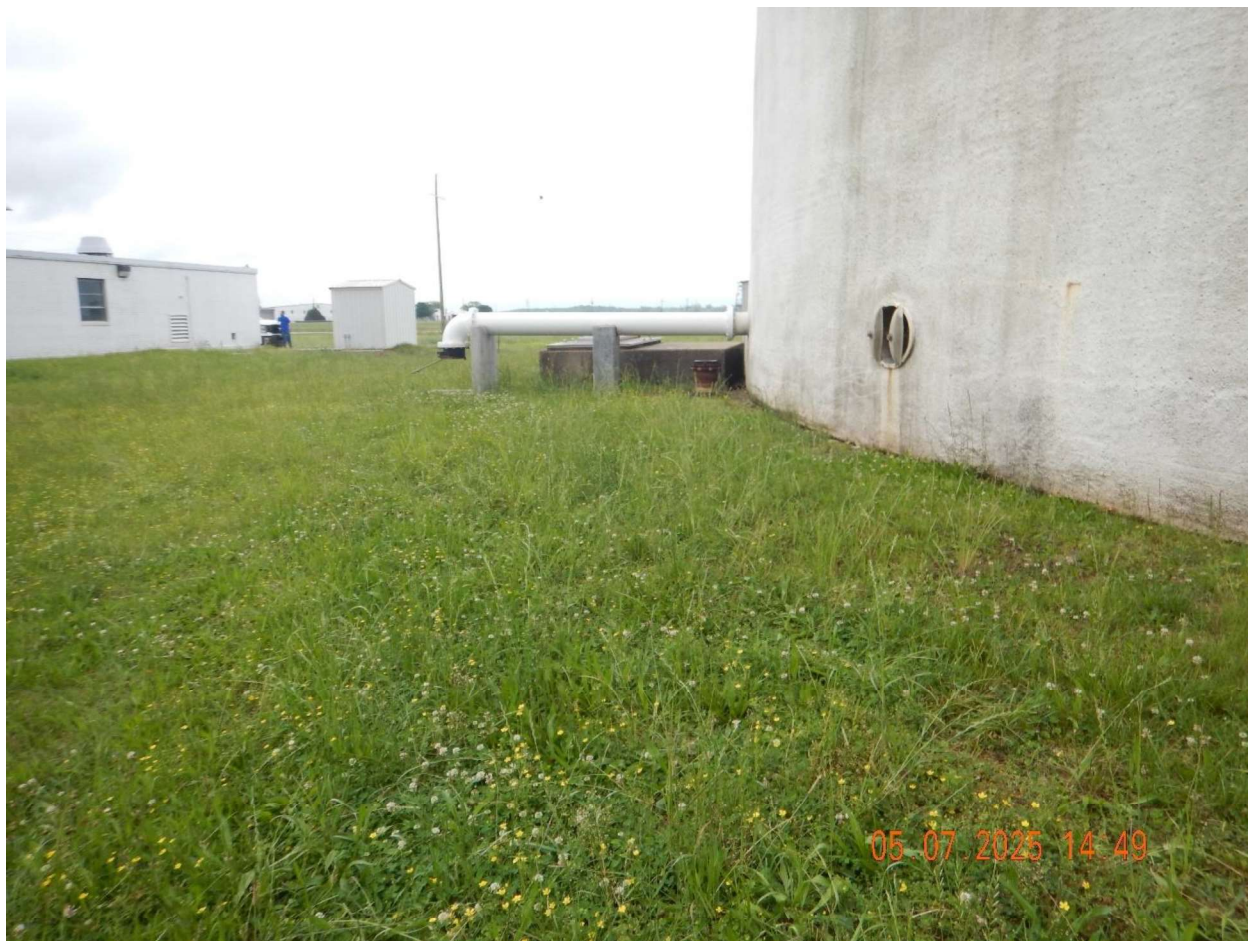
Next, the Selman tank was observed, which is a 4 MG concrete tank. The overflow was flapped and screened.

**Overflow** View of overflow pipe at Selman tank.

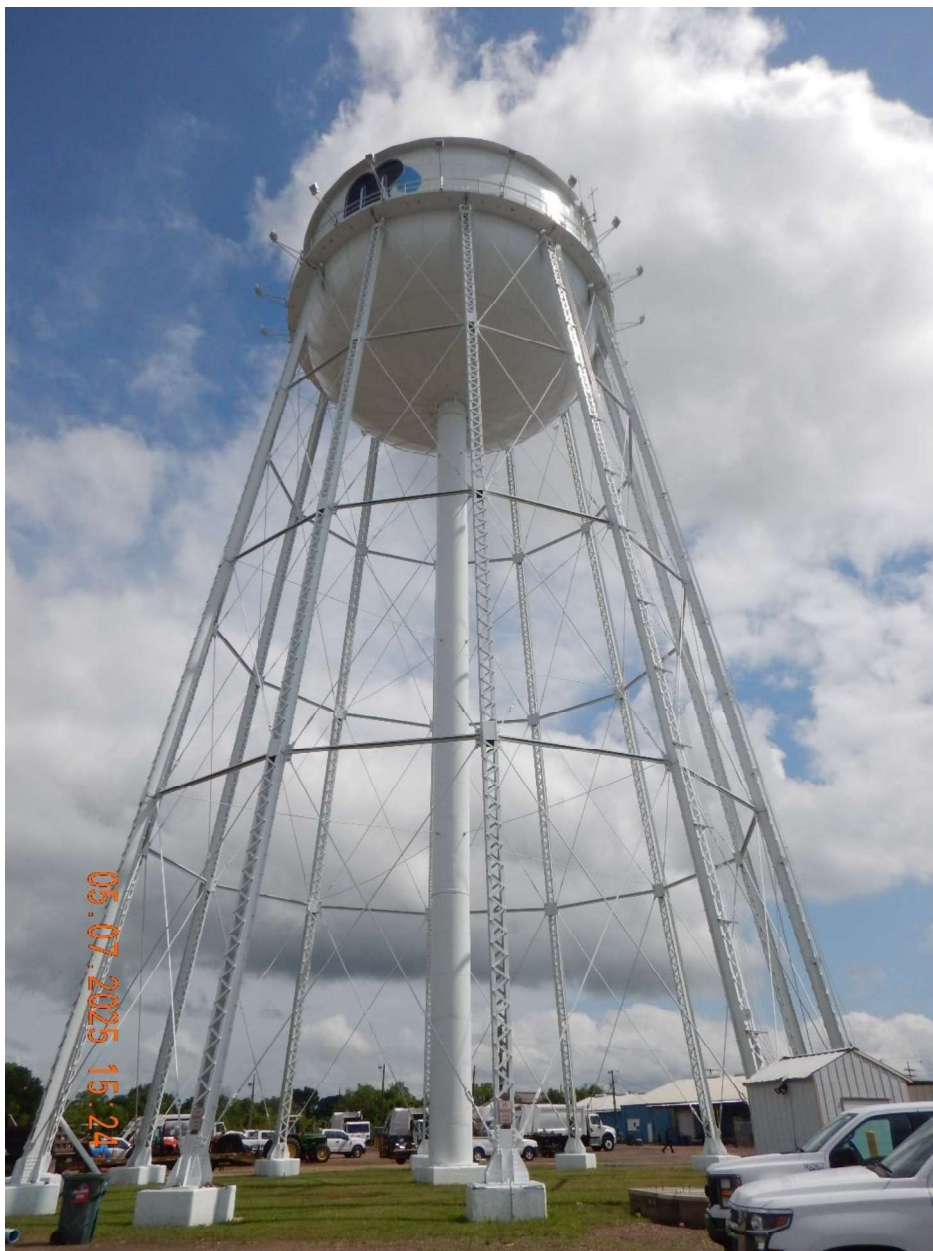
Next, the Grammont tower was observed. Its capacity is 500,000 gallons, and its height is 115 feet. The overflow was flapped and screened. The chlorine residual was observed to be 1.87 ppm, the pH was 8.51, and the turbidity was 0.107 NTU.

**Grammont Tower** View of Grammont tower.

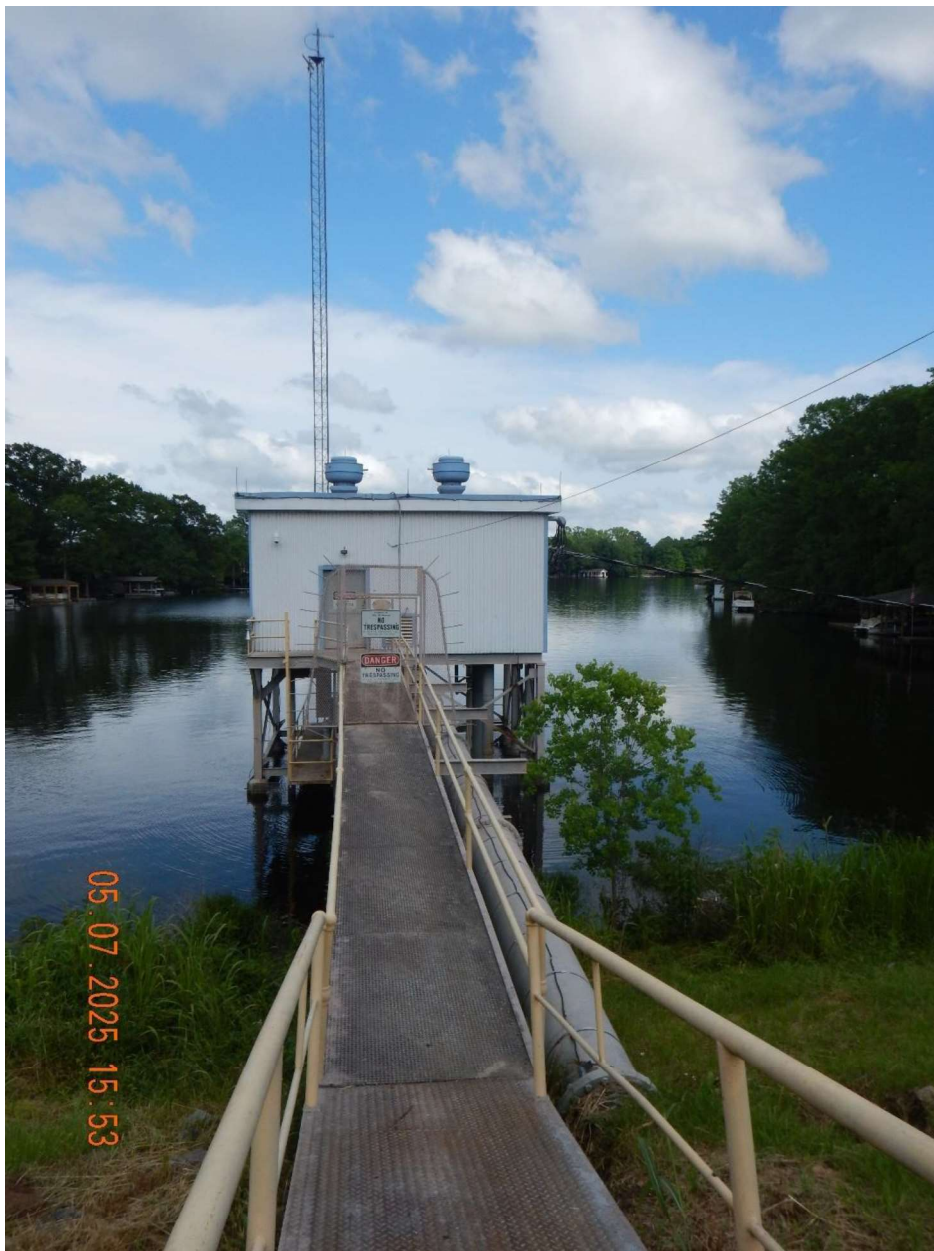
Next, we observed the bayou intake, which had three pumps. Pump 1 had a capacity of 7 MGD, Pump 2 had a capacity of 12 MGD, and Pump 3 had a capacity of 7 MGD. System representatives mentioned that raw water testing was completed everyday, including measurements for turbidity, alkalinity, and pH. It was also discussed that there were bar screens at the intake. If leaves get stuck on the screen, the pumps are shut down to remove the debris. The indicator for debris being stuck on the screen is that the pumps usually struggle to work. The intake was at a depth of 65 feet, and there were cameras installed.

**Bayou Intake** View of bayou intake station.

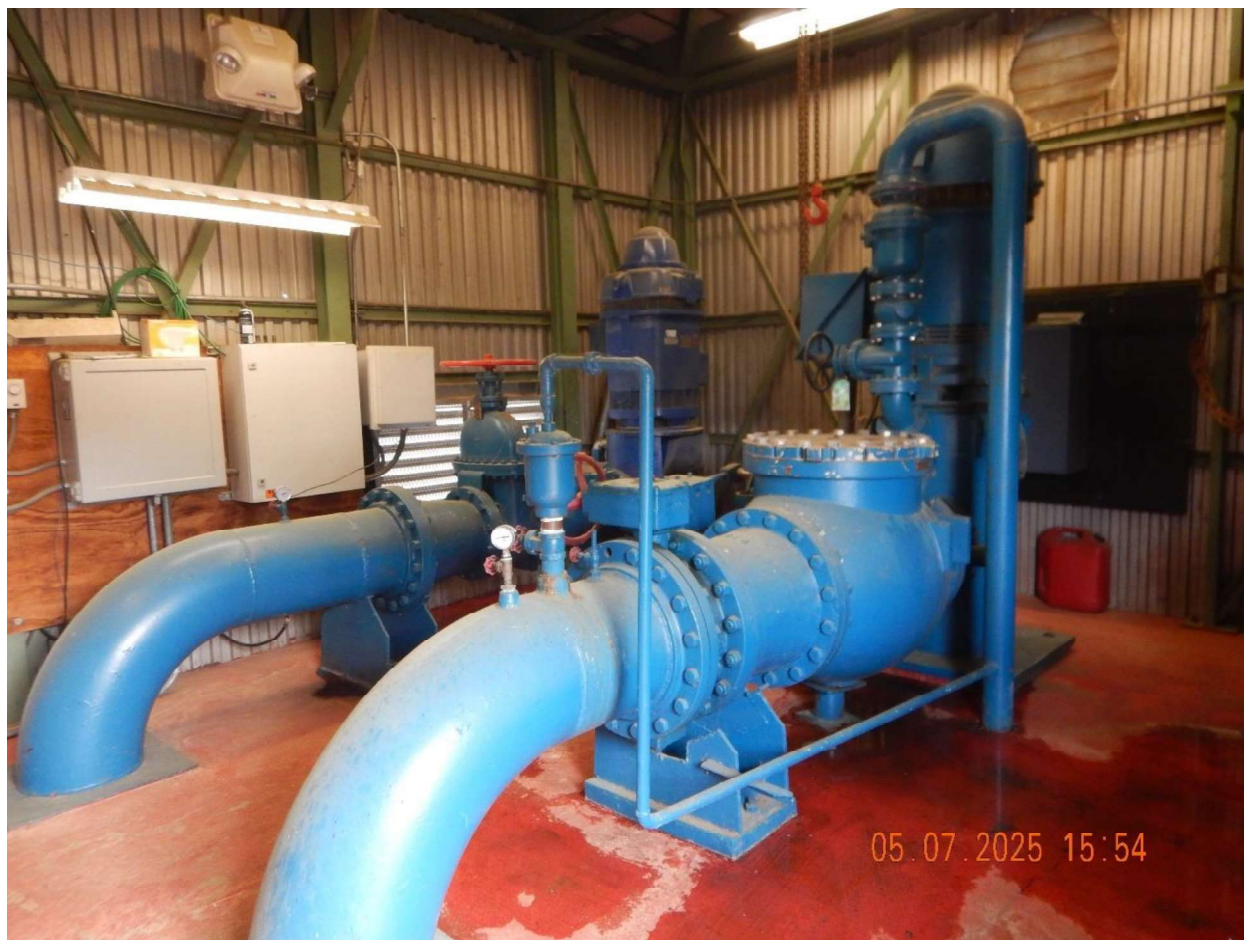
**Pumps** View of pumps at Bayou intake.

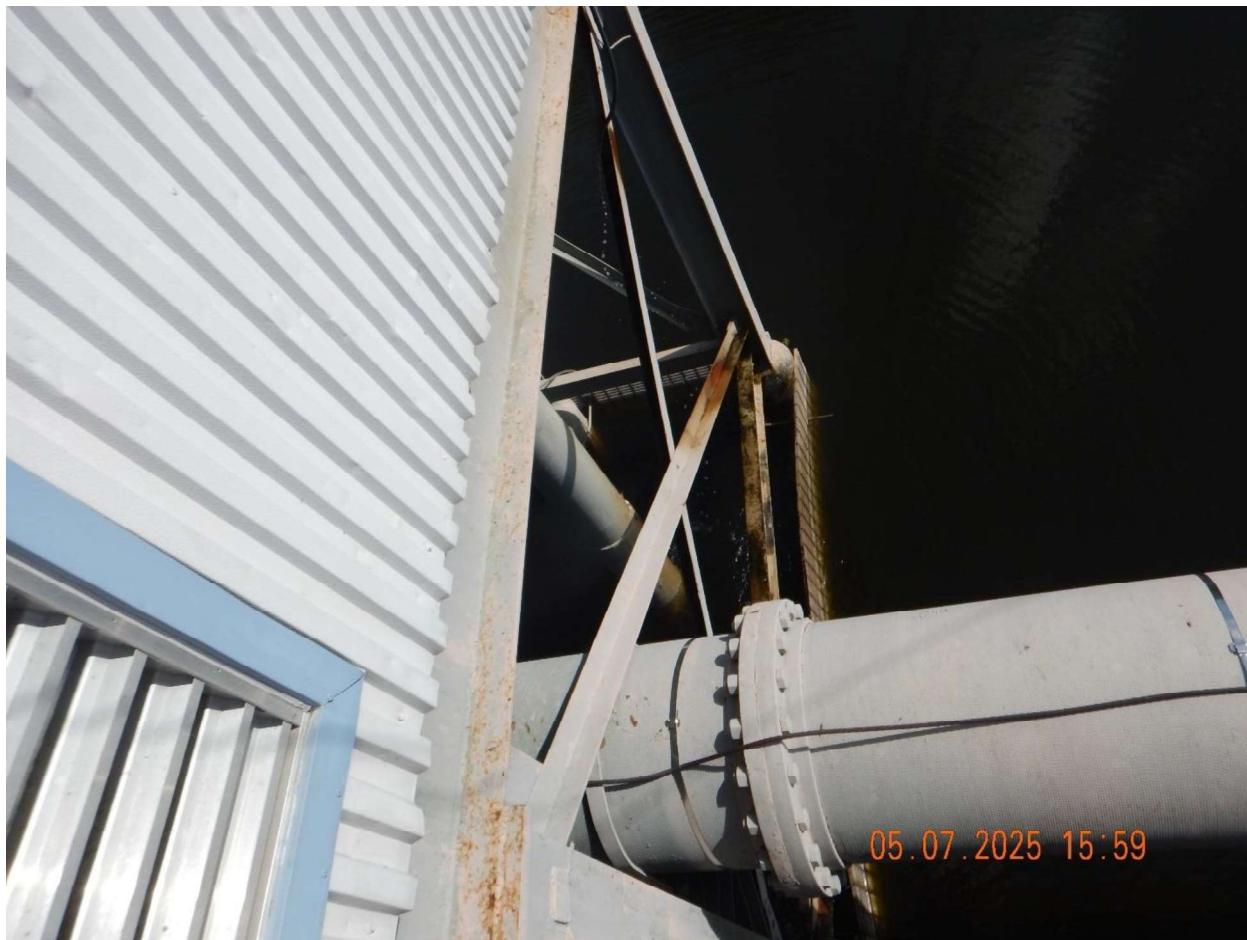
**Bayou Intake** View of water at intake location.

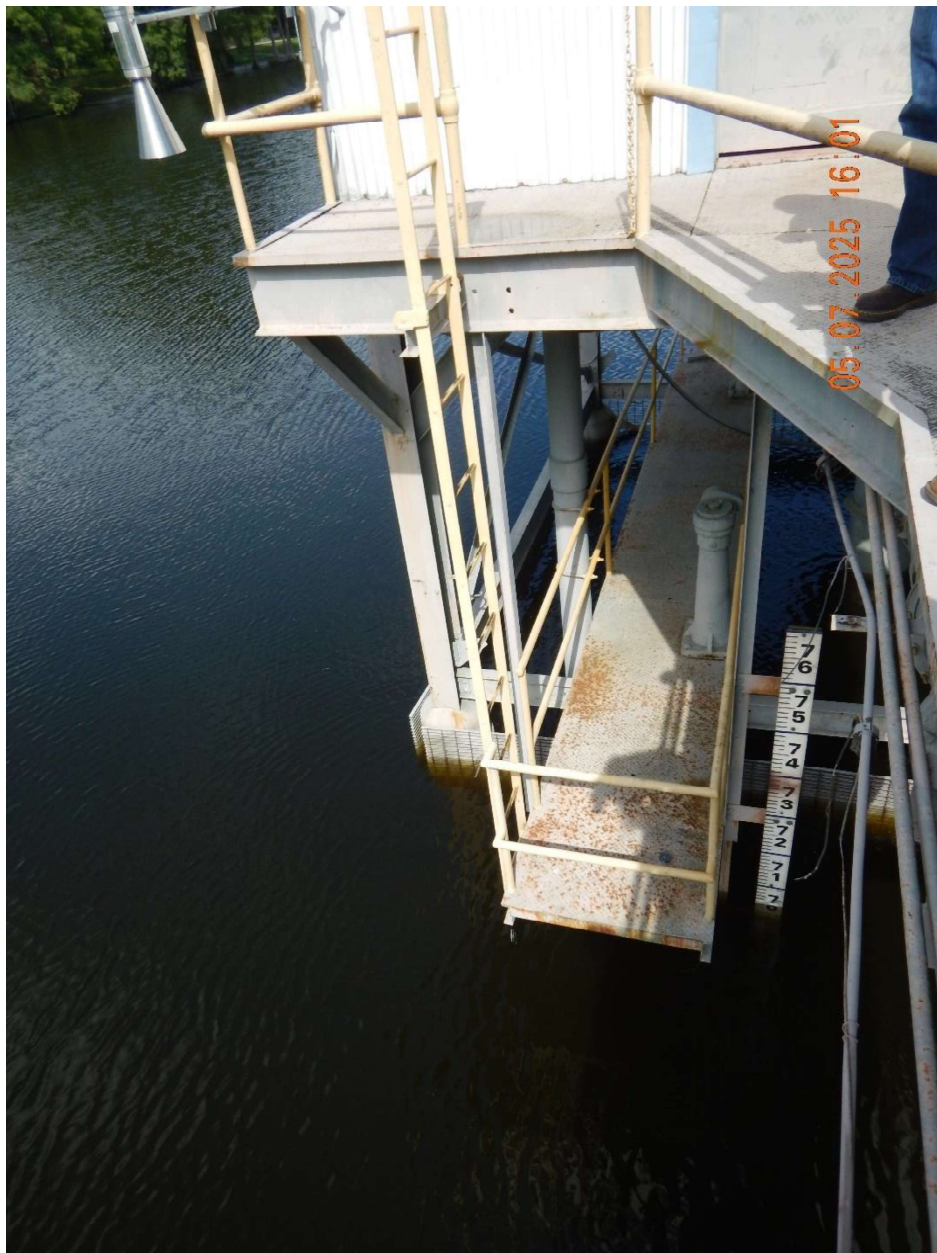
**Bayou Intake** View of water level at intake.
