Re: EPA Inspection Report – Michigan Sugar Company Piling Grounds

**CLEAN WATER ACT COMPLIANCE EVALUATION INSPECTION REPORT  
U.S. ENVIRONMENTAL PROTECTION AGENCY, REGION 5**

**Purpose:** Compliance Evaluation Sampling Inspection

**Facilities:** Michigan Sugar Company – Piling Grounds of Albee,  
Blumfield, Breckenridge, Au Gres and Hope/Midland

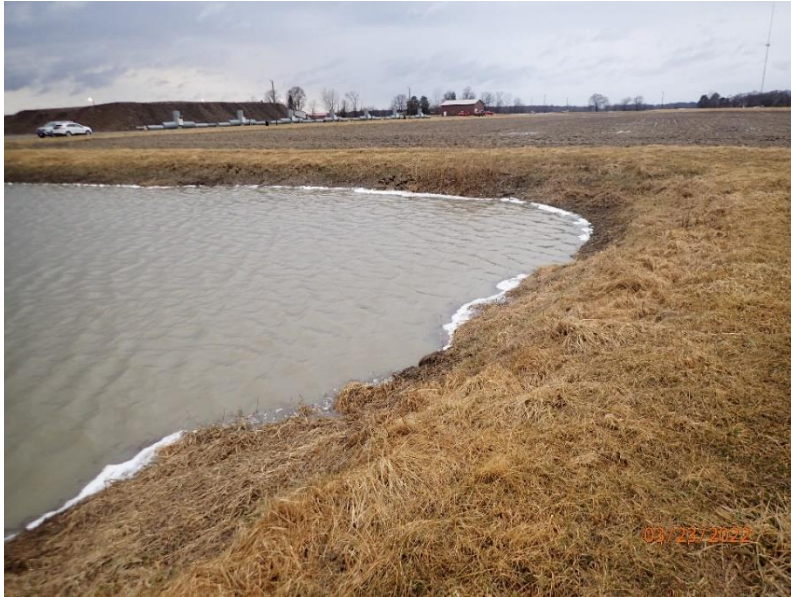
1: P3230078

Description: The pond at the Albee Piling Ground. The pipe from the piling ground is under water.

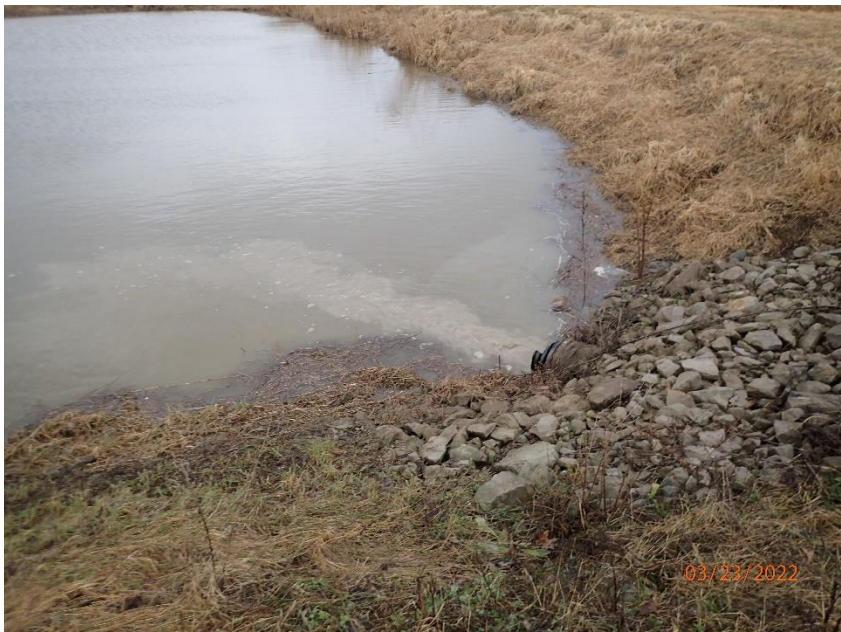
8: P3230085

Description: Note the plume into the pond from the pipe from the piling ground.

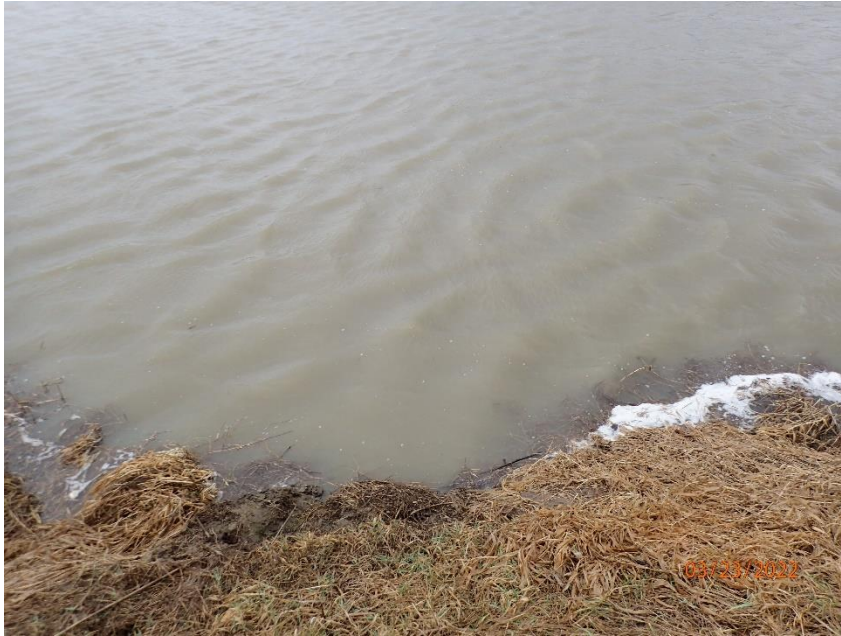
8: P3230092

Description: A sample was taken from this location in the Albee pond. Sample was named “Albee Pond” and was taken at 8:42 A.M.

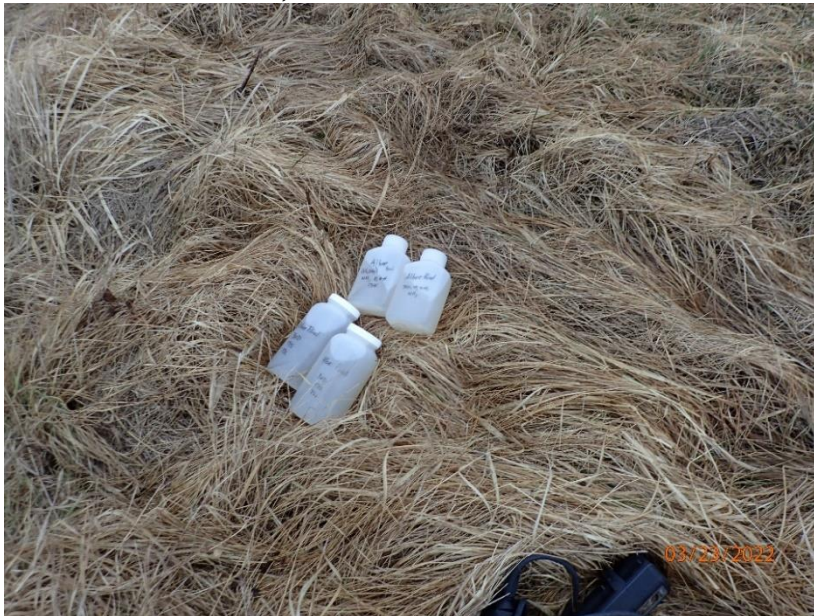
9: P3230093

Description: Sample named “Albee Pond” was taken from the pond at the Albee Piling Ground at 8:42 A.M. The dissolved oxygen (DO) at the pipe to the pond was 38.6% and the DO in the pond was 14.8%

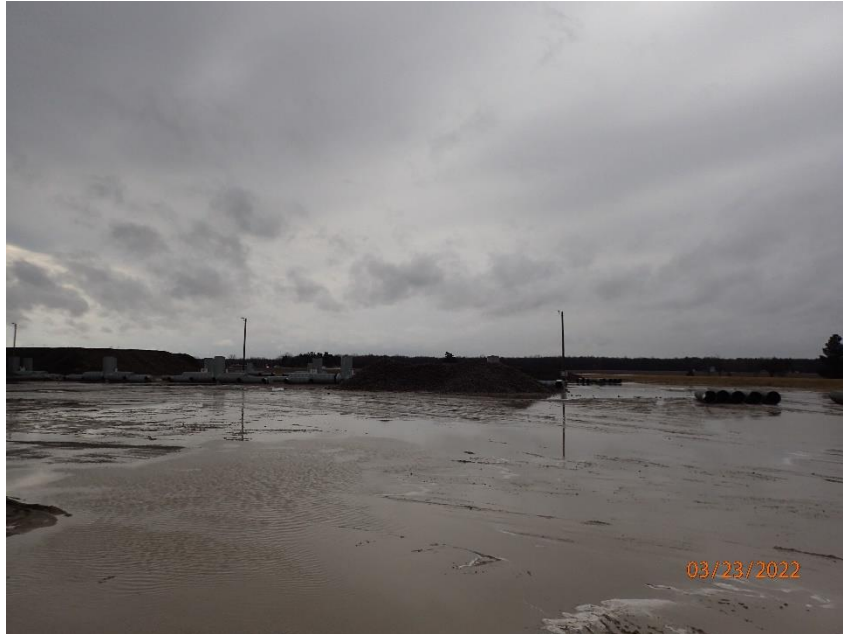
19: P3230096

Description: Precipitation that falls on the piling ground also falls on the piles of sugar beets.

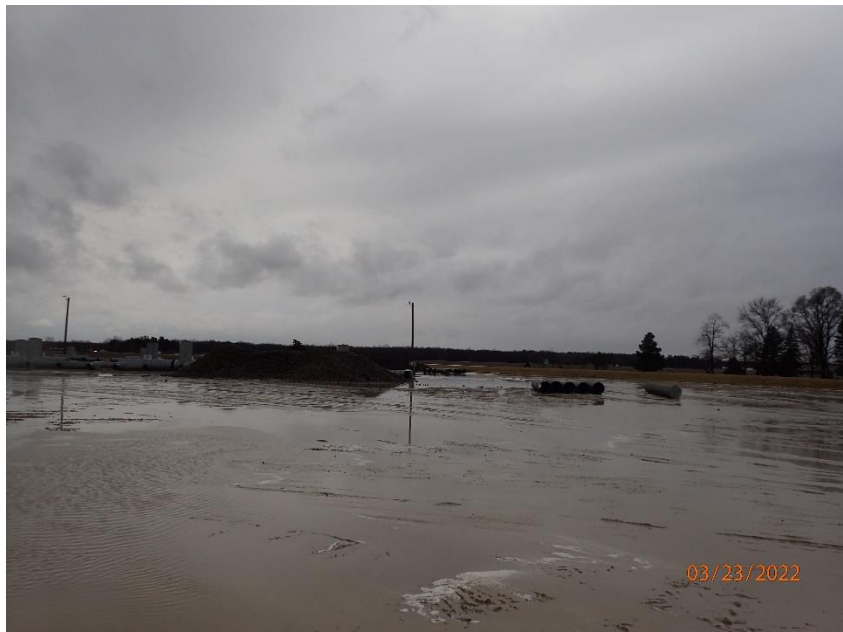
11: P3230097

Description: Precipitation that falls on the piling ground also falls on the piles of sugar beets.

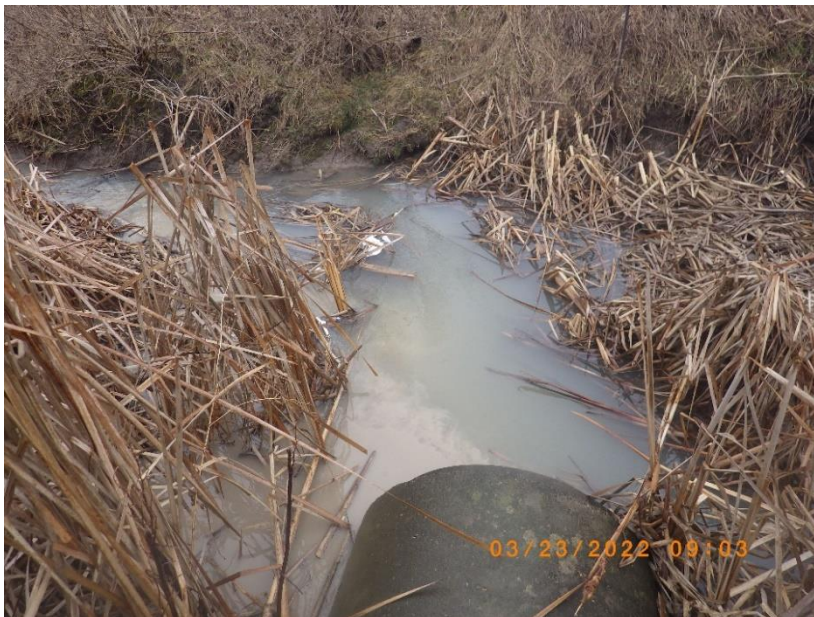
25: RIMG2487

Description: Pipe discharging runoff from the Blumfield East piling ground into an unnamed tributary north of the piling ground.

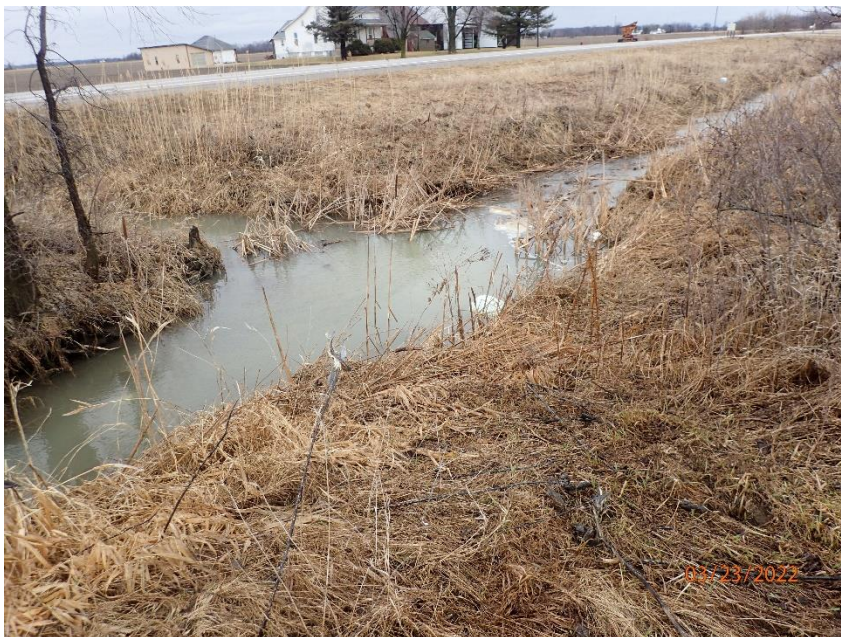
18: P3230108

Description: The pond discharges to a roadside ditch. The pipe was under water on the day of the inspection.

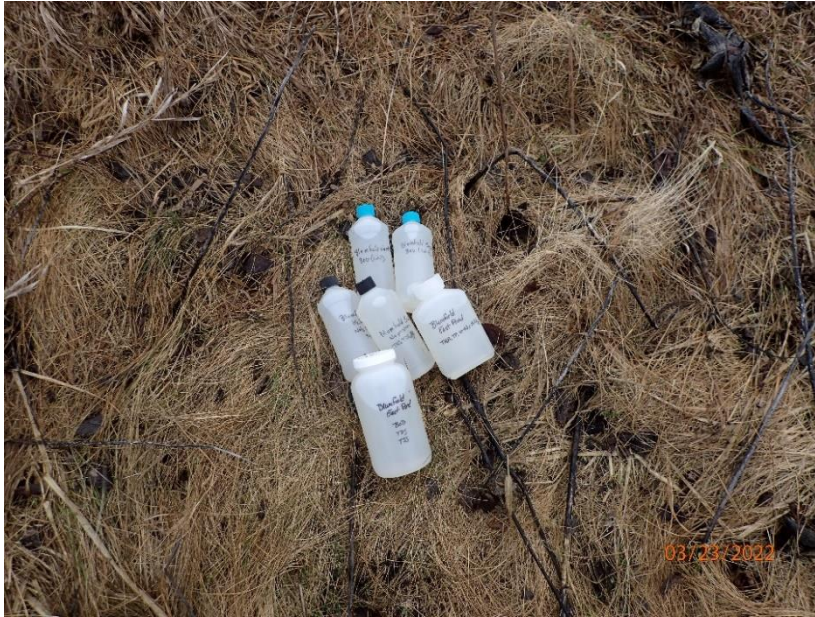
19: P3230109

Description: At 10:38 A.M., EPA took sample named “Blumfield East Pond” from the pond at the Blumfield East Piling Ground near the pond’s discharge pipe on the west side. The DO level was 65%

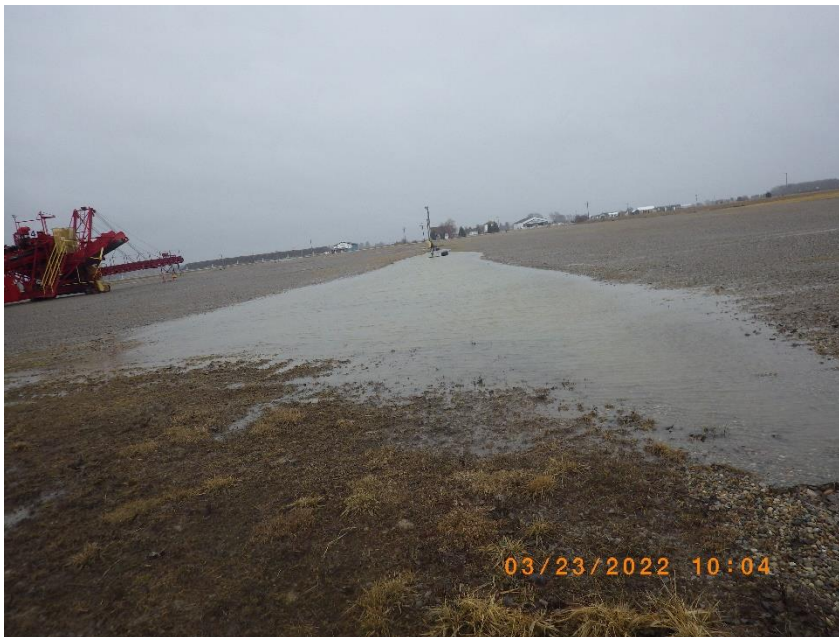
37: RIMG2490

Description: Runoff flowing west at Blumfield West piling ground.

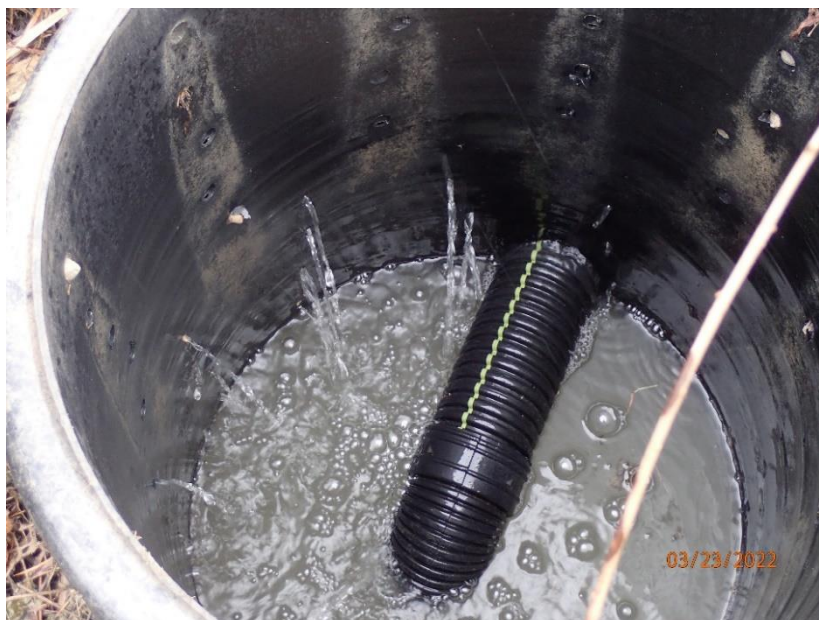
40: P3230113

Description: Water flowing into the catch basin on the west end of the Blumfield West Piling Ground.

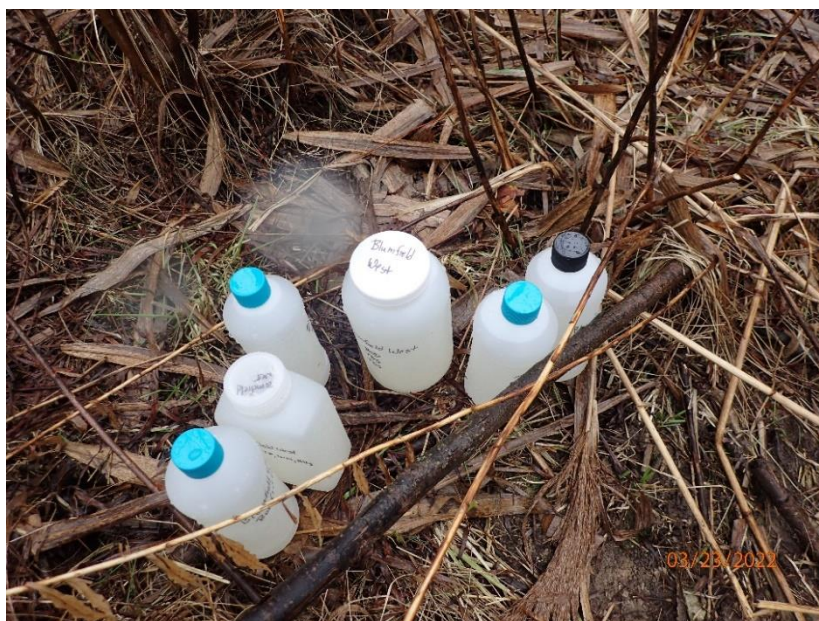
41: P3230114

Description: EPA took sample named "Blumfield West" from the discharge from a pipe on the west side of the berm on the west side of the Blumfield West Piling Ground.

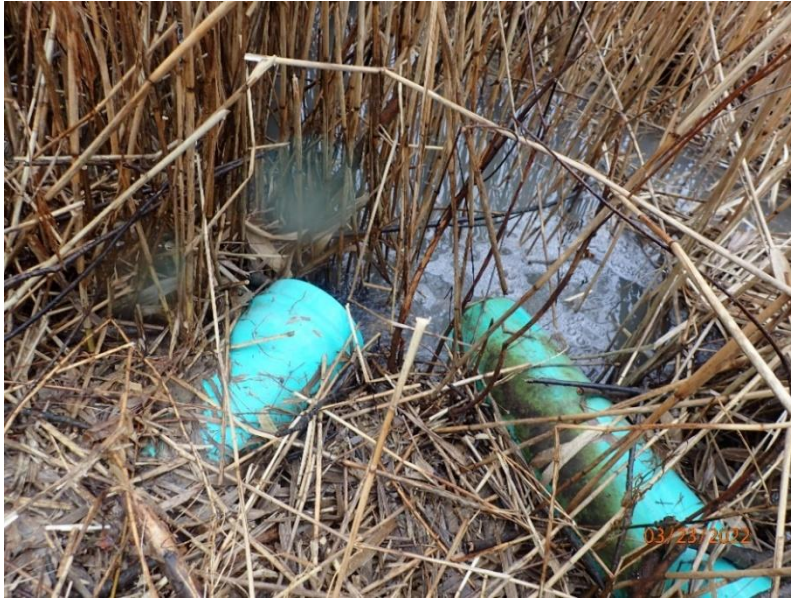
42: P3230115

Description: The pipe from the Blumfield West Piling Ground goes through a berm to the west and discharges to a ditch.

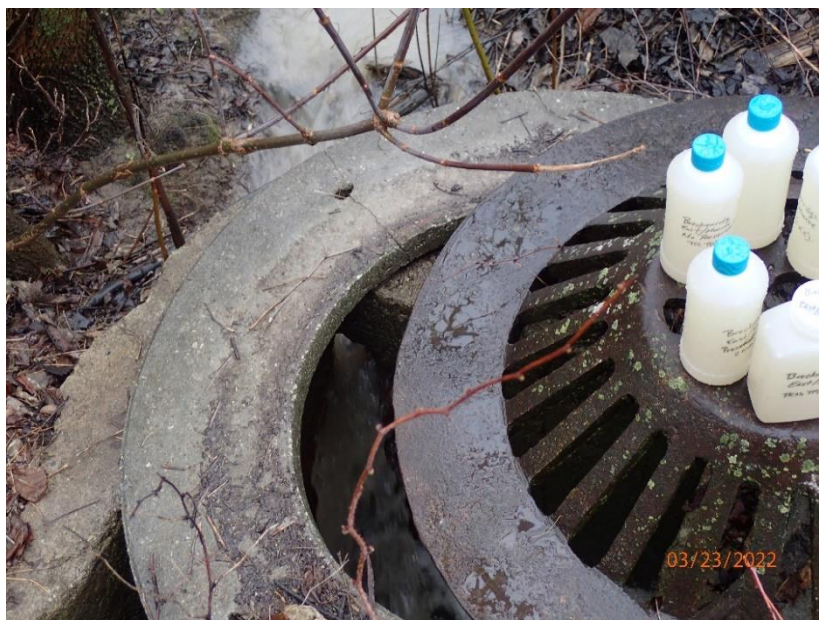
63: P3230131

Description: EPA took sample named “Breckenridge East/Monroe” from the flow into the storm water structure on the north side of the piling ground at 1:37 P.M.

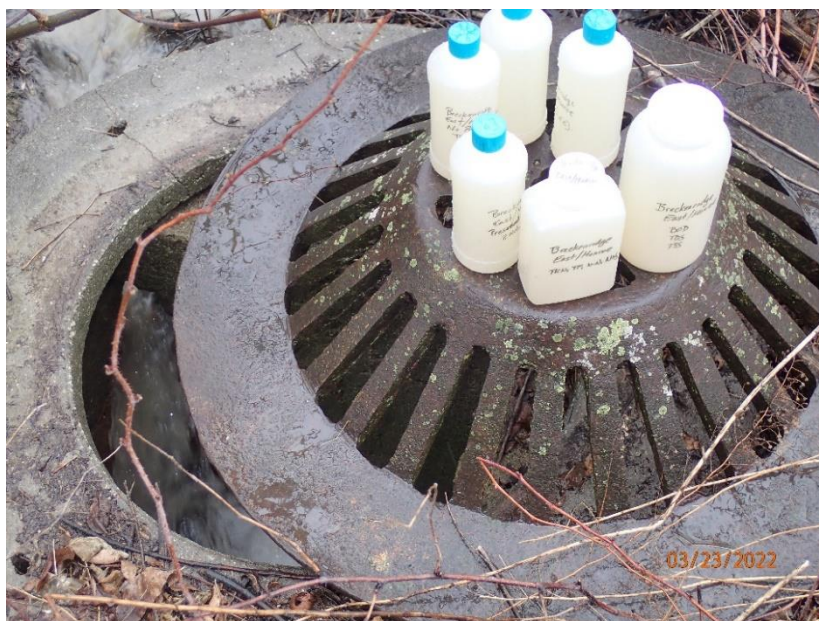
64: P3230132

Description: EPA took sample named “Breckenridge East/Monroe” from the flow into the storm water structure on the north side of the piling ground at 1:37 P.M.

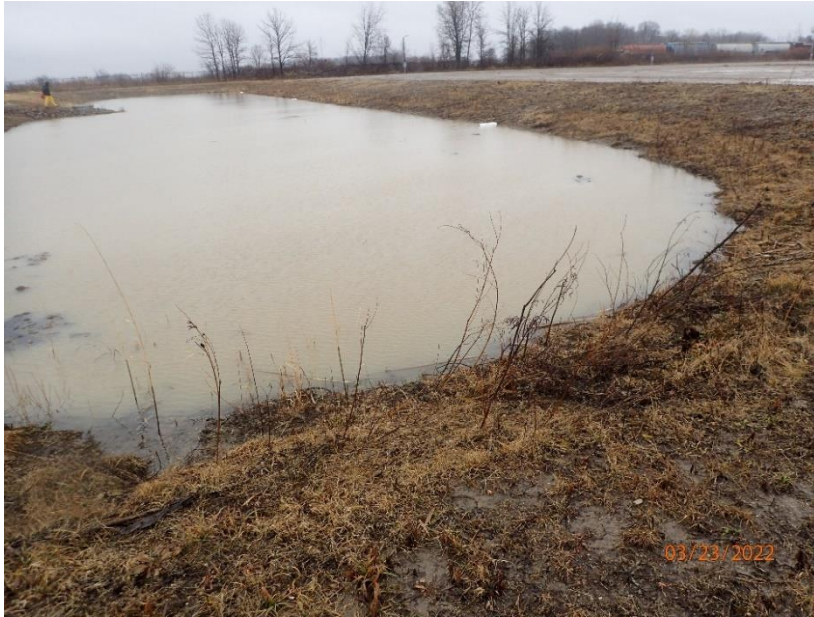
65: P3230133

Description: The stone outlet structure from the Breckenridge Piling Ground pond is on the left hand side of the photo.

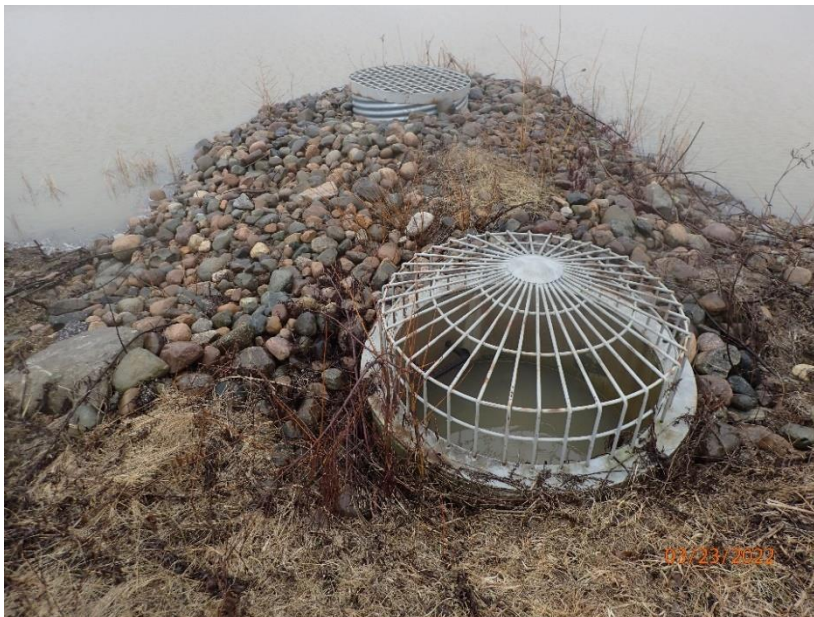
66: P3230134

Description: The stone outlet structure from the Breckenridge Piling Ground pond to the ditch along Ransom Road. The inlet pipe is in the inlet structure furthest from the camera.

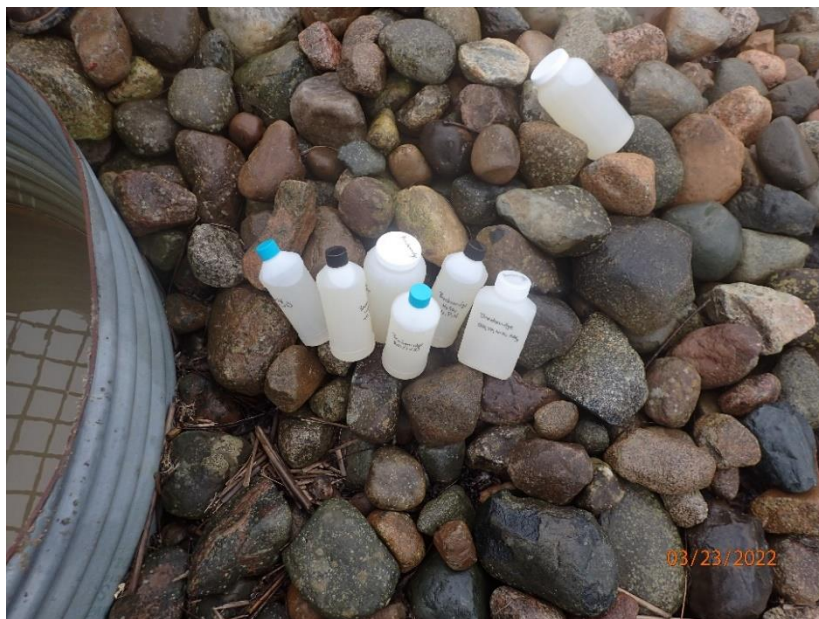
68: P3230136

Description: EPA took sample named "Breckenridge" from the inlet structure at 2:07 P.M.

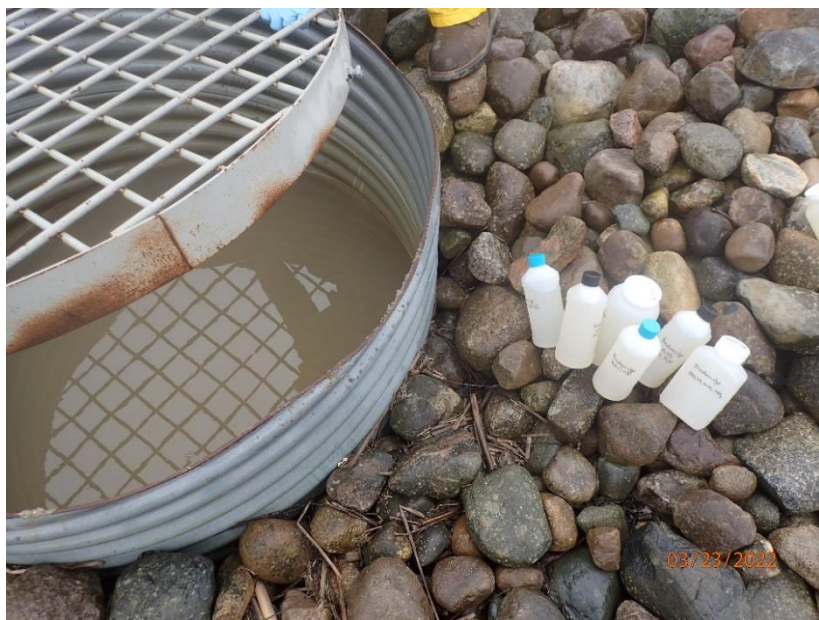
69: P3230137

Description: EPA took sample named “Breckenridge” from the inlet structure at 2:07 P.M.

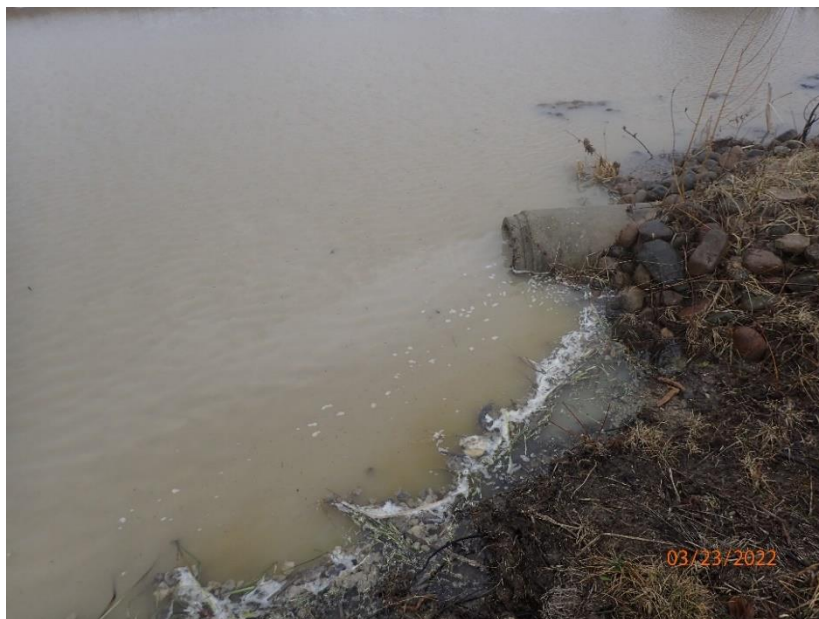
70: P3230138

Description: The inlet pipe to the Breckenridge Piling Ground pond from the piling ground. Note the plume from the pipe.

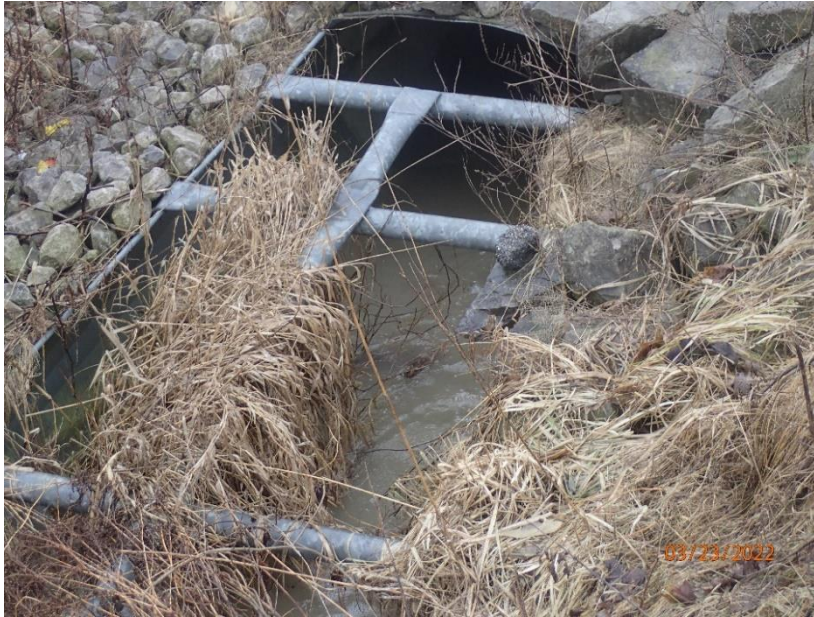
73: P3230141

Description: The flow in the ditch on the east side of Ransom road flows into a culvert under Monroe Road.

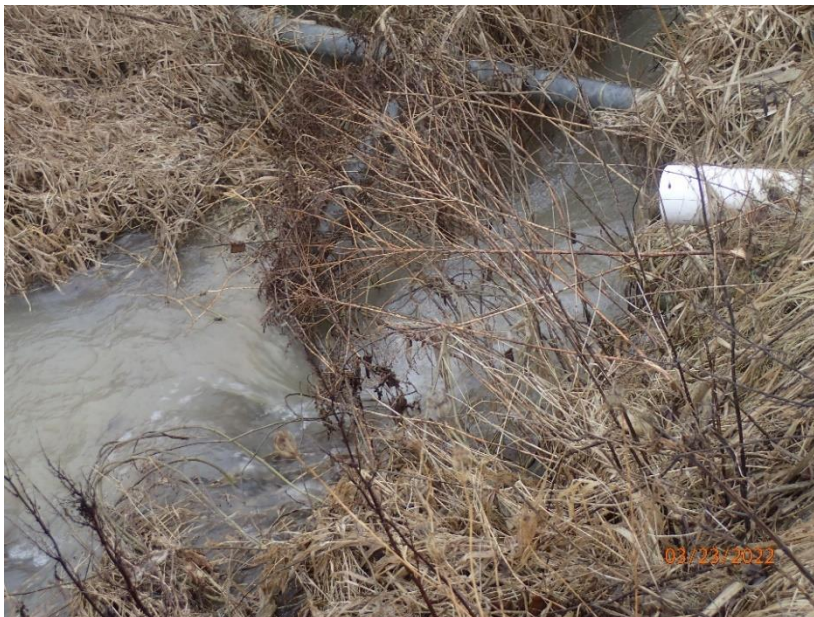
74: P3230142

Description: The flow in the ditch on the east side of Ransom road flows into a culvert under Monroe Road.

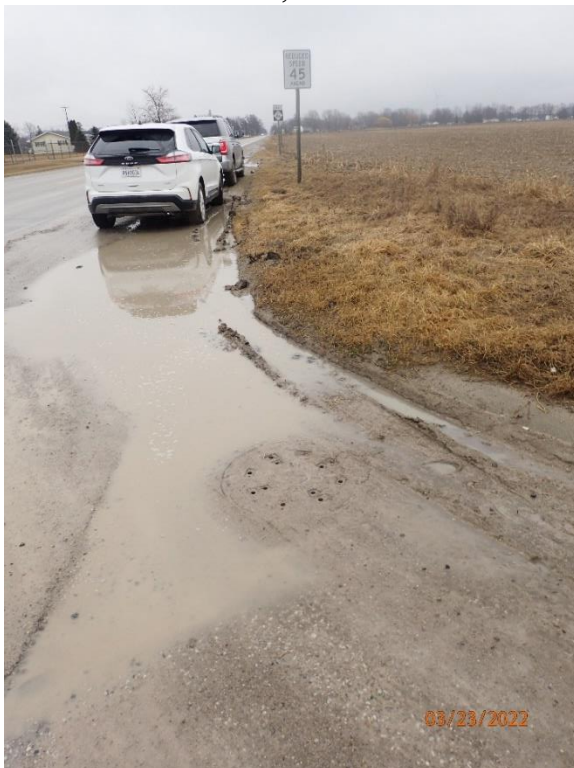
76: P3230144

Description: Manhole in the road is location of pipe under East Monroe Road.

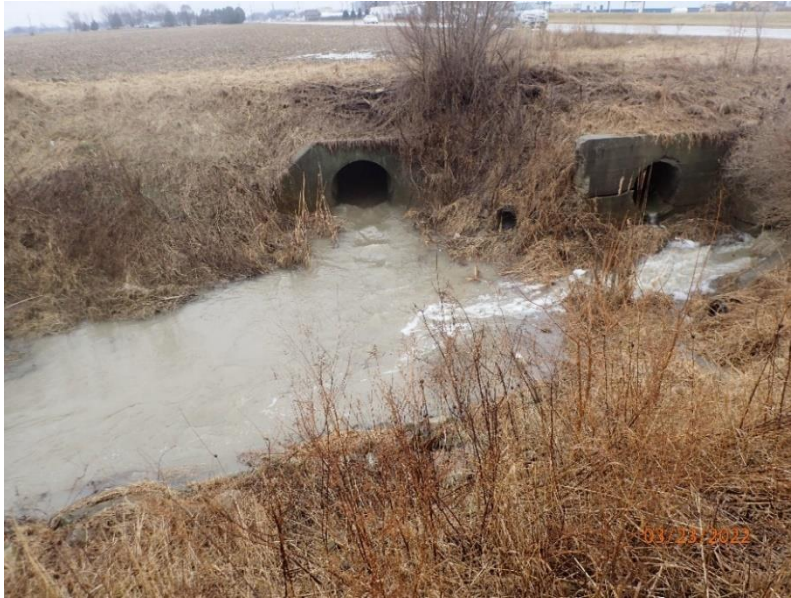
77: P3230145

Description: Flow enters a ditch on the south side of Monroe Road from three pipes. EPA believes that the one on the right is from the flow from the culvert at the corner of Ransom Road and Monroe Road.

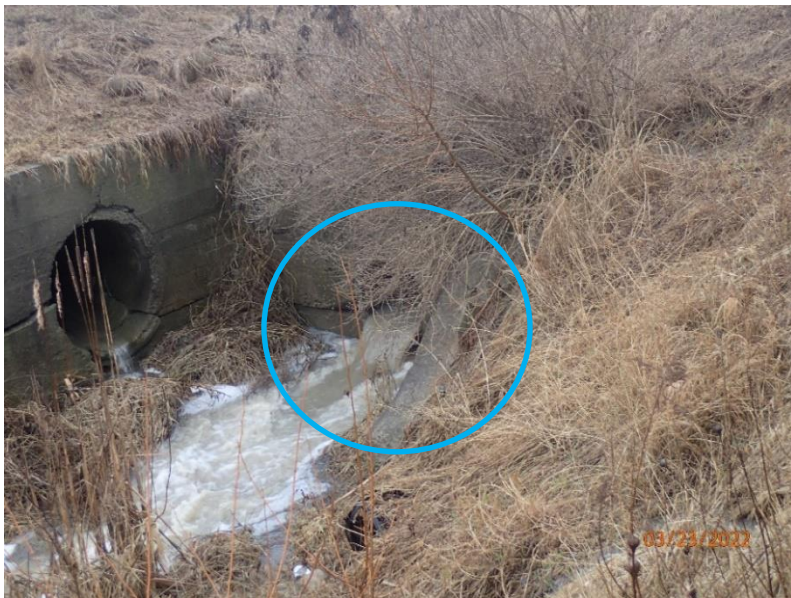
78: P3230146

Description: A third pipe (denoted with blue circle) is from the storm structure on the north side of the Breckenridge Piling Ground.

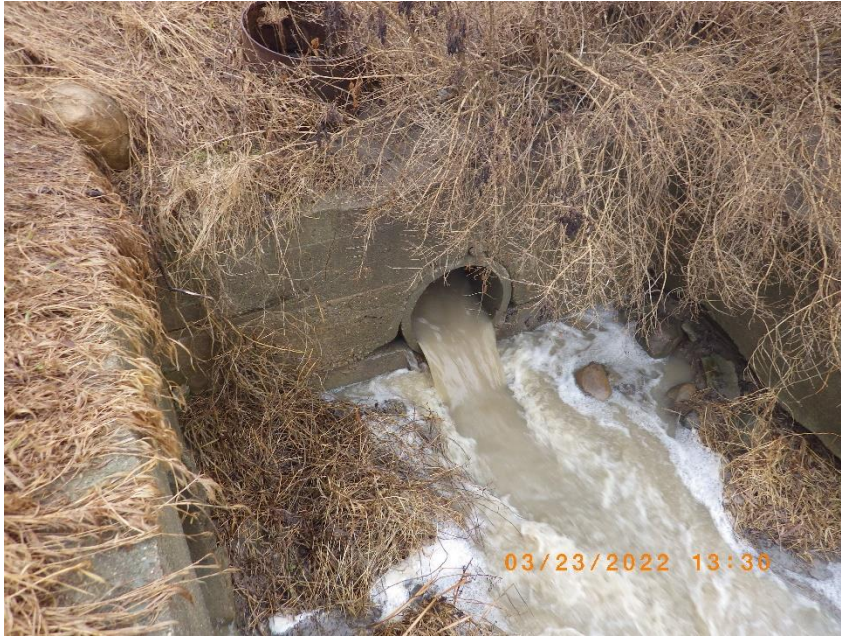
79: RIMG2506

Description: Discharge from the underground county drain that runs from north to south through the Breckenridge piling ground. It discharges into the unnamed tributary south of East Monroe road.

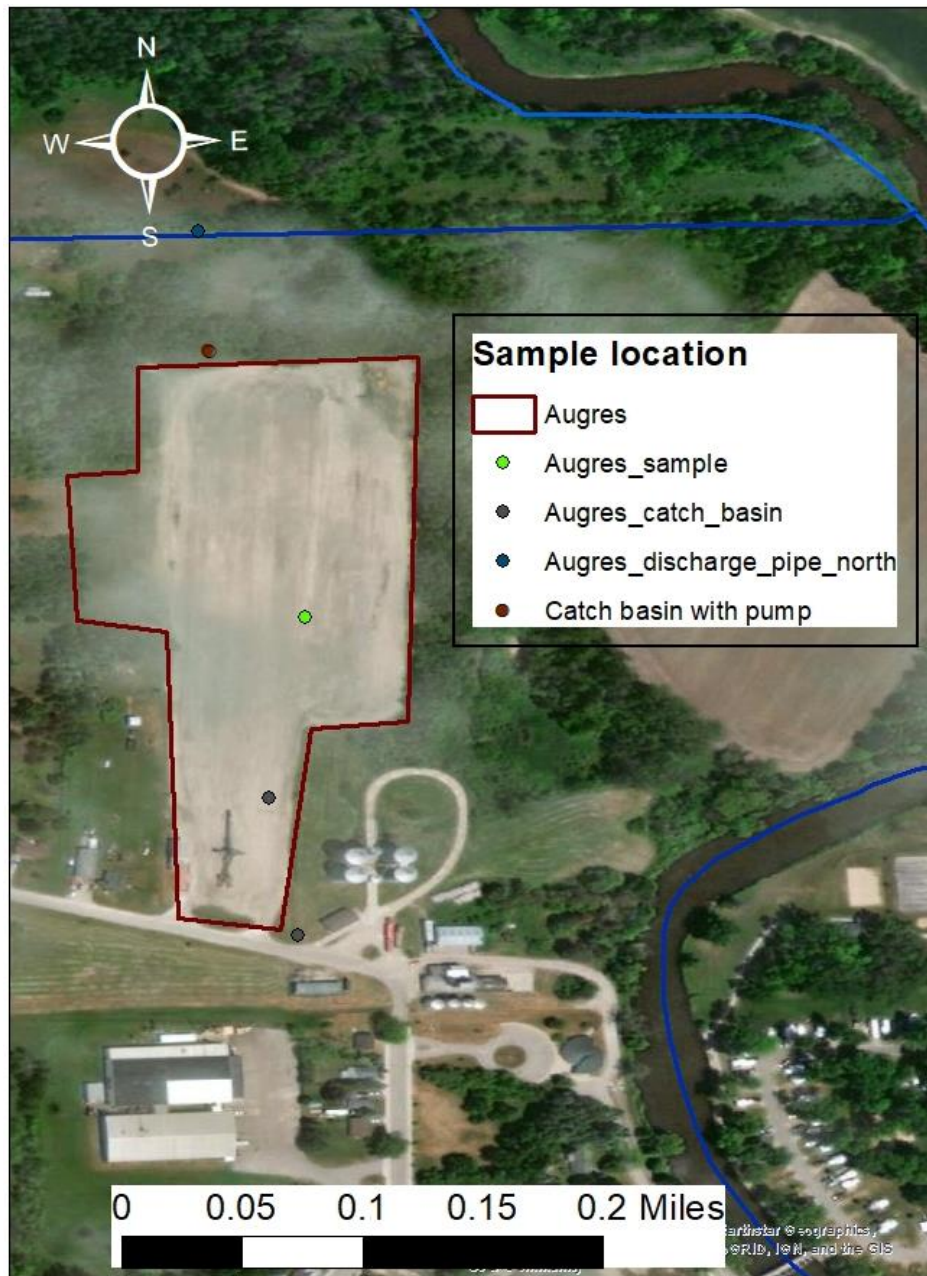
Figure 7. Aerial image of the Au Gres piling ground, the location where the sample was taken, catch basins on site and the locations of the outlet pipe.

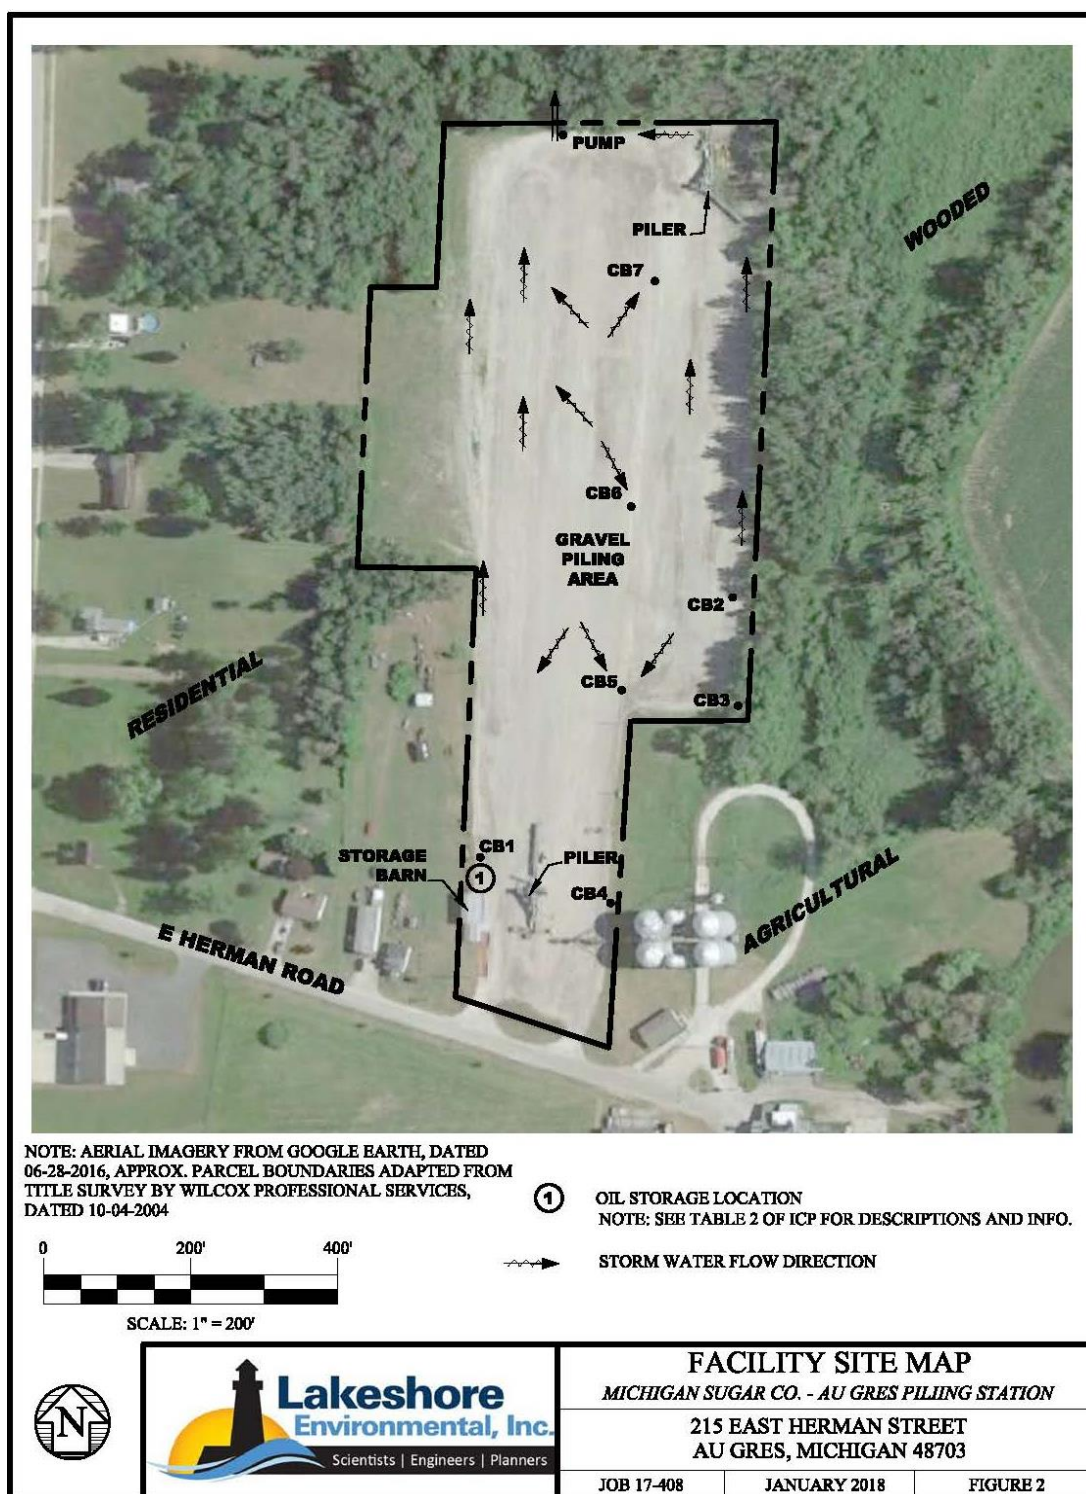
Figure 8: Aerial image of the Au Gres piling ground provided to EPA by MSC in response to the December 11, 2017 information request. The aerial image shows the catch basins on site and the stormwater flow direction.

Au Gres, Michigan and has a surface area of approximately 14.5 acres. According to the map in Figure 8 that was provided to EPA by MSC, two rows of underground catch basins on the east and west side of the piling ground, convey runoff to a catch basin near the northwest corner of the piling ground and from there, water is pumped into an unnamed tributary of the Au Gres River, just north of the piling ground and approximately 250 feet from it. During the inspection time, EPA observed that flow from catch basins was routed south instead. EPA observed runoff entering one of the catch basins (photos 83, 84) on the east side of the piling ground and took sample “Au Gres” at 4:29 P.M. EPA observed flow was routed south from the catch basin where the sample was taken, through two more catch basins, at the southern most tip of the property and from there flowing southeast.

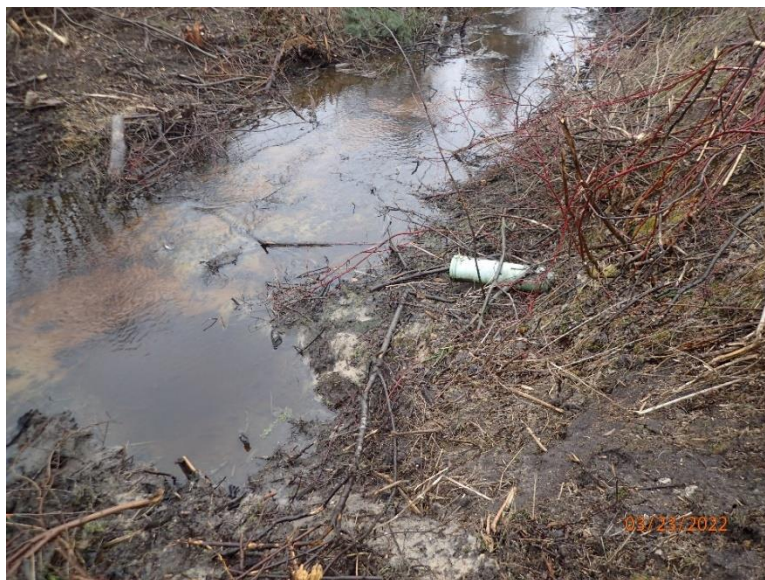
80: P3230147

EPA observed no flow from the pipe on the north side of the piling ground to the unnamed tributary of the Au Gres River.

Description: Pipe from the piling ground to a ditch on the north side of the Au Gres Piling Ground.

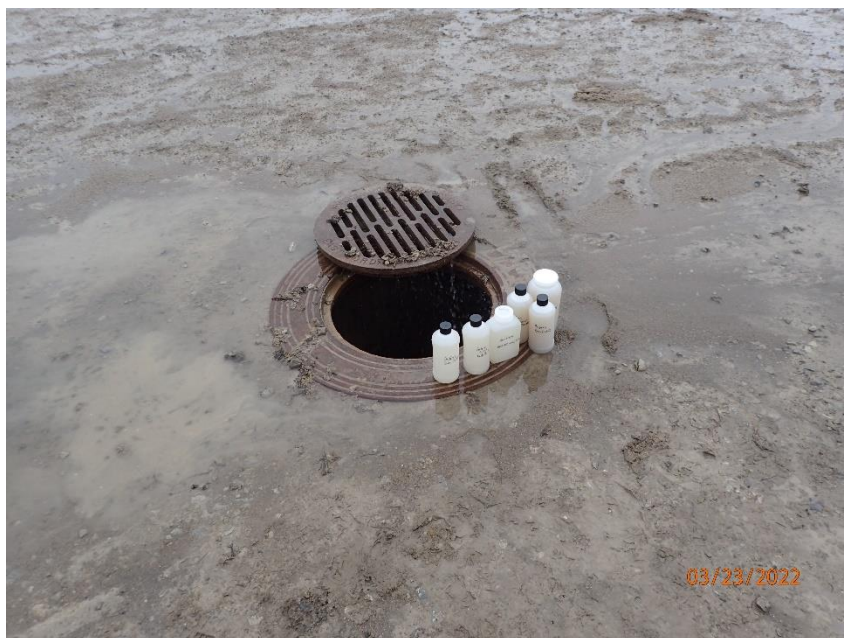
83: P3230150

Description: EPA took the sample named “Au Gres” from the southernmost manhole on the Au Gres Piling Ground at 4:29 P.M.

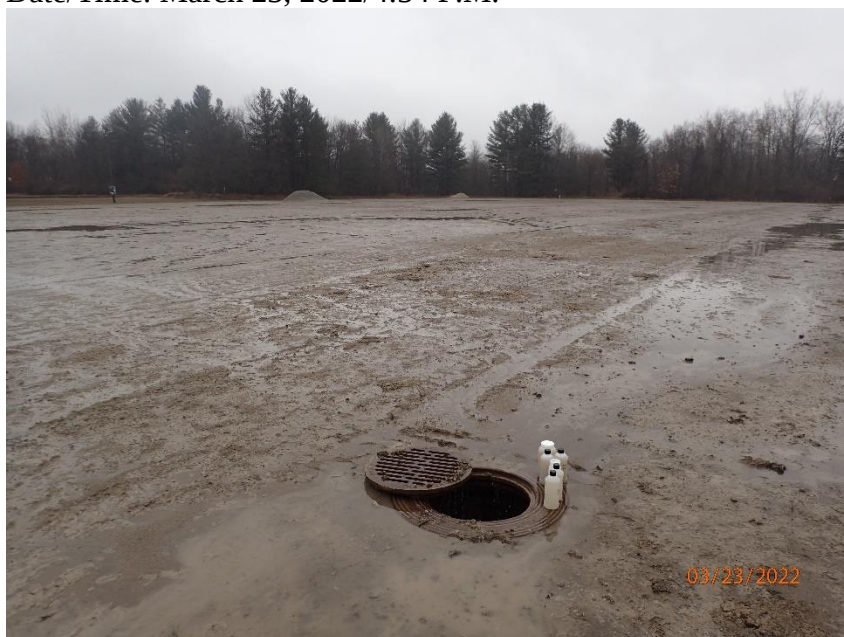
84: P3230151

Description: EPA took the sample named “Au Gres” from the southernmost manhole on the Au Gres Piling Ground at 4:29 P.M.

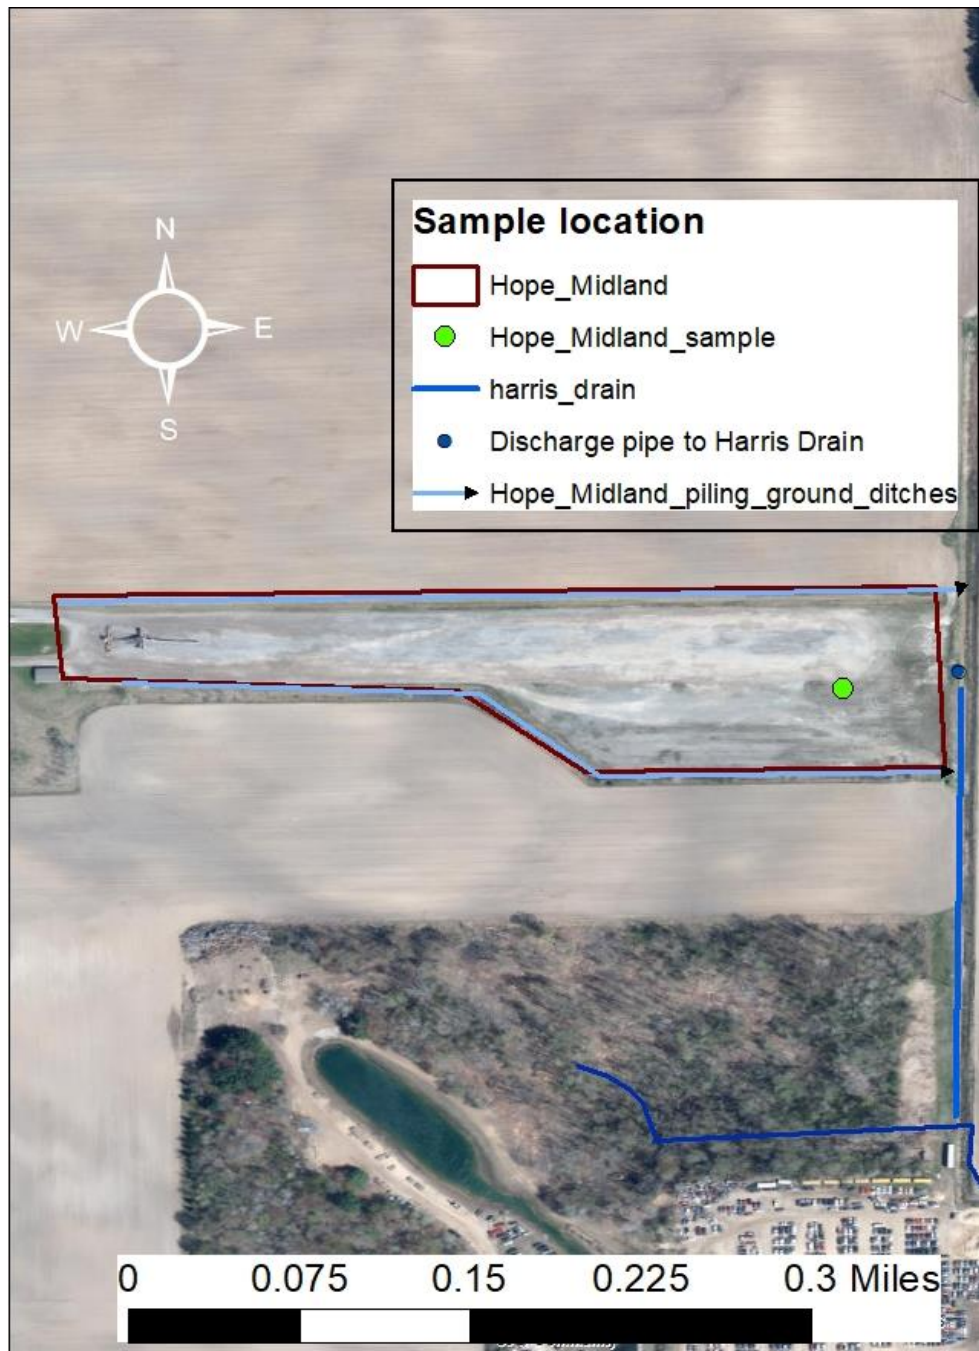
Figure 9. Aerial image of the Hope/Midland piling ground, the location where the sample was taken, catch basin on site and the locations of the outlet pipe.

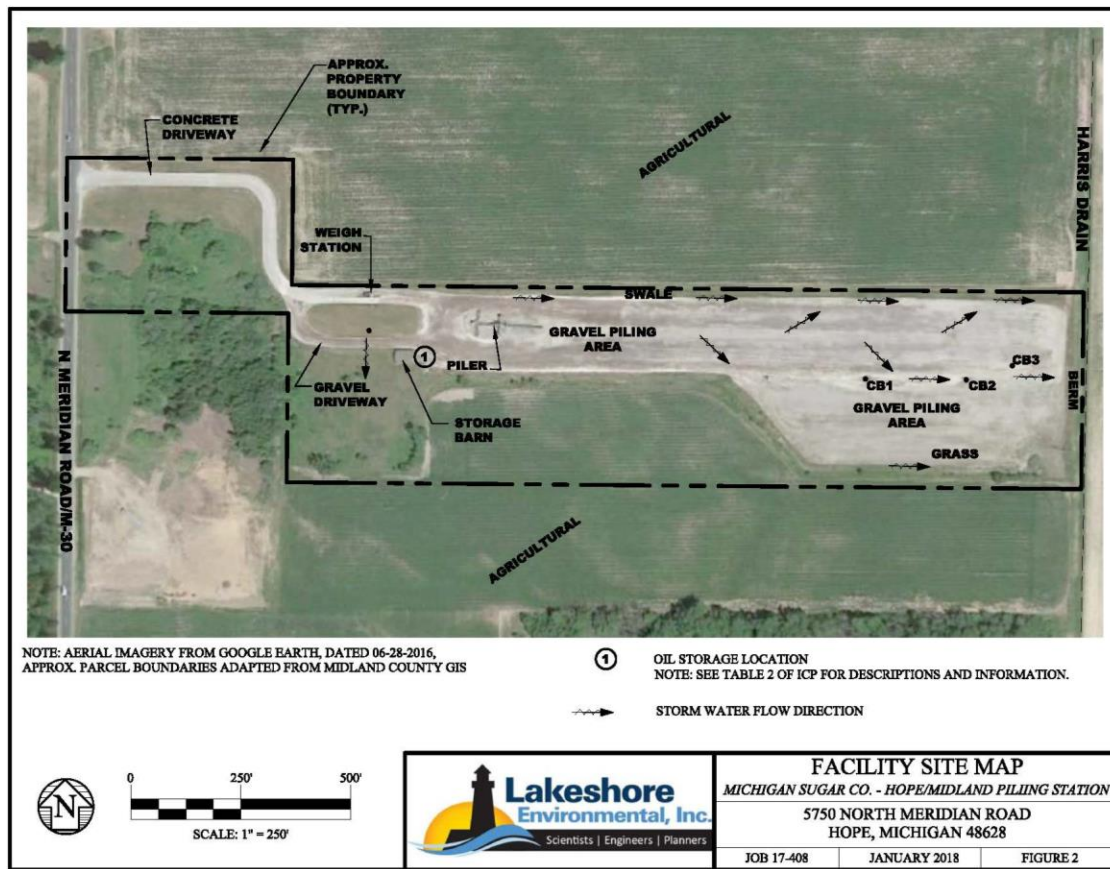
Figure 10: Aerial image of the Hope/Midland piling ground provided to EPA by MSC in response to the December 11, 2017 information request. The aerial image shows the catch basins on site and the stormwater flow direction.

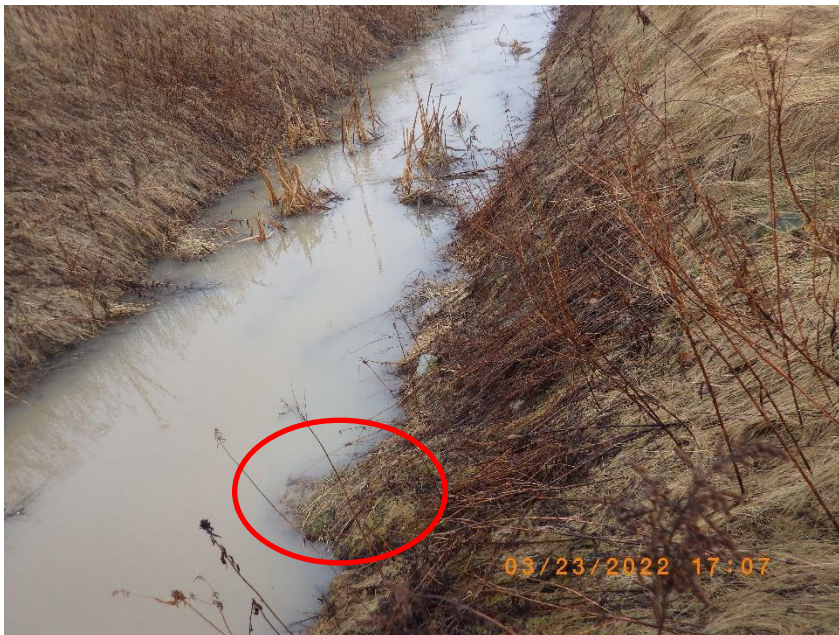
90: RIMG2513

The outlet pipe that conveyed water from the catch basins on site to Harris Drain where EPA took a sample from in April 2019, was under water at the time of this inspection (photos 89 and 90). EPA observed runoff flowing into a catch basin, approximately 200 feet west of the discharge pipe. EPA took sample "Hope/Midland" from inside the catch basin at 6:17 P.M. The sample was immediately preserved. The water in the catch basin flowed east towards Harris Drain.

Description: Discharge pipe at the Hope/Midland piling ground was under water. Red circle indicates the location of the pipe.

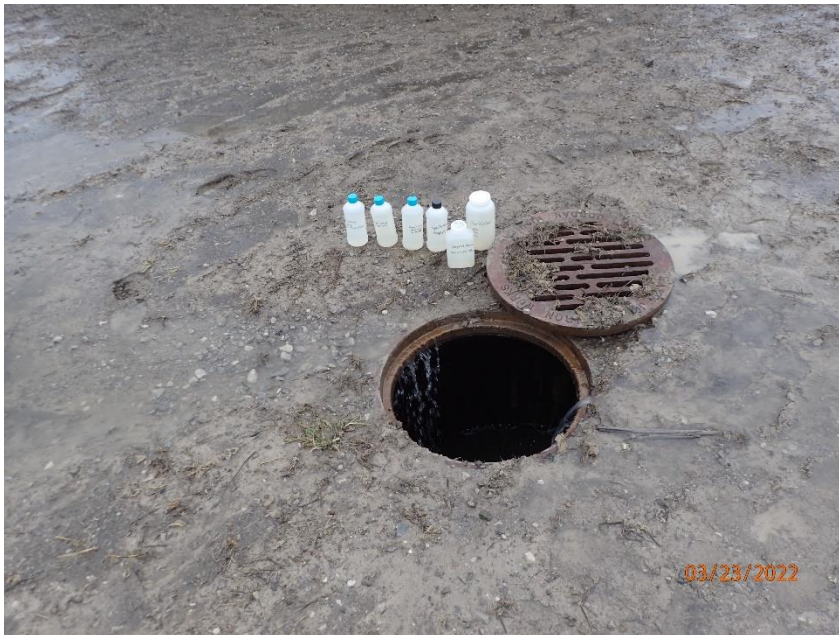
92: P3230158

Description: EPA took sample named "Hope/Midland" from the flow into a manhole on the south side of the site at 6:17 P.M. The DO level was 124%
