Re: EPA Inspection Report – Michigan Sugar Company Piling Grounds

**CLEAN WATER ACT COMPLIANCE EVALUATION INSPECTION REPORT  
U.S. ENVIRONMENTAL PROTECTION AGENCY, REGION 5**

**Purpose:** Compliance Evaluation Sampling Inspection

**Facilities:** Michigan Sugar Company – Piling Grounds of Albee,  
Blumfield, Breckenridge, Au Gres and Hope/Midland

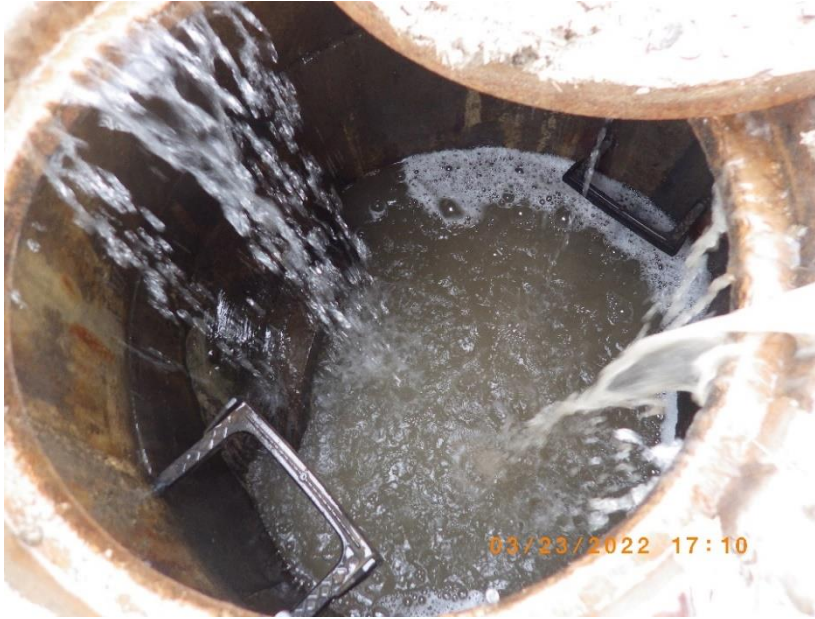
95: RIMG2515

Description: Catch basin at Hope/Midland piling ground that was receiving runoff and conveying it into the Harris Drain, east of the piling ground.
