**UNITED STATES ENVIRONMENTAL PROTECTION AGENCY, REGION 2
CARIBBEAN ENVIRONMENTAL PROTECTION DIVISION
MULTIMEDIA PERMITS AND COMPLIANCE BRANCH**

**NPDES Stormwater Inspection
Industrial Site**

CHITOLIE TRUCKING SERVICE, LLC

Inspection Date: March 30, 2023

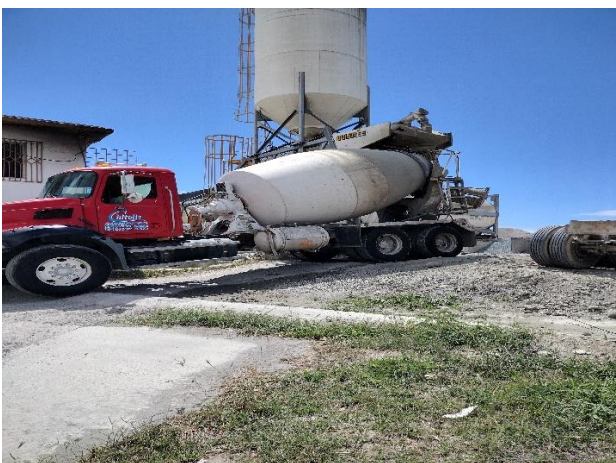
2. ***Discharge of Pollutants from Ready-Mixed Concrete Residues Spills in the Product Loading Bay*** – Observed residue of ready-mixed concrete and wastewater that flow through the product loading bay and that drains-off beyond a concrete berm, and eventually into the nearby road. See **IMGs 6690, 2419 and 6311 of CHITOLIE’S March 30, 2023 NPDES SWI Photo Album, ATTACHMENT 3**, of the 2023 Inspection Report.

IMG 2419-Entrance/exit into product loading bay. Ready-mixed concrete residues cover the pavement, and exposed to all environmental conditions.
