*Resource Conservation and Recovery Act (RCRA) Compliance Evaluation Inspection (CEI)*  
*Quality Electroplating Corp.*  
 PRD090592544

*Resource Conservation and Recovery Act (RCRA)*  
 Compliance Evaluation Inspection (CEI)

<b>Facility Name:</b>		<b>Quality Electroplating Corp.</b>					
<b>EPA ID Number:</b>		<b>PRD090592544</b>					
<b>Completion Date:</b>		<b>March 30, 2023</b>					
Generator Status in Record:		Large Quantity Generator					
RCRA Permitted:		No					
Corrective Action:		No					
Project ID		CEPD-RCRA-08-0090					
Basis for Inspection:		Core Program (Conducted during the COVID-19 pandemic timeframe.)					
<b>Facility Personnel:</b>							
Name:	Title:	Email:	Phone:	Attend to:			
				OM <sup>1</sup>	FW <sup>2</sup>	DR <sup>3</sup>	CM <sup>4</sup>
Ms. Jeannette Miranda	ES <sup>5</sup> Manager	<a href="mailto:jeannettemirandapr@hotmail.com">jeannettemirandapr@hotmail.com</a>	787-743-0825	√	√	√	√
<b>EPA Personnel:</b>							
Inspector's Name		EPA Region 2-CEPD	Enforcement Officer	phone/email			
Ms. Rosana Caballer-Cruz		EPA Region 2-CEPD	Enforcement Officer	787-977-5880/ <a href="mailto:caballer.rosana@epa.gov">caballer.rosana@epa.gov</a>

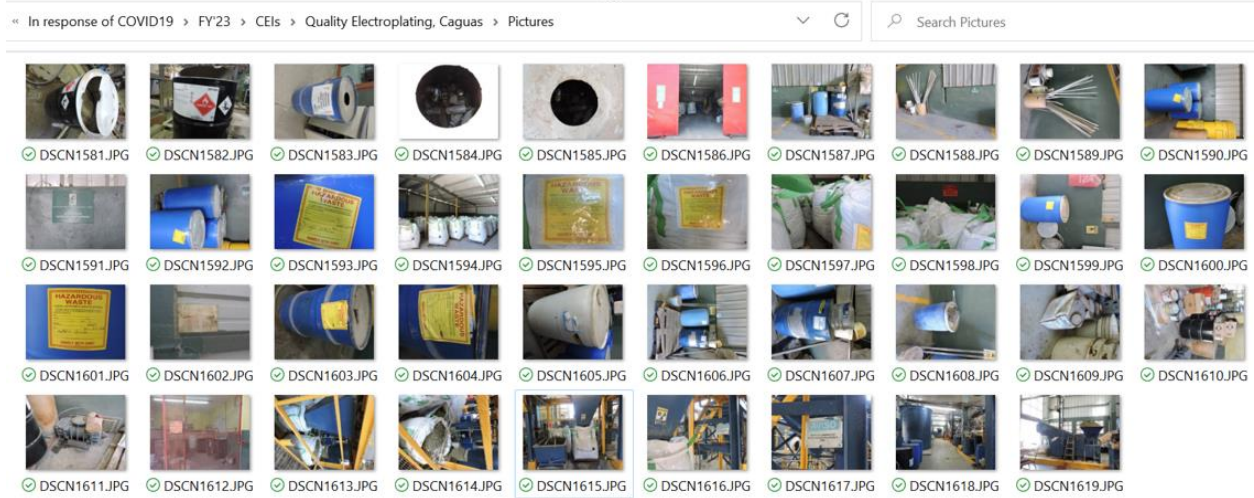
Here, one (1) 55-gallon steel container was observed with a flammable liquid label (Picture #1). I asked Ms. Miranda about this container since, at the time of the inspection, it was being used to store sand in order to dry the pieces already manufactured. As a result, I asked her how this sand is handled and disposed of and if any hazardous waste determination has been made. She replied that, by knowledge, they have determined that the content in this container was not hazardous waste, and they dispose of the latter as regular waste. Also, she told me that this was not the correct container to store the sand and requested one of her employees to change the container.

Picture 1 — Tin Subarea— Here, one (1) 55-gallon steel container was observed with a flammable liquid label. This container was being used to stored sand in order to dry the pieces already manufactured.
