## Region 6 - Enforcement & Compliance Assurance Division

### INSPECTION REPORT

| Company Name: | <b>Citation Oil and Gas Corporation</b> | |
| Facility Name: | <b>Bayou Unit</b> | |

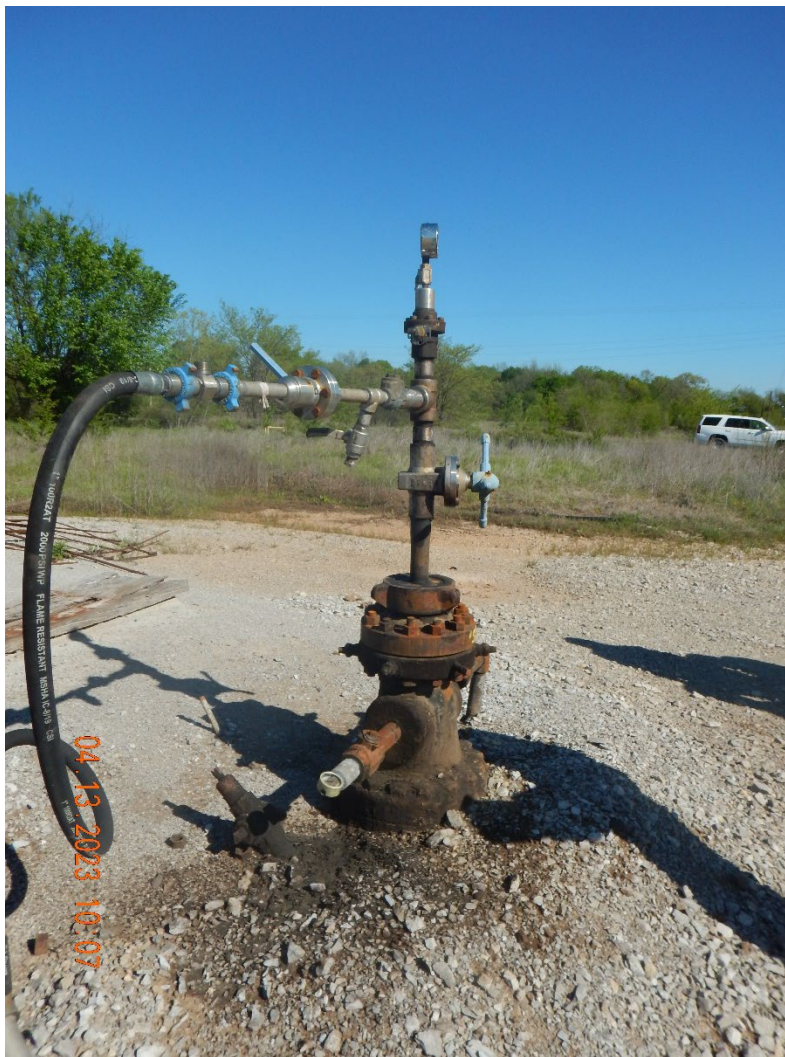
**Photo File Name:** DSCN4763.JPG

**Description:** This was the injection well Bayou Unit #59 at the time of the inspection. the time of the inspection this well was considered an active injection well and was hooked up for injection activities. Some oil staining was present around this well during the inspection.

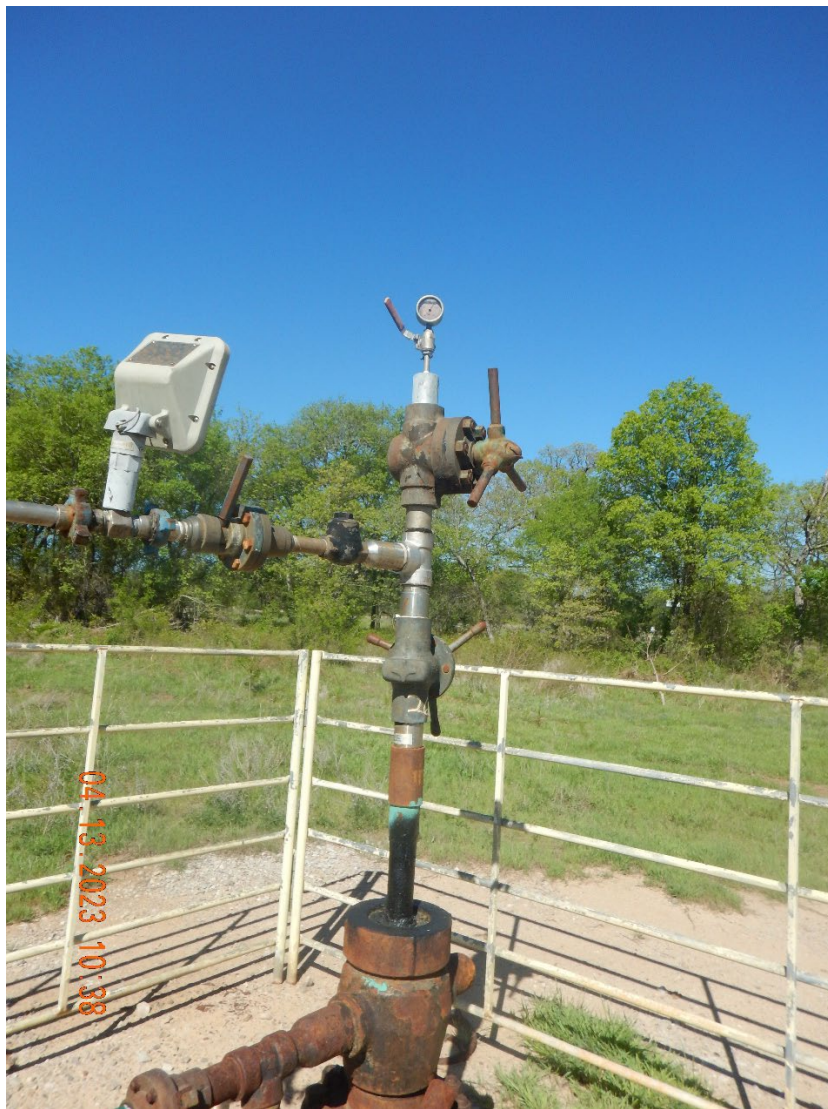
**Photo File Name:** DSCN4775.JPG

**Description:** This was the injection well Bayou Unit #26 at the time of the inspection. This well is near well #27, seen in Photo Nos. 13-15. This photo shows the hooked up injection well during the inspection with some oil staining around the well. The tubing had a gauge (company) on this well, but this photo doesn't clearly show the gauge reading at the time of the inspection.

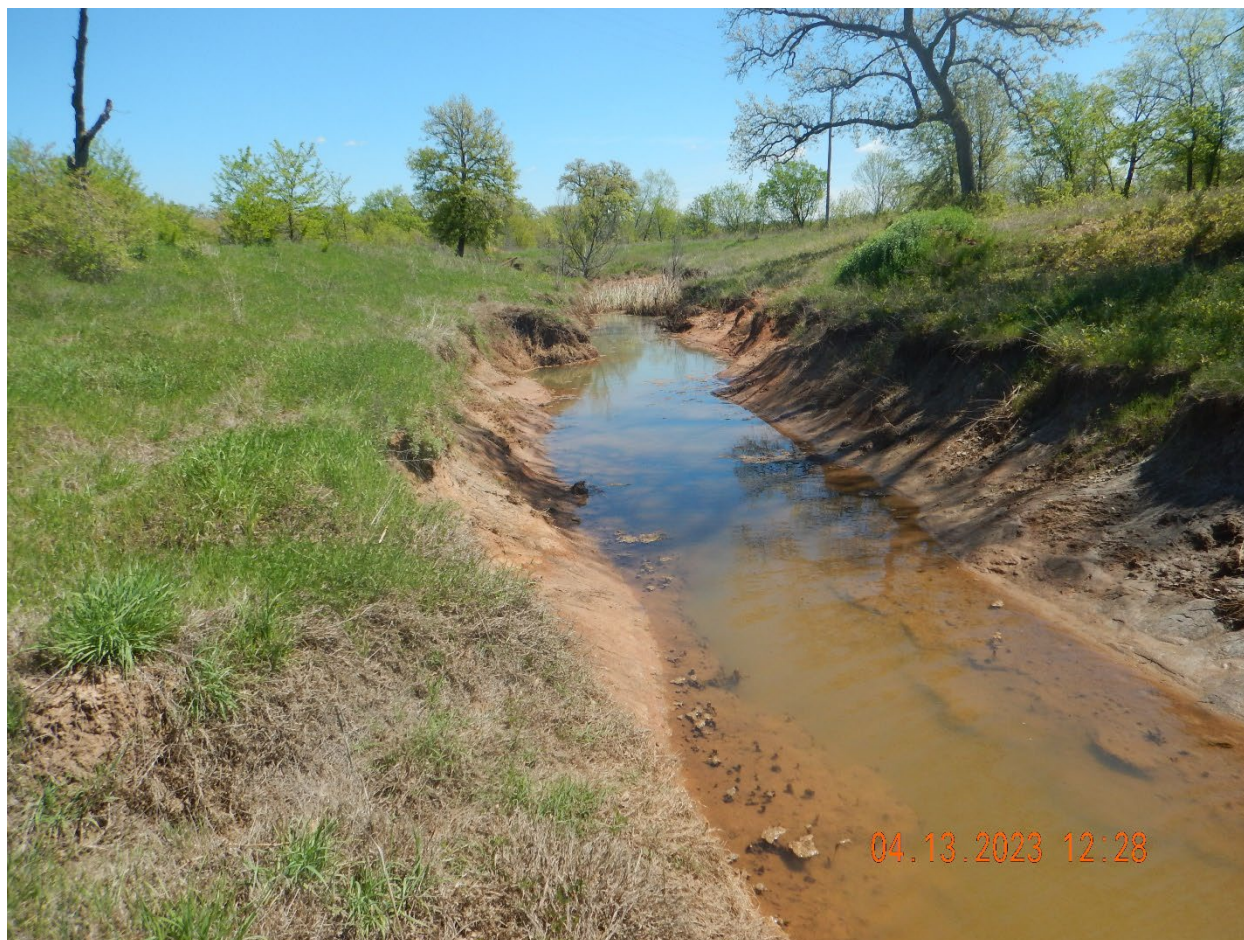
**Photo File Name:** DSCN4819.JPG

**Description:** This photo showed the tributary location during the inspection approximately 1000 feet downstream from the pond seen in Photo No. 22 of this Appendix. There was some slight black discoloration observed along the banks of the tributary during the inspection, seen towards the bottom right of this photo.

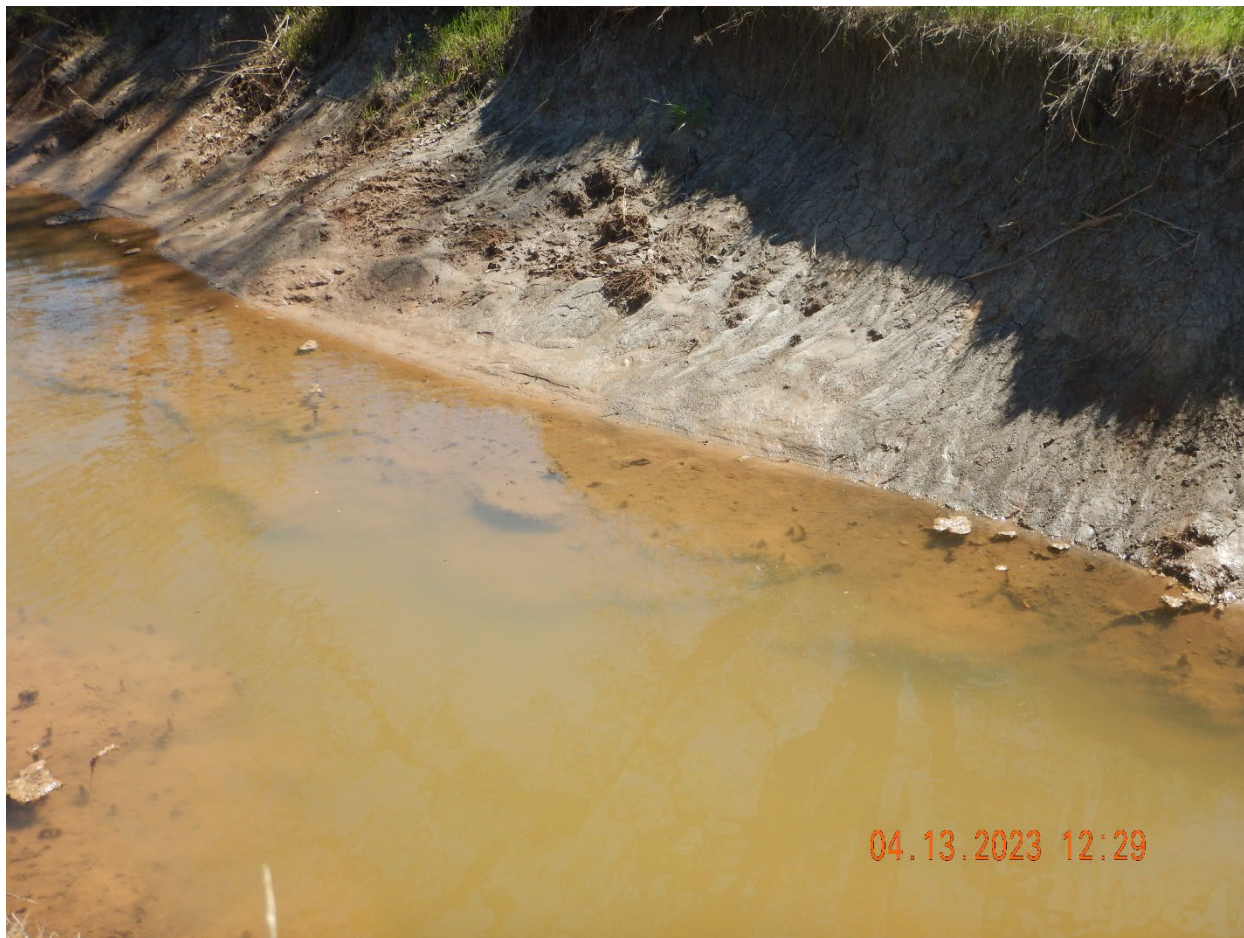
**Photo File Name:** DSCN4820.JPG

**Description:** This photo showed the tributary location during the inspection approximately 1000 feet downstream from the pond seen in Photo No. 22 of this Appendix. There was some slight black discoloration observed along the banks of the tributary during the inspection, seen along the eastern bank of the tributary at this location.

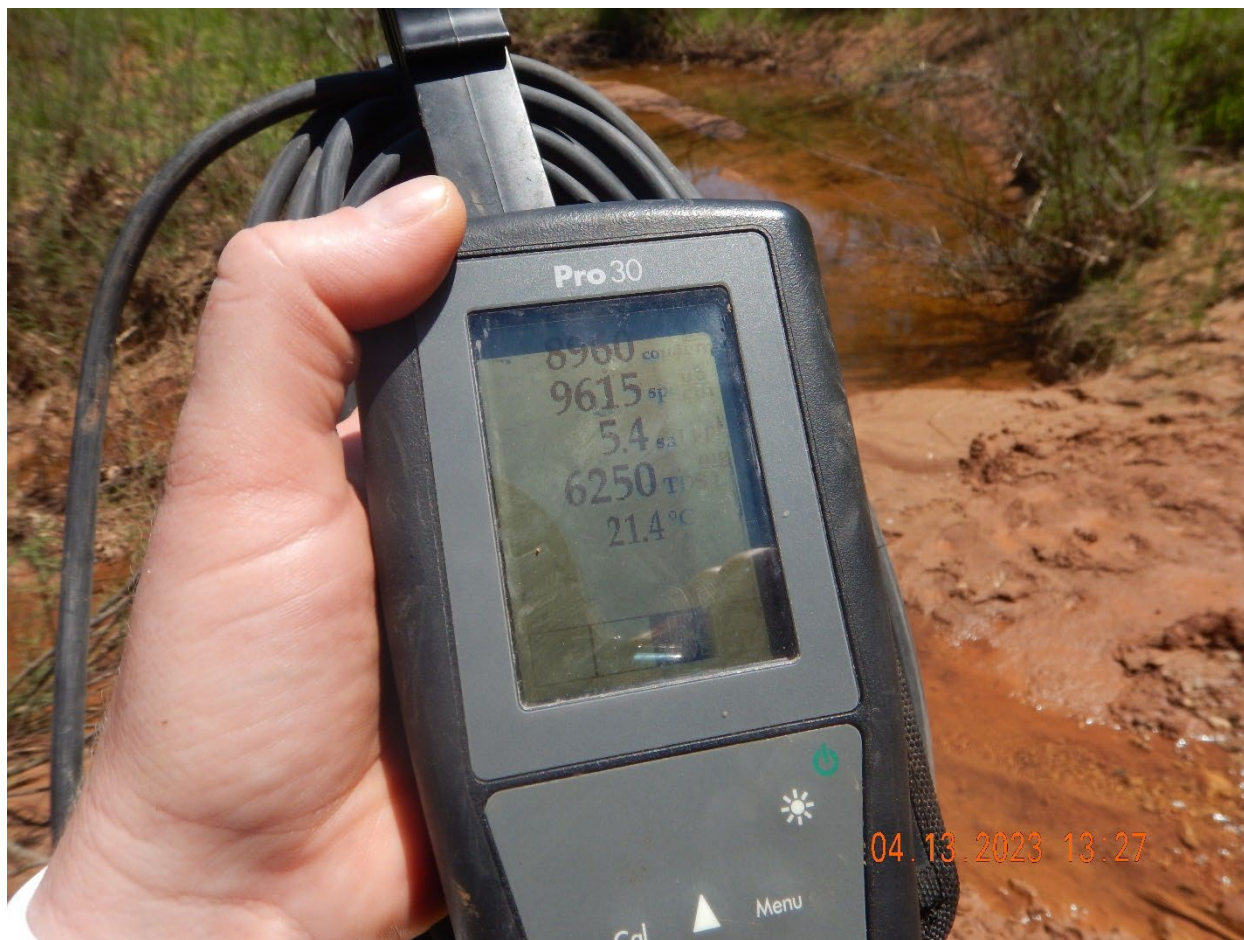
**Photo File Name:** DSCN4863.JPG

**Description:** This photo showed a downstream view of the tributary approximately ½ mile downstream from the pond shown in Photo No. 22. A TDS reading 6,250 mg/L was taken at this location. This is referred to by the state representatives on site as the "beaver slide" location in this tributary. I observed minnows and perch at this location in the tributary.

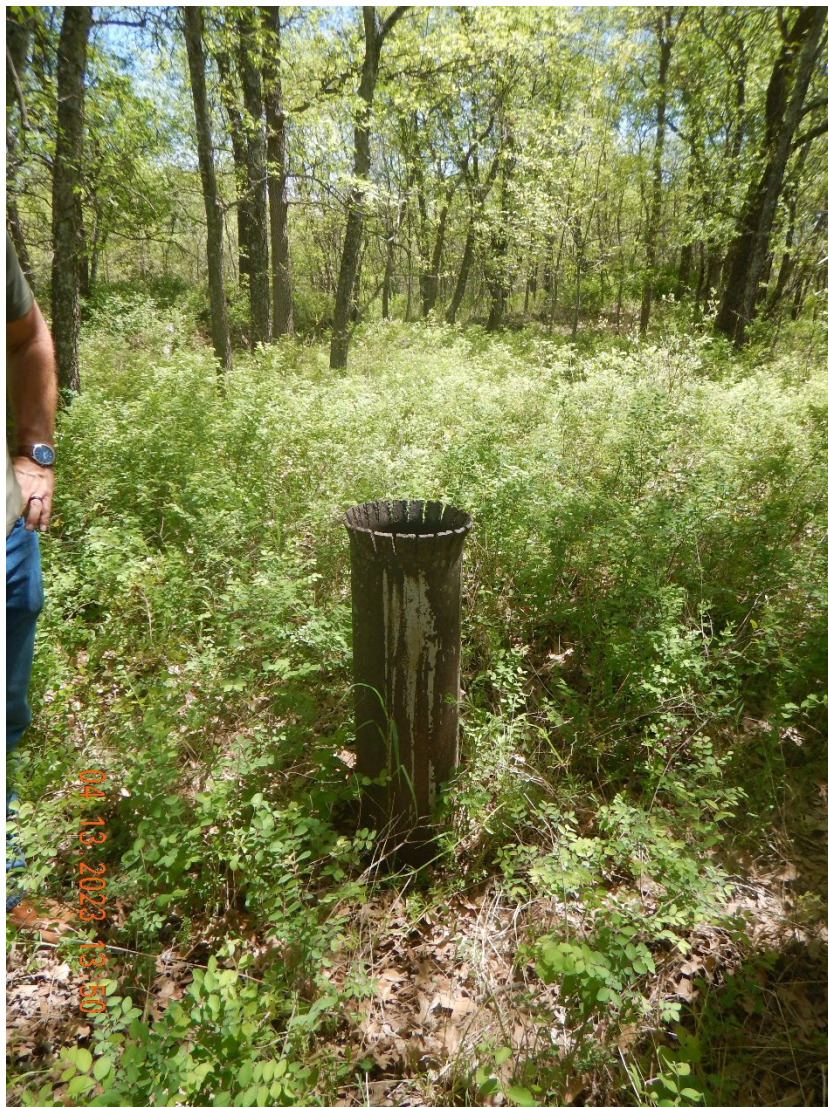
**Photo File Name:** DSCN4868.JPG

**Description:** This photo shows an abandoned well found near the tributary we were surveying during the inspection. The well appeared to be open to atmosphere.

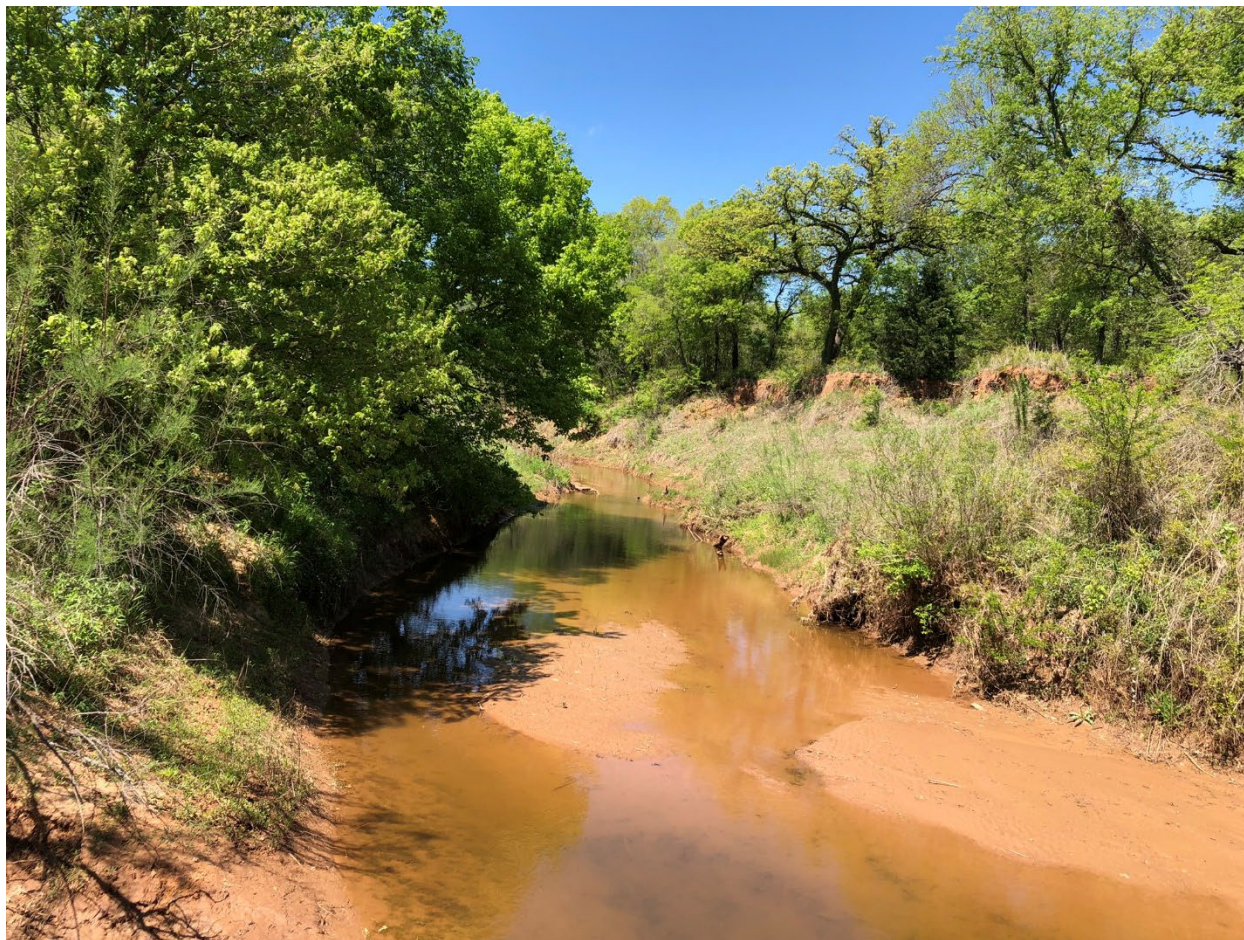
**Photo File Name:** IMG\_2315.JPEG

**Description:** This photo shows an upstream view of Walnut Creek during the inspection, downstream from the confluence of the tributary observed in Photo Nos. 22 – 61 of this Appendix. Walnut Creek had ordinary high water mark, bed features, bank features, and riparian vegetation at this location.

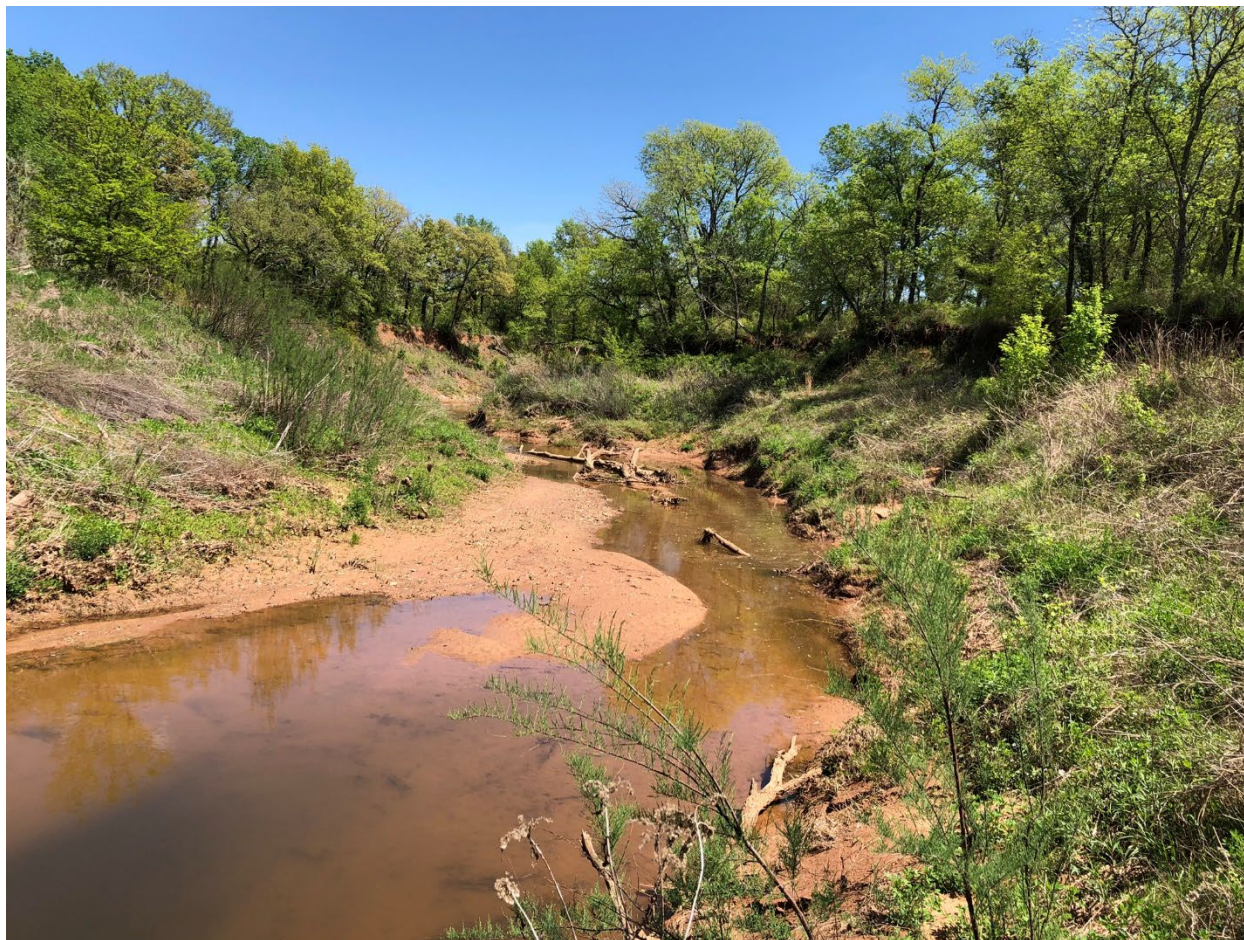
**Photo File Name:** IMG\_2314.JPEG

**Description:** This photo shows a downstream view of Walnut Creek during the inspection, downstream from the confluence of the tributary observed in Photo Nos. 22 – 61 of this Appendix. Walnut Creek had ordinary high water mark, bed features, bank features, and riparian vegetation at this location.

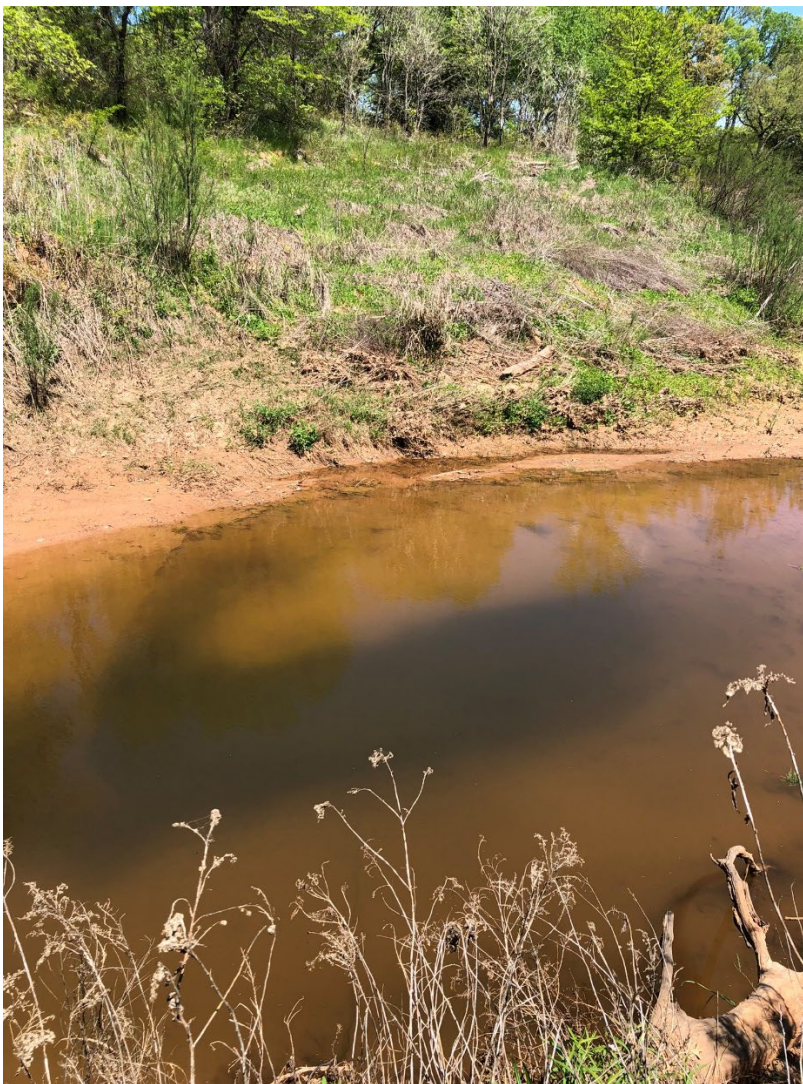
**Photo File Name:** IMG\_2316.JPEG

**Description:** This photo shows a view of Walnut Creek from one side to the other bank side during the inspection, downstream from the confluence of the tributary observed in Photo Nos. 22 – 61 of this Appendix. Walnut Creek had ordinary high water mark, bed features, bank features, and riparian vegetation at this location. The water in this location was discolored in comparison to the rest of the creek and looked darker and black.

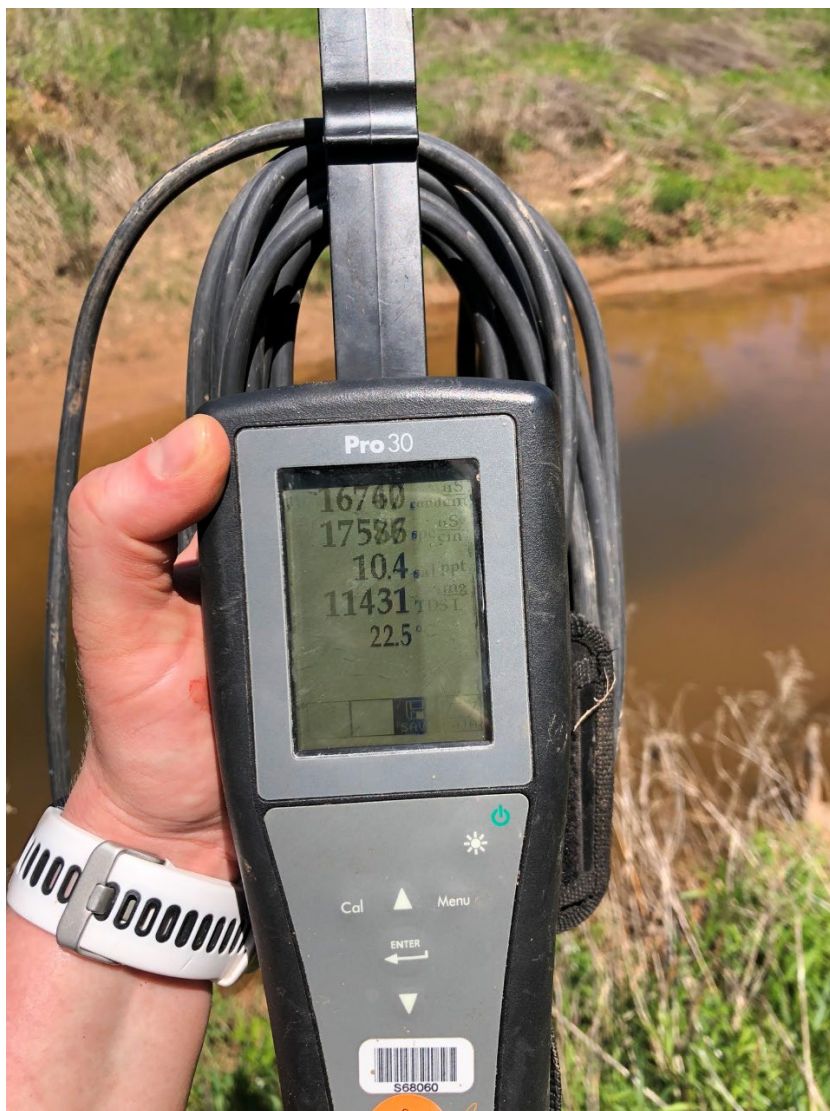
**Photo File Name:** IMG\_2317.JPEG

**Description:** This photo shows a view of Walnut Creek during the inspection, downstream from the confluence of the tributary observed in Photo Nos. 22 – 61 of this Appendix. An elevated TDS reading of 11,431 mg/L was taken at this location during the inspection.

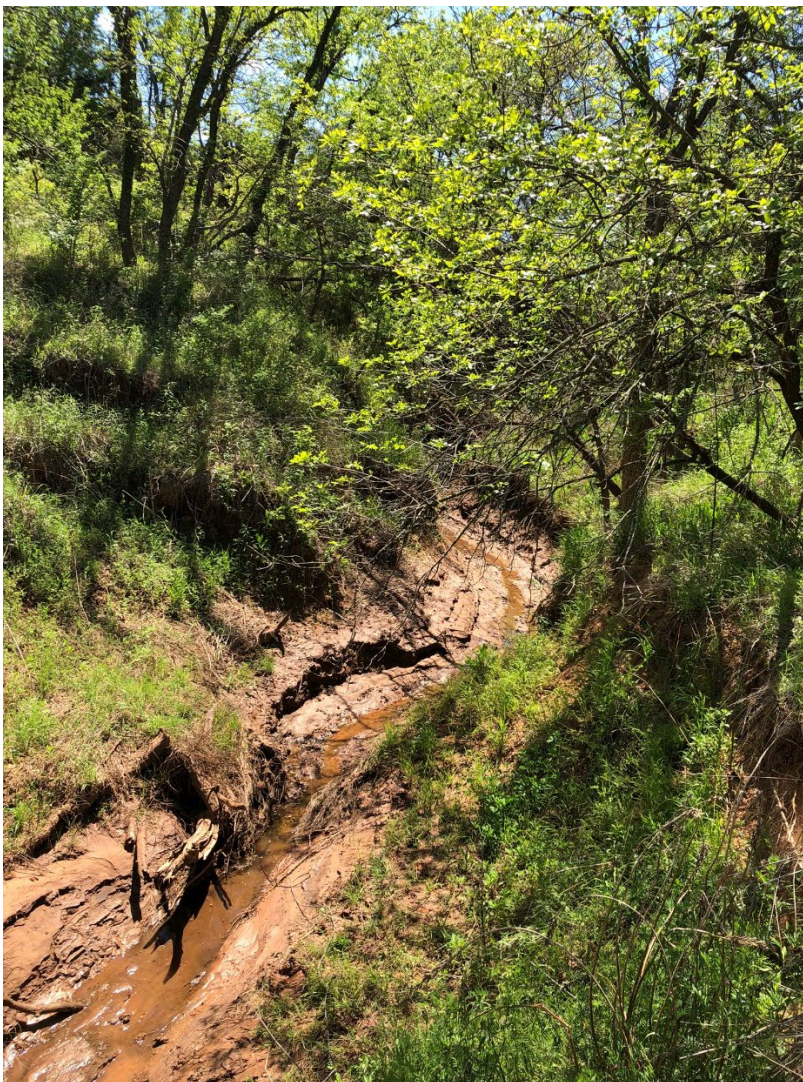
**Photo File Name:** IMG\_2325.JPEG

**Description:** This photo shows an upstream view of a second tributary that we surveyed during the inspection. Walnut Creek during the inspection, downstream from the confluence of the first tributary observed throughout the inspection and Walnut Creek. Bed tributary features, bank features, and riparian vegetation were observed at this location. This location is downstream from the 3 acre area of concern (GPS: 34.165328, -97.360706).

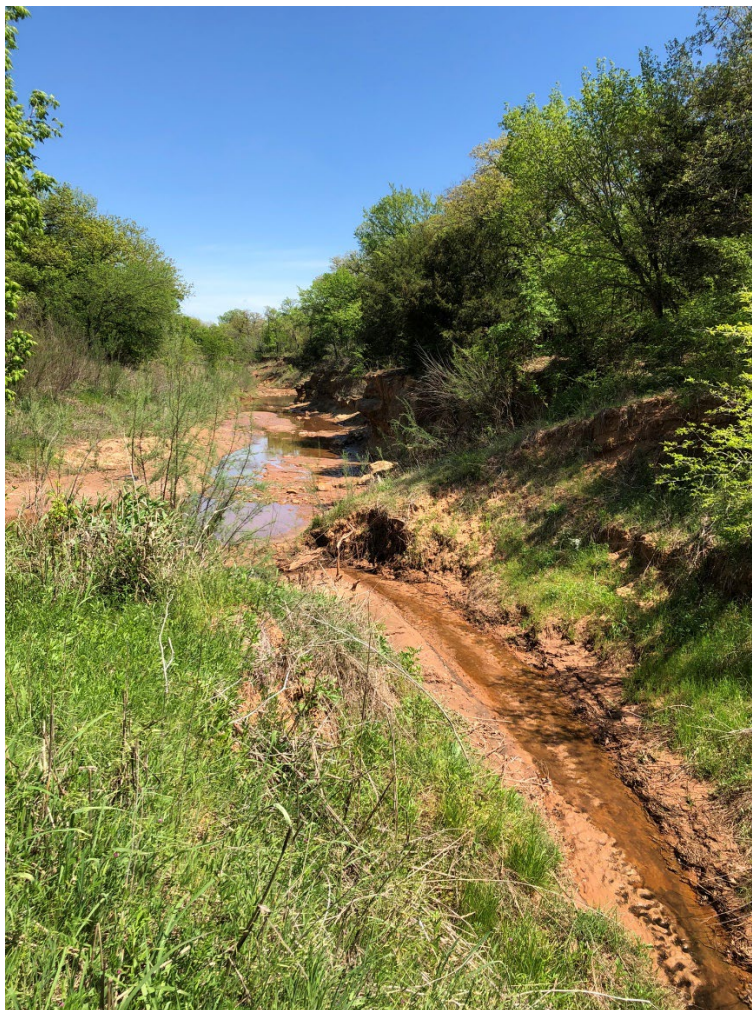
**Photo File Name:** IMG\_2325.JPEG

**Description:** This photo shows a downstream view of a second tributary that we surveyed near its confluence with Walnut Creek during the inspection, downstream from the confluence of the first tributary observed throughout the inspection and Walnut Creek. Bed tributary features, bank features, and riparian vegetation were observed at this location. This location is downstream from the 3 acre area of concern (GPS: 34.165328, -97.360706). The confluence of the second tributary and Walnut Creek were observed here.

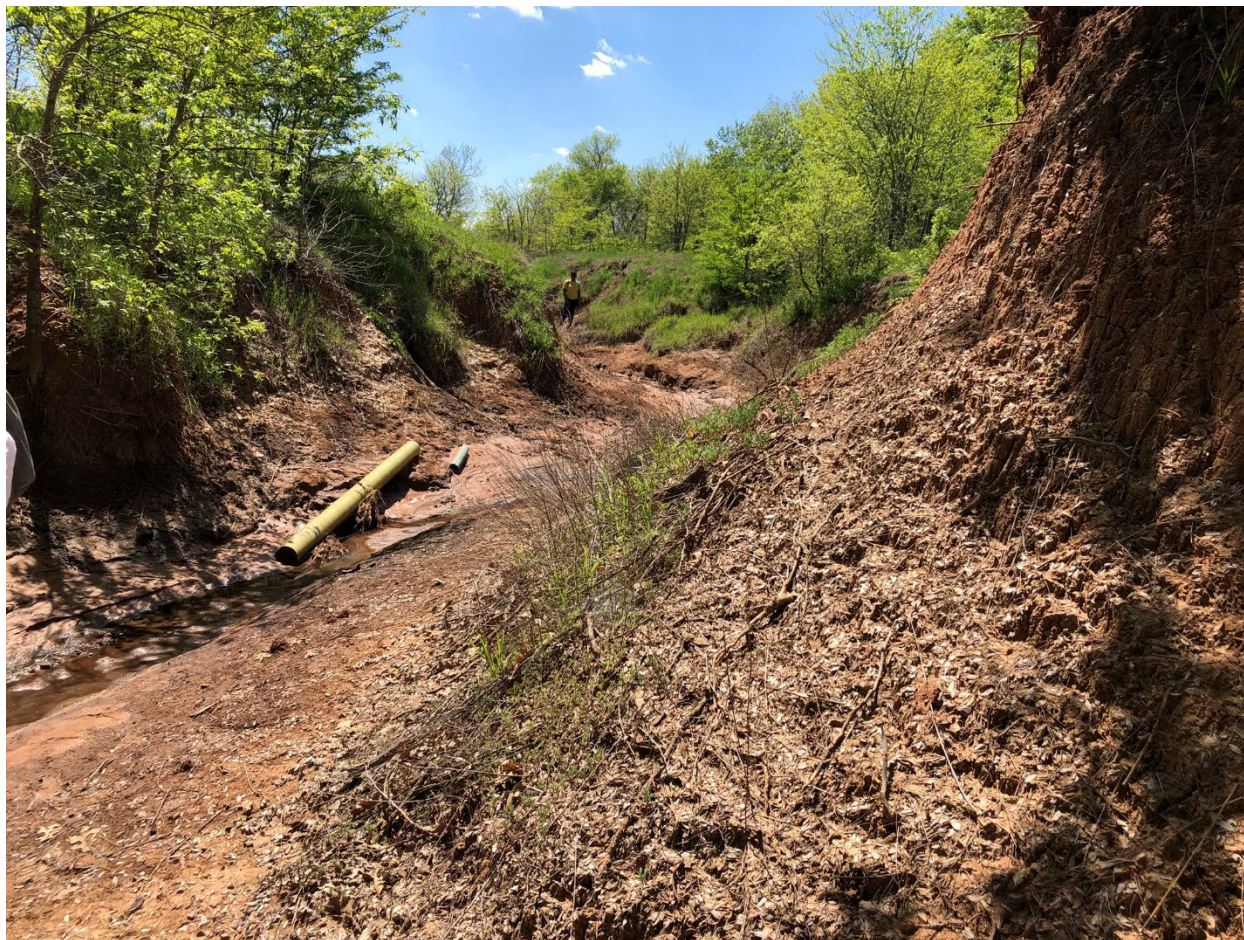
**Photo File Name:** IMG\_2331.JPEG

**Description:** This photo shows an upstream view of a second tributary that we surveyed during the inspection. This location is downstream from the 3 acre area of concern (GPS: 34.165328, -97.360706). Tributary features including bed, bank, and some flow were observed during the inspection.

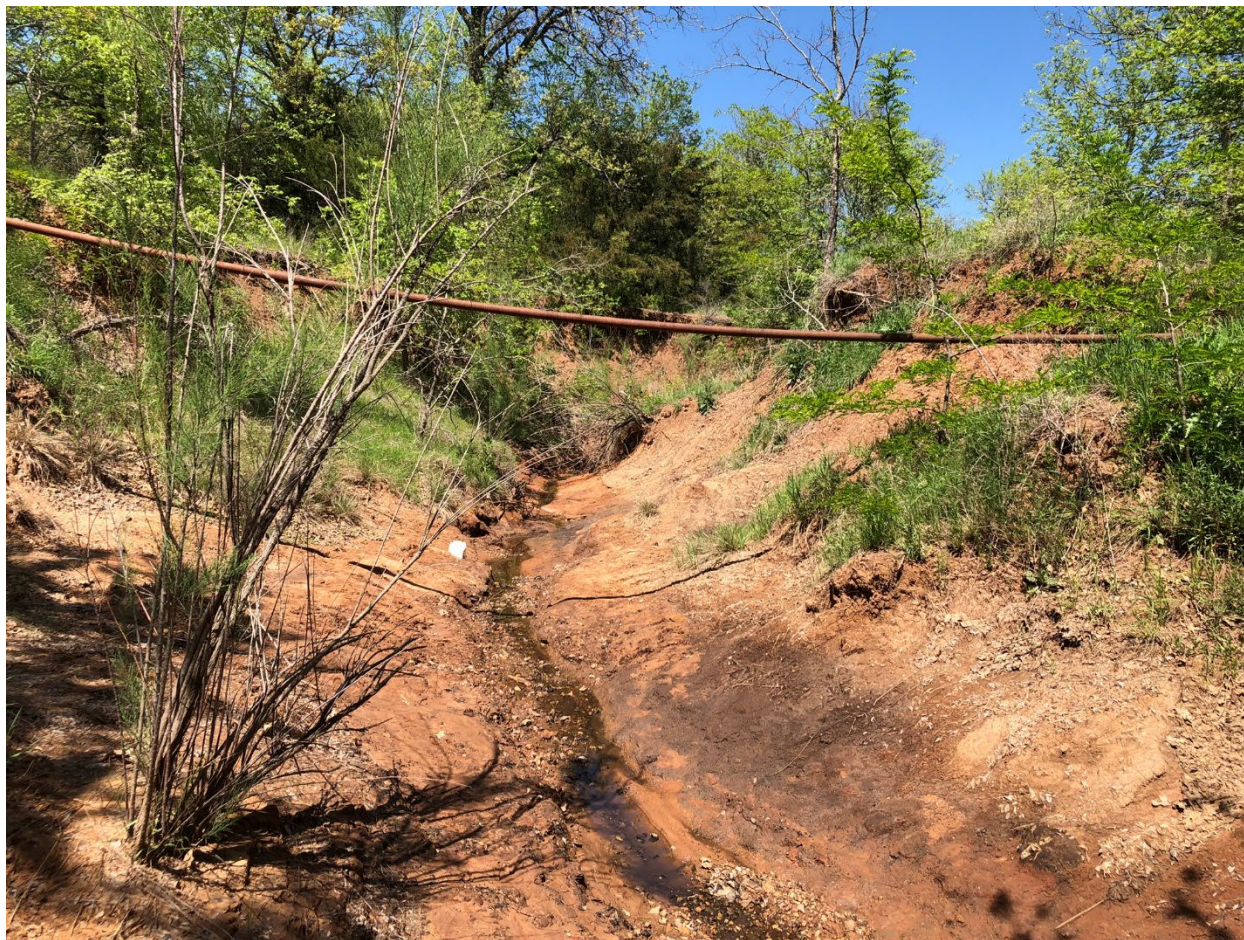
**Photo File Name:** IMG\_2329.JPEG

**Description:** This photo shows a downstream view of a second tributary that we surveyed during the inspection. This location is downstream from the 3 acre area of concern (GPS: 34.165328, -97.360706). Tributary features including bed, bank, and some flow were observed during the inspection.

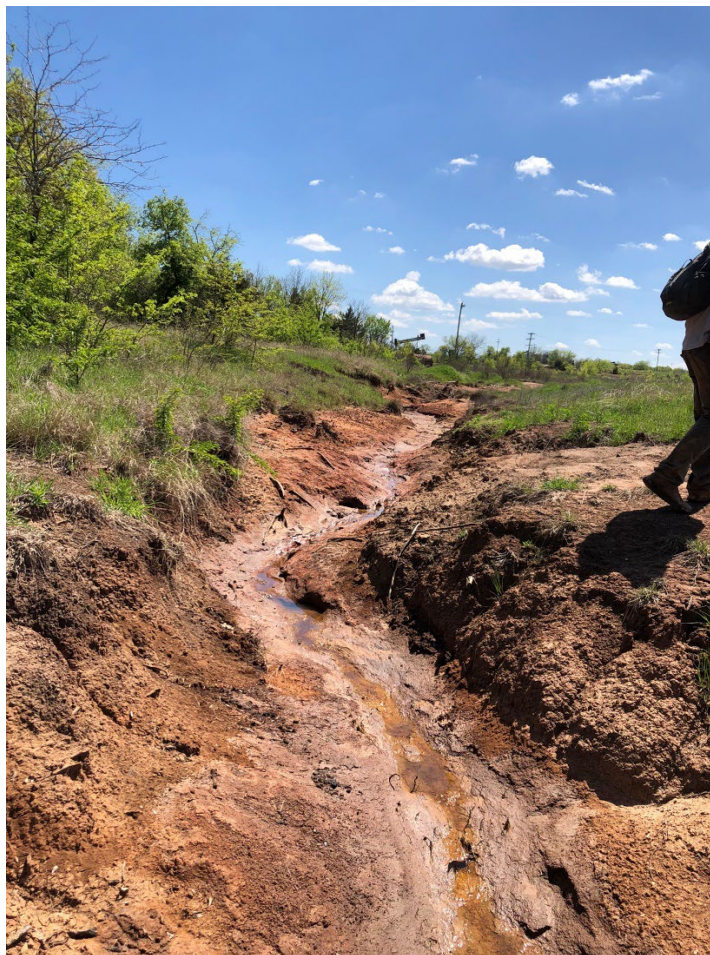
**Photo File Name:** IMG\_2341.JPEG

**Description:** This photo shows an upstream view of the second tributary that we surveyed during the inspection. This location is downstream from the 3 acre area of concern (GPS: 34.165328, -97.360706). The tributary at this location had some bed and bank features that we observed. Additionally, more prolific surface erosion and potential contamination was apparent in this area. Approximately 3 acres of degraded surface was observed in this area. Soil discoloration, including black soil along the entire tributary were observed. This was in an area with both potentially active and historical contamination without proper remediation from historical brine (produced water) and oil field fluids.

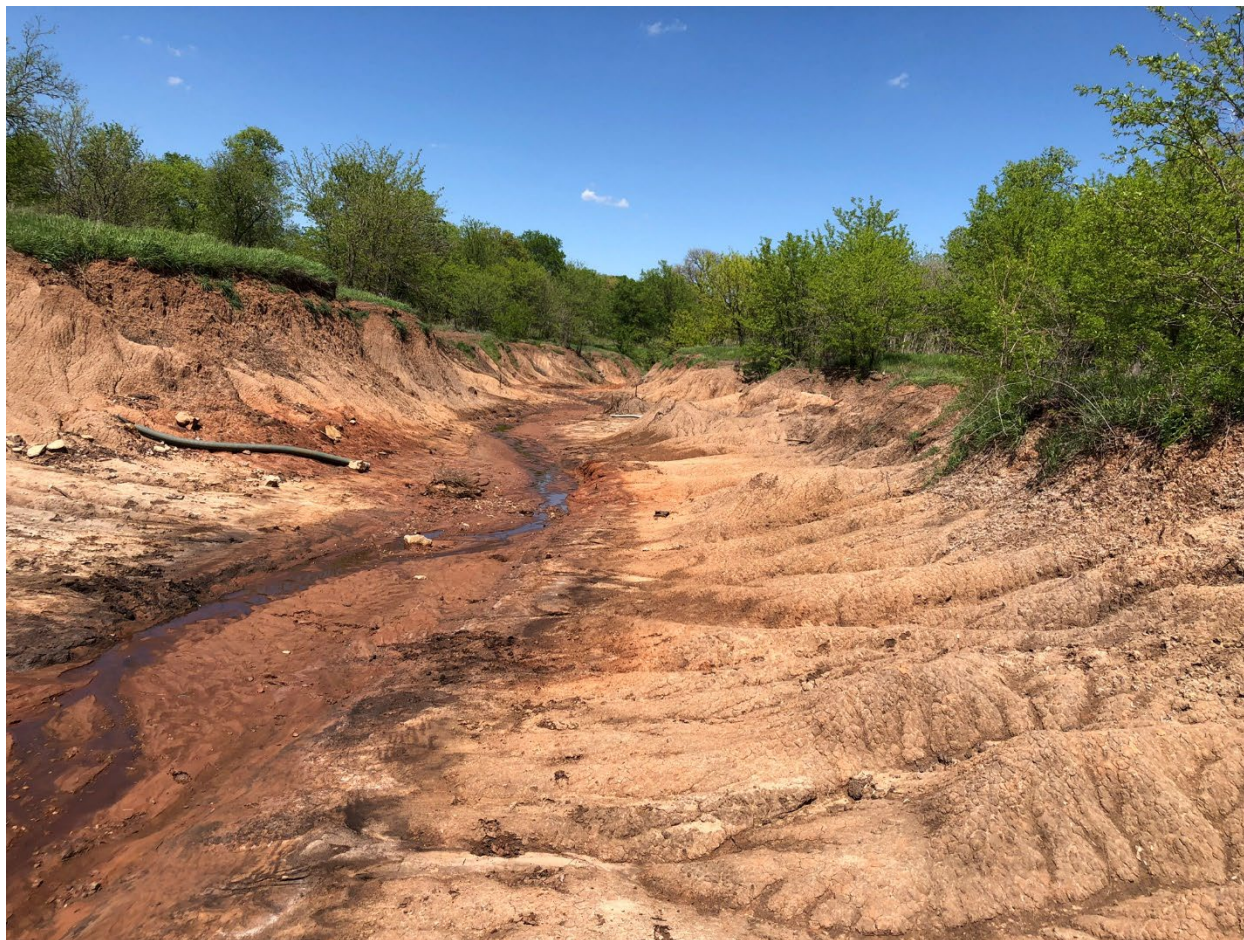
**Photo File Name:** IMG\_2340.JPEG

**Description:** This photo shows a downstream view of the second tributary that we surveyed during the inspection. This location is downstream from the 3 acre area of concern (GPS: 34.165328, -97.360706). The tributary at this location had some bed and bank features that we observed. Additionally, more prolific surface erosion and potential contamination was apparent in this area. Approximately 3 acres of degraded surface was observed in this area. Soil discoloration, including black soil along the entire tributary were observed. This was in an area with both potentially active and historical contamination without proper remediation from historical brine (produced water) and oil field fluids.

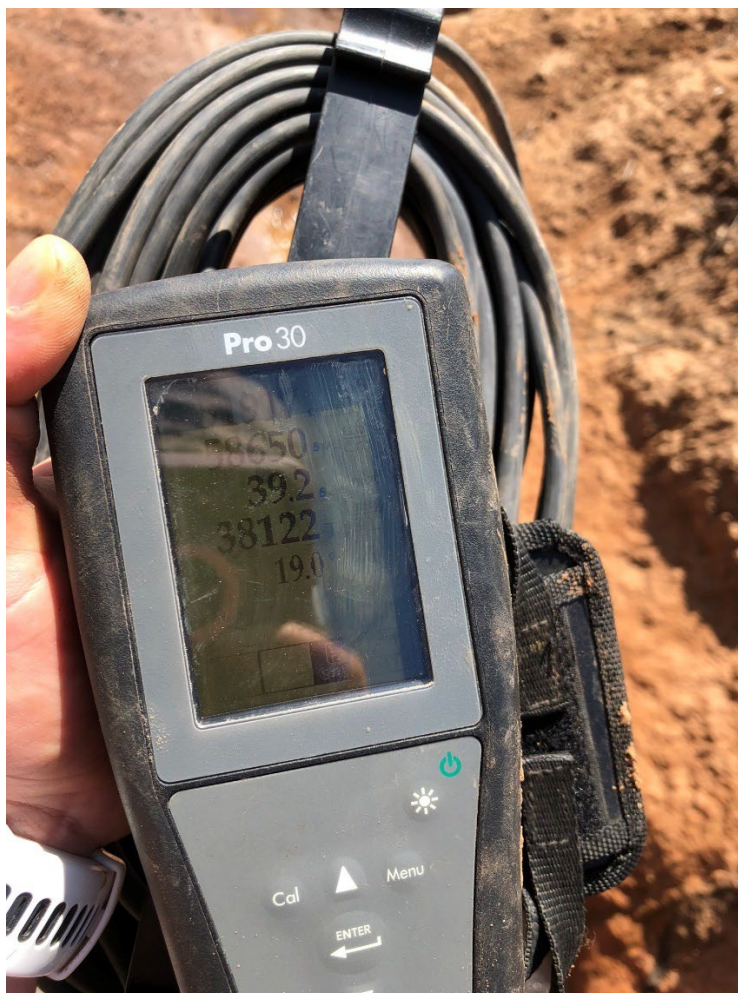
**Photo File Name:** IMG\_2343.JPEG

**Description:** This photo shows a second tributary that we surveyed during the inspection. This location is downstream from the 3 acre area of concern (GPS: 34.165328, -97.360706). The tributary at this location had some bed and bank features that we observed. Additionally, more prolific surface erosion and potential contamination was apparent in this area. Approximately 3 acres of degraded surface was observed in this area. An elevated TDS reading of 38,122 mg/L was taken here. This was in an area with both potentially active and historical contamination without proper remediation from historical brine (produced water) and oil field fluids.

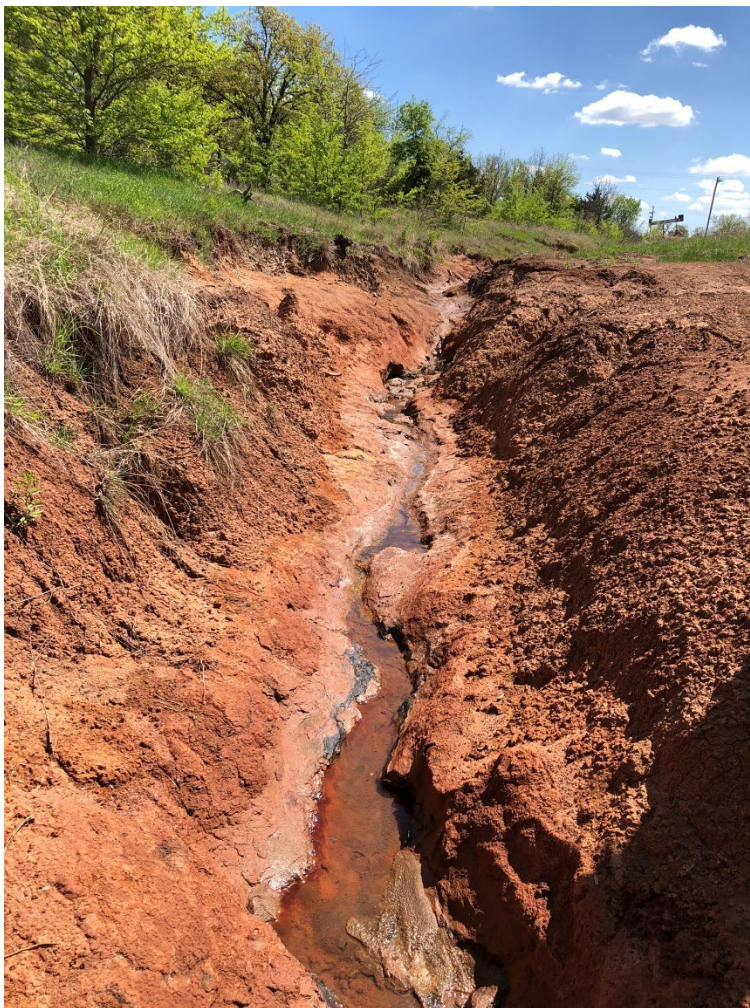
**Photo File Name:** IMG\_2345.JPEG

**Description:** This photo shows a downstream view of the second tributary that we surveyed during the inspection. This location is downstream from the 3 acre area of concern (GPS: 34.165328, -97.360706). The tributary at this location had some bed and bank features that we observed. Additionally, more prolific surface erosion and potential contamination was apparent in this area. Approximately 3 acres of degraded surface was observed in this area. Soil discoloration, including black soil along the entire tributary were observed. This was in an area with both potentially active and historical contamination without proper remediation from historical brine (produced water) and oil field fluids.

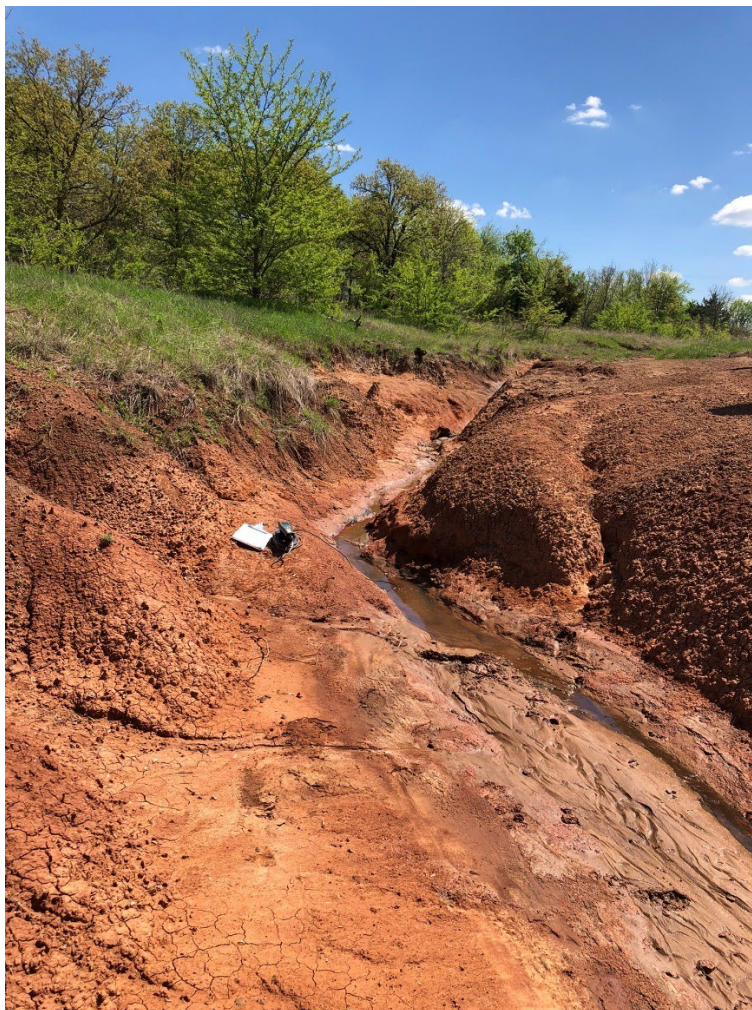
**Photo File Name:** IMG\_2347.JPEG

**Description:** This photo shows an downstream view of the second tributary that we surveyed during the inspection. This location is downstream from the 3 acre area of concern (GPS: 34.165328, -97.360706). The tributary at this location had some bed and bank features that we observed. Additionally, more prolific surface erosion and potential contamination was apparent in this area. Approximately 3 acres of degraded surface was observed in this area. Soil discoloration, including black soil along the entire tributary were observed. This was in an area with both potentially active and historical contamination without proper remediation from historical brine (produced water) and oil field fluids.

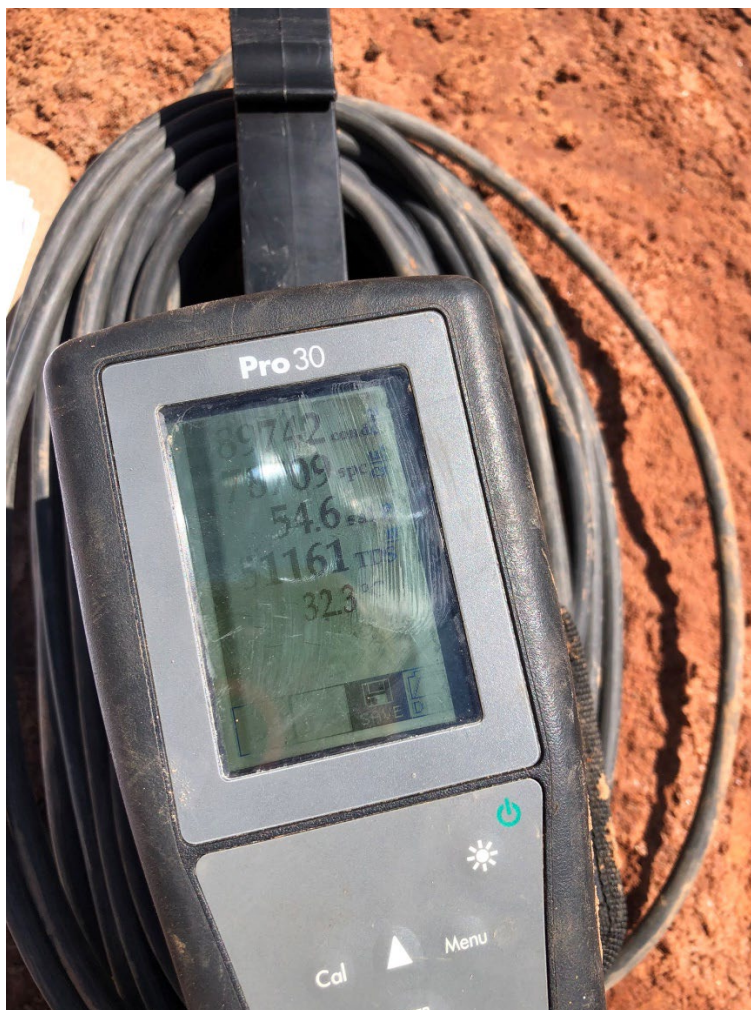
**Photo File Name:** IMG\_2346.JPEG

**Description:** This photo shows a downstream view of the second tributary that we surveyed during the inspection. This location is downstream from the 3 acre area of concern (GPS: 34.165328, -97.360706). An elevated TDS reading of 51,161 mg/L was taken. Additionally, more prolific surface erosion and potential contamination was apparent in this area. Approximately 3 acres of degraded surface was observed in this area. Soil discoloration, including black soil along the entire tributary were observed. This was in an area with both potentially active and historical contamination without proper remediation from historical brine (produced water) and oil field fluids.
