## Region 6 - Enforcement & Compliance Assurance Division

### INSPECTION REPORT

| Company Name: | <b>Citation Oil and Gas Corporation</b> | |
| Facility Name: | <b>Bayou Unit</b> | |

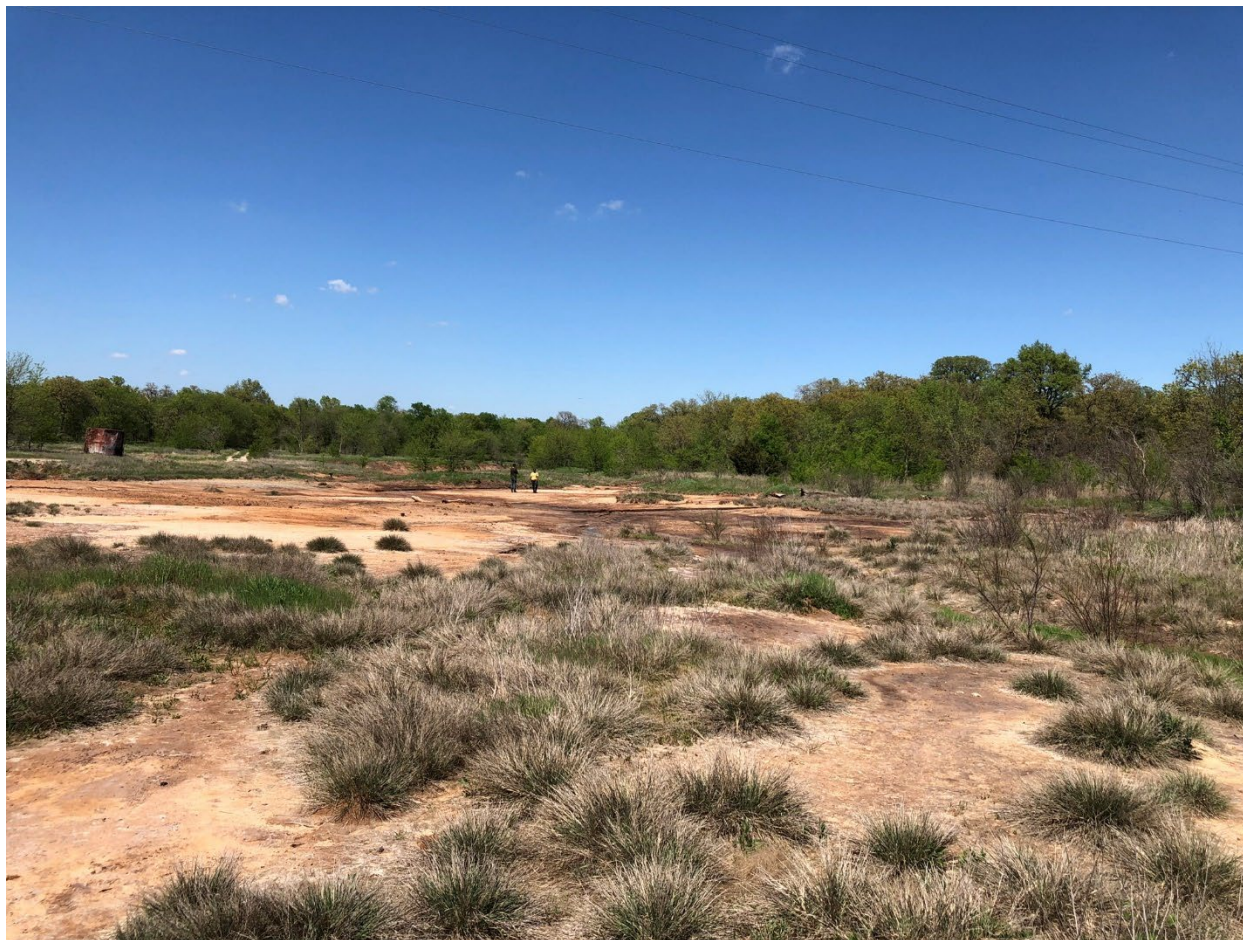
**Photo File Name:** IMG\_2355.JPEG

**Description:** This photo shows a downstream view of the second tributary that we surveyed during the inspection. This location was in the 3 acre area of concern (GPS: 34.165328, -97.360706). Additionally, more prolific surface erosion and potential contamination was apparent in this area as observed in this photo. Approximately 3 acres of degraded surface was observed in this area. Soil discoloration, including black soil along the entire tributary were observed. Patches of grass were observed. This was in an area with both potentially active and historical contamination without proper remediation from historical brine (produced water) and oil field fluids.

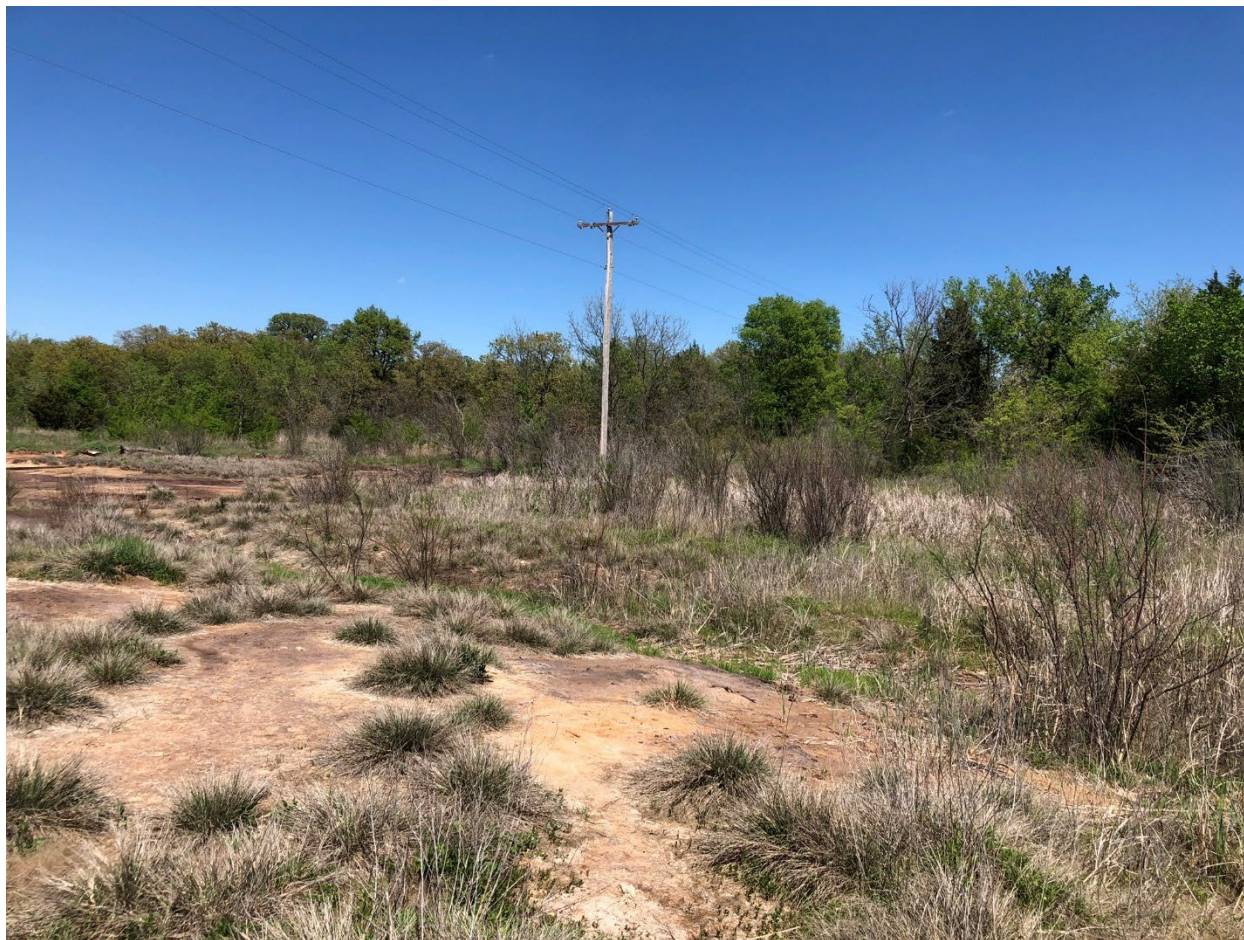
**Photo File Name:** IMG\_2356.JPEG

**Description:** This photo shows a downstream view of the second tributary that we surveyed during the inspection. This location was in the 3 acre area of concern (GPS: 34.165328, -97.360706). Additionally, more prolific surface erosion and potential contamination was apparent in this area as observed in this photo. Approximately 3 acres of degraded surface was observed in this area. Soil discoloration, including black soil along the entire tributary were observed. Patches of grass and cattails were observed. This was in an area with both potentially active and historical contamination without proper remediation from historical brine (produced water) and oil field fluids.

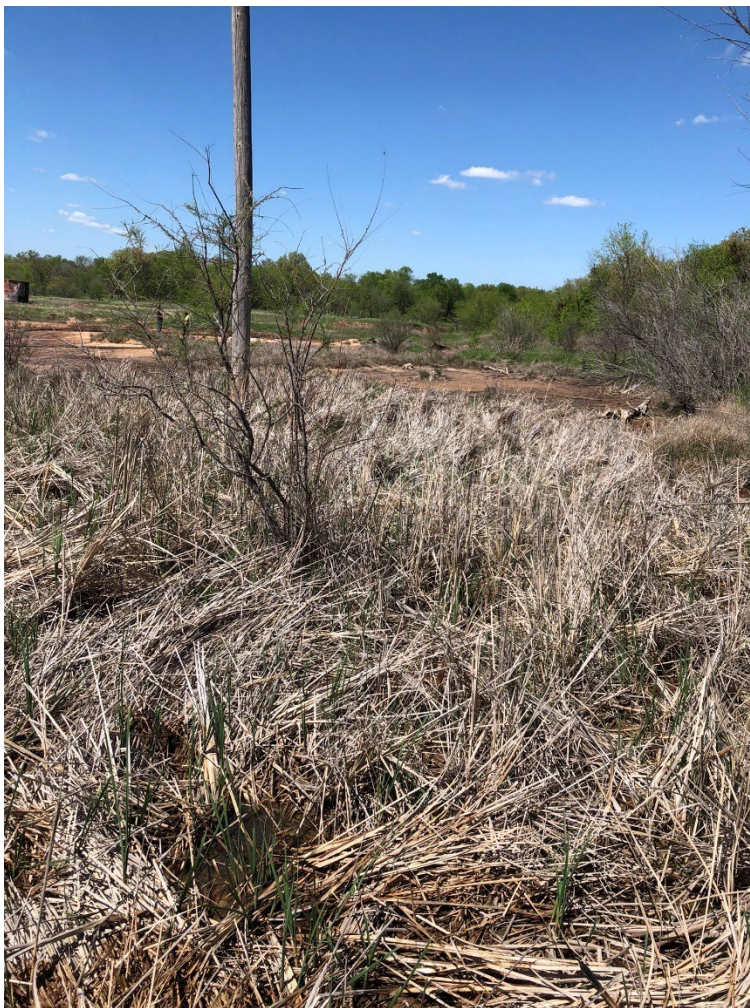
**Photo File Name:** IMG\_2353.JPEG

**Description:** This photo shows a downstream view of the second tributary that we surveyed during the inspection. This location was in the 3 acre area of concern (GPS: 34.165328, -97.360706). Additionally, more prolific surface erosion and potential contamination was apparent in this area as observed in this photo. This part of the area was marshy and had cattails. This was in an area with both potentially active and historical contamination without proper remediation from historical brine (produced water) and oil field fluids.
