**Region 6 - Enforcement & Compliance Assurance Division**  
**INSPECTION REPORT**

| Inspection Date(s): | 07/10/2024 | |
| Regulatory Program(s) | NPDES | |
| Facility Name: | <b>Cutter Treatment Plant Lateral (CTPL)</b> | |

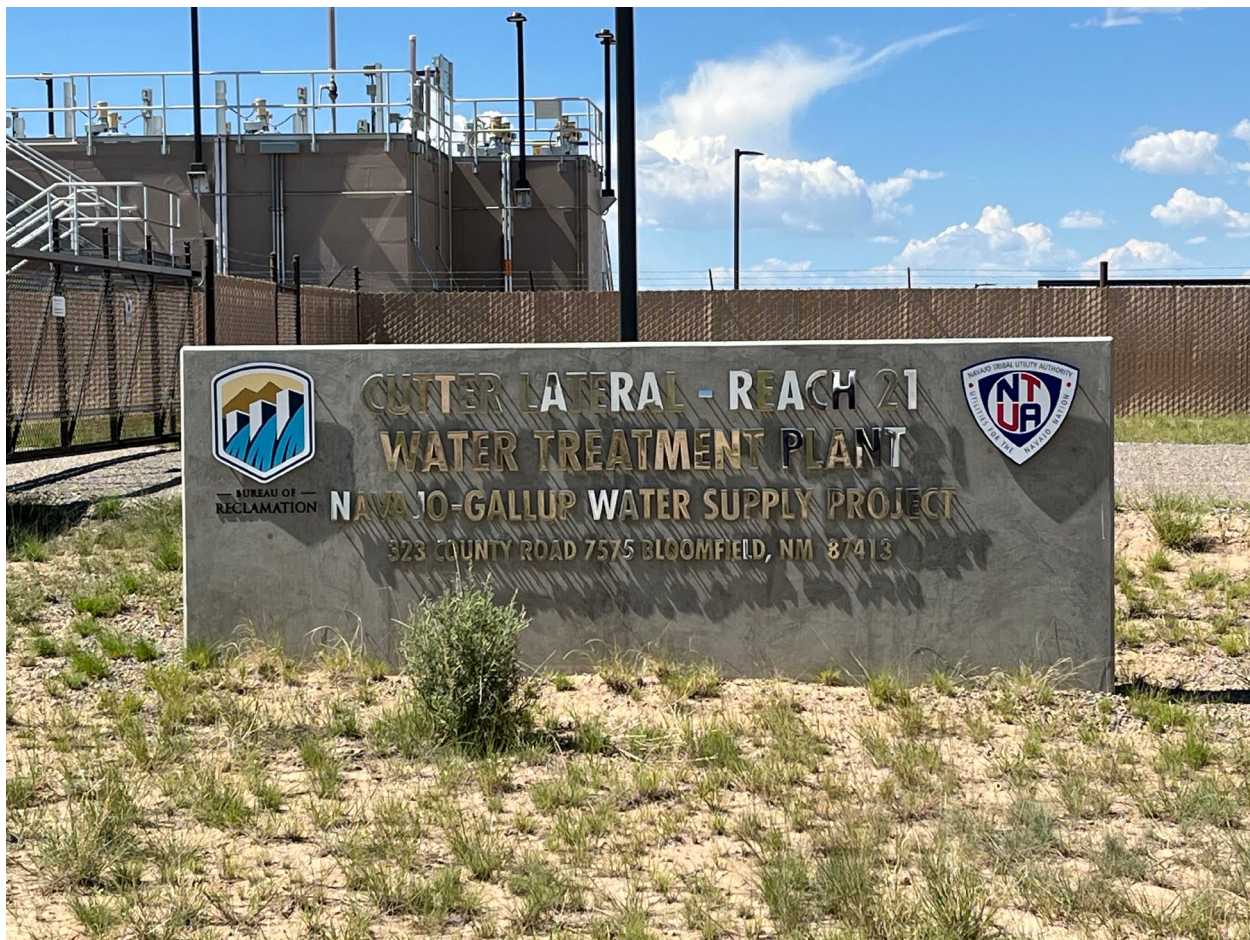
Photo No. 1

Entrance sign to Cutter Lateral Water Treatment Plant. (IMG\_0058) (July 10, 2024: 3:40 PM) Photographed by D. Esparza
