**Region 10 Enforcement and Compliance Assurance Division**  
**1200 6th Avenue**  
**Seattle, WA 98101**  
**INSPECTION REPORT**

| <b>Regulatory Program:</b> | CWA NPDES/Construction Stormwater | |
| <b>Site Name:</b> | Falcon Crest Subdivision | |

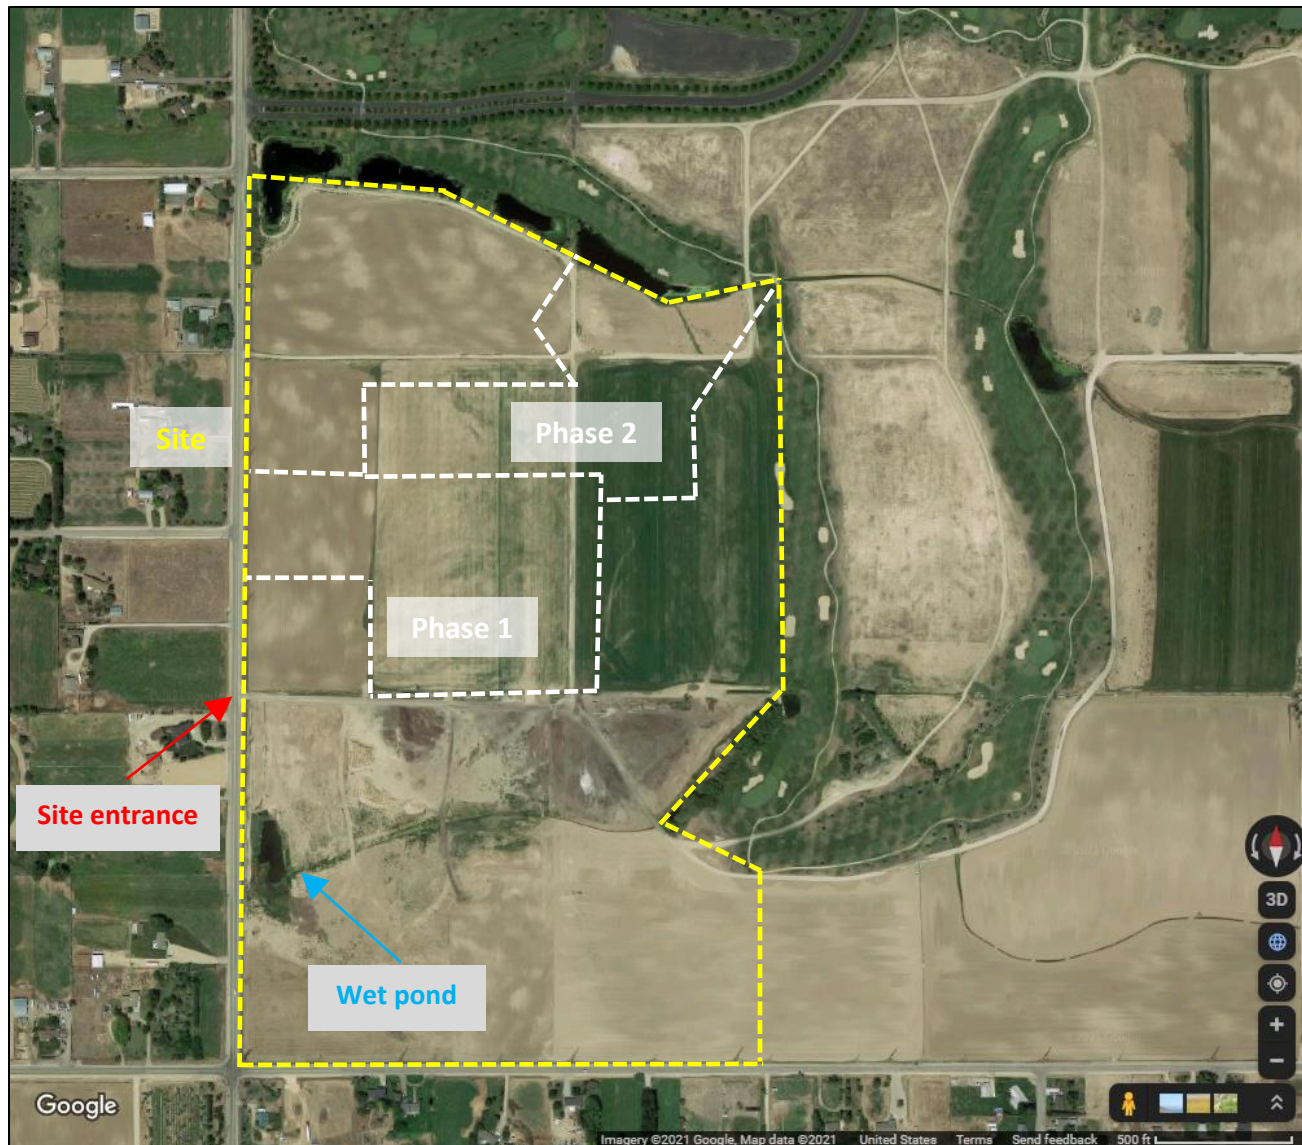
**Exhibit 1.** Google Earth Pro (imagery date: 3/30/2021). Location of Falcon Crest Subdivision in Meridian, Idaho. Note the approximate Site boundary outlined with the dotted yellow line and approximate phase perimeters outlined with the dotted white line.
