**U.S. Environmental Protection Agency  
Region 5**

**Purpose:** Clean Water Act National Pollutant Discharge Elimination System Compliance Evaluation Inspection

**Facility:** Cleveland-Cliffs Inc. – Empire Mine  
County Road PEE  
Ishpeming, Michigan 49849

**Inspection Date:** September 13 - 15, 2022

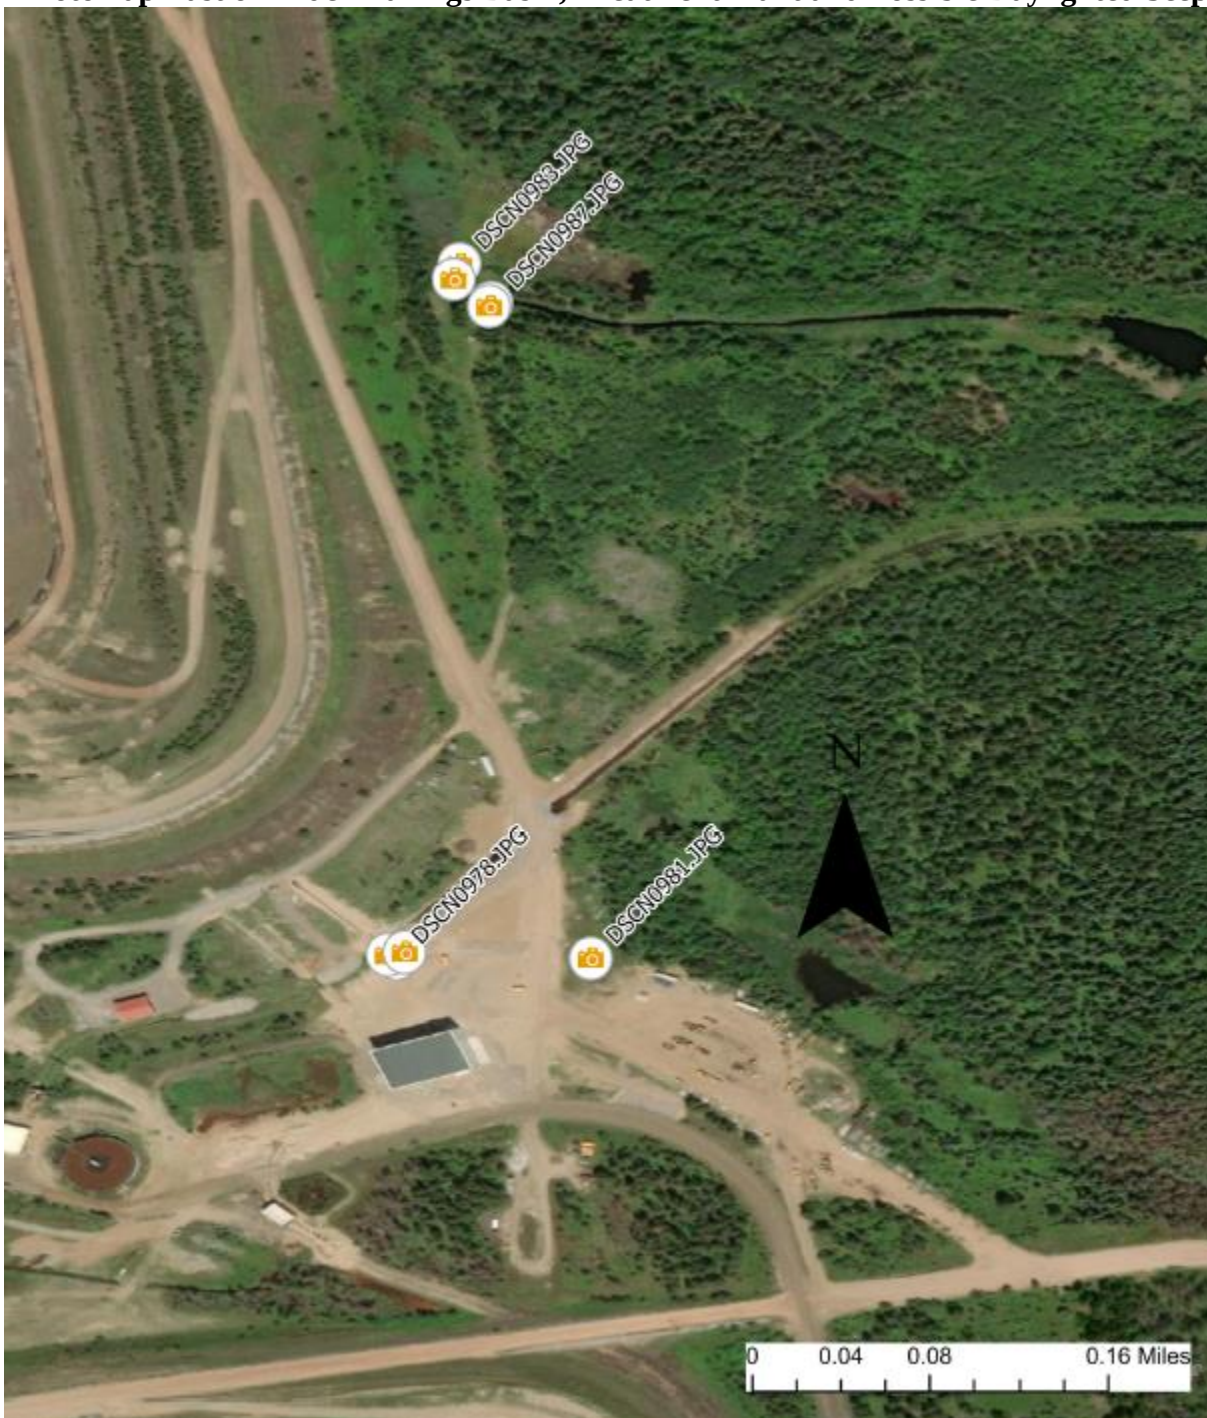
**Photomap East of Tilden Tailings Basin, Treatment Plant and Possible Daylighted Seep**

- USEPA observed and conducted field monitoring on flowing water originating from a location near the toe of the outslope of the east side of the Tilden tailings basin, at a location north of the Gribben Clarification Facility. The waterway is shown in photos 19 through 24, including a video of the flowing water. This location is a possible daylighted seep, which is not monitored as an NPDES outfall, stormwater monitoring location, nor an SSMP location. USEPA field monitoring at this location showed a conductivity of greater than 1,000  $\mu\text{S}/\text{cm}$ , which is above the background values.

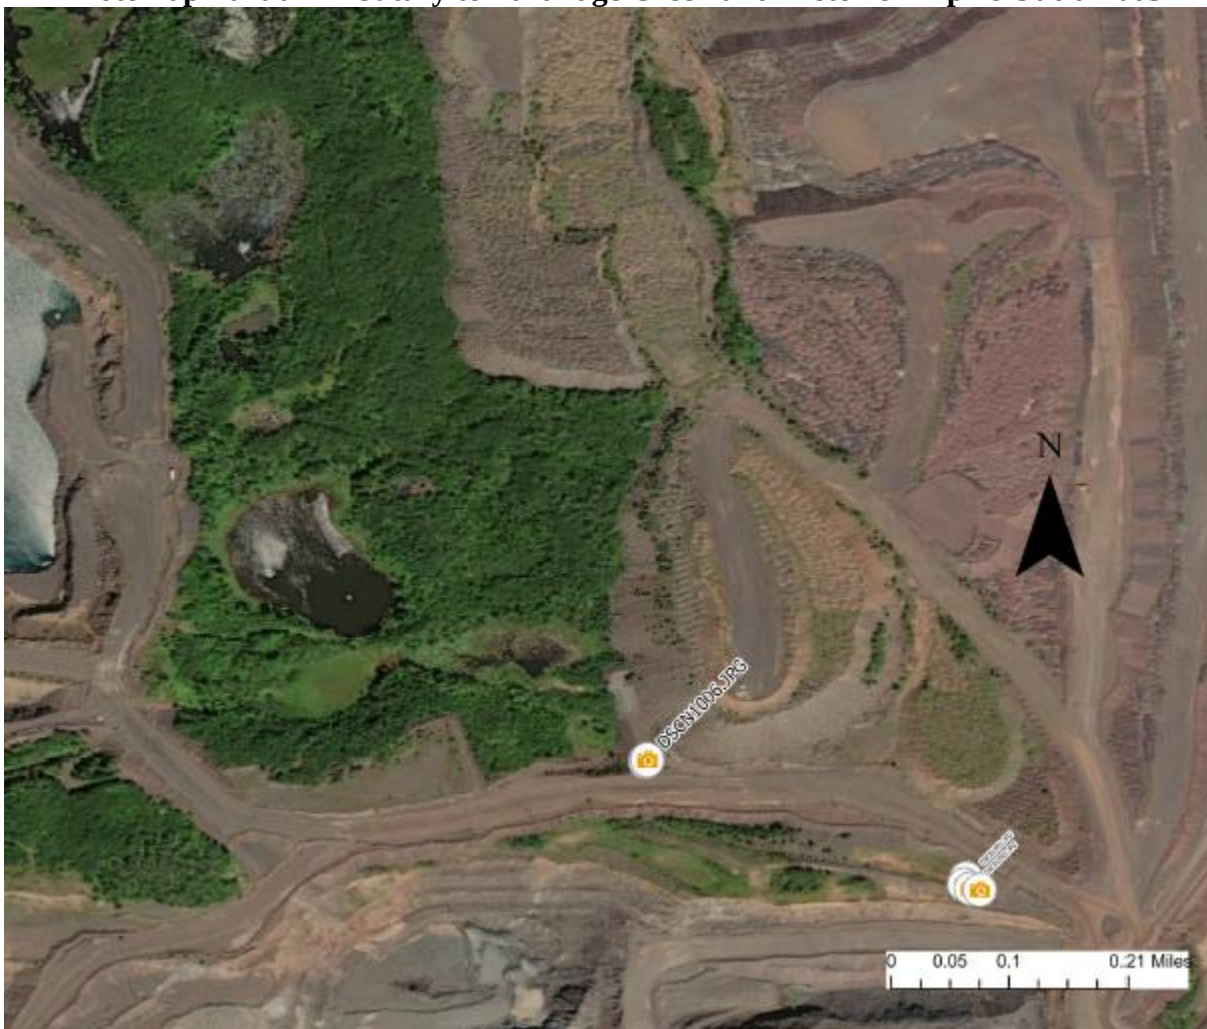
**Photomap Partial Tributary to Partridge Creek and Historic Empire Outfall 003**

- During the inspection, USEPA observed waste material from mining operations adjacent to a waterway known as Partridge Creek. Runoff from the slopes of the waste material would drain into a waterway flowing through a historic outfall 003. This is shown in Photos 37 through 42. The Facility representatives stated that NPDES compliance monitoring was no longer being conducted at this location because the discharge was not considered a wastewater. A copy of a cover letter from Michigan Department of Environmental Quality (now EGLE) on June 29, 2017, transmitting the compliance evaluation inspection notes from an April 27, 2017, visit at the Empire Mine (MI0000094) was given to EPA. The June 29, 2017 cover letter was provided as the record of the approval from EGLE. The June 29, 2017, letter references a low selenium concentration and no active mine pit dewatering as justification for changing the NPDES permit, which had expired in 2016.

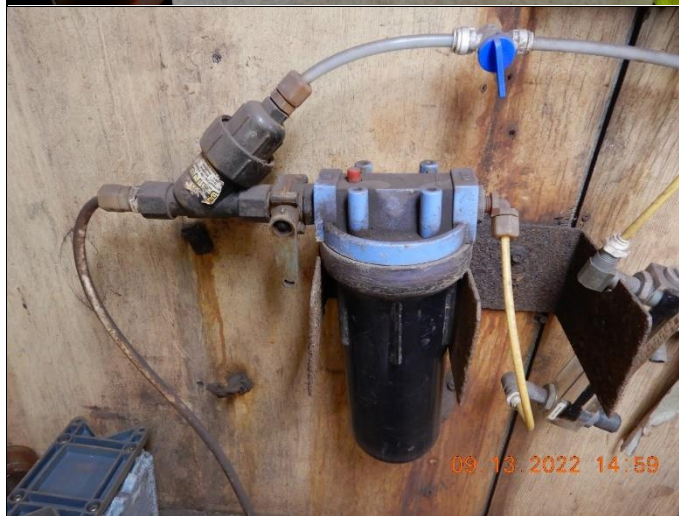
2: DSCN0961.JPG

Description: Filter on the water line with the continuous chlorine analyzer at the Tilden sewage treatment system.

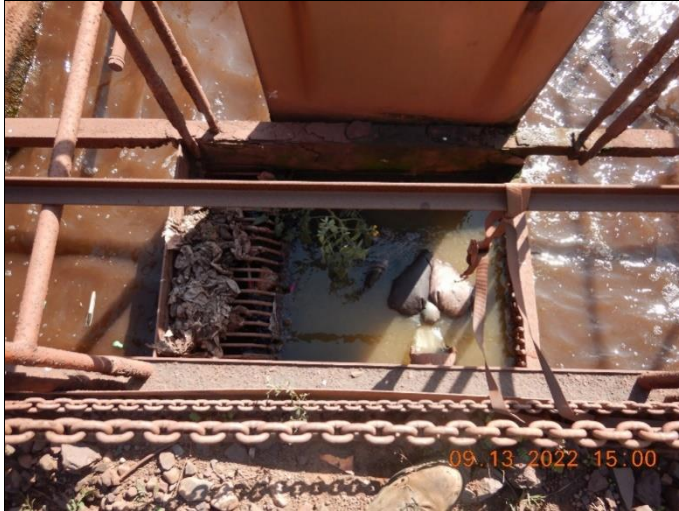
4: DSCN0963.JPG

Description: Tilden sewage treatment.

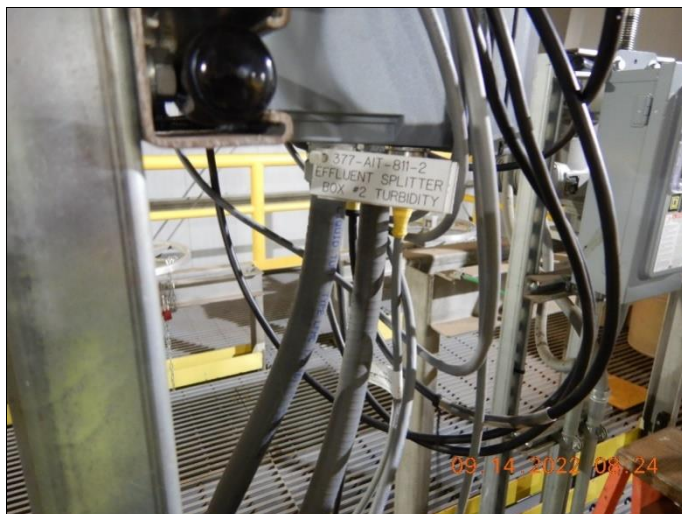
10: DSCN0969.JPG

Location: Tilden and Empire Mine  
 Photographer: Jonathan Moody  
 Date/Time: 9/14/2022 8:24 AM  
 Description: At the Tilden mine treatment plant for the discharge from the Tilden tailings basin.

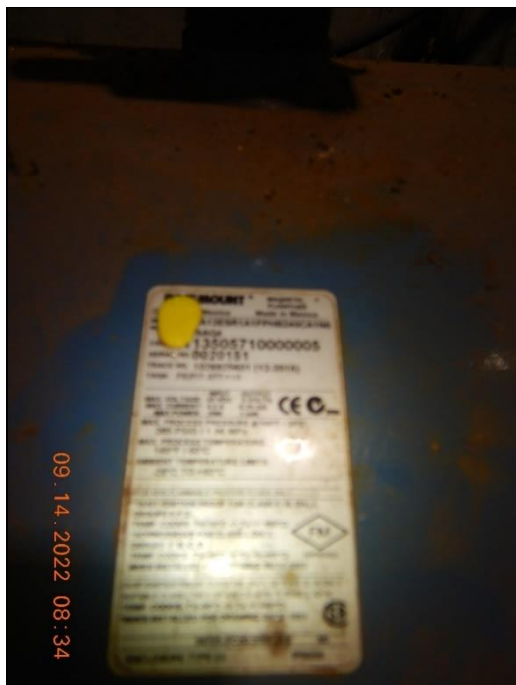
13: DSCN0972.JPG

Description: Label for the Rosemount flow meter at the influent to the treatment facility used for the Tilden mine tailings basin discharge.

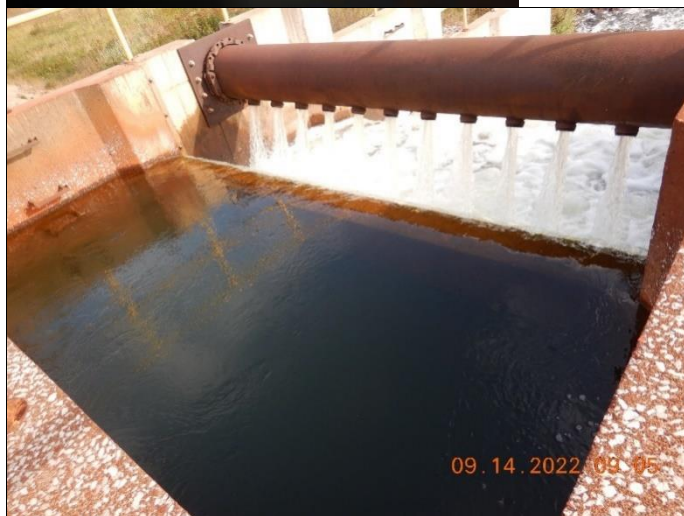
14: DSCN0978.JPG

Description: Discharge structure at the Tilden tailings basin treatment facility. This is where monitoring for Outfall 002A and 002B is collected. The diffuser structure brings in replenishment water for augmenting the discharge to meet the water quality based effluent limits. Location of monitoring point 01.

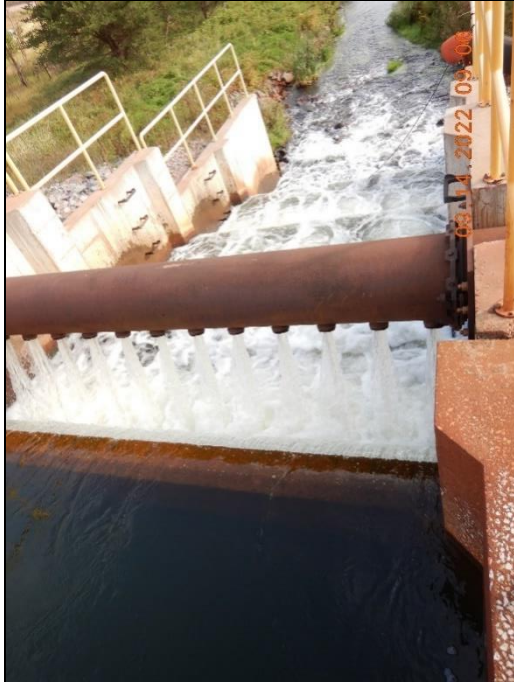
15: DSCN0979.JPG

Description: Discharge structure at the Tilden tailings basin treatment facility. This is where monitoring for Outfall 002A and 002B is collected. The diffuser structure brings in replenishment water for augmenting the discharge to meet the water quality based effluent limits.

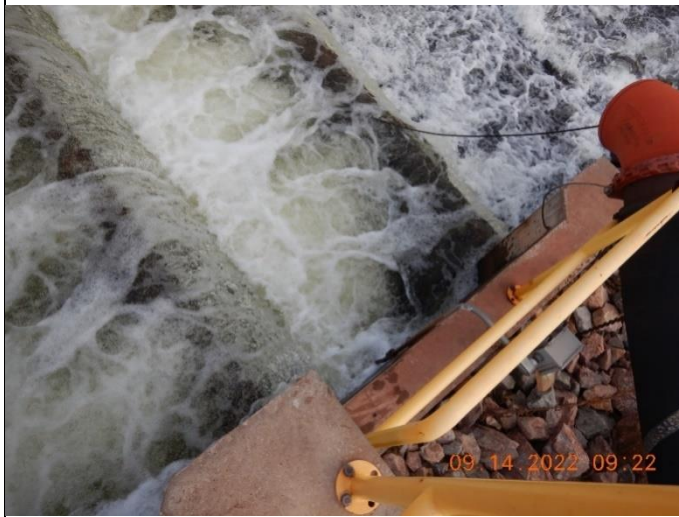
16: DSCN0980.JPG

Description: Discharge structure at the Tilden tailings basin treatment facility. This is where monitoring for Outfall 002A and 002B is collected. Looking down at the location where samples are collected for compliance with water quality based effluent limits. Location of monitoring point 02.

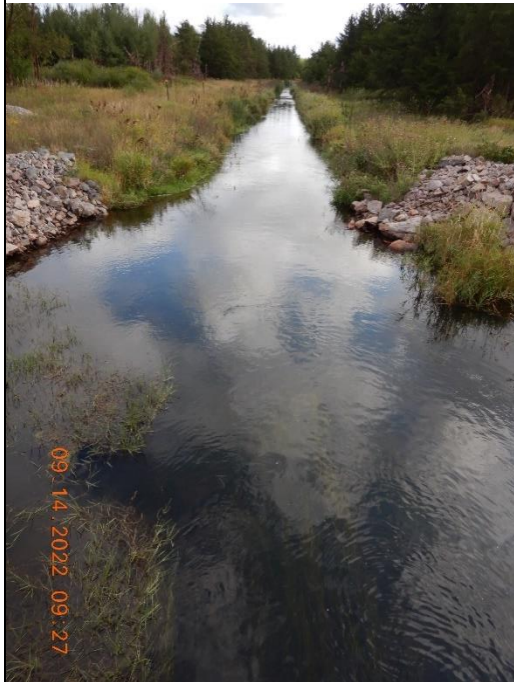
17: DSCN0981.JPG

Description: Channel conveying the discharge from Tilden outfall 002. Photographer is standing on a roadway bridge and camera is looking downstream.

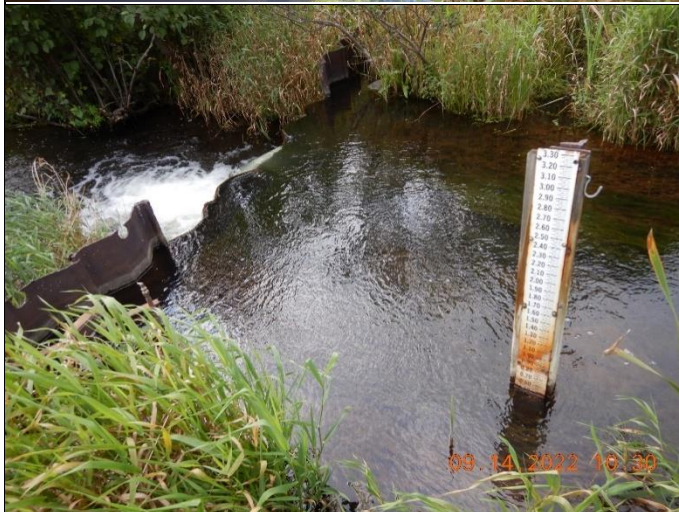
25: DSCN0989.JPG

Description: Control structure at Empire outfall 001. Staff gage for flow measurement.

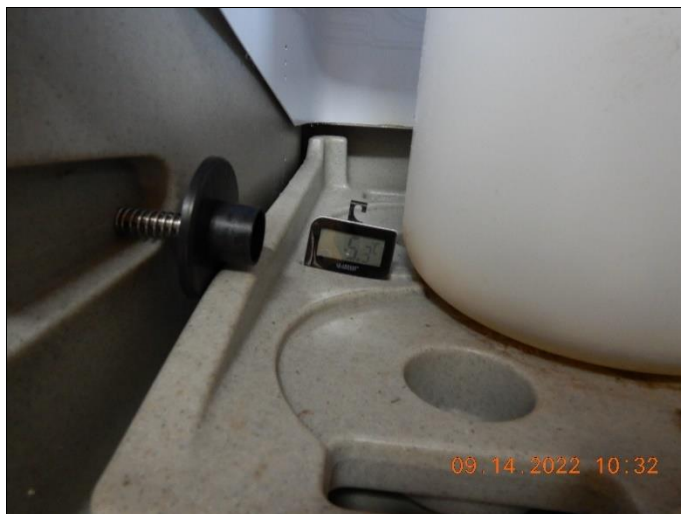
26: DSCN0990.JPG

Location: Tilden and Empire Mine  
Photographer: Jonathan Moody  
Date/Time: 9/14/2022 10:32 AM  
Description: Thermometer at the composite sampler at Empire outfall 001.

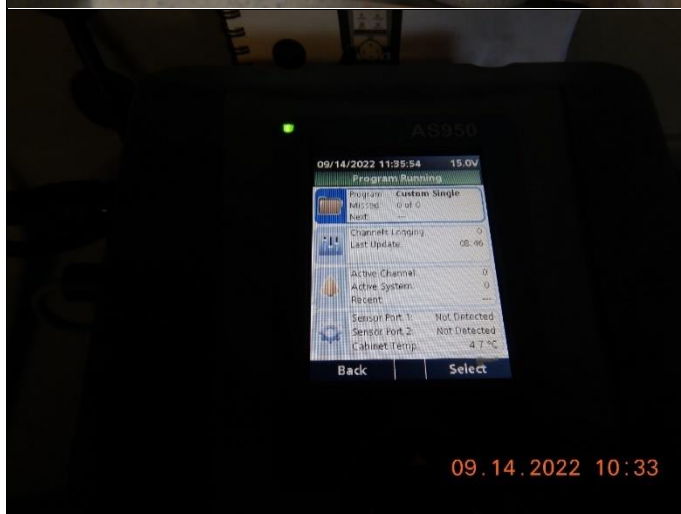
27: DSCN0991.JPG

Location: Tilden and Empire Mine  
Photographer: Jonathan Moody  
Date/Time: 9/14/2022 10:33 AM  
Description: Control screen for the composite sampler at Empire outfall 001. This temperature is the compliance temperature.

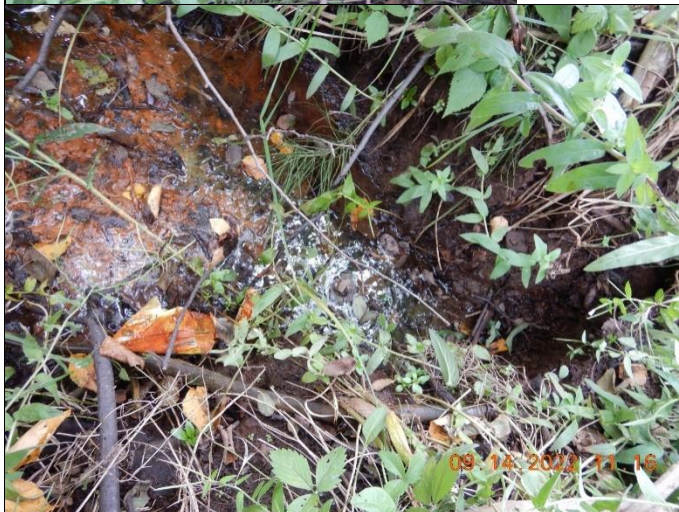
31: DSCN0995.JPG

- USEPA observed and conducted field monitoring of flowing water originating near Hoover Pond impoundment of process water. Water flowing from inside culvert connected to impoundment was originating from an unspecified source. Northeast of the culvert is a possible daylighted seep and EPA field monitoring at this location showed a conductivity of greater than 900  $\mu\text{S}/\text{cm}$  , which is above the background values. The waterway, culvert, and possible daylight seep are depicted in photos 29 through 32.

Location: Tilden and Empire Mine  
 Photographer: Jonathan Moody  
 Date/Time: 9/14/2022 11:16 AM  
 Description: Northeast of the location of the downstream end of the culvert shown in photo 29. Possible location of a daylighted seep. At the time of the inspection the water shown in this photo was flowing and had a red/orange discoloration.

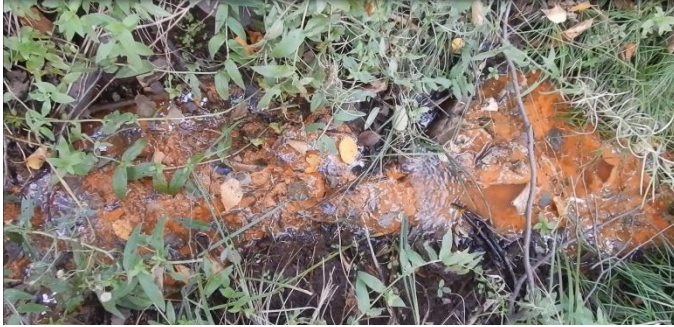
32: DSCN0996.MP4

Description: Northeast of the location of the downstream end of the culvert shown in photo 29. Possible location of a daylighted seep. At the time of the inspection the water shown in this video

was flowing and had a red/orange discoloration.

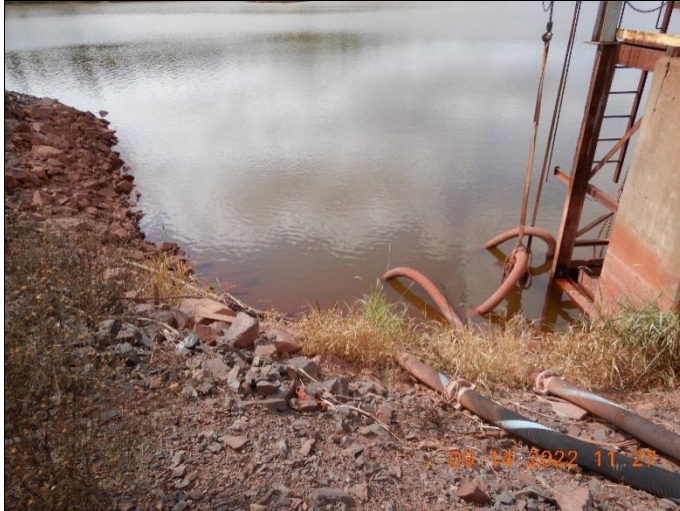
33: DSCN0997.JPG

Location: Tilden and Empire Mine  
 Photographer: Jonathan Moody  
 Date/Time: 9/14/2022 11:27 AM  
 Description: Hoover pond at the control structure at the upstream end of the culvert shown in photo 29. Monitoring point 08.

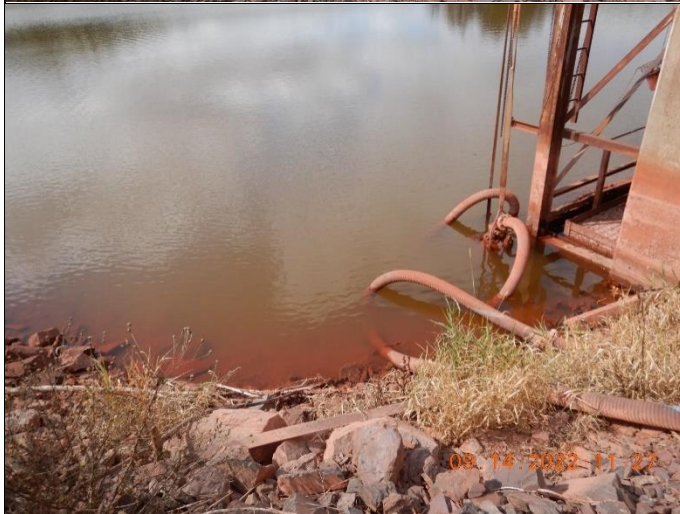
34: DSCN0998.JPG

Location: Tilden and Empire Mine  
 Photographer: Jonathan Moody  
 Date/Time: 9/14/2022 11:27 AM  
 Description: Hoover pond at the control structure at the upstream end of the culvert shown in photo 29. Monitoring point 08.

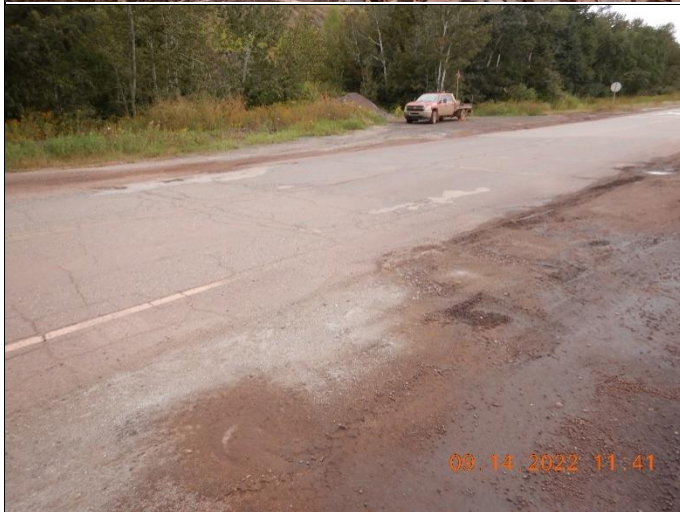
35: DSCN0999.JPG

Location: Tilden and Empire Mine  
 Photographer: Jonathan Moody  
 Date/Time: 9/14/2022 11:41 AM  
 Description: Roadway next to the drainage structure shown in photo 29.

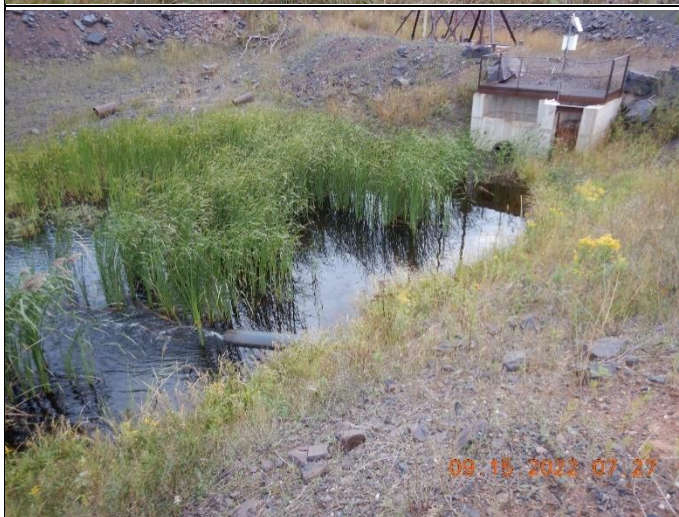
38: DSCN1002.JPG

Location: Tilden and Empire Mine  
 Photographer: Jonathan Moody  
 Date/Time: 9/15/2022 7:27 AM  
 Description: At the historic Empire outfall 003, the pipe in the foreground is replenishment water.

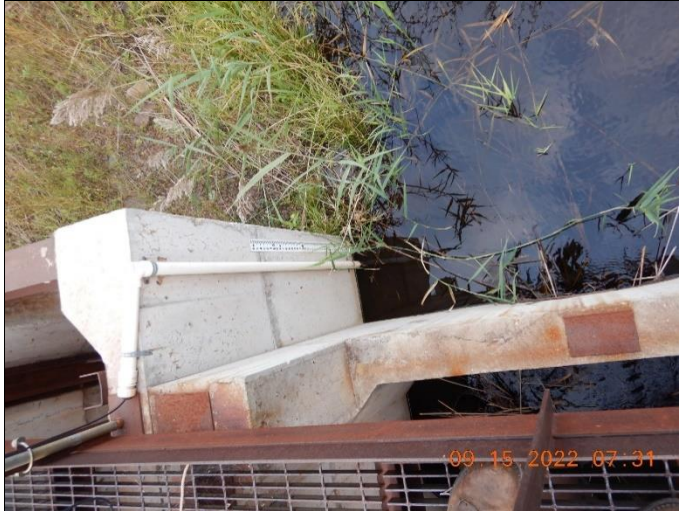
39: DSCN1003.JPG

Location: Tilden and Empire Mine  
 Photographer: Jonathan Moody  
 Date/Time: 9/15/2022 7:31 AM  
 Description: Staff gage at the historic Empire Outfall 003. Facility representatives said they no longer use this staff gage. Location of monitoring point 09.

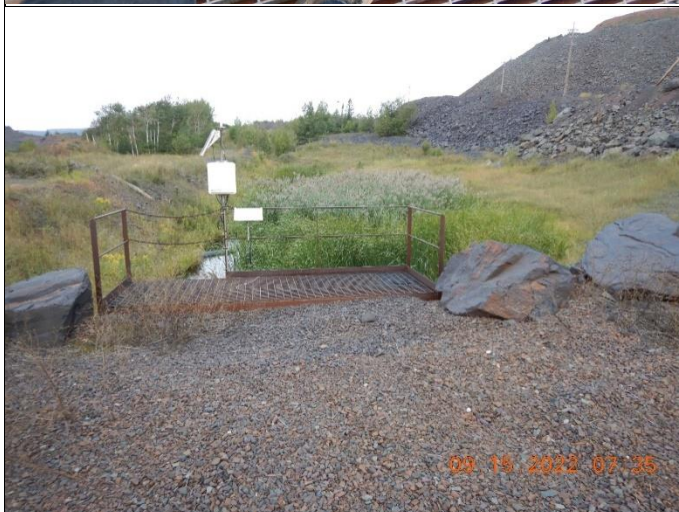
41: DSCN1005.JPG

Location: Tilden and Empire Mine  
 Photographer: Jonathan Moody  
 Date/Time: 9/15/2022 7:35 AM  
 Description: Overview of the control structure at the historic Empire Outfall 003.

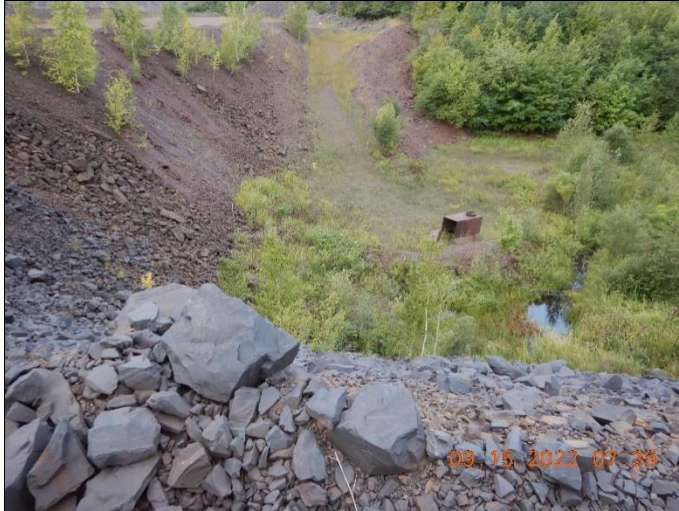
42: DSCN1006.JPG

Description: Area tributary to Partridge Creek. Runoff from this area is tributary to the control structure shown in photos 37 through 41.

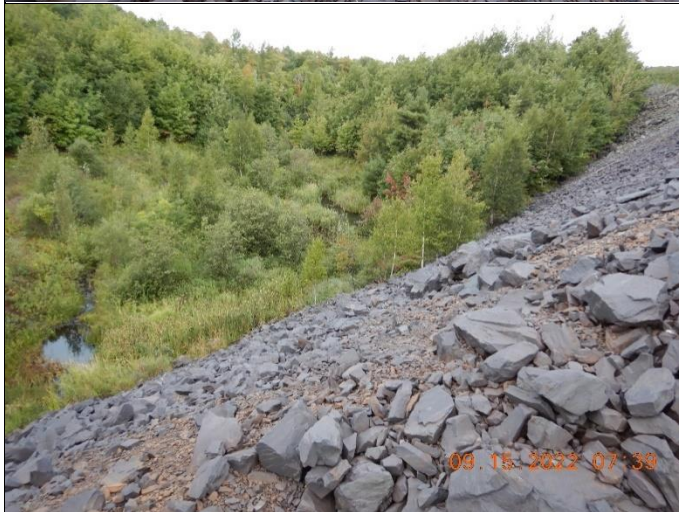
43: DSCN1007.JPG

Description: Area tributary to Partridge Creek. Area tributary to Partridge Creek. Runoff from this area is tributary to the control structure shown in photos 37 through 41.

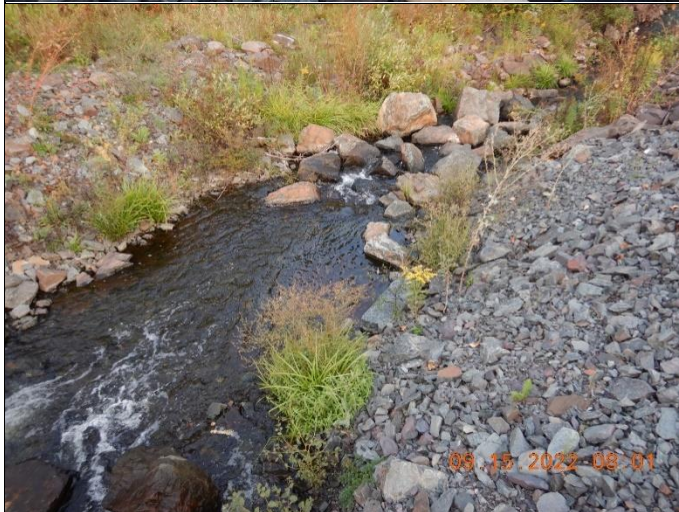
46: DSCN1010.JPG

Location: Tilden and Empire Mine  
Photographer: Jonathan Moody  
Date/Time: 9/15/2022 8:01 AM  
Description: Downstream of the control structure shown in Photo 45. EPA monitoring location 12.

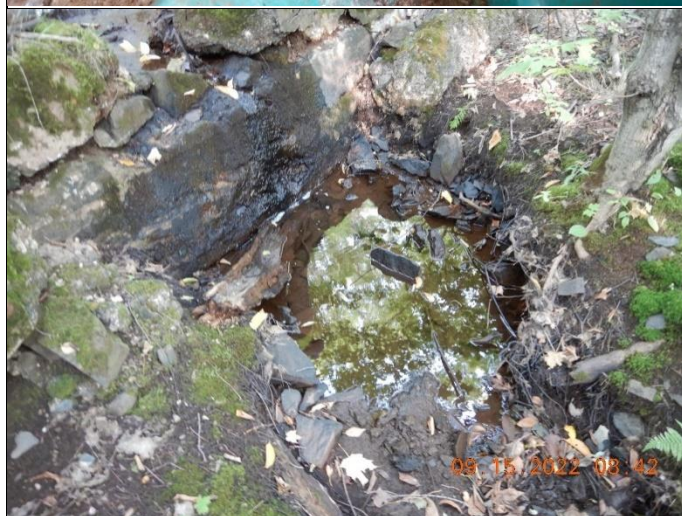
50: DSCN1014.JPG

Description: At stormwater monitoring location '12' or CC-175. Stormwater is monitored at the location shown in this photo, as the water flows over the end of a small stone bridge. EPA monitoring location 13.

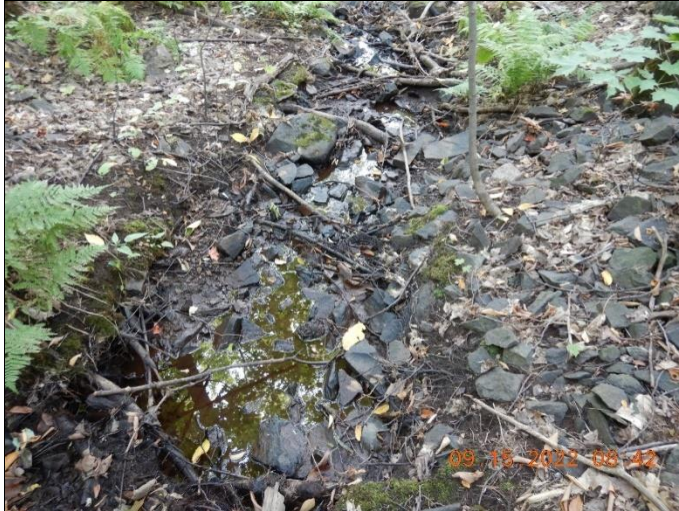
51: DSCN1015.JPG

Location: Tilden and Empire Mine  
 Photographer: Jonathan Moody  
 Date/Time: 9/15/2022 8:42 AM  
 Description: At stormwater monitoring location '12' or CC-175. Looking downstream from where stormwater monitoring occurs.

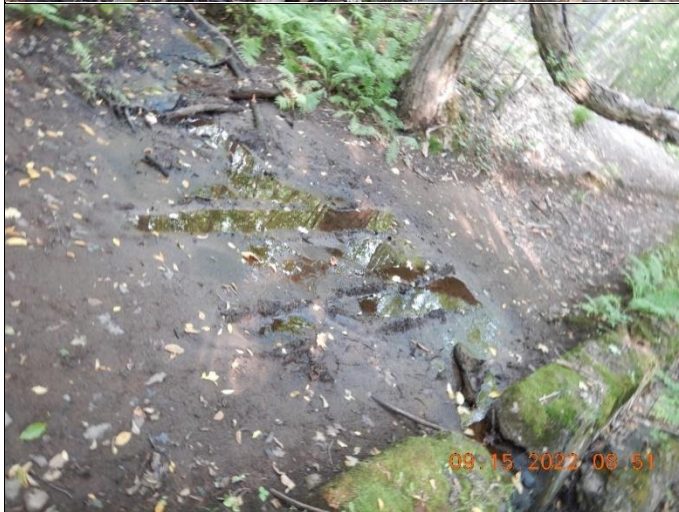
52: DSCN1016.JPG

Location: Tilden and Empire Mine  
 Photographer: Jonathan Moody  
 Date/Time: 9/15/2022 8:51 AM  
 Description: At stormwater monitoring location '12' or CC-175. Location where stormwater flows across the top of a bridge for a rough pathway upstream of where stormwater monitoring occurs.

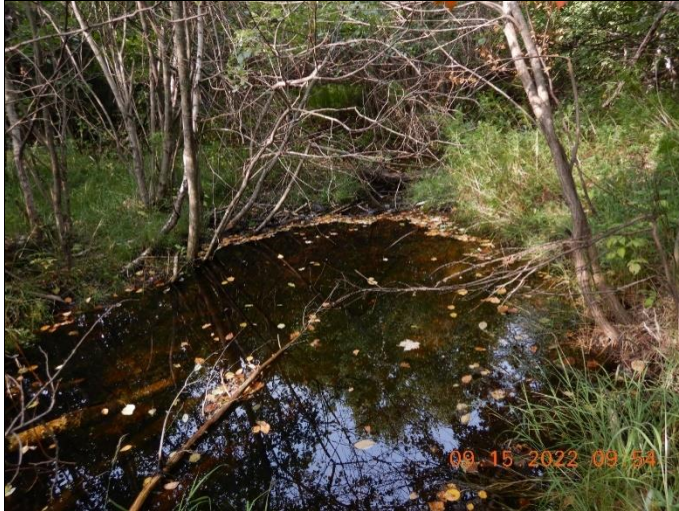
53: DSCN1017.JPG

Location: Tilden and Empire Mine  
 Photographer: Jonathan Moody  
 Date/Time: 9/15/2022 9:54 AM  
 Description: At stormwater monitoring location '12' or CC-175. Looking upstream of where stormwater monitoring occurs.

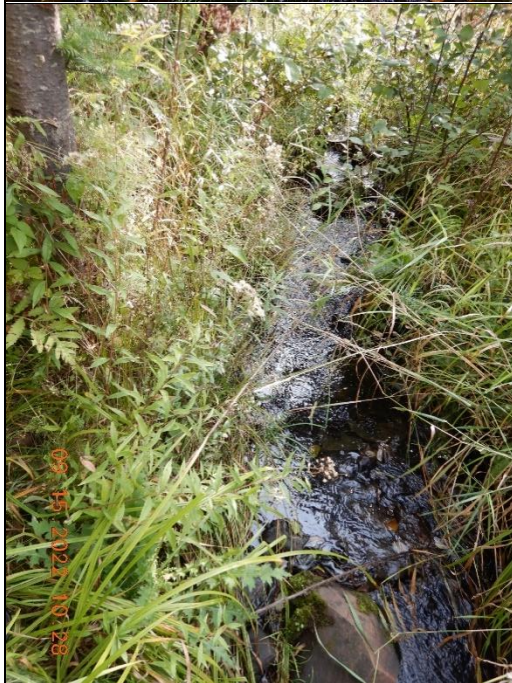
54: DSCN1018.JPG

Location: Tilden and Empire Mine  
 Photographer: Jonathan Moody  
 Date/Time: 9/15/2022 9:54 AM  
 Description: At stormwater monitoring location '12' or CC-175. Looking upstream of where stormwater monitoring occurs.

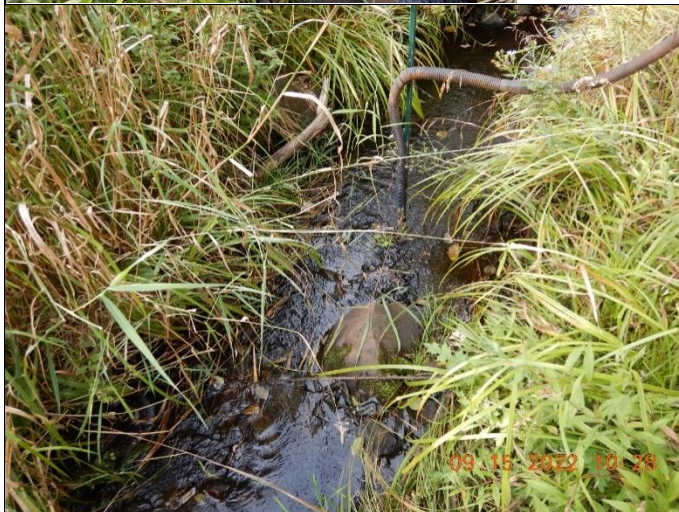
55: DSCN1019.JPG

- Locations CC-291 and CC-292 were not in the current version of the SWPPP available during the inspection, and are not associated with an NPDES outfall. USEPA field monitoring during the inspection showed a specific conductivity of 623  $\mu\text{S}/\text{cm}$  and 439  $\mu\text{S}/\text{cm}$  respectively. At the time of the inspection, these monitoring locations were flowing despite dry weather conditions.
- During the inspection, USEPA observed unvegetated rock piles in the tributary for the water flowing to the control structure for the historic Empire outfall E003.
- Several on-site water bodies present with dark orange coloring, suggesting high levels of iron and conductivity within the water.
  - Stormwater monitoring location '13' or CC-179, was visited during the inspection. The water at this location had an unnatural red color and is shown in photo 63.

Location: Tilden and Empire Mine  
 Photographer: Jonathan Moody  
 Date/Time: 9/15/2022 10:28 AM  
 Description: At the location of stormwater monitoring location CC-292. This location is downstream from location 'M' or CC-93. At the time of the inspection, the depth of the water at this location was several inches.

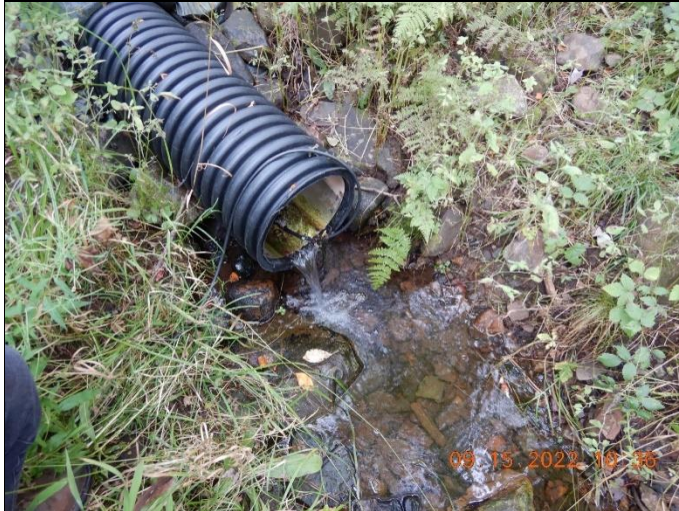
56: DSCN1020.JPG

Location: Tilden and Empire Mine  
 Photographer: Jonathan Moody  
 Date/Time: 9/15/2022 10:28 AM  
 Description: At the location of stormwater monitoring location CC-292. At the time of the inspection, the depth of the water at this location was several inches. EPA monitoring location 15.

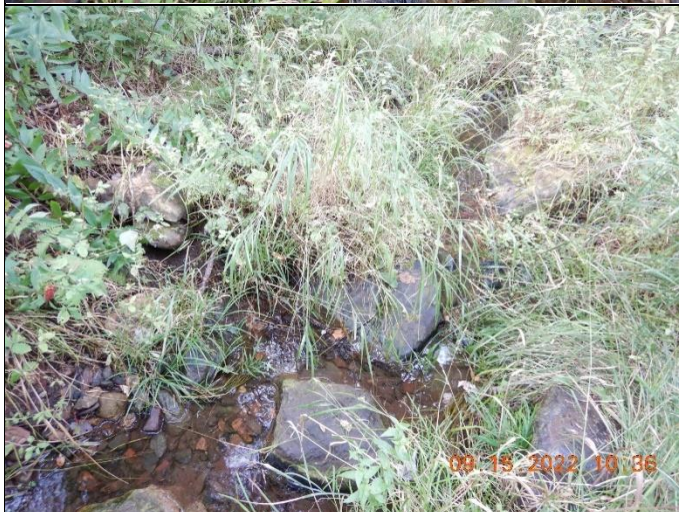
57: DSCN1021.JPG

Description: At the location of the selenium monitoring location CC-291. EPA monitoring location 16.

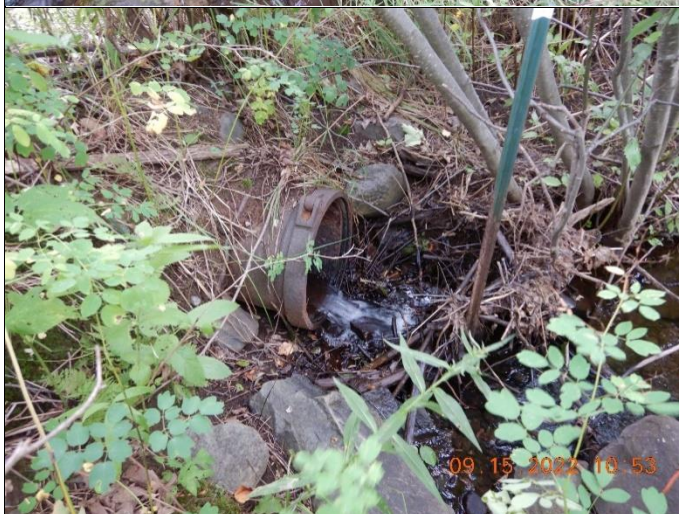
58: DSCN1022.JPG

Description: Downstream of the location of the selenium monitoring location CC-291.

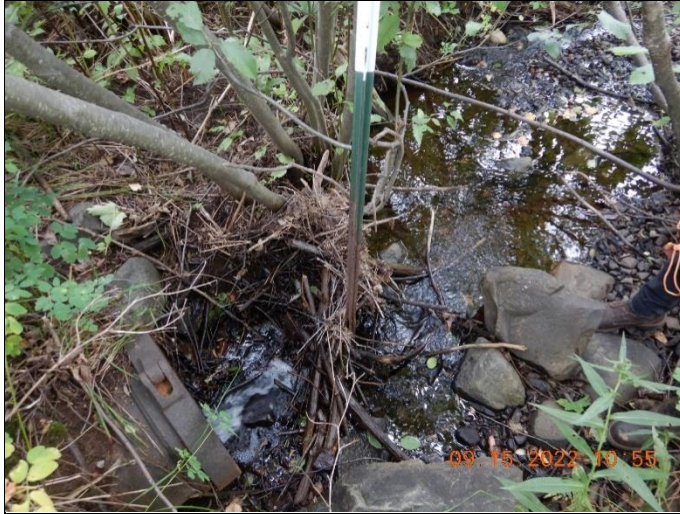
59: DSCN1023.JPG

- Stormwater monitoring location 'M' or CC-93: the SWPPP shows that the rock stockpiles are a source of exposure in the tributary to this location. Field monitoring conducted by USEPA showed a conductivity of 585  $\mu\text{S}/\text{cm}$  , which is above the background values. At the time of the inspection, this stormwater monitoring location was flowing despite dry weather conditions.

Description: At the location of the stormwater monitoring location 'M' or CC-93.

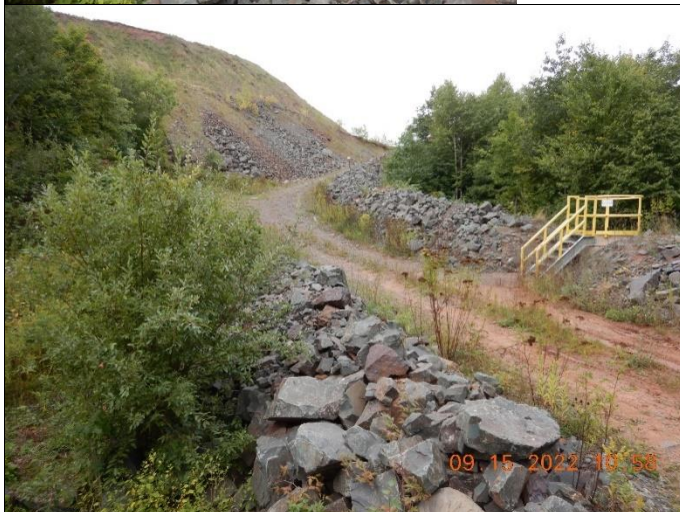
61: DSCN1025.JPG

Location: Tilden and Empire Mine  
 Photographer: Jonathan Moody  
 Date/Time: 9/15/2022 10:58 AM  
 Description: Upstream of the stormwater monitoring location 'M' or CC-93.
